MARCH 2023

Unified School District of De Pere

District-Wide Facilities Condition &
Education Adequacy Assessment

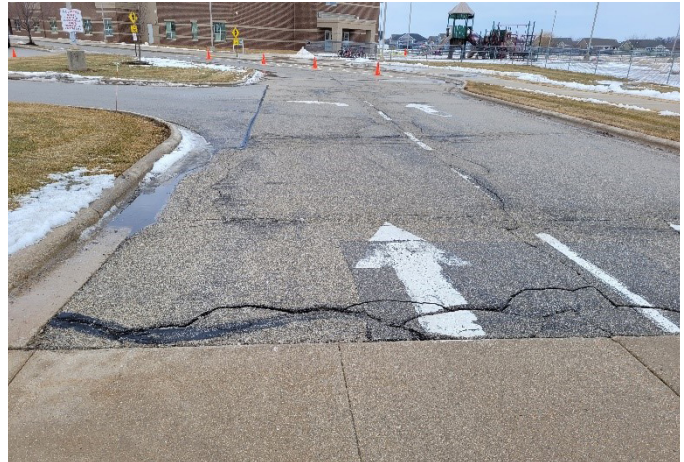
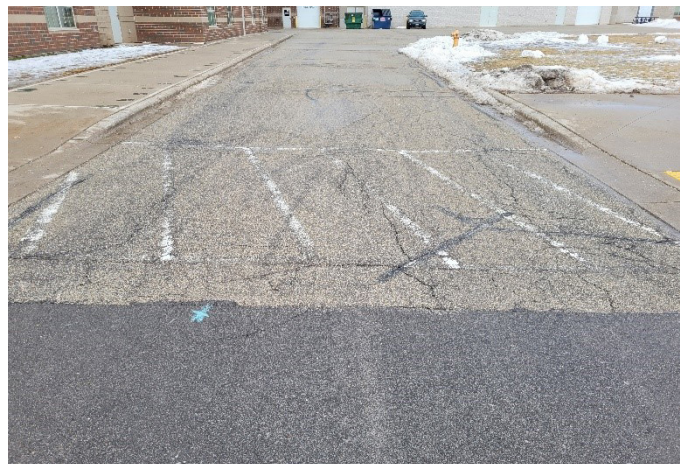
RECEIVING AREA

- Some locations of settlement and rutting
- Many unsealed transverse and longitudinal cracks throughout the surface
- Most of the pavement has alligator cracking and signs of the base failing
- Edge of pavement is cracking and breaking off
- Asphalt is settling in front of receiving dock and difficult to unload trucks with forklift

- Remove existing pavement
- Remove 18" of base/subgrade
- Install drain tile along edge of pavement to existing inlet
- Add geotextile fabric
- Add 12" of breaker run
- Add 6" of base
- Pave 4" of asphalt
- Add pavement markings

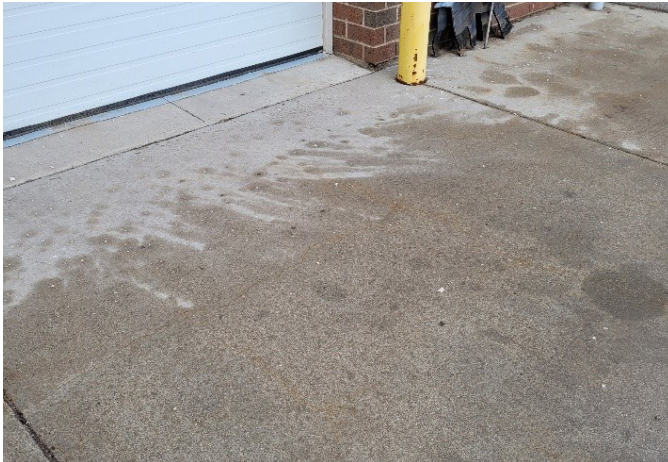
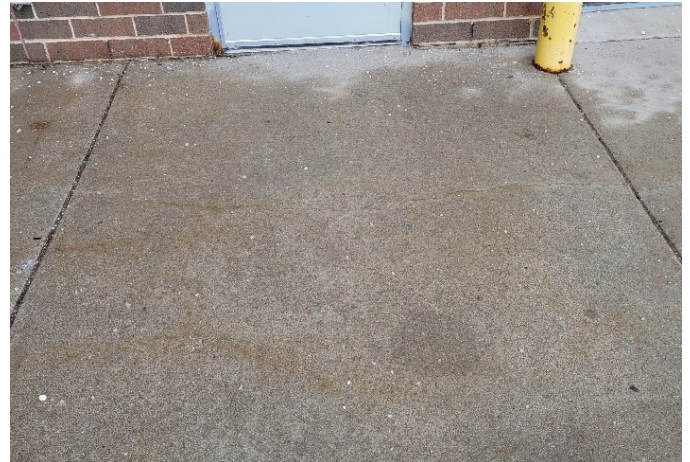
- Concrete pads have narrow cracks

- Remove existing pavement
- Crack fill narrow cracks in concrete pads
- Remove 18" of base/subgrade
- Install drain tile under the edge of pavement and daylight out to basin
- Add geotextile fabric
- Add 12" of breaker run
- Add 6" of base
- Pave 4" of asphalt

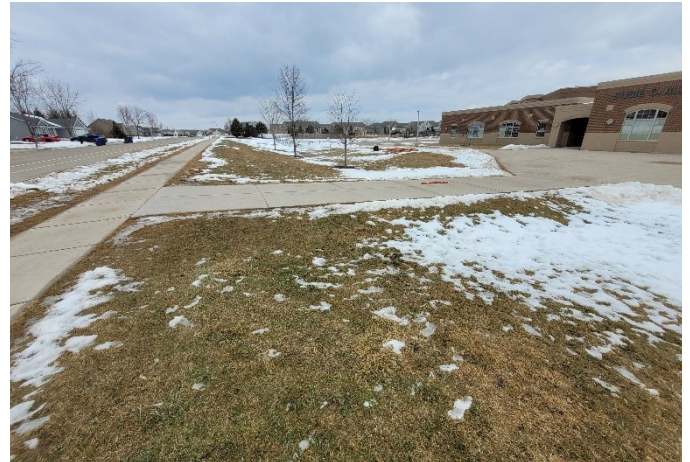
- The concrete sidewalk, on the west entrance of the school, has a slope of 1:18. This section of sidewalk exceeds the maximum slope of 1:20 and the max rise of 30" before a landing pad or railing needs to be installed.

- Remove and replace panels with adequate landing areas.

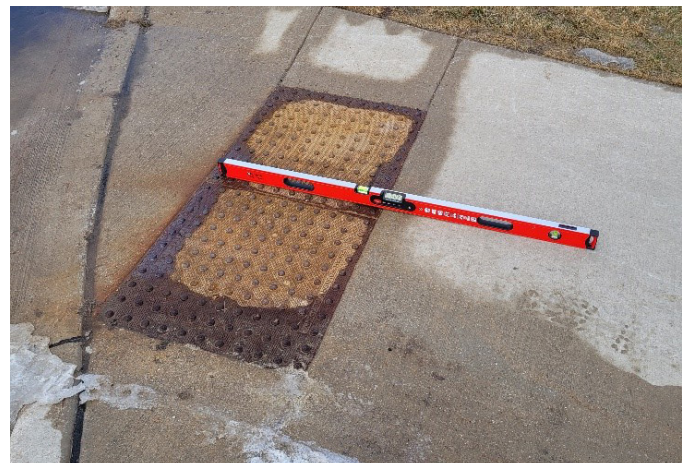
- 6 curb ramps on site do not meet the requirements for ADA Compliance. Slopes are too steep or there is a vertical deviation greater than a 1/4" where it meets the pavement.
- Multiple missing detectable warning fields.
- Many detectable warning fields have air and water under them between the concrete and warning field plate
- Some of the detectable warning fields have lots all paint and domes are starting to deteriorate

- Remove and replace non-compliant curb ramps
- Install detectable warning fields

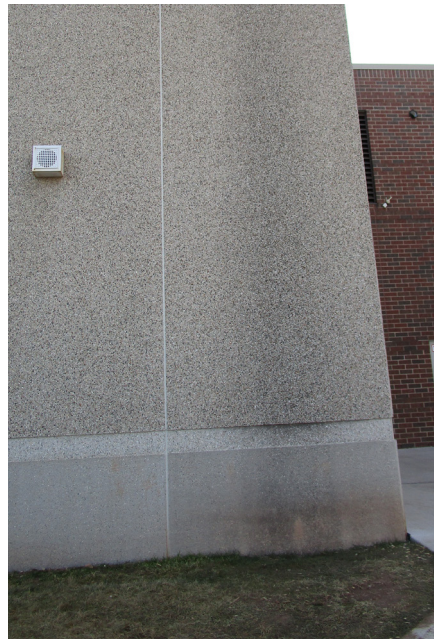
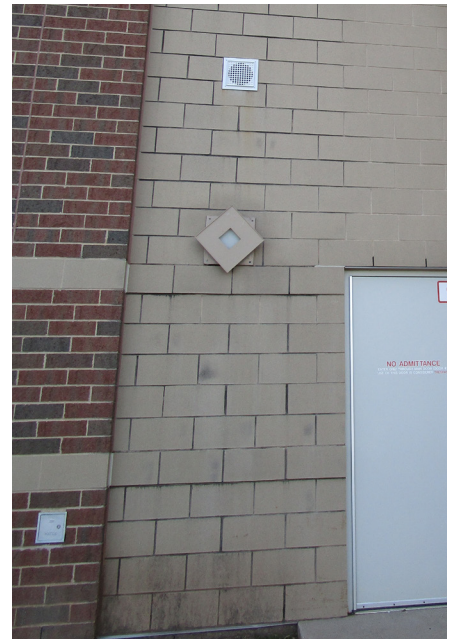
- Two overflow roof drains appear to be active enough to stain the wall below. East side gym at precast wall panel, and west side of the building, east of door 4. Relief drains are intended to provide drainage only when the main drains are not functioning.
- Efflorescence noted on the southwest canopy column outside door 7. Efflorescence is a chalky white powder that is drawn out of the joint mortar when moisture within the wall evaporates. This is a sign that moisture is, or has been, within the interior cavity of the wall.

TWO LOCATIONS OF STAINING FROM ROOF OVERFLOW WATER

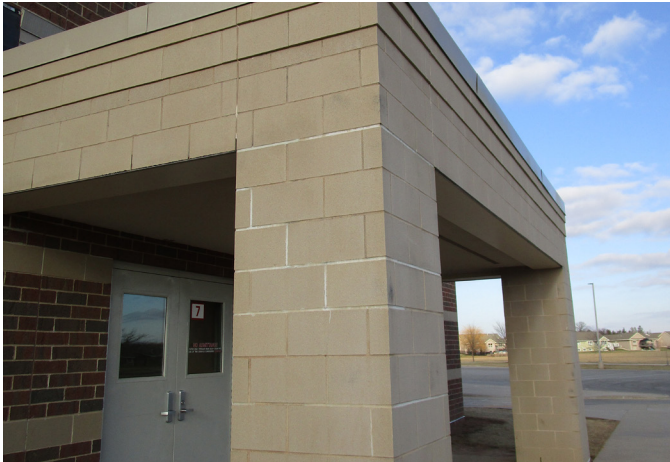
EFFLORESCENCE IN BLOCK COLUMN

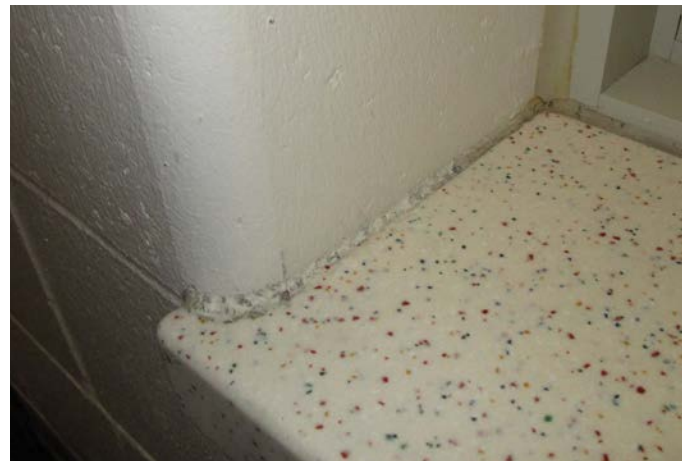
- The sealant at the interior, solid surface window sills, shows signs of degradation. The typically smooth, flexible, sealant is soft, sticky, dirty, and crumbling apart. This could be caused by repeated cleaning with a liquid cleanser or disinfectant which is chemically deteriorating the sealant. While not a concern for a failure, the soft caulk does attract dirt which promotes additional cleaning. Removal and reinstallation of sealant is recommended.

INTERIOR WINDOW SILL SEALANT JOINT

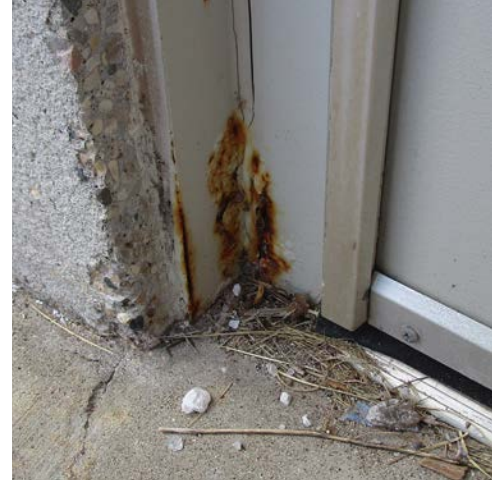
- A majority of the exterior door frames have visible rust near the threshold where they meet the concrete. There is evidence that some of these frames have had spray paint applied to cover the rust. This is a cosmetic remedy, but won't stop the rust from continuing. The hollow metal doors are in acceptable condition.

RUST AT EXTERIOR HOLLOW
METAL DOOR FRAME

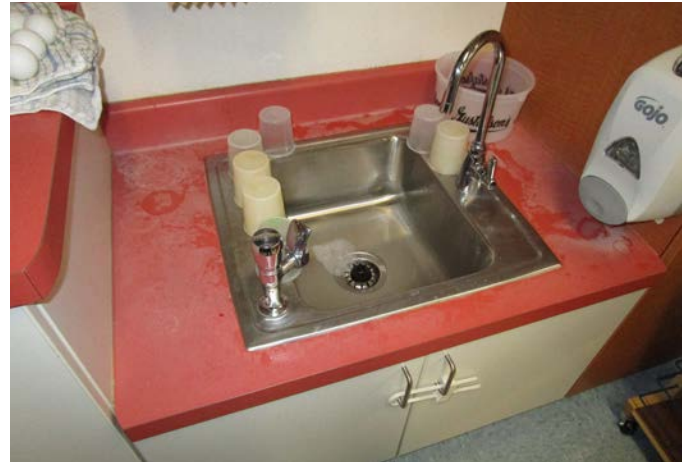
FADED PLASTIC LAMINATE COUNTER

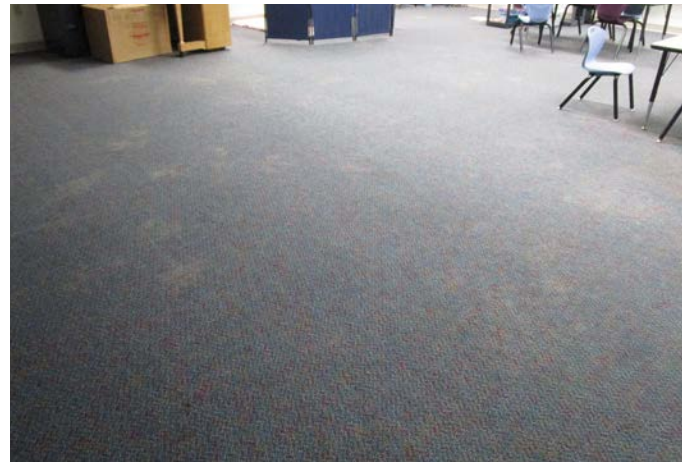
STAINS ON CARPET

- No concerns overall. Budget for new carpet flooring in the future.

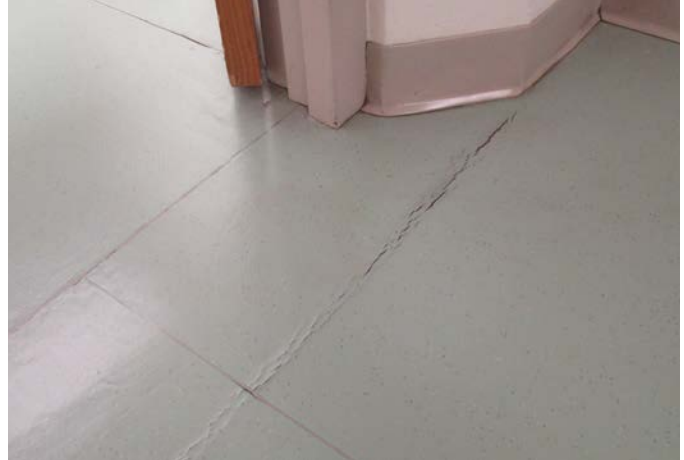
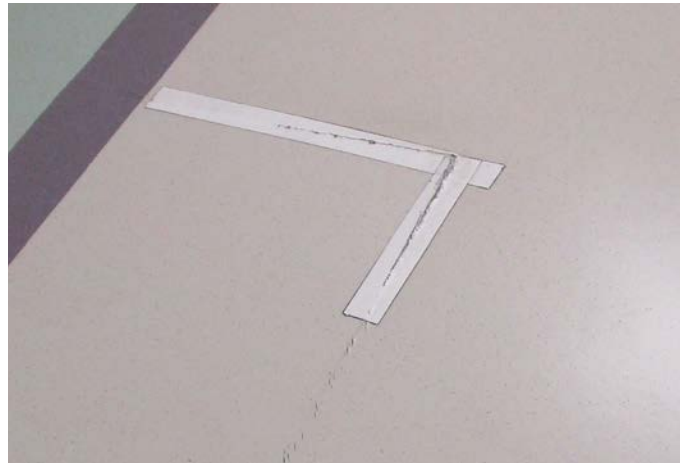
- On the 2nd floor, the floor structure joints between different sections of the building were not honored, and the sheet rubber was installed over these joints. Considering there is an open gap under the rubber flooring at these joints, continued pressure from foot traffic and cleaning machines has compressed on the joint, causing cracking of the material as it degrades due to age. This condition will likely worsen over time.

JOINTS BELOW RUBBER FLOORING SHOWING THROUGH

- Monitor the joints for continued wear. Since a dedicated metal expansion joint cover would be hard to install in an existing building, a 4'-6' section of the rubber could be replaced and centered over the joint, with filler material added under the flooring within the concrete joint below the flooring for strength.

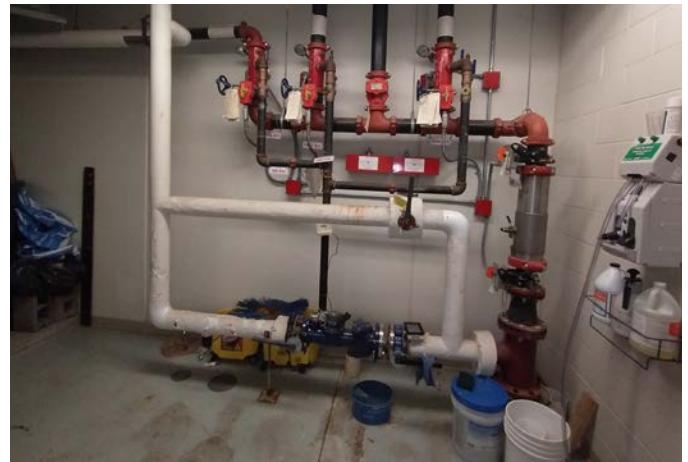
The water service lateral is a 6" diameter main which enters the building on the south wall of the receiving room. The existing water meter is 4" with a 4" diameter bypass. The water meter and service entrance piping appear to be in good condition. There are signs of insulation damage near the meter, and the flange located on the incoming side of the water meter appears to have a very slow leak. At the time of the site visit there was a small drain pan placed below the leak. The water pressure observed on the day of the site visit was 52 psi. This pressure reading was taken at a pressure gauge near the water heaters in the second level mechanical room.

WATER SERVICE ENTRANCE

- The damaged insulation near the water meter could cause condensation to build up on the piping, leading to potential corrosion on the piping.
- The leak at the flange of the water meter should be repaired.

- Recommend repairing or replacing damaged insulation near water meter.
- Recommend repair of the flange at the water meter to seal up leak.

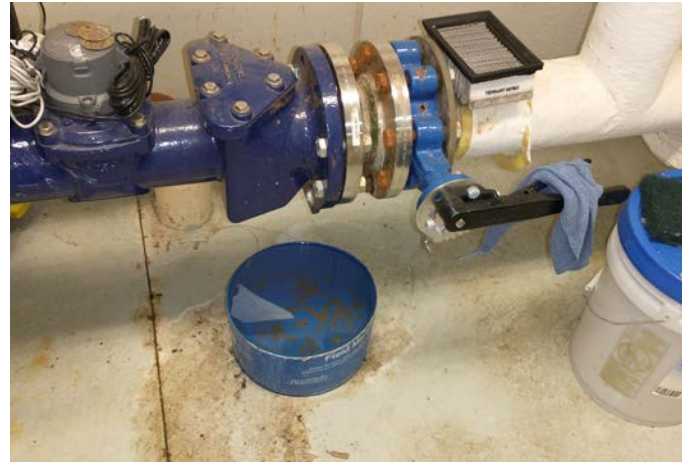
WATER METER LEAK

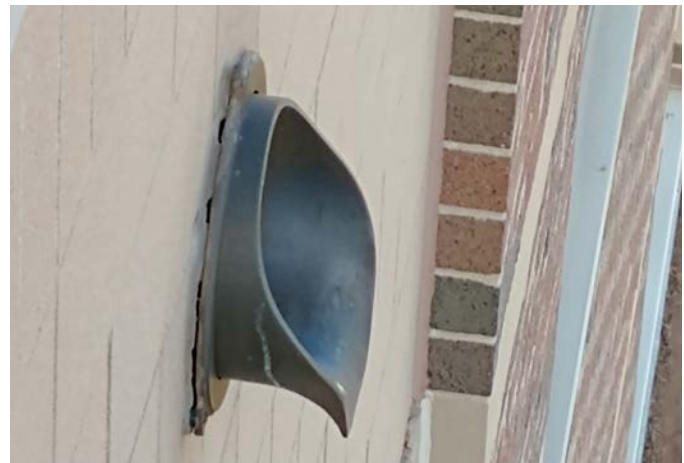
In a few locations, the caulk at the trim ring of the lambs-tongue was showing signs of wear and had separated from the façade of the building.

CAULK JOINT AT LAMBS-TONGUE

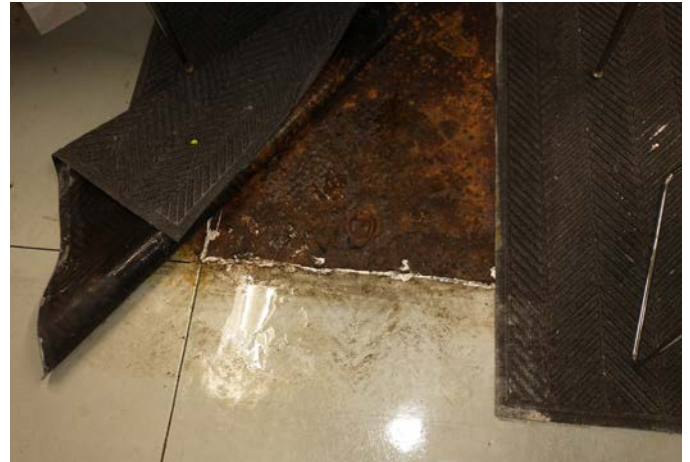
There is a grease interceptor located in the break area, which is near the receiving dock. The cover of the interceptor was hidden with loose carpets under the break room table. The cover of the interceptor felt warm to the touch and was quite corroded. When we removed the carpet, there was quite a bit of moisture build up on the bottom side of the carpet, which would be causing the corrosion. This would indicate that the cover of the grease interceptor is not sealing correctly to the basin and will require maintenance or replacement.

GREASE INTERCEPTOR COVER

- Rust is forming on the cover of the grease interceptor due to an incorrect seal between the cover and the basin.

- Remove the cover of the grease interceptor and repair the seal between the basin and the cover so it will seal properly. Remove the carpeting over the top so any heat from the interceptor can dissipate into the room and not cause condensation.

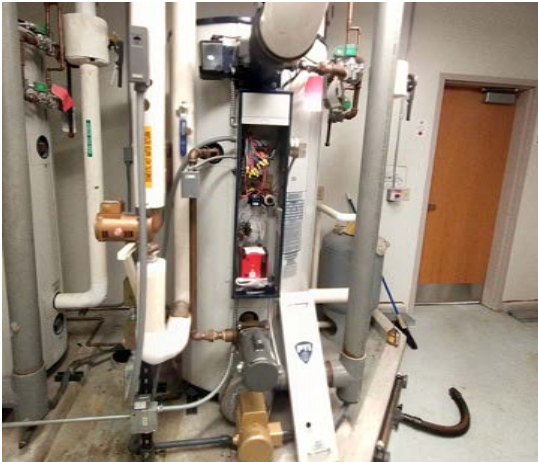
WATER HEATER WITH COVER REMOVED

The school has (2) 125 gallon natural gas water heaters, located in one of the second level mechanical rooms. The water heaters were installed during the construction of the school which puts them at approximately 16 years old. According to maintenance personnel during the time of our site visit, there are issues with the water heater control panels, and parts are becoming difficult to purchase from the manufacturer. Overall, the water heaters appear to be in fair condition. During the time of our site visit, one of the control panel covers was removed for maintenance purposes. The temperature gauges near the water heaters were reading 126°F during the time of our site visit.

- Water heaters are nearing the end of the expected service life and require frequent maintenance.
- Replace the thermostatic mixing valves to temper the water delivered throughout the school.

- Consider replacement of the water heaters, recirculation pumps, and thermostatic mixing valves.

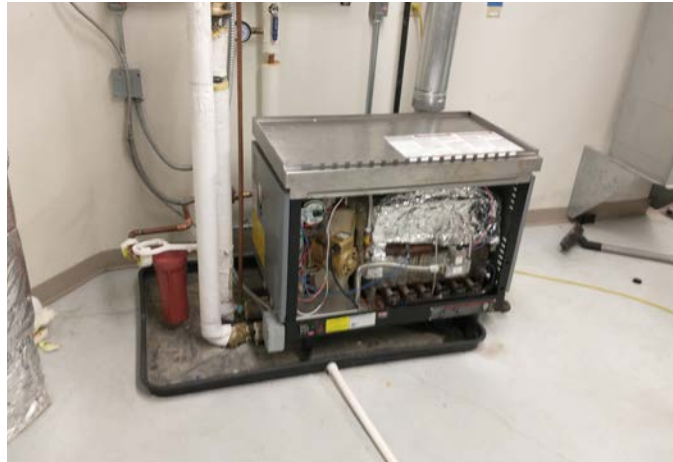
BOOSTER HEATER

The booster heater for the dishwasher appears to be in good condition. Some of the pipe insulation near the booster heater appears to have been damaged during routine maintenance. The side panel of the booster heater was also removed during the time of our site visit.

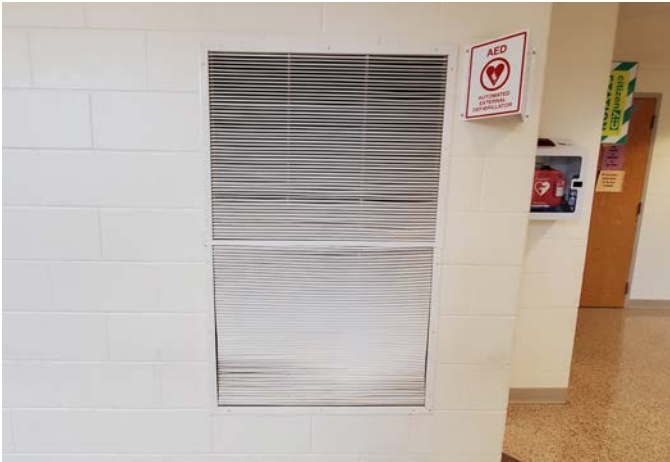
DAMAGED LOW RETURN GRILLE AT COMMONS

- It was discussed that AHU-3 (serving the LMC) has experienced multiple freeze / burst events on the heating coil. The outside air percentage and associated freeze risk is relatively low, which seems to indicate an operational issue with this AHU.
- Several locations are present in which low return grilles are damaged (for example, in Commons A128) due to accessibility at height of students. Replacement of these grilles with heavy duty gymnasium grade grilles will prevent future damage.

- Recommend testing and revision to control device installation and programming strategy to fix issues with existing AHU-3.
- Replace low return grilles where damage is present. In addition to the aesthetic benefit, this will provide additional return air where free area has been reduced by damage.
- Consider tune-up of roof mounted exhaust fans including replacement of belts.
- Clean dryer vent and associated ductwork. It is likely that lint has settled in the duct given the current condition.
- Recommend repair of fabric duct segment to prevent further damage and improve air distribution.

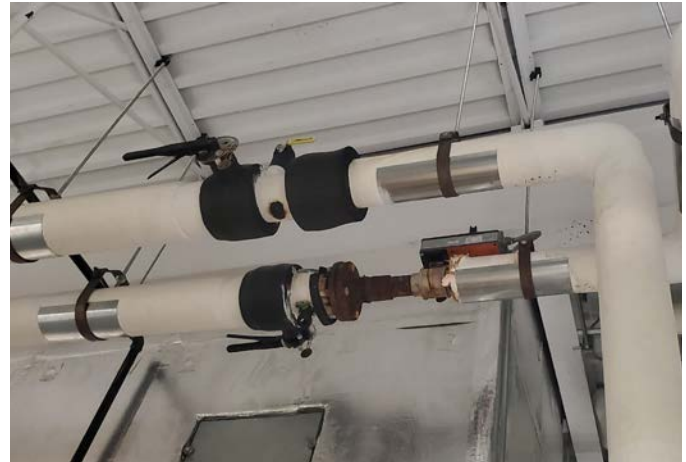
MISSING PIPE INSULATION AT REPAIR LOCATION

- Insulation vapor barrier issues are present throughout on chilled water pipe insulation, particularly at isolation valves. Recommend diligent repair of vapor barrier issues to prevent condensation on chilled water piping, as this could lead to moisture and corrosion issues in the future.
- Vibration and loose belts were observed on a selection of powered roof ventilators. Roof Ventilator EF-3 was noted to be non-operational with the cover missing. This exhaust fan serves toilet rooms on the North wing of the school.
- A dryer vent located near the receiving area was noted to be clogged with lint. This could pose a fire hazard if not cleared.
- One location was identified in which “Duct-Sox” fabric duct product within gymnasium has been damaged due to interference with structural bracing.

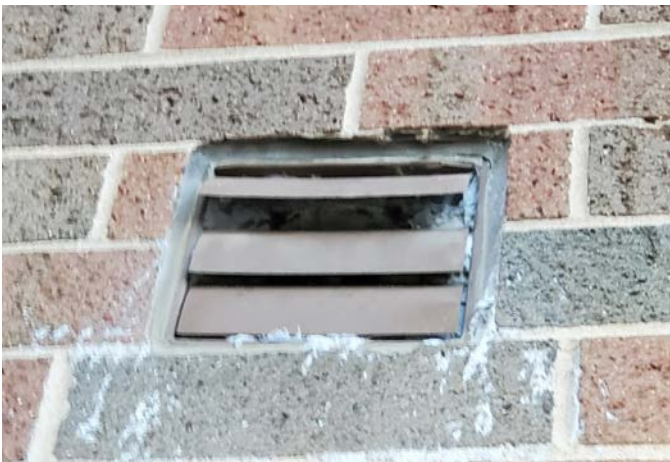
DRYER EXHAUST REQUIRES CLEANING

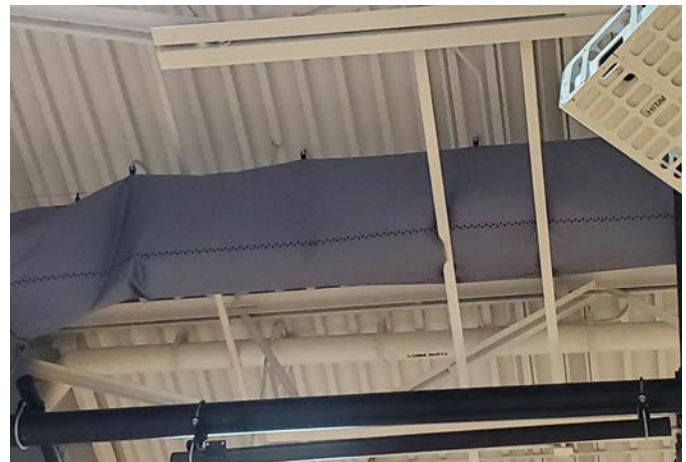
TORN FABRIC DUCT AT GYMNASIUM

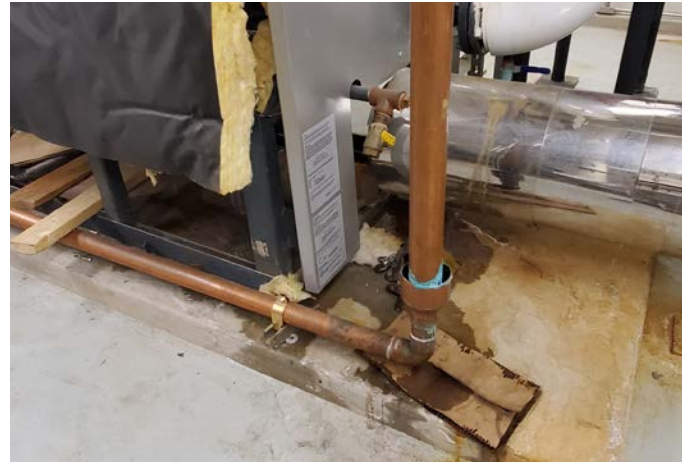
BOILER UNDER REPAIR FOR CRACKED HEAT EXCHANGER

- Facilities staff indicated that both heating boilers have experienced issues with leaking heat exchangers. One boiler is currently disassembled and under warranty repair by the manufacturer.

- Consideration for addition of a single boiler for emergency heating only, or a formalized plan of action in case both boilers have failed, is recommended. This plan could include load shedding (removal of outside air and exhaust load from the facility), sourcing and connection of an emergency boiler, or a combination of items. The priority or urgency of this item can be determined by facility staff observation – for example, if both boilers regularly are required to run to meet heating load during the winter, a failure scenario may be more severe.

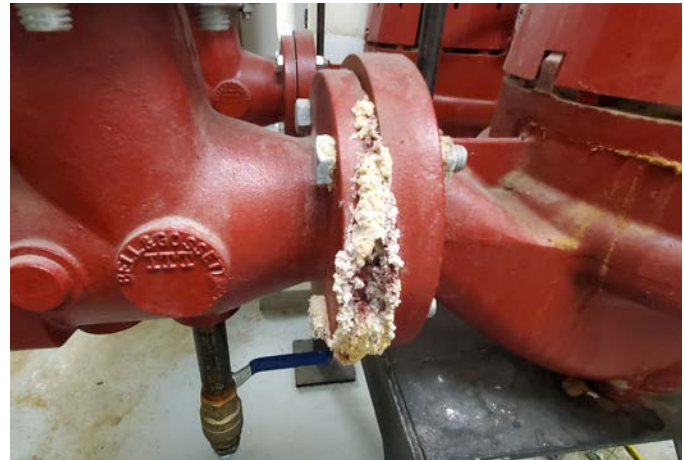
PRIOR LEAK AT HEATING PUMP

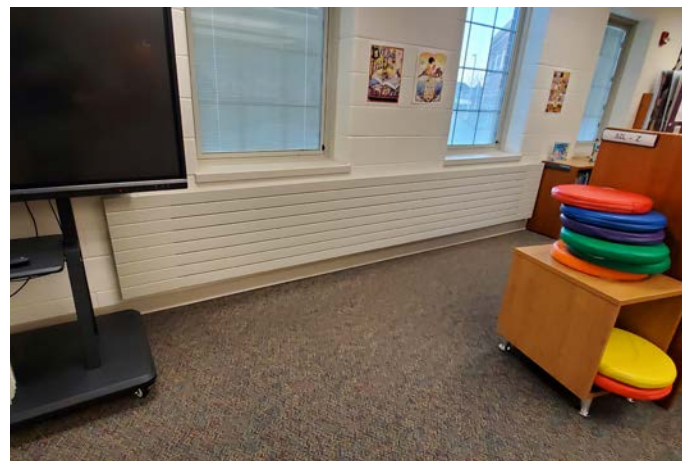
- Lack of redundancy in heating plant can be a concern in our climate. The risk of catastrophic boiler failure increases with age of a facility.
- Supplementary panel radiators are present in several locations, including areas occupied by students. The panel radiators are served by the heating hot water plant which has a design supply temperature of 180°F. Due to the age of students at this school, we feel this configuration provides a burn risk for the students. Temperatures warm enough to provide burns was noted during survey.

POTENTIAL BURN RISK FOR SMALL CHILDREN

- Consider adding a tertiary loop to mix down supply water temperature to panel radiators exposed to students, to limit burn risk.
- Recommend implementing an aggressive hot water reset schedule to limit supply water temperature to as low as 120°F during shoulder seasons. This will encourage condensing operation and will dramatically improve boiler efficiency. Trend and adjust reset schedule for at least 1 year to confirm adequate performance with lower water temperature. Alternatively, implement a trim-and-respond control strategy to automatically reset water temperature as low as possible based on terminal unit valve positions.

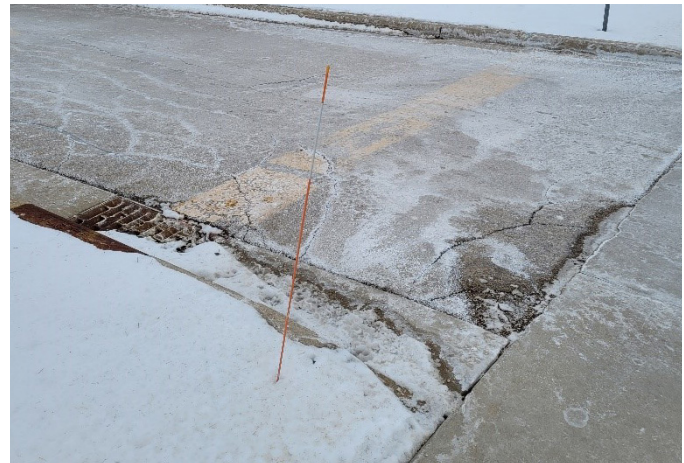
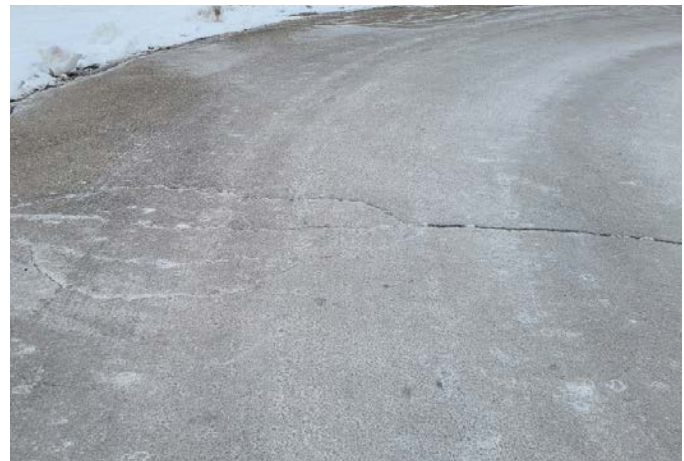
- Many locations throughout the traveled lanes have alligator cracks with signs of failing base.
- Various unsealed longitudinal and transverse cracks throughout the pavement.

- Remove existing pavement
- Stormwater management improvements
- Base repairs as needed
- Pave 4" of asphalt in parking lot
- Install pavement markings

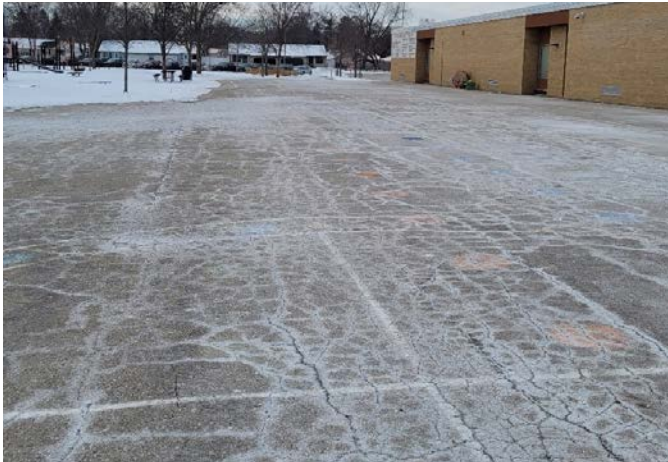
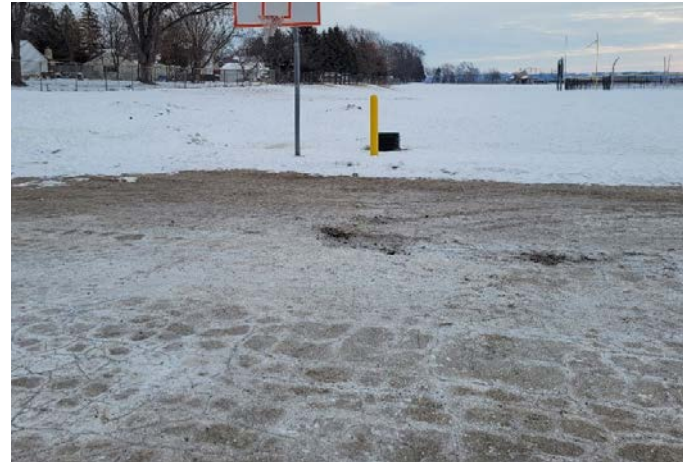
ELEMENTARY PLAYGROUND LOT

SITE CONCERNS - ASPHALT

- Excessive settlement and rutting throughout the pavement
- Many unsealed transverse and longitudinal cracks throughout the surface
- Entire surface has severe alligator cracking
- Water ponding in various locations in the field next to playground lot

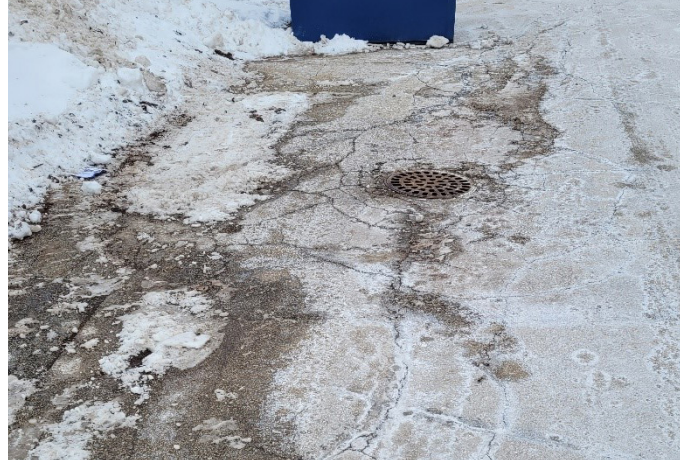
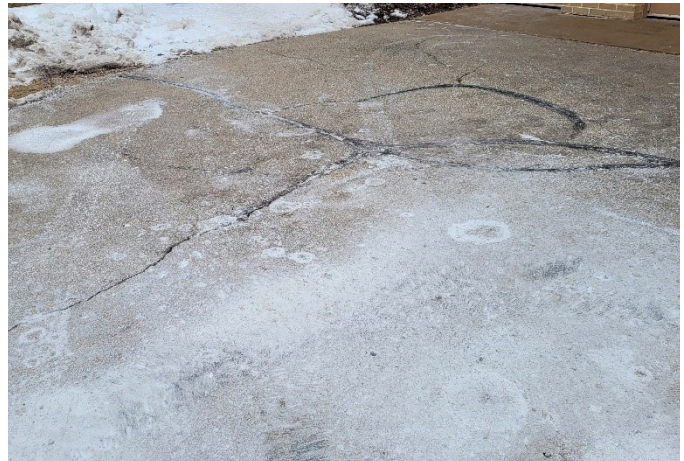
SITE CONCERNS - ASPHALT

- Excessive settlement and rutting throughout the pavement
- Many unsealed transverse and longitudinal cracks throughout the surface
- Entire surface has severe alligator cracking and base has failed

SITE RECOMMENDATIONS

- Remove existing pavement
- Remove 18" of base/subgrade
- Install drain tile under the pavement to existing inlet
- Add geotextile fabric
- Add 12" of breaker run
- Add 6" of base at
- Pave 4" of asphalt

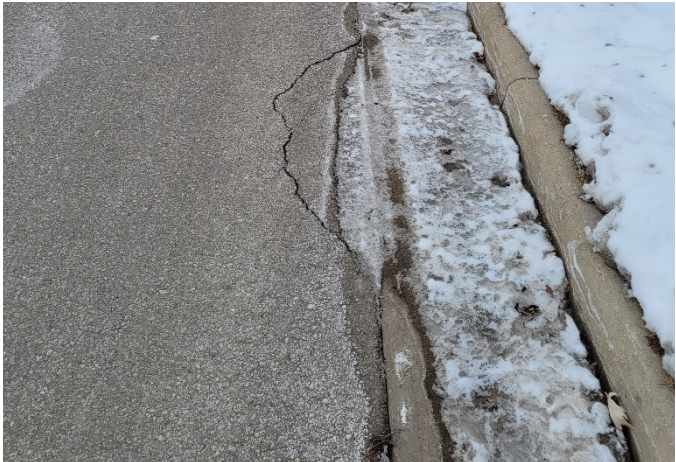
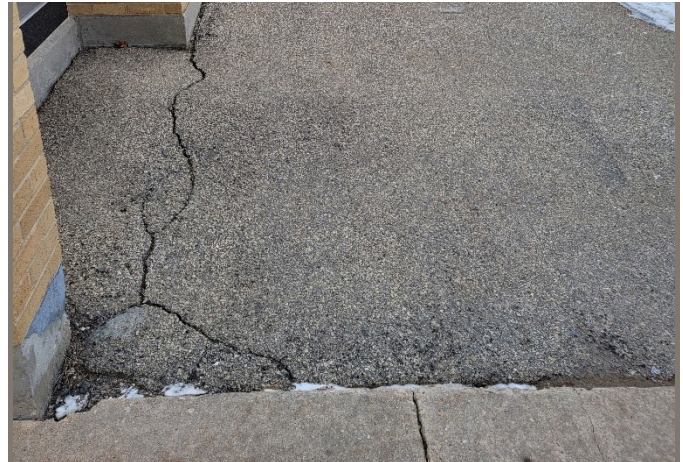
ELEMENTARY DROP OFF/PICK UP AREA

SITE CONCERNS - ASPHALT

- Multiple unsealed transverse and longitudinal cracks throughout the surface
- Some alligator cracking starting to appear along the gutter flange in a few locations

SITE RECOMMENDATIONS

- Crack seal transverse and longitudinal cracks (yearly)

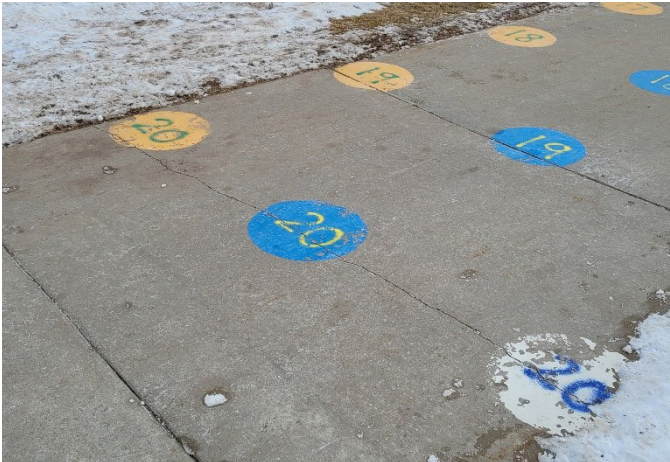
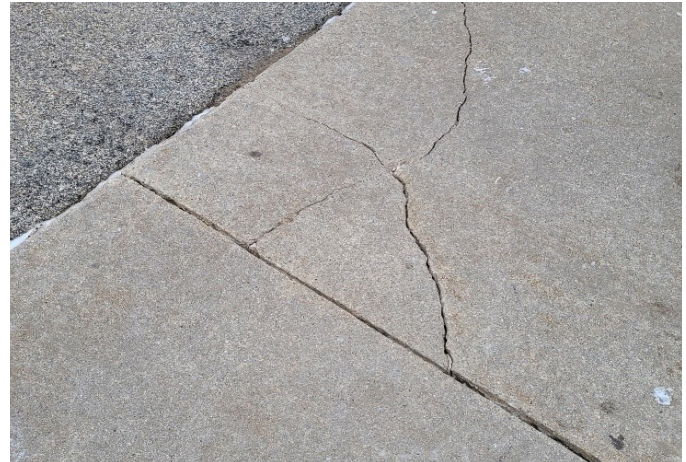
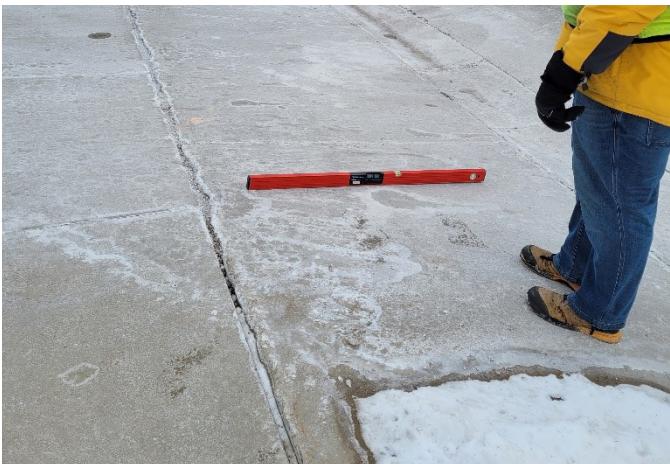
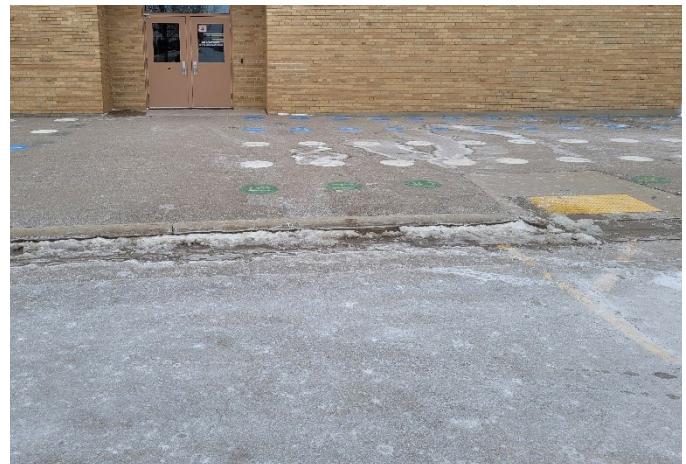
SITE CONCERNS – CONCRETE SIDEWALK

- Multiple concrete panels cracked and some with minor spalls
- Settlement of the entrance footing with a vertical deviation greater than ½”
- South edge of the sidewalk, north of the playground, has abrasion and small spalls from snow plowing
- Concrete aprons at the SE entrance have slopes of 12%
- Concrete pad, for garbage dumpster, has multiple narrow cracks with some areas of light map cracking
- Asphalt surface behind the curb, and at entrance No. 4 have some diagonal cracks.

SITE RECOMMENDATIONS

- Remove and replace broken panels
- Repair shallow spalls at concrete surface
- Crack seal narrow cracks in the concrete panels and retaining wall
- Remove and replace concrete pad for dumpster with 6" reinforced concrete
- Remove and replace concrete entrance aprons at a 6% or less.
 - Remove adjacent 2-3 concrete sidewalk panels
- Replace asphalt sidewalk with concrete in SW corner of school
- Replace asphalt pavement and pave 4" of concrete at entrance No. 4 behind curb and gutter

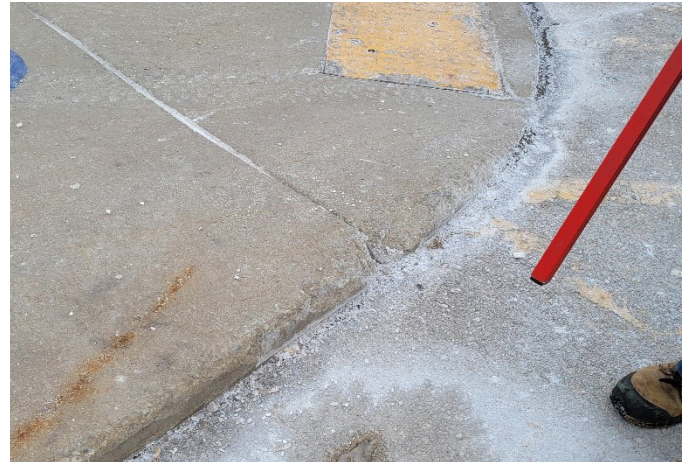
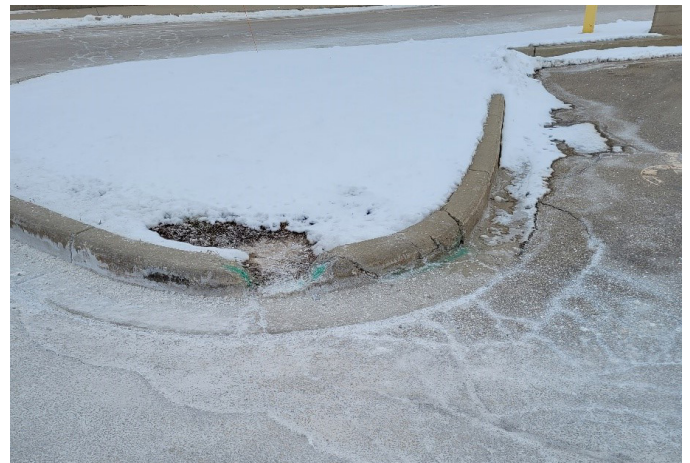
SITE CONCERNS – CONCRETE CURB & GUTTER

- Multiple sections have cracks through the curb and gutter.
- Some areas of curb and gutter have spalls
- Multiple sections of raised sidewalk curb have abrasion and small spalls
- Vertical cracks on the retaining wall and railing section on the SW corner of the school

SITE RECOMMENDATIONS

- Remove and replace all damaged curb head sections
- Sawcut raised concrete sidewalk 2' back
- Remove concrete sidewalk
- Pour 24" curb and gutter

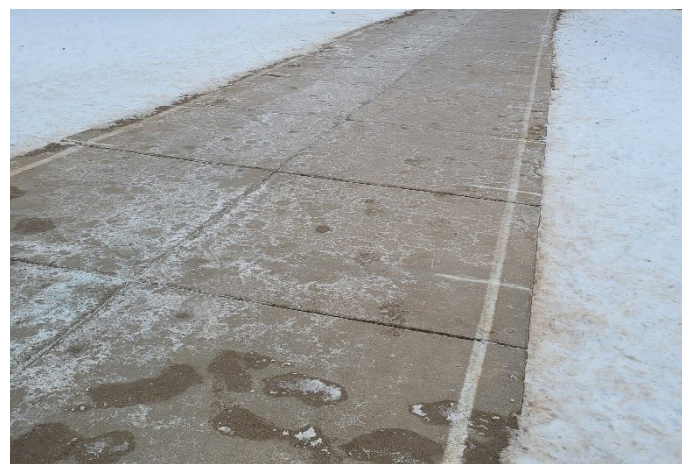
SITE CONCERNS – CONCRETE SIDEWALK

- The concrete sidewalk, on the NW corner the school, has two sections of sidewalk that have a slope of 1:15 and 1:11. These sections of sidewalk exceed the maximum slope of 1:20 and the max rise of 30" before a landing pad or railing needs to be installed.
- Some detectable warning fields are deteriorating and no longer have effective domes.
- 2 curb ramps have cracks and spalls in the concrete

SITE RECOMMENDATIONS

- Remove and replace panels with adequate landing areas.

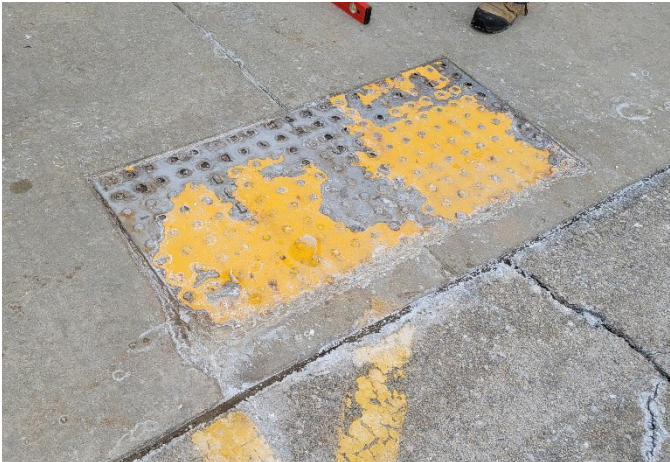
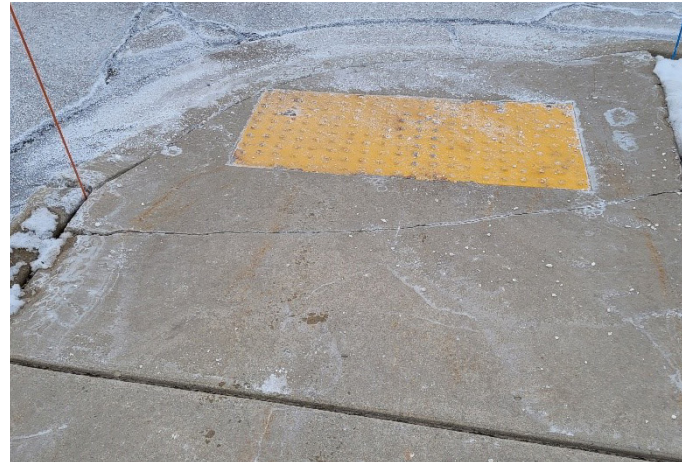
SITE CONCERNS – CONCRETE CURB RAMPS

- 6 curb ramps on site do not meet the requirements for ADA Compliance.

SITE RECOMMENDATIONS

- Remove and replace all cracked sidewalk ramps panels
- Remove and replace non-compliant curb ramps

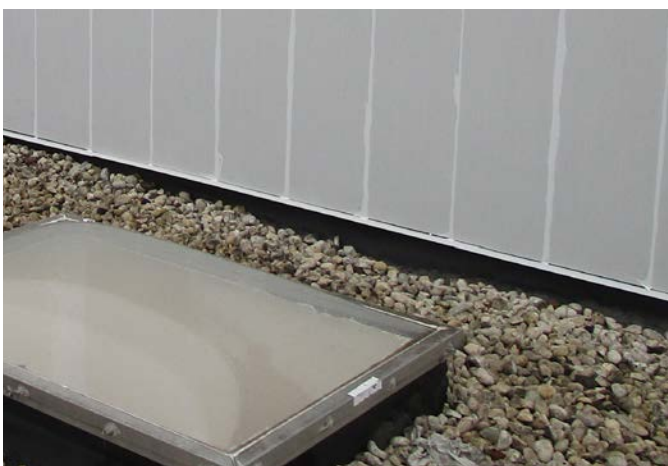
- There are concerns at the roof level with the metal panel wall construction enclosing the high ceiling spaces at the roof level. In center area of the building, the walls at the cafeteria are clad with metal panels. Due to water infiltration issues, the vertical joints in the panels were sealed with caulk on the north, west side, and east side which, staff report this appears to have stopped water leaks.

CAULKING USED TO SEAL METAL WALL PANELS

- Repairs to the vertical metal wall panels and metal wall flashing should be addressed as part of a total building re-roofing project. See the roofing comments below.

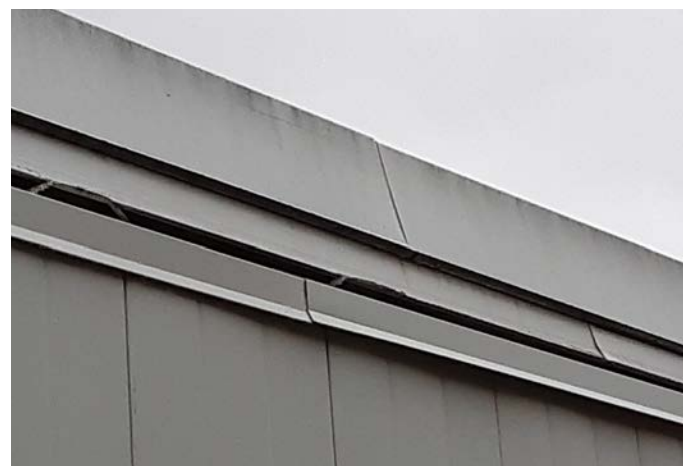
SUCCESSIVE LAYERS OF ROOF COPING TRIM WITH VISIBLE GAPS

However, there are also large gaps in the layers of existing wall flashing at the high roof which are potential points of water infiltration. This layering of flashing suggests that the contractor installed the new metal panels and roofing material over the existing construction, rather than removing the old materials and covering the intersection of the wall and roof with a single flashing system.

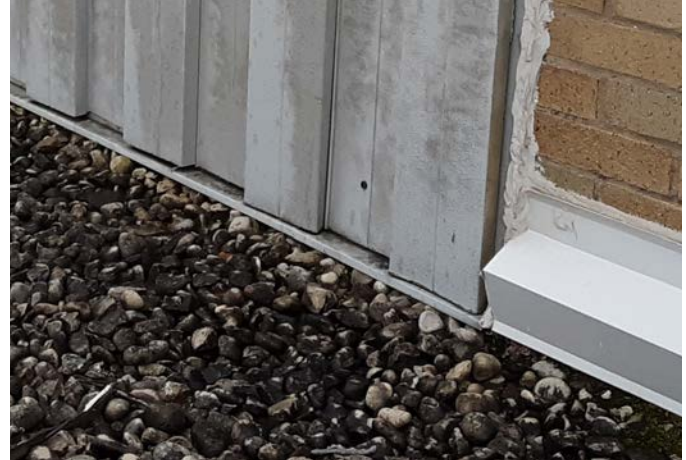
Above the Library, there are existing metal panels that meet the roofing ballast. The metal panels and roofing membrane should be above the roofing ballast a minimum of 8"-12". This condition also would be suspect for water infiltration.

METAL WALL PANELS TOO CLOSE TO THE ROOF

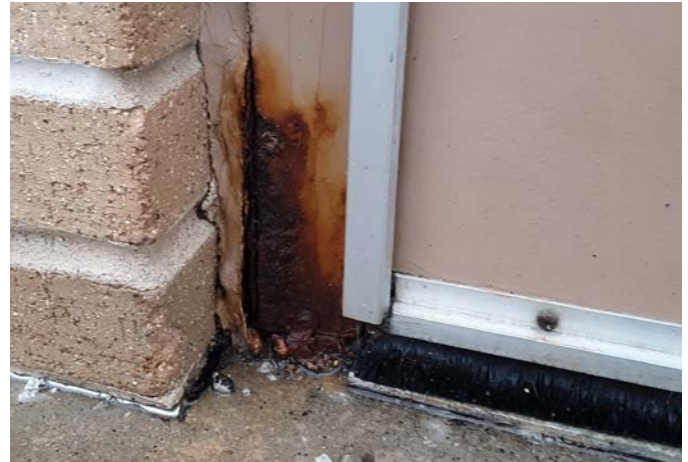
- A majority of the hollow metal exterior door frames show extensive rust and corrosion at the threshold where they meet the concrete. The doors themselves appear average condition.

RUST AT HOLLOW METAL DOOR FRAMES

- The rusting of the hollow metal door frames will likely worsen in the coming years. Due to the severity of the deterioration, in all probability, they will all need to be replaced within the next 5-10 years. Fiberglass reinforced plastic is a good alternative to hollow metal and will not corrode like the existing frames.

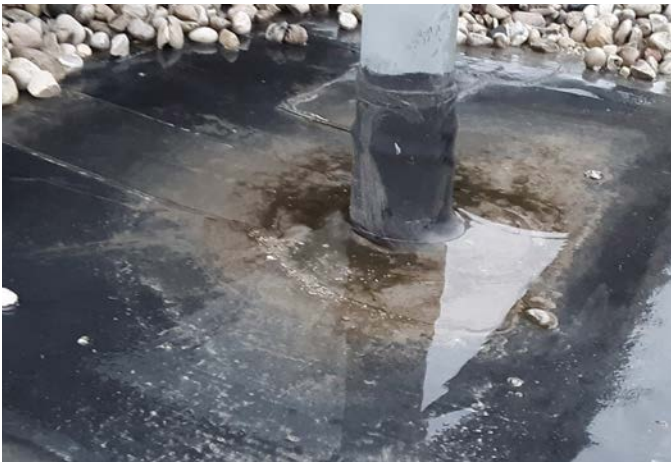
- Ponding water and areas that are not adequately pitched to reach a roof drain were observed. In two areas on the 1956 classroom wing, there is apparently no slope to allow water to reach the roof drains which is creating ponding.
- At areas under the roof top air handlers, the roof membrane is depressed and ponding water.
- Staff report constant issues with water leaking at the skylights and the at the raised roof areas of the cafeteria and library.
- There are a few areas where the insulation has lifted up from the deck and is pushing up on the roof membrane.

RECESSED ROOFING AT HVAC PENETRATION

- Address the concerns above with a comprehensive re-roofing project for the entire Building.
- Add additional roofing insulation where needed to create the proper slope to roof drains.
- Investigate areas of insulation push-up to determine cause. Repair/replace defective insulation.
- Remove skylights and roof over the openings.
- Replace the metal panel walls on the roof with an entirely new wall system that provides the proper flashing into the roofing membrane.

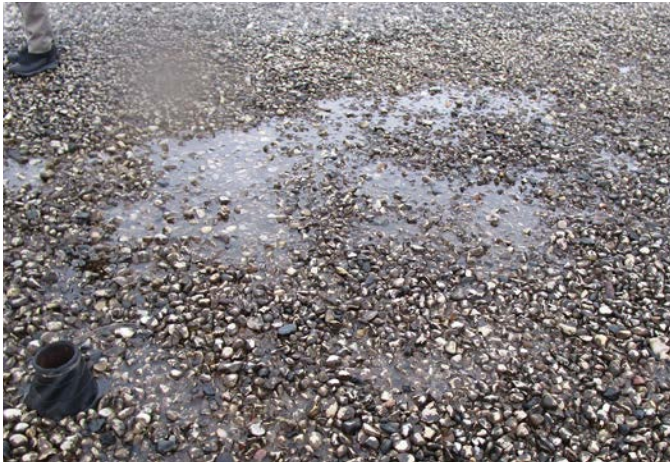
EXCESSIVE PONDING WATER NOT REACHING A DRAIN

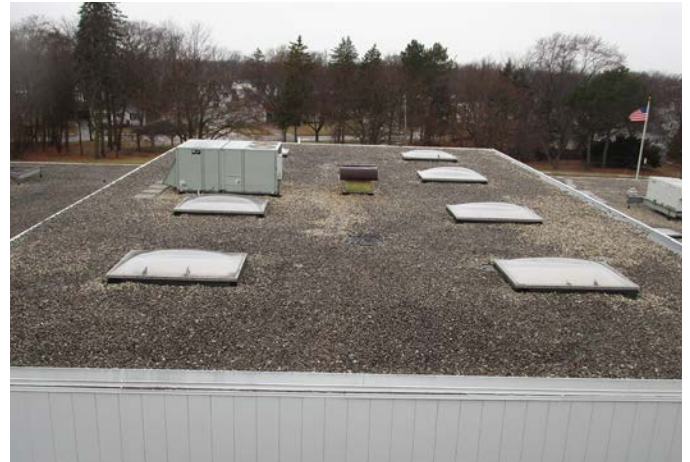
SKYLIGHTS ON ROOF ABOVE CAFETERIA

- Staff report continuing issues with the skylights over the cafeteria. Rain water and moisture from condensation are seeping into the drywall side walls of the light well, damaging the drywall and blistering the paint. Cracks in the skylight's plastic dome have been fixed with sealant applied to the exterior of the dome. The dark streaks in the photos are from this sealant.

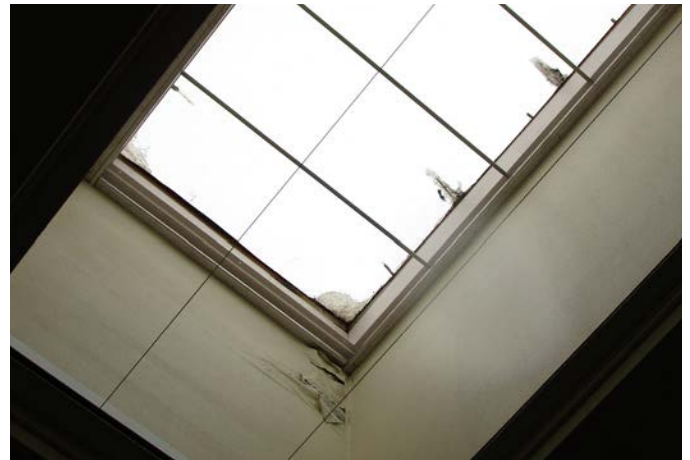
INTERIOR OF SKYLIGHT WELL

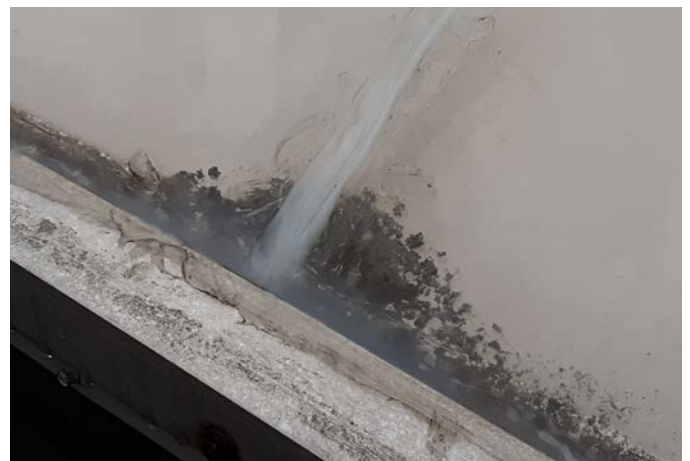
CAULKING AT CRACKED SKYLIGHT

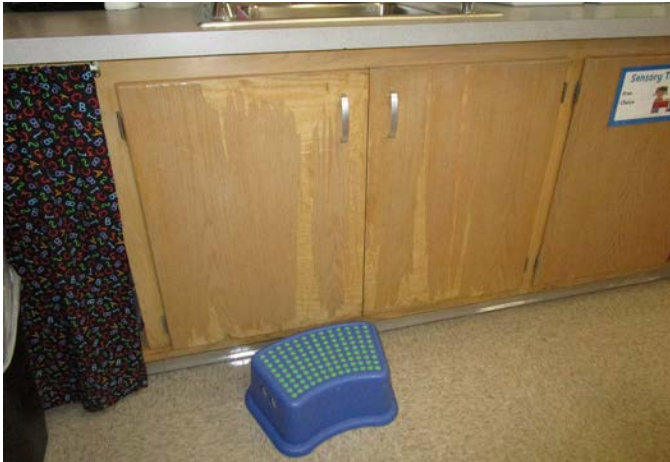
1958 CASEWORK DOORS AT SINKS

- Asbestos floor tile should be abated, and new carpet installed.
- Replace ceiling tile and grid.
- Replace the cabinet doors under the sinks in the 1956 section as needed.

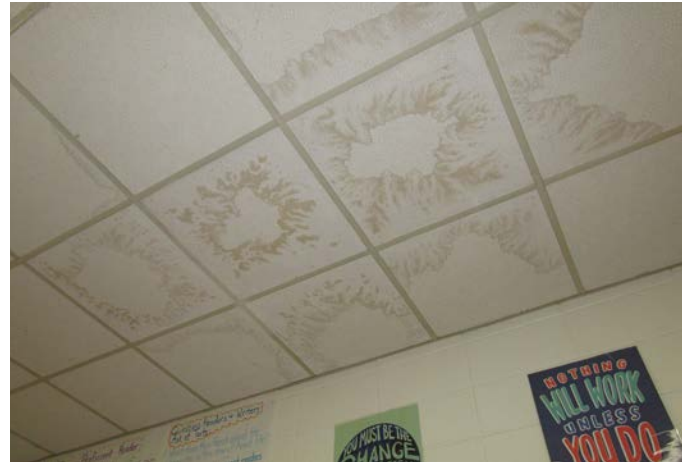
ROOF LEAK STAINS ON YELLOWING CEILING TILES
