MARCH 2023

Unified School District of De Pere

District-Wide Facilities Condition &
Education Adequacy Assessment

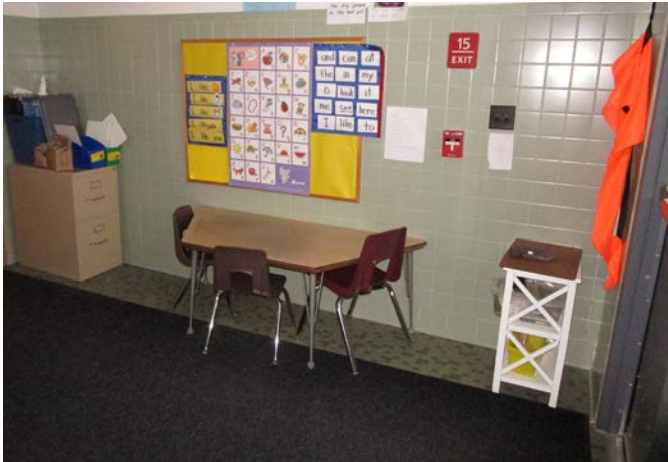
- In one of the entry vestibules adjacent to the kindergarten classrooms, there is a teaching area with a table, chairs, and teaching materials. It's apparent that this is being used as an area for one-on-one, specialized instruction. The other vestibule is being used for playground equipment storage. This demonstrates the need for both storage and one on one instructional space. Per the building code, these vestibules cannot contain these types of stored items as they may hinder the emergency evacuation of the building.

EXIT VESTIBULE USED AS INSTRUCTIONAL SPACE

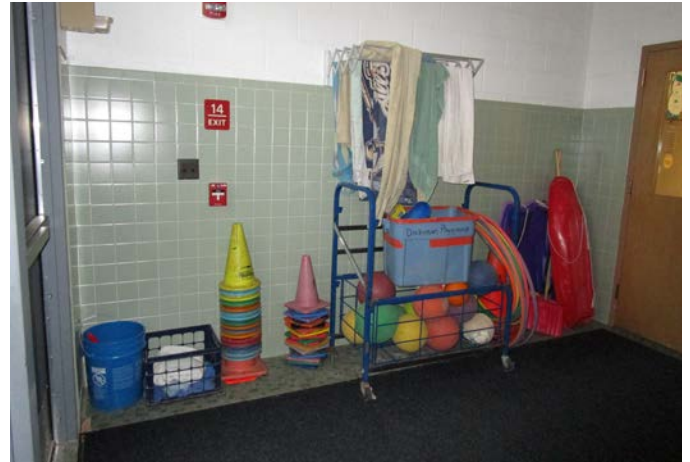
EXIT VESTIBULE USED TO STORE PLAYGROUND EQUIPMENT

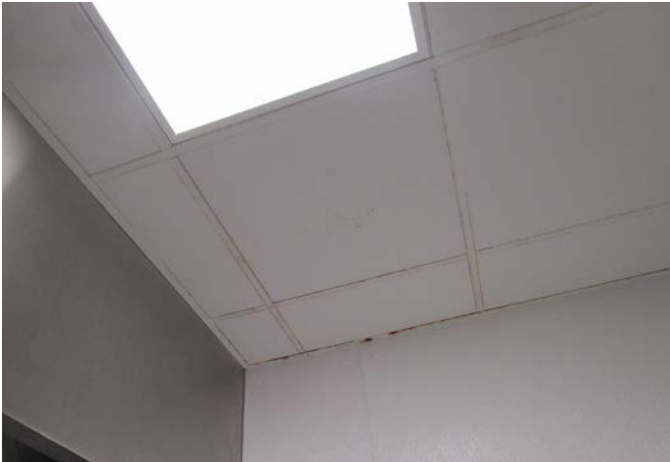
RUSTING DISH ROOM CEILING GRID

- The stair in the kitchen area which accesses an air handler room does not meet today's code. Staff report that the washer and dryer that were recently relocated from the upstairs area to the main school level due to safety concerns.
- The metal ceiling grid in the dish washing room is rusting.

- Replace the dish washing room ceiling grid and tiles with an aluminum grid and vinyl covered gypsum board ceiling tiles; these will not rust or hold moisture.

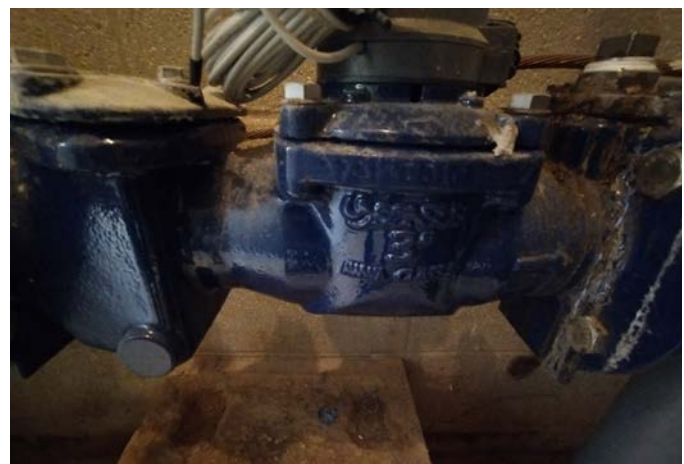
WATER METER LEAK

The water meter appears to be leaking from one of the service ports and dripping onto the floor. Scale and build-up was seen running down the meter body. The water pressure observed on the day of the site visit was 54 psi. The pressure reading was taken at the hot water storage tank near the gas fired water heater.

- Repair the leaking service port on the water meter.

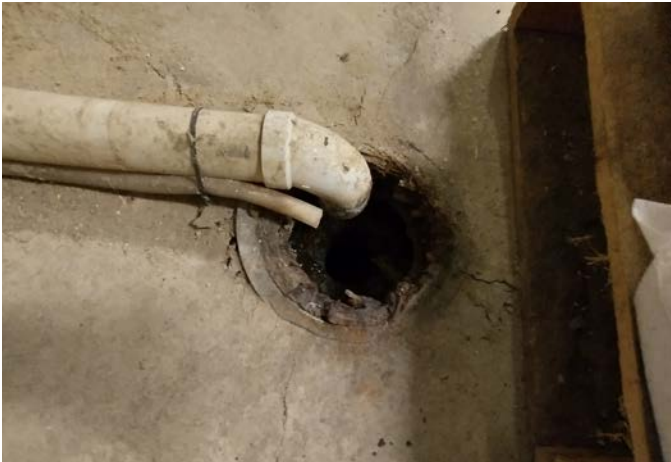
WATER SOFTENER DRAIN

There is a water softener located on the mezzanine above the kitchen. The floor drain which the water softener discharges into is heavily corroded, and in very poor condition. During our site investigation it was noted that the floor deck directly below this floor drain, which is in the outdoor storage area, is in poor condition. It can be assumed that the floor drain is leaking into the concrete surrounding the drain, and is corroding the metal decking in that area.

- The floor drain on the mezzanine is leaking and corroding the floor deck directly below the drain.

- Replace the section of floor deck and drain in the area of that floor drain.
- Consider televising the sanitary mains prior to any system modifications to ensure the integrity of the piping.

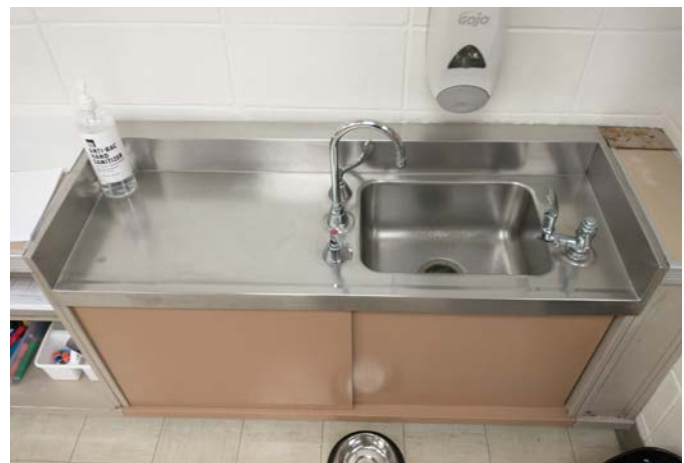
CLASSROOM SINK

The classroom sinks have surpassed their expected service life and are showing signs of age. These items should be replaced in the near future. The strainer at the bottom of most of the classroom sinks appears to be corroded, and the chrome is delaminating. It was noted that many of the classroom sinks, and casework, were separating from the exterior wall. These fixtures should be caulked to the wall to prevent any backsplash from getting behind the casework.

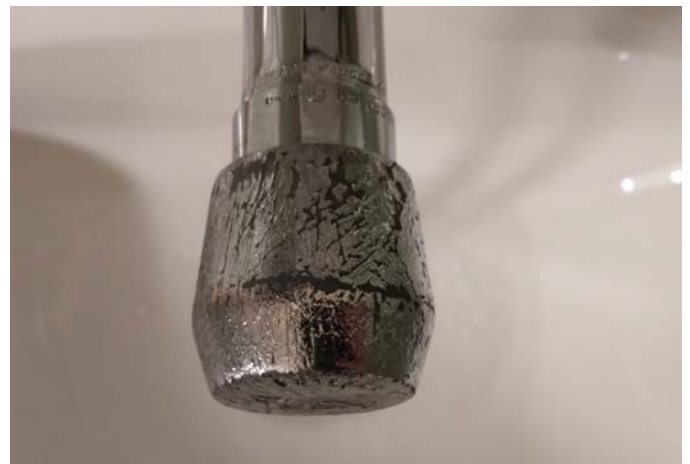
LAVATORY FAUCET DELAMINATING

The lavatories are wall mounted porcelain with metering faucets. It appears that the metering faucets have been replaced at some point over the life of the fixtures. Most metering faucets are in good condition, however, a few of them stay on longer than needed. The chrome on a few of the metering faucet handles is delaminating. Located near each restroom, is a single thermostatic mixing valve which provides tempered water for the lavatories. These thermostatic mixing valves are located a good distance away from the outlets of the lavatories, which means it takes a while to get tempered water, especially because in some instances the tempered water lines run below the floor slab.

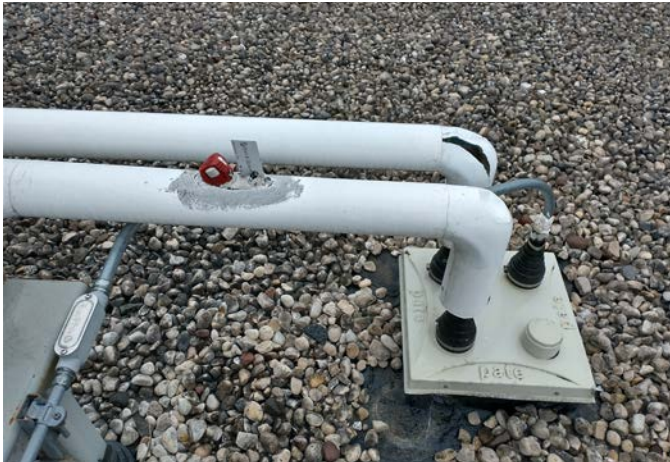
SOLAR ARRAY PIPE INSULATION

The solar array and associated piping are in fair to poor condition. In a few locations on each array, the piping is no longer supported from the framework and is free floating. This puts additional stress on soldered pipe joints and could cause leaks. The piping insulation is also falling apart at many elbows and joints.

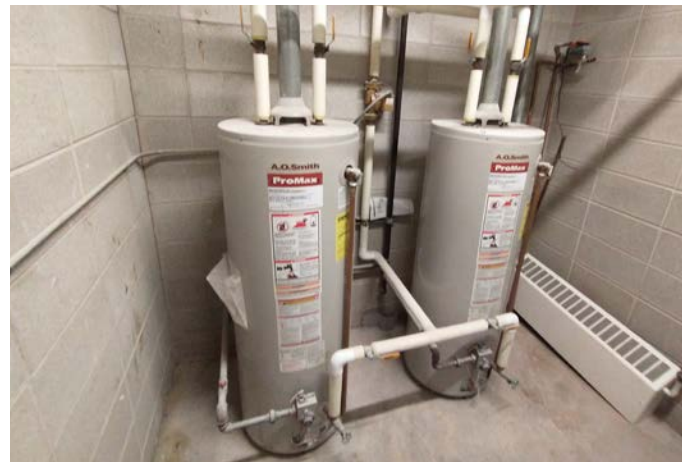
SOUTH WATER HEATERS

The southern wing of the school is served by two 50 gallon natural gas water heaters and a separate recirculation pump. Based on the serial number of the water heaters they were built in 2003. This means these water heaters are at the expected service life and the school should consider replacement prior to failure. These two water heaters are also connected to a single flue up through the roof. Common flue venting may be allowed based on the manufacturer, however, on the flue there is a draft inducing fan, which is currently not connected to electricity. This means that the fan is obstructing the flow of the combustion gases whenever either of these water heaters is in operation. This installation should be reviewed by a master plumber to ensure this meets the manufacturer's installation instructions.

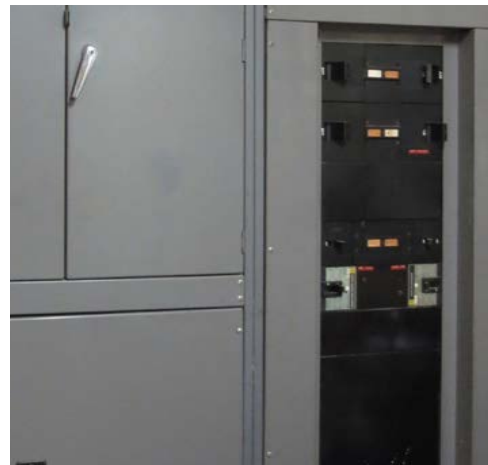
ORIGINAL MAIN DISTRIBUTION PANEL

- The original 1958 Square-D distribution panel is still in operation. These panels are out of date and need replacing.
- The original distribution does not have a proper lock-out mechanism to limit unauthorized persons from entering the energized equipment bay.
- Several of the branch panels are original to the building. These panels are showing signs of rust and over-use; and are past their life expectancy.

- Replace existing Square-D distribution and branch panels with new equipment.
- Provide lock-out/tag-out latching on original distribution.
- Provide the proper PPE labeling.
- Electrical service equipment typically has a service life of approximately 30-40 years. The primary cause of the replacement is the inability to produce breakers which properly fit and operate within the existing branch and distribution panels toward the end of life.

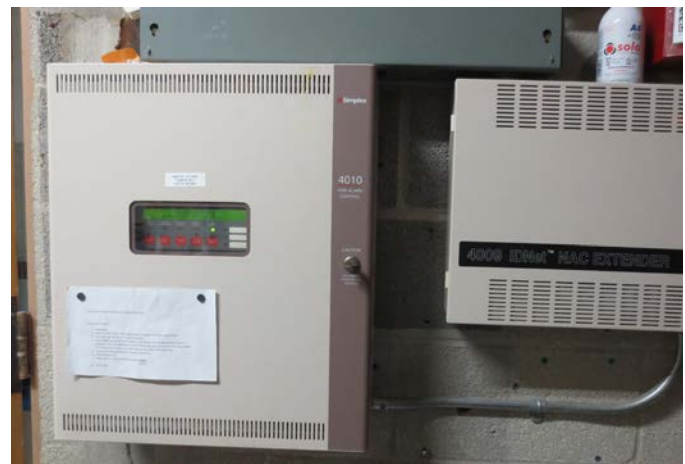
FIRE ALARM CONTROL PANEL

- Overall, the system appears to be fully operational and meeting codes that were in place at time of installation. The system does appear to be outdated and replacement parts and service could be challenging.
- Current code requirements call for a voice / mass notification system with annunciation devices that allow a central station to broadcast a verbal warning for directions to evacuate the building or property. Existing system is "grandfathered" in to when it was installed, but any major remodel or additions would require the system to be upgraded or be able to communicate with any new installations in remodeled areas.

- Replace existing system to meet current code requirements.
- Fire Alarm systems typically have a service life of approx. 20-30 years, with the issue of finding replacement parts that will keep the system operating properly.

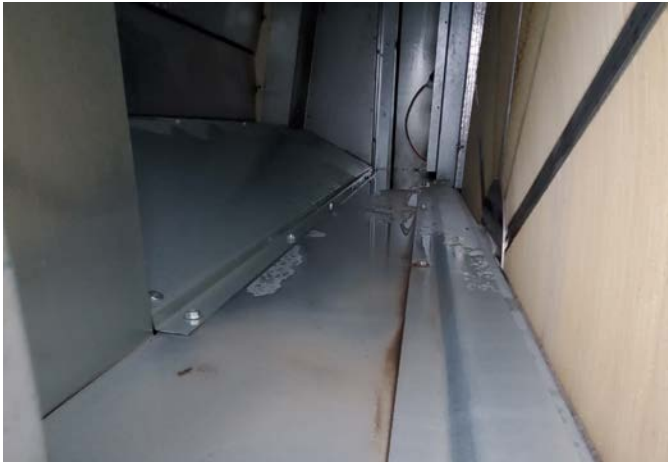
WATER INFILTRATION INTO DOAU CABINET

- Facility staff indicated several leaks are present through ductwork at air handling units. It was noted that outside air intakes for older rooftop units are very close to roof surface. It is likely that rain and snow is pulled in through intakes especially when windy conditions are present.
- DOAU-3 intake is adjacent to water heater flue. Recommend relocating flue to prevent contamination for ventilation air.

- Condition of packaged rooftop units is poor. Consider replacement including serving from geothermal system.
- Condition of DOAU units varies. Several outside air intakes are clogged, components are beginning to rust, and variable frequency drive reliability is low.
- Maintenance and repair of distributed heat pumps is challenging for facilities staff.
- Ductwork throughout the facility is in poor condition with large air leaks, particularly at connection to heat pumps.

- Replace (3) existing packaged rooftop units.
- Perform general preventative maintenance throughout the facility (duct sealing, sensor repair, etc.) to prevent more serious issues in the future.
- Provide new variable frequency drives for all dedicated outside air units to improve reliability.

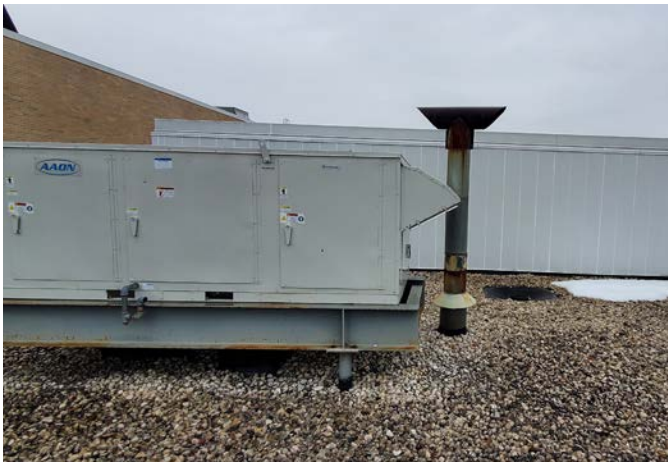
FLUE LOCATED NEAR OUTSIDE AIR INTAKE

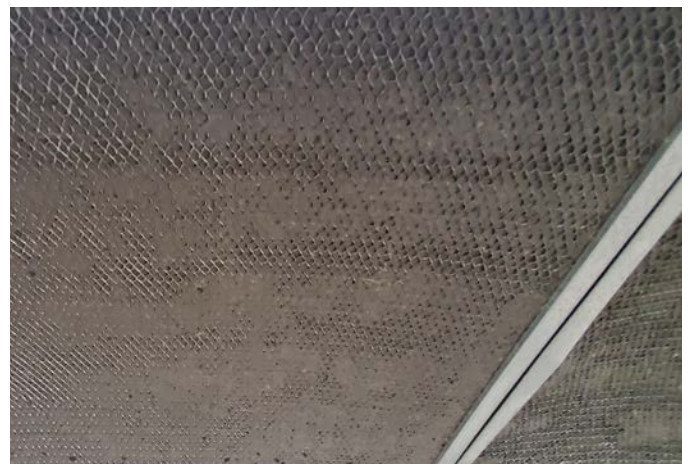
CLOGGED OUTSIDE AIR INTAKE ON DOAU

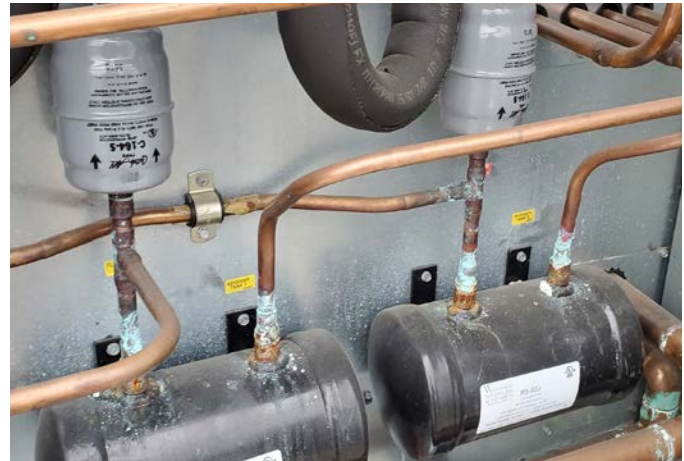
DOAU UNIT DETERIORATION AT MULTIPLE COMPONENTS

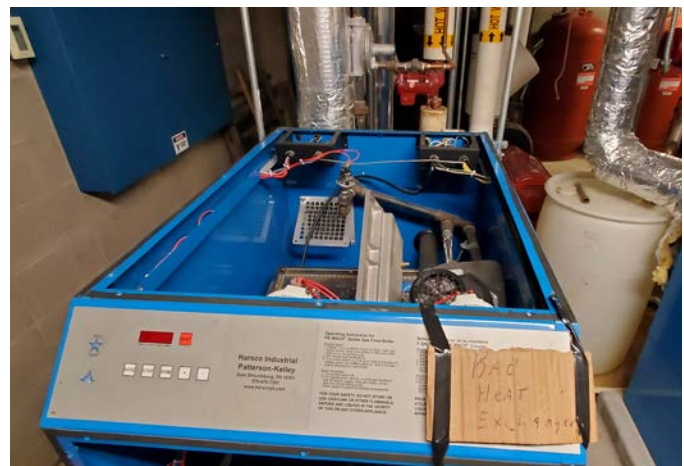
FAILED BOILER B-1

- Larger condensing boiler is currently failed and non-functional.
- Several heating devices appear to be non-functional including hot water cabinet unit heaters at vestibules.
- Significant cold air infiltration occurs at abandoned unit ventilators and is resulting in high heating load in classrooms.

- Remove existing unit ventilators or, at minimum, seal the outside air louvers permanently to limit air infiltration.
- Repair heat exchanger or replace failed condensing boiler.
- Recommend implementing an aggressive hot water reset schedule to limit supply water temperature to as low as 120°F during shoulder seasons and for use to supplement geothermal heating system (instead of use as primary heat source). This will encourage condensing operation and will dramatically improve boiler efficiency. Trend and adjust reset schedule for at least 1 year to confirm adequate performance with lower water temperature. Alternatively, implement a trim-and-respond control strategy to automatically reset water temperature as low as possible based on terminal unit and booster heating coil valve positions.

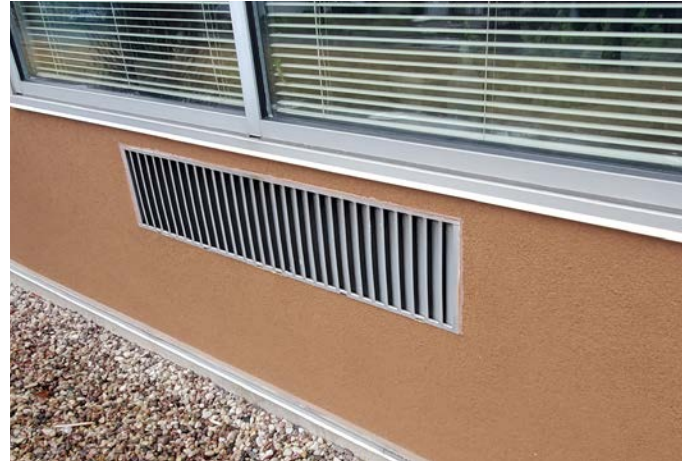
ABANDONED UNIT VENTILATOR OUTSIDE AIR LOUVER

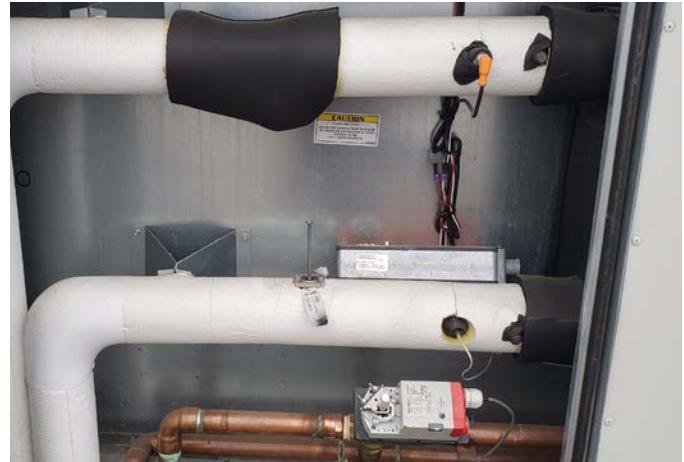
Several anomalies were noted during the site visit. First, it was noted that all geothermal valves on the DOAU units were fully opened and the associated valve actuators were removed. It also appears that many of the heat pump actuators have failed and are also fully opened. De-commissioning these valves is resulting in higher pump energy consumption and will lower the efficiency of the geothermal system. During the site visit, the dedicated outside air units were frequently cycling on and off. It is anticipated that the operation would provide a steady source of ventilation air during occupied times. It was also noted that radiant heat from the boiler system was active in nearly all classrooms, and each zone was warm. However, it was rarely observed that any of the heat pumps were active for heating. The geothermal heating system is significantly more efficient than hot water heat from natural gas boilers, so should be used as the first stage of heating whenever possible. Finally, observed operation of the DOAU units was not as expected. There were times in which the energy recovery wheels were observed to be spinning actively while the associated fans were off and coils were isolated.

- Use of natural gas boilers as primary heat source is not efficient and should be reconsidered.
- Bypassing of geothermal water through DOAU units and heat pumps is resulting in excess energy consumption.
- In discussion with facilities staff and observation of the operating equipment, it appears there are several control sequences which are not optimal for energy savings or system performance.
- Some areas, including several cabinet unit heaters and terminal units, are not functioning properly, leading to noticeably hot or cold spots throughout the building.

DOAU UNIT WITH GEOTHERMAL VALVE LOCKED OPEN

- Recommend that a thorough review and revision to HVAC control sequences is considered. The system type is likely capable to provide much more efficient operation than it is currently achieving. Consider conducting Retro-commissioning survey to “tune-up” and confirm proper operation of all control sequences. This may qualify for a Focus on Energy incentive.
- Replace all geothermal actuators and implement a sequence of operations to lower geothermal pump speed at low load conditions.

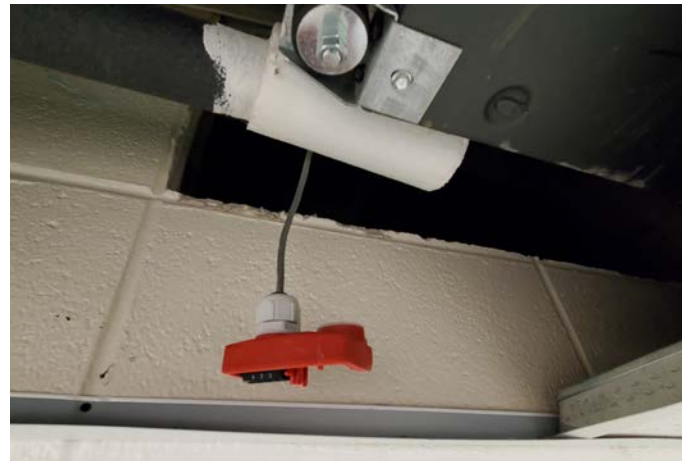
HEAT PUMP VALVE ACTUATOR WIRING HARNESS REMOVED

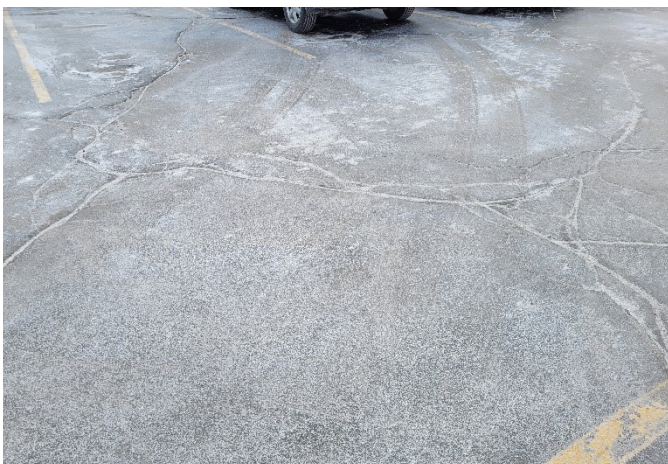
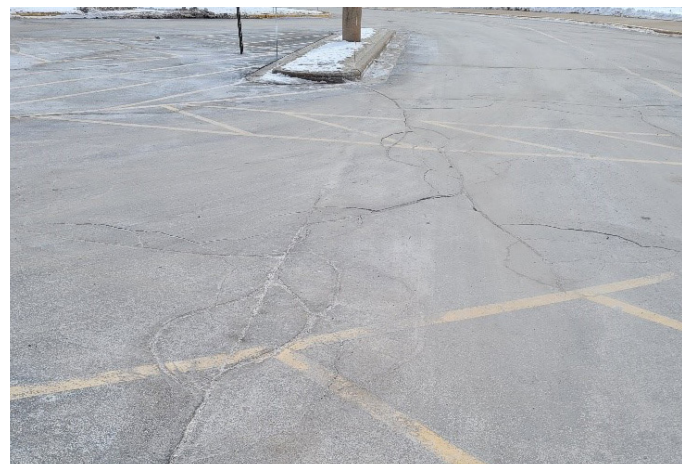
- Multiple areas have alligator cracking where concentrated traffic flow.
- Various wide unsealed longitudinal and transverse cracks throughout the pavement.
- Parking lot may benefit from improving the stormwater management by adding additional inlets.

- Remove existing pavement
- Base repairs as needed
- Stormwater Improvements
- Pave 4" of asphalt in parking lot
- Install pavement markings

- Sawcut and remove distressed pavement areas
- Base repairs as needed
- Pave 4" of asphalt in distressed locations removed
- Crack filling and seal coat surface
- Install pavement markings

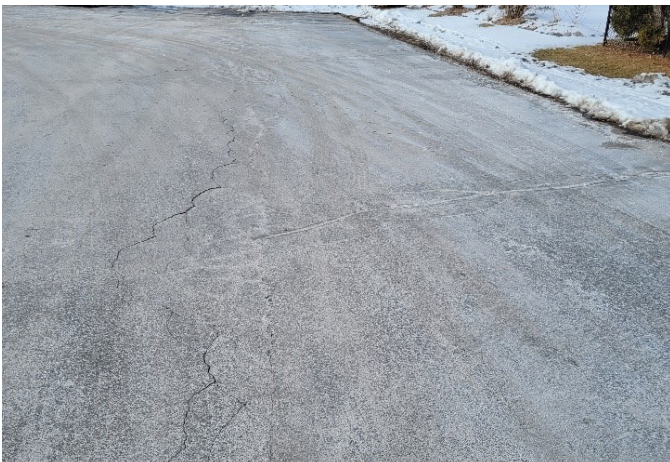
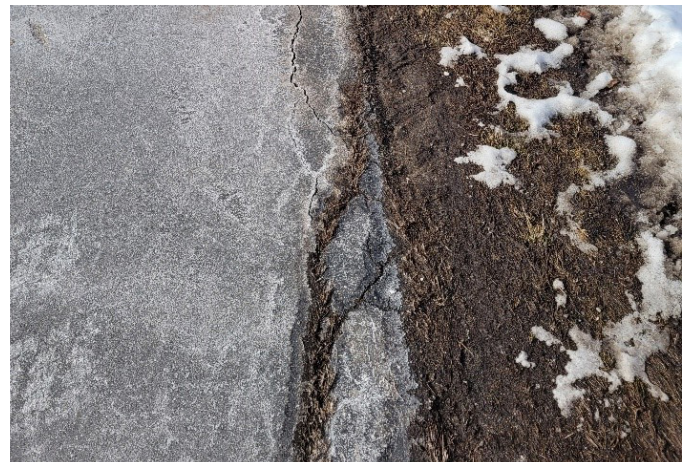
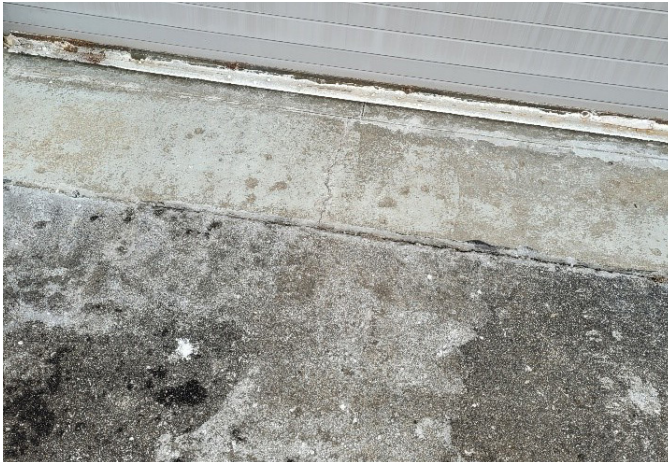
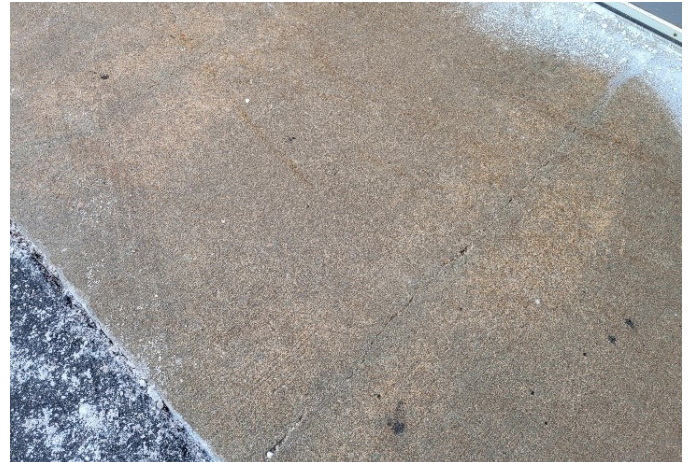
- Settlement and rutting throughout the pavement
- Many unsealed transverse and longitudinal cracks throughout the surface
- Most of the pavement has alligator cracking and signs of the base failing
- Edge of pavement is cracking and breaking off
- Asphalt is settling in front of receiving dock and difficult to unload trucks with forklift

- Concrete pads have narrow/medium cracks
- Install larger loading area with concrete for trucks and garbage dumpsters
- Some concrete parking blocks are damaged

- Remove existing pavement
- Crack filling concrete panels
- Remove 18" of base/subgrade
- Install drain tile under the edge of pavement and daylight out to basin
- Add geotextile fabric
- Add 12" of breaker run
- Add 6" of base
- Pave 4" of asphalt
- Install 6" Reinforced Concrete Pavement
- Replace damaged concrete parking blocks

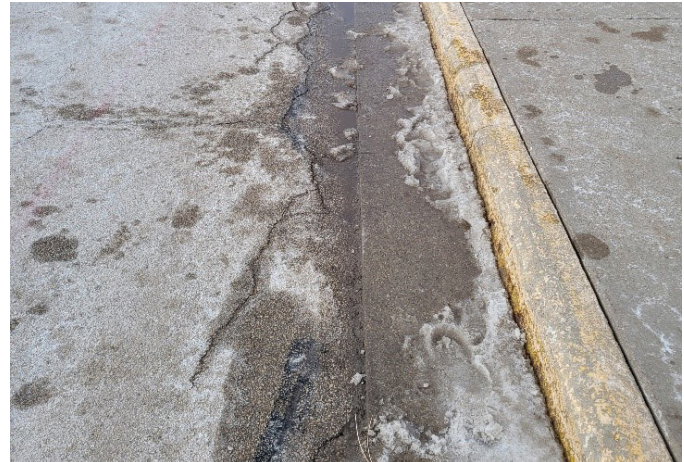
- Many areas of settlement and rutting throughout the pavement
- Multiple wide unsealed transverse and longitudinal cracks throughout the surface
- Most of the surface has severe alligator cracking and base has failed
- Edge of pavement cracking and breaking off
- Drainage issues were observed during the site visit

- Remove existing pavement
- Remove 18" of base/subgrade
- Stormwater management improvements
- Install drain tile along edge of pavement to existing inlet
- Add geotextile fabric
- Add 12" of breaker run
- Add 6" of base
- Pave 4" of asphalt
- Add pavement markings

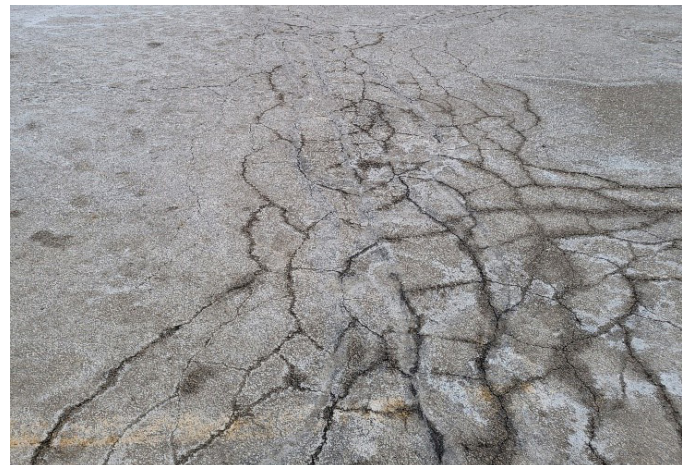
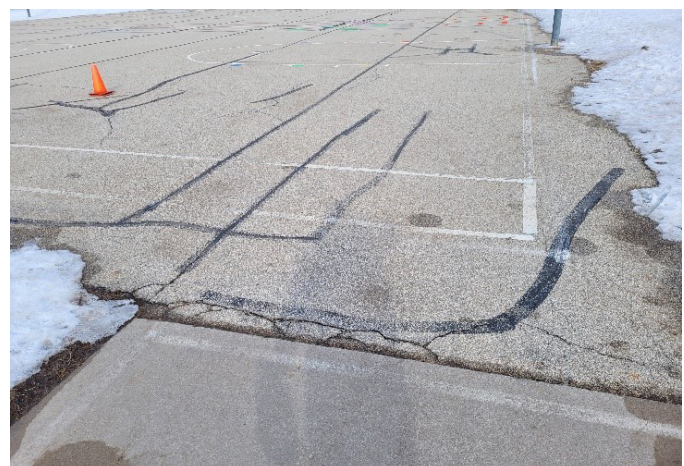
PLAYGROUND LOT

- Multiple unsealed, transverse and longitudinal cracks, throughout the surface
- Most cracks are sealed, or have been sealed, in the past
- A few areas where the edge of pavement is cracking
- 6 Basketball hoops are leaning over and footings look to be overturning

- Replace basketball hoops and footings
- Crack Seal and Seal Coat Surface
- Add pavement markings

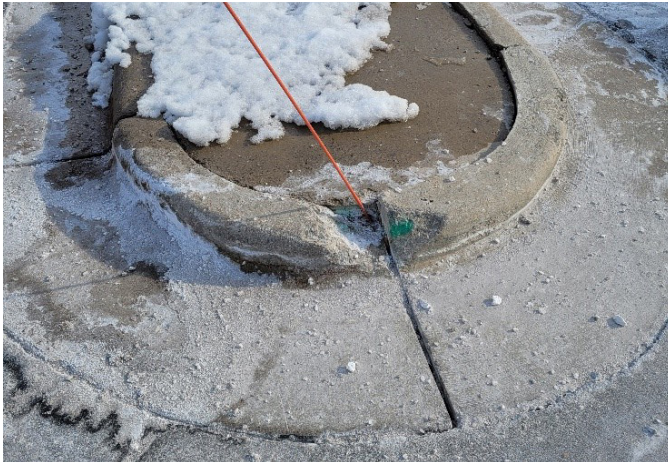
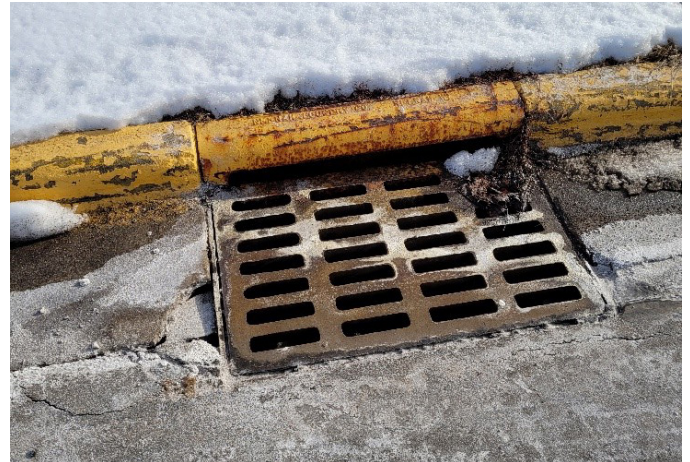
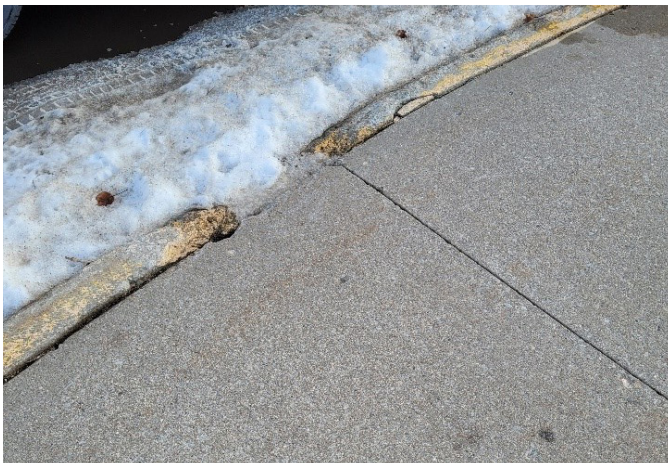
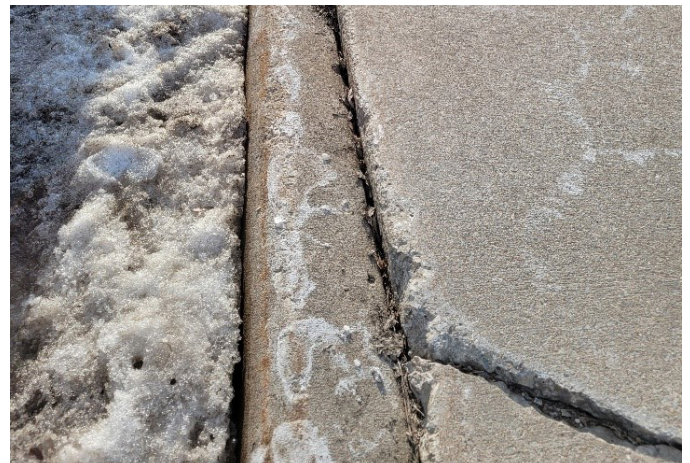
CURB & GUTTER

- Multiple sections have cracks through the curb and gutter.
- Multiple areas of curb and gutter have medium abrasion and spalls
- Many sections of curb have settled along Swan Rd from vehicle parking and driving on them

- Remove and replace all damaged curb and gutter areas

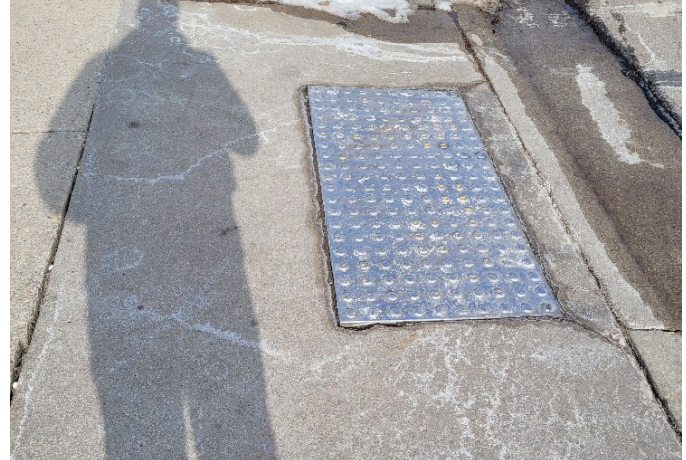
- 7 curb ramps on site do not meet the requirements for ADA Compliance. Slopes are too steep or there is a vertical deviation greater than a ¼" where it meets the pavement.
- Multiple missing detectable warning fields.
- Some of the detectable warning fields have lost all paint and domes are starting to deteriorate

- Remove and replace non-compliant curb ramps
- Install detectable warning fields

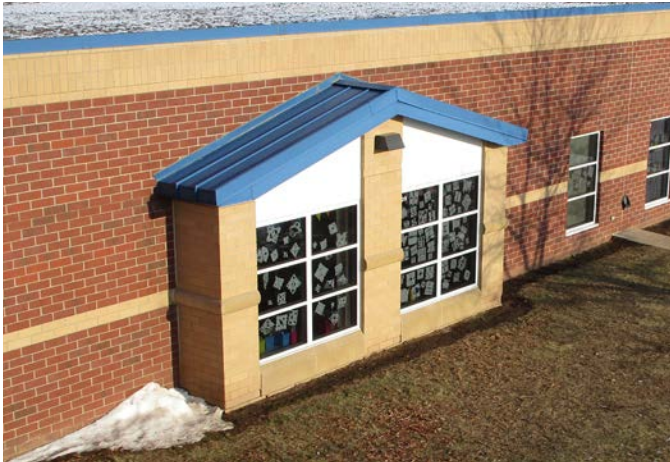
BUMP OUT AT CLASSROOMS

- In the typical classroom, there are bump outs that contain windows. These are covered by a standing seam metal roof. Staff reports continual issues with leaking, depending on the magnitude and direction of wind driven rain. Water is entering the brick cavity through cracked and deteriorating mortar joint at the brick setback above the metal roofing, and running the interior face of the CMU wall and on to the classroom ceiling tile.

- A review of the roof flashing condition and the examination of the construction detailing, suggests that water is infiltrating the brick entering the air cavity and running down the wall. In a June 2021 report, Specialty Engineering Group evaluated the exterior walls and concluded the cavity should contain a flashing membrane to stop water from going below the level of the metal roofing. Evidence of repeated applied sealant at the roofing trim and on the bricks themselves may have helped to keep some water out, however it has not addressed the root cause of the issue.

- The proper solution is to open up the brick wall and properly flash the cavity between the brick and the CMU. Specialty Engineering Group estimates this could cost approximately \$162,000 – \$216,000 to repair all these conditions in the building.

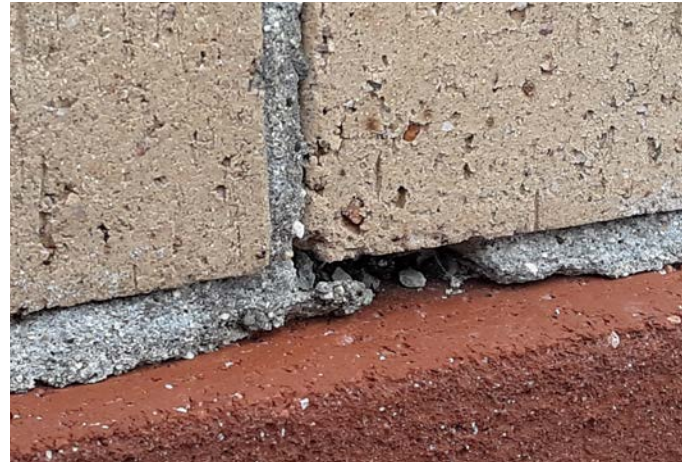
CRACKED MORTAR AT BRICK SETBACK

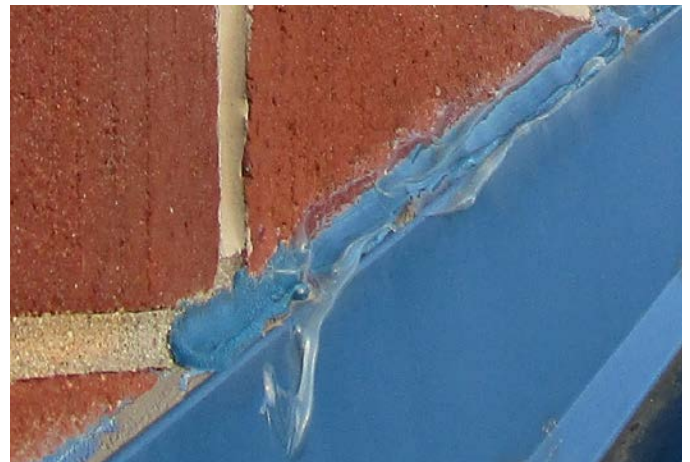
EXTERIOR CAULKING REPAIRS

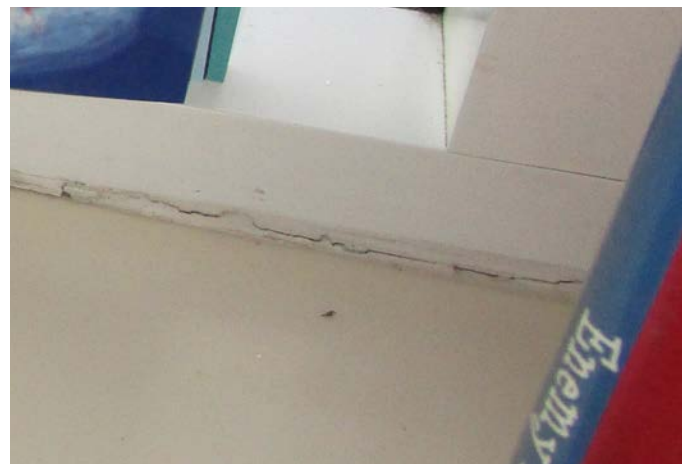
The windows are extruded aluminum frames with double pane insulated glass. Interior sealant at the perimeter windows appears to be fairly new and in good condition. There are several locations where the sealant did not adhere properly, or has cracked and is leaving a gap. These gaps need touch up sealant as part of regular maintenance.

CRACKED CAULKING AT INTERIOR WINDOW FRAMES

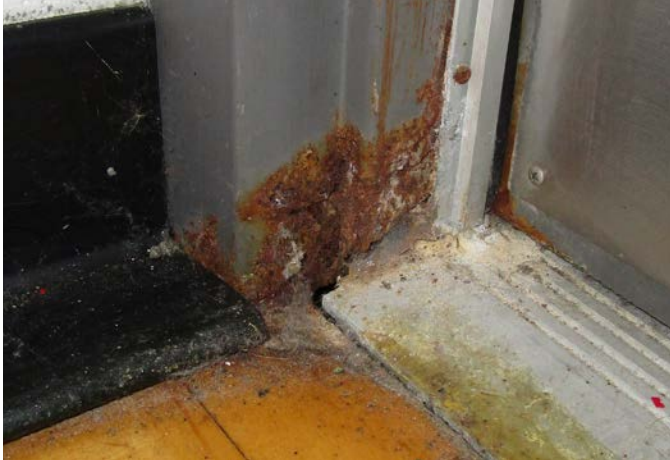
INTERIOR SIDE OF RUSTING DOOR FRAMES

- A majority of the exterior hollow metal door frames show extensive rust and corrosion at the threshold where they meet the concrete. In some locations this rust has completely rotted through the metal on both the exterior, and interior sides, of the frame. The doors appear in good condition.

- The rusting of the hollow metal door frames will likely worsen in the coming years. Due to the severity of the deterioration, a few of these frames should be replaced immediately, especially in the gym, where they are adjacent the wood flooring. The remainder of the frames will, in all probability, need replacement within the next 5 years. Fiberglass reinforced plastic is a good alternative to hollow metal and will not corrode out like the existing frames.
- At the aluminum doors, the center mullion is steel. Consider having these steel mullions sandblasted and repainted with a salt water resistant, high performance coating. Painting over the rust will only encapsulate the rust and allow it to hold water. The center mullion could also be replaced with aluminum.

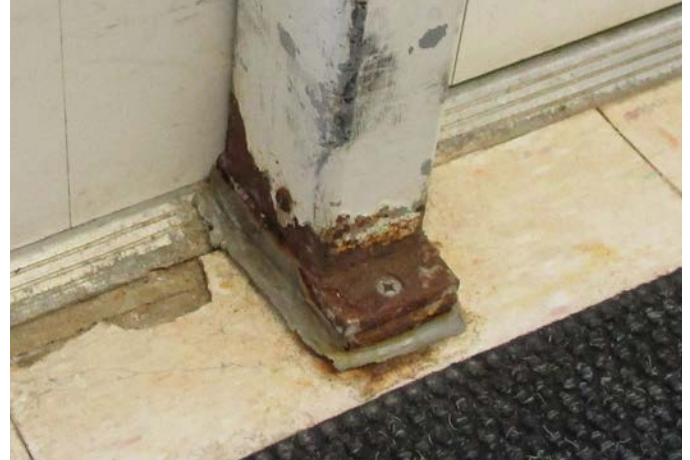
CENTER MULLION AT ALUMINUM DOORS

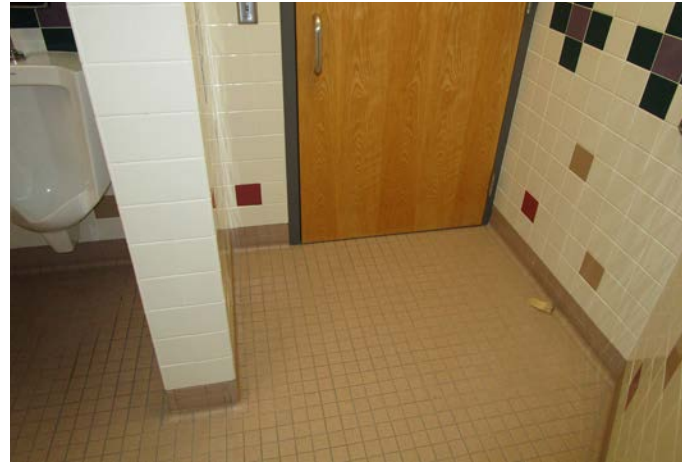
- The adult restrooms across from the Media Center, B132 and B134, contain the proper accessible toilet and lavatory fixtures, however the door leading into the room does not meet the code required pull side clearance of 18" required for wheelchair maneuvering space.

RESTROOM WITHOUT THE REQUIRED
PULL SIDE DOOR CLEARANCE

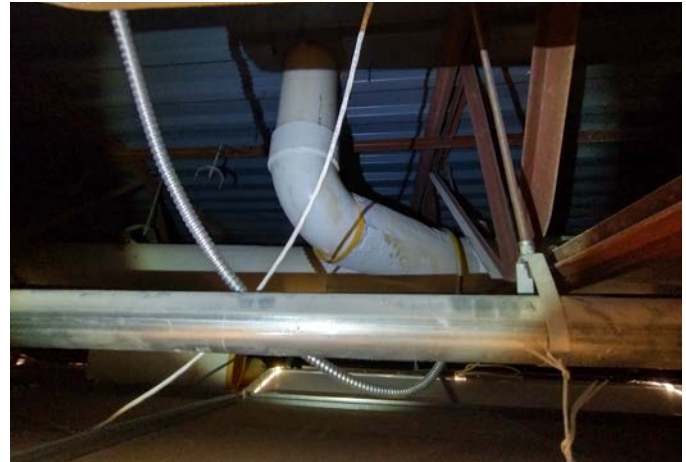
LEAKING ROOF DRAIN

A roof drain located above the art room near the commons, had shown signs of leaking and dripping onto the ceiling tiles located directly below. This was not a major leak by any means, but enough to damage the ceiling tile within the room.

- Repair leaking roof drain above the art room near the commons.
- Main drains discharging to lambs-tongues cause discoloration on exterior of the building.
- Evaluate options for main drain discharging to sidewalk near gym storage.

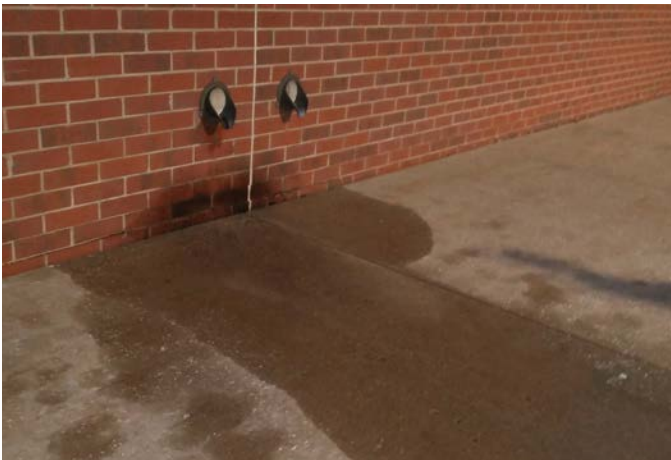
MAIN DRAIN ICE ON SIDEWALK

Overflow storm drainage is accomplished with relief roof drains that terminate above grade, via lambs-tongues, on the exterior of the building. The lambs-tongues which are used as the main drain have caused discoloration and mold growth on the exterior of the building. The main drain coming from the storage area adjacent to the gym, discharges to the sidewalk and could create a slip hazard during the winter freeze/thaw cycles.

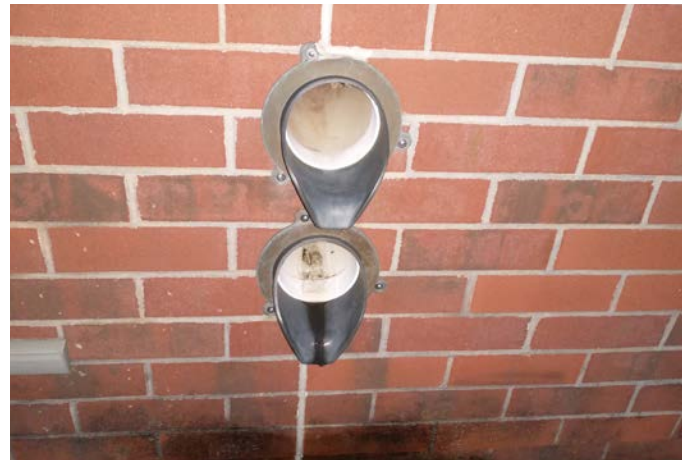
MAIN DRAIN CAUSING DISCOLORATION

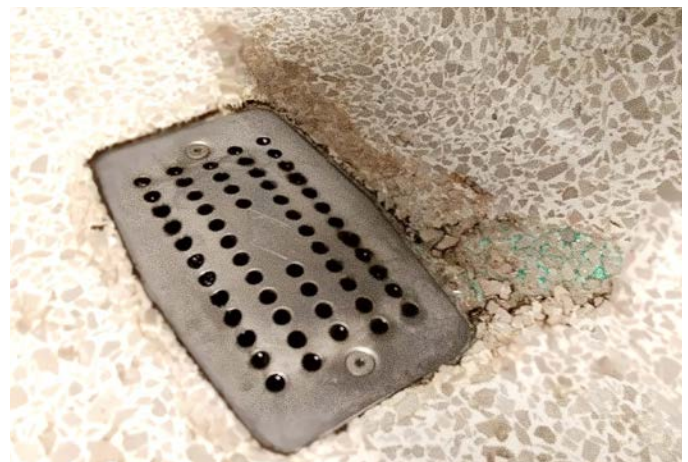
The building has multi station wash fountains in the group restrooms and porcelain lavatories in individual restrooms. The individual lavatories appear to be in good condition. It was noted that at a few of the multi station hand wash fountains, the basin appears to be corroded where water tends to sit for long periods of time. This could lead to leaks in the future.

- Faucets and flush valves are at or near their life expectancy.
- Multi station wash fountains are being corroded where water sits for long periods of time.

WASH STATION CORROSION

- Consider replacement of faucets and flush valves.
- Repair or replace multi station wash fountains prior to leaks forming at drains.

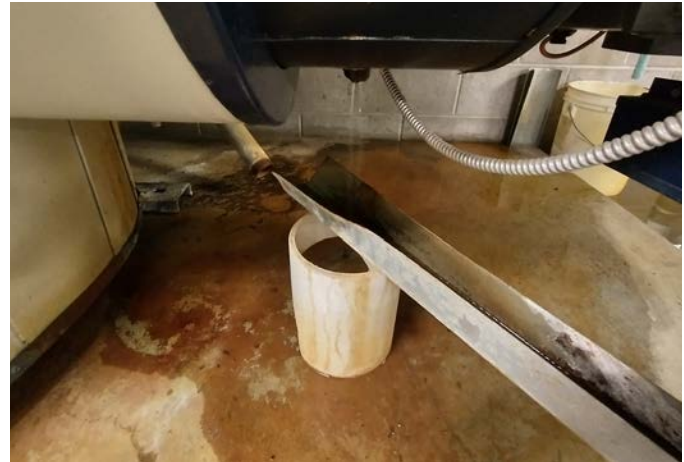
The school has (1) 600 gallon natural gas water heater located in the boiler room. The water heater was installed during the original construction of the school, which puts it at approximately 28 years old. At the time of our site visit, the water heater had a steady stream of water leaking from around the burner unit. The facilities personnel had created a gutter out of sheet metal for the water to flow to the floor drain within the room. This is obviously a waste of water and energy as it is dumping heated water down the drain.

WATER HEATER LEAK

- The water heater is leaking a steady stream of heated water down the drain.

- The water heater should be replaced immediately.
- The recirculation pump has surpassed its expected service life. Consider replacement of the recirculation pump prior to failure as preventative maintenance.

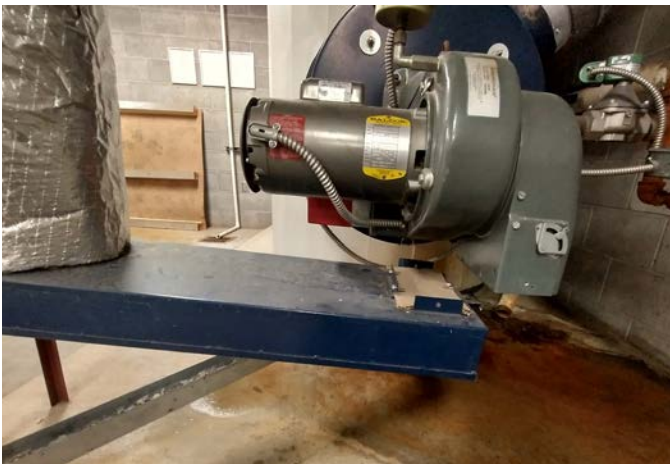
The combustion air ductwork was also disconnected from the burner on the water heater and was hanging freely within the boiler room. The water heater flue also has quite a bit of corrosion leaking from all of the joints. In general, the water heater, burner, and associated ductwork appear to be in poor condition and should be replaced immediately. The hot water temperature delivered from the water heater at the time of our site visit was 130°F.

COMBUSTION AIR DUCTWORK DISCONNECTED

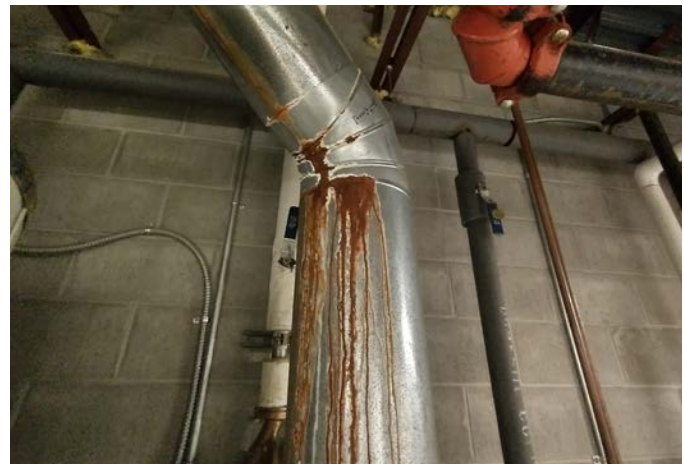
WATER HEATER FLUE

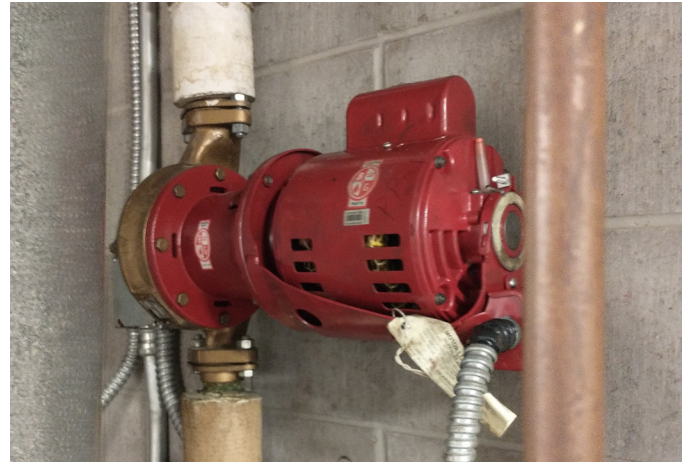
The domestic hot water recirculation pumps appear to be in fair condition, but does have some fluid dripping from the point where the pump and motor connect. The recirculation pumps have surpassed their expected service life and will likely need to be replaced soon.

RECIRCULATION PUMP

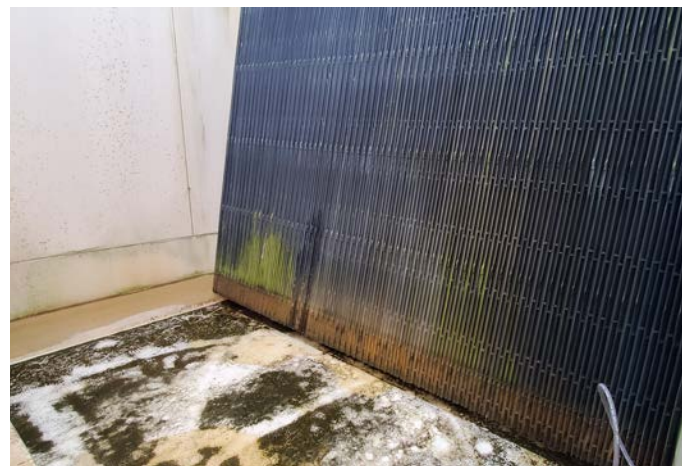
ALGAE GROWTH WITHIN COOLING TOWER MEDIA

- Cooling tower condition is generally poor. Fill material is damaged in places. Evidence of biological growth is present which could be a safety issue for building occupants. The cooling tower basin has rust typical of its age but has evidence of leaking through the basin on to the roof. It is likely that annual maintenance cost for the cooling tower will rise in the coming years.

- While more efficient, water-cooled chillers have a significantly higher cost and maintenance burden than air-cooled chillers. For a facility of this size and the number of days cooled, we would recommend consideration of conversion to an air-cooled chiller when replacement is needed.
- Replace pumps in the near future to improve reliability and efficiency of the water distribution system.
- Perform general preventative maintenance throughout the facility (insulation repair, sensor repair, etc.) to prevent more serious issues in the future.
- Consider adding cooling coils to the gymnasium and locker room air handling units to match the capability of other schools within the district.
- Consider revising the plenum configuration to use the ceiling cavity space for return air instead of egress corridors. Alternatively, consider fully ducting the return air for best performance.

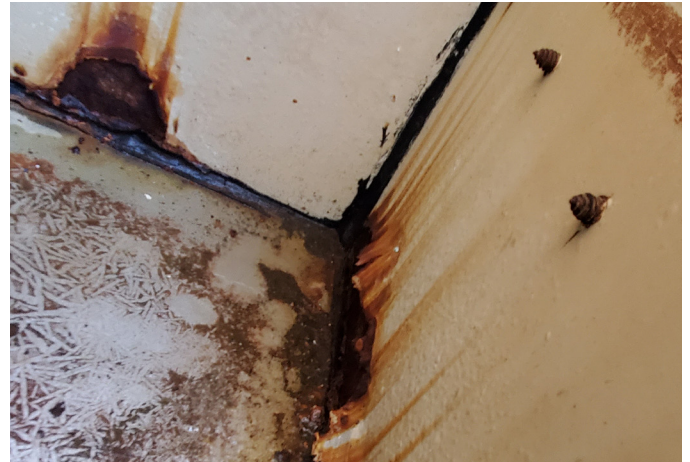
DETERIORATING COOLING TOWER SUMP
