MARCH 2023

Unified School District of De Pere

District-Wide Facilities Condition &
Education Adequacy Assessment

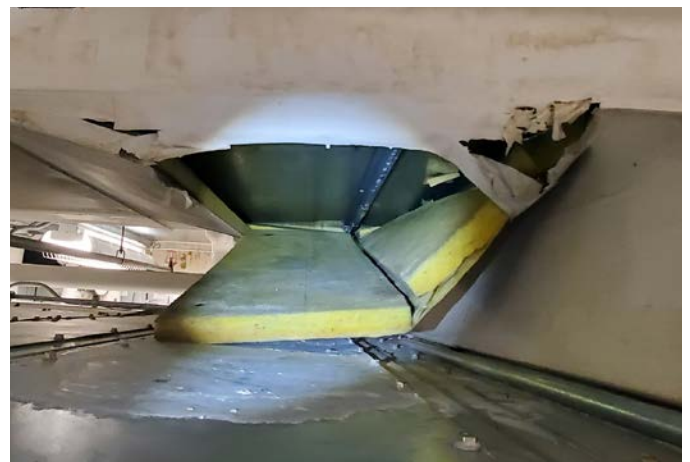
- Excessive positive building pressure was observed during the site visit. It is likely that this is the result of HVAC controls issues, but it is possible that equipment failures are contributing.
- Maintenance burden and cost of chemical treatment is high for cooling tower operation. It is likely that the efficiency gained by using a water-cooled chiller is not justified for this facility size and type.
- Local pressure issues are present, including doors slamming, ceiling tiles being lifted when doors are closed, etc. This is indicative of design issues and is primarily present in the areas renovated in 2016.
- General deferred maintenance items were noted. Items such as failed or abandoned sensors, water leaks, air leaks, etc. were present and prominent. Repair of these items can boost performance and efficiency of the HVAC system.

DUCT INSULATION DAMAGE

- While more efficient, water-cooled chillers have a significantly higher cost and maintenance burden than air-cooled chillers. For a facility of this size and the number of days cooled, we would recommend consideration of conversion to an air-cooled chiller when replacement is needed.
- Replace pumps in the near future to improve reliability and efficiency of the water distribution system.
- Perform general preventative maintenance throughout the facility (insulation repair, sensor repair, etc.) to prevent more serious issues in the future.
- Consider adding cooling coils to the gymnasium and locker room air handling units to match the capability of other schools within the district.
- Consider revising the plenum configuration to use the ceiling cavity space for return air instead of egress corridors. Alternatively, consider fully ducting the return air for best performance.

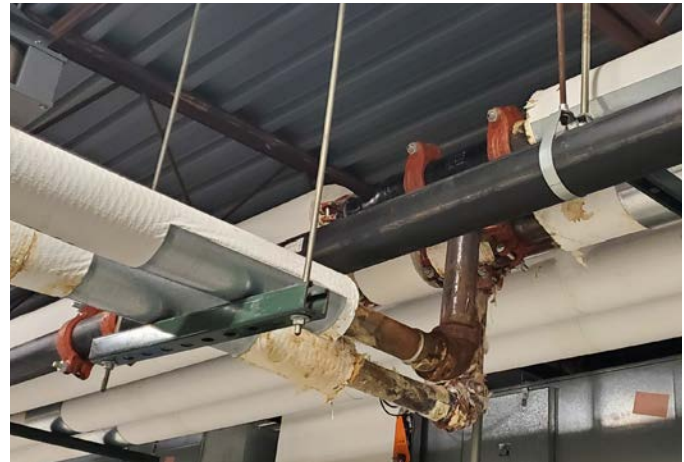
It was noted at several locations that the heating hot water system has been repaired, particularly at Victaulic grooved pipe fittings, due to the development of leaks. At repair locations, insulation has not been repaired or replaced. In addition, it was identified that several terminal coils have been isolated by closing their manual ball valves. An example of this condition occurs within the Art room, where it was noticeably colder during our survey than surrounding rooms.

REPAIRED SEGMENT OF LEAKING PIPING

- General deferred maintenance items were noted, such as pipe leaks, missing insulation, missing sensors, etc. Repair of these items can improve reliability and limit risk of failure of the heating system.
- Secondary pumps are nearing their expected useful life and are likely losing efficiency and reliability due to age.

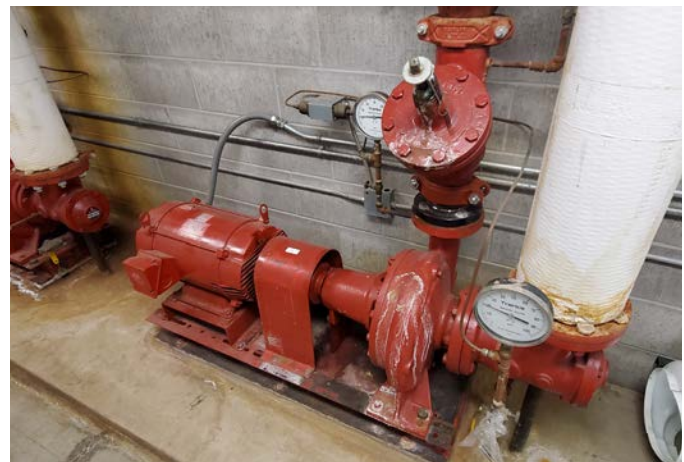
TYPICAL PUMP CONDITION

- Repair apparent condensate leaks within condensing boiler and associated flue.
- Replace secondary heating pumps in the near future to improve reliability and efficiency of the water distribution system.
- Perform general preventative maintenance throughout the facility (insulation repair, sensor repair, etc.) to prevent more serious issues in the future.

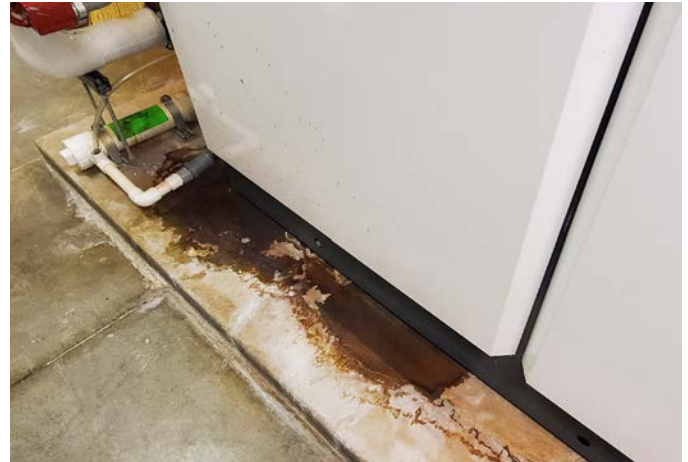
CONDENSATE LEAKING FROM BOILER

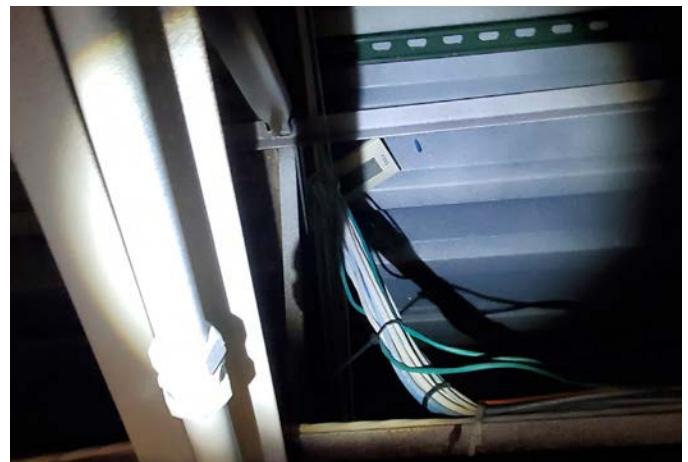
Existing control devices and Trane controllers appear to be abandoned in place throughout the facility. Sensors and control devices vary in condition. Building pressure reference sensors appear to be non-functional, while an outdoor air pressure reference device appears to be installed within the gymnasium. It is likely, due to the previously indicated building pressurization issues, that the airflow sensors, pressure sensors, or HVAC programming is not functioning properly to maintain building pressure. It is also worth noting that several anomalies were present, such as a thermostat installed above the ceiling.

THERMOSTAT INSTALLED ABOVE FINISHED CEILING

- Consider conducting Retro-commissioning survey to “tune-up” and confirm proper operation of all control sequences. This may qualify for a Focus on Energy incentive.
- Recommend hiring a Testing, Adjusting, and Balancing contractor to periodically read out and calibrate outside air airflow measuring stations to confirm accuracy. It is common for this style of airflow measuring station to become fouled with dirt and debris and read artificially low, causing more outside air to be brought in than desired.
- Recommend hiring a Testing, Adjusting, and Balancing contractor to investigate water-side balancing for improved heating performance.

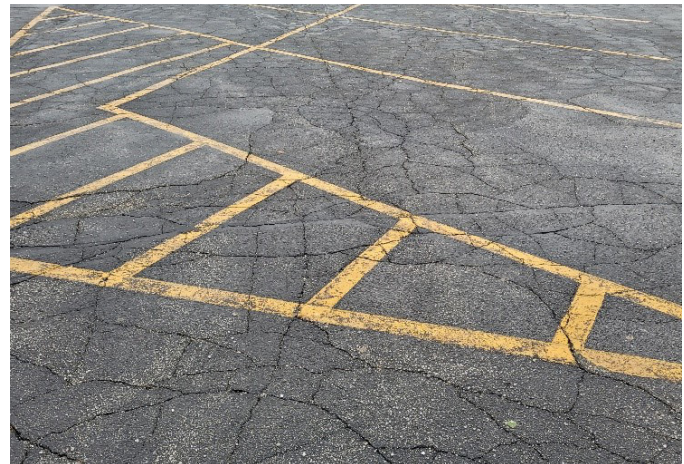
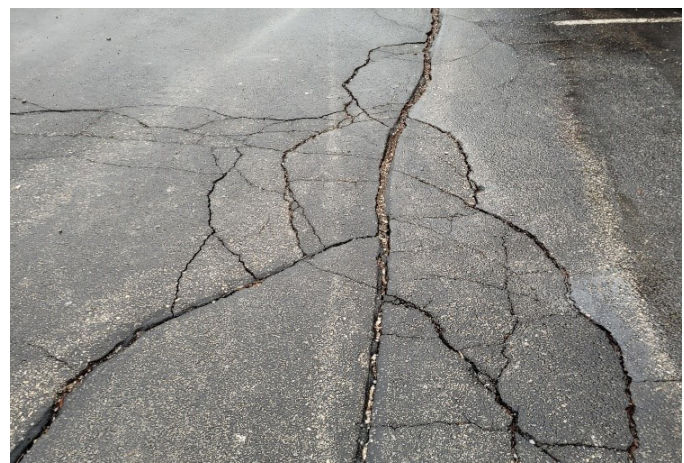
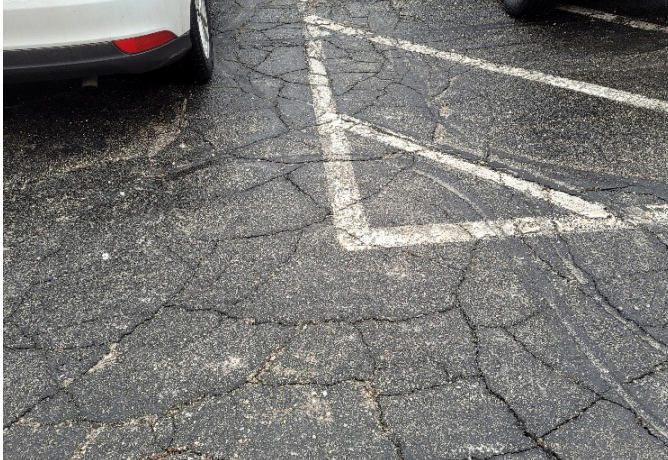
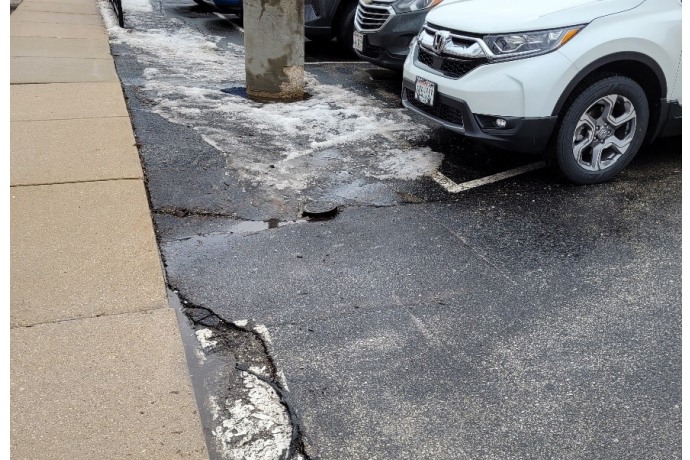
- Many areas have alligator cracking and signs of base failures
- Multiple wide, unsealed, longitudinal and transverse cracks throughout the pavement.

- Remove existing pavement
- Remove 12" of base/subgrade
- 12" of dense base
- Pave 4" of asphalt
- Install pavement markings

- Salvage light poles
- Remove light pole foundation
- Pour new light pole foundation 2.5' closer to fence with additional conduit for future surveillance growth
- Re-assemble light pole on new foundation
 - Allows an additional 2.5' width of through width in parking lot

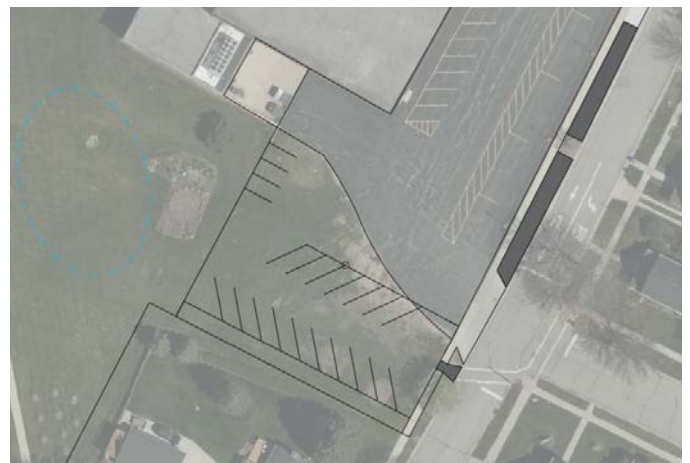
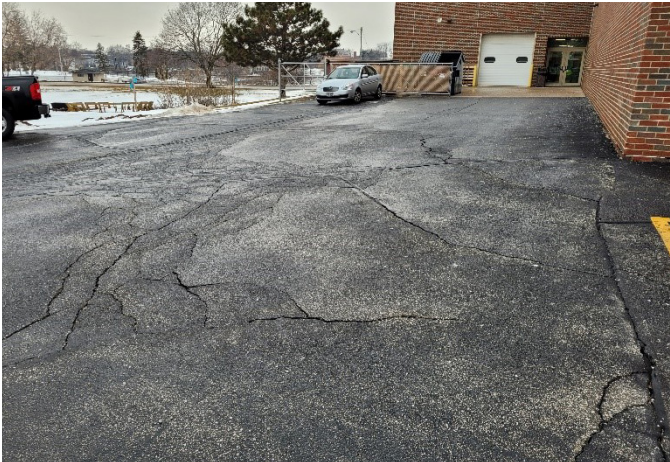
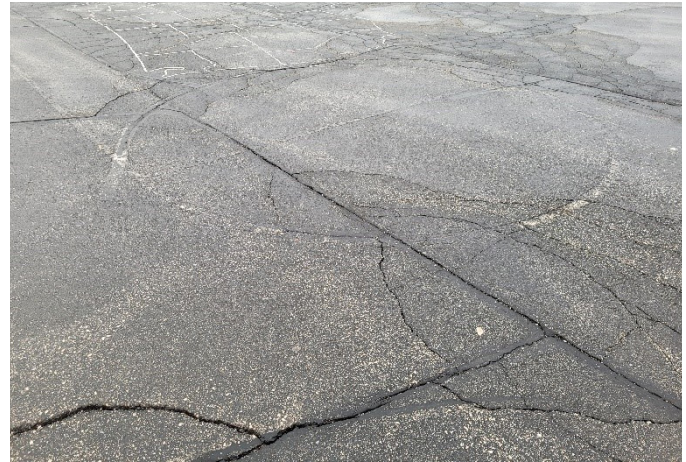
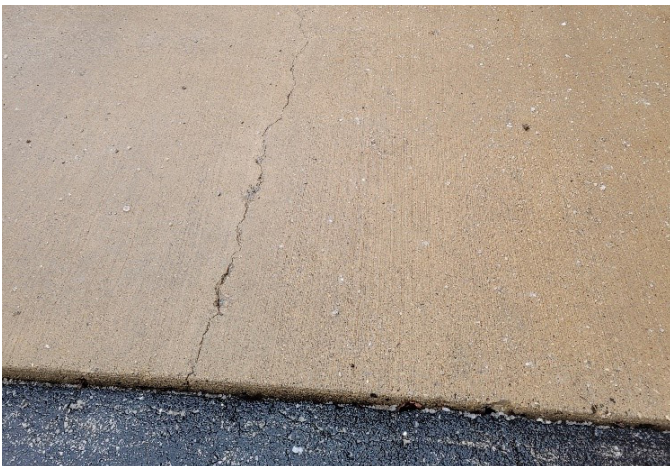
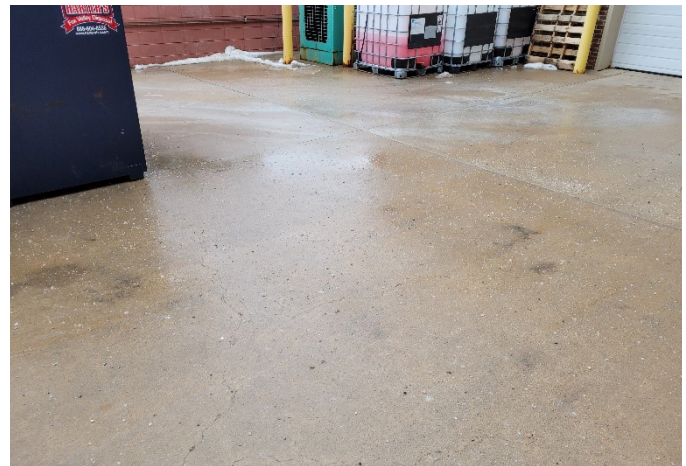
- Settlement and rutting throughout the pavement
- Many unsealed transverse and longitudinal cracks throughout the surface
- Most of the pavement has alligator cracking and signs of the base failing
- Edge of pavement is cracking and breaking off
- Drainage issues were observed during the site visit
- Comments to add additional parking to the SW area of the school

- Concrete pads have narrow/medium cracks
- Some concrete footings are starting to deteriorate and spall on the surface
- Most light pole concrete footings have surface deterioration and one footing appears to be tipping.

- Remove existing pavement
- Epoxy crack filling narrow cracks in concrete pads
- Remove old concrete footings
- Remove and replace basketball hoop and footings
- Remove 18" of base/subgrade

- Install drain tile under the edge of pavement and daylight out to stormwater inlets
- Culvert pipes w/inlets
- Install curb and gutter along to fence to collect runoff
- Stormwater management basin
- Salvage light poles
- Remove light pole foundation
- Pour new light pole foundation 2.5' closer to fence with additional conduit for future surveillance growth
- Re-assemble light pole on new foundation
- Add geotextile fabric
- Add 12" of breaker run
- Add 6" of base
- Pave 4" of asphalt
- Install pavement markings

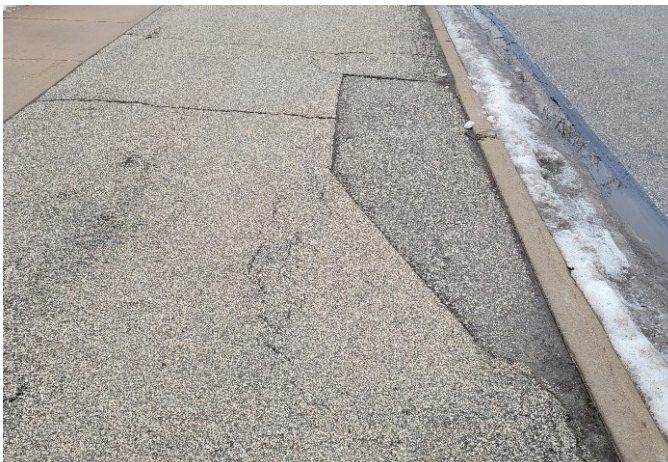
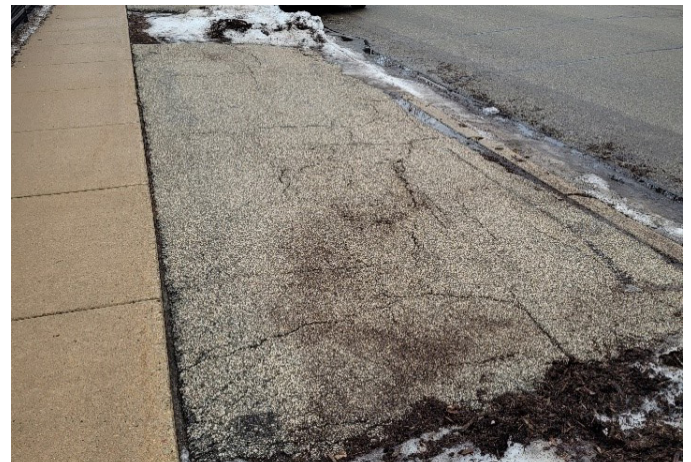
- Multiple unsealed transverse and longitudinal cracks throughout the surface
- Many areas have significant settling
- City requires these areas to be concrete instead of asphalt

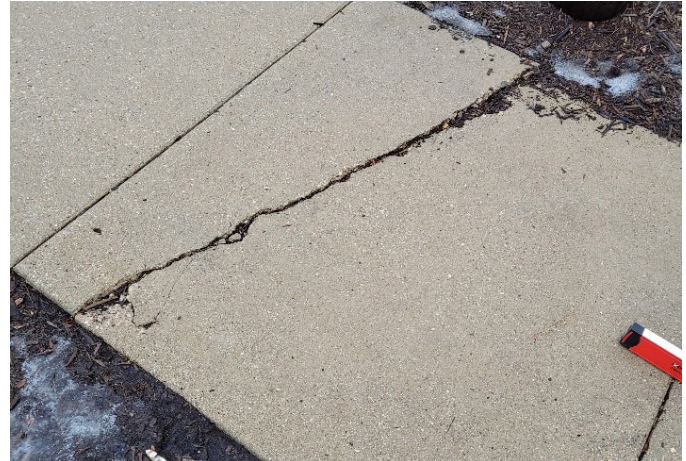
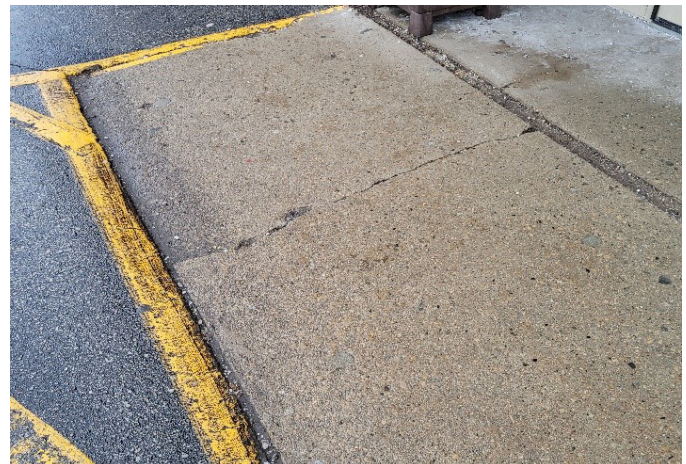
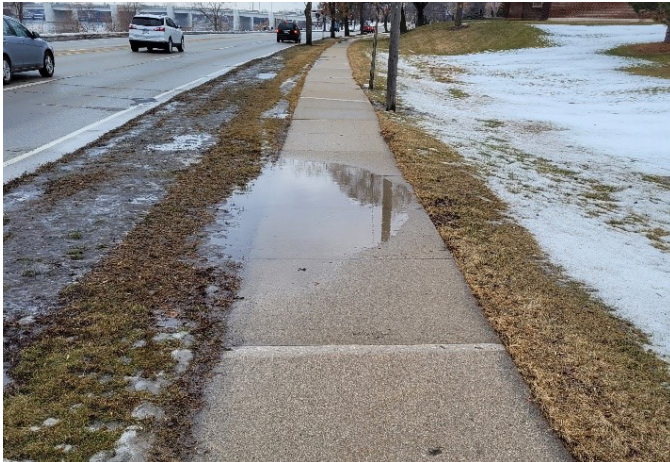
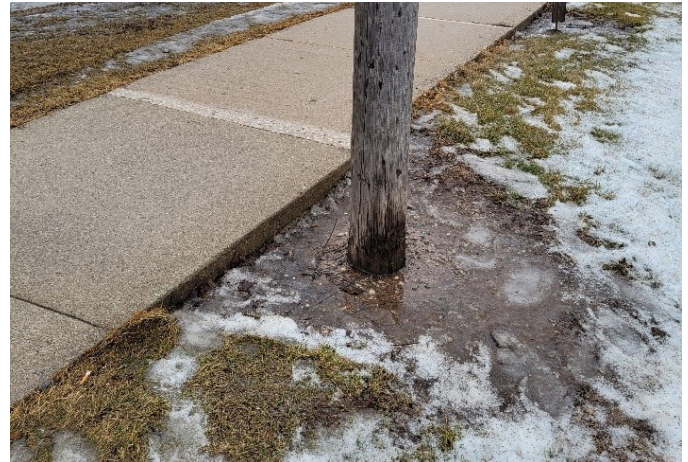
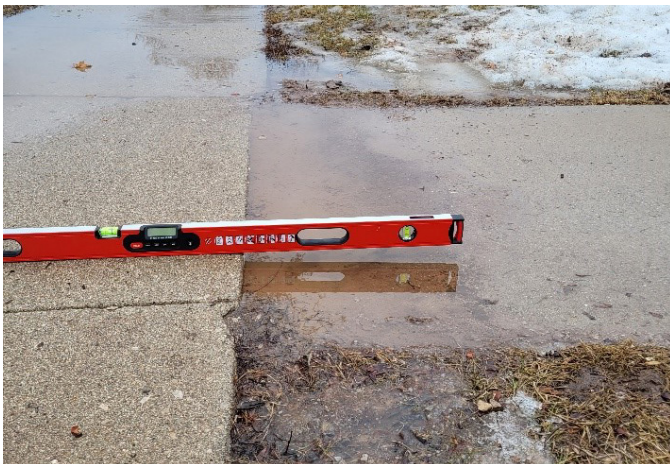
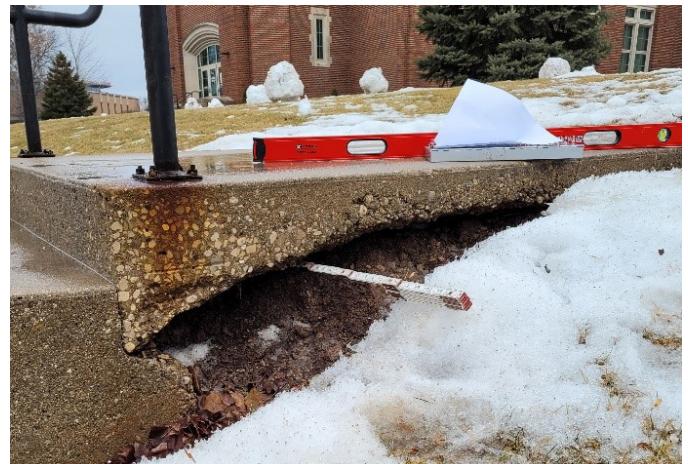
- Multiple concrete panels cracked and some with minor spalls
- Many concrete panels with a vertical deviation greater than ½"
- Multiple concrete footings at entrances have medium cracks
- Some concrete panels joints are deteriorating with a 2" wide gap
- Multiple areas along Broadway St have standing water on sidewalk
- Some areas along side of the sidewalk have material washed out and a 4"-6" drop off
- Significant undermining on the stairs on the west side of the school
- NE concrete apron entrance is deteriorating and heaving

- Remove concrete pavement
- 4" concrete sidewalk
- Epoxy crack filling narrow cracks
- Drainage Improvements
- Replace stairs and railing on the west entrance of building
- Remove and replace medium/wide cracked or spalled panels
- Remove and replace concrete sidewalk panels that have a vertical deviation greater than ¼"
- Remove and replace damaged concrete entrance aprons
 - Remove adjacent 2-3 concrete sidewalk panels
- Remove and replace concrete sidewalk along Broadway St to correct slopes and eliminate standing water

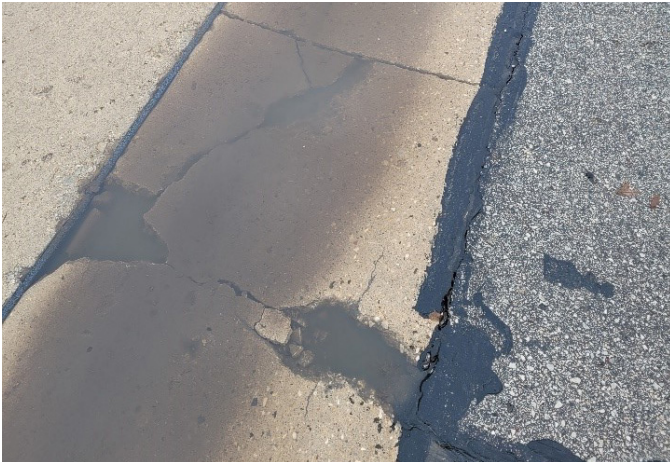
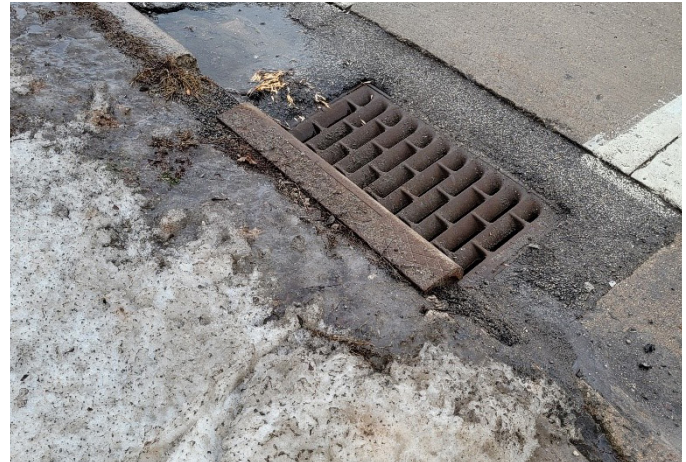
CURB & GUTTER

- Multiple sections have cracks through the curb and gutter.
- Multiple areas of curb and gutter have medium abrasion and spalls
- Some sections of curb are settling and tipping

- Remove and replace all damaged curb and gutter areas

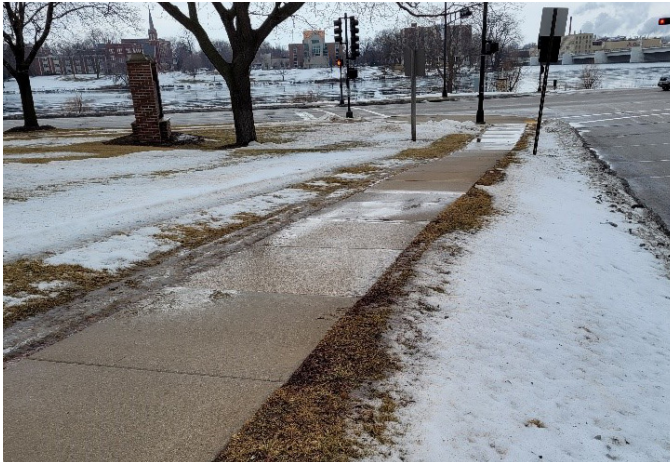
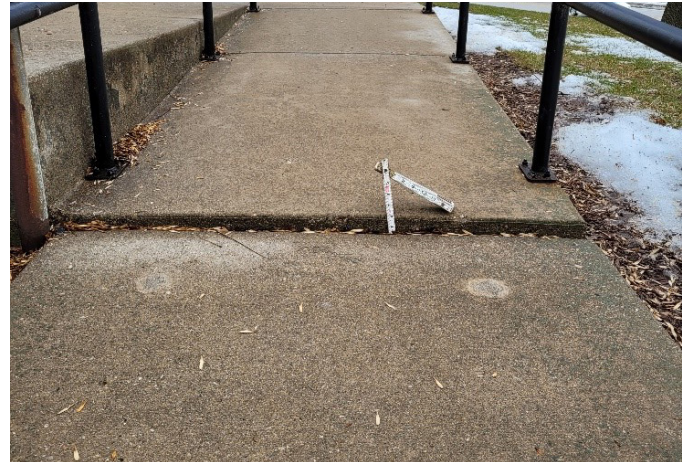
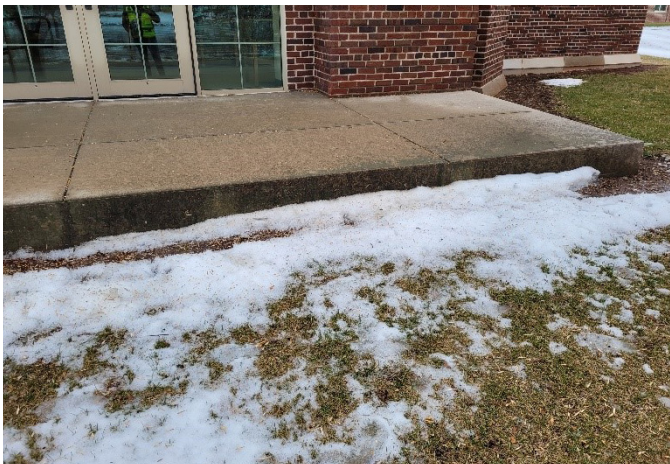
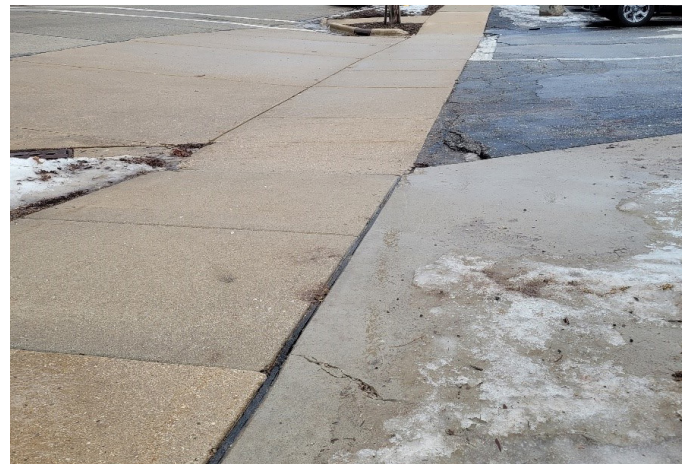
- The concrete sidewalk on the NW corner the school, near intersection has a slope of 1:14. This section of sidewalk exceeds the maximum slope of 1:20 and the max rise of 30" before a landing pad or railing needs to be installed.
- There is a section of a sidewalk ramp with railing that has a panel of sidewalk that has settled 1-3/4".
- North entrance sidewalk leading into the concrete apron exceeds to maximum slope of 1:20.

- Remove and replace panels with adequate landing areas.
- Removed and replace concrete panel in the SW entrance to eliminate the vertical deviation greater than $\frac{1}{4}$ ".
- Grading around SW entrance with raised concrete to eliminate drop off
- Remove and replace concrete entrance apron to achieve adequate slopes for adjacent sidewalk panels.
 - Remove adjacent 2-3 concrete sidewalk panels

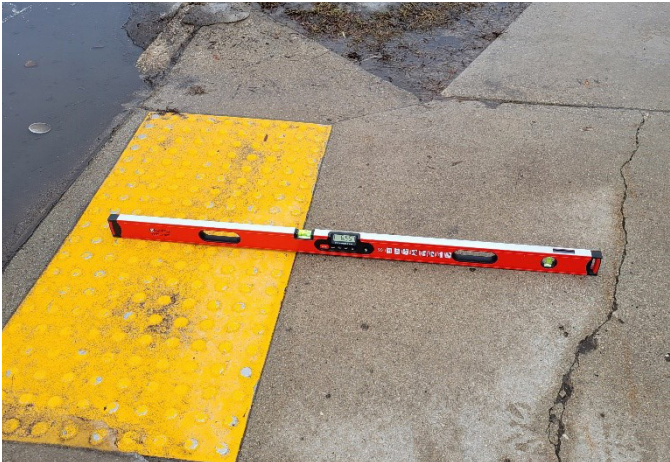
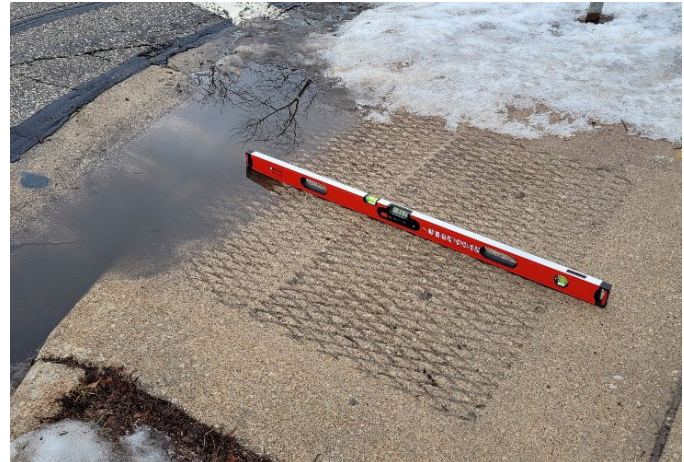
- 7 curb ramps on site do not meet the requirements for ADA Compliance. Slopes are too steep or there is a vertical deviation greater than a ¼” where it meets the pavement.
- Multiple missing detectable warning fields.
- Some of the detectable warning fields have lost all paint and domes are starting to deteriorate

- Remove and replace non-compliant curb ramps
- Install detectable warning fields

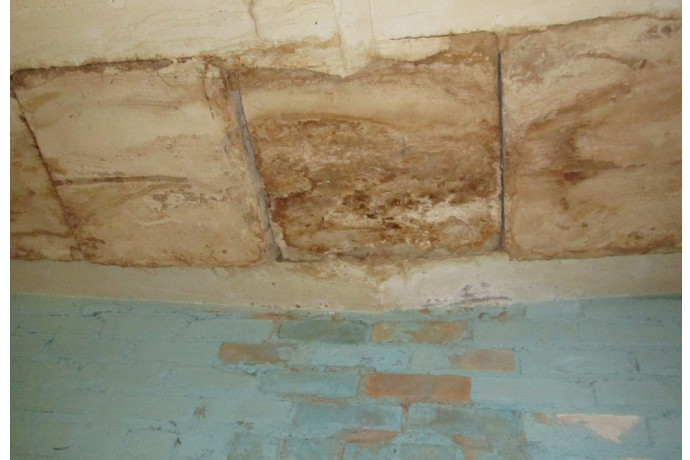
- In the 1939 auditorium, the concrete block roof structure of the balcony storage room shows signs of prolonged water infiltration at the underside of the roof and on exterior walls.
- The wall above the doorway shows flaking paint and chalky plaster, also with signs of water infiltration. This wall continues up and emerges outside the building and receives two different roof planes flashing into the wall.

PROLONGED WATER INFILTRATION ON THE CEILING

- Structural issues related to water infiltration are currently being addressed based on conditions documented by Specialty Engineering Group. See section below.

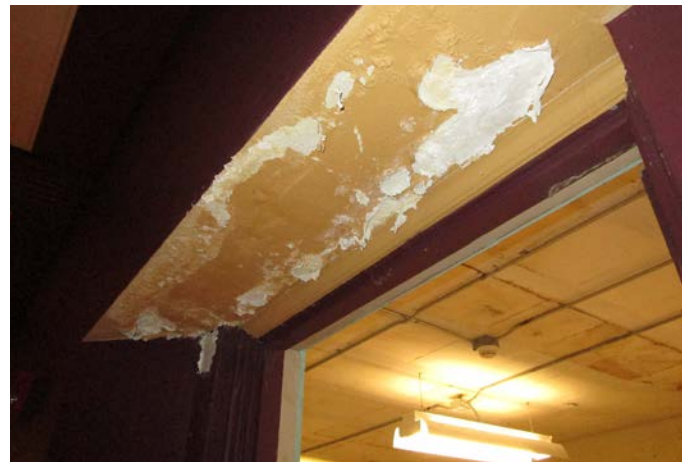
WATER INFILTRATION BEHIND THE PAINT

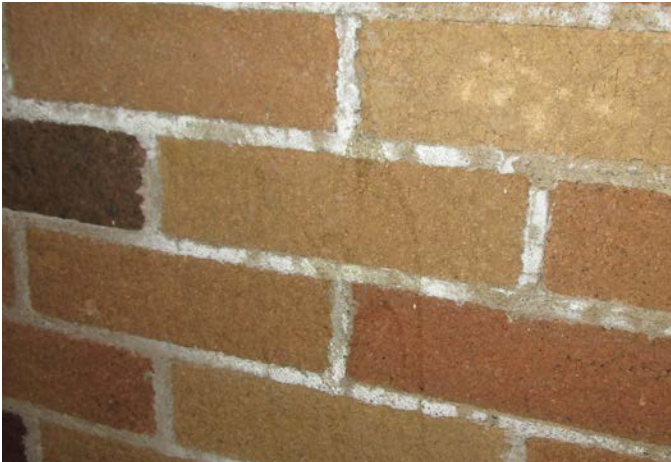
- A 2014 Industrial Roofing inspection found step cracking in various areas of mass wall construction in the 1930's buildings, as well as deterioration of sealant joints at the stone window sills. In June of 2021, Specialty Engineering Group conducted a Building Envelope Assessment. The report indicated the following issues: weathered and failed sealants; damage at brick masonry including cracked and spalled brick units, weathered and unbonded mortar joints, damage at limestone masonry accents including cracked, spalled, and shifted stone units and weathered and unbonded mortar joints. At the auditorium, moisture is being pulled into the building and evaporating leaving behind a whiteish powder in a process called efflorescence.

EFFLORESCENCE ON THE INTERIOR OF THE AUDITORIUM

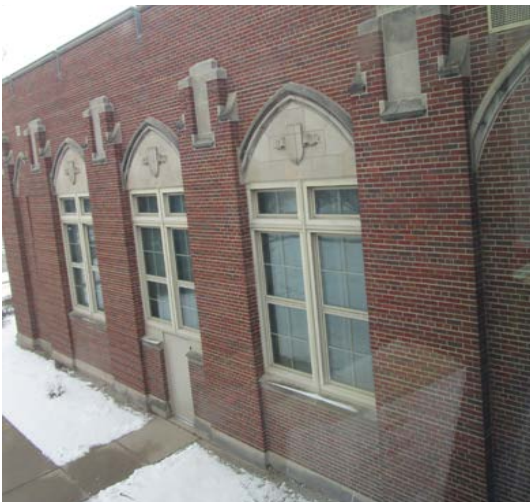
- As identified in the 2021 Specialty Engineering Group report, and noted by staff during our assessment, leaking is occurring at several ceiling locations where walls are adjacent to lower roof to upper roof transitions. As brick is a porous material, absorbing water, the leaking can be traced back to deficiencies in the brick masonry construction and lack of proper flashing and drainage channels within the walls. This is confirmed by staff comments that not all locations are leaking during all rain events and varies depending on the direction of wind driven rain.

EXTERIOR VIEW OF THE AUDITORIUM, AND A CONSTRUCTION DOCUMENT FROM SPECIALTY ENGINEERING GROUP NOTING WORK TO REPLACE SEALANT, TUCKPOINTING MORTAR JOINTS, REPLACING LIMESTONE TRIM, AND RE-GASKETING WINDOW SEALS.

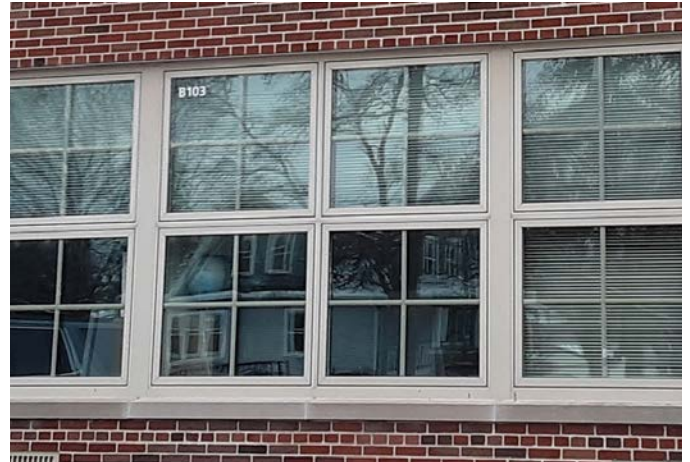
EXTERIOR ALUMINUM CLAD WOOD WINDOWS

- Replace all the aluminum clad wood windows with thermally broken, all-aluminum frame, and argon filled 1" insulated glazing panels.
- Phase 1 and 2 of the Specialty Engineering Group exterior envelope rehabilitation will address the water infiltration around the sides of the window. However, the thermal performance of the system is still a single pane of uninsulated glazing.

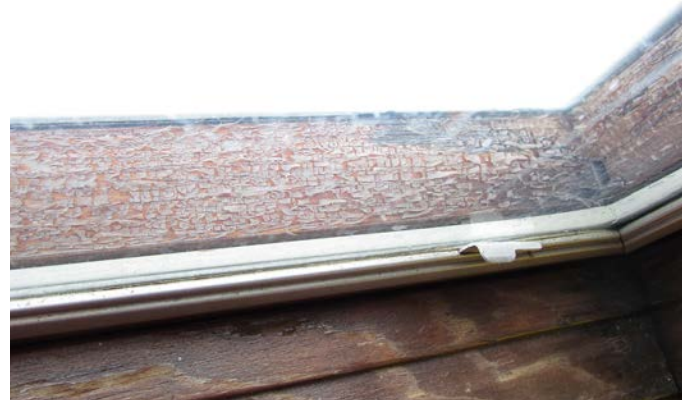
WOOD WINDOW FRAME WITH DELAMINATED POLYURETHANE FINISH IN THE CAVITY BEHIND THE STORM GLASS

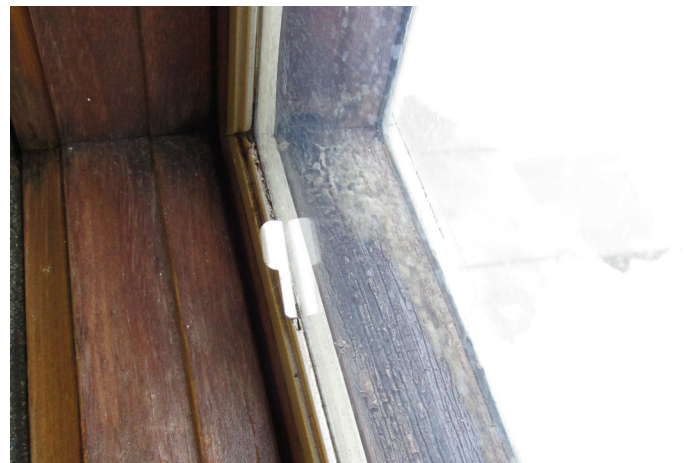
VIEW OF MOLD WITHIN THE CAVITY

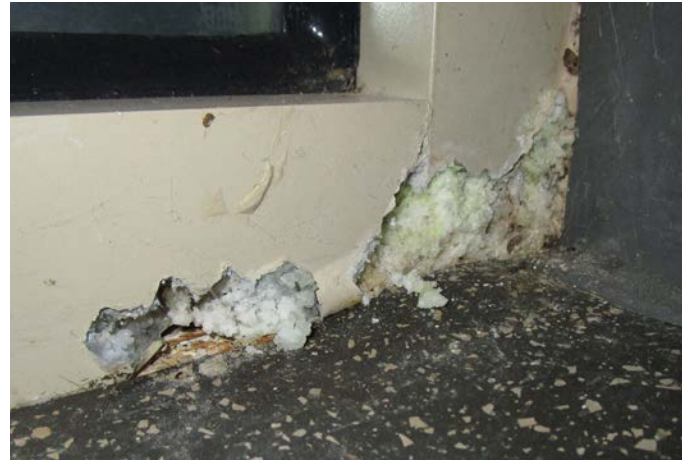
- The school has a combination of aluminum, and hollow metal doors and frames. The aluminum doors and frames are at primary entrances, and the hollow metal are at emergency exits. A majority all of the exterior hollow metal door frames are showing rust and corrosion at the threshold where they meet the concrete. Exposure to salt laden water is the key factor leading to this deterioration.

AT THE NORTHEAST ENTRY ALUMINUM DOORS

- The rusting of the hollow metal door frames and corrosion of the aluminum frames will likely worsen in the coming years. In all probability, they all will need replacement within the next 5 years. Fiberglass reinforced plastic is a good alternative to hollow metal and will not rust like the existing frames.

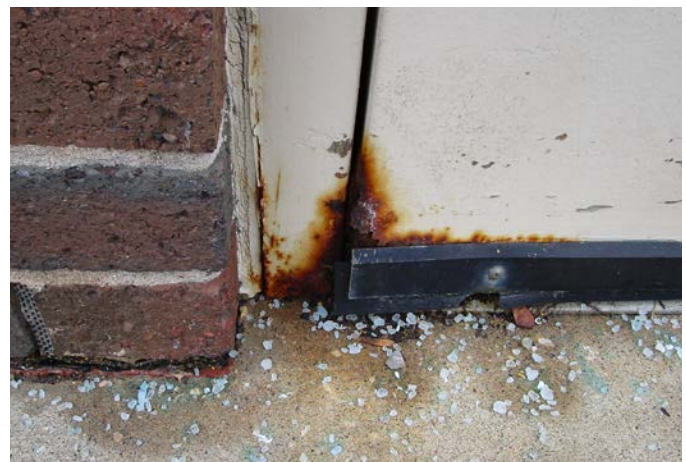
AT THE EAST GYM EXIT DOORS

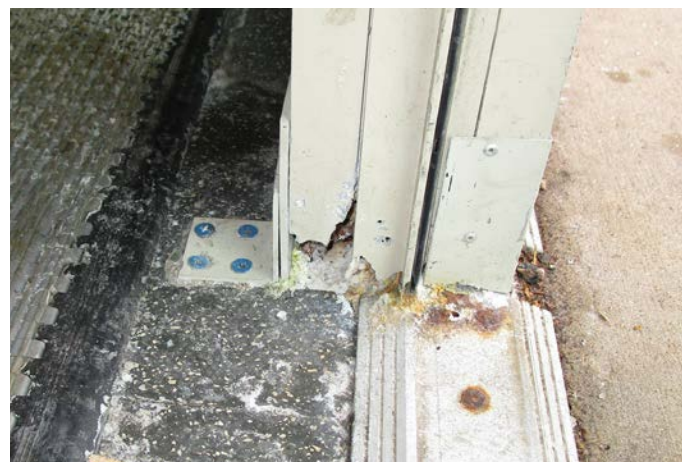
ATTEMPTS HAVE BEEN MADE TO FIX THE FRAMES

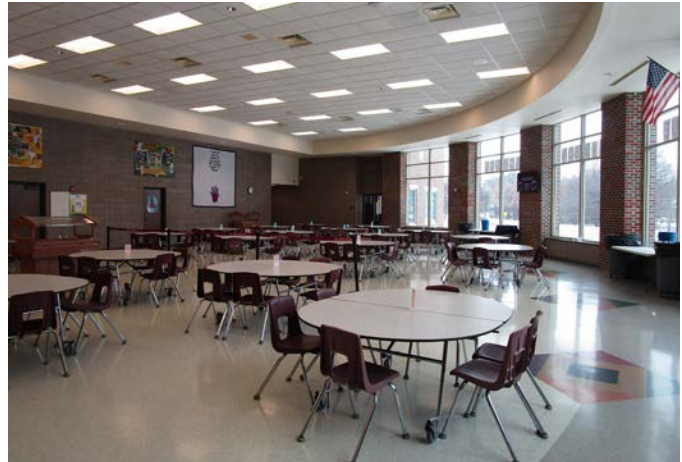
VIEW OF COMMONS

- The Commons has vinyl composite tile flooring which staff reports is at the end of its serviceable life. The building expansion joint through the Commons was not honored causing the vinyl to crack along the joint extending the entire width of the room.

- Common flooring should be replaced within the next 5-10 years.

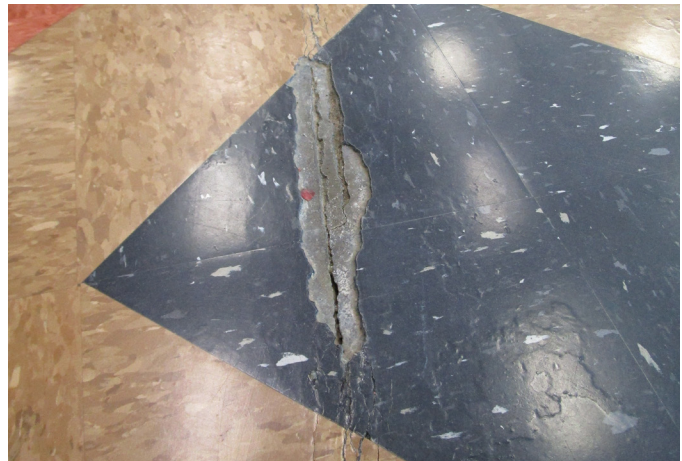
VCT FLOORING CRACKED OVER CONCRETE JOINT

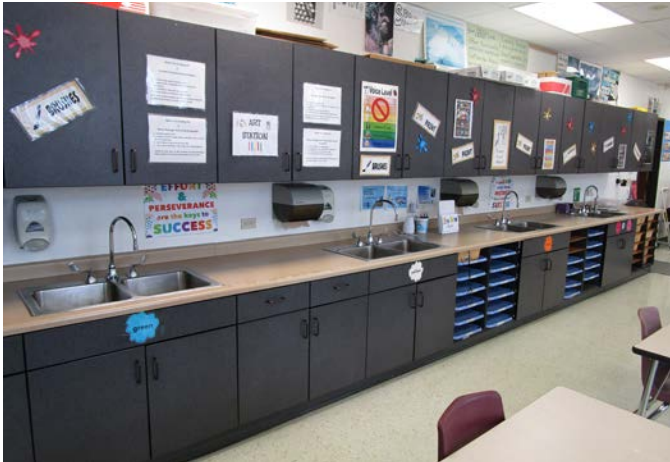
- The art room does not have any sinks which meet ADA for roll under access. In addition, the plastic laminate countertop has cracked in back of the sinks and extends the entire length of the countertop.

ART ROOM CASEWORK WITHOUT ADA SINK

- Replace the Art room sink countertop and remodel a minimum of one sink station to meet ADA for roll under access.

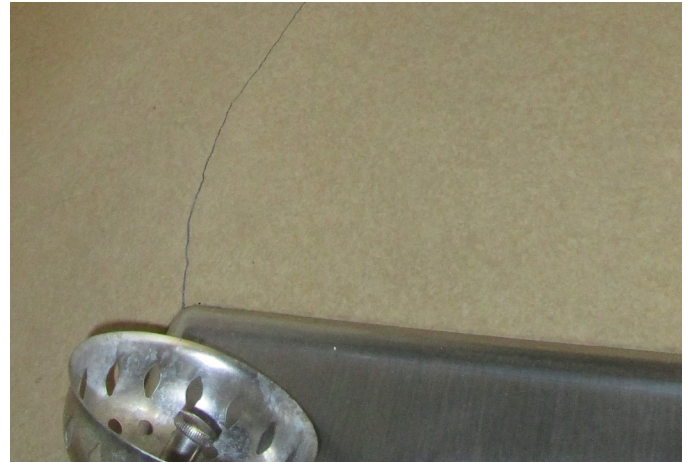
CRACKED PLASTIC LAMINATE COUNTERTOP

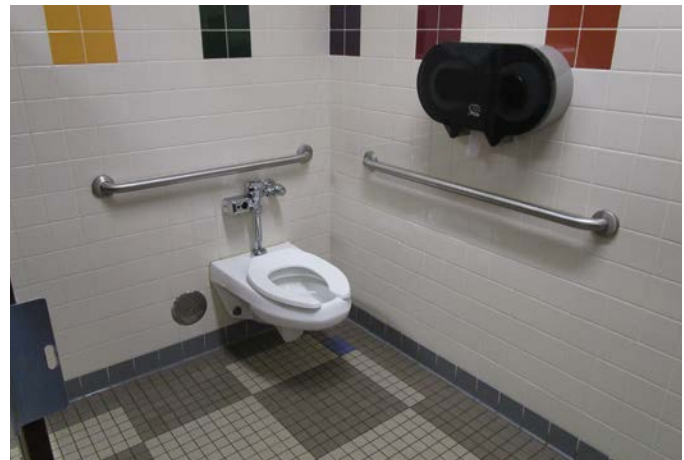
Restrooms were remodeled in 2001 and are in good condition, with the proper ADA toilet stall dimensions and are only missing the vertical grab bar where the current toilet paper dispenser is located.

ADA TOILET MISSING VERTICAL GRAB BAR

- Remove and relocate existing toilet tissue dispenser, install code compliant vertical grab bar to all ADA assessable toilets rooms and stalls.

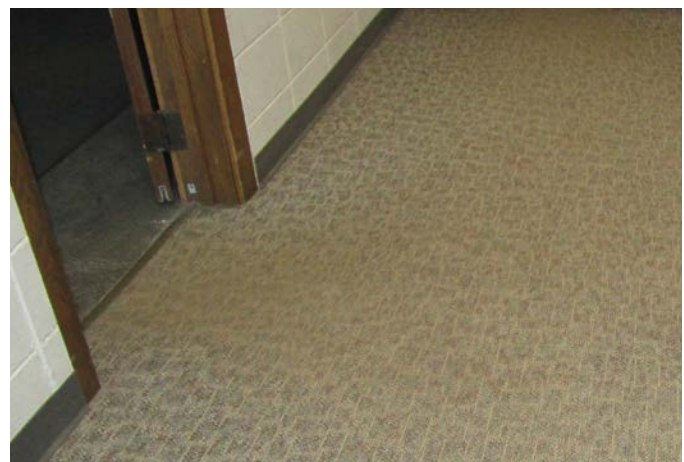
These offices are in good condition except for the same window issues mentioned earlier. There are, however, dirty carpet wear patterns beginning to show at the main office entry.

CARPET AT MAIN OFFICE ENTRANCE

- The main entry into the office should receive new carpet in the high traffic area in front of the receptionist's desk.

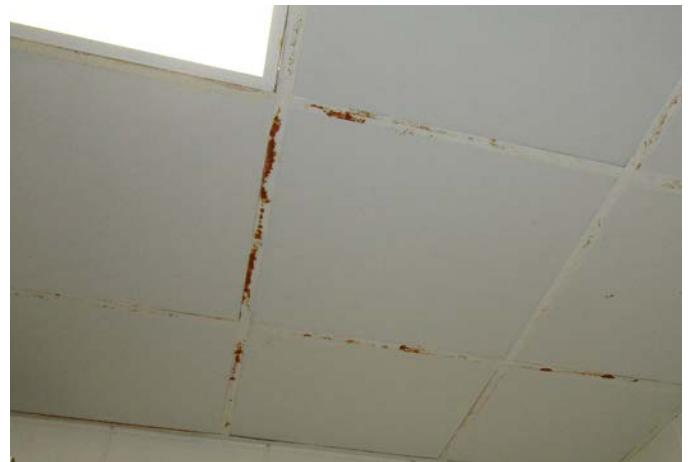
RUSTING CEILING GRID

- The steel grid of the suspended ceiling in the dish room is rusting.

- The suspended ceiling in the dishwash room should be replaced with a new system of aluminum grid and vinyl covered gypsum panels.

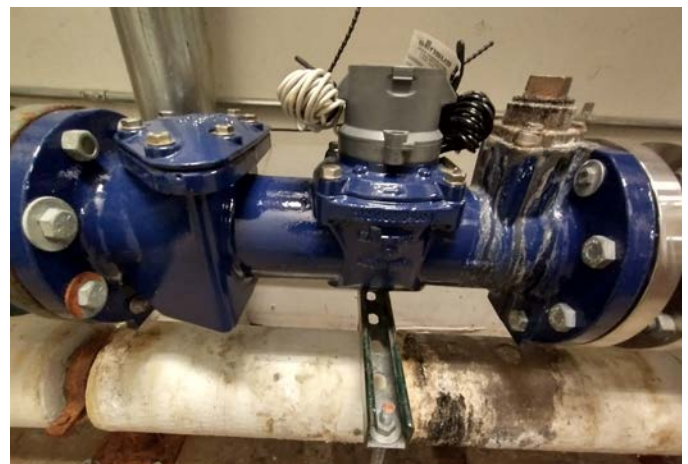
WATER METER

The water service lateral is a 4" diameter main which enters the building from Merrill St. The existing water meter is a 4" meter with a 4" diameter bypass. The water meter appears to be leaking from one of the test ports, and dripping on the piping, and insulation below. The water pressure observed on the day of the site visit was 52 psi. This pressure reading was taken on an existing pressure gauge near the booster heater in the kitchen.

- Repair the leaking service port on the water meter

- Replace damaged insulation near water meter after water meter leak is fixed.

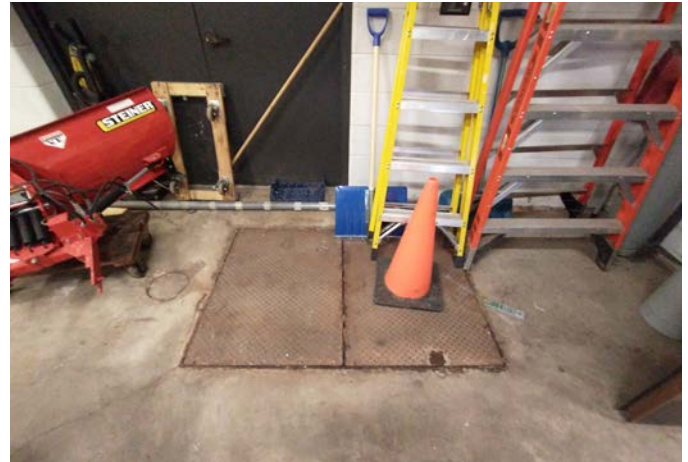
GREASE INTERCEPTOR

The school has a grease interceptor which is located in the receiving area. The facilities staff indicated that the cover is in poor condition and should be replaced. They also mentioned that the last time the grease interceptor was pumped out, the internals of the interceptor appeared to be in fair condition.

- The cover of the grease interceptor is in poor condition and sanitary smells often get into the receiving area.

- Replace the grease interceptor with an updated style which will tolerate chemicals used in the dishwashing equipment.

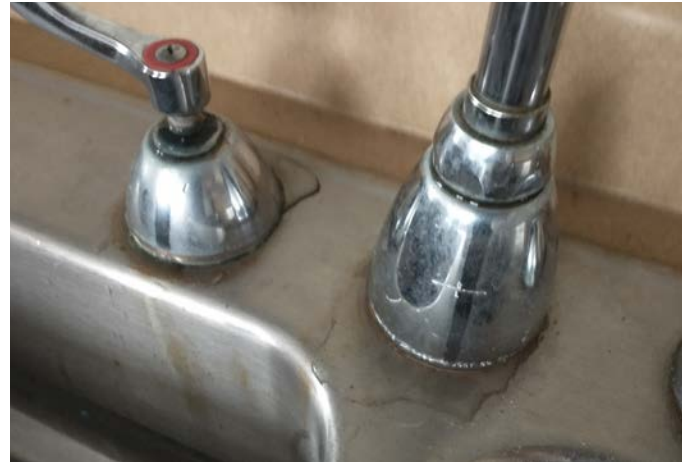
The stainless steel sinks within classrooms are in fair condition. Some sink spouts are very loose and will require maintenance. Some faucet goose necks have minor leaks, which pool at the base of the faucet and leave a calcium deposit.

CALCIUM DEPOSIT AT BASE OF FAUCET

- Consider replacement of faucets and flush valves.
- Consider replacing drinking fountains with a more vandal proof style fixture.

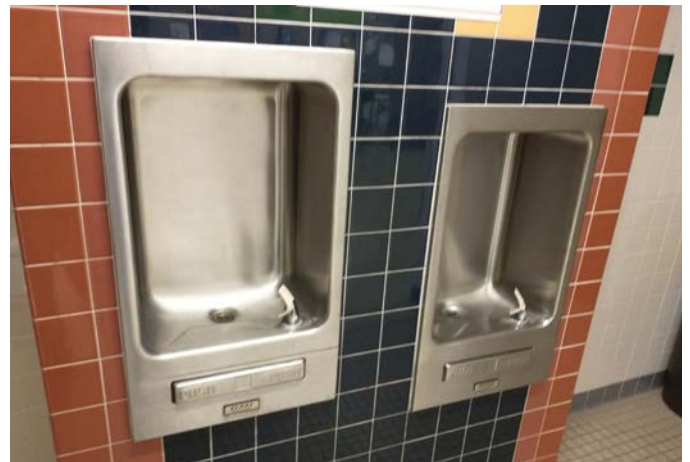
DRINKING FOUNTAIN

The school has several sets of water cooler and bottle fill stations, these fixtures appear to be in good condition. Facilities staff indicated that the style of drinking fountain which is inset within the wall causes issues at times. The push button on the face of the drinking fountain gets hit by students and ends up sticking. The other issue occurs when children twist the bubbler at the spout, which kinks the pipe inside the drinking fountain and causes leaks. The facilities staff indicated that this is more of a behavioral issue and is being resolved with student observation.

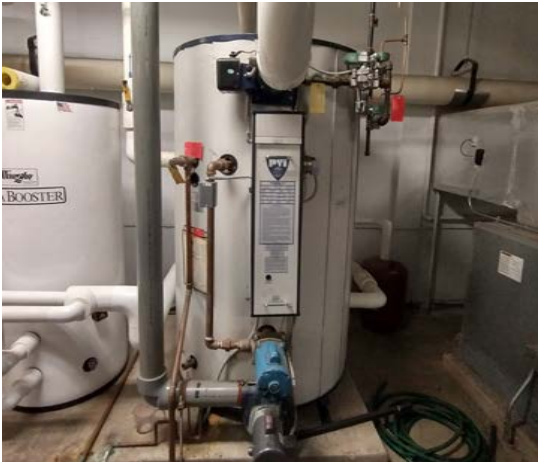
WATER HEATER

The school has (1) 250 gallon natural gas water heater located in the boiler room. The water heater was installed during the 2001 renovation which puts it at 22 years old. This water heater is at the end of its expected service life and should be replaced soon.

- The water heater has surpassed its expected service life. Consider replacement of the water heater prior to failure as preventative maintenance.
- The recirculation pumps have surpassed their expected service life. Consider replacement of the recirculation pump prior to failure as preventative maintenance.

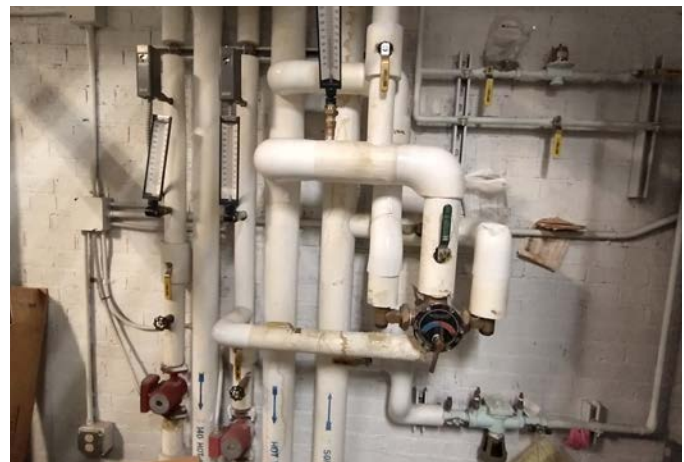
THERMOSTATIC MIXING VALVE AND RECIRCULATION PUMPS

The 140°F and 120°F domestic hot water recirculation pumps appear to be in good condition. However, they are at the end of their expected service life and will likely need to be replaced soon. The recirculation loops appear to be meeting the original design intent by keeping water temperatures consistent throughout the school.

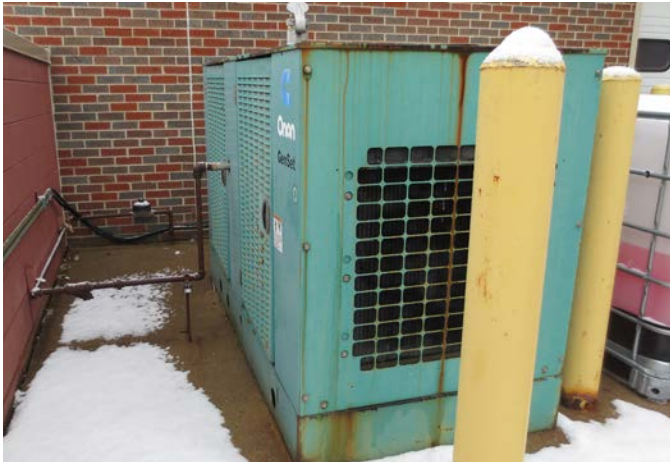
GENERATOR

The generator is a 277/480V, 30 KW, natural gas unit manufactured by Cummins. This unit mainly feeds Life Safety branch circuits through one automatic transfer switch located on second floor mechanical room. Power circuits which are backed up by the generator include: emergency corridor lighting, exit signage, Area of Rescue devices, fire protection alarm bell, and power operated doors. This existing generator is budgeted for replacement of this school year 2023.

- This existing generator is budgeted for replacement this year, 2023; based on conversations with school staff.
- Continue Generator maintenance. Regular scheduled maintenance is of high importance since this is a system that will energize other operating systems within the building (fire alarm, security, etc.) when there is a normal power outage.
- Generators typically have a service life of approximately 20-25 years, with the issue of finding replacement parts that will keep the generator operating properly.

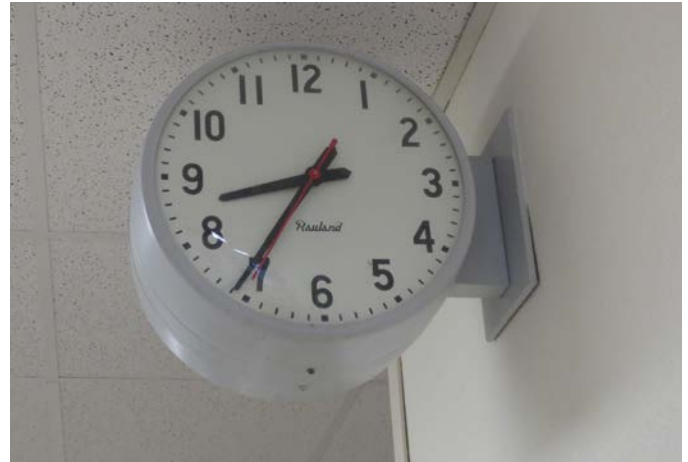
TYPICAL CLOCK

- Clock system is outdated and finding replacement parts and service is challenging.
- Paging system is controlled through the clock system.
- Security system has some communication issues at a couple door locations. Currently, the system is not able to unarm doors when the doors are in the OFF schedule mode.
- Existing floor boxes in Commons are abandoned and not used.

- Replace existing clock system with modern technology for more reliability and serviceability. Possibly a wireless/GPS system.
- Provide new paging system and utilize phone/VoIP for communication.
- Verify Security system operations with the local vendor on record as the installer, to have them perform a system test of proper terminations and programming.
- Existing floor boxes in Commons are considered a tripping hazard and cleaning obstacle. These devices should be removed and the flooring made flush with adjacent surface.
