MARCH 2023

Unified School District of De Pere

District-Wide Facilities Condition &
Education Adequacy Assessment

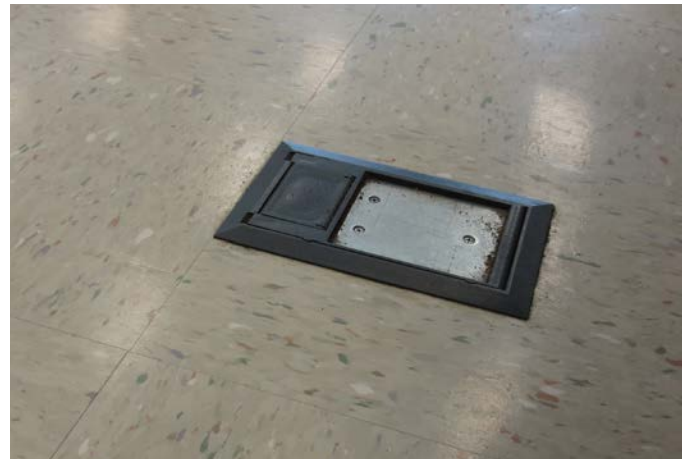
- Clock system is outdated and finding replacement parts and service is challenging.
- Paging system is controlled through the clock system.
- Security system has some communication issues at a couple door locations. Currently, the system is not able to unarm doors when the doors are in the OFF schedule mode.
- Existing floor boxes in Commons are abandoned and not used.

UNUSED FLOOR BOX (TYP.)

- Replace existing clock system with modern technology for more reliability and serviceability. Possibly a wireless/GPS system.
- Provide new paging system and utilize phone/VoIP for communication.
- Verify Security system operations with the local vendor on record as the installer, to have them perform a system test of proper terminations and programming.
- Existing floor boxes in Commons are considered a tripping hazard and cleaning obstacle. These devices should be removed and the flooring made flush with adjacent surface.

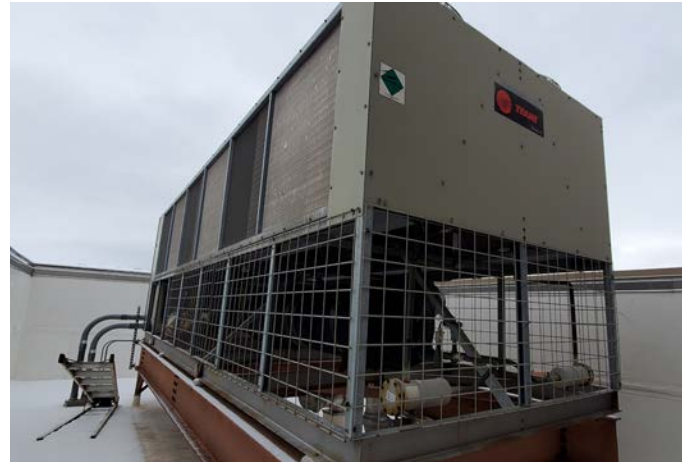
AIR-COOLED CHILLER HAS EXPERIENCED
MULTIPLE FAILURES

Chilled water for cooling and dehumidification is provided by a single 215-Ton nominal size Trane air-cooled chiller, located on the roof of the single story receiving area. This system circulates a mixture of 30% Ethylene Glycol to chilled water coils on each air handling unit. In discussion with facilities staff, the chiller has experienced multiple failures and has a significant repair project planned for spring 2023. The chilled water distribution system is a primary-secondary pumping configuration, which provides consistent flow through the chiller with varying system demand conditions. A single pump is provided for each primary chilled water and secondary chilled water, so the failure of either pump will prevent circulation of chilled water through the facility. Chilled water piping within mechanical rooms is welded carbon steel, but distribution throughout the facility is via Schedule 40 PVC pipe which is generally not as durable as carbon steel piping. At least one active leak was noted in the PVC piping above Girl's Restroom A207. Several locations within mechanical rooms were identified in which insulation has been removed from chilled water piping to fix leaks, but has not been replaced. This will lead to faster deterioration of chilled water piping and accessories due to condensation on piping.

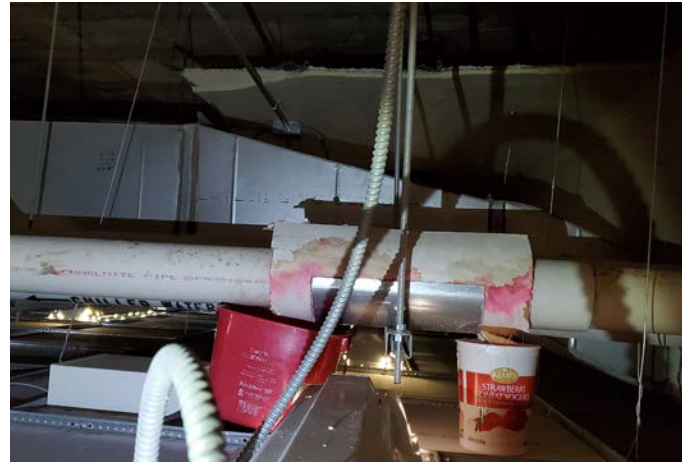
- Negative building pressure was observed during the site visit. It is likely that this is the result of HVAC controls issues, but it is possible that equipment failures are contributing.
- General deferred maintenance items were noted. Items such as failed or abandoned sensors, water leaks, air leaks, etc. were present and prominent. Repair of these items can boost performance and efficiency of the HVAC system.
- Pump condition for chilled water and condenser water pumps is fair. It is likely that pumping efficiency has deteriorated over time.
- Egress corridors are currently used as return air plenums. This is no longer a code compliant practice due to the inherent risk to building occupants during a fire situation.
- AHU-1 chilled water insulation is stained, indicating a potential current leak or vapor barrier issue. Other locations throughout have missing or stained insulation.

CHILLED WATER PIPE LEAK

- Plan for chilled water pump replacement in the near future to improve reliability and efficiency of the water distribution system.
- Perform general preventative maintenance throughout the facility (insulation repair, sensor repair, etc.) to prevent more serious issues in the future.
- Consider revising the plenum configuration to use the ceiling cavity space for return air instead of egress corridors. Alternatively, consider fully ducting the return air for best performance.

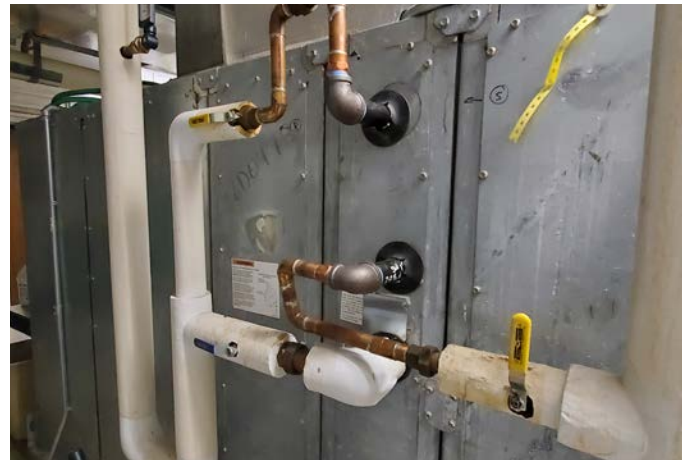
The indoor air handling units each include one or more hot water heating coils to temper the outside air for distribution throughout the facility. Freeze protection is via external face and bypass for all air handling units. Facilities staff commented that freezing of coils is relatively common at this school. This seems to indicate the control strategy for face & bypass operation is not correct or that damper leakage has become an issue over time. It was noted that a repair for AHU-4's heating coil was in progress during the site survey.

AHU-4 HOT WATER COIL REPAIR IN PROGRESS

- Replace full heating plant in the near future including all boilers and pumps.
- Perform general preventative maintenance throughout the facility (insulation repair, sensor repair, etc.) to prevent more serious issues in the future.
- Investigate and repair heating coil issues both at the air handling unit and terminal unit levels.

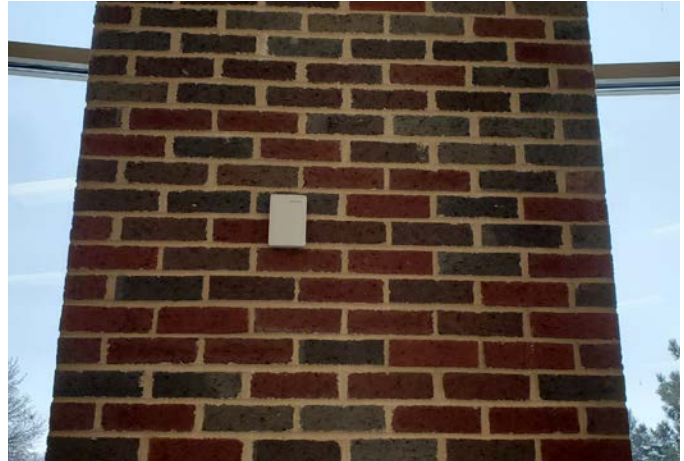
THERMOSTAT PLACEMENT ALONG EXTERIOR WALL

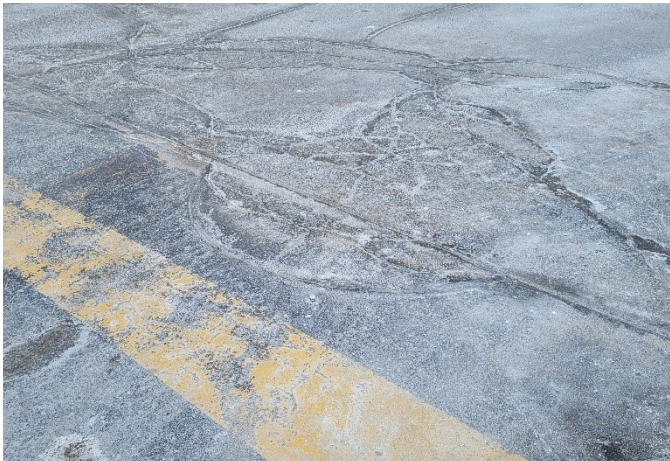
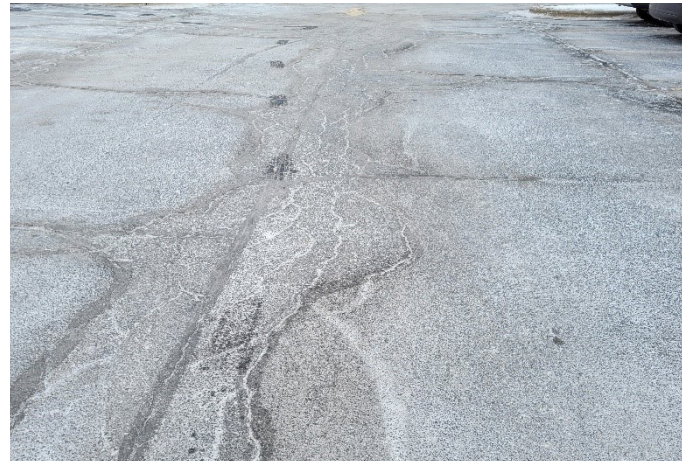
- Multiple areas have alligator cracking where base is starting to fail
- Various unsealed longitudinal and transverse cracks throughout the pavement

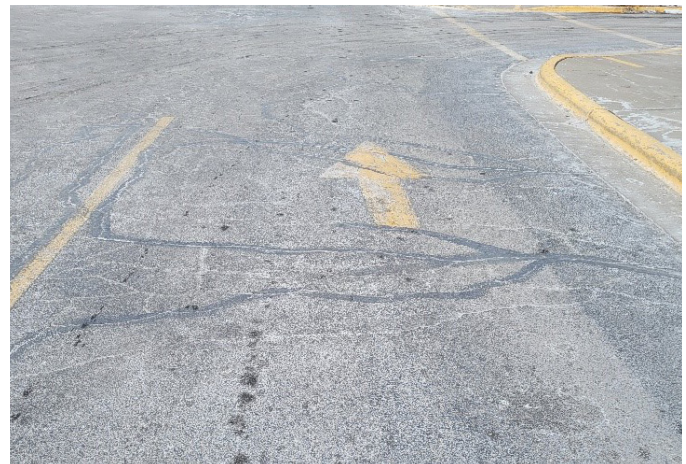
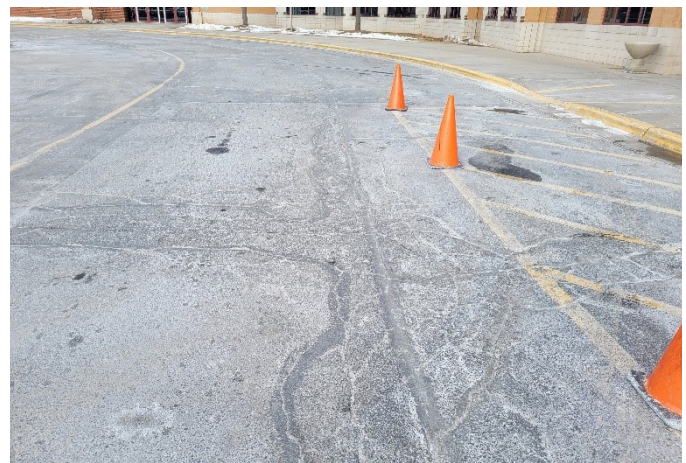
- Excessive settlement and rutting throughout the pavement
- Many unsealed transverse and longitudinal cracks throughout the surface
- Most of the pavement has severe alligator cracking showing signs of base failures

- Remove existing pavement
- Remove 18" of base/subgrade
- Stormwater Improvements
- Install drain tile along edge of pavement to existing inlet or daylight out
- Add geotextile fabric
- Add 12" of breaker run
- Add 6" of base
- Pave 4" of asphalt
- Add pavement markings

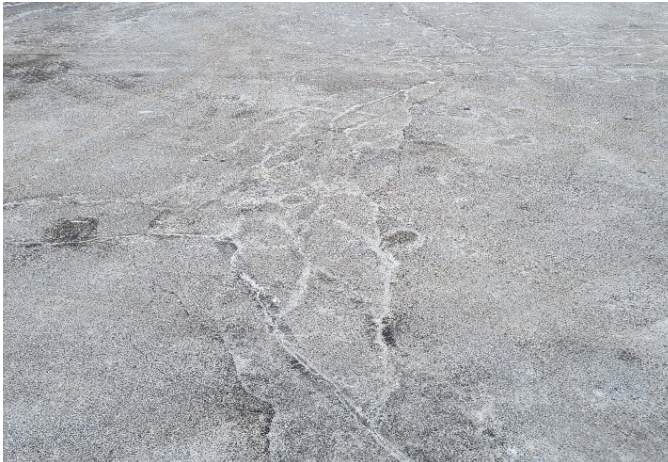
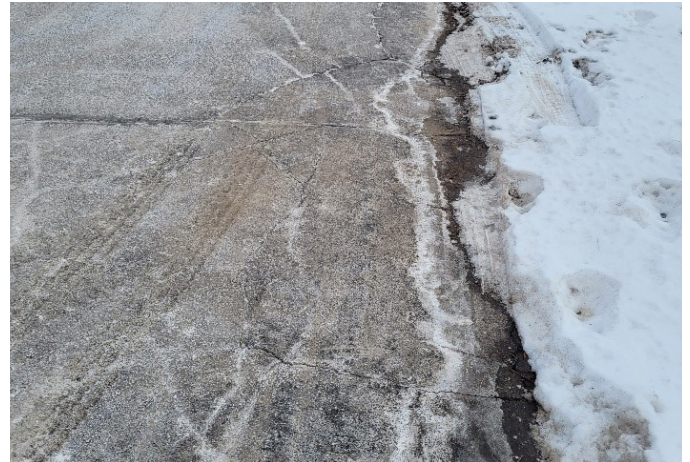
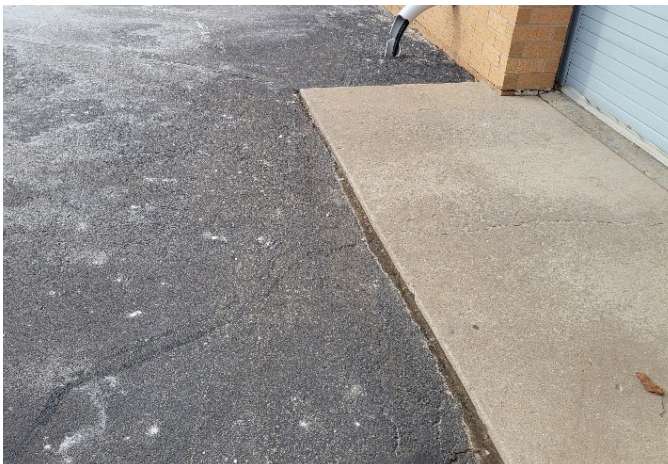
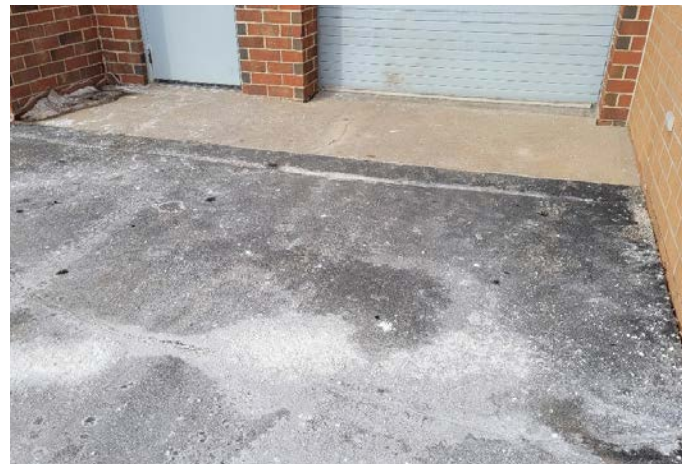
RECEIVING AREA

- Excessive settlement and rutting throughout the pavement
- Many unsealed transverse and longitudinal cracks throughout the surface
- Most of the pavement has alligator cracking and base is failing
- Edge of pavement is cracking and breaking off
- Asphalt is settling in front of receiving dock and difficult to unload trucks with forklift

- Two of the concrete pads have narrow/medium cracks
- Install larger loading area with concrete apron for trucks and garbage dumpsters

- Remove existing pavement
- Crack filling concrete
- Remove 18" of base/subgrade
- Install drain tile under the edge of pavement and daylight out to basin
- Add geotextile fabric
- Add 12" of breaker run
- Add 6" of base
- Pave 4" of asphalt
- Install 6" Reinforced Concrete Pavement

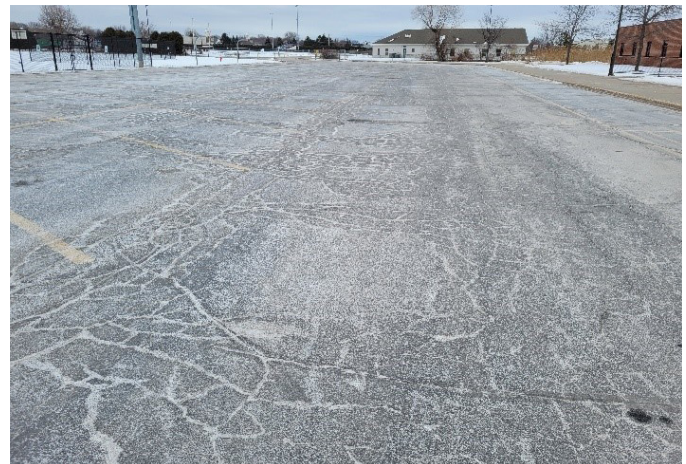
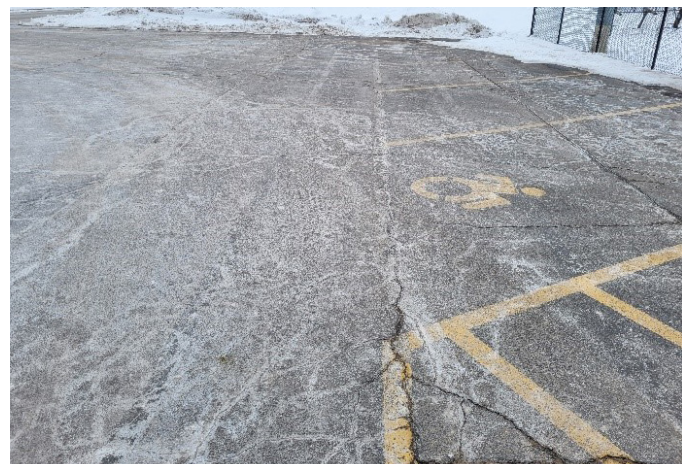
- Many areas of settlement and rutting throughout the pavement
- Multiple unsealed transverse and longitudinal cracks throughout the surface
- Most of the surface has severe alligator cracking and base has failed
- Edge of pavement cracking and breaking off
- Drainage issues were observed during the site visit

- Remove existing pavement
- Remove 18" of base/subgrade
- Stormwater Improvements
- Install drain tile along edge of pavement to existing inlet
- Add geotextile fabric
- Add 12" of breaker run
- Add 6" of base
- Pave 4" of asphalt
- Add pavement markings

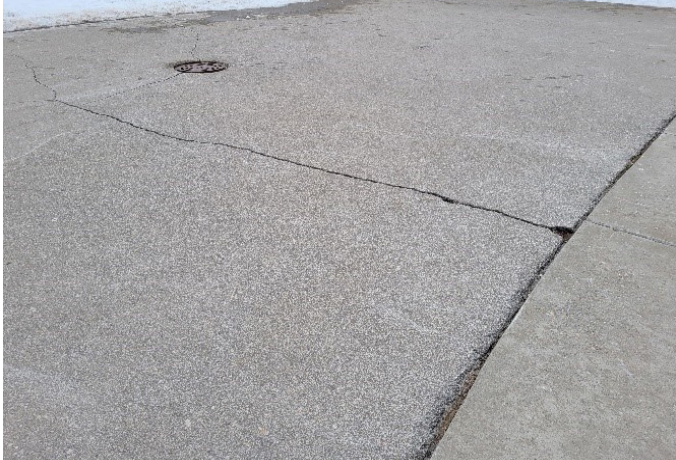
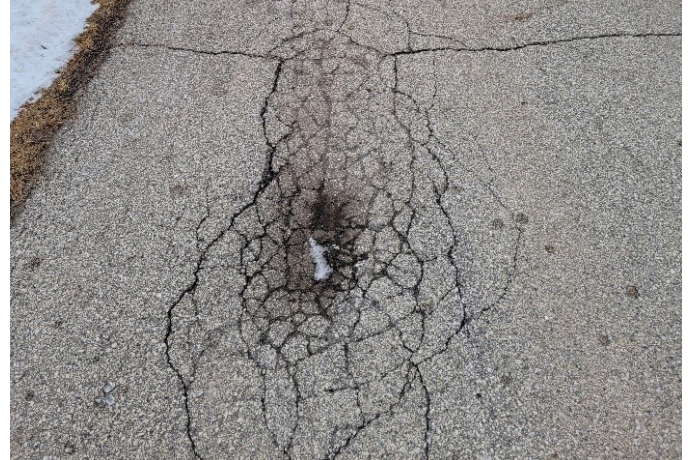
SIDEWALK

- Multiple unsealed wide transverse and diagonal cracks throughout the pavement
- Edges of pavement have alligator cracking
- Most areas have settlement and rutting in the pavement
- Suggest replacing asphalt paths with concrete
- Add sidewalk adjacent to the building connecting, the main sidewalk area to the receiving area. Comments provided by custodian indicate that a many staff members cut through the grass, creating mud.

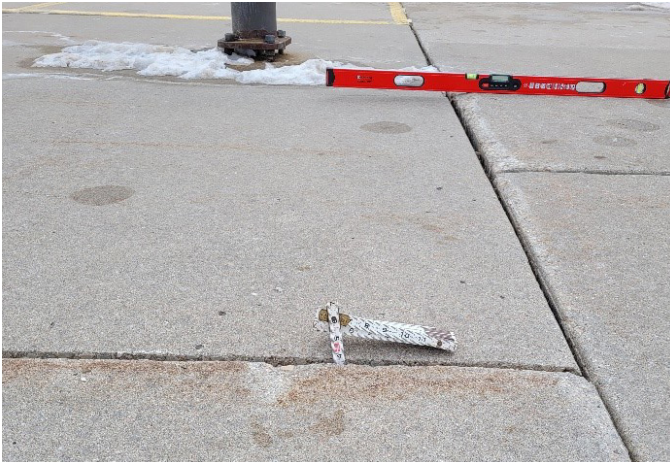
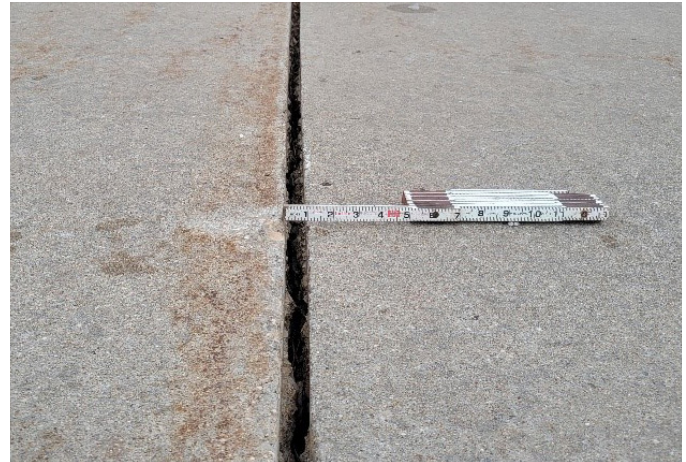
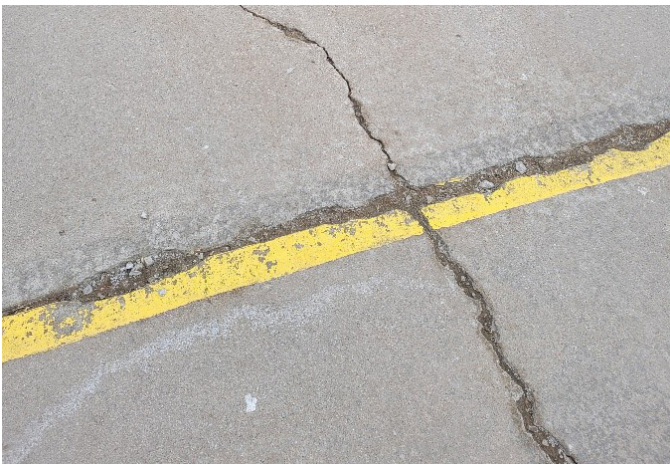
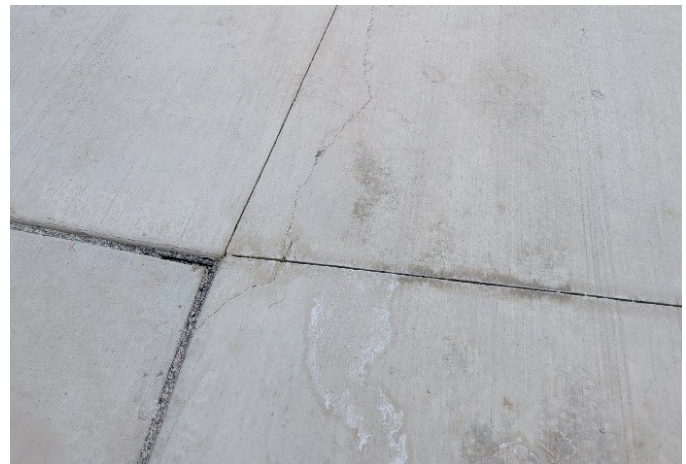
- Multiple concrete panels cracked and some with minor spalls
- Multiple concrete panels with a vertical deviation greater then $\frac{1}{2}$ "
- Concrete panels, along the bus lot, have a 4" deep void with a $\frac{1}{2}$ "-1" gap at the joint
- New concrete pads in the courtyard were poured too high and some doors cannot open properly
- Multiple hairline cracks in the new pavement in the courtyard behind the school

- Remove and replace cracked or spalled panels
- Remove and replace concrete sidewalk panels that have a vertical deviation greater than ¼"
- Pour elastomeric hot joint sealer in the void between the concrete panels along the bus parking lot
- Crack filling with epoxy all hairline cracks in the new pavement in the courtyard

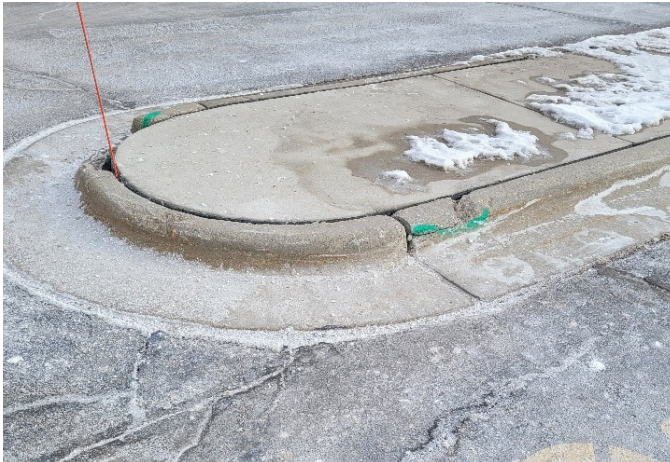
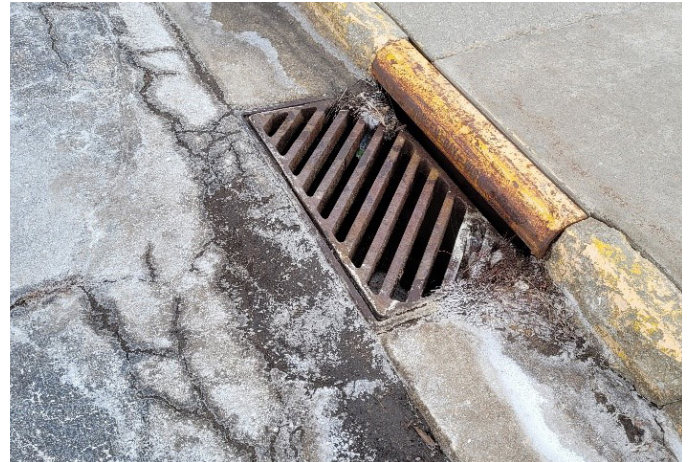
- Multiple sections have cracks through the curb and gutter.
- Multiple areas of curb and gutter have medium abrasion and spalls
- Isolated areas around inlets have spalls on the curb and gutter

- Remove and replace all damaged curb and gutter areas

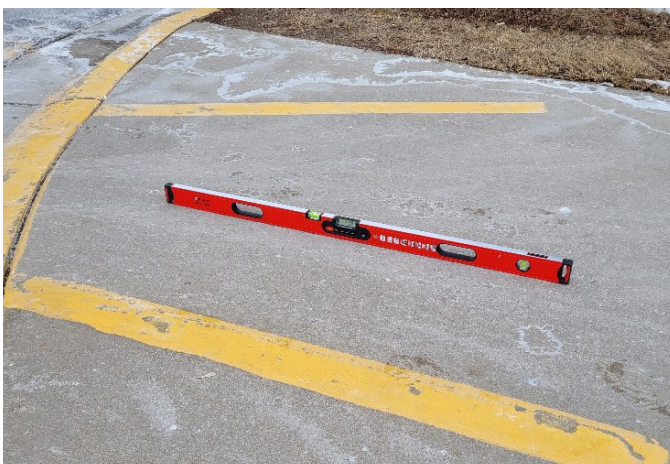
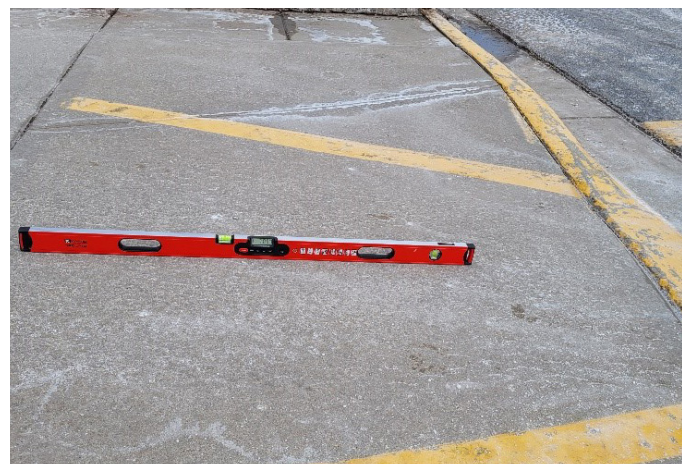
- 6 curb ramps on site do not meet the requirements for ADA Compliance. Slopes are too steep or there is a vertical deviation greater than a 1/4" where it meets the pavement.
- Multiple missing detectable warning fields.

- Remove and replace non-compliant curb ramps
- Install detectable warning fields

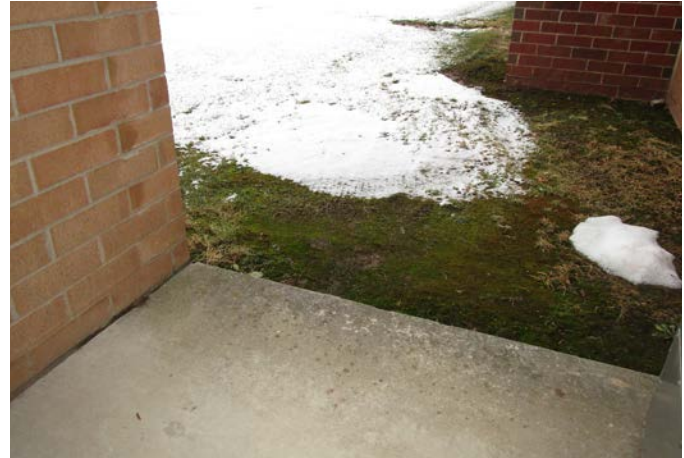
EXIT DOOR WITH NO CONNECTING SIDEWALKS

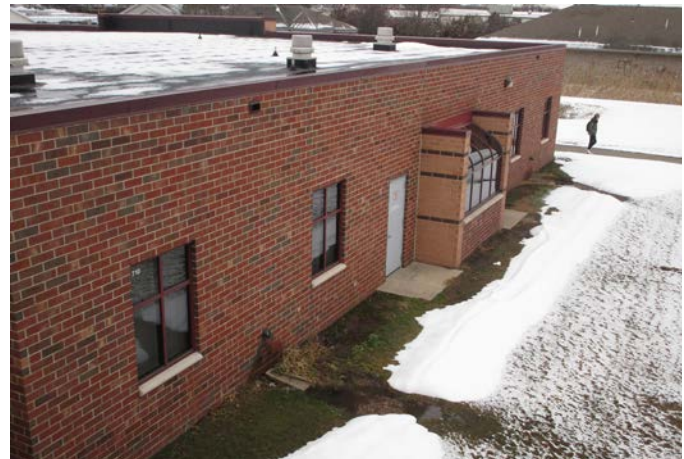
EXIT DOORS WITH NO CONNECTING SIDEWALKS

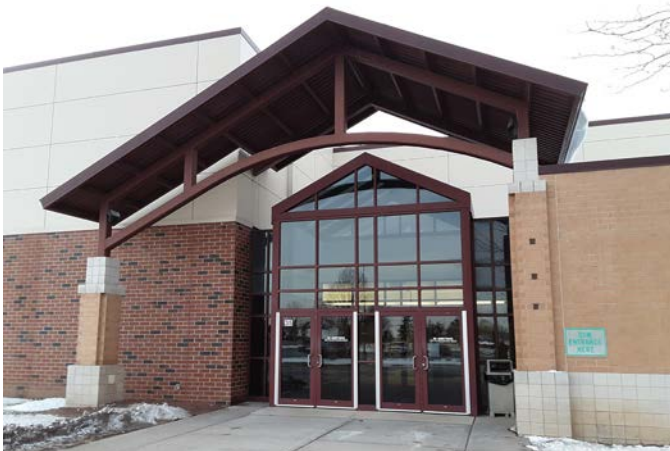
- There are several locations where the EIFS wall covering is in need of repair.
- The three (3) glass and exposed steel vestibules all display similar issues. The insulation at the roof level is thin, to non-existent, causing water vapor on the interior of the vestibule to condense on the steel and flow down onto the gypsum board below. The steel itself at the roof level is rusting in places and there is noticeable water damage at the gypsum board. Sealant has been applied on the exterior metal trim and glass to stop water exterior infiltration, but it can't not stop condensation within the vestibule.

TYPICAL GLASS BOX ENTRY

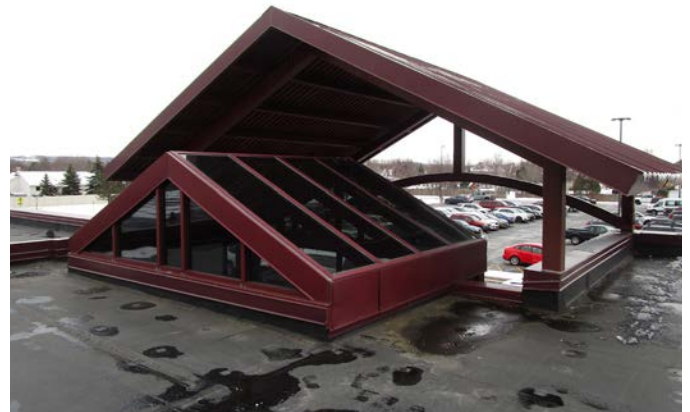
SKYLIGHT ABOVE ENTRY VESTIBULE

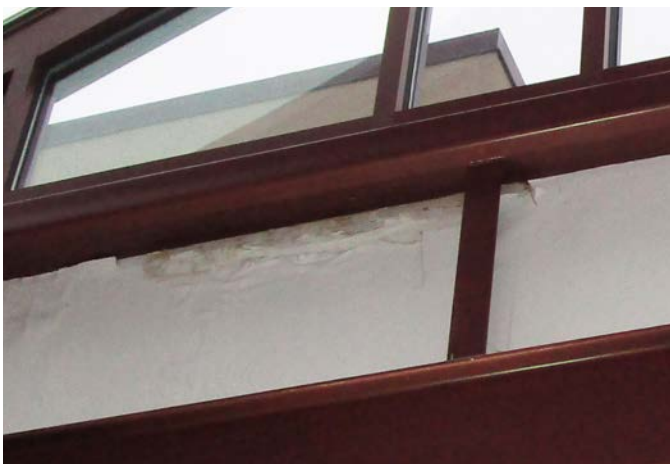
WATER DAMAGE UNDER SKYLIGHT

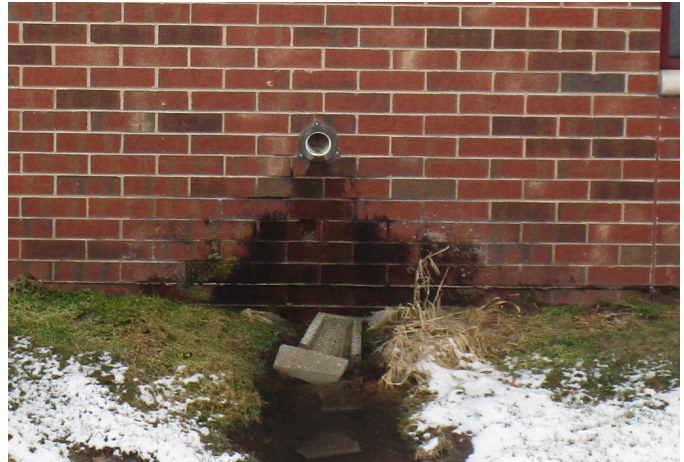
EROSION UNDER ROOF DRAIN OUTLET

- Repair selected area of EIFS and paint the entire surface with exterior waterproof paint to minimize future issues..
- Re-design the upper vestibule glazing and walls to increase the thermal efficiency of the vestibule and stop water infiltration.
- Add a pipe receiver to roof drain outlet to direct water down without excessive splashing, and add basin of crushed stone to receive water. Repair mortar joints that have been degraded due to moisture.

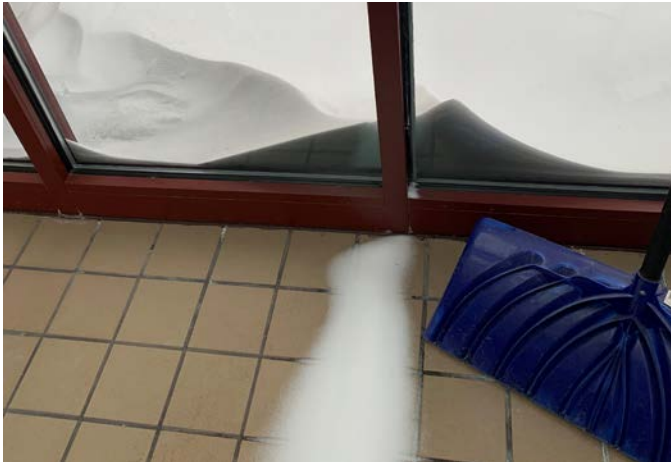
GAP IN GLAZING PANEL

- Glass panels in the vestibules that have moved need to be removed and reinstalled correctly into the gasket pocket, and to have the gasket material replaced per the manufacturer's requirements.
- Roof and window flashings at problem areas should be inspected and repaired/replaced.
- Solarium windows should be removed and a standard window and roof system installed.

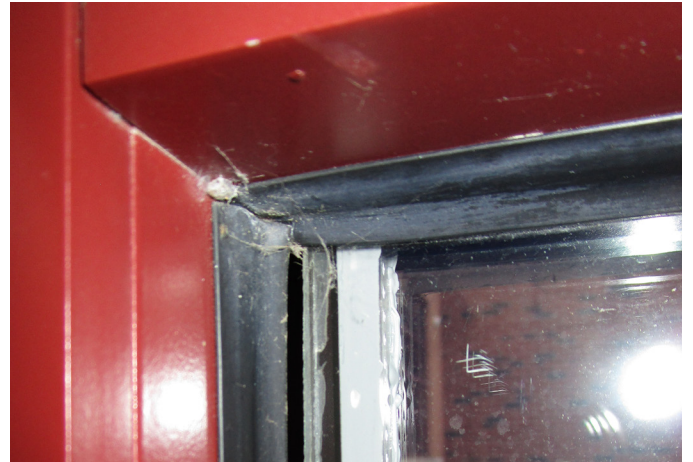
GLAZING PANEL SHIFTED IN WINDOW FRAME

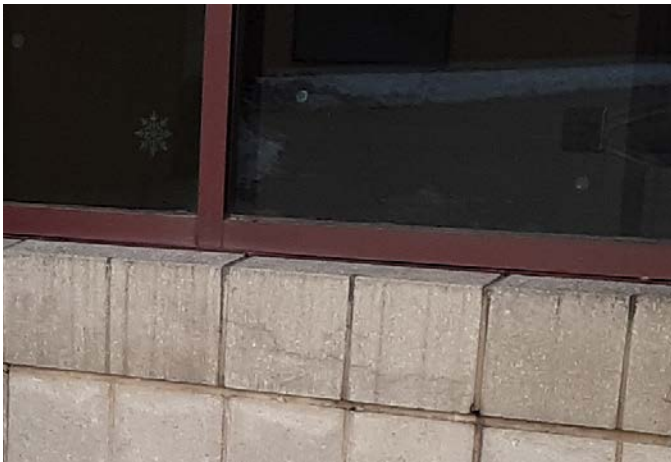
- At the administration offices, there are two windows which are severely leaking during wind driven rain events, as described by staff. There is also cracked and missing mortar at the exterior masonry veneer of the wall below these windows. The primary cause of this water infiltration is likely through damaged roof flashing and/or above brick flashing located above the window.

CRACKED MORTAR AT WINDOW SILL

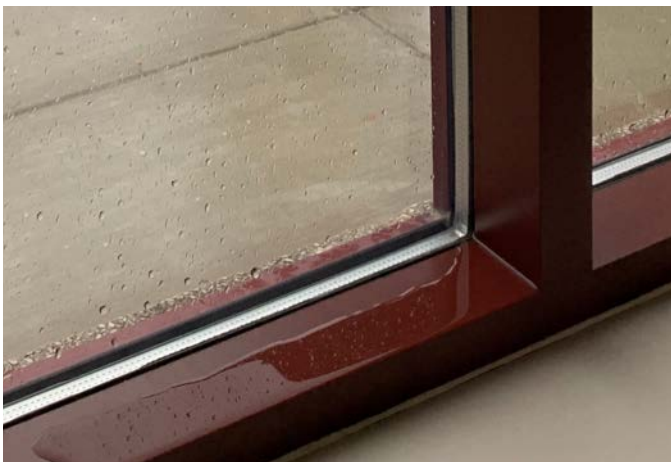
- At the west entry corridor, staff reports water running down the window frame onto the window sill, during driving rain events.
- There are (3) three rooms with curved glass, solarium type bay, windows in the science storage rooms of each classroom wing. Water has made its way behind the paint on the CMU wall below the windows and bubbled the paint. The exterior wall shows visible evidence of water intrusion.

WATER LEAKING FROM GLAZING PANEL GASKETS

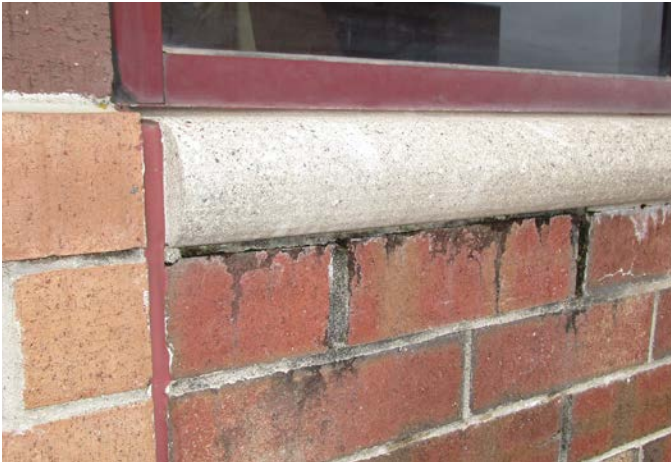
CRACKED MORTAR AT THE EXTERIOR WALL OF
THE SOLARIUM

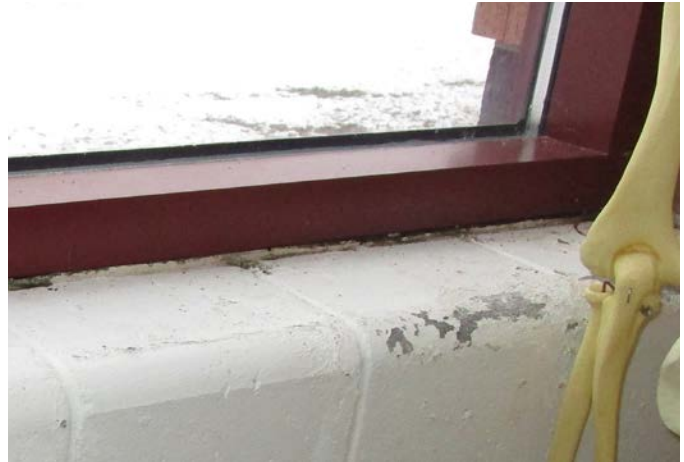
BUBBLED AND MISSING PAINT AT THE INTERIOR SILL

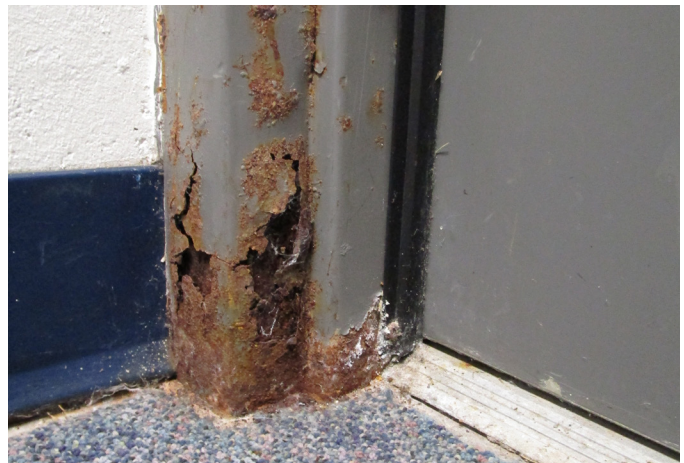
- A majority of the exterior hollow metal door frames show extensive rust and corrosion at the threshold where they meet the concrete. In some locations this rust has completely rotted through the metal both on the exterior and interior sides of the frame. The hollow metal doors appear in good condition.

RUSTED HOLLOW METAL INTERIOR DOOR FRAME

- Replace all hollow metal exterior doors and frames with fiber reinforced plastic doors and frames. This is a good alternative to hollow metal and will not corrode like the existing frames.

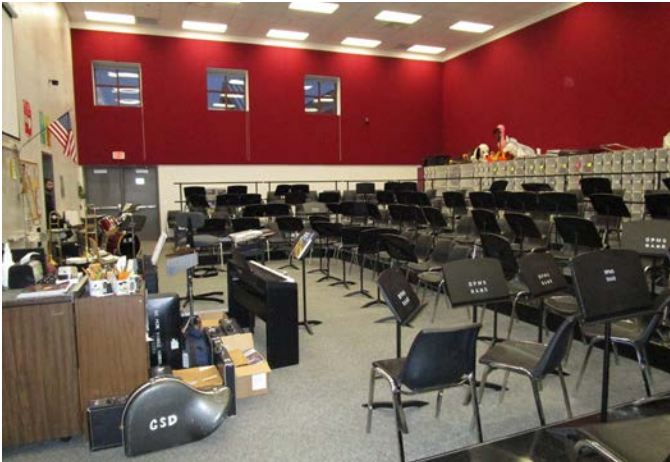
The Band Room has stepped, platform risers, that nearly fill the entire room. In order to change fluorescent light bulbs in the 20' high ceiling, many of these risers must be disassembled and moved to allow for a lift to access the lights. The choir and orchestra rooms have a similar the same ceiling height but are without risers.

BAND ROOM WITH RISERS

- Replace the band room lighting with LED's, for longer life without maintenance.
- Create several private showers in each locker room and utilize the remaining space for additional storage rooms. Build a dedicated storage room addition to the south of the gym.

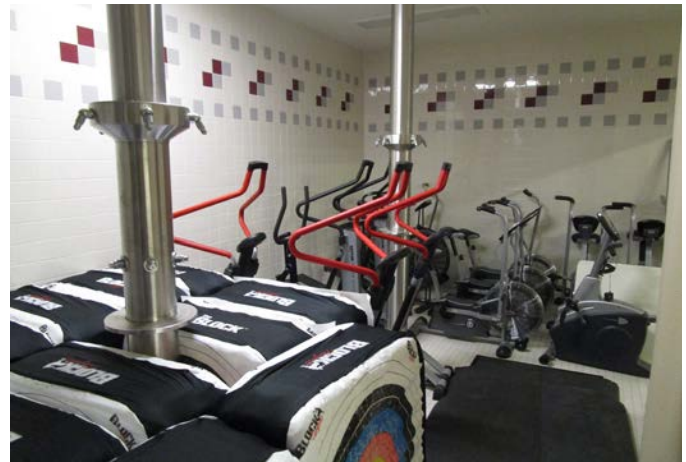
GYM STORAGE IN SHOWER ROOMS

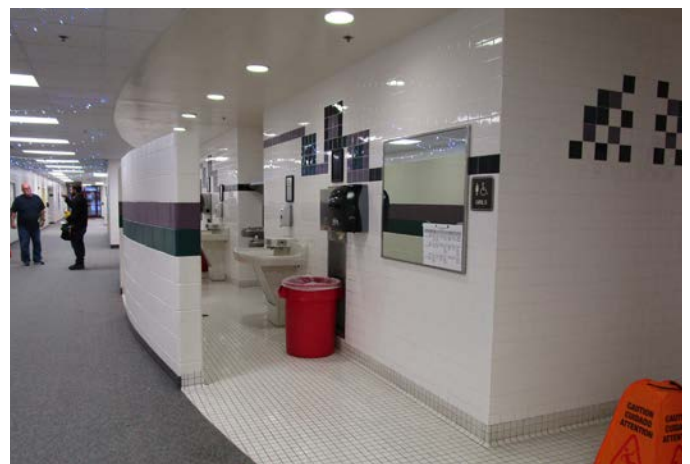
- The hand washing station is located outside of the student toilet rooms and is partially separated from the corridor by a 6' high wall. This partial height wall obscures views of this area by staff.
- While not part of the building code in 1997, vertical grab bars are now required in ADA accessible toilet rooms and stalls.

HAND WASHING AREA AND ADJACENT CORRIDOR

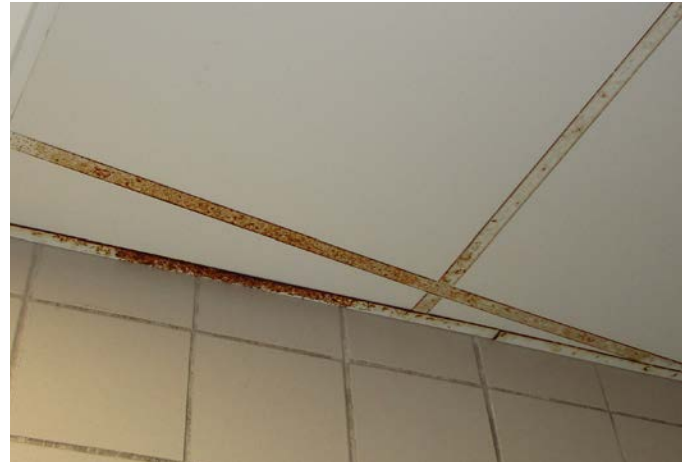
- The suspended ceiling grid in the dishwashing area is rusting. Considering the cooking area and the dishwashing areas are in one continuous space, it's recommended that entire the suspended ceiling be replaced with an aluminum grid and vinyl covered ceiling tile system.

RUSTY LAY-IN CEILING GRID

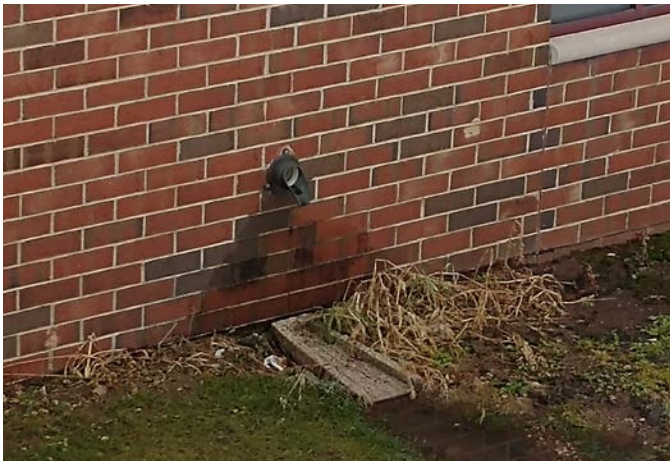
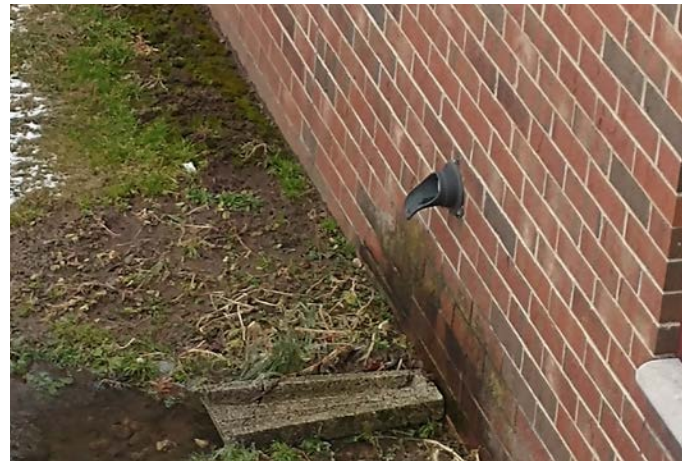
LAMBS-TONGUE

- Main drains discharging to lambs-tongues cause discoloration on the exterior of the building.

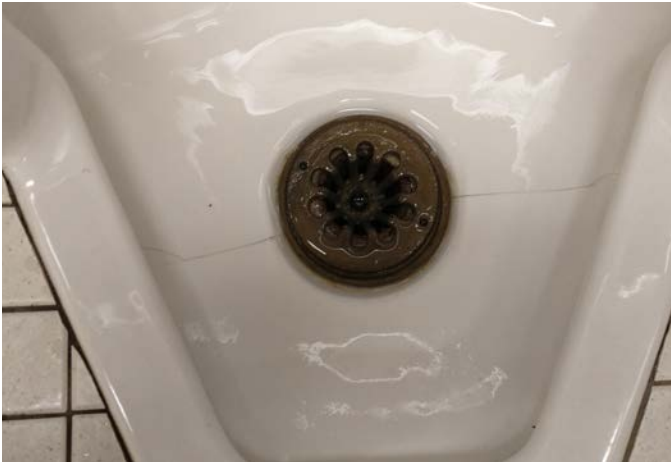
CRACKED URINAL

The urinals are wash down floor outlet style with sensor operation. Many of the strainers at the bottom of the urinal are loose and are not in the correct spot. There are two urinals that are cracked near the bottom. One of the urinals was near the main entrance of the school, and the second is in the restroom group between classroom wings 'A' and 'B'. These fixtures should be replaced. The flush valves on the urinals appear to be in good condition.

- Faucets and flush valves are at or near their life expectancy.
- Urinal in restroom near the main entrance is cracked.

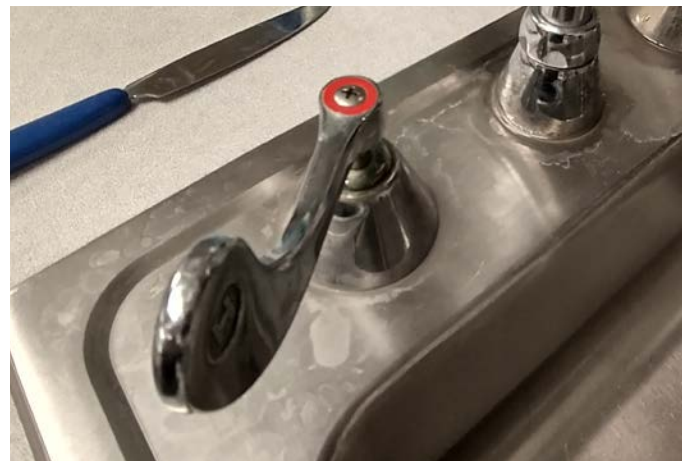
CLASSROOM SINK CALCIUM DEPOSIT

The stainless steel sinks within the classrooms are in good to fair condition. Some of the goosenecks on the faucets are loose, and some wrist blade handles are difficult to turn. Many sinks have calcium deposits on the rim of the sink from the faucet leaking during operation. The sink basins are nearing the end of their expected service life, and the faucets have surpassed their expected service life.

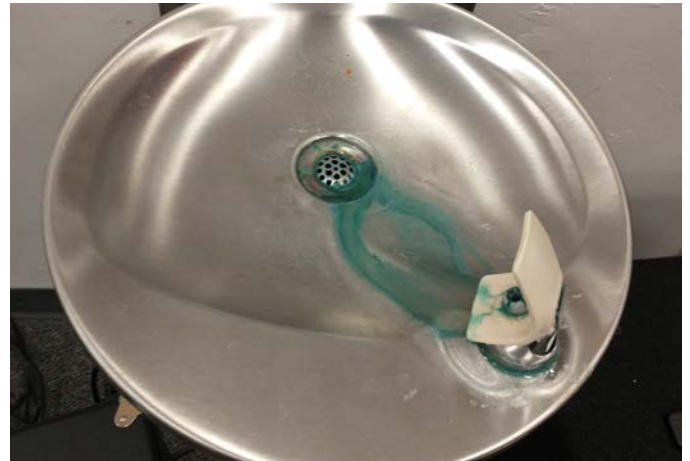
The school has several sets of drinking fountains, many of these fixtures appear to be in good condition. There are a couple that appear to be leaking and it is causing corrosion from the copper piping to leach onto the fixture. The fixtures with the corrosion appear to be in locations where the fixture is not utilized often.

DRINKING FOUNTAIN

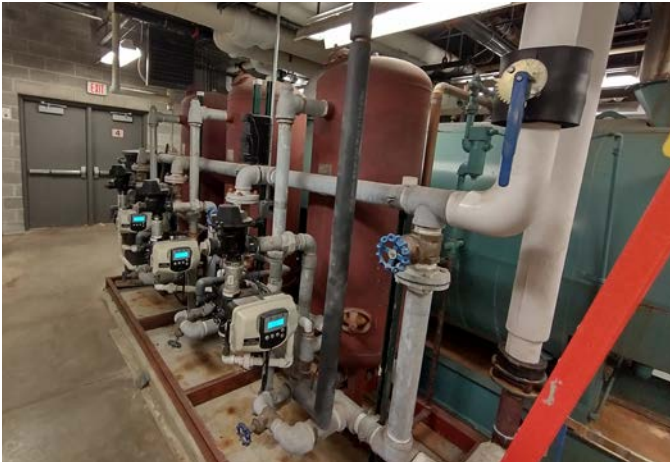
The water softener located in the boiler room is in fair condition. In our meeting with the facilities personnel, they noted that the water softener gives them trouble quite often. The water softener was in service on the day of our site investigation and the salt storage bin was full.

WATER SOFTENER

- The water softener has surpassed its expected service life. Consider replacement of the water softener prior to failure as preventative maintenance.
- The recirculation pumps have surpassed their expected service life. Consider replacement of the recirculation pump prior to failure as preventative maintenance.

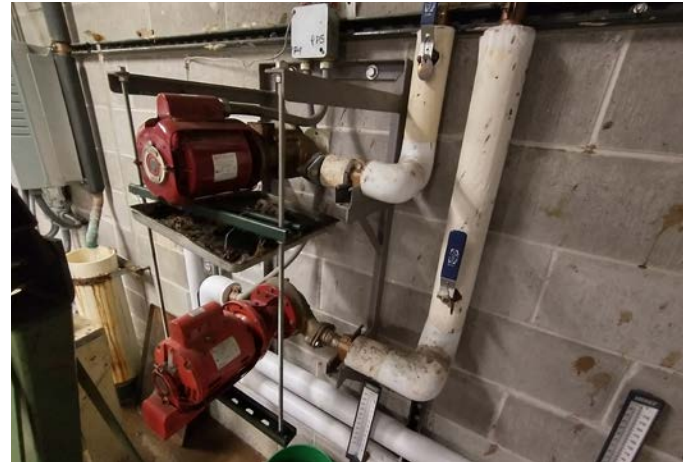
RECIRCULATION PUMPS

The domestic hot water recirculation pumps appear to be in air condition. The pumps appear to be original from the construction of the school. They have surpassed their service life expectancy and should be replaced. One of the pumps is set up with a tray to catch a slow leak that is coming from the pump.

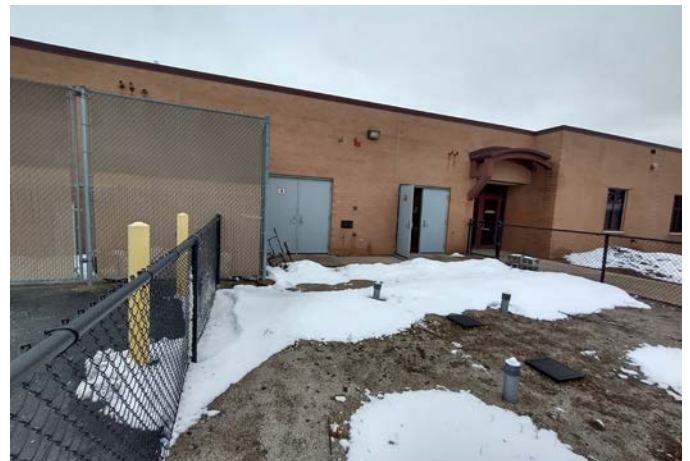
The fire department connection is located within the fenced in area on the east side of the school. The fence was to enclose the area around the chilled water storage tanks that were removed a few years ago. In our opinion, this fence is an additional layer that the fire department would need to work around to connect to the building in the event of a fire.

FIRE DEPARTMENT CONNECTION

- Consider removing the fence which surrounded the previously removed chilled water storage tanks to allow the fire department direct access to the fire department connection.

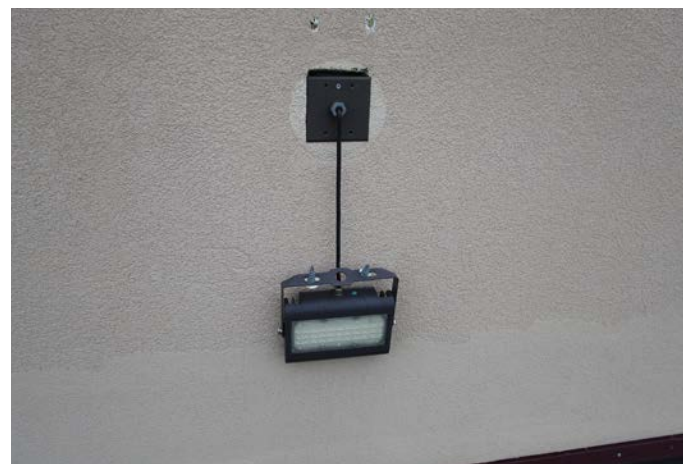
EXISTING LIGHT FIXTURE TO BE RE-MOUNTED

- Consider installing additional occupancy sensors in offices, classrooms, restrooms and corridors.
- Verify the path of egress lighting in all corridors and ensure exits have proper illumination per code requirements of IBC 1008 and/or NFPA 101 section 7.9.
- Re-mount an exterior wall mount light fixture which has become disconnected from the building mounts. It is located above the Main entrance, second level of EIFS.

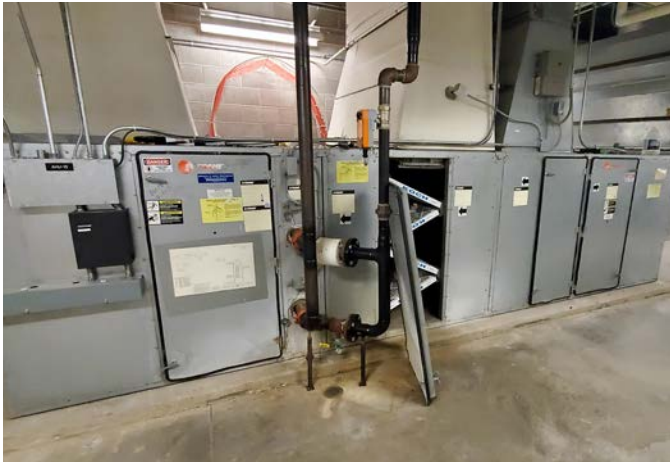
- Excessive positive building pressure was observed during the site visit, particularly at the office area and main entrance. It is likely that this is the result of HVAC controls issues, but it is possible that equipment failures are contributing. This is likely masking some of the building envelope issues noted during our walkthrough.
- Maintenance burden and cost of chemical treatment is high for cooling tower operation. It is likely that the efficiency gained by using a water-cooled chiller is not justified for this facility size and type.
- General deferred maintenance items were noted. Items such as failed or abandoned sensors, water leaks, air leaks, etc. were present and prominent. Repair of these items can boost performance and efficiency of the HVAC system. It was noted that AHU-15 had its filter rack access door removed during the survey.

AHU-15 DOOR IS REMOVED

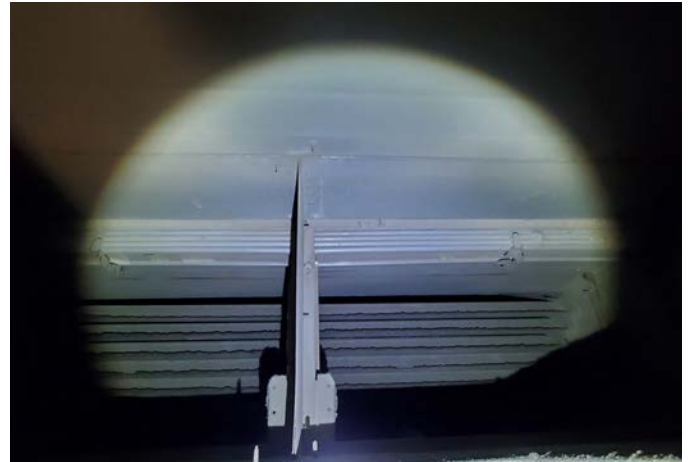
INTERIOR OF DUCTWORK IS DIRTY THROUGHOUT

- It was noted that supply ductwork was generally very dusty.
- Significant drafts and airflow issues are present in mechanical penthouses, particularly the gymnasium penthouse. This may be a symptom of broader building pressurization issues.

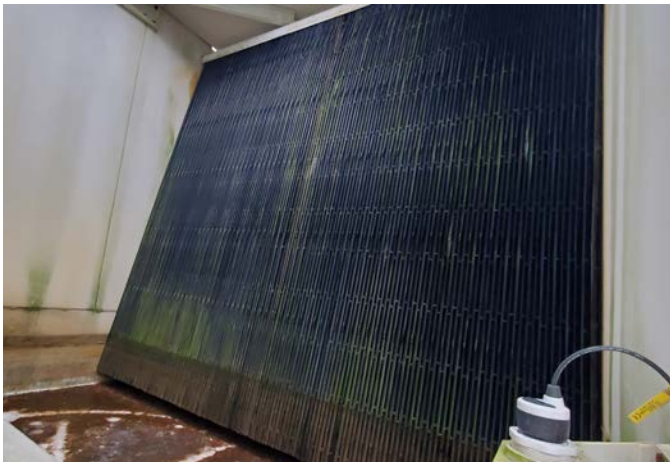
ALGAE GROWTH ON COOLING TOWER MEDIA

- Cooling tower condition is generally poor. Fill material is damaged in places. Evidence of biological growth is present which could be a safety issue for building occupants. The cooling tower basin has rust typical of its age, but has evidence of significant leaking through the basin on to the roof. In addition, it appears that the fill water float is not functional, which could describe the excessive leakage and staining noted. It is likely that annual maintenance cost for the cooling tower will rise in the coming years.

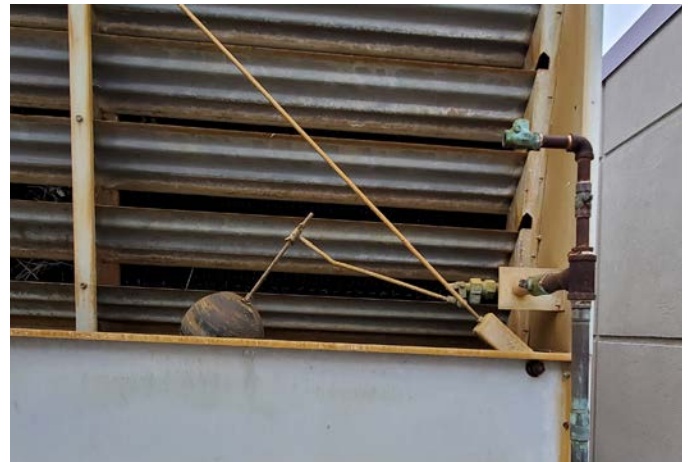
COOLING TOWER FILL VALVE IN NEED OF REPAIR
