MARCH 2023

Unified School District of De Pere

District-Wide Facilities Condition &
Education Adequacy Assessment

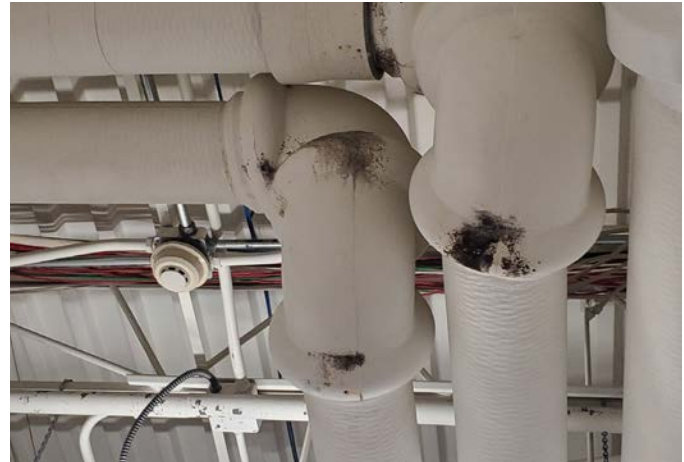
- Chilled water piping and plumbing piping insulation throughout the facility has minor mold/mildew present. It is possible that this is due to either vapor barrier issues on the insulation or, more likely, is a symptom of intermittent cooling and dehumidification in summer months. This type of control will lead to high humidity conditions which will cause moisture on cold surfaces.

TYPICAL MOLD ON CHILLED WATER INSULATION

- Replace pumps in the near future to improve reliability and efficiency of the water distribution system.
- Perform general preventative maintenance throughout the facility (insulation repair, sensor repair, etc.) to prevent more serious issues in the future. Recommend adding air handling unit coil cleaning to preventative maintenance procedures.

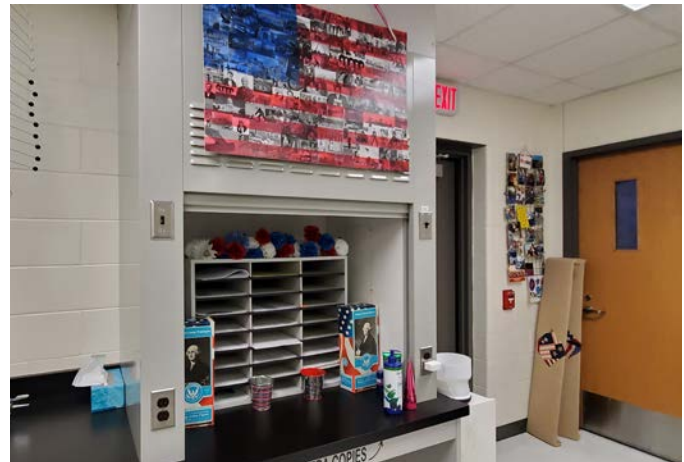
- Science classrooms have increased ventilation rates, including fume hoods which are not used by teachers.

SCIENCE ROOM FUME HOOD NO LONGER USED

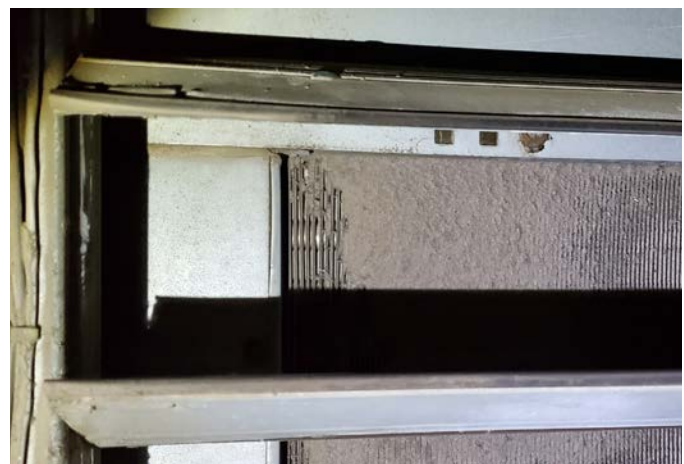
- Some air handling unit coils were noted to be very dirty. While it was clear that routine filter changes are completed by maintenance staff, leakage around the filter rack blank-offs has caused deposits of dirt and debris.

DIRTY AHU COIL FROM LEAKING FILTER RACK

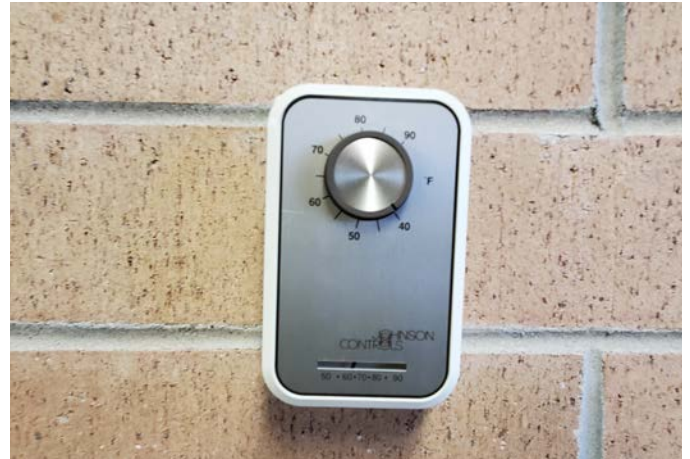
LOW THERMOSTAT SETPOINT LEADS TO FREEZE RISK

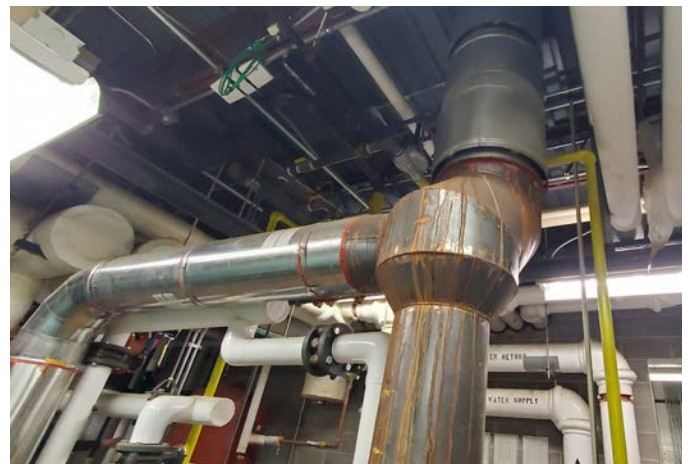
CONDENSATION AT FLUE FOR BOILERS

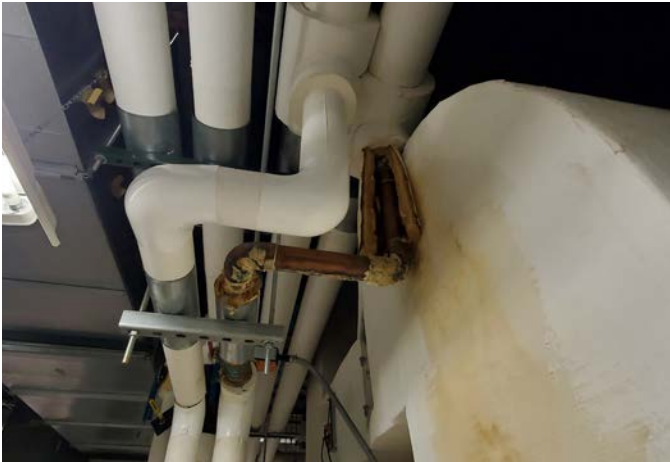
It was noted at several locations that the heating hot water system has been repaired, particularly at Victaulic grooved pipe fittings, due to the development of leaks. At repair locations, insulation has not been repaired or replaced. It was discussed that leaks are most common during the summer months when the boiler plant is not run. Facilities staff indicated that frequent freeze-stat trips are a common occurrence at this facility. This could indicate that freeze protection measures (face & bypass dampers and pumped coils) are not operating correctly, controls programming is not performing well, or that outside air rates are higher than intended. Another freeze risk was identified, in that vestibules were set to maintain only 40°F zone temperature. On a cold day, zone temperature in this range is likely to result in freezing a sprinkler head or a similar failure. Low return water temperature (less than 140°F) was noted at the boilers during the site investigation. This condition will result in condensation at the boiler heat exchangers and could lead to premature heat exchanger failure.

TYPICAL LEAK REPAIR ON HOT WATER PIPING

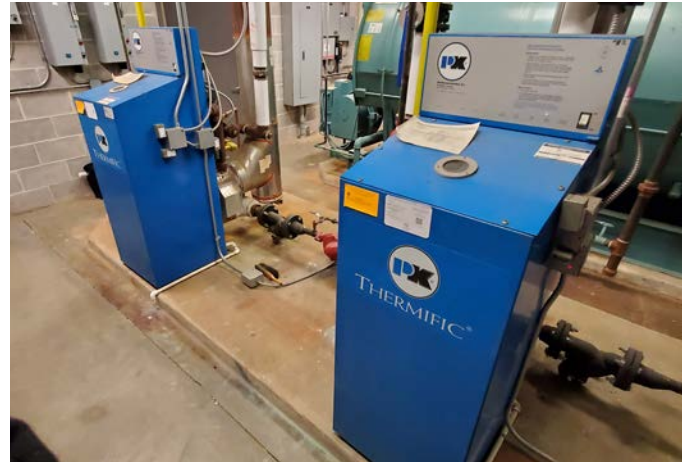
UNDERSIZED SUPPLEMENTARY BOILERS

- Replace secondary heating pumps in the near future to improve reliability and efficiency of the water distribution system.
- Replace (2) Patterson-Kelley water-tube boilers with higher capacity boiler as a suitable backup to the main Cleaver Brooks boiler. Consider a higher capacity condensing boiler which could provide energy savings and better dehumidification during the summer months.
- Perform general preventative maintenance throughout the facility (insulation repair, sensor repair, etc.) to prevent more serious issues in the future.
- Investigate and make corrections related to freeze risk conditions at air handling units.

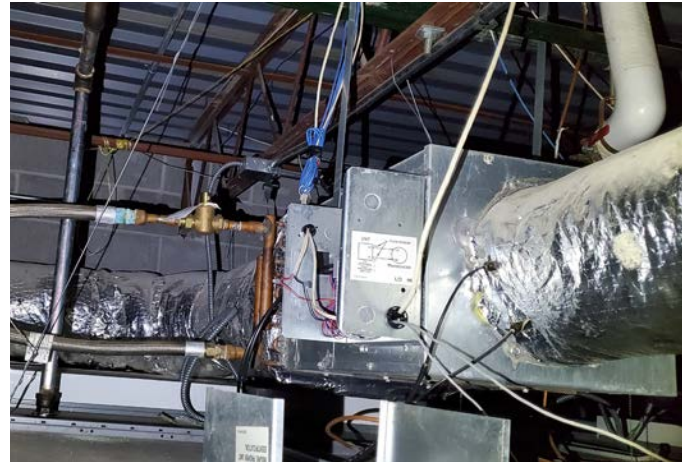
Sensors and control devices vary in condition. Some actuators on terminal device coil valves have been removed. It is likely, due to the previously indicated building pressurization issues, that the airflow sensors, pressure sensors, or HVAC programming is not functioning properly to maintain building pressure. Facility staff commented that, when certain conditions are present, the duct smoke detectors have an issue with nuisance trips.

REMOVED HEATING VALVE ACTUATOR ON VAV

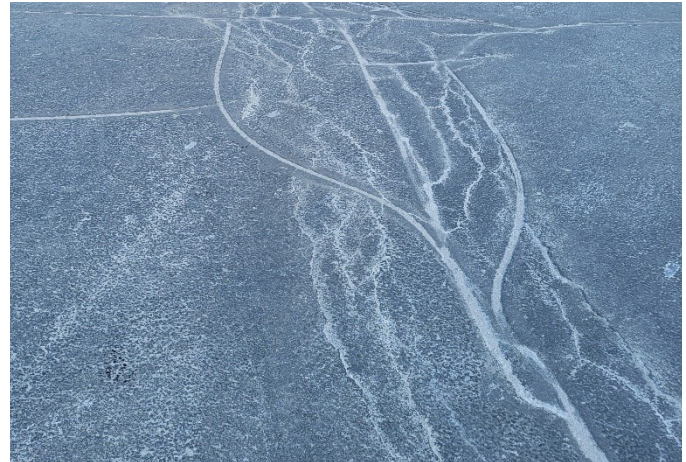
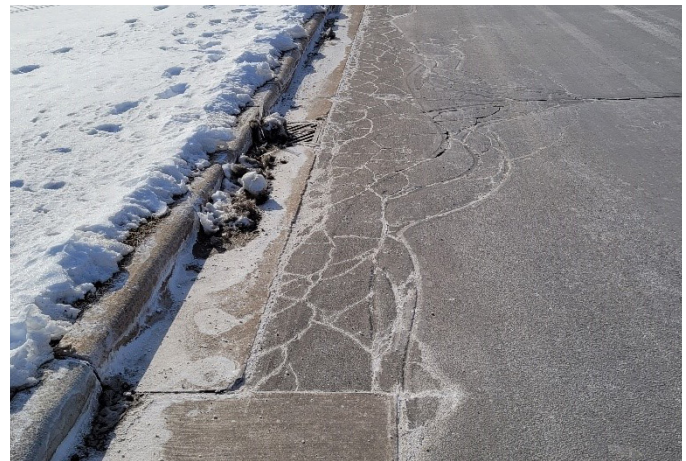
- Isolated areas have alligator cracking where concentrated traffic flow.
- Various unsealed longitudinal and transverse cracks throughout the pavement.

- Sawcut and remove distressed pavement areas
- Base repairs as needed
- Pave 4" of asphalt in distressed locations removed
- Crack filling and seal coat surface
- Install pavement markings

- Remove existing pavement
- Base repairs as needed
- Pave 4" of asphalt in parking lot
- Install pavement markings

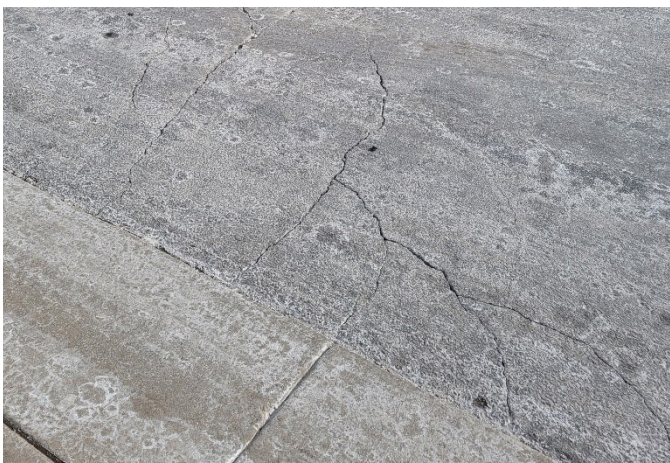
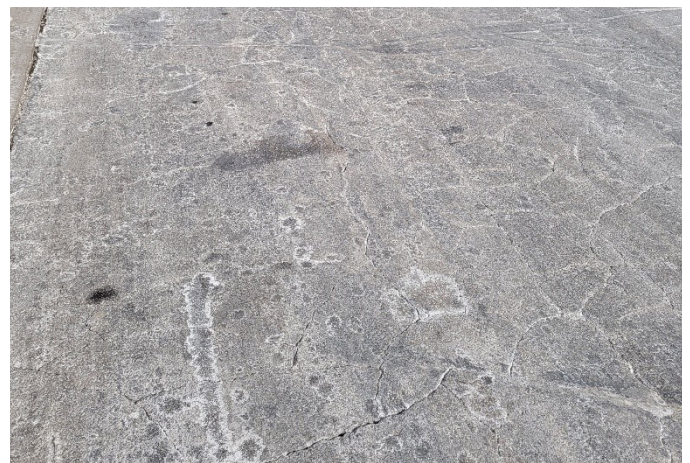
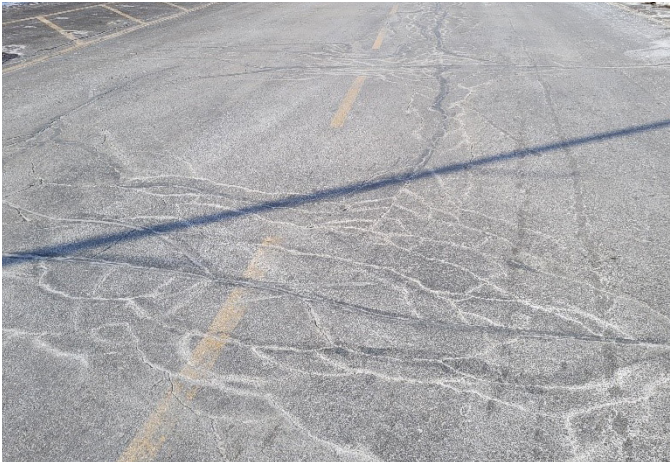
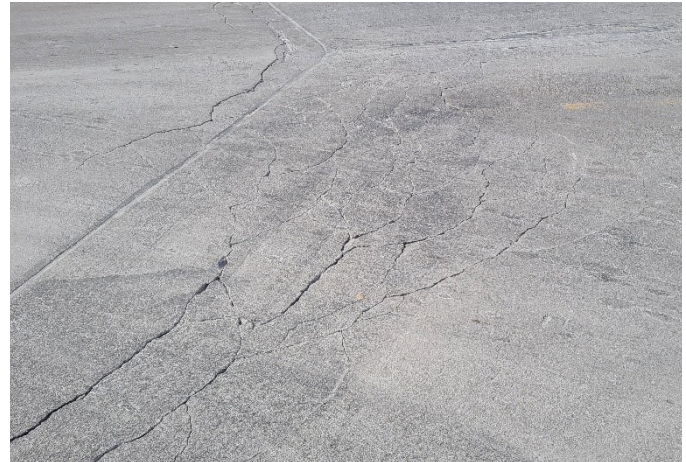
- Excessive settlement and rutting throughout the pavement
- Many unsealed transverse and longitudinal cracks throughout the surface
- Entire surface has severe alligator cracking

- Remove existing pavement
- Remove 18" of base/subgrade
- Stormwater management improvements
- Install drain tile along edge of pavement to existing inlet
- Add geotextile fabric
- Add 12" of breaker run
- Add 6" of base
- Pave 4" of asphalt
- Add pavement markings

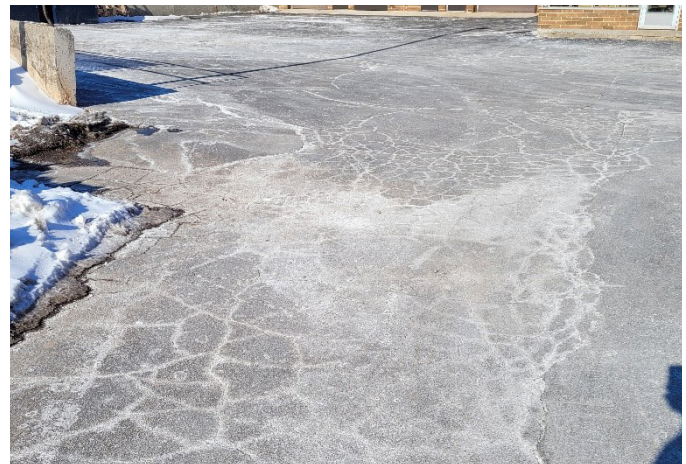
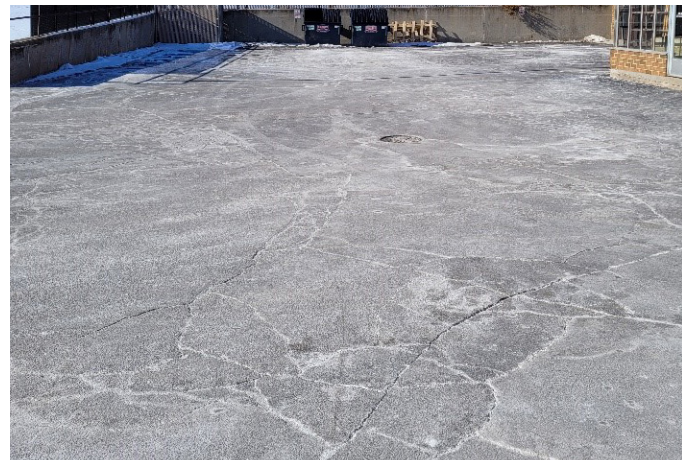
RECEIVING AREA

- Excessive settlement and rutting throughout the pavement
- Many unsealed transverse and longitudinal cracks throughout the surface
- Entire surface has severe alligator cracking and base has failed

- Many concrete pads have cracks and some spalling.
- Retaining wall is failing and leaning at 15.4%, likely due to saturated soil pressure behind the wall and no weeps for drainage.

- Remove existing pavement
- Remove concrete pavement
- Remove retaining wall to the west corner
- Remove fence
- Remove 18" of base/subgrade
- Crack fill the remaining cracks on the west retaining wall that will remain
- Install drain tile under the pavement to existing inlet
- Install new retaining wall with proper drain tile
- Install Fence
- Add geotextile fabric
- Add 12" of breaker run
- Add 6" of base
- Pave 4" of asphalt
- 6" reinforced concrete pavement

- Remove existing pavement
- Remove concrete pavement
- Remove retaining wall to the west corner
- Remove fence
- Remove 18" of base/subgrade
- Crack fill the remaining cracks on the west retaining wall that will remain
- Install drain tile under the pavement to existing inlet
- Install new retaining wall with proper drain tile
- Install Fence
- Add geotextile fabric

- Add 12" of breaker run
- Add 6" of base
- Pave 4" of asphalt to the end of the retaining wall
- Install 6" reinforced concrete pavement from the retaining wall to the building

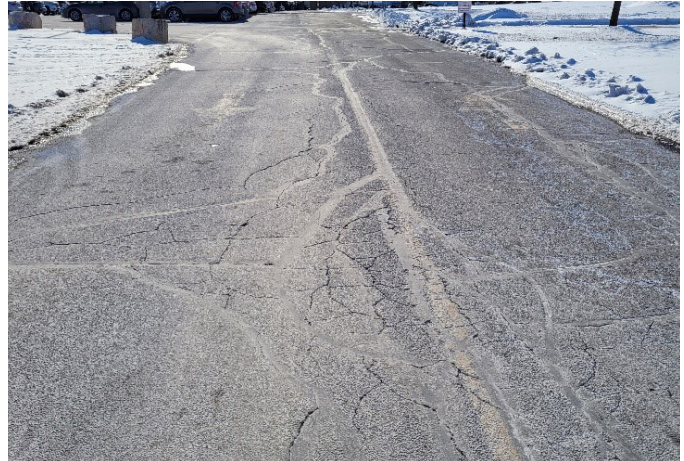
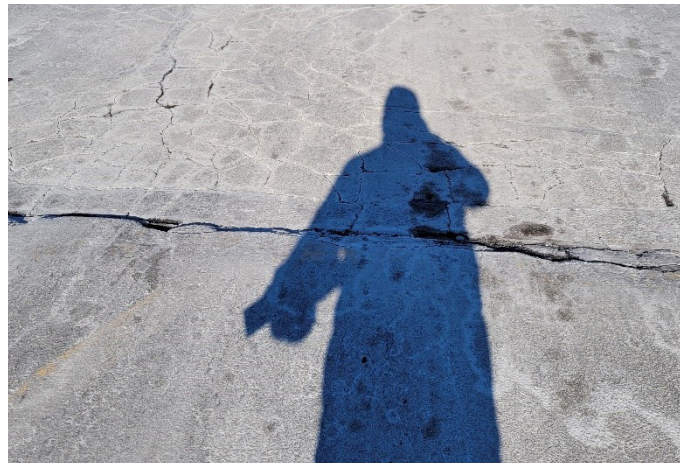
- Many areas of settlement and rutting throughout the pavement
- Multiple unsealed transverse and longitudinal cracks throughout the surface
- Most of the surface has severe alligator cracking and base has failed

- Remove existing pavement
- Remove 18" of base/subgrade
- Install drain tile along edge of pavement to existing inlet
- Add geotextile fabric
- Add 12" of breaker run
- Add 6" of base
- Pave 4" of asphalt
- Add pavement markings

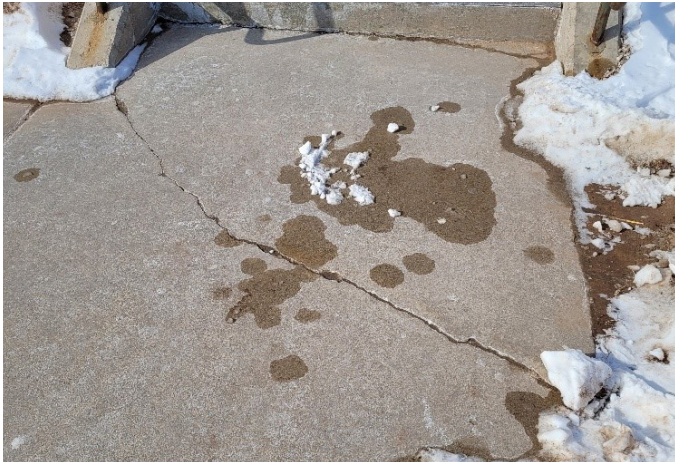
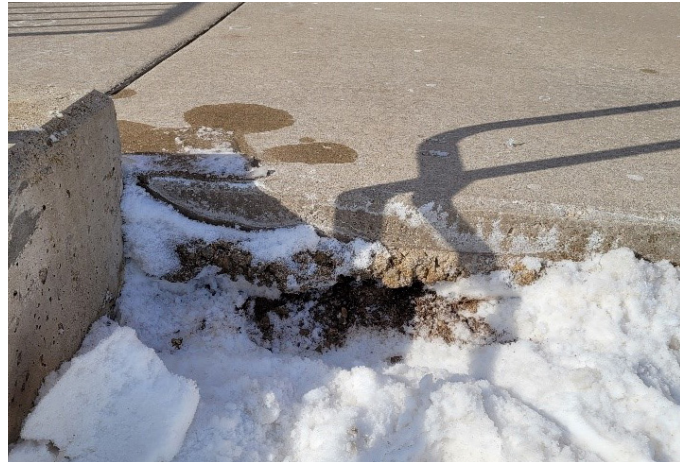
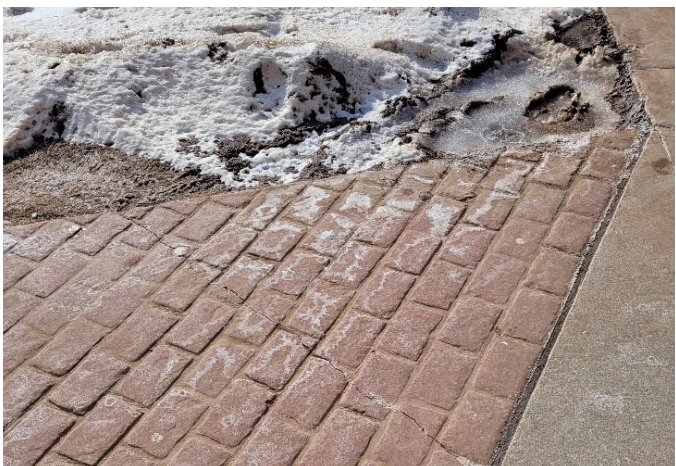
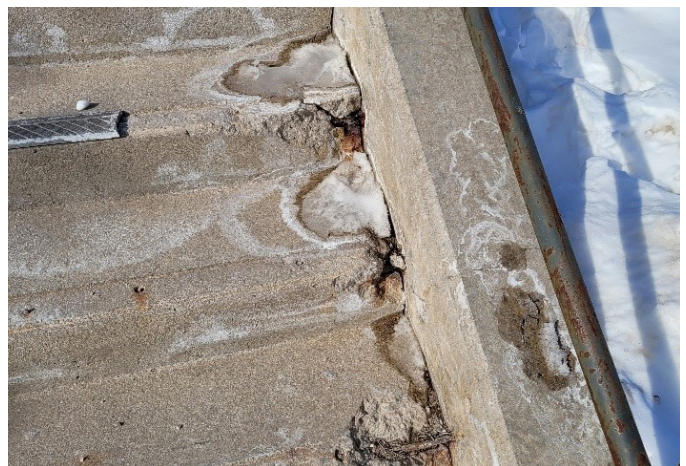
SIDEWALK

- Multiple concrete panels cracked and some with minor spalls
- Multiple concrete panels with a vertical deviation greater than ½"
- South set of stairs in front of the school have small spalls with exposed rebar
- Section of concrete panels, on the NE corner of the district lot, have spalls at the joints
- Colored and stamped concrete panels has a narrow crack through corner
- The northern most set of stairs, in the front of the school, has some undermining of the adjacent sidewalk starting
- Concrete apron, on the south main entrance to the student lot, is at a 11.3% slope

- Remove and replace cracked or spalled panels
- Concrete surface repair spalls on stairs
- Crack filling narrow cracks in the concrete panels
- Remove and replace concrete entrance apron at a 6% slope or less.
 - Remove adjacent 2-3 concrete sidewalk panels
- Remove and replace concrete sidewalk panels that have a vertical deviation greater than ¼"
- Add dense graded base, topsoil, seed, and emat around undermining sidewalk

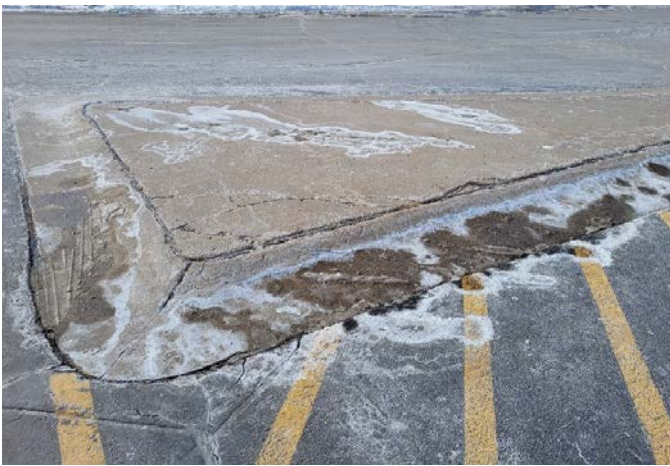
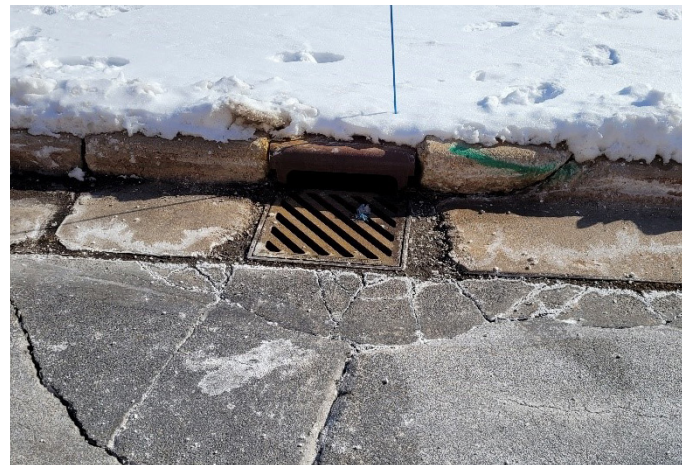
CURB & GUTTER

- Multiple sections have cracks through the curb and gutter.
- Multiple areas of curb and gutter have medium abrasion and spalls
- Isolated areas around storm water inlets have spalls on the curb and gutter
- Concrete sloped curb, gutter and median have cracks and spalls
- Multiple areas of raised sidewalk have abrasions and spalls

- Remove and replace all damaged curb and gutter sections
- Sawcut raised concrete sidewalk 2' back
- Remove concrete
- Pour 24" curb and gutter
- Install 6" reinforced concrete in the concrete median

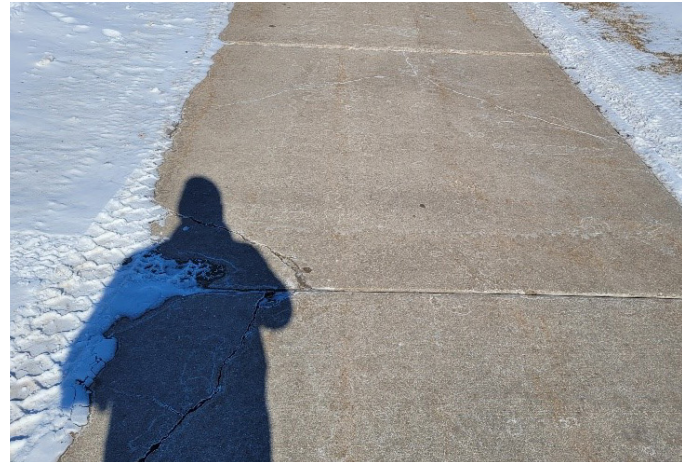
- Concrete sidewalk south of district lot has a slope of 1:11. This section of sidewalk exceed the maximum slope of 1:20 and the max rise of 30" before a landing pad or railing needs to be installed.

- Remove and replace panels with adequate landing areas.

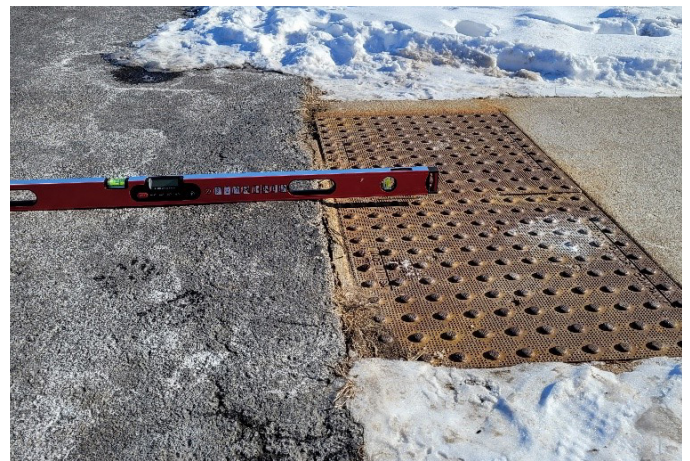
- 5 curb ramps on site do not meet the requirements for ADA Compliance. Slopes are too steep or there is a vertical deviation greater than a 1/4" where it meets the pavement.
- Some detectable warning fields are deteriorating and no longer have effective domes.

- Remove and replace non-compliant curb ramps

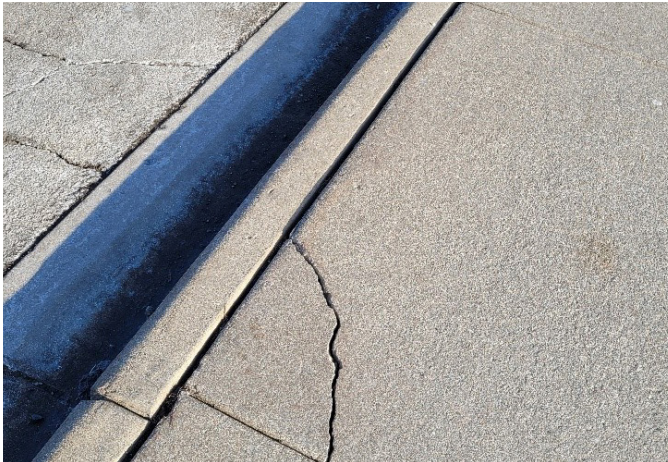
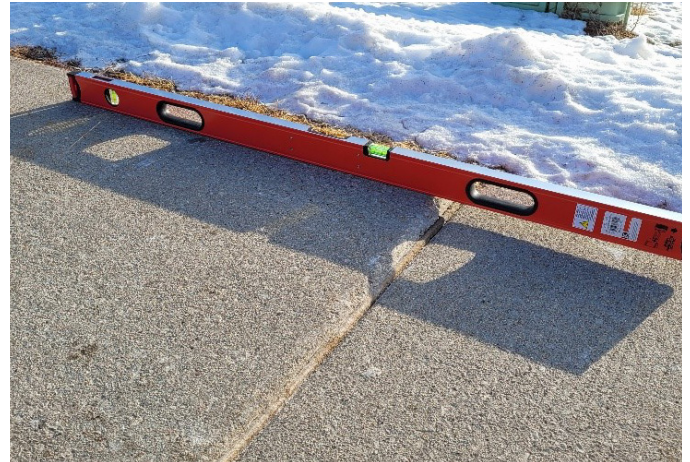
LIBAL STREET SIDEWALK

- Some concrete panels are cracked and have minor spalls
- A few concrete panels have a vertical deviation greater than ½"

- Remove and replace cracked or spalled panels
- Concrete surface repair shallow spalls
- Crack filling narrow cracks in panels
- Remove and replace concrete sidewalk panels that have a vertical deviation greater than ¼"

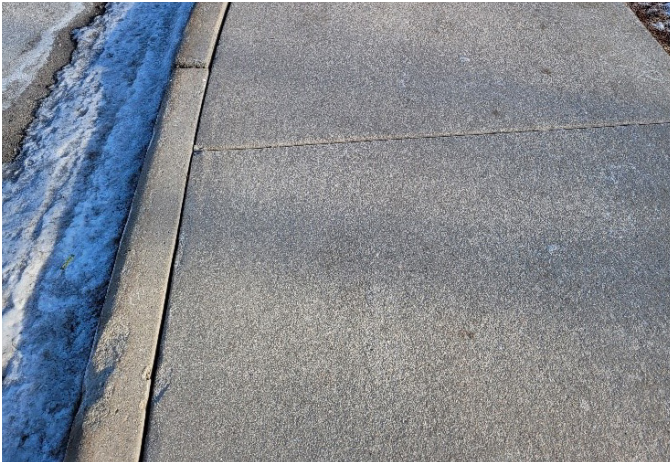
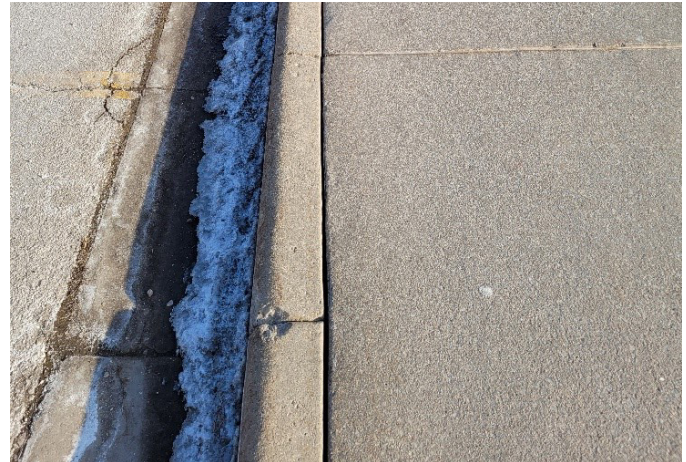
LIBAL STREET CURB & GUTTER

- Some sections have minor cracks through the curb and gutter.
- A few areas of curb and gutter have medium abrasion and minor spalls

- Surface repair areas of minor spalls

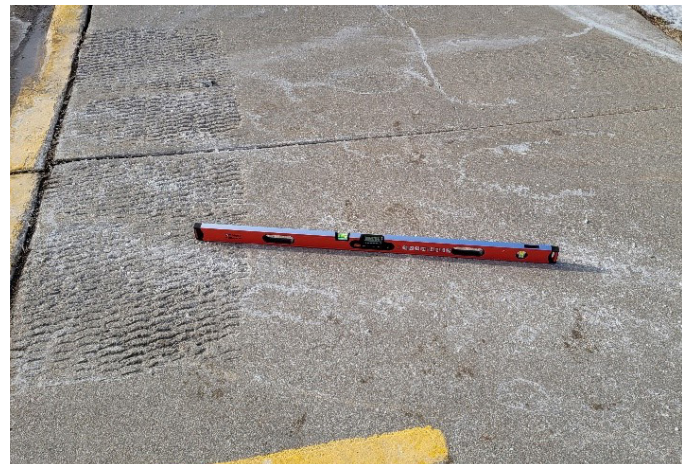
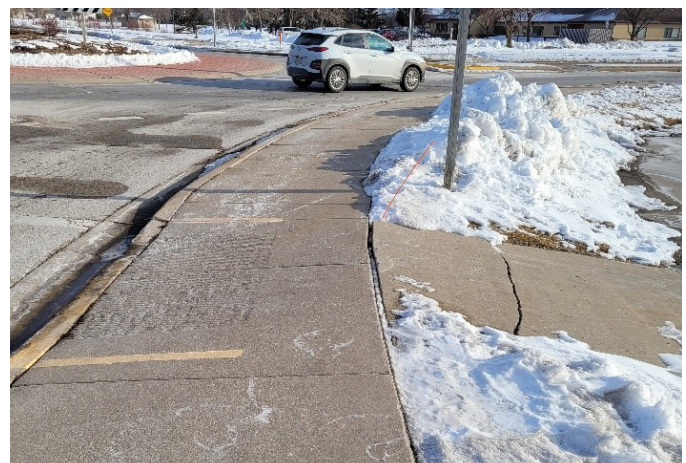
LIBAL STREET ADA COMPLIANCE

- 3 curb ramps on site do not meet the requirements for ADA Compliance. Slopes are too steep or there is a vertical deviation greater than a ¼" where it meets the pavement.
- Some detectable warning fields are deteriorating and no longer has effective domes.

- Remove and replace non-compliant curb ramps
- Remove adjacent sidewalk panels as necessary

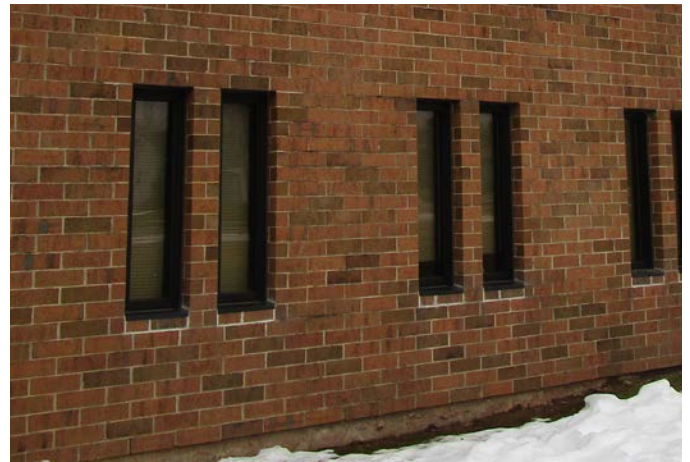
REPLACEMENT WINDOWS WITH NEW SILLS

- When the windows on the north and west of the 1976 building were replaced, the sloped brick exterior windows sills were replaced with an additional exterior brick and a flat metal sill. There is no pitch on the metal sill which allows water to pool against the window and brick veneer at the jambs. Without a pitch to force the water away the only barrier is the sealant joint to protect the inside of the wall.

- The root cause of water infiltration is possibly within the wall itself which would require a destructive evaluation by removal of the inner or outer covering of the walls to determine the issue. Continue inspection and recaulking of both the interior and exterior window frame. If water infiltration resumes on the frames with sufficient sealant, then there is an issue with the flashing within the wall.

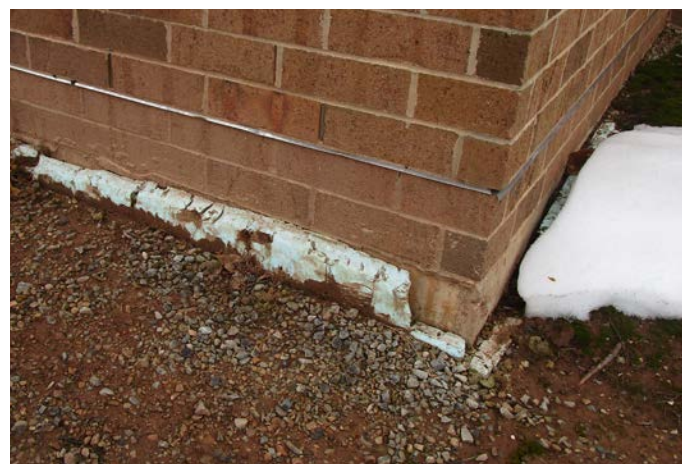
- See window section below.
- At the gym, the foundation insulation is exposed to view.

EXPOSED EXTERIOR WALL INSULATION

- See window section below.
- While the exposed insulation is unsightly, the insulation within the wall extends 8" down below the floor line to protect the end of the floor slab. Adding a stainless steel cover to protect the insulation, similar to what was done at the 2017 music addition, or trimming back to insulation is also an option.

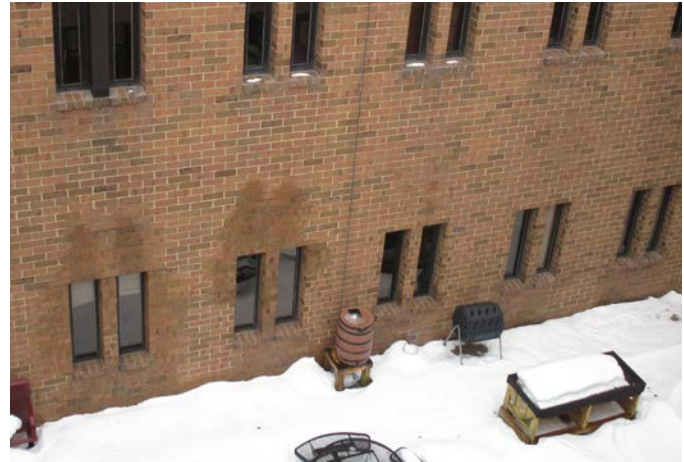
- Facility staff report that there are 36, east facing windows, in the A-wing courtyard which date to 1976 and need to be replaced, as they are single pane glass and contain asbestos in the glazing.

ORIGINAL WINDOWS YET TO BE REPLACED IN THE
COURTYARD

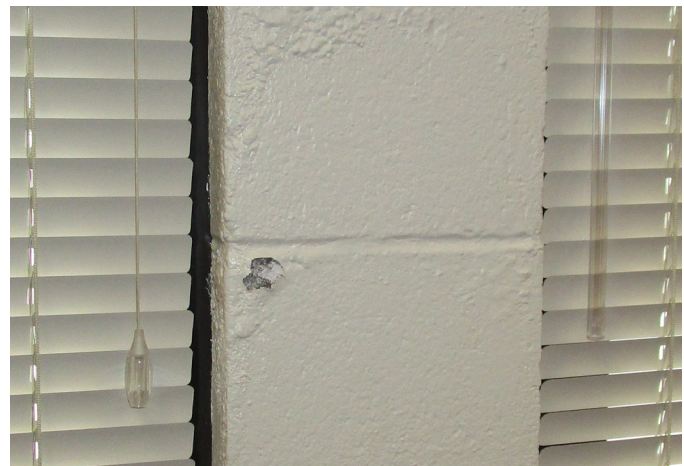
- Of concern is how moisture has gathered in the walls behind paint and drywall at the window sills. This has happened to both the windows installed in CMU block and in metal studs and drywall. At the time of our visit on December 28th, these areas were dry. It's probable that the moisture is from the exterior and is being pulled inside the building. At window jambs in CMU walls, the water has delaminated the interior paint and sealant. In some areas of the 1976 building, this delamination is on the interior wall face, suggesting that the water has migrated horizontally to the interior of the CMU walls.

INTERIOR DAMAGE FROM WATER INTRUSION
BEHIND THE PAINT

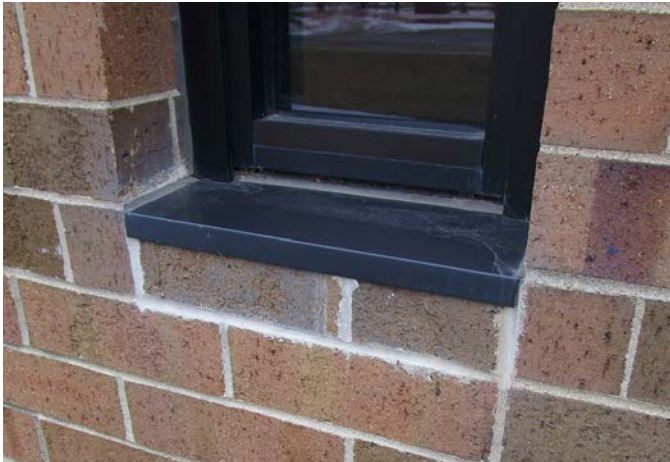
FLAT WINDOW SILLS AT REPLACEMENT WINDOWS

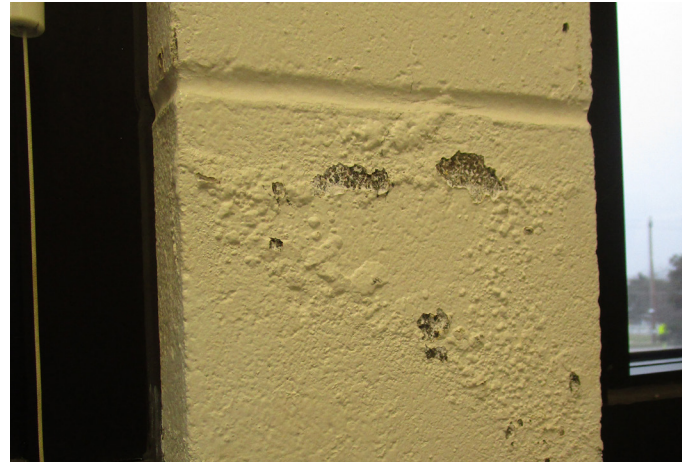
INTERIOR DAMAGE FROM WATER INTRUSION
BEHIND THE PAINT

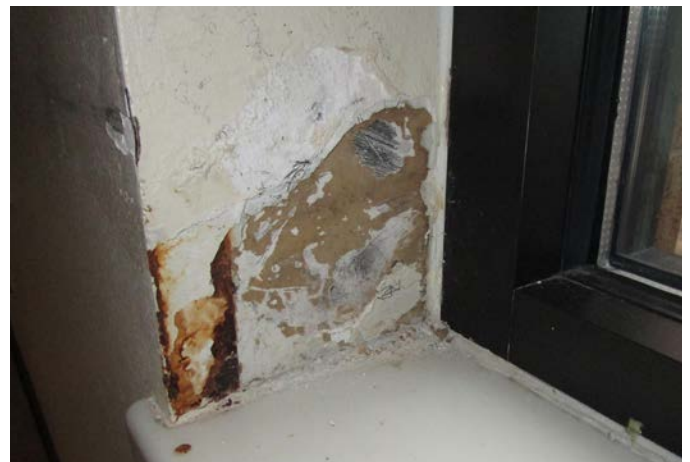
- At metal stud walls in the 2001 addition, water has soaked into the drywall compound, rusted the metal drywall trim bead and delaminated the drywall filler and paint. The sealant joints between the frame and the wall have also split apart.

WATER DAMAGE AT DRYWALL WINDOW JAMB

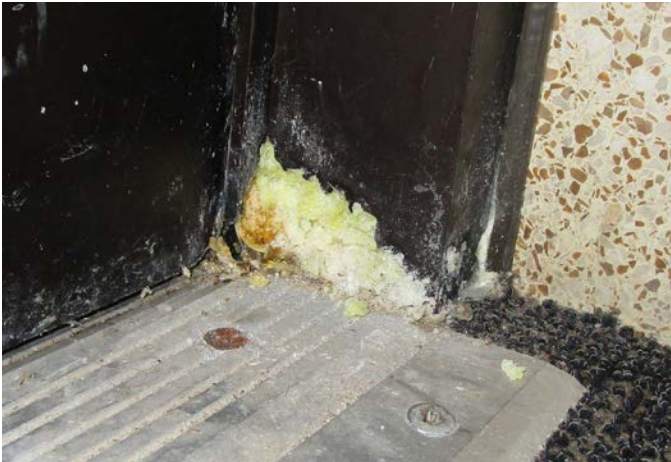
- At the aluminum doors at main entry, the base of the frames and associated steel support brackets are beginning to deteriorate due to moisture and salt.
- The hollow metal door frames are showing extensive rust and corrosion where they contact the concrete at the threshold. Some of these door frames are completely rusted through into the interior, as shown by the photo below in the gym.

ALUMINUM DOOR FRAME DETERIORATION – INTERIOR

- Aluminum door frames should be replaced.
- Replace all hollow metal exterior doors and frames with fiber reinforced plastic doors and frames. This is a good alternative to hollow metal and will not corrode like the existing frames.

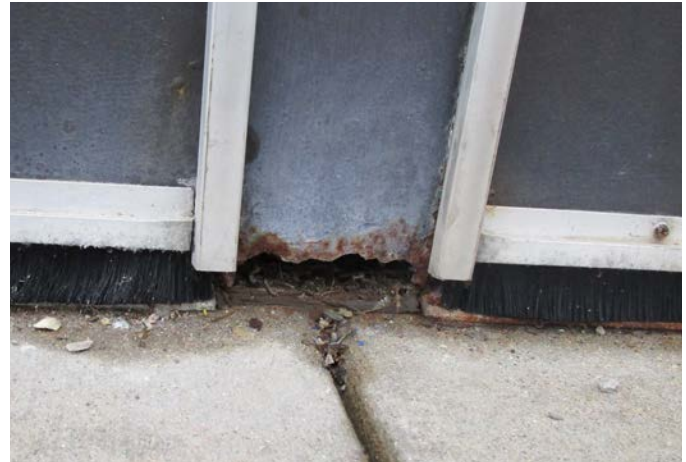
RUSTING HOLLOW METAL DOOR FRAME - EXTERIOR

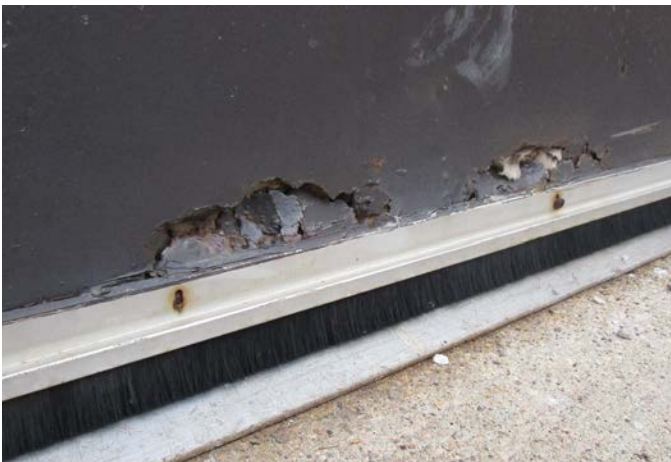
RUSTING HOLLOW METAL DOOR - EXTERIOR

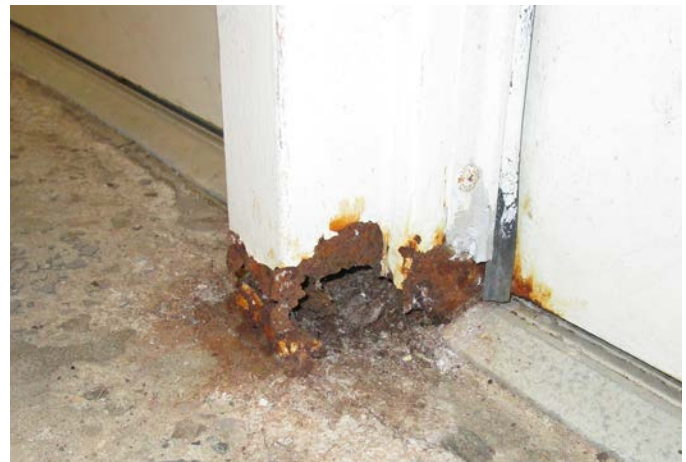
RUSTING HOLLOW METAL DOOR FRAME – INTERIOR

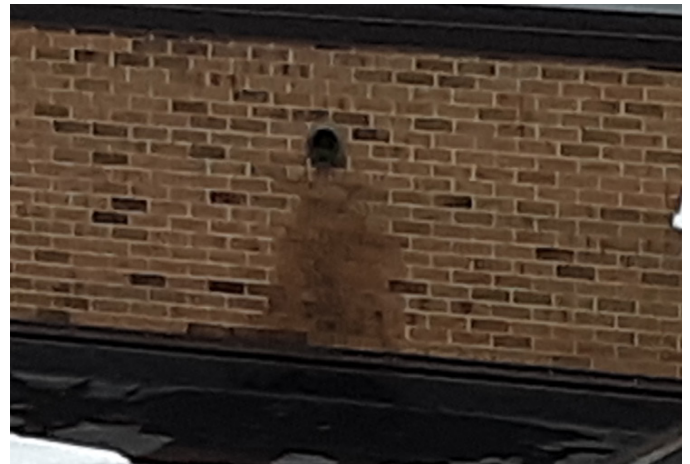
- Above Mechanical rooms C201 and E214, relief roof drains are set too low. As a result, water from a section of the roof is bypassing the main drain and using the relief roof drain wall outlet. Continued water flow over the exterior wall face is collecting dirt, and staining the wall, and causing moss growth.
- Above stairway 7, at the northeast edge of the roof, there is insufficient pitch to allow the water to flow to the roof drain.
- Facilities Staff report roof leaks where the main office in "F" wing meets the Commons in "C" wing. Leaks mainly appear during a driving rain. Repairs have been made to the roofing, bricks, and flashing in this area, but leaks still persist.
- Staff reports that the west wall of the gym, above the corridor also leaks in a driving rain.

ACTIVE RELIEF ROOF DRAINS STAINING EXTERIOR WALLS

- Raise the height of the two existing relief drains noted above to allow water to flow to the primary drains first.
- Leaking at walls that penetrate between two roofs are hard to pinpoint due to the fact that the water infiltration might be coming through the wall and wall flashing and not the actual roof membrane. A building envelope specialist should be hired to investigate persistent roof water infiltration issues.

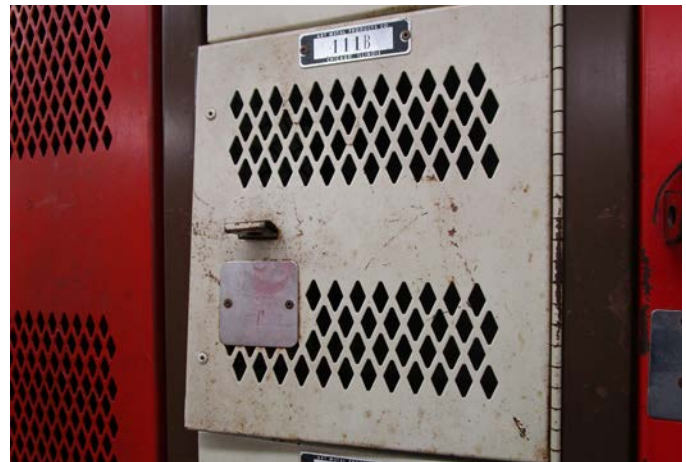
- The team locker rooms are from the original 1976 construction and show their age. Hollow metal door frames are rusting, the lockers are worn, damaged and rusting, and tile base is chipped and broken. Currently the showers and toilets do not meet ADA code compliance.
- The vanities in the main locker rooms are plastic laminate with surface mounted sinks. These are sagging downward and have been patched with caulk to prevent water from reaching the wood substrate under the laminate.

RUST ON ORIGINAL 1976 LOCKERS

- The team locker rooms should be fully renovated to include a private shower option, new lockers, and ADA compliant toilets, showers, and locker/bench locations.
- Replace the main locker room vanities with new integral bowl solid surface units.

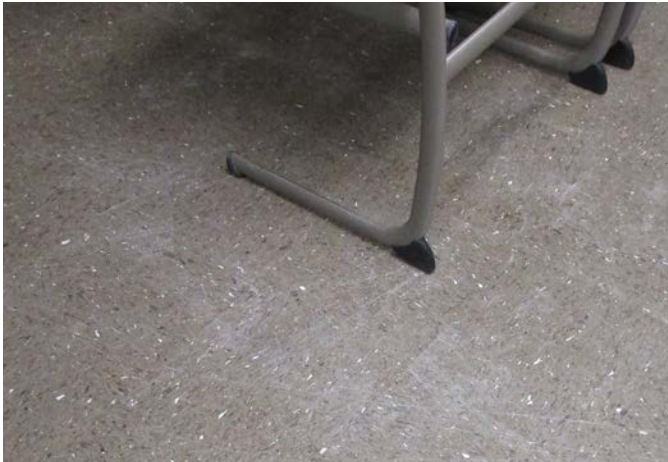
SCRATCHED ON FLOOR FROM PLASTIC FOOT PAD

- Work with furniture vendor to retrofit chair legs to eliminate floor scratching and preserve the useful life of the vinyl tile flooring.
- Renovate at least one station in these rooms to meet ADA. In science labs a sink area is needed which allows for the proper side approach reach to the faucet handles. In the Foods Room a roll under work sink, cook top. In art rooms, a roll under work sink. An ADA work surface/countertop should be provided at 34" above the floor.
- Increased space for the metal shop should be considered for any future expansion of the building.

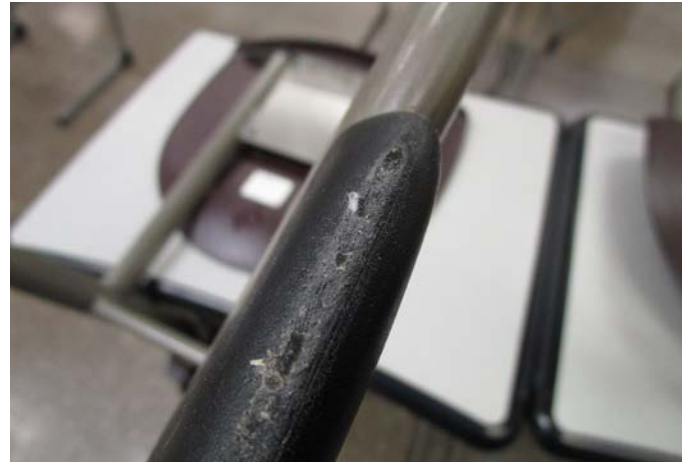
CLOSE UP OF DIRT EMBEDDED IN PLASTIC FOOT PAD

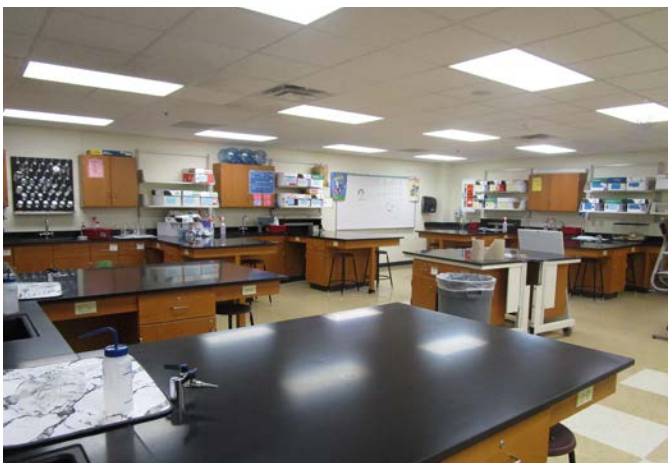
TYPICAL SCIENCE ROOM

- Currently no ADA compliant countertops or sinks were observed in these areas.

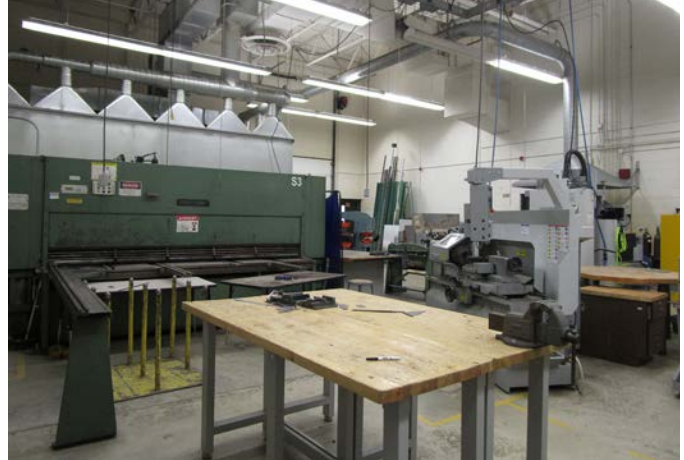
- The metal shop is congested with equipment and work benches. This area could be unsafe depending on the number of students using the space at the same time.

METALS SHOP WITH LIMITED EQUIPMENT CLEARANCE

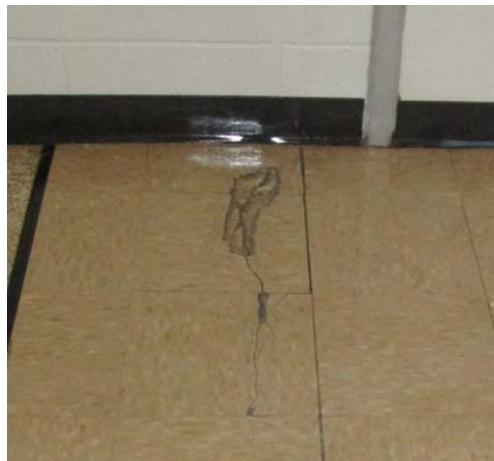
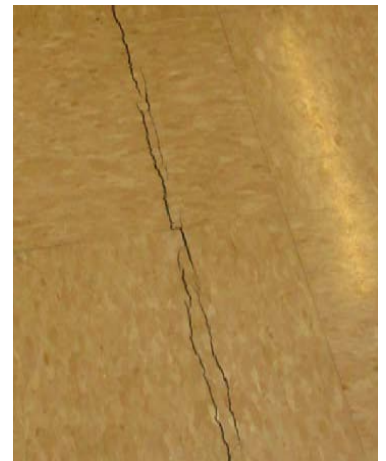
- In areas of vinyl tile flooring, expansion and building floor joints were not honored. The flooring material was installed over the gap without support from below and/or a break in the material itself. These building joints are easy to see since the vinyl tile has cracked, pulled apart, and sunk in.

VCT FLOORING THAT CROSSES A BUILDING JOINT, THAT HAS NOW CRACKED

- Proper floor joint/coverings should be installed that honor these building joints. Joints could be filled with grout and new flooring installed over the joint.

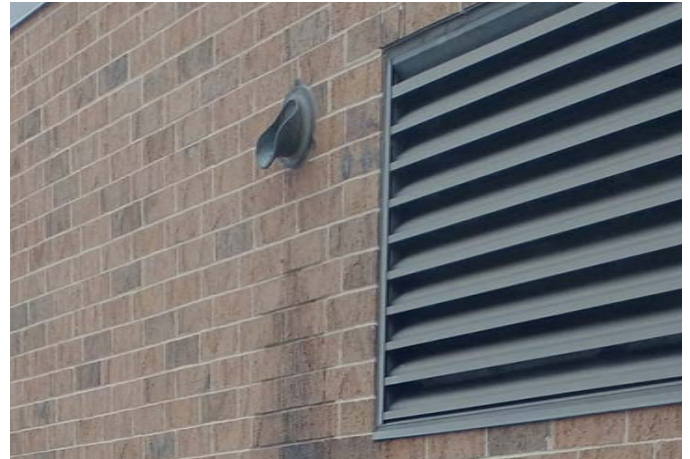
In the area to the southeast of the courtyard, it appears that an additional roof drain was added either during construction or shortly thereafter. This additional roof drain is terminated at a lambs-tongue which discharges into the courtyard. During any rain event, the lambs-tongue continually drips on the building exterior, which has resulted in dirt and mold growth on the side of the building in the courtyard.

COURTYARD LAMBS-TONGUE

- Ground water bubbles up through the floor in the commons area during heavy rain events.
- Lambs-tongues and roof scuppers in a few locations are causing discoloration of the building exterior. This could lead to issues with brick spalling in the future.

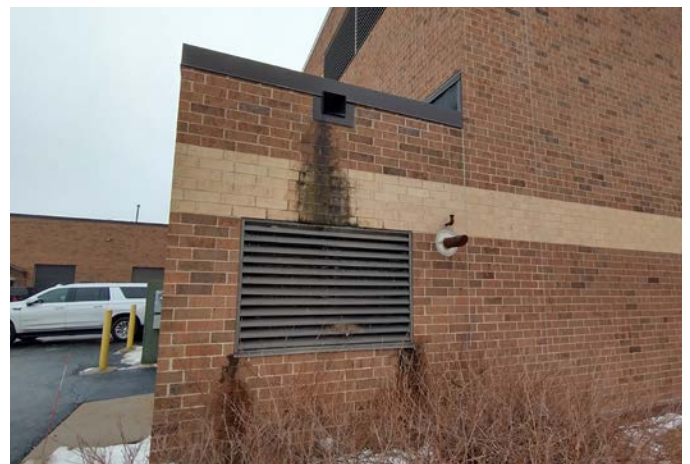
The generator enclosure does not have a primary roof drain, the roof is scuppered and drains out the side wall to the south. The drainage from this scupper has caused dirt and mold growth on the building exterior.

GENERATOR ENCLOSURE ROOF SCUPPER

- Consider some destructive testing in the area when the floor in the commons will be replaced. Removal of the floor in this area could identify issues with the piping configuration, or determine if the issue associated with the storm piping or if it is a ground water issue.
- Consider rerouting the lambs-tongue near the courtyard to connect to the main storm drainage.
- Consider adding a primary roof drain in the generator enclosure.

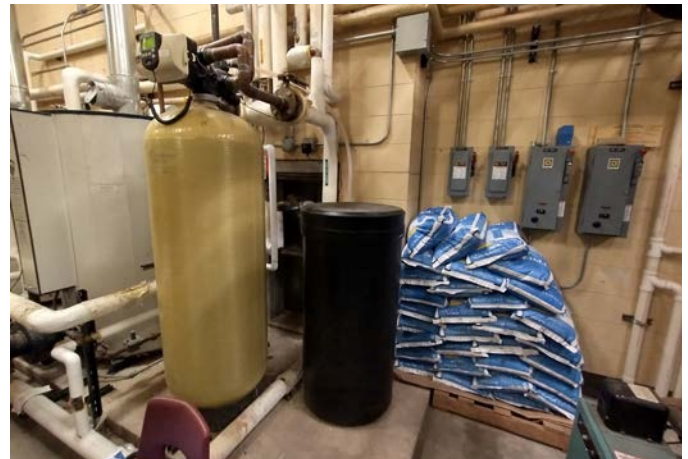
The school is served by a 4" diameter combined fire protection water service main. There is a water softener located within the boiler room which provides softened water for the domestic hot water system as well as soft cold water for the kitchen. The piping around the water softener is not currently insulated. This could cause corrosion of the piping and lead to early pipe failure.

WATER SOFTENER

- Lack of insulation on domestic water piping at water softener
- Damaged pipe insulation at water heaters.

- Consider repairing or replacing all damaged or missing pipe insulation within the boiler room.

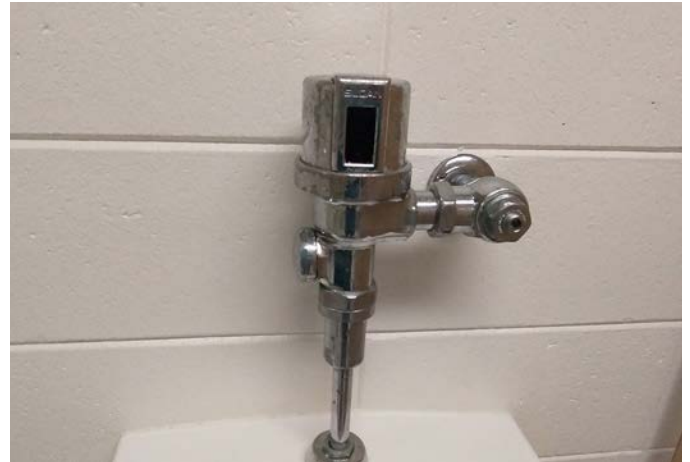
The urinals are wash down floor outlet style with sensor operation. Some urinals have fully concealed flush valves while others have exposed sensor type flush valves with a manual flush option. The newer sensor style flush valves appear to be in good condition, but have likely surpassed their expected service life and will require replacement soon. One thing noted during our site investigation is that many of the wash down urinals splash water on the floor at the base of the urinal. This causes urine to be splashed on the floor when the urinal is flushed, which causes an odor within the restroom.

URINAL FLUSH VALVE

- Faucets and flush valves are at or near their life expectancy.
- Urinals splash onto the floor when flushed, causing an unsanitary condition.

- Consider replacement of faucets and flush valves that have long surpassed their expected service life.
