MARCH 2023

Unified School District of De Pere

District-Wide Facilities Condition &
Education Adequacy Assessment

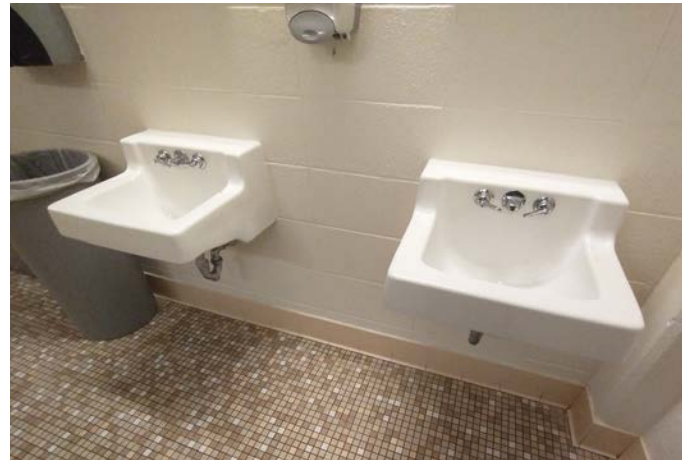
The school has a mixture of restrooms with multi-station wash fountains and restrooms with individual lavatories. The multi-station wash fountains have sensor operation and in general appear to be in good condition despite being close to the end of their expected service life. The individual porcelain lavatories have metered faucets and all appear to be in good condition. It was noted that several of the metering faucets do not stay on when the button is pushed, which makes it difficult to wash your hands properly at those lavatories.

ORIGINAL LAVATORIES

- Consider replacement of faucets and flush valves that have long surpassed their expected service life.

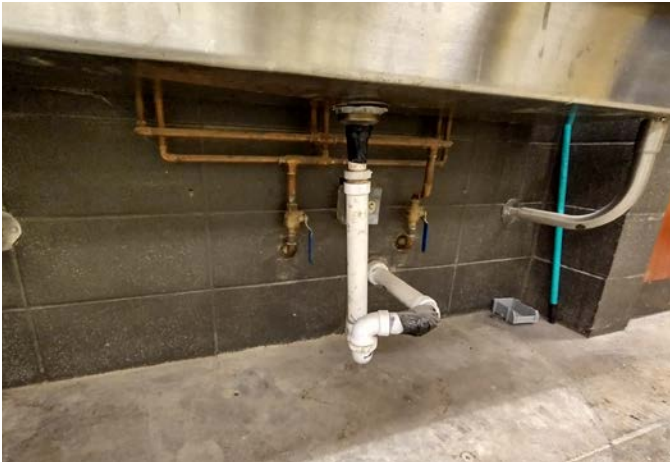
The stainless steel sinks within the classrooms are in fair to poor condition. Some of the goosenecks on the faucets are loose, and some wrist blade handles are difficult to turn. Many sinks have calcium deposits on the rim of the sink from the faucet leaking during operation. The sink basins are nearing the end of their expected service life, and the faucets have surpassed their expected service life. One of the traps for the stainless steel wash basins in the shop area is being held together by tape.

TAPED P-TRAP

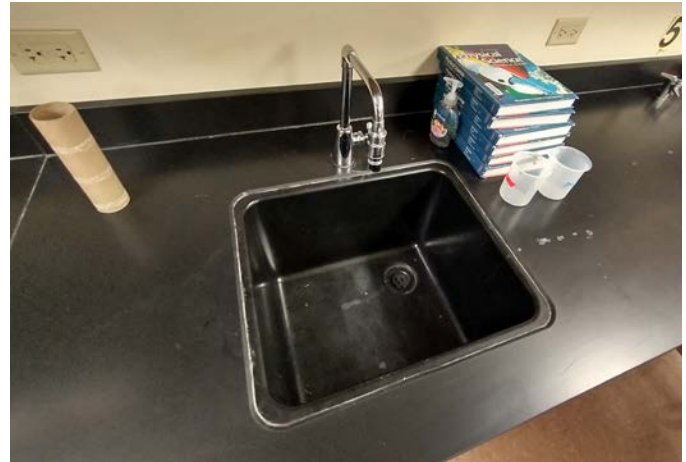
SCIENCE ROOM SINK

Science room sinks from the original 1976 construction are in poor condition. Many of the sinks do not work and the aerators spray water out of the side. The science room fixtures from the 2001 remodel are in good condition considering their age.

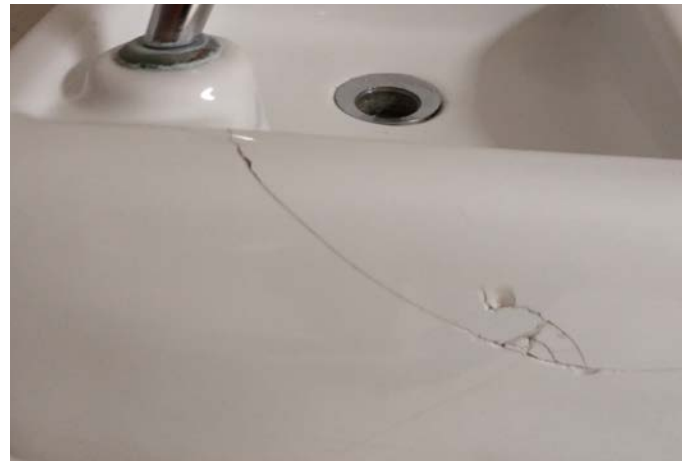
CRACKED DRINKING FOUNTAIN

The school has several sets of drinking fountains. The porcelain basin drinking fountains from the original school are in poor condition. Many of them are out of order, cracked, or have loose components. These fixtures are 47 years old and have surpassed their expected service life.

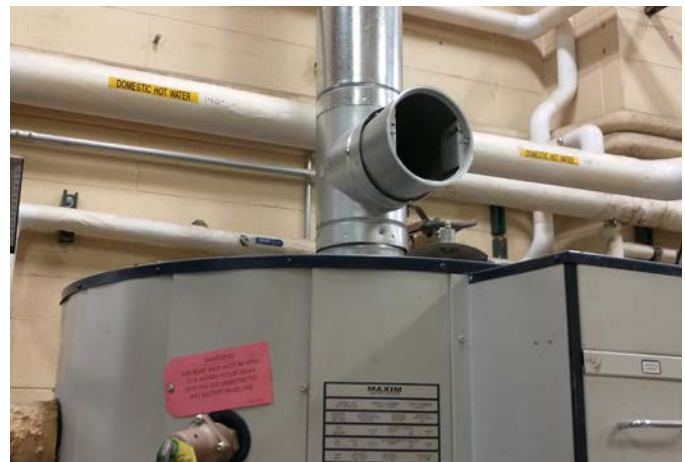
MISSING BAROMETRIC DAMPER

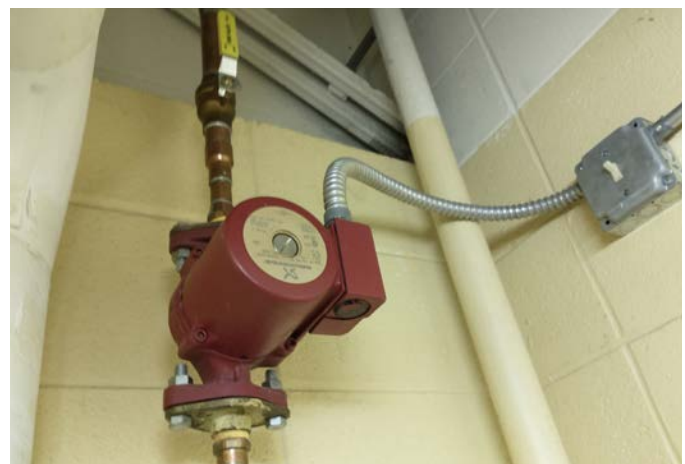
The domestic hot water recirculation pumps appear to be in good condition. Based on the existing drawings they were installed during the 2001 renovation. Given that information, they are likely close to their expected service life and should be replaced.

RECIRCULATION PUMP

The expected service life of recirculation pumps is 10 years depending upon water quality and maintenance.

- The recirculation pumps have surpassed their expected service life. Consider replacement of the recirculation pump prior to failure as preventative maintenance.
- The recirculation pumps have surpassed their expected service life. Consider replacement of the recirculation pump prior to failure as preventative maintenance.

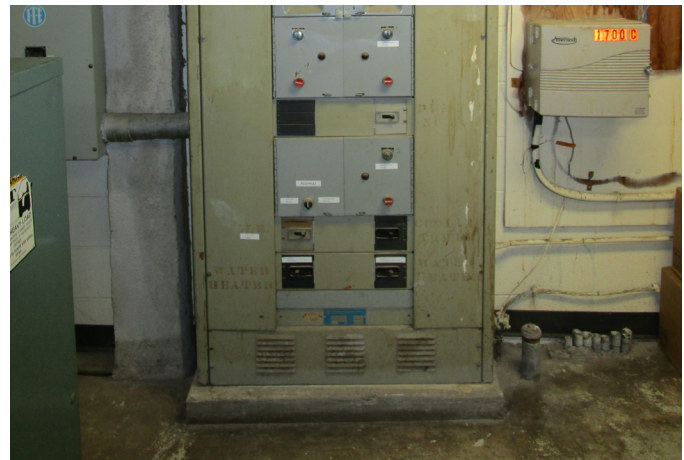
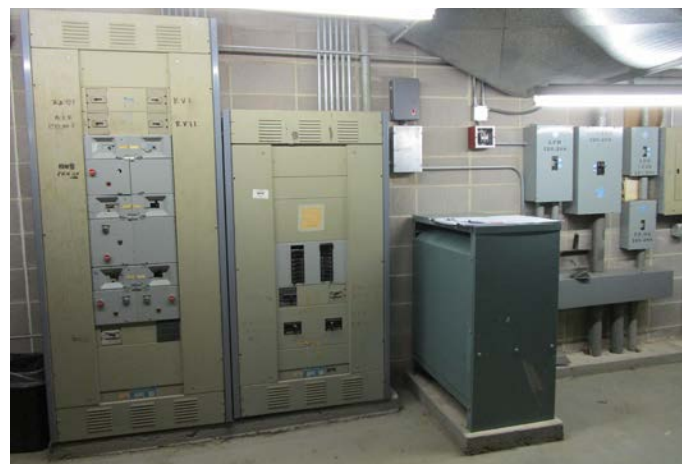
- Existing I.T.E. equipment is outdated and finding parts for replacement or servicing will be difficult.

OUTDATED I.T.E DISTRIBUTION PANEL

- Replace existing I.T.E. electrical panels with similar Square-D equipment.
- Electrical service equipment typically has a service life of approximately 30-40 years. The primary cause of the replacement is the inability to procure breakers which properly fit and operate within the existing branch and distribution panels toward the end of life.
- Replacement of the main switchgear of the electrical distribution system is not a requirement at this time. Preparations should be considered in a 20-25 year timeline.

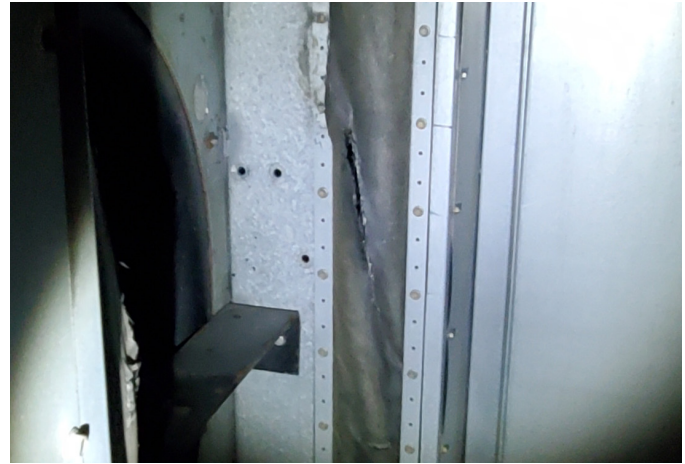
TORN FLEXIBLE CANVAS CONNECTION AT SUPPLY FAN

- Perform general preventative maintenance throughout the facility (insulation repair, sensor repair, etc.) to prevent more serious issues in the future.
- Consider revising the plenum configuration to use the ceiling cavity space for return air instead of egress corridors. Alternatively, consider fully ducting the return air for best performance.
- Measure and confirm proper ventilation rates are provided at all locations as required by Wisconsin codes and regulations.

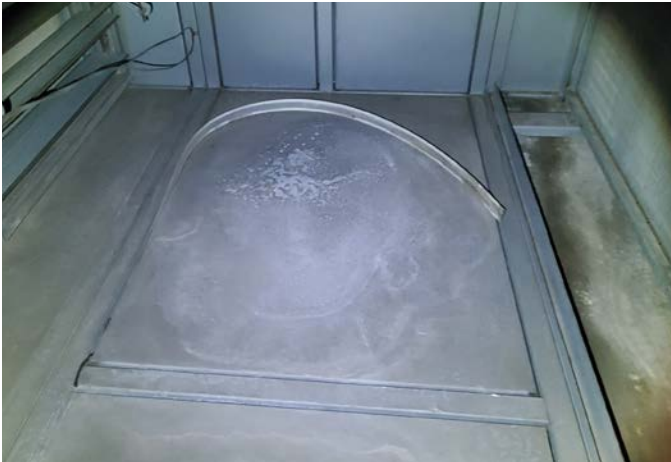
DETERIORATING SEAL AT AIR HANDLING UNIT CASING

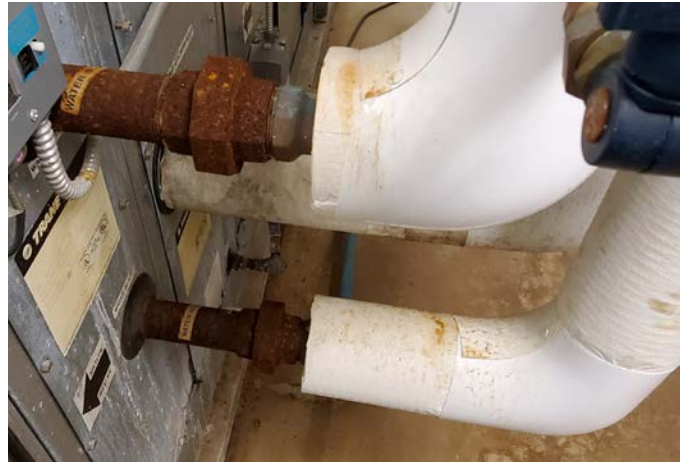
PIPE CORROSION DUE TO LACK OF INSULATION

- Chilled water piping at multiple locations has missing insulation or compromised vapor barrier. This will lead to further deterioration of piping and insulation due to condensation on exposed cold piping during humid weather. Pipe insulation is currently saturated above the humidifier in the “H-Wing.”

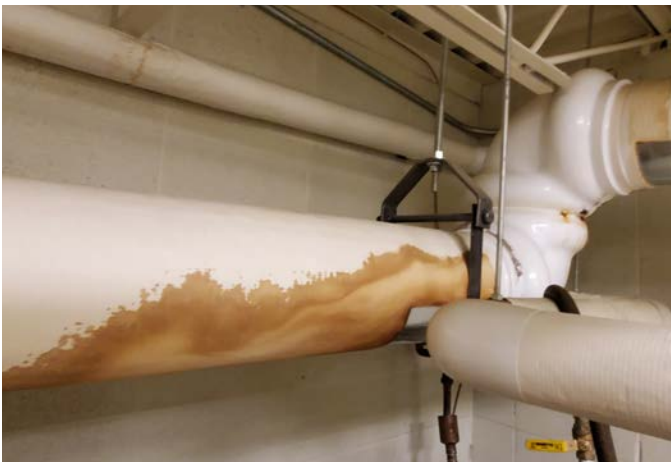
CONDENSATION ON CHILLED WATER PIPING

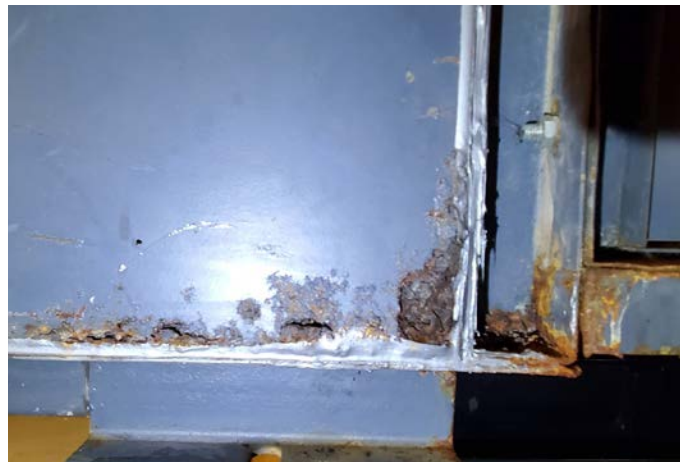
DETERIORATION OF 1976 AHU

- The remaining original 1976 air handling units are in poor condition and should be replaced.
- Combustible materials are currently stored within the return air plenum in the gymnasium. This is a violation of Wisconsin codes and a potential life safety risk in the case of a fire.

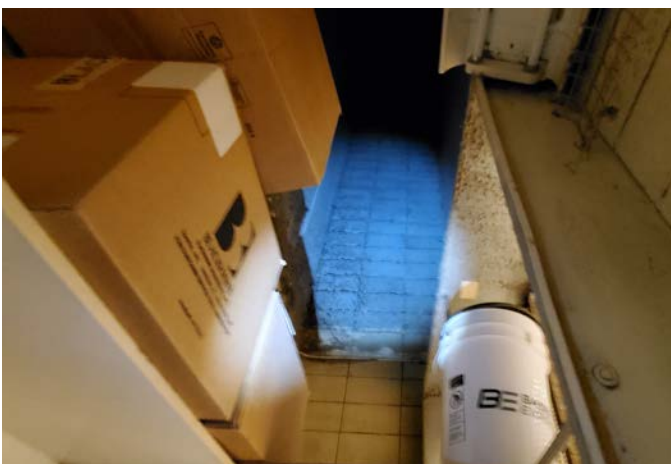
FLAMABLE MATERIALS STORED WITHIN RETURN AIR PLENUM

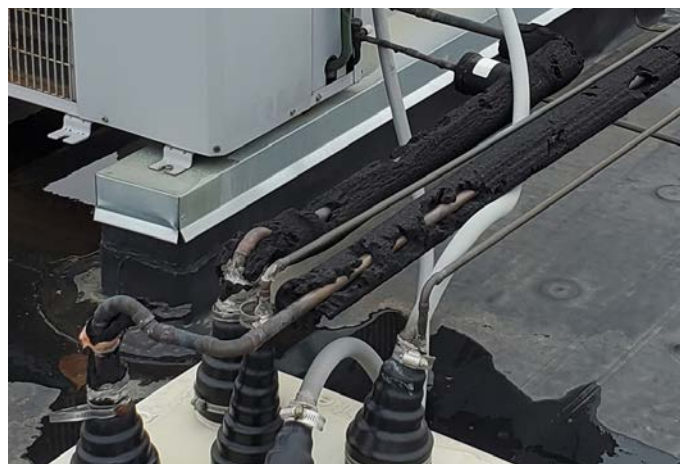
DETERIORATED PIPE INSULATION ON ROOF

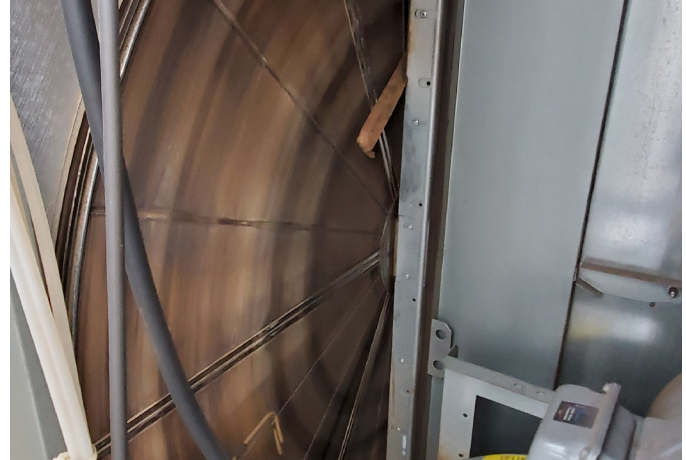
HEAT WHEEL IN METALS AIR HANDLING UNIT

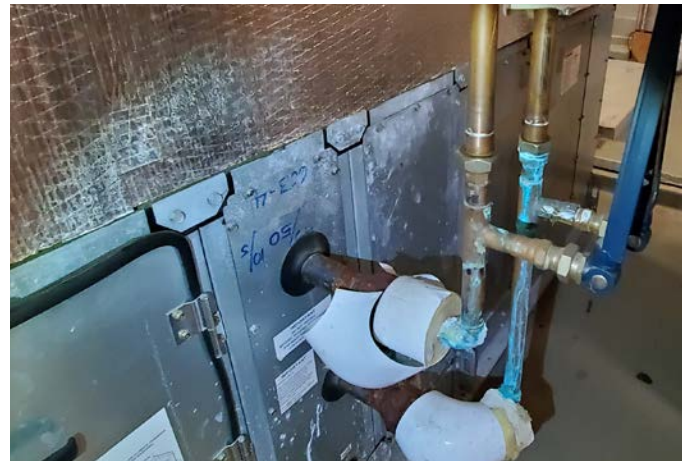
This facility appears to have significant issues with leakage at Victaulic grooved pipe fittings and threaded valves and devices. There is staining on the ceiling tiles below nearly all VAV boxes throughout the facility, indicating a widespread issue is present. It was also noted that, at locations with leaks, the copper piping is commonly corroded. An issue of this magnitude could be the result of water chemistry issues or the presence of excessive dissolved oxygen in the hot water distribution system. As leaks occur, a large quantity of make-up water is required which increases oxygen levels and decreases the concentration of corrosion inhibitors in the water system. We recommend conducting widespread repair efforts to break this cycle and improve the reliability of the hot water piping system. In addition to the leaking issues, it was identified that several terminal coils have been isolated by closing their manual ball valves or by removing valve actuators. Several classrooms were noted to be colder than surrounding rooms due to inactive VAV reheat coils.

EVIDENCE OF CORROSIVE WATER LEAK

- Repair pipe fittings, valves, accessories, and insulation throughout where leaks have developed.
- Perform extensive water treatment regimen to reduce the corrosive nature of the heating water.
- Replace heating pumps and copper tube boiler in the near future to improve reliability and efficiency of the water distribution system.
- Perform general preventative maintenance throughout the facility (insulation repair, sensor repair, etc.) to prevent more serious issues in the future.

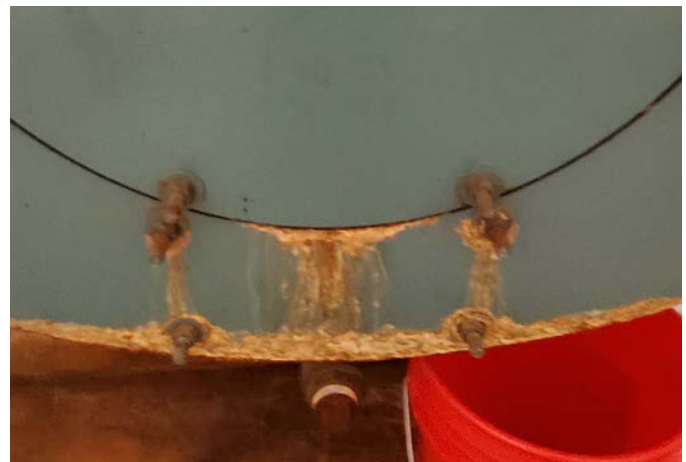
EVIDENCE OF PRIOR BOILER LEAKAGE

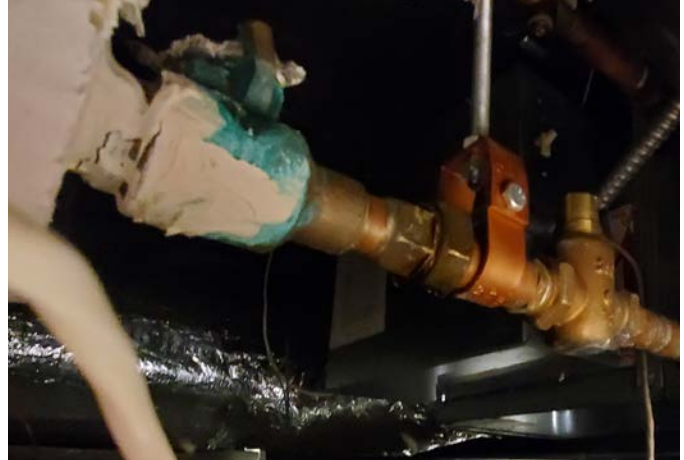
Failures of terminal valve actuators, particularly within the additions and areas renovated during the 2001 project, were prevalent. In discussions with facilities staff, it was indicated that replacement parts for the present actuators are prohibitively expensive. As such, consideration should be made to replace all control valves to improve system performance and reliability. Conditions within occupied spaces varied during our site visit. Several rooms were noted to be very cold, while others were quite comfortable. Some control behavior was noted which requires correction. For example, one of the chilled water pumps was operating during the inspection, but the outdoor air temperature was less than 40°F.

VALVE ACTUATOR REMOVED FROM VALVE BODY

- Consider conducting Retro-commissioning survey to “tune-up” and confirm proper operation of all control sequences. This may qualify for a Focus on Energy incentive.
- Recommend hiring a Testing, Adjusting, and Balancing contractor to periodically read out and calibrate outside air airflow measuring stations to confirm accuracy. It is common for this style of airflow measuring station to become fouled with dirt and debris and read artificially low, causing more outside air to be brought in than desired.
