Darien School District #61

Facilities Condition Assessment

Eisenhower Junior High School

September 13, 2021

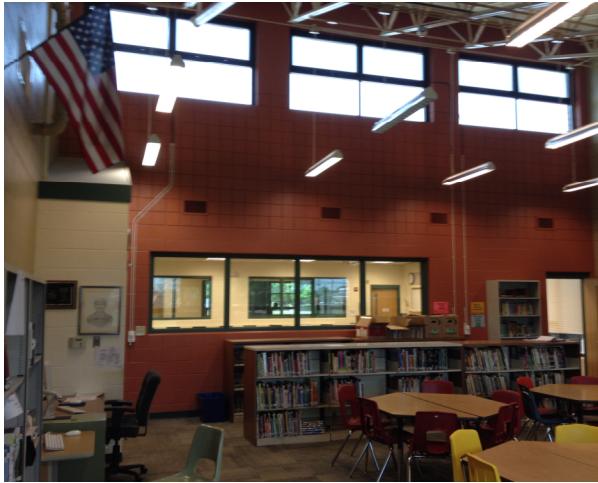
LIBRARY / STEM LAB

The STEM lab is currently located within a classroom sized space, and lacks the amenities that would be preferred for a STEM lab. Additionally, the library, which is adjacent to the STEM lab, is isolated from surrounding spaces. Consideration should be given to remodeling these spaces to better connect them to the surrounding spaces, and to incorporate current educational amenities.
