Darien School District #61

Facilities Condition Assessment

Eisenhower Junior High School

September 13, 2021

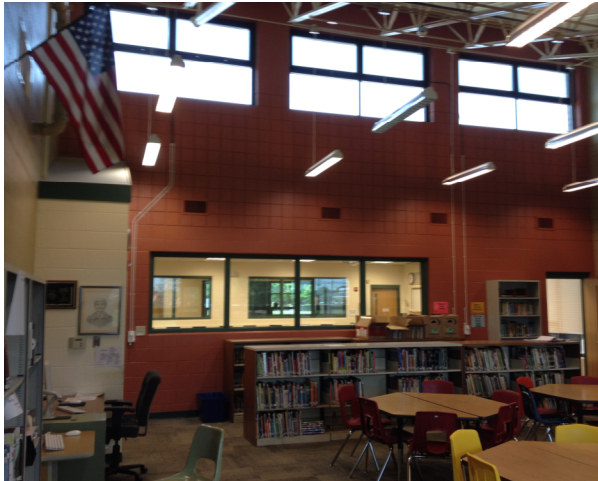
LIBRARY / STEM LAB

The STEM lab is currently located within a classroom sized space, and lacks the amenities that would be preferred for a STEM lab. Additionally, the library, which is adjacent to the STEM lab, is isolated from surrounding spaces. Consideration should be given to remodeling these spaces to better connect them to the surrounding spaces, and to incorporate current educational amenities.

Renovations						
"Light & Bright" All Classrooms and Corridors	40,000 sf	x \$60	per sf	=	\$2,400,000	
"Light & Bright" District and School Offices	3,900 sf	x \$60	per sf	=	\$234,000	
"Light & Bright" Corridors Only	9,400 sf	x \$60	per sf	=	\$564,000	
Common Area (1965 Wing)	2,400 sf	x \$100	per sf	=	\$240,000	
Library / STEM Lab	2,000 sf	x \$225	per sf	=	\$450,000

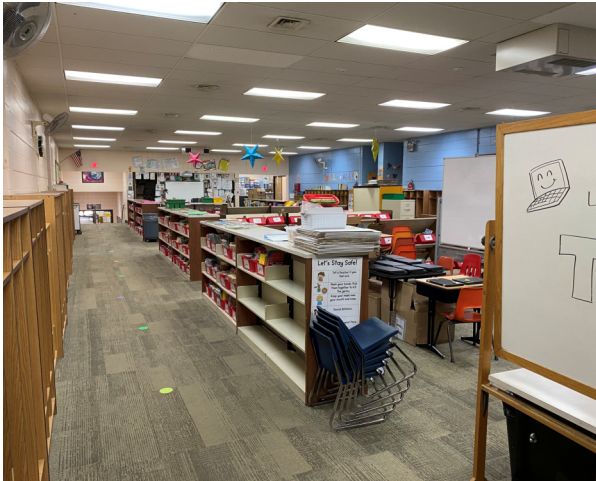
COMMON AREAS

The common areas are larger open spaces that are used for a variety of functions; including the library, small group activities, and technology services. It is recommended that these spaces be considered for renovation to provide task-specific areas that are more specifically designed for the intended uses. Renovation would also allow incorporation of current educational amenities within the common areas.
