— GRIFFITH PUBLIC SCHOOLS

District Facility Assessment
June 11, 2020

Beiriger Elementary School

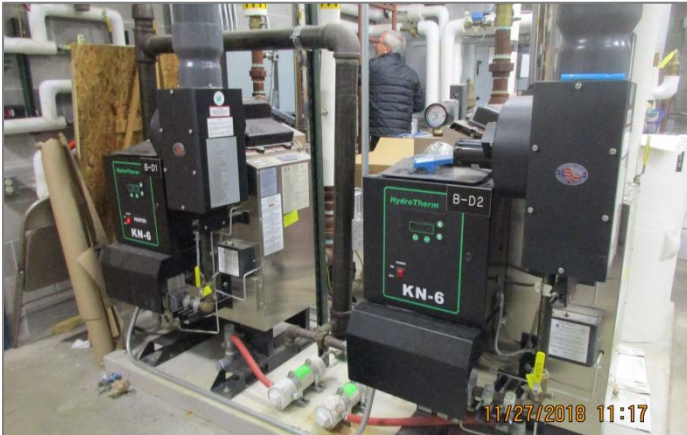
2010 BOILER PLANT

- ✓ Two (2) Hydrotherm KN-6 boilers were installed in the 2010 renovation, and two (2) Hydrotherm KN-20 boilers were installed in the 2008 renovation.
- ✓ Boilers are 93% efficient.
- ✓ Boilers are in good condition.

- ✓ None at this time.

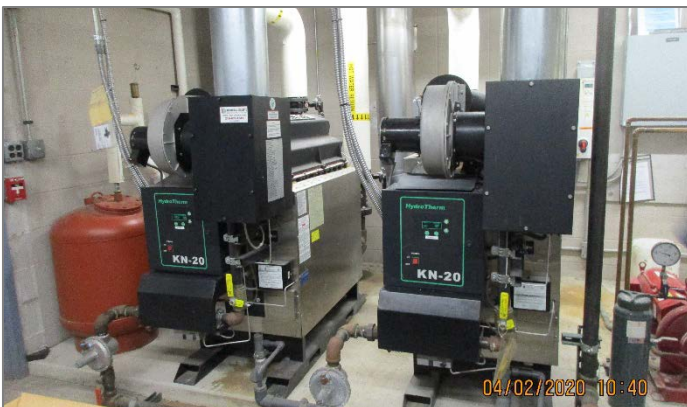
2008 BOILER PLANT

- ✓ Main heating distribution pumps are original to the recent renovations.
- ✓ The pumps are in fair condition.
- ✓ Heating water systems are currently variable volume primary configuration.

- ✓ None at this time.

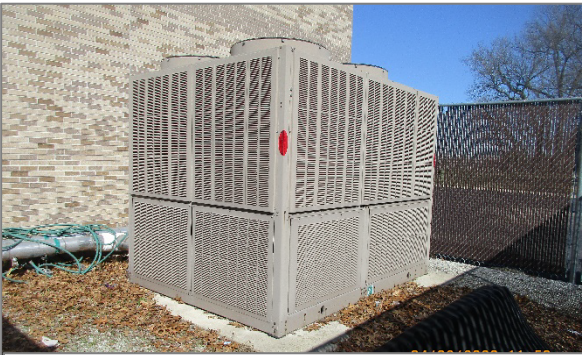
2010 YORK CHILLER

- ✓ The chilled water systems utilize variable primary pumping. Both sets of pumps are base mounted end-suction pumps. This arrangement is beneficial for maintenance access.
- ✓ The chilled water pumps are in good condition.

- ✓ None at tis time.

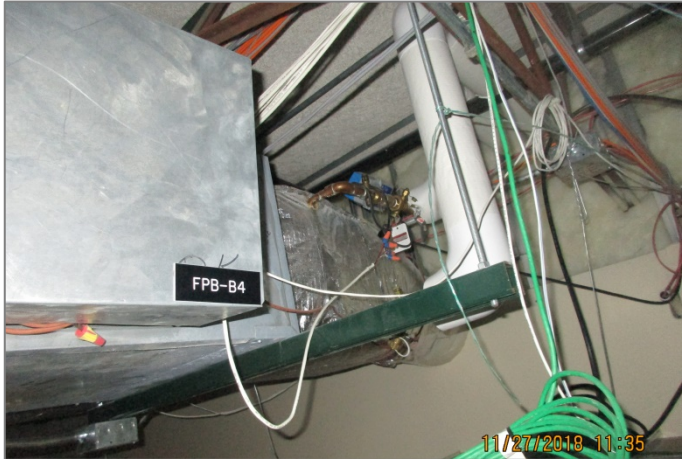
FAN POWERED VAV BOXES ARE INSTALLED ABOVE THE CEILING AND ARE DIFFICULT TO SERVICE (LADDER WORK)

- ✓ Recommend replacing fan powered VAV boxes at the end of their life, with standard VAV boxes to eliminate filter changes and motor maintenance.
- ✓ Safety - Maintenance people would not need to routinely get on a ladder and change filters/oil motors/etc. Most units require filter changes three times per year.

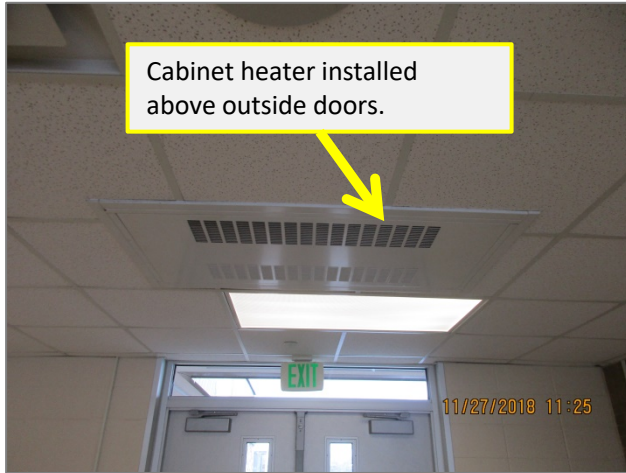
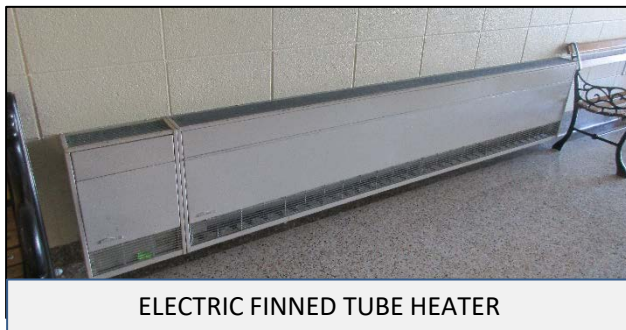
ELECTRIC FINNED TUBE HEATER

- ✓ Terminal heating equipment at entries and auxiliary spaces is typically 2-pipe heating cabinet units within the building.
- ✓ Electric finned tube heat is installed at some windows and entries. Date of installation unknown.
- ✓ Mechanical spaces have propeller unit heaters.
- ✓ Units are original to both renovations.

- ✓ None at this time.

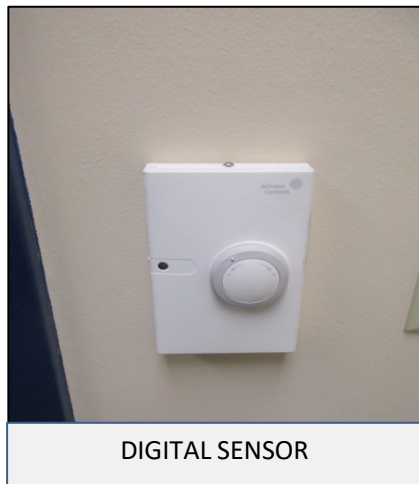
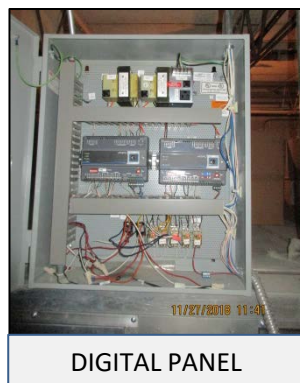
- ✓ Existing temperature controls at this building are a Johnson Controls, digital system.
- ✓ The system was installed in 2014.
- ✓ Service support is by Johnson Controls.
- ✓ Digital controls are necessary in a school to properly monitor and control the learning environment. The system is in good condition but occupants complain about erratic temperatures.

- ✓ Re-commission the controls for more comfort and room-to-room consistent temperatures.

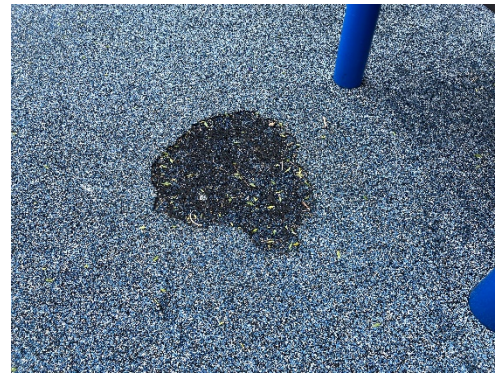
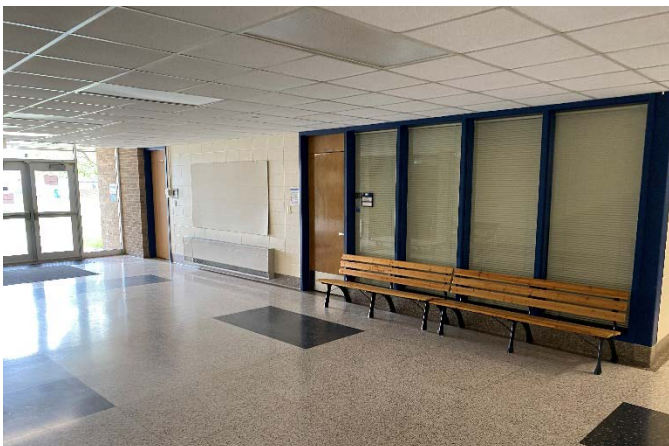
- ✓ The playground surface is worn in many locations and should be patched.

- ✓ The bus exit door does not have vestibule doors, allowing cold air to enter the building. As this door is commonly used, vestibules are recommended to improve comfort.

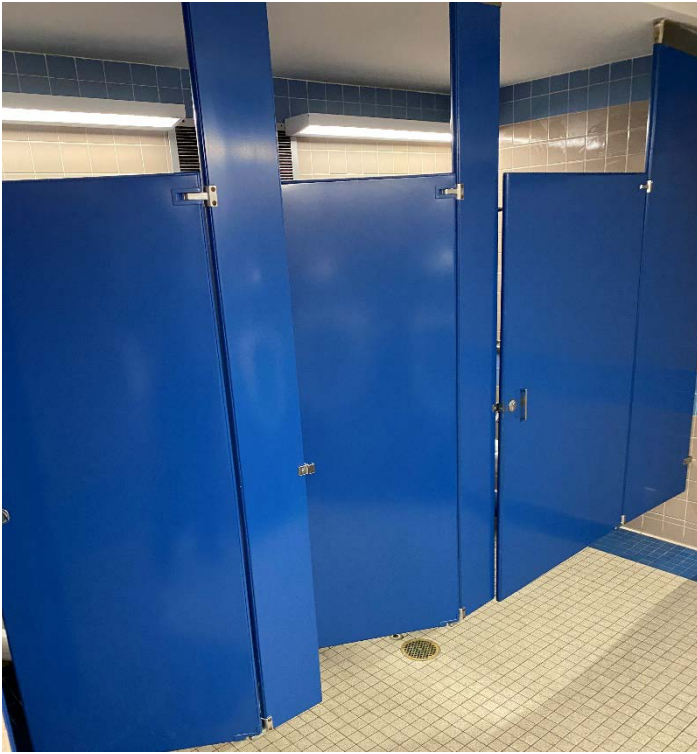
- ✓ Metal partitions in B212 and B221 in average condition.

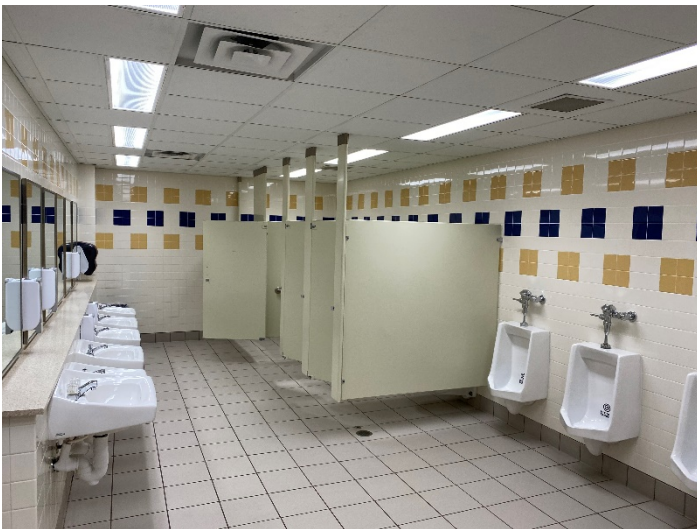
- ✓ Other restrooms have been remodeled and are in good condition.

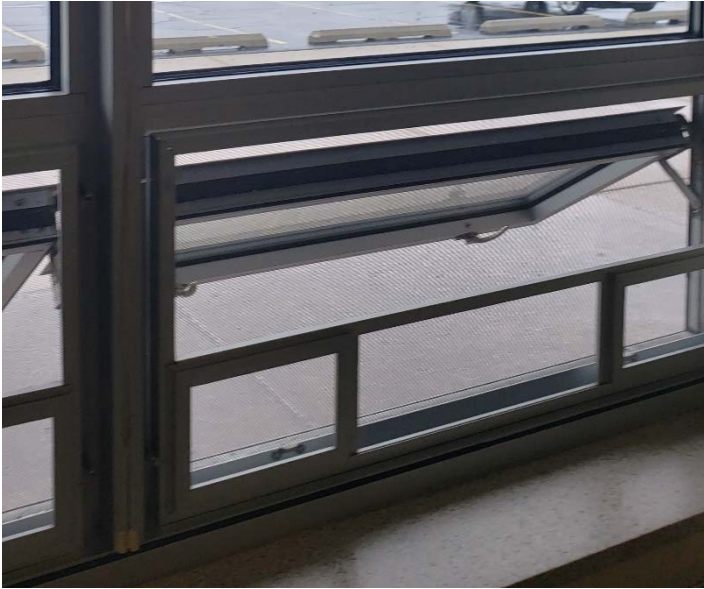
- Fenestration in good shape aesthetically.
- Windows appear to be 30+ years old. No visible signs of failure.
- It is assumed that the current windows have at least 5 years of life left.
- Lack of sun / natural light control requiring blinds. New glass should have low-e coating to improve thermal performance .

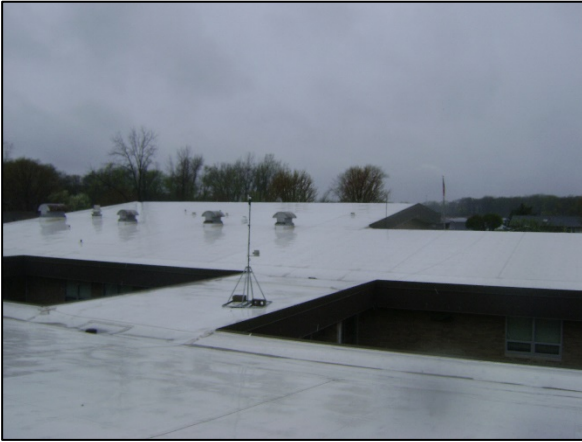
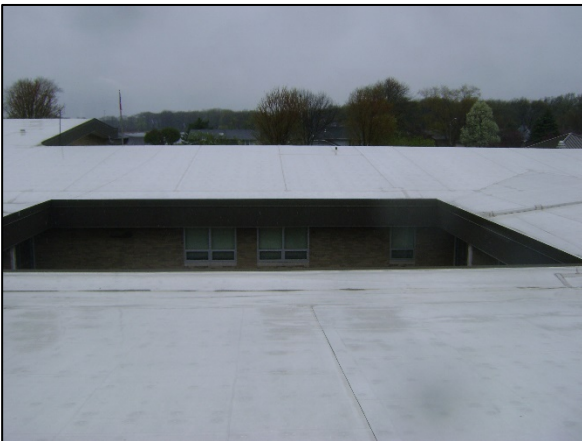
- ✓ These roofs were found in good condition.
- ✓ They appear to have been replaced in the last 10 to 12 years.
- ✓ We did find some snow guards loose on a small canopy roof over a door entry on the North Side.

- ✓ Replace missing snow guards.

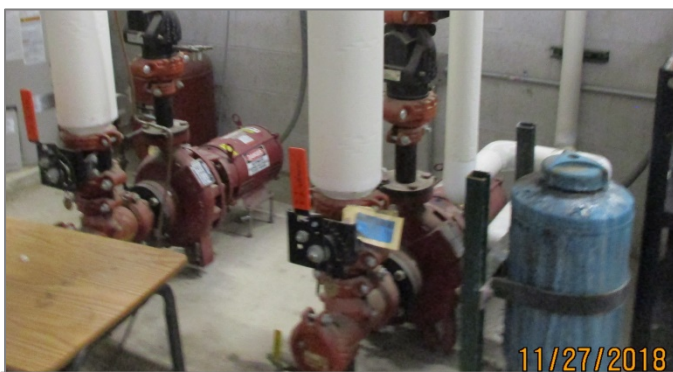
HEATING WATER PUMPS

- ✓ Main heating distribution pumps are original to the 2001 renovation and are in fair condition.
- ✓ Heating water system is currently primary secondary pumping with constant volume on the secondary side.

- ✓ Recommend replacing heating water pumps with new pumps and drives when high efficiency boilers installed.

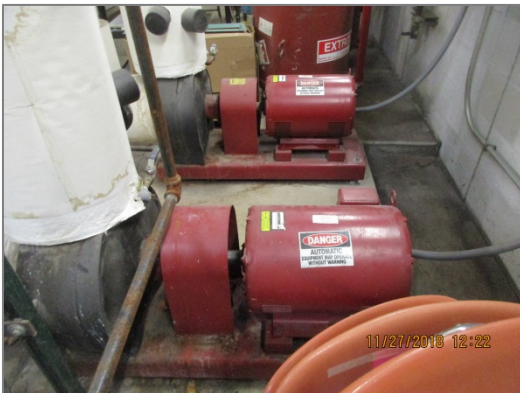
CHILLER DISTRIBUTION PUMPS

EXISTING CONDITIONS

- ✓ The chilled water system utilizes primary/secondary pumping system. Both sets of pumps are base mounted, end-suction pumps. This arrangement is beneficial for maintenance access.
- ✓ The chilled water pumps are in good condition and the secondary pumps currently utilize variable frequency drives.

- ✓ None at this time.

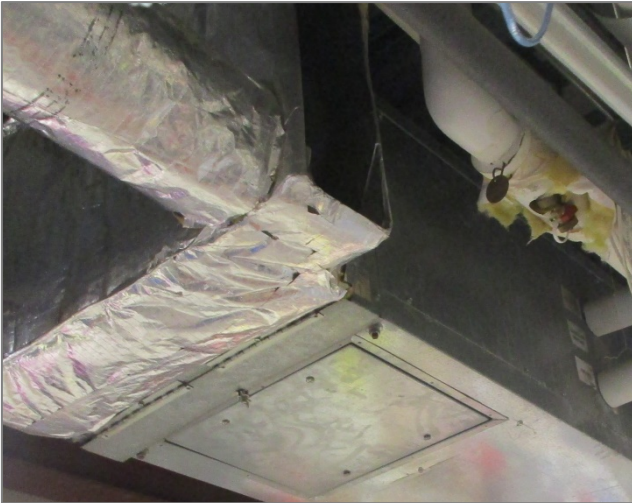
FAN COIL UNITS ARE INSTALLED ABOVE THE CEILING AND ARE DIFFICULT TO SERVICE (LADDER WORK)

- ✓ Recommend replacing fan coil units at the end of their life, with either a VAV system or vertical classroom units.
- ✓ Safety - Maintenance people would not need to routinely get on a ladder and change filters/oil motors/etc. Most units require filter changes three times per year.

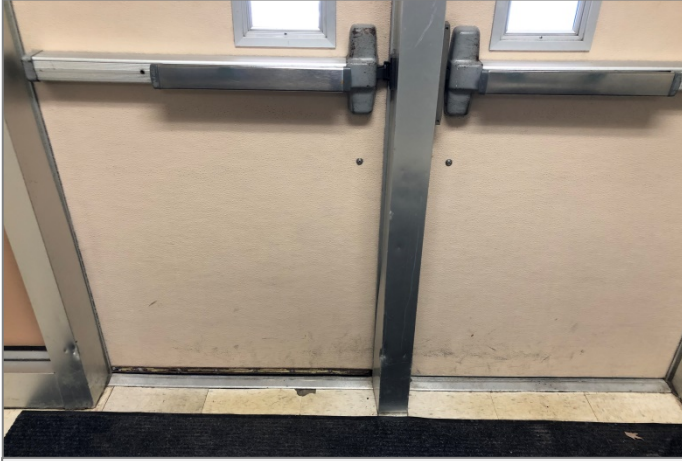
SOME DOOR THRESHOLDS NEED ATTENTION

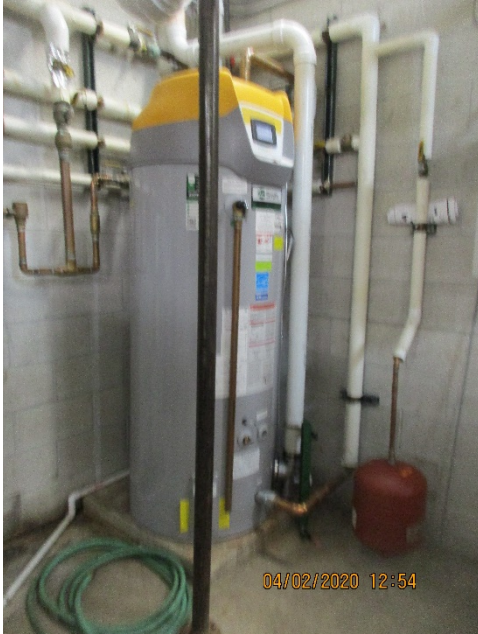
DOMESTIC WATER HEATER

- ✓ Domestic hot water heater is a model manufactured by A. O. Smith.
- ✓ The unit is high efficiency.
- ✓ This unit was installed in 2019 to replace a unit that had been causing maintenance problems, and appears to be in good condition.

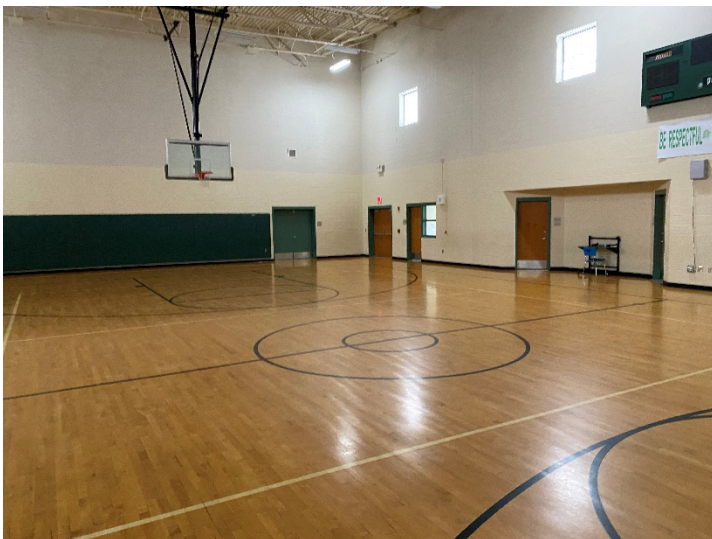
- ✓ Existing gym appears to be in good condition.

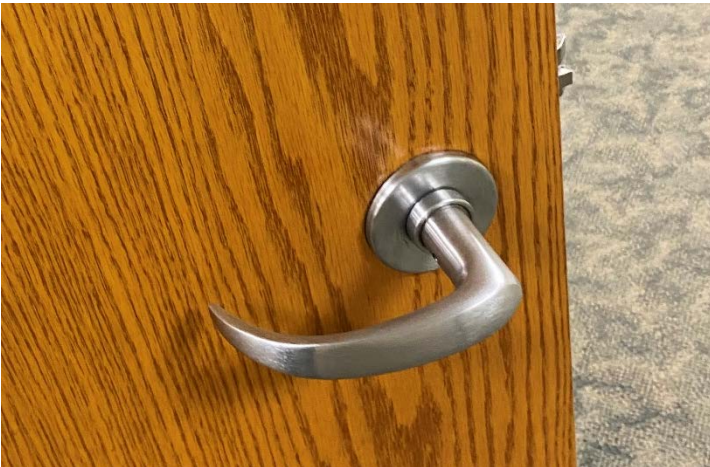
- ✓ Classroom door hardware is in good condition. However, the locks cannot be secured from the inside of the classroom in an emergency situation.

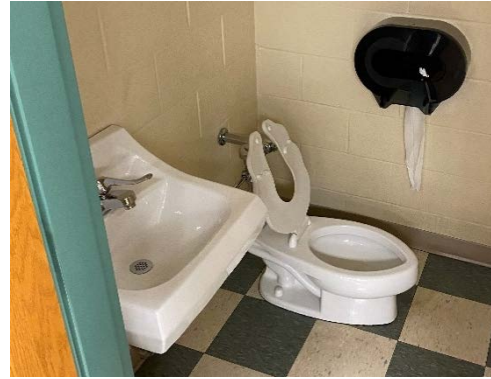
- ✓ The kindergarten restroom floors are VCT and is failing. As this will commonly be subject to water, it is recommended these be replaced with a resinous floor.

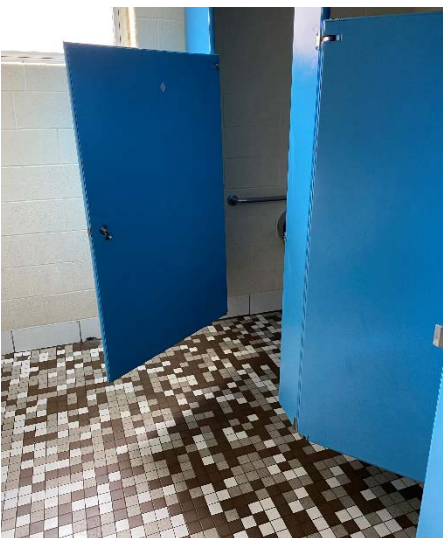
- ✓ The restroom partition in the oldest wing are in poor condition and should be replaced.

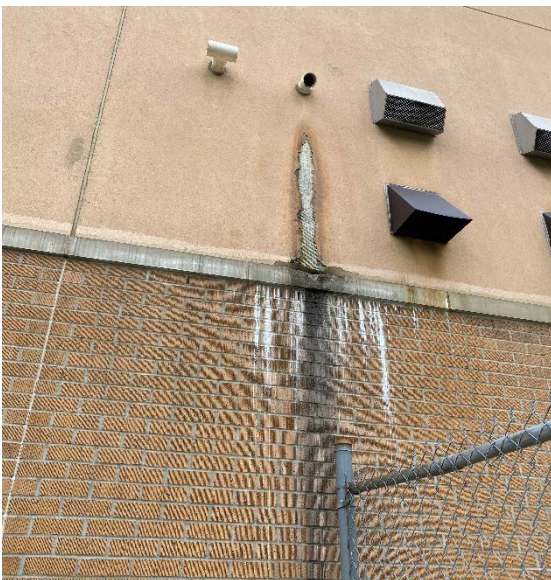
- ✓ Existing EIFS and masonry is damaged on the west elevation of the gym due to the exhaust of the water heater. The exhaust system should be addressed and the wall repaired.

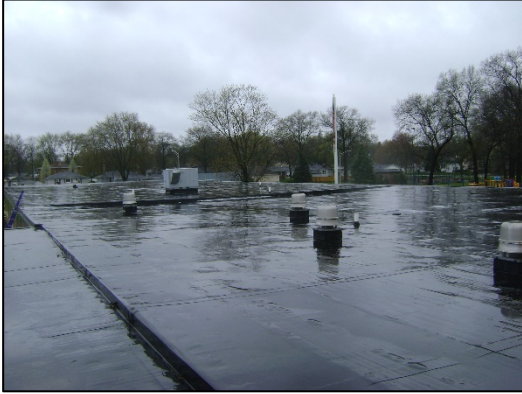
EXISTING CONDITIONS ON ROOFING SYSTEMS

- ✓ Appear to be in good condition. No deficiencies noted.
- ✓ From records these Fully Adhered EPDM roof systems look like they were recently installed in 2015.
- ✓ A external ladder should be installed from the lower roof levels to access the higher bay Gym roof.

- ✓ Install ladder from lower elevation to gym roof.

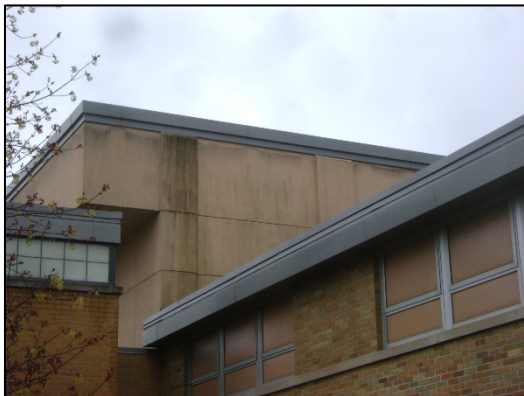
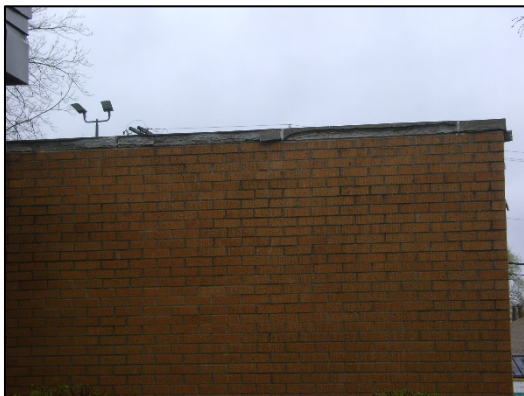
EXISTING CONDITIONS ON EIFS WALLS & COPING CAP

- ✓ EIFS walls appear to be in a state of deterioration on the North side of the gym.
- ✓ Deficient caulking joints, minor cracking of the EIFS top coat and severe algae/staining on surface of the EIFS.
- ✓ Limestone coping cap around brick walls of dumpster enclosure are failing.

- ✓ Restore EIFS walls with new waterproofing coating and repairs.
- ✓ Replace existing limestone coping cap with new limestone copings.

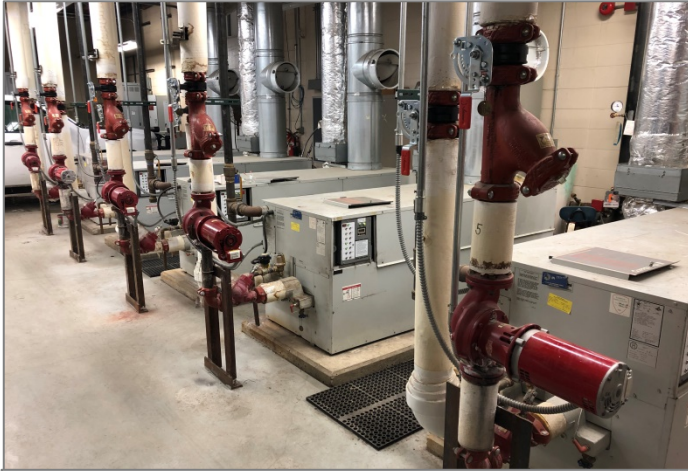
BOILER PLANT

- ✓ Six (6) atmospheric Lochinvar boilers are original to the 2001 renovation.
- ✓ Boilers are only 80% efficient.
- ✓ Boilers are in fair to poor condition due to their age and hours of operation.
- ✓ The boilers run all year around....they heat the domestic water and pool water in addition to the building heat.
- ✓ One boiler was recently replaced because of a failure of an original boiler.

- ✓ Recommend replacing boilers with two high efficiency condensing boilers.
- ✓ Replace pool water heat exchanger with a high efficiency dedicated heater.
- ✓ Replace the domestic water heat exchanger with a high efficiency heater.

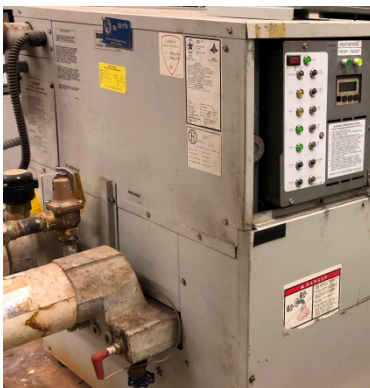
EXISTING BOILER SHOWING
SIGNS OF WEAR AND TEAR

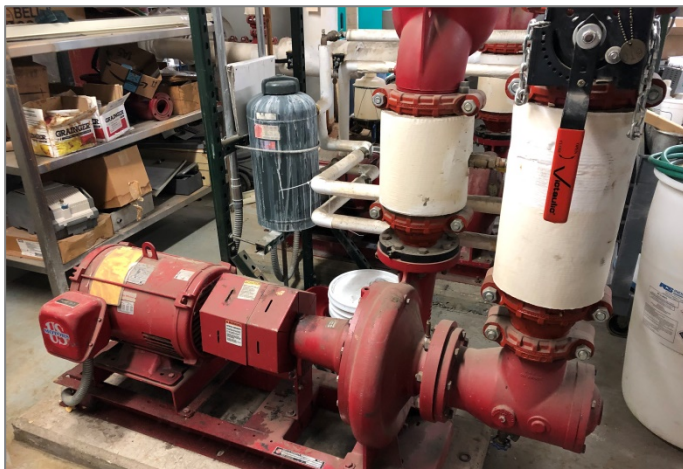
BOILER DISTRIBUTION PUMPS

- ✓ Main heating distribution pumps are original to the 2001 and are in fair condition due to good maintenance practices.
- ✓ Heating water system is currently variable volume on the secondary side.

- ✓ Recommend replacing heating water pumps with new pumps and drives when high efficiency boilers installed.

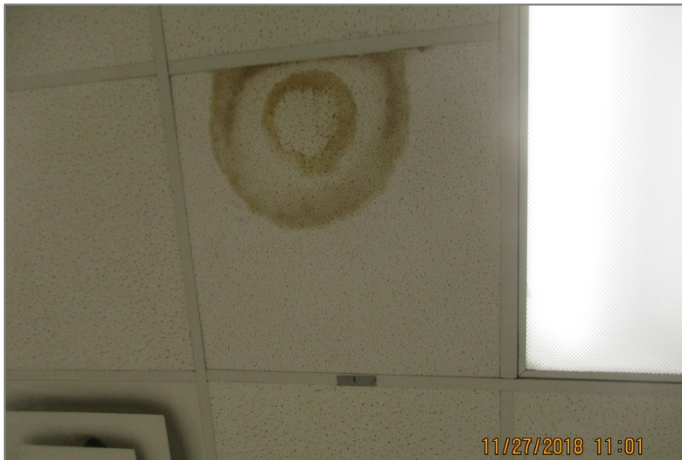
FAN COIL UNITS AND VAV BOXES ARE INSTALLED ABOVE THE CEILING

- ✓ Recommend replacing the fan coil units at the end of their life with a system that is designed to better control humidity and temperatures including either a VAV system or vertical classroom units.
- ✓ Recommend replacing fan powered VAV boxes at the end of their life, with standard VAV boxes to eliminate filter changes and motor maintenance.
- ✓ Safety - Maintenance people would not need to routinely get on a ladder and change filters/oil motors/etc. Most units require filter changes three times per year.

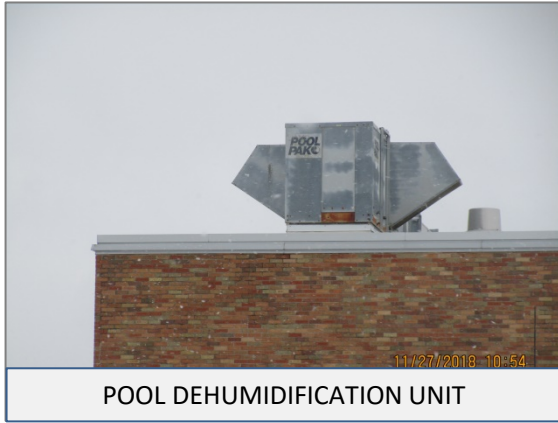
- ✓ The pool is currently conditioned by two DX Pool Pak units mounted on the roof.
- ✓ These units are at or near the end of its life.
- ✓ Refrigerant is R-22 that is no longer manufactured and is expensive to replace.

- ✓ Recommend replacing Pool Pak unit with similar piece of equipment for pool conditioning.

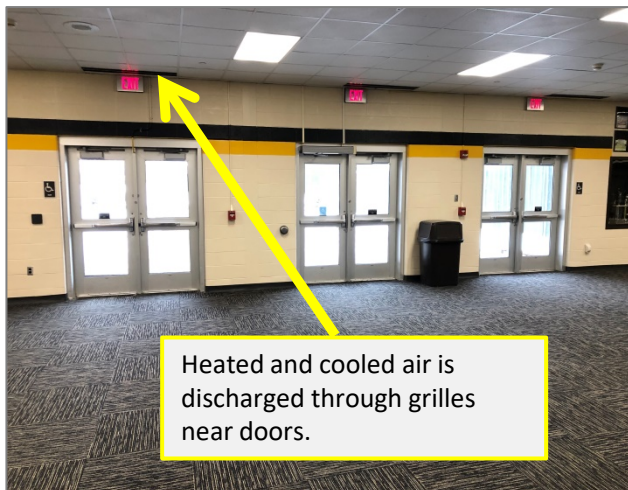
Terminal Heating Equipment

- ✓ Terminal heating equipment at entries and auxiliary spaces is typically 4-pipe heating/cooling cabinet units within the building and above ceilings.
- ✓ Mechanical spaces have propeller unit heaters.
- ✓ Units are original to 2001 renovation.

- ✓ Replacement of units would be needed to take advantage of a new condensing boiler system.

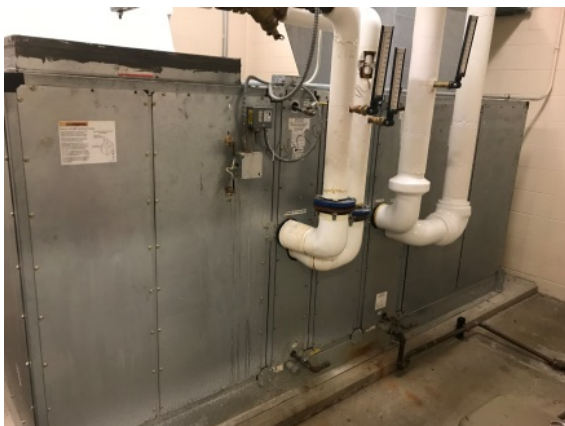
Air Handling Equipment

- ✓ The large areas of the building are served by 4-pipe, Trane air handling units (from the 2001 renovation).

- ✓ Recommend adding CO₂ based control of outdoor air to reduce energy usage.
- ✓ The heating coils may need to be replaced to take advantage of a new condensing boiler system.

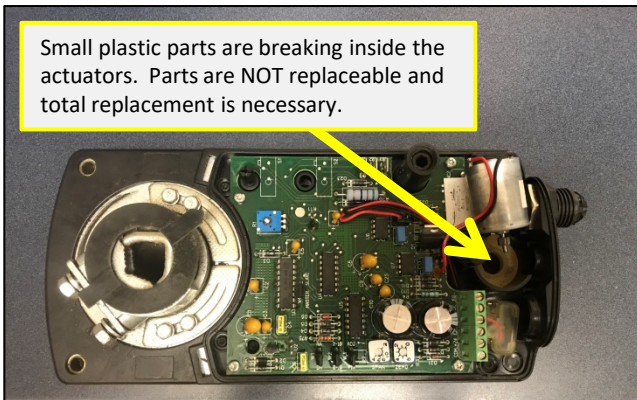
Small plastic parts are breaking inside the actuators. Parts are NOT replaceable and total replacement is necessary.

JOHNSON CONTROLS ACTUATORS HAVE BEEN FAILING AT A RAPID RATE

- ✓ Existing actuators on damper motors and valves are manufactured by Johnson Controls and are at their life expectancy.
- ✓ Failures have become common which leads to uncomfortable students/staff members.

- ✓ Audit all the air handling devices and determine the quantity of actuators needing replacement.
- ✓ Audit all the air handling control valves and determine the quantity of valves needing replacement.
- ✓ Get pricing from multiple vendors and replace devices.

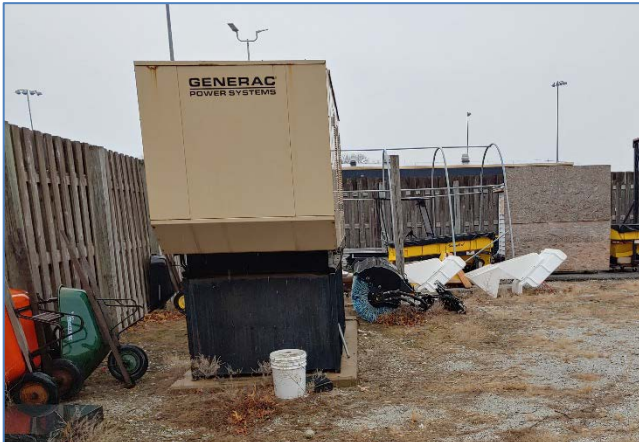
EMERGENCY GENERATOR

- ✓ There is a backup generator currently at this building that serves the computer systems, pool pump, lighting, etc.
- ✓ The capacity of the generator and what is currently connected would need to be evaluated to make proper recommendations.

- ✓ Increase the size of the generator.
- ✓ Most school generators have the following loads connected: boiler(s), boiler pumps, emergency lighting including exit signs, computers/servers in the IT room, telephone system, door locks and swipes, fire alarm panels, cameras, security system, cooling for the IT room, kitchen freezer and cooler, temperature controls for the boiler room, sump pumps, well pumps and sewage pumps.

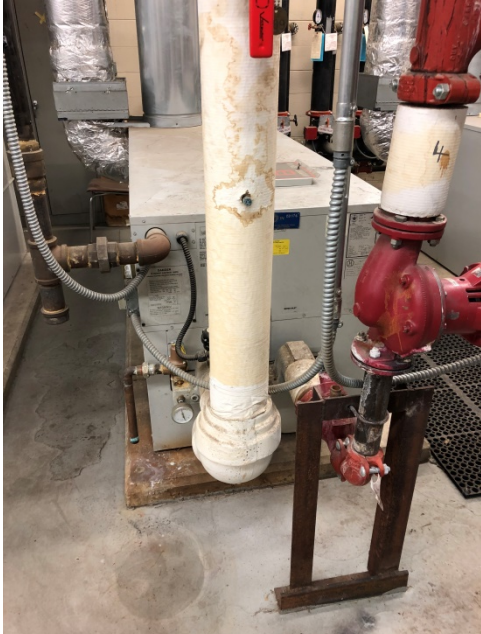
DOMESTIC WATER IS HEATED BY
MAIN BOILERS

EXISTING CONDITIONS

- ✓ Replace the domestic water tank heat exchanger with a high efficiency heater.

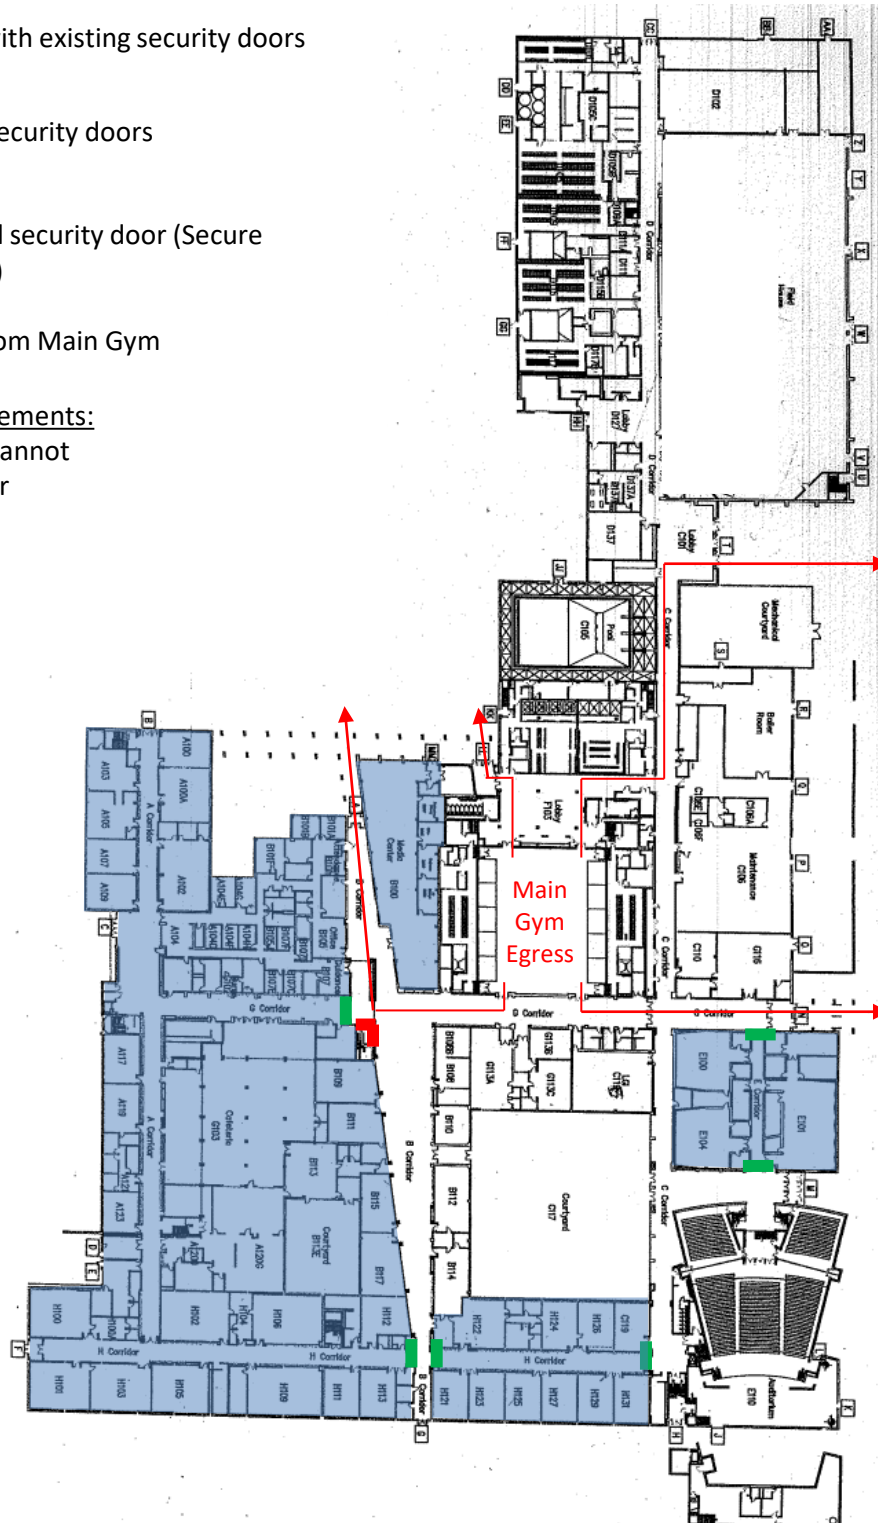
Egress from Main Gym

Dead-End Corridor Requirements:
Security doors and gates cannot create a dead-end corridor

- ✓ Existing security gates create dead-end corridors creating life safety issues. Reference security door diagram for secured sections of the building. Additional security gates can be provided to secure sections of building. However, these doors must be located as to not create dead-end corridors.
- ✓ Additional doors are recommended to be installed at one staircase to secure the 2nd floor.

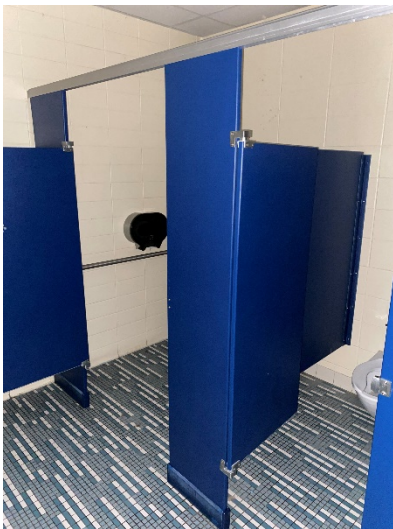
- ✓ Restrooms appear to meet accessibility requirements. Partitions throughout the building look in good condition.
- ✓ Many restrooms floor and wall finish appear dated. Replacing the floor and painting the walls could modernize the appearance.

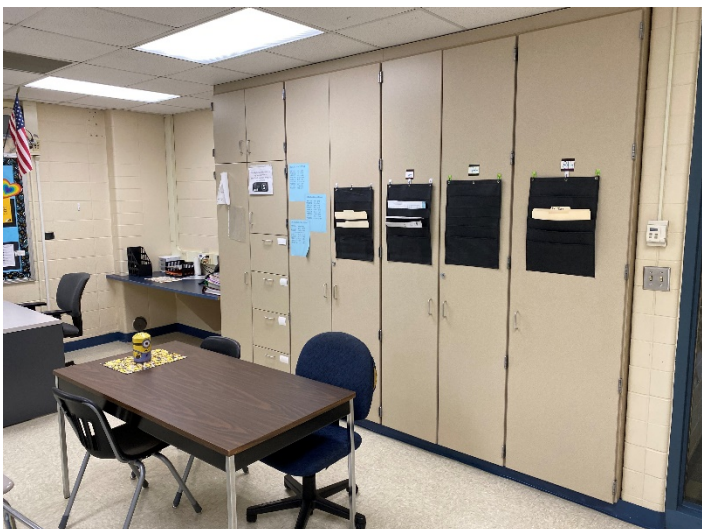
- ✓ Existing classroom casework is in good condition.

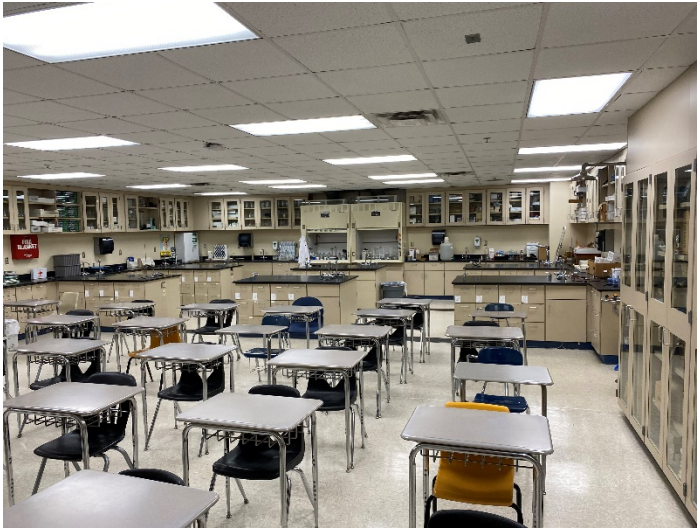
- ✓ Science casework is in good condition.

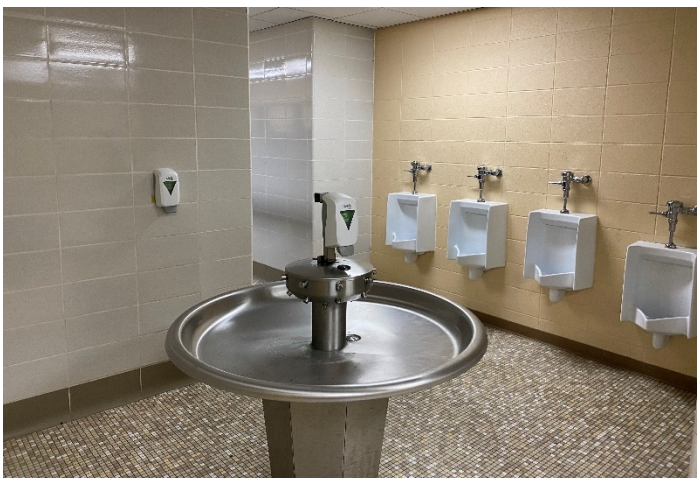
- ✓ Restrooms are in average condition.

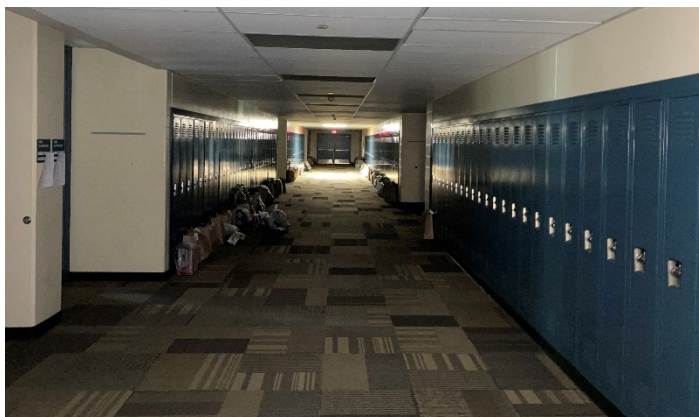
- ✓ The corridor lockers, ceiling, and carpet floor are in good condition.

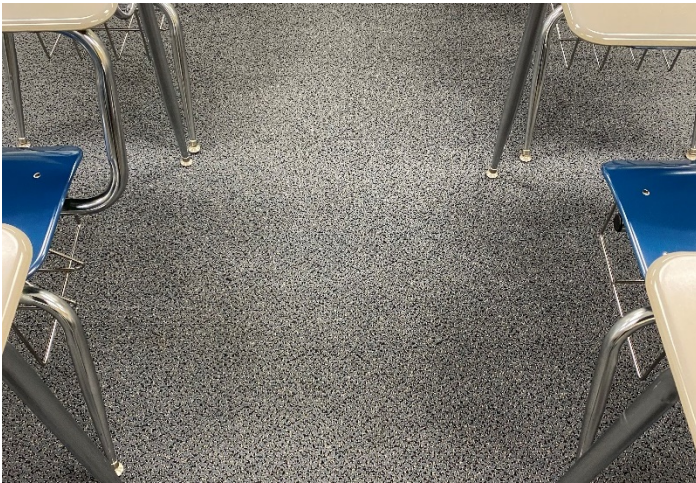
- ✓ Classroom carpet is in average condition.

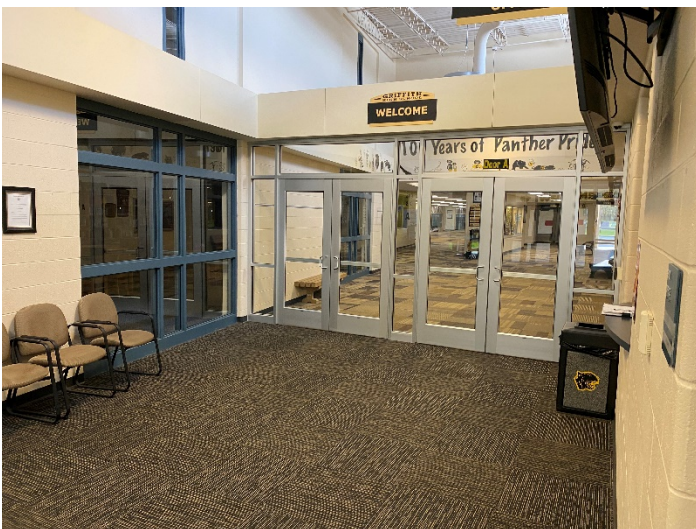
- ✓ The main entrance currently has a secure entry vestibule and is in good condition.

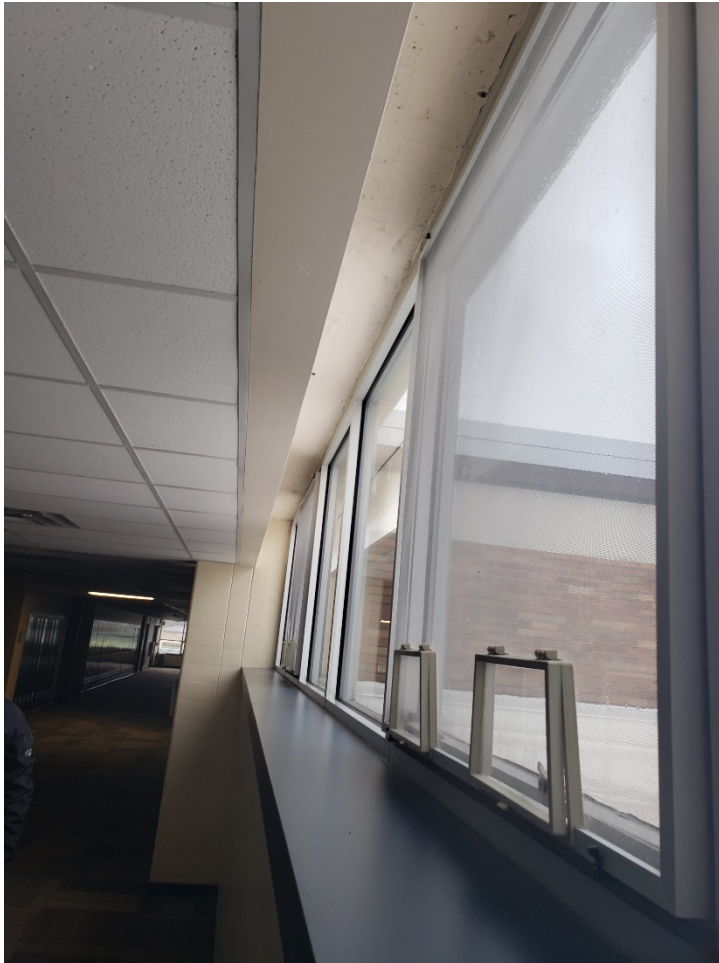
✓ **Window Assessment:**

- Fenestration in good share aesthetically.
- Windows appear to be 20 years old. No visible signs of failure.
- Approximately 10 units showed signs of failure.
- Some metal sills are sloped towards the glass which causes leak issues.
- Lack of sun / natural light control requiring blinds. New glass should have low-e coating to improve thermal performance .

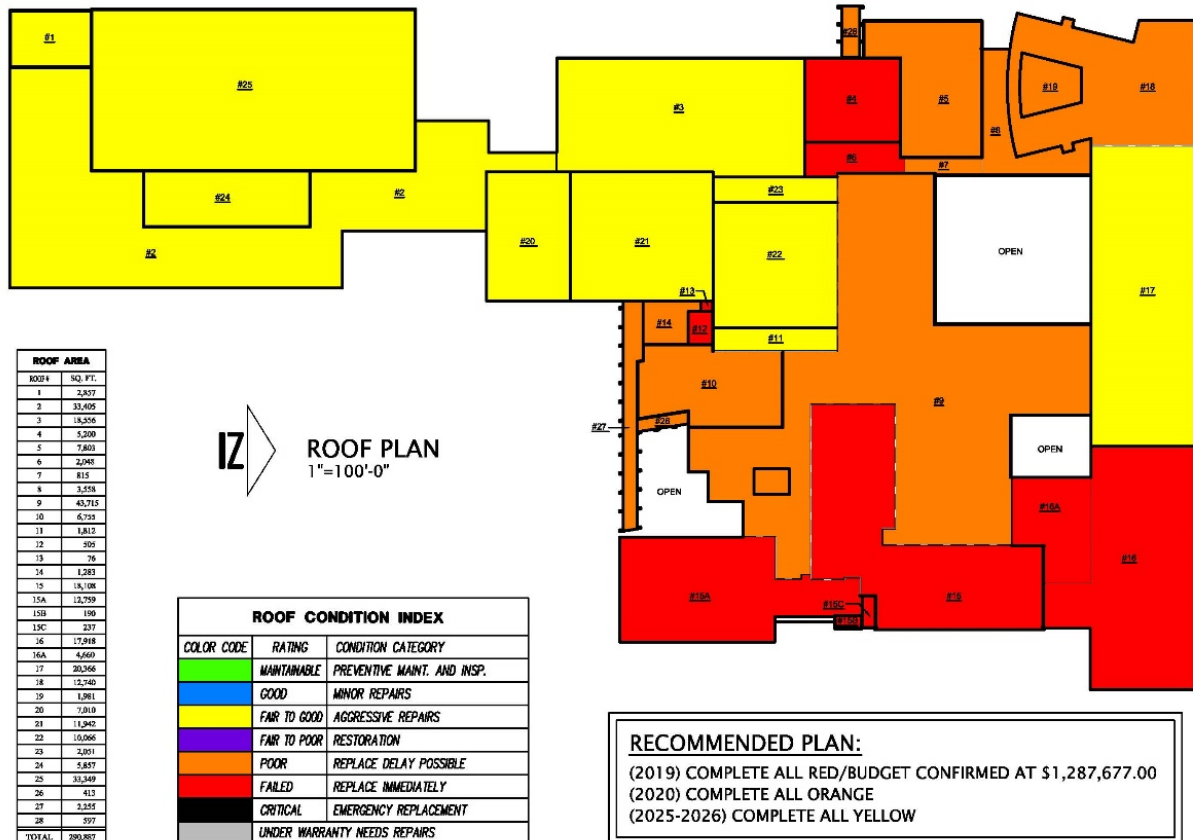
- ✓ 21 roof sections on the HS/MS were replaced in 2019.
- ✓ All other roof sections on the HS/MS appear to be in good condition with only minor maintenance recommended.
- ✓ All Roofs are Fully Adhered Polyvinyl Chloride (PVC) roof systems.
- ✓ Below: all roofs in Red and Orange were completed in 2019.

- ✓ Roofs in yellow should be good until 2026.
