# **A. EXISTING BUILDING INVENTORY**

Winship Elementary School is located at 1412 5th Avenue N in Grand Forks. The original building was built in 1973 and there was a remodel in 2001 to rework the hallways in the building to allow for more emergency exits.

Winship Elementary School Grand Forks, ND 11/2/2022

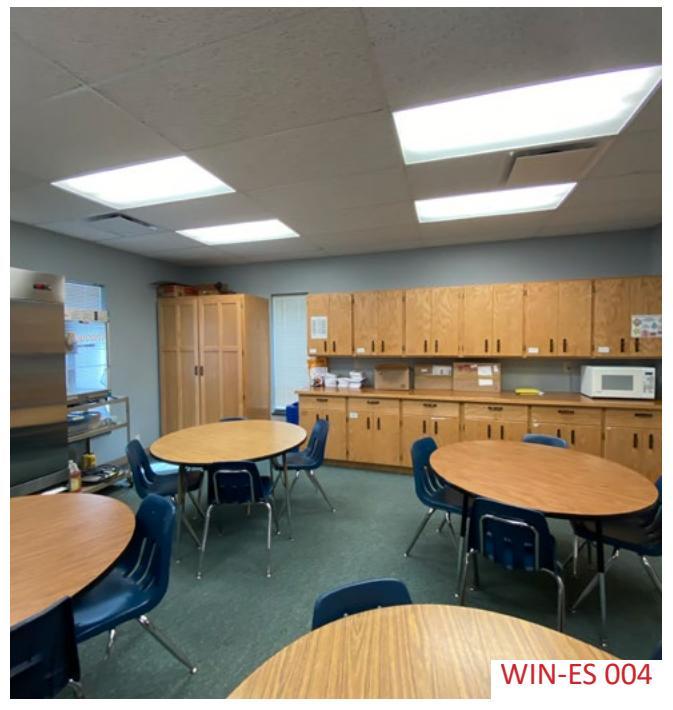
The casework in the building is dated but is functionally sound.

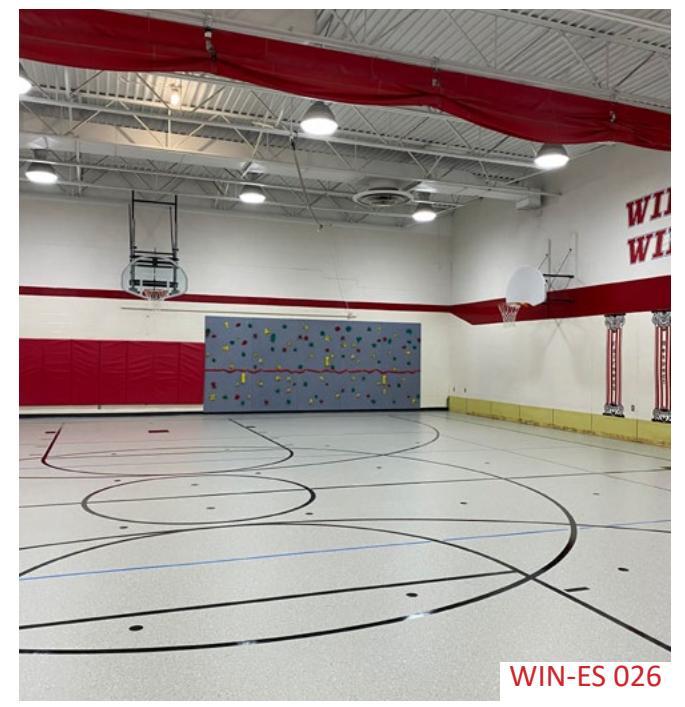
The floors in Winship are either carpet or various types of tile. The carpet in the hallway was recently replaced, but the classrooms still have old carpet (025). Some portions of original tile in the bathrooms, offices and support spaces are dated, but still in relatively good shape. The vinyl flooring in the cafeteria was recently updated. The gym floor was recently redone and is in great shape (026).

The gym floor was recently redone and is in great.
