Darlington County School District
Facility Study
July 29, 2019

Brockington Elementary Magnet School for Science and Technology

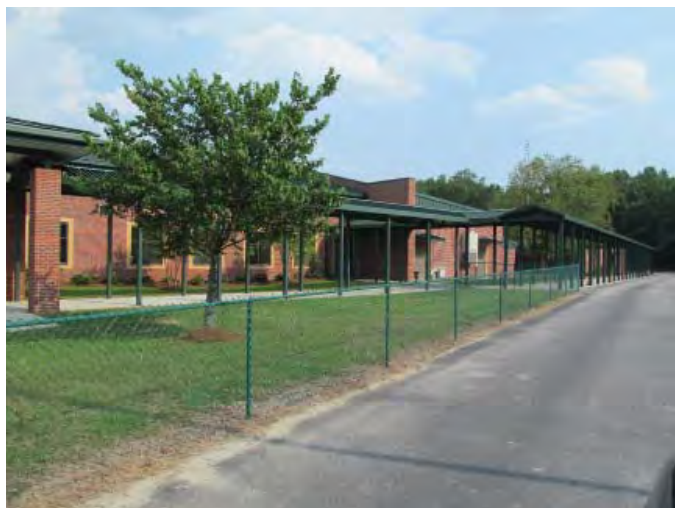
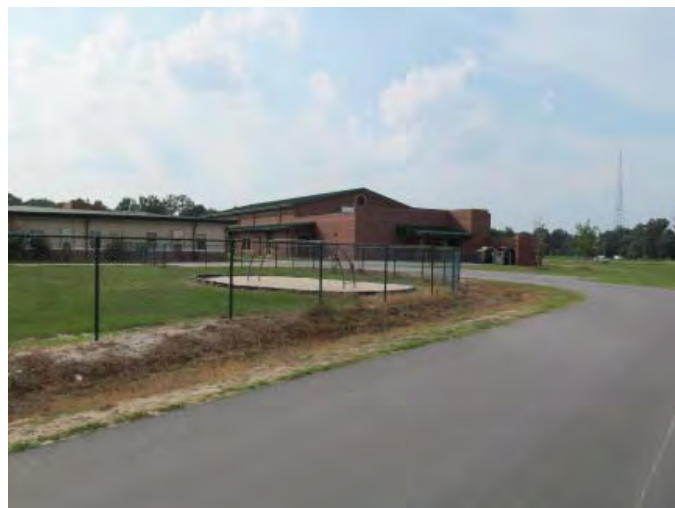
- A larger parent drive separated from bus drive would be ideal
- General maintenance is required to keep water away from buildings

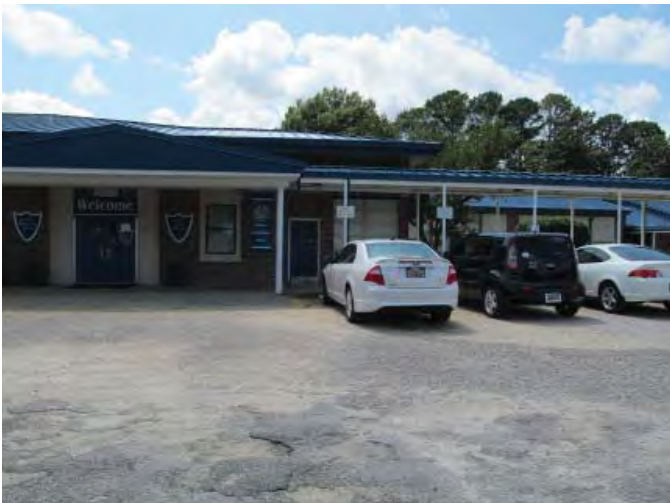
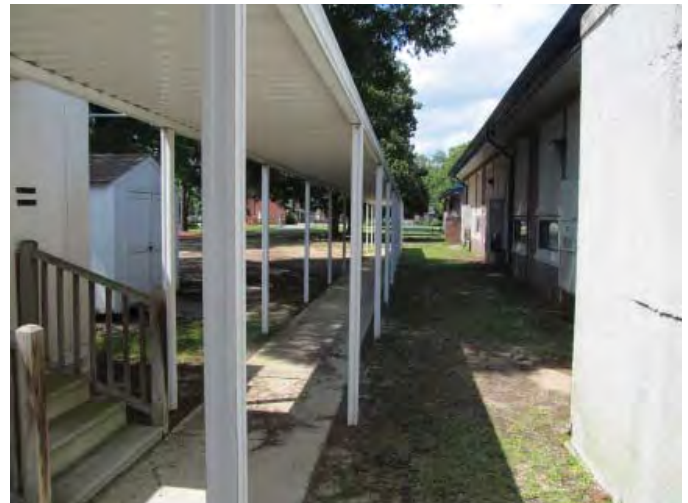
- Awkward traffic patterns
- Parking area in need of repaving and drainage control via curb, gutter, and storm drains
- Ramps at portables to be addressed, ADA issues and not covered

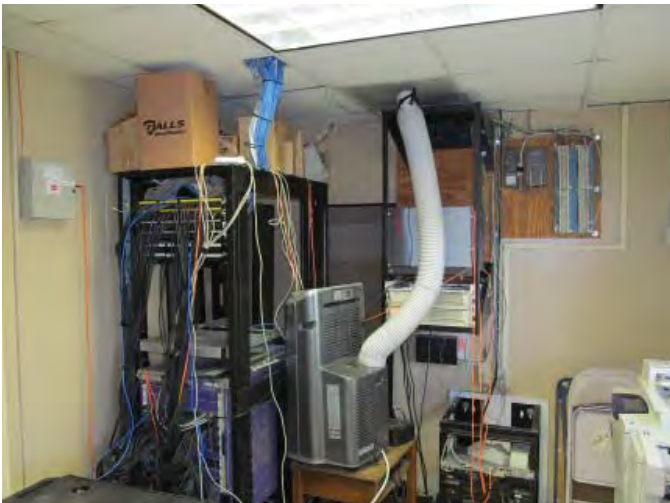
- GFI breakers needed in wet areas
- Emergency lighting needed at exterior doors
- Several old electrical panels and wiring not NEC compliant
- MDF security and dedicated power a concern

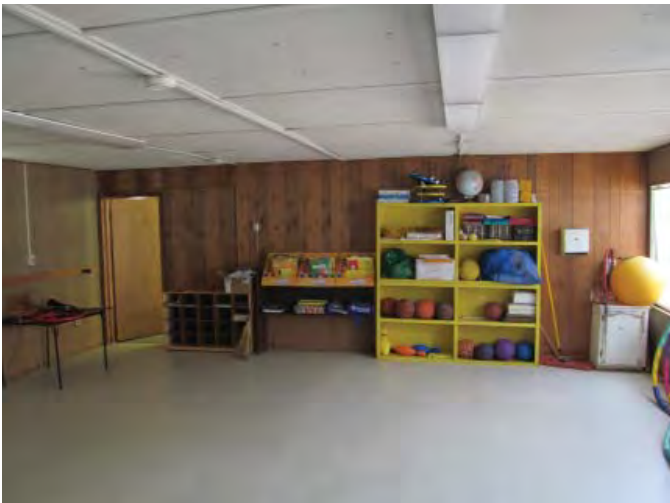
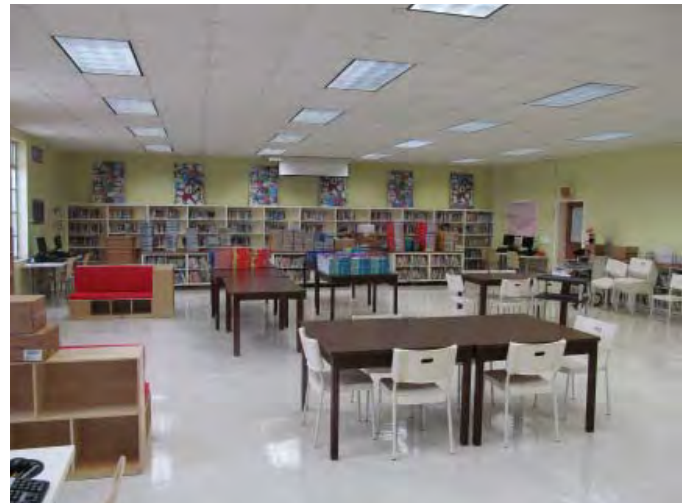
- Small administration offices and waiting area
- Classrooms are around 700sf
- Toilet facilities need to be added for the cafeteria
- More natural light recommended in several instructional and gathering spaces
- PE and music are taught in portables
- Stage appears to be undersized for population of the school

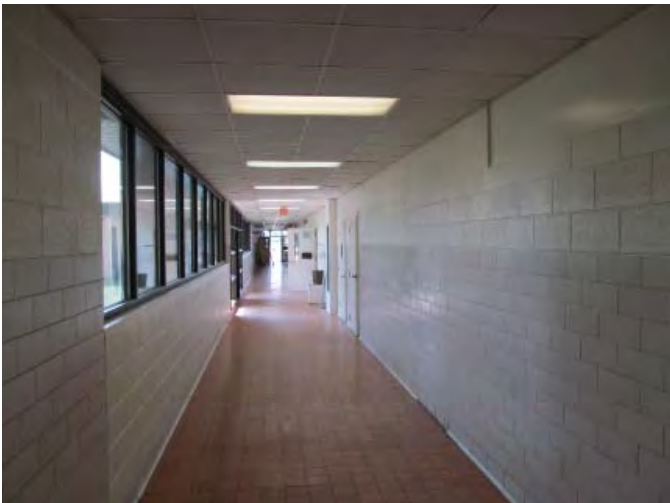
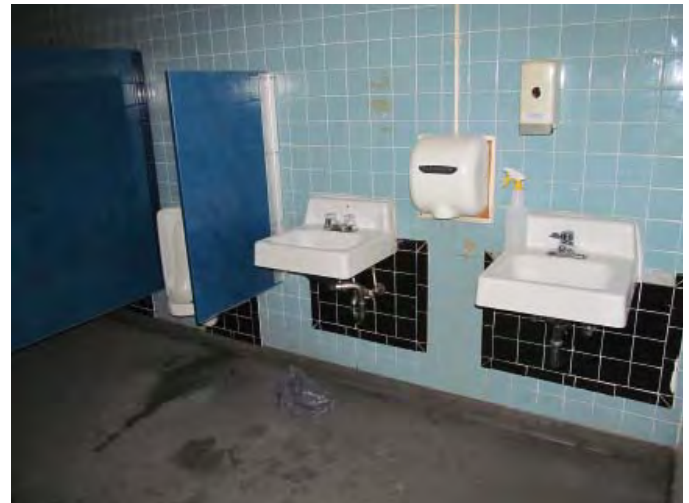
- Some interior doors not rated

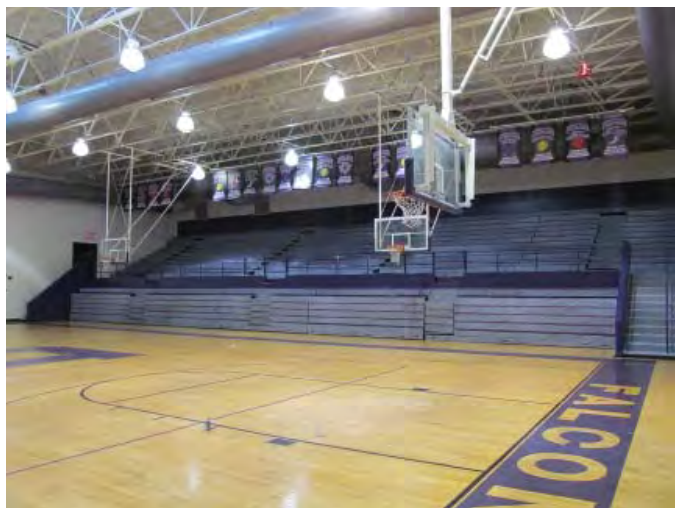
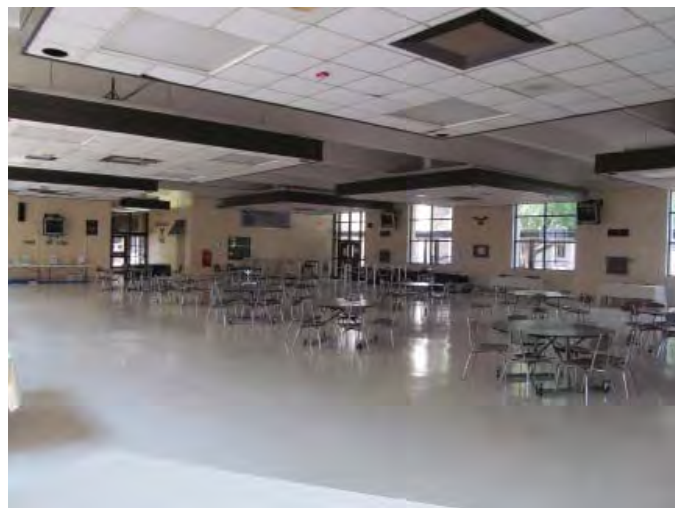
- More natural lighting recommended in classroom and media spaces
- Additional sinks in Art room are needed and suggest access to outdoor area
- Connectivity to music spaces from classroom spaces via covered walk or addition is recommended

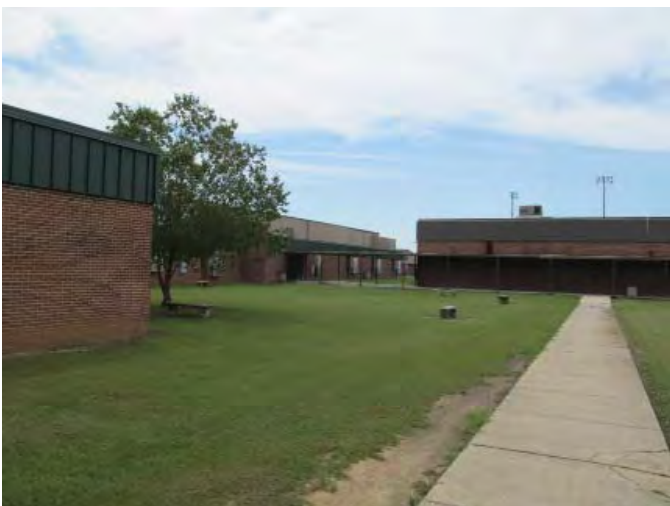
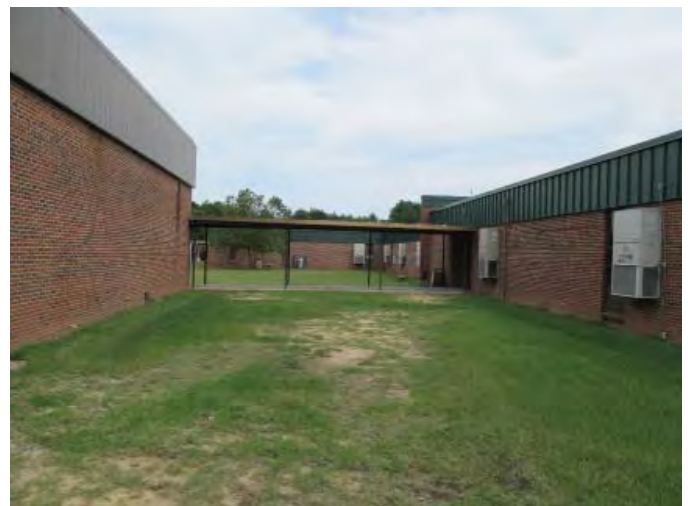
- Ramps to some doors are not ADA compliant

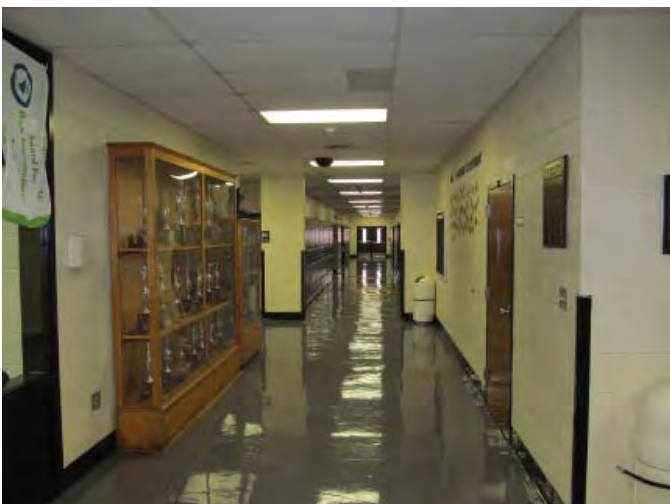
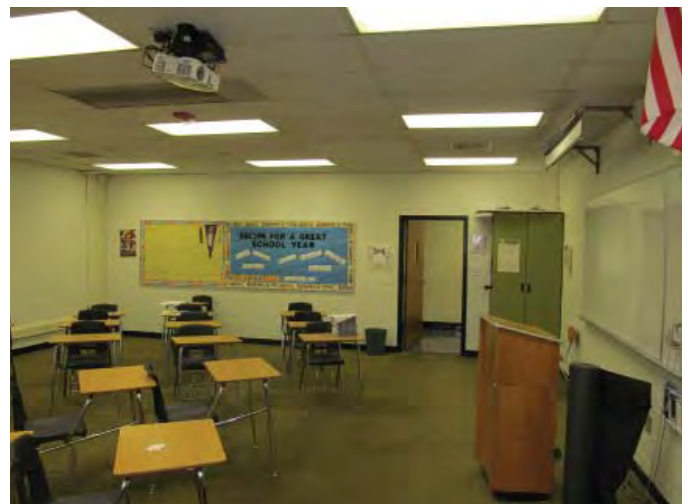
- Exterior doors are not energy efficient and require replacement due to hardware or ADA
- Brick needs tuck-pointing

- Needs ADA restrooms for both student and staff

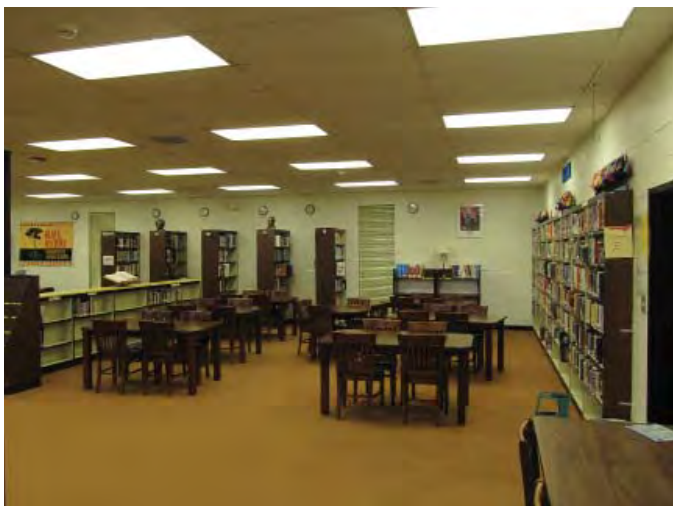
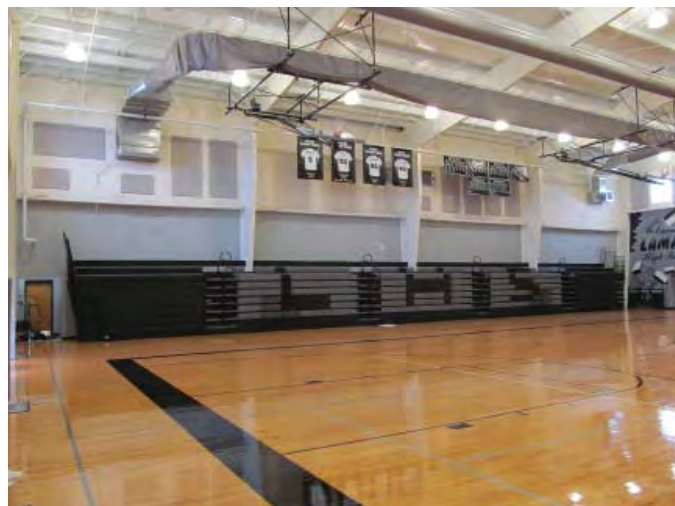
- Offices and waiting areas lack space
- More natural light recommended in media center
- Art room can benefit from more natural lighting and access to outdoor space
- Stage is undersized for larger productions

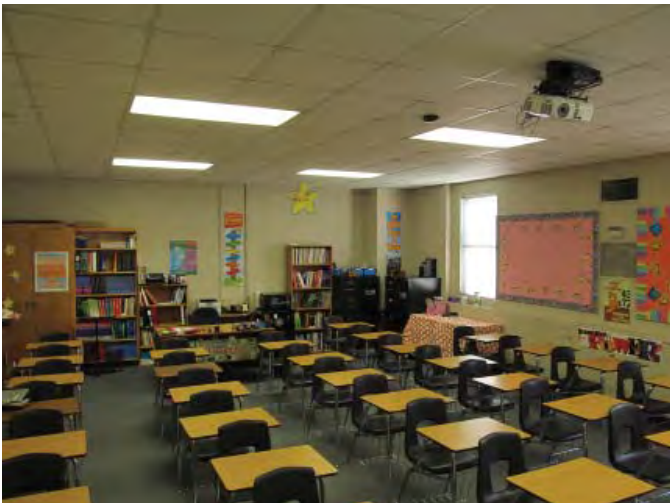
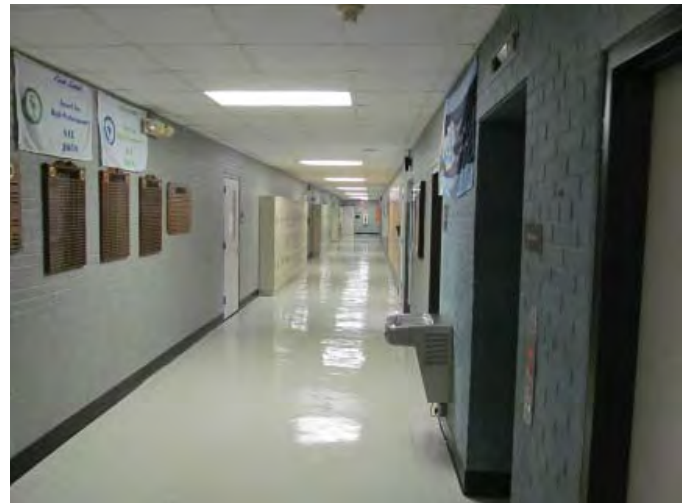
- Some doors not rated
- ADA issues with door clearances and hardware
- Fixtures and access create ADA issues at the restrooms

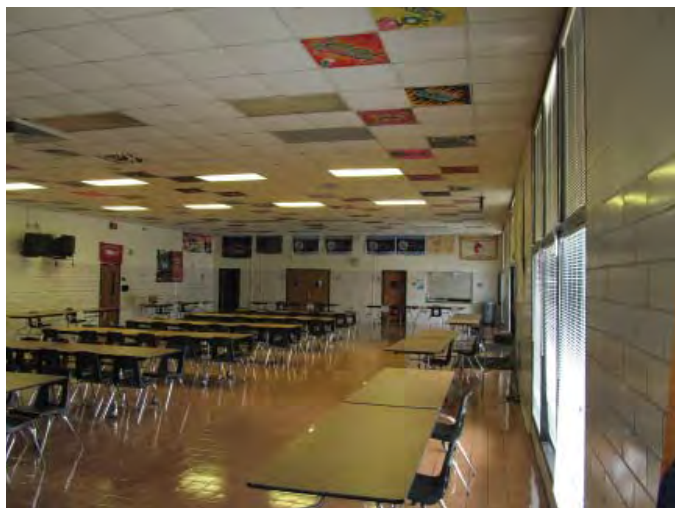
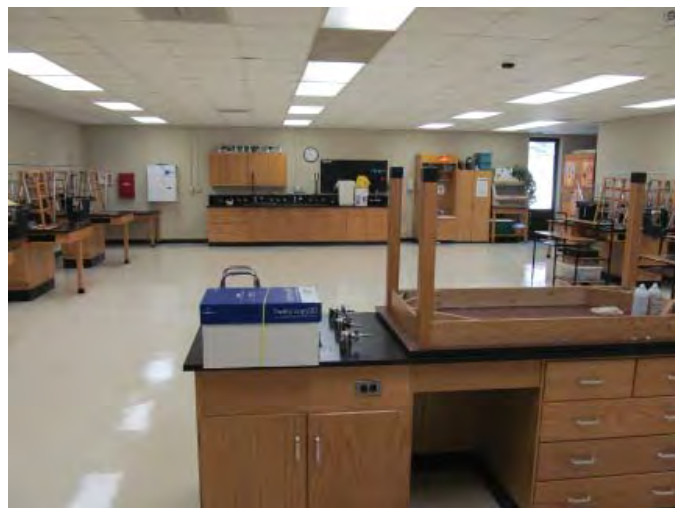
- Office and waiting areas are small
- Media center lacks natural lighting
- Gym and support spaces are inadequate
- Art room needs more sinks and lacks natural light
- Band and Music rooms need additional acoustical treatments

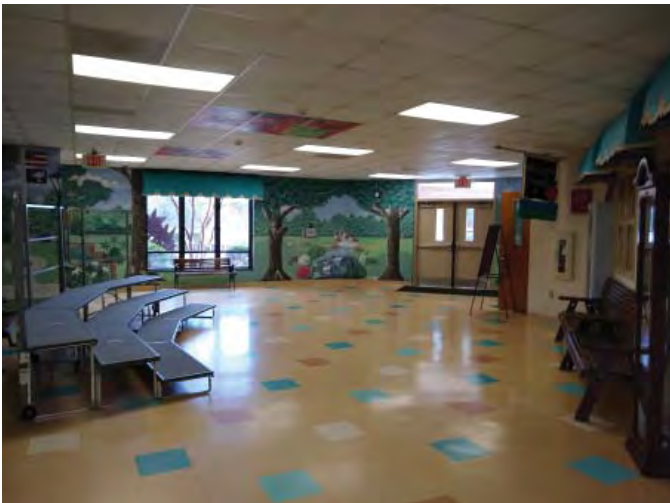
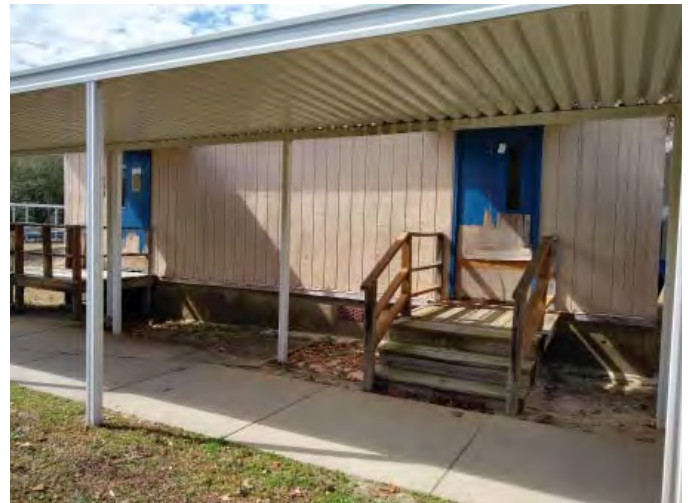
- Some interior doors are not ADA accessible
- Some restrooms and plumbing fixtures are not ADA compliant

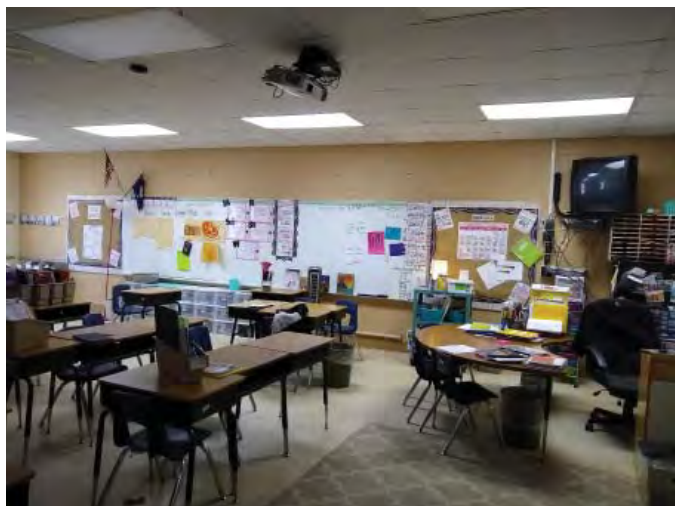
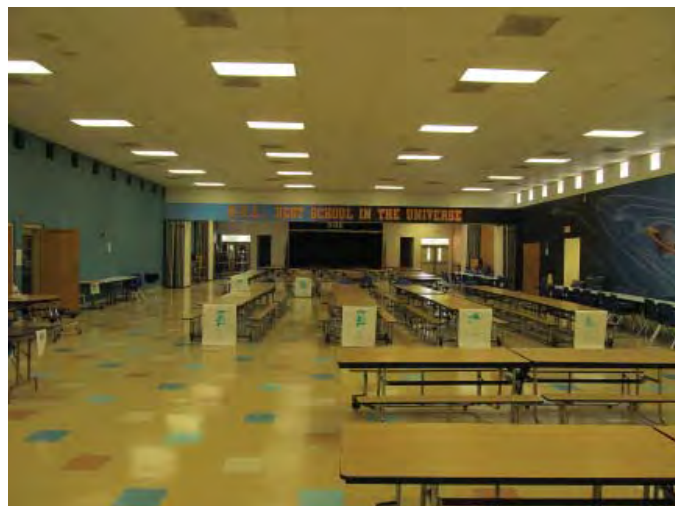
- Secure entry at main entrance is recommended
- Guidance, music, and PE are currently in portable classrooms
- Additional natural light recommended in the cafeteria, media center, and art room
- Access from art room to outdoor space is recommended

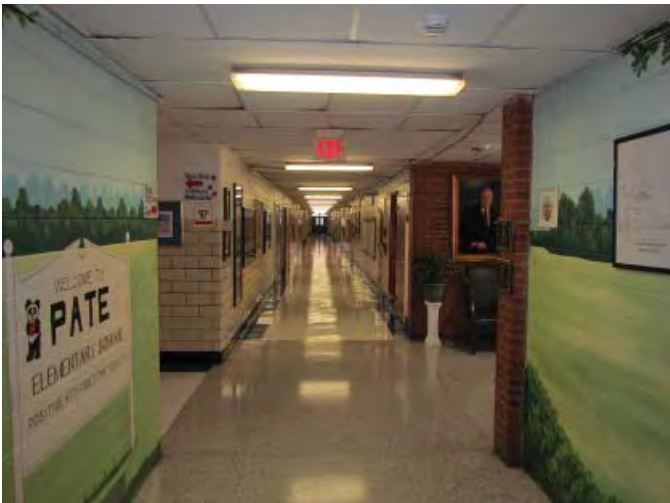
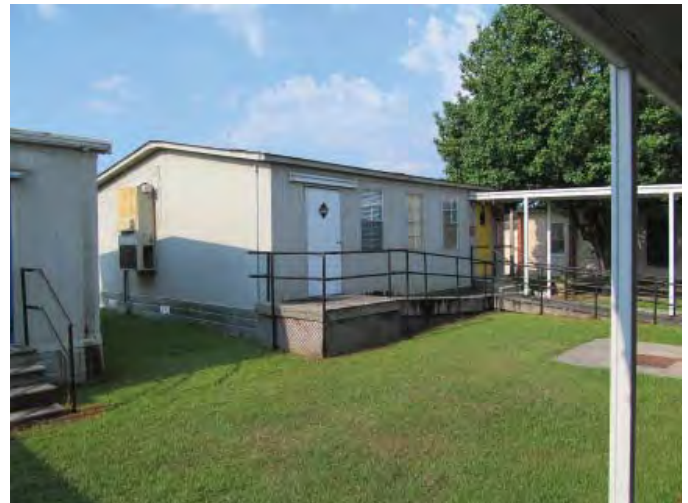
- Interior doors need new hardware in some spaces
- Several restrooms need new fixtures or do not meet ADA

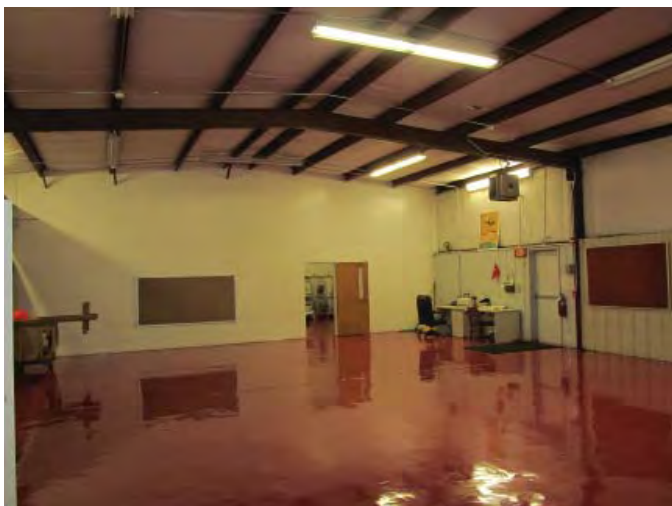
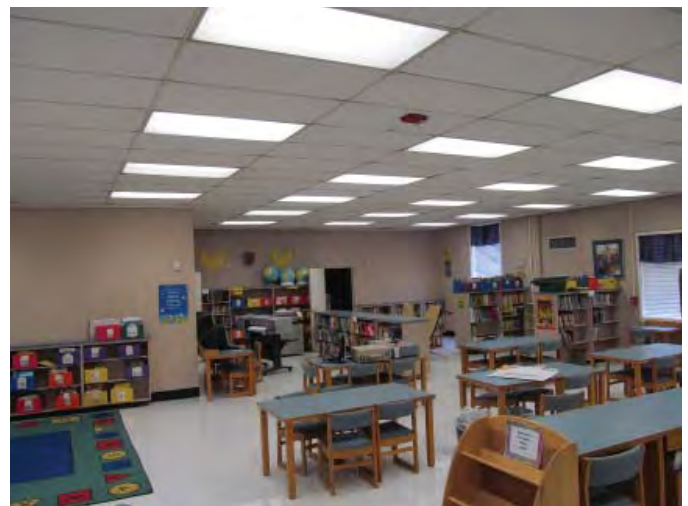
- Main office does not have visual connection to school entry
- Offices and waiting area are cramped
- All classrooms are in need of updated finishes
- No stage/platform on campus
- Crack in multipurpose concrete slab has telegraphed to floor finish
- Music room could use additional acoustical treatment
- Art room lacks natural light and needs additional sinks

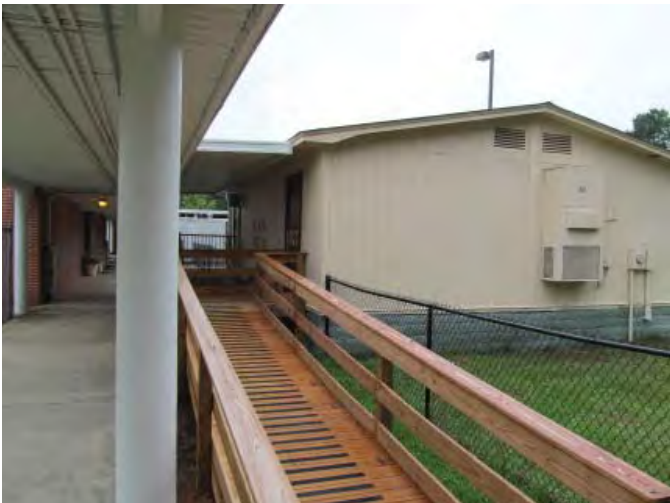
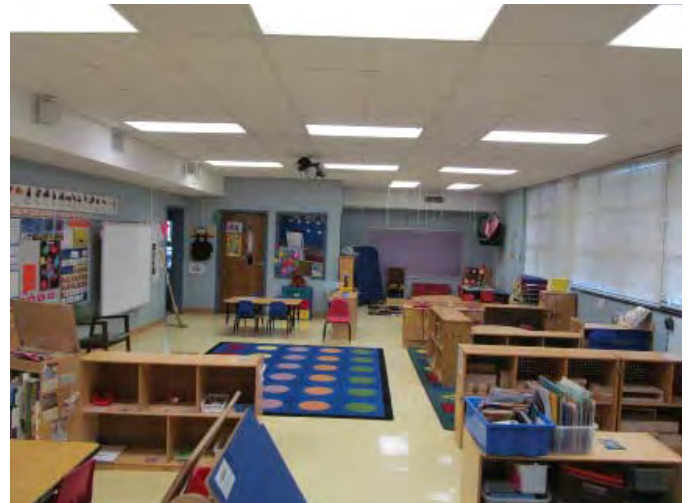
- Some doors do not meet ADA clearances
- Restrooms and plumbing fixtures need to be updated to address ADA

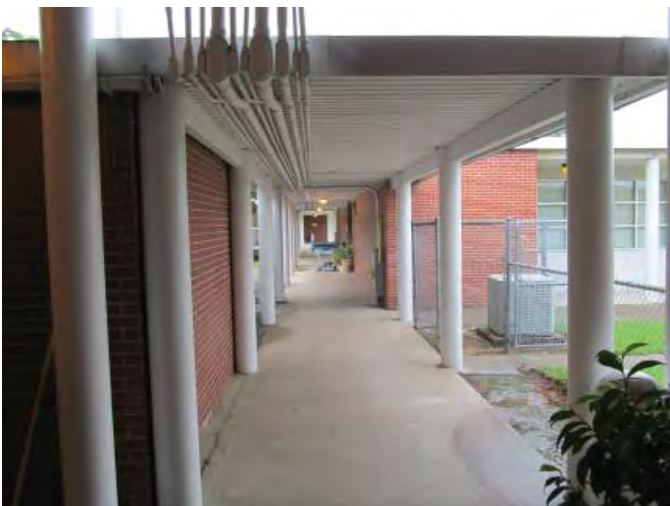
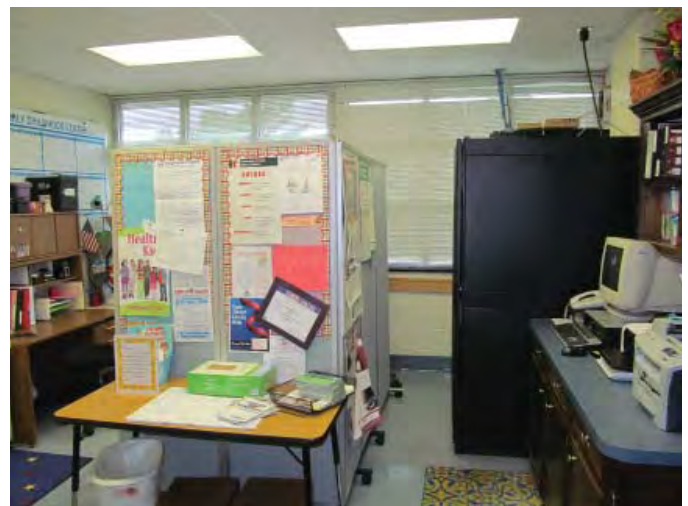
- GFI breakers needed in wet areas in Building 3
- Emergency lighting needed at exterior doors
- Some wiring does not meet NEC
- MDF security and dedicated power to be addressed

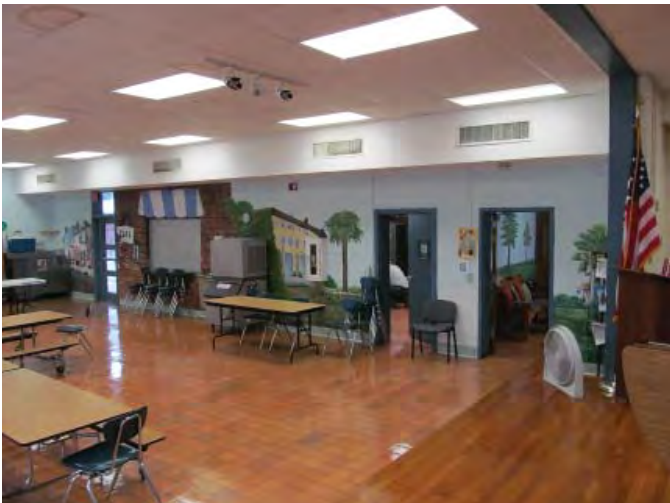
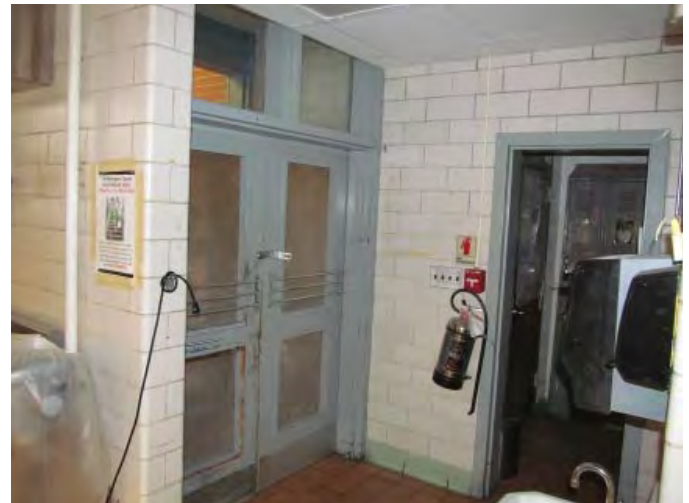
- Offices and waiting areas are small
- Cafeteria appears small for student population
- Media center and music are in portable classrooms
- No dedicated multipurpose or PE space

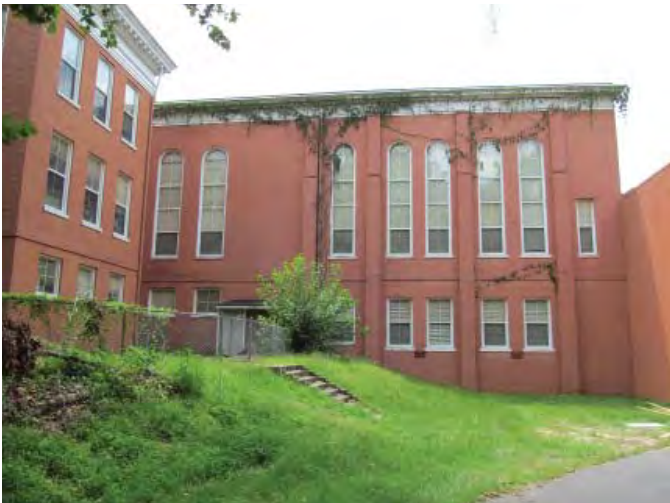
- Site drainage needs to be addressed to address mold on brick
- Restriping of parking areas is recommended
- Traffic patterns are awkward for parent and bus drop off
- Have to cross the street to access play areas
- Sidewalks between buildings create accessibility issues for entry to buildings

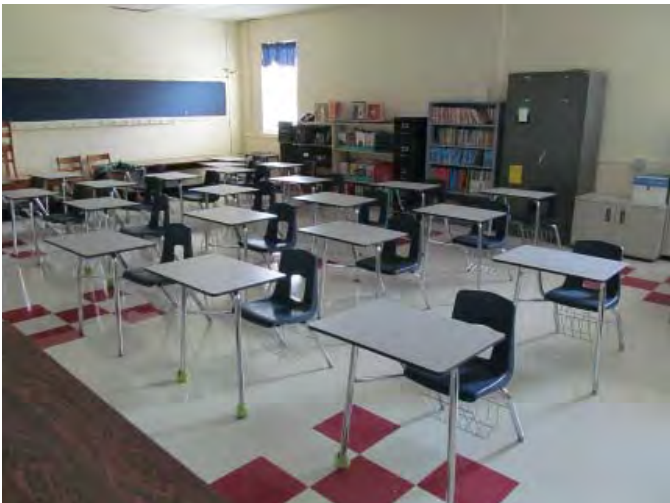
- Some doors are not rated
- Door clearances or hardware replacement needed to meet ADA compliance
- Restrooms and fixtures need to address ADA

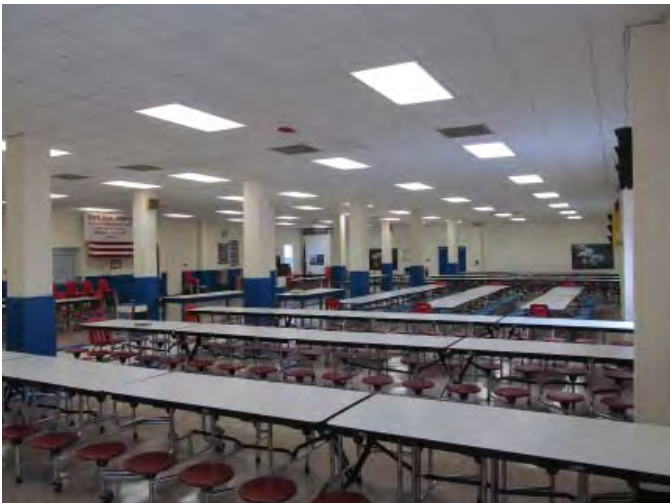
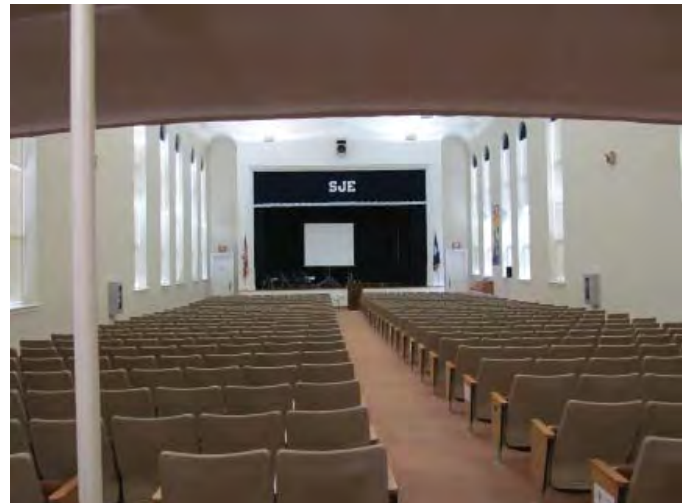
- Offices and waiting areas are small
- Conference spaces are lacking
- Media center would benefit from additional natural lighting and higher ceilings
- Gym and support spaces are in need of renovations
- Art room needs additional sinks, more natural light, and possibly another classroom space
- There is no dedicated science classroom
- Access to music room is awkward and size is not adequate

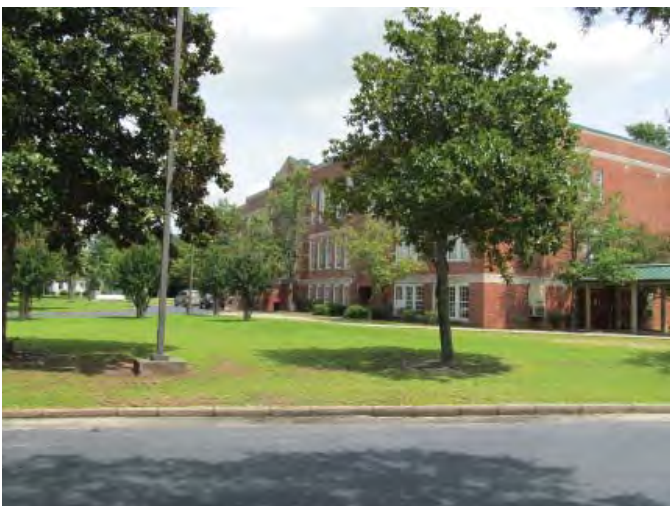
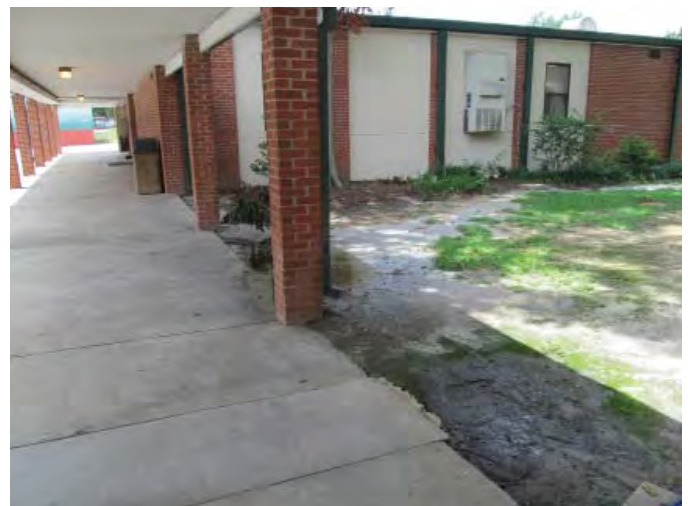
- Parking areas need improved circulation and efficiency as well as signage
- Ramps at some doors are not ADA accessible

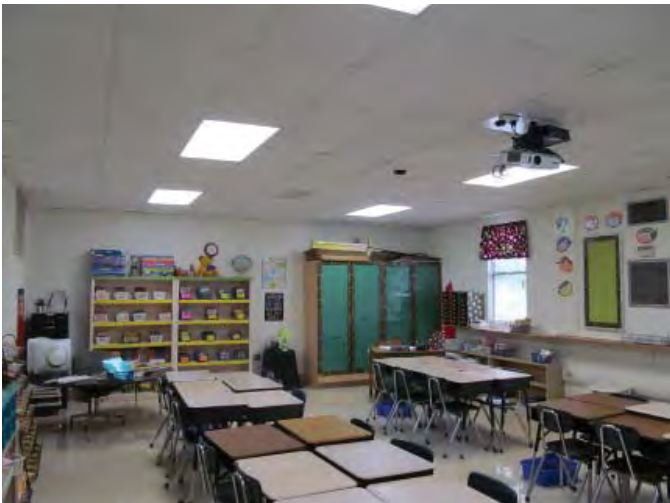
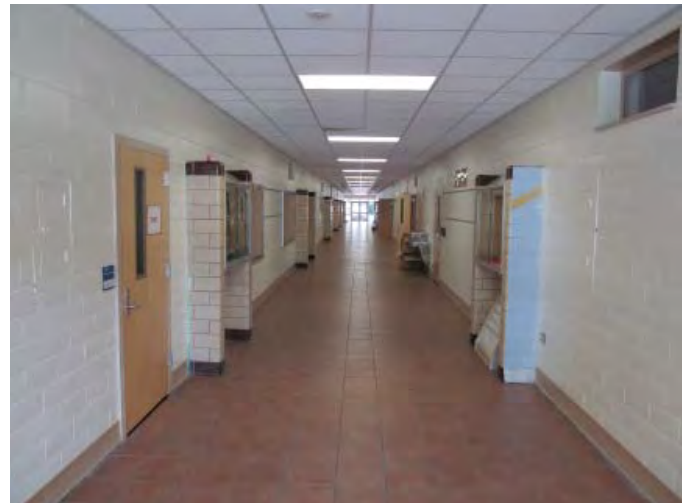
- Some interior doors need to address ADA clearances
- Restrooms and fixtures do not meet ADA standards

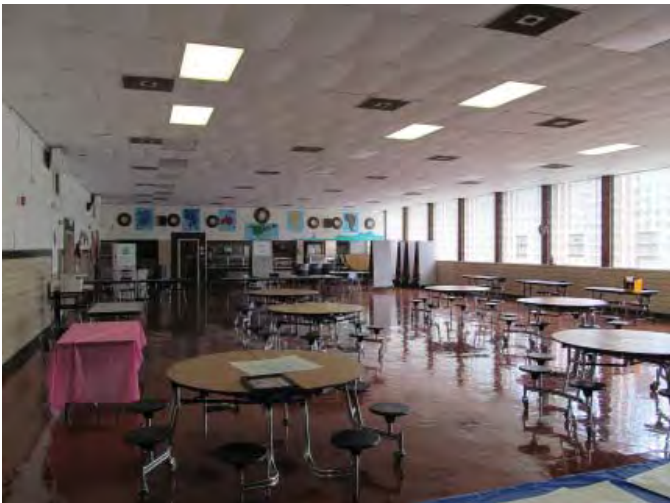
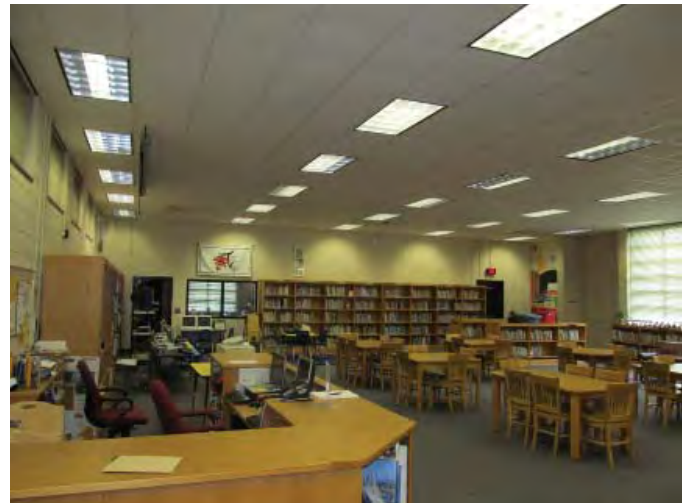
- Offices and waiting area are small
- Additional conference spaces are recommended
- Kitchen needs walls patched where windows once were located
- Music room remoteness is a security concern
- Lower bookshelves recommended in media center for age group
- Art room would benefit from more natural light and access to outdoor space
- Gym and support spaces need renovations
