Principal	Kristi Austin
Grades	1-5
Staff	49
Current Enrollment	631
Site Size	11 Acres
Square Footage	66,200
Year Constructed	1951, 1985, 1999
Renovations	1999

North Hartsville Elementary School

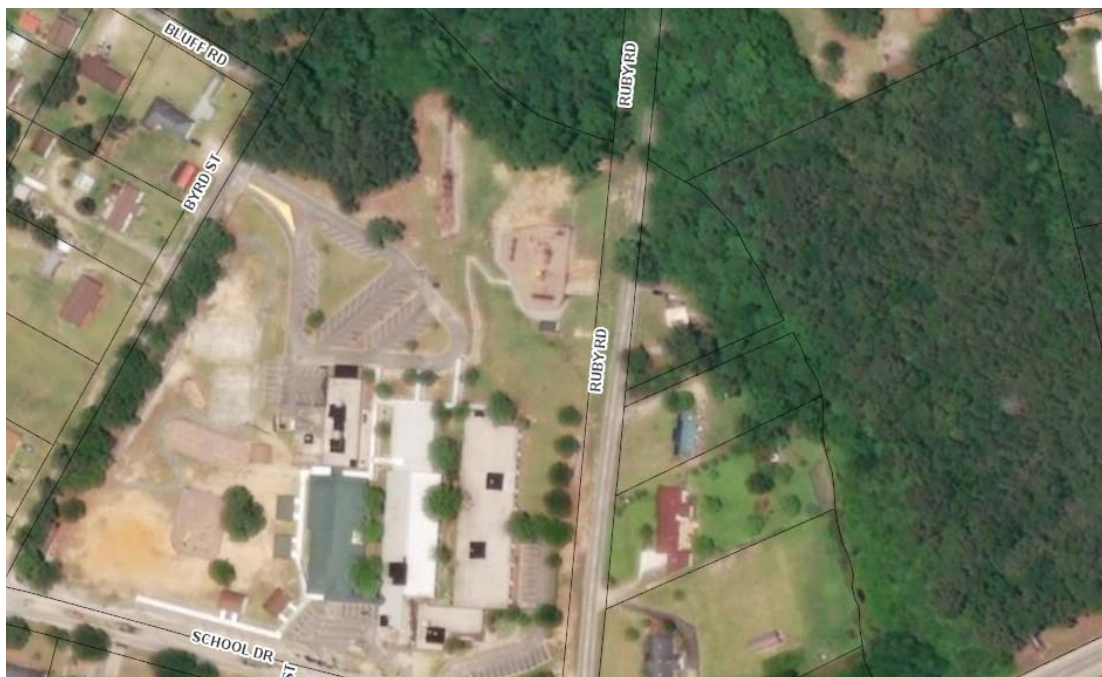
as it relates to current codes. Some roofing has been completed recently and should address moisture issues present in the cafeteria. Stacking for parent drop-off and pick-up is lacking so there are two separate areas used as well as the nearby Lakeview Baptist Church parking lot for stacking space.
