Darlington County School District

Darlington Area Schools - Building Evaluations

School Name: Brunson-Dargan Observed By: Creed/Carter
Principal: Mrs. Ada O Sindab
Grade Levels: 3rd – 5th
Site Size: Approximately 16 Acres
Student Population: 221 (Approximate Student Population)
Staff Size: 34 (Approximate Staff Size)

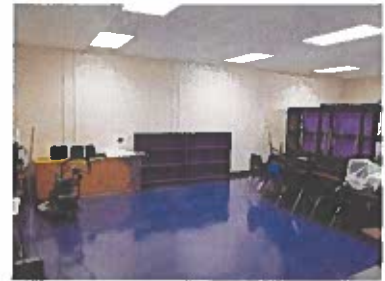
Arts Rooms:	Natural light is lacking Additional sinks are needed Outdoor areas for 2-D and 3-D art are suggested No Kiln
Music Spaces:	The sizes of the rooms appear to be adequate. Need acoustical treatment on walls. Ideally this room would also have a higher volume
Other:	Contiguous buildings to increase security Consideration of ambient noise when selecting mechanical systems
