Darlington County School District
Darlington, South Carolina
August 8, 2012

Lamar Area Schools - Building Evaluations

School Name: Lamar Elementary Observed By: Cannon/Carter
Principal: Mr. Garry Fowlers
Grade Levels: Pre-K – 2nd Grades
Site Size: Approximately 10 Acres
Student Population: 300 (Approximate Student Population)
Staff Size: 37 (Approximate Staff Size)

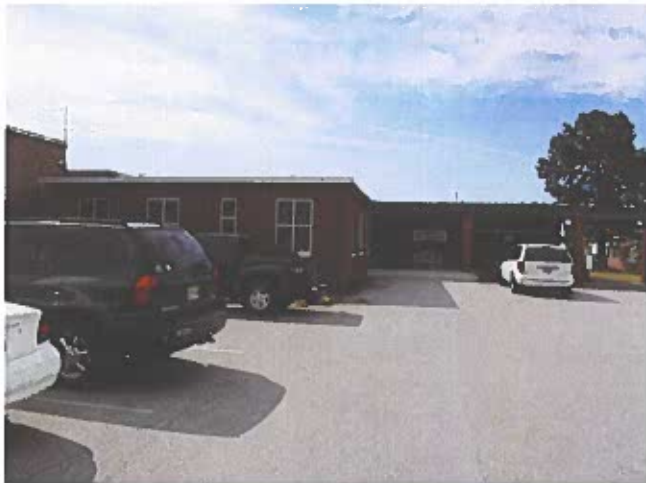
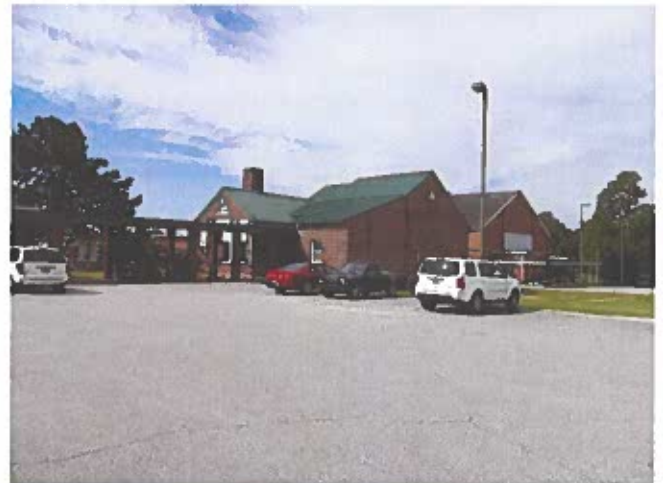
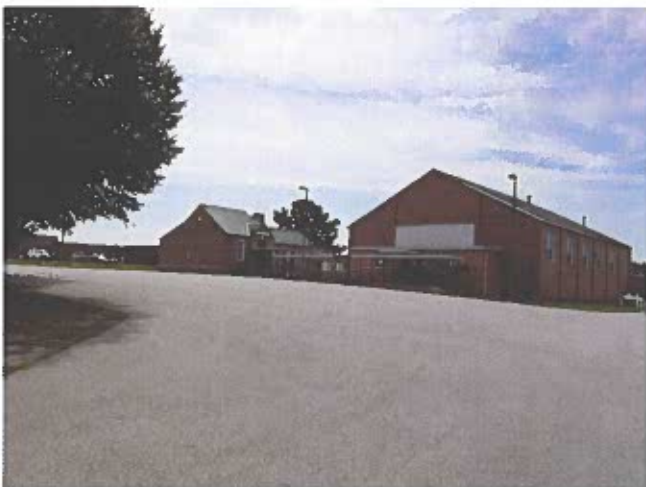
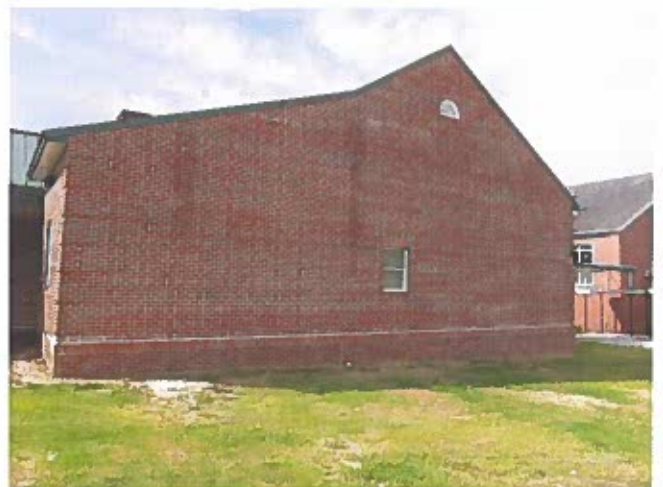
Main Building: (5K and 1st & 2nd Grades)

Year Const.: 1930's and later additions

Renovations: Various Years

Due to the age of the buildings and the extreme age difference between the Primary and High Schools this school should be replaced with a school with closer age association.
