Darlington County School District

Hartsville Area Schools - Building Evaluations

School Name: Thornwell School of the Arts Observed By: Cannon/Carter
Principal: Ms. Julie Mahn
Grade Levels: 1st – 5th Grades
Site Size: Approximately 10 Acres
Student Population: 400 (Approximate Student Population)
Staff Size: 48 (Approximate Staff Size)

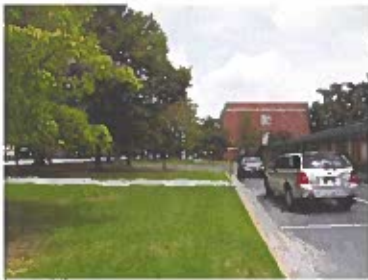
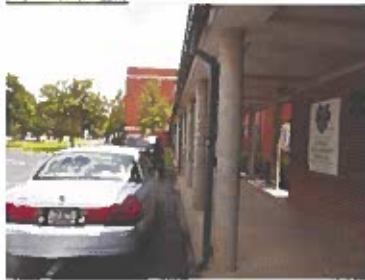
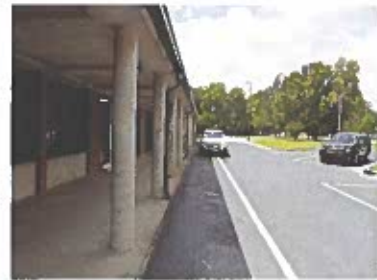
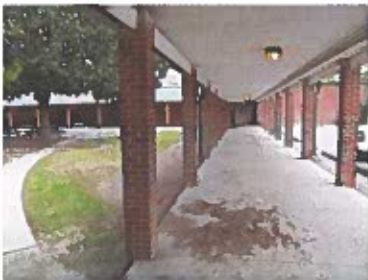
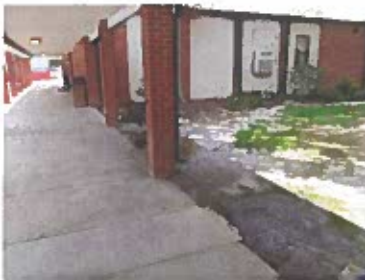
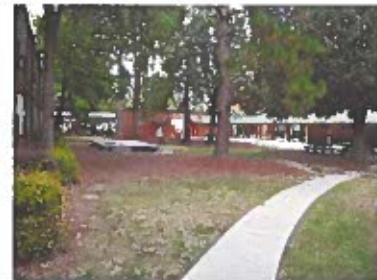
Thornwell School of the Arts is located on an urban site in the downtown area of Hartsville. This campus is shared with the 1926 facility which is being used predominantly for Adult Education. There are five (5) separate buildings being used on the site which includes: Building 1 (the two story administration building); Building 2 (the one story building); Building 3 (the cafeteria/media building); Building 4 (the gymnasium); and Building 5 (music).

The school has done a good job of directing traffic to separate buses from parents but because of the site size, traffic issues exist. Deliveries to the cafeteria also block a portion of Marlboro Ave. at the rear of the school. Drainage is an issue around and between buildings. Students also have to cross backup areas to access the playground.

Since the buildings are not connected through an enclosed protected structure, security is a greater issue as doors to buildings must remain unlocked to allow access to students and staff. Additionally, when students and staff move from building to building in inclement weather, they are subjected to rain, cold, heat and wind. These conditions contribute to higher energy costs, greater maintenance, and wet floors creating slip/fall hazards and damage to flooring and floor substrates.
