DAMIANO BARILE ENGINEERS, P.C.

September 18, 2015

RE: CROTON-HARMON UNION FREE SCHOOL DISTRICT
VENTILATION EVALUATION

RE: CROTON-HARMON UFSD
5 YEAR CAPITAL PLAN
ENGINEERING SERVICES
VENTILATION EVALUATION

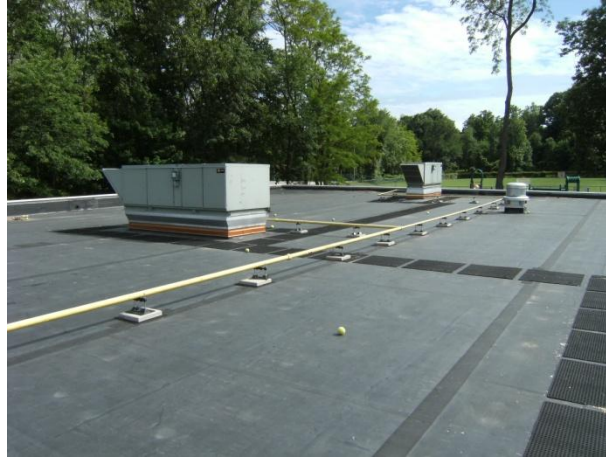
Figure 16: Cafeteria and Cafeteria Platform Units

The 1997 addition is primarily served by gas fired rooftop units that were installed in 2010 at the same time the Library units were installed in the 1954 Wing. These spaces include the Cafeteria, Cafeteria Platform, Cafeteria Lobby, Art Room and Music Room. The District retained a copy of the balancing report that was issued at the completion of this work in 2010. The report indicates all outdoor air design quantities were met or exceeded.

There are no reported operational problems in any of these spaces.

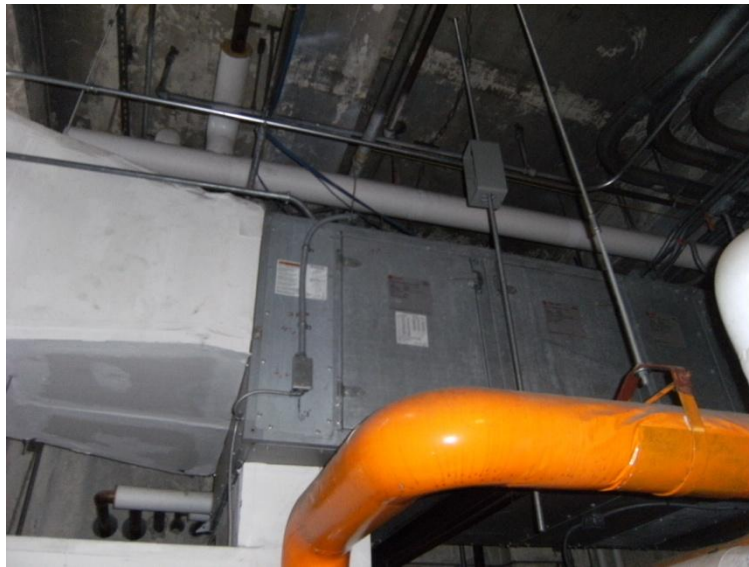
Figure 24: Home and Careers Air Handler

The Home and Careers Room is served by an air handling unit in the boiler room and an exhaust fan in the adjacent storage room. Exhaust is ducted down over each cooking range and is not rated for commercial use. Faculty Dining and adjacent closets are also served by this air handler. This system does not have air conditioning, and serves some interior spaces, which is code compliant unless any of these interior spaces are student occupied.

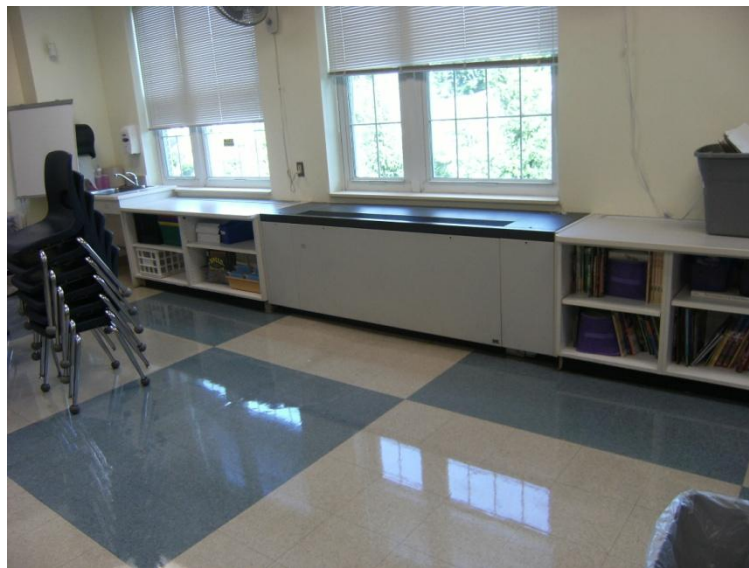
Figure 29: Typical 2004 Addition Classroom Unit Ventilator

Classrooms in the new addition are served predominantly by floor mounted unit ventilators and plenum ceilings for exhaust. This equipment is well within its useful life.

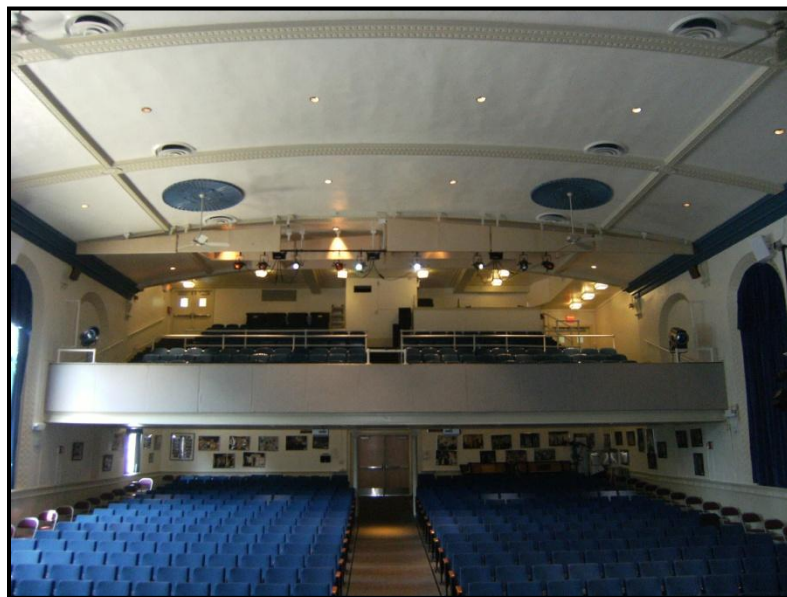
Figure 37: Auditorium Ceiling Diffusers

The Auditorium receives outdoor air through a second floor mechanical equipment room air handler with a condensing unit on an adjacent roof installed in 2013. There is a ducted distribution system in the ceiling of the auditorium with return grills in the back of the space and exhaust fans on the roof of the stage.
