## Management Report

Emmett Independent School District #221  
Emmett Bus Barn  
1380 North Washington Avenue, Emmett, ID

Prepared For  
Emmett Independent School District #221

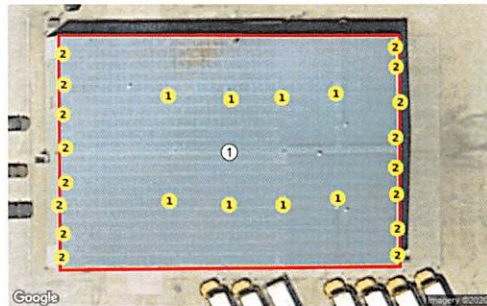
### METAL - Pipe removal-Abandoned - Metal (Emergency)

Abandoned Pipe flashing to be removed and roof patched. Metal deck patching to be done by other.

Technicians will remove Pipe and pip flashing's and install a metal patch.

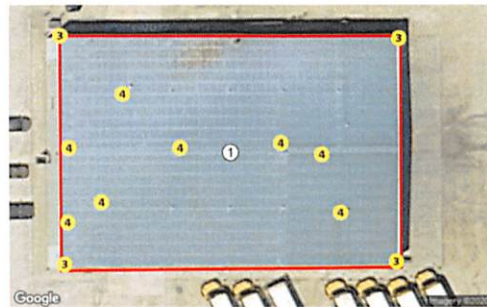
**METAL - Fasteners - Failing/Missing (Emergency)**

As the building moves and flexes the fasteners will loosen up and eventually back out completely resulting in water infiltration.

A new fastener, 1 size larger, would be installed to ensure a water tight seal.

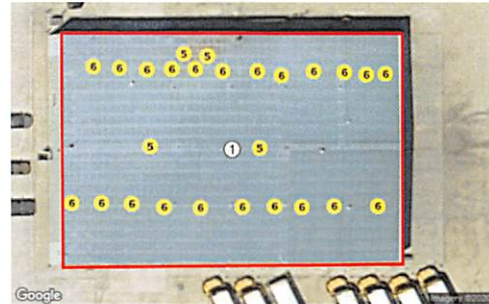
**METAL - Coating of rust areas (Emergency)**

Panels have rust on the surface and will need to have a rust inhibitor applied to stop the panel from rusting.

Clean loose debris from rust areas apply top coat with rust inhibitor to extend the life of the affected panels.

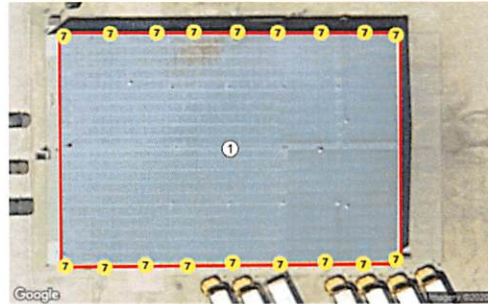
### METAL - Edge Detail Re-flashing (Emergency)

Edge detail is missing fasteners and in some areas the panel does not extend over the drip edge.
