Seismic Evaluation & Conceptual Retrofit Isbell Middle School - Building A

Dated: May 29, 2019

Prepared By: SSG Structural Engineers, LLP 811 El Capitan Way, Suite 240 San Luis Obispo, CA 93401

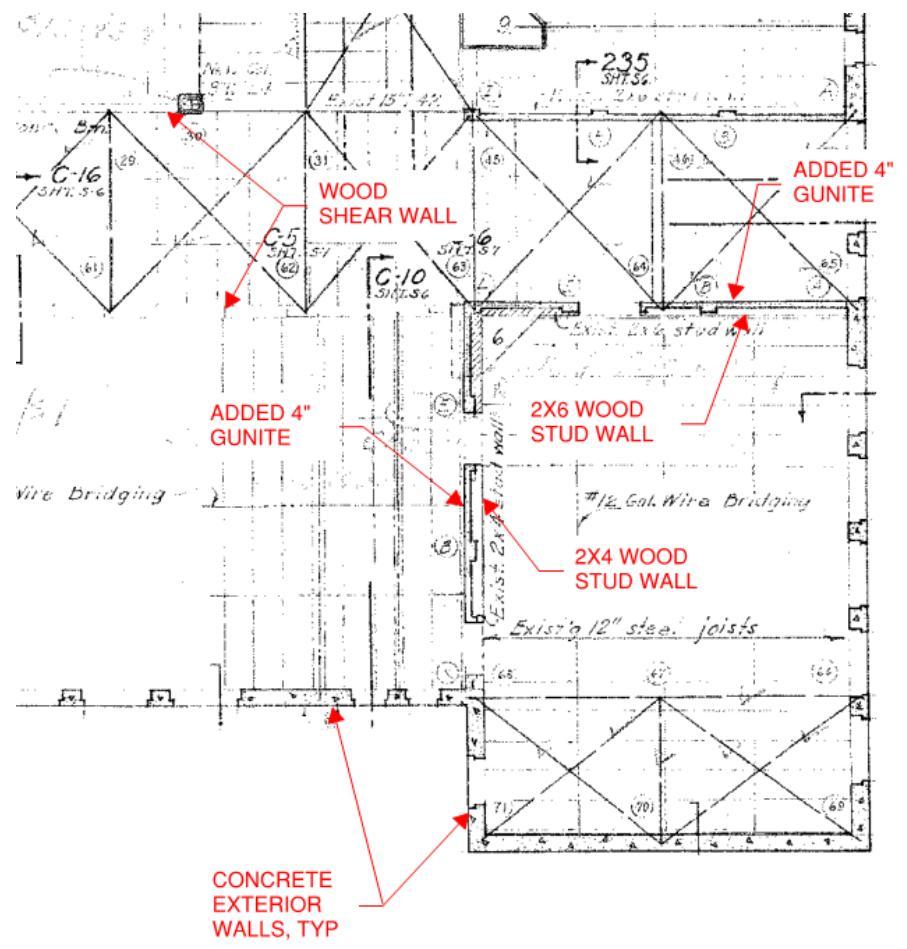
Figure 4 - Second Floor Partial Framing Plan - Sheet S-3 of 1939 Rehabilitation Set

The 1939 rehabilitation of Building A incorporated several changes to the structure that remain today. All exterior walls at the ground level and most of the exterior walls at the second level are reinforced concrete. Second floor walls at corridor ends are typically reinforced gunite shot on 2x wood stud walls, while the rest of the corridor is wood shear walls with a few 1x diagonal braces. First floor corridor walls are a combination URM with reinforced gunite system, see Figure 4.

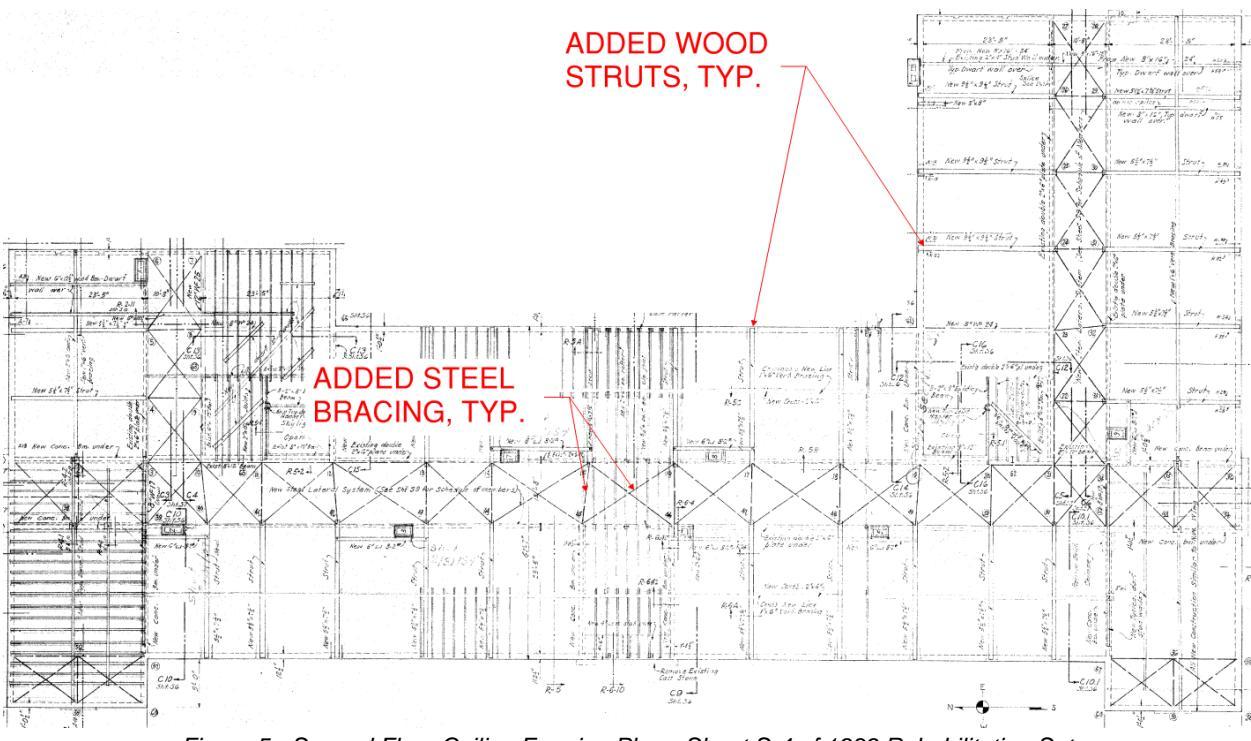
Figure 5 - Second Floor Ceiling Framing Plan - Sheet S-4 of 1939 Rehabilitation Set

The original straight-sheathed 1x6 roof diaphragm remains and is supplemented by a steel and wood strut and bracing system at the second-floor ceiling level, see Figure 5. The second floor is strengthened in a similar manner.

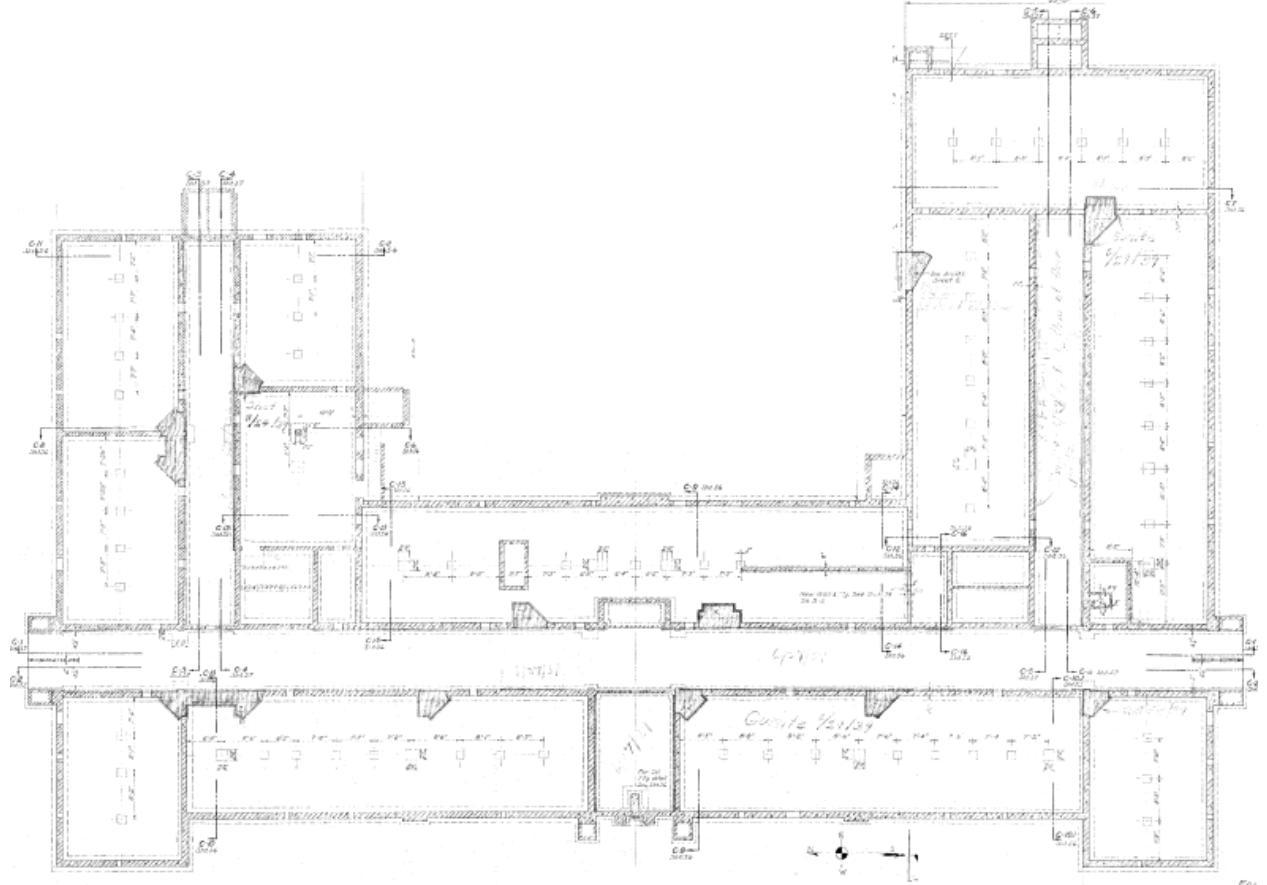
Figure 6 - Foundation Plan, Sheet S-1 of 1939 Rehabilitation Set

Exterior walls are 12.5-inches of reinforced concrete full height. Interior walls at the second floor vary between wood stud bearing walls and reinforced gunite over wood stud walls. Interior walls at the first floor are 4-inches of reinforced gunite over 8.5-inch URM. The foundation system is conventional, with continuous and spread concrete footings with no evidence of connecting grade beams, see Figure 6.

Foundation systems in Site Class D soils should have ties between foundation elements if a slab on grade or other restraints are not present. There are no grade beams between long foundation elements supporting Building A.

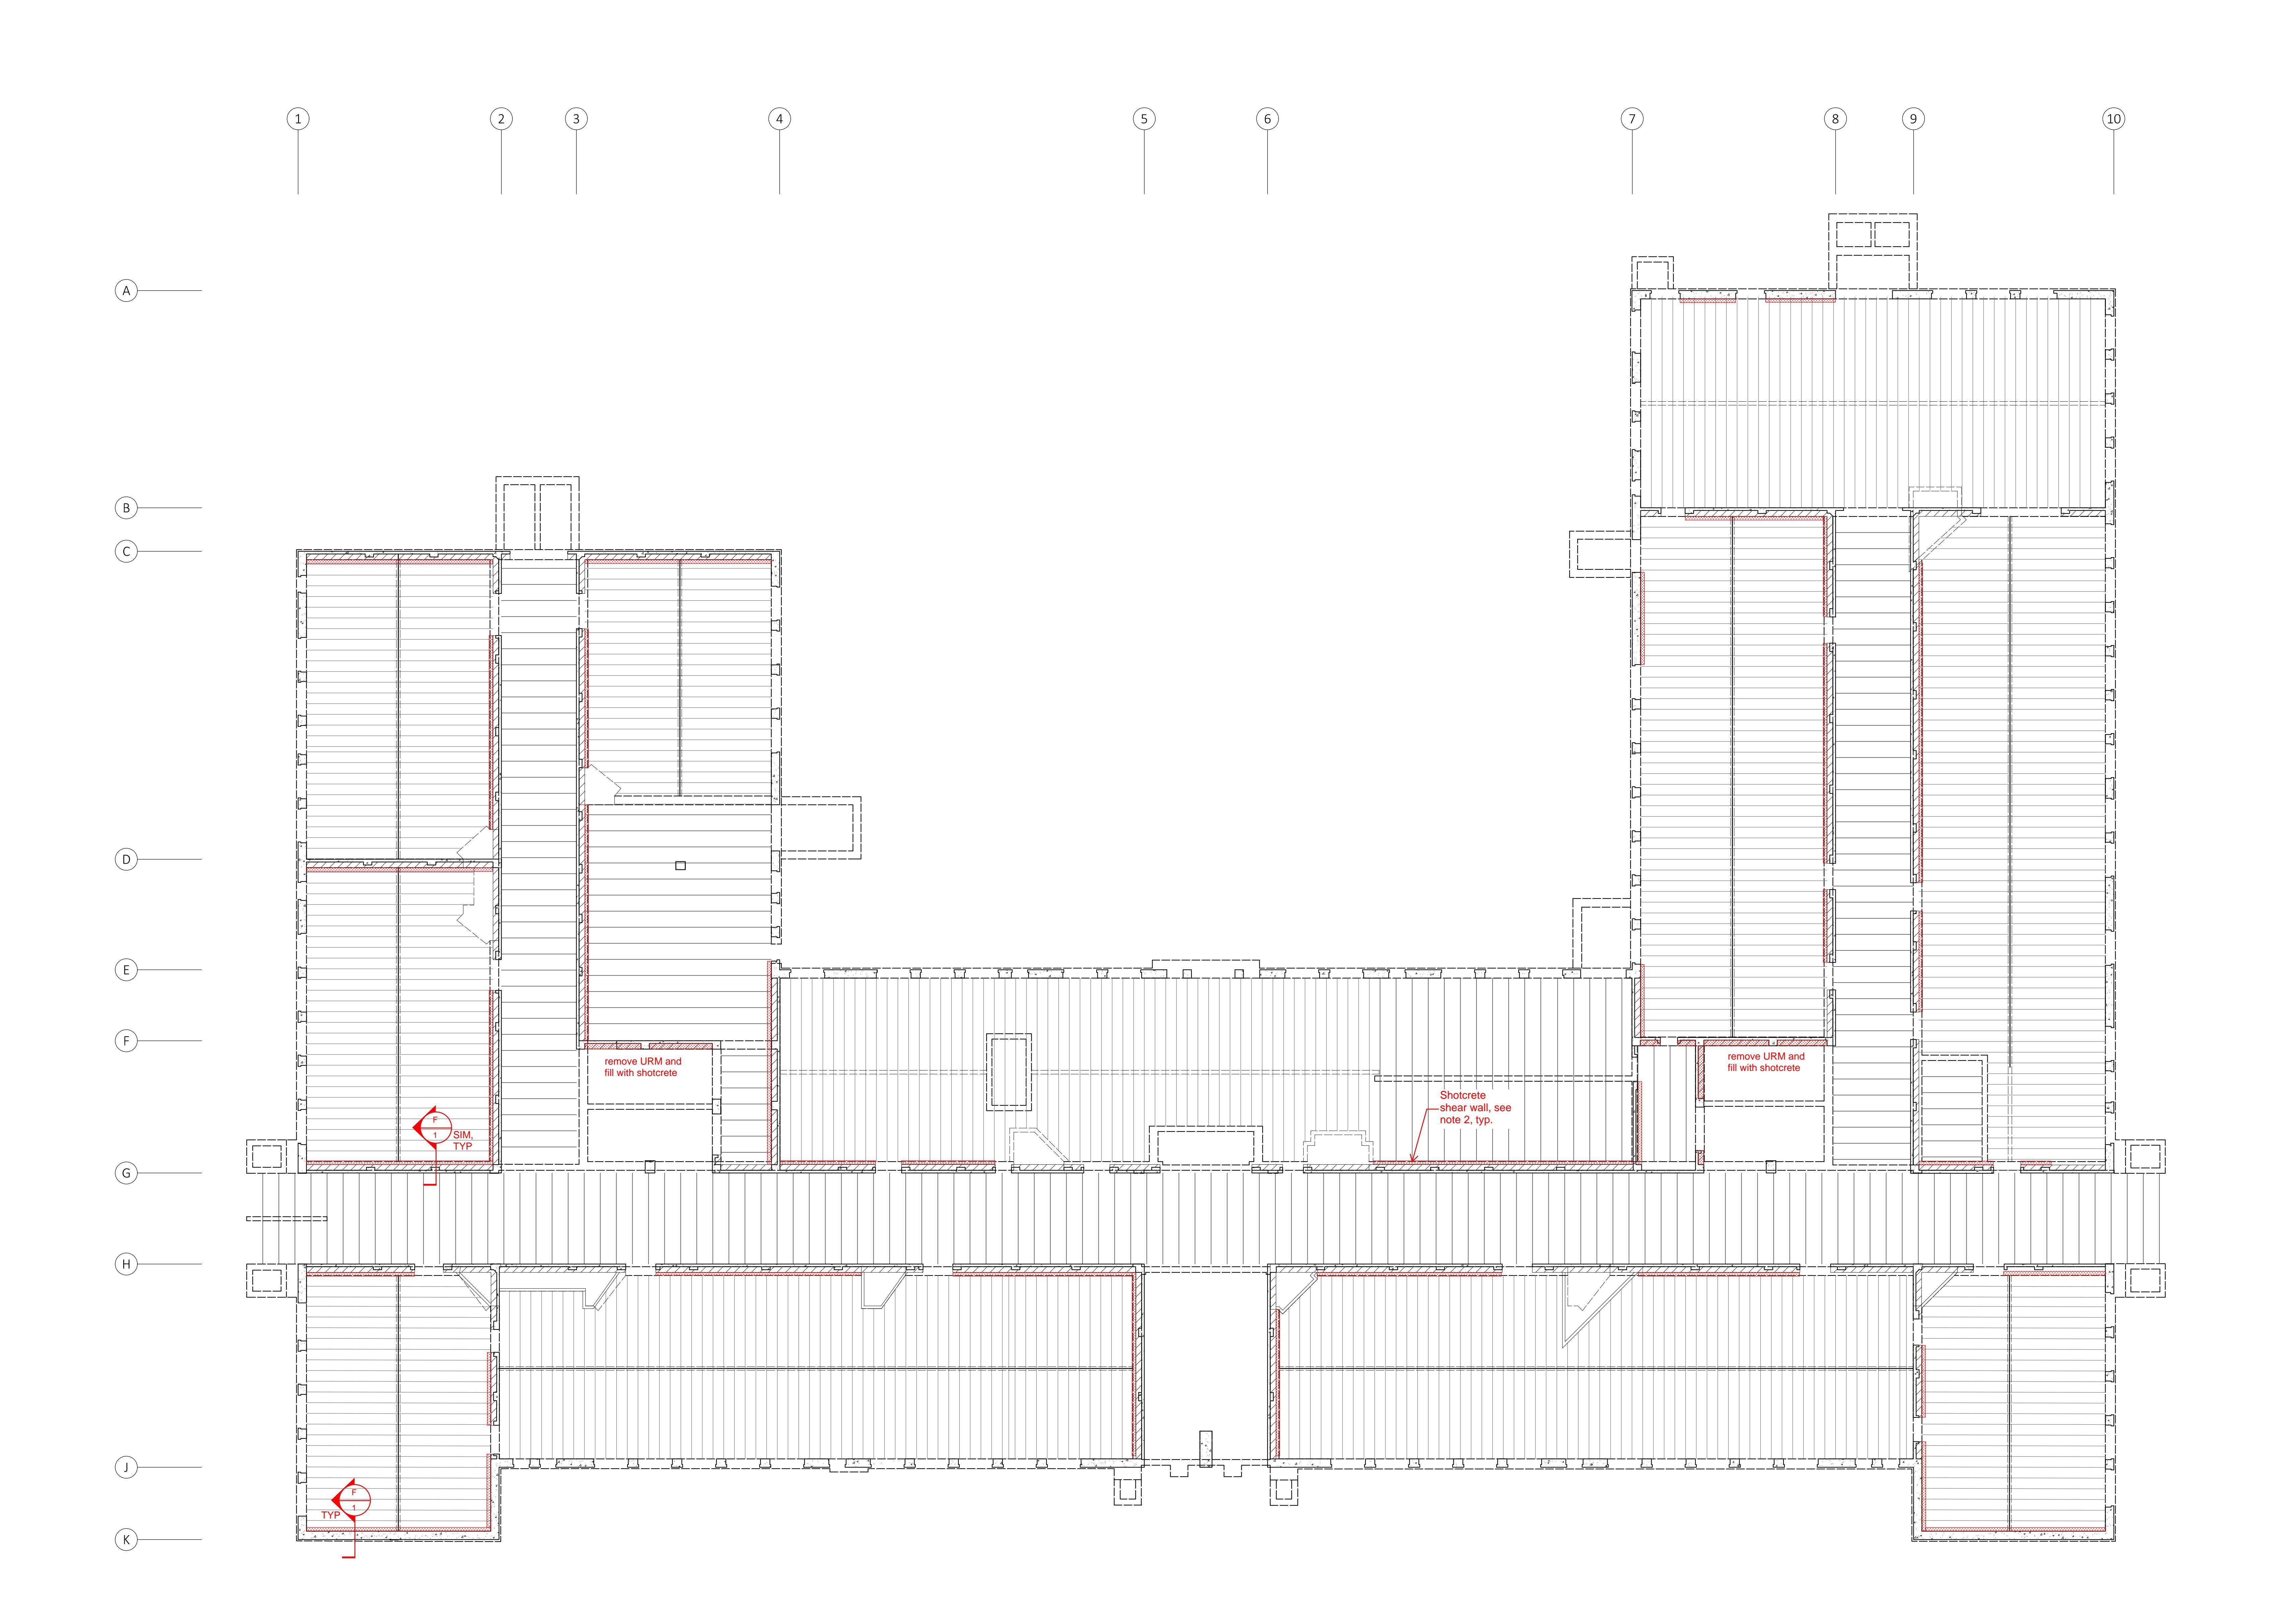
1st FLOOR FRAMING PLAN SCALE: 1/8" = 1'-0"

need footings under shear walls on this sheet

FIRST FLOOR PLAN NOTES: 1. All added shotcrete shall be f'c=4-ksi. 2. 6" shotcrete shear wall, reinforce with #4@12" o.c. each way
