Fort Stockton ISD - Condition Assessment

Alamo Elementary

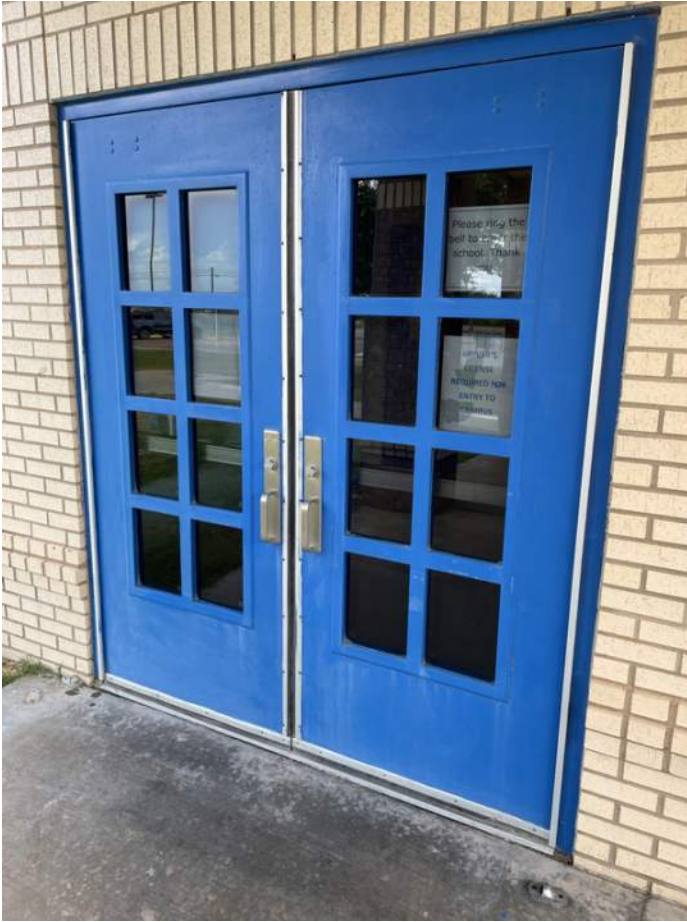
Type Description-Exterior Doors	Hollow Metal
Condition Rating-Exterior Doors	Fair - exhibiting deficiencies requiring minor service/repair to extend useful life
Deficiency Category-Exterior Doors	No Immediate Action

Quantity-Exterior Doors	100
Unit-Exterior Doors	%
Year Installed-Exterior Doors	2001
Comments-Exterior Doors	Repainting will extend lifespan.

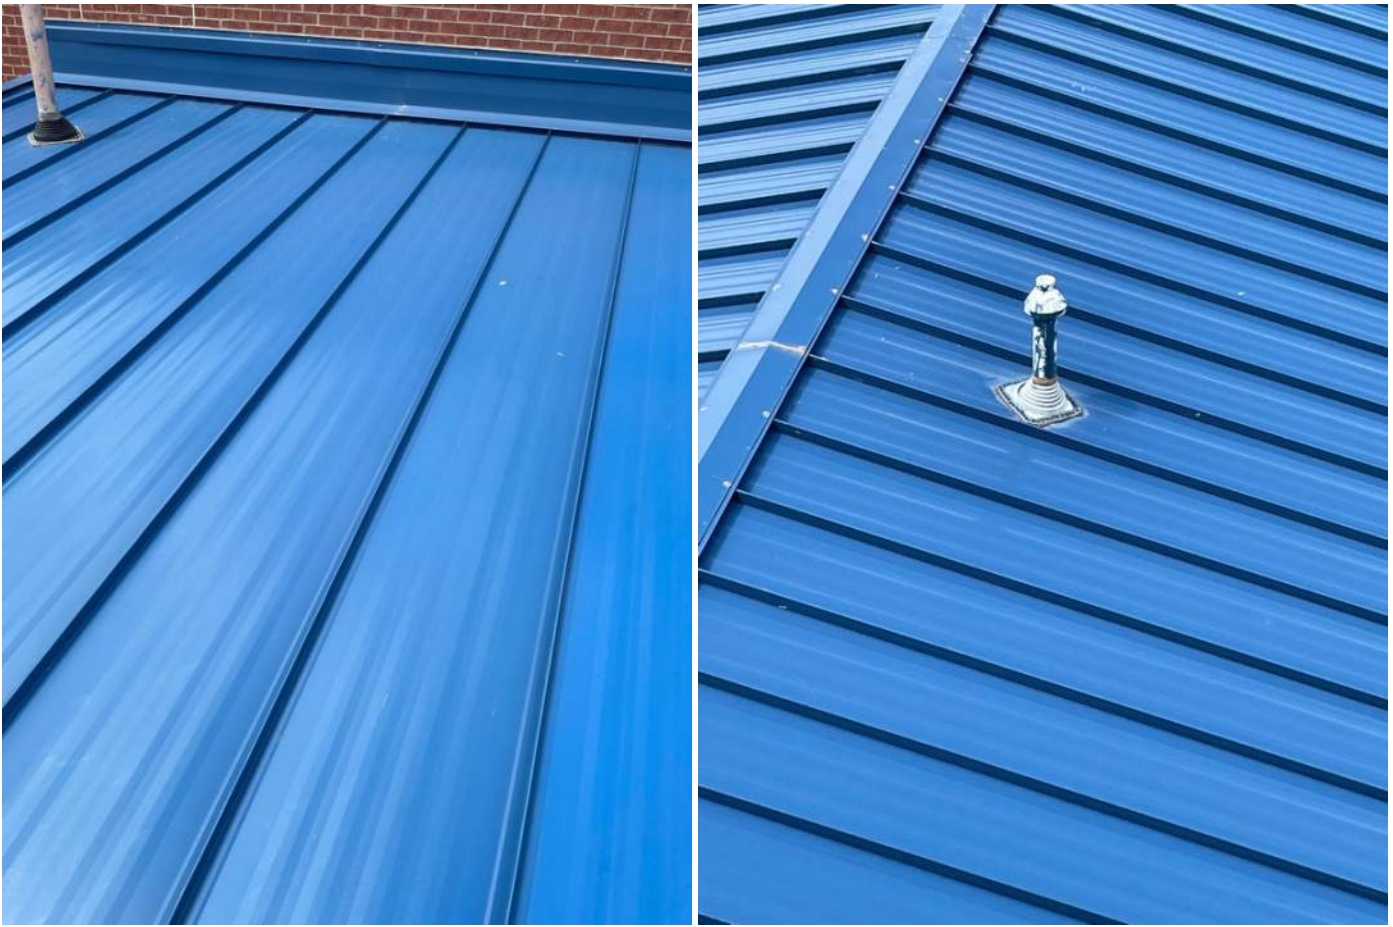
Type Description-Roofing	Metal
Condition Rating-Roofing	Excellent - no known deficiencies or visible depreciation
Deficiency Category-Roofing	No Immediate Action
Quantity-Roofing	90
Unit-Roofing	%
Year Installed-Roofing	2017
Comments-Roofing	n/a

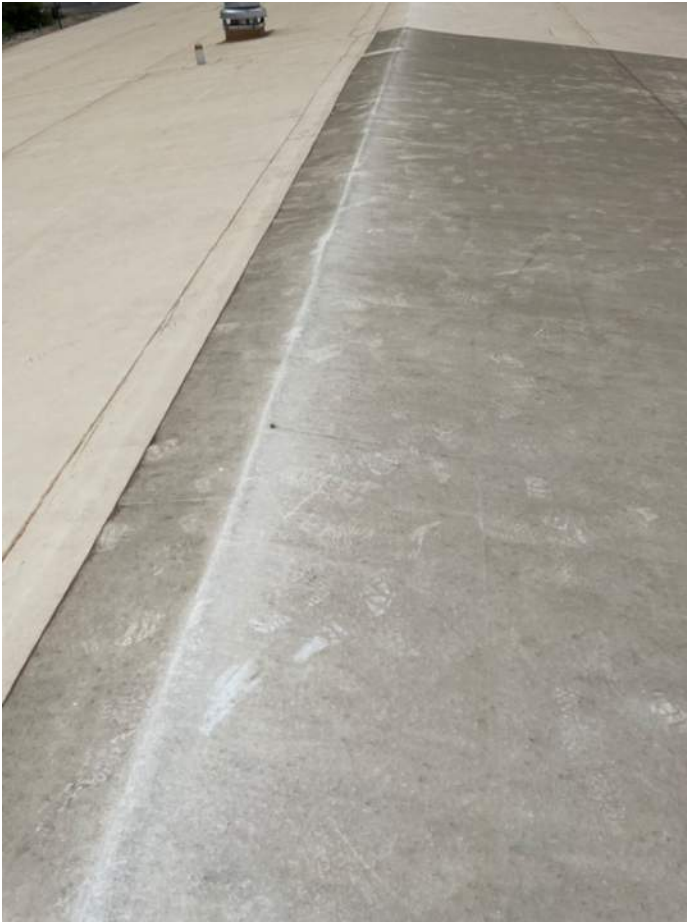
Type Description-Roofing	TPO
Condition Rating-Roofing	Excellent - no known deficiencies or visible depreciation
Deficiency Category-Roofing	No Immediate Action
Quantity-Roofing	10
Unit-Roofing	%
Year Installed-Roofing	2017
Comments-Roofing	n/a

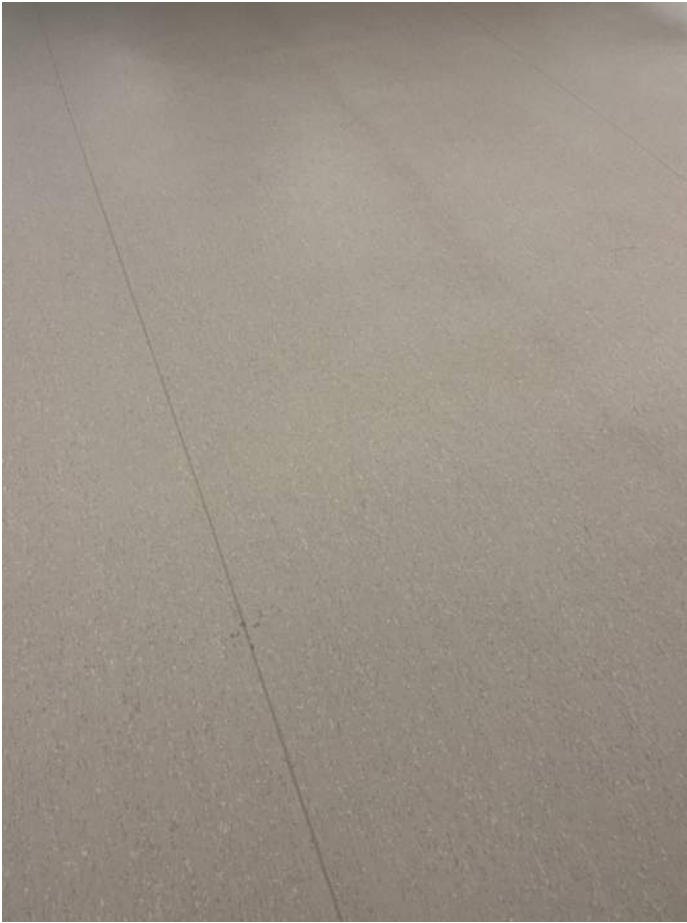
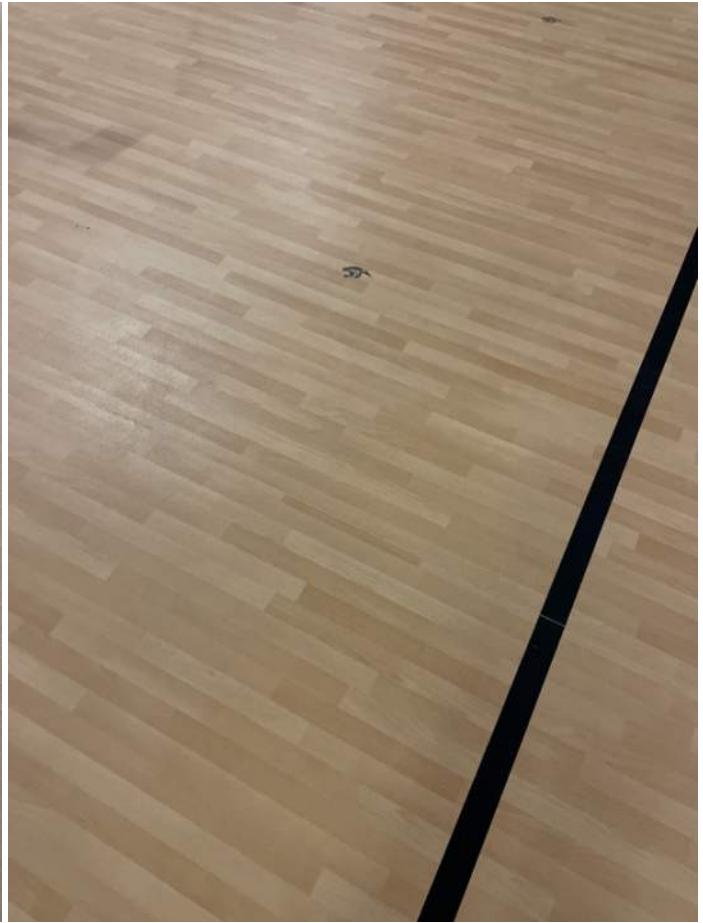
Type Description-Flooring Finishes	Rubber
Condition Rating-Flooring Finishes	Good - minimal depreciation, consistent with asset age
Deficiency Category-Flooring Finishes	No Immediate Action
Quantity-Flooring Finishes	30
Unit-Flooring Finishes	%
Year Installed-Flooring Finishes	2001
Comments-Flooring Finishes	n/a

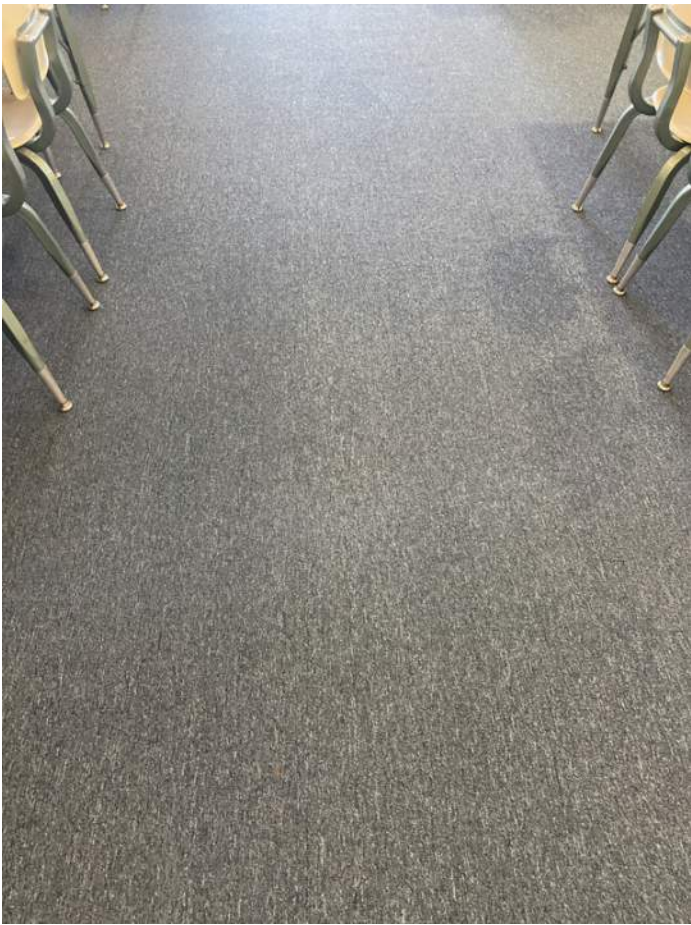
Type Description-Flooring Finishes	Carpet
Condition Rating-Flooring Finishes	Good - minimal depreciation, consistent with asset age
Deficiency Category-Flooring Finishes	No Immediate Action
Quantity-Flooring Finishes	25
Unit-Flooring Finishes	%
Year Installed-Flooring Finishes	n/a
Comments-Flooring Finishes	n/a

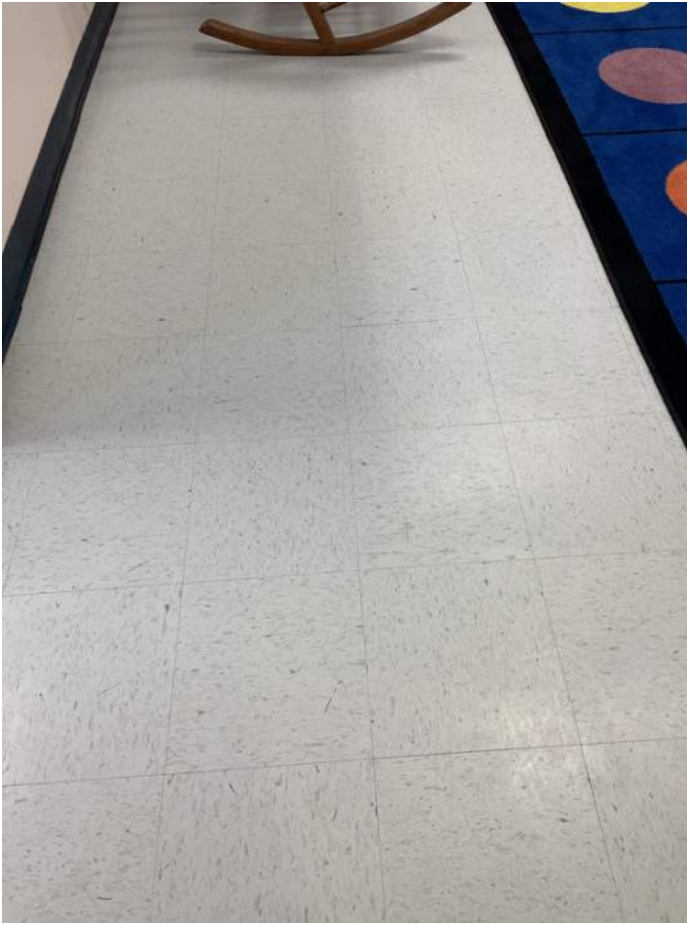
Type Description-Flooring Finishes	VCT
Condition Rating-Flooring Finishes	Good - minimal depreciation, consistent with asset age
Deficiency Category-Flooring Finishes	No Immediate Action
Quantity-Flooring Finishes	25
Unit-Flooring Finishes	%
Year Installed-Flooring Finishes	2001
Comments-Flooring Finishes	n/a

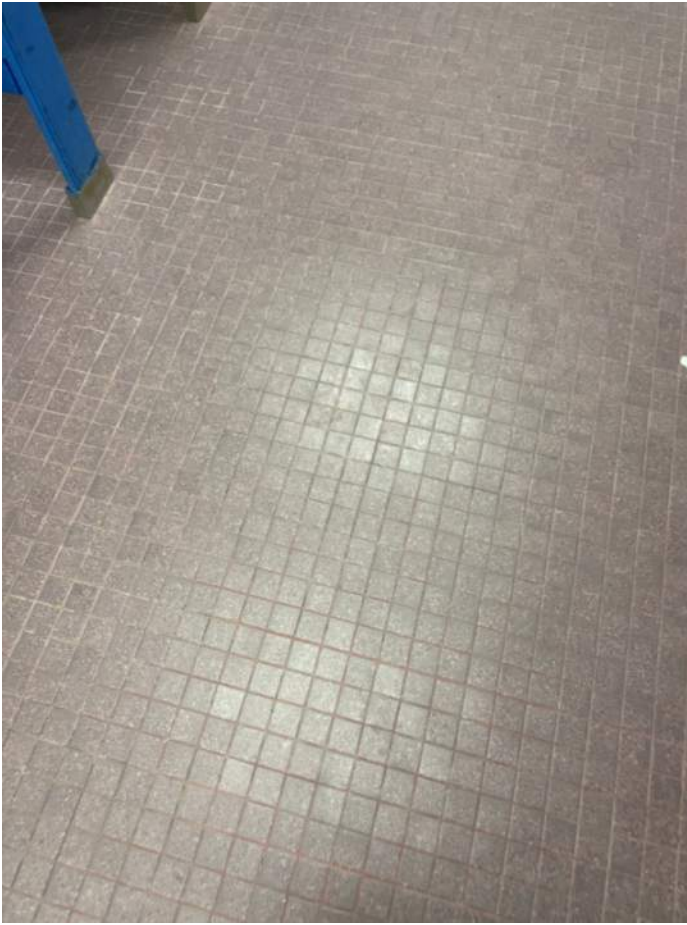
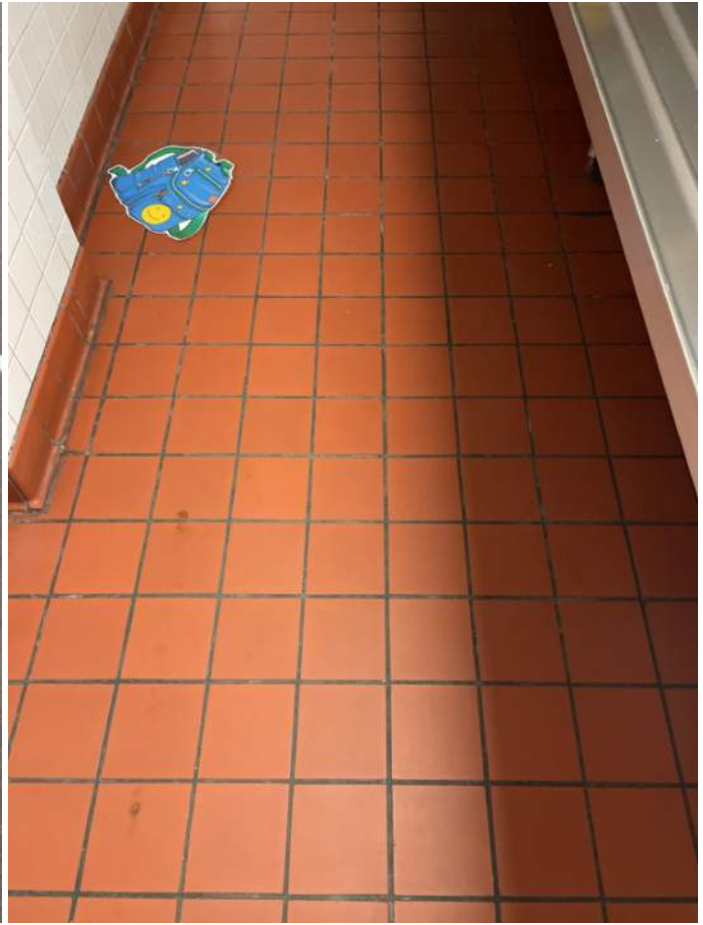
Type Description-Flooring Finishes	Ceramic Tile
Condition Rating-Flooring Finishes	Good - minimal depreciation, consistent with asset age
Deficiency Category-Flooring Finishes	No Immediate Action
Quantity-Flooring Finishes	10
Unit-Flooring Finishes	%
Year Installed-Flooring Finishes	2001
Comments-Flooring Finishes	n/a

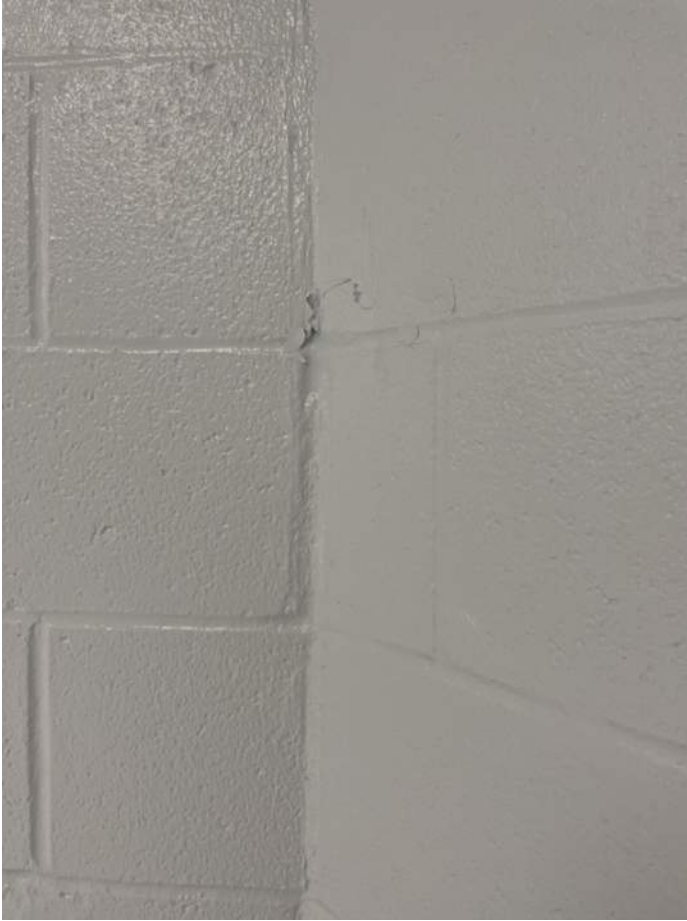
Type Description-Wall Finishes	Paint
Condition Rating-Wall Finishes	Poor - nearing end of useful life, and requiring major service/repair to remain operational
Deficiency Category-Wall Finishes	Beyond Useful Life
Quantity-Wall Finishes	60
Unit-Wall Finishes	%
Year Installed-Wall Finishes	n/a

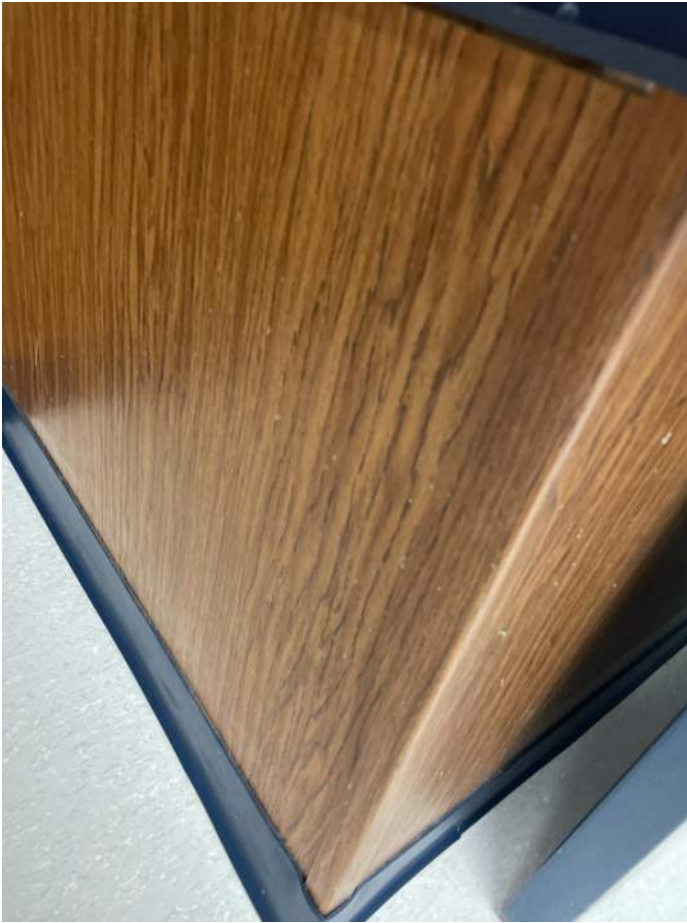
Type Description-Wall Finishes	PLAM
Condition Rating-Wall Finishes	Good - minimal depreciation, consistent with asset age
Deficiency Category-Wall Finishes	No Immediate Action
Quantity-Wall Finishes	10
Unit-Wall Finishes	%
Year Installed-Wall Finishes	2001
Comments-Wall Finishes	n/a

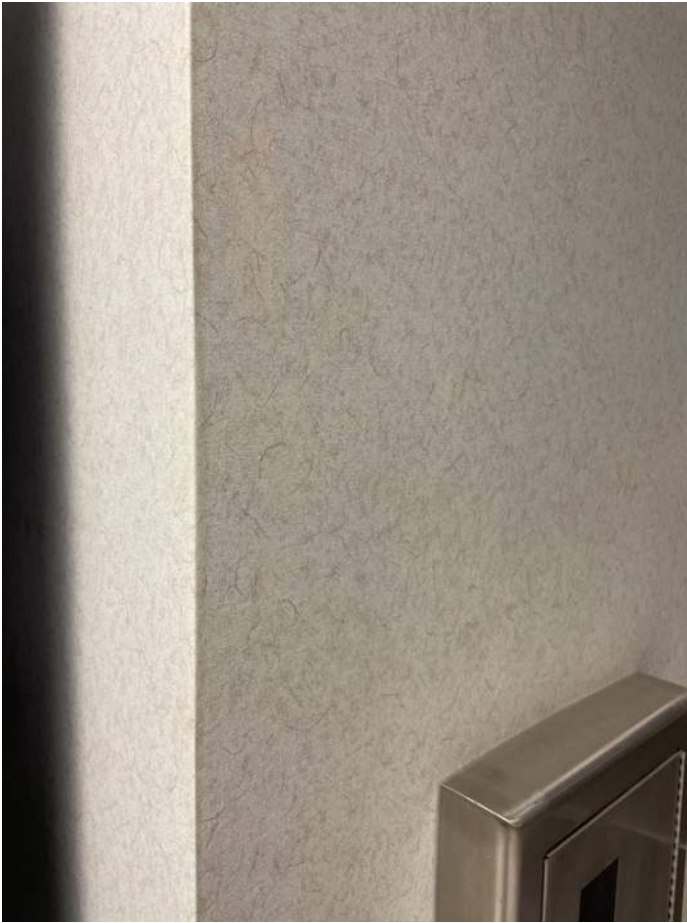
Type Description-Wall Finishes	Vinyl
Condition Rating-Wall Finishes	Good - minimal depreciation, consistent with asset age
Deficiency Category-Wall Finishes	No Immediate Action
Quantity-Wall Finishes	20
Unit-Wall Finishes	%
Year Installed-Wall Finishes	2001
Comments-Wall Finishes	n/a

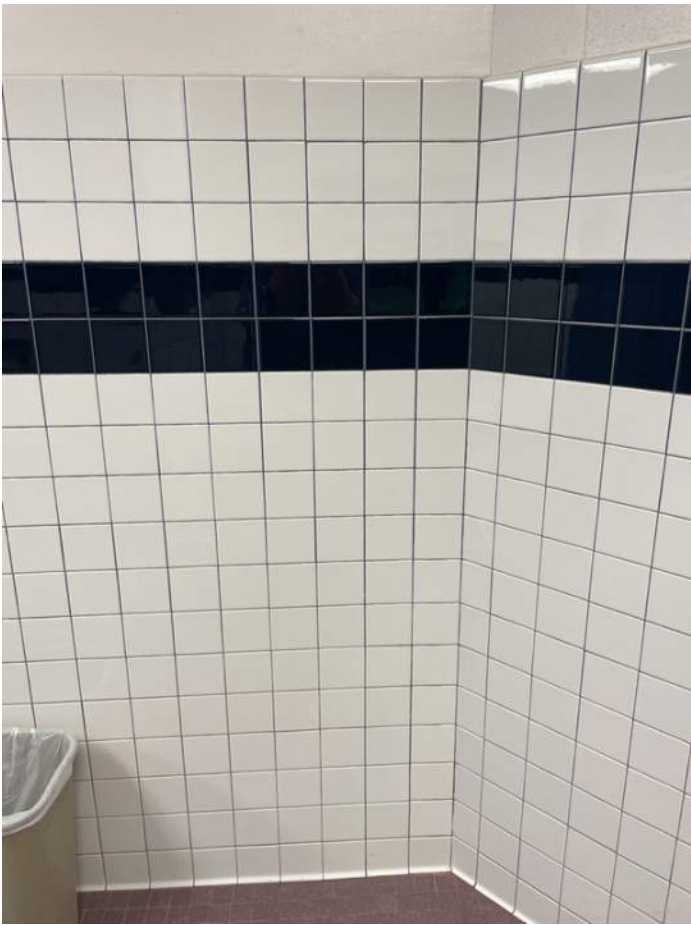
Type Description-Wall Finishes	Ceramic Tile
Condition Rating-Wall Finishes	Good - minimal depreciation, consistent with asset age
Deficiency Category-Wall Finishes	No Immediate Action
Quantity-Wall Finishes	10
Unit-Wall Finishes	%
Year Installed-Wall Finishes	2001
Comments-Wall Finishes	n/a

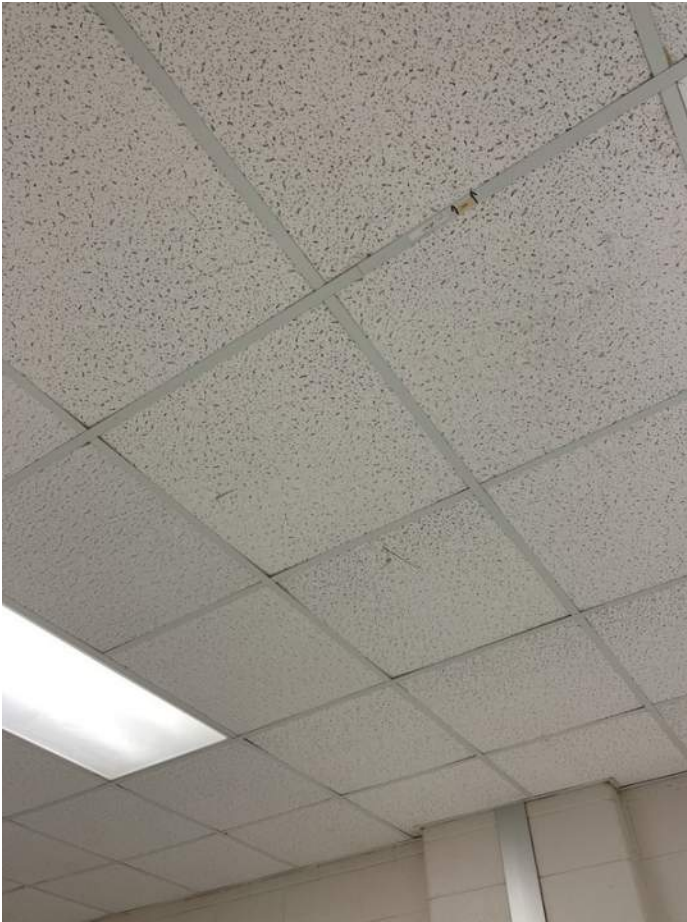
Type Description-Ceiling Finishes	2x2 Acoustical Tile
Condition Rating-Ceiling Finishes	Good - minimal depreciation, consistent with asset age
Deficiency Category-Ceiling Finishes	No Immediate Action
Quantity-Ceiling Finishes	95
Unit-Ceiling Finishes	%

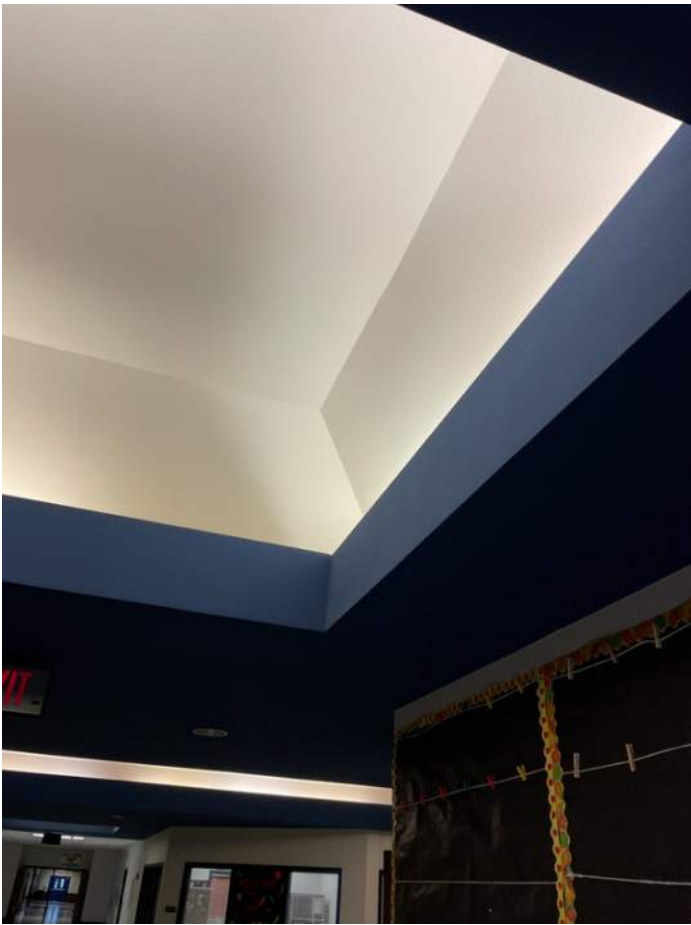
Type Description-Ceiling Finishes | Gypsum

Condition Rating-Ceiling Finishes | Good - minimal depreciation, consistent with asset age

Deficiency Category-Ceiling Finishes | No Immediate Action

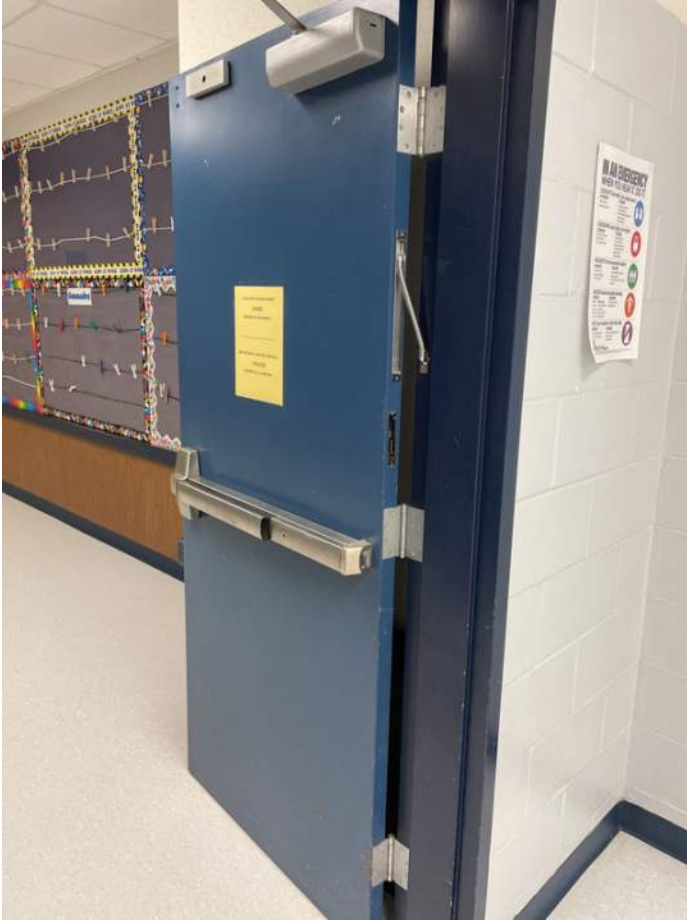
Type Description-Interior Doors	Hollow Metal
Condition Rating-Interior Doors	Good - minimal depreciation, consistent with asset age
Deficiency Category-Interior Doors	No Immediate Action
Quantity-Interior Doors	10
Unit-Interior Doors	%
Year Installed-Interior Doors	2001

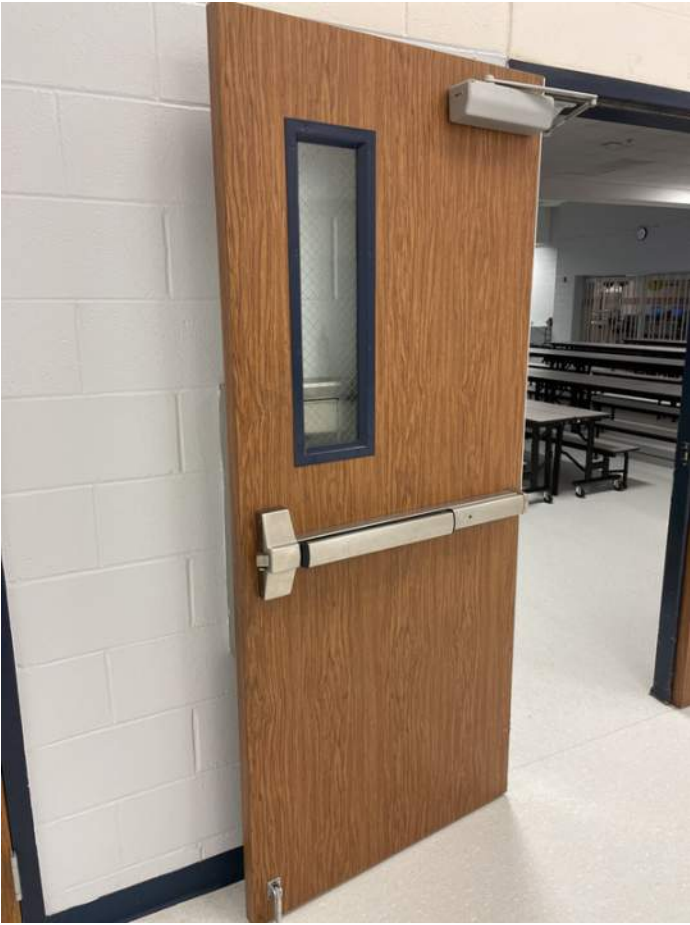
Type Description-Interior Doors	Wood
Condition Rating-Interior Doors	Good - minimal depreciation, consistent with asset age
Deficiency Category-Interior Doors	No Immediate Action
Quantity-Interior Doors	80
Unit-Interior Doors	%
Year Installed-Interior Doors	2001
Comments-Interior Doors	n/a

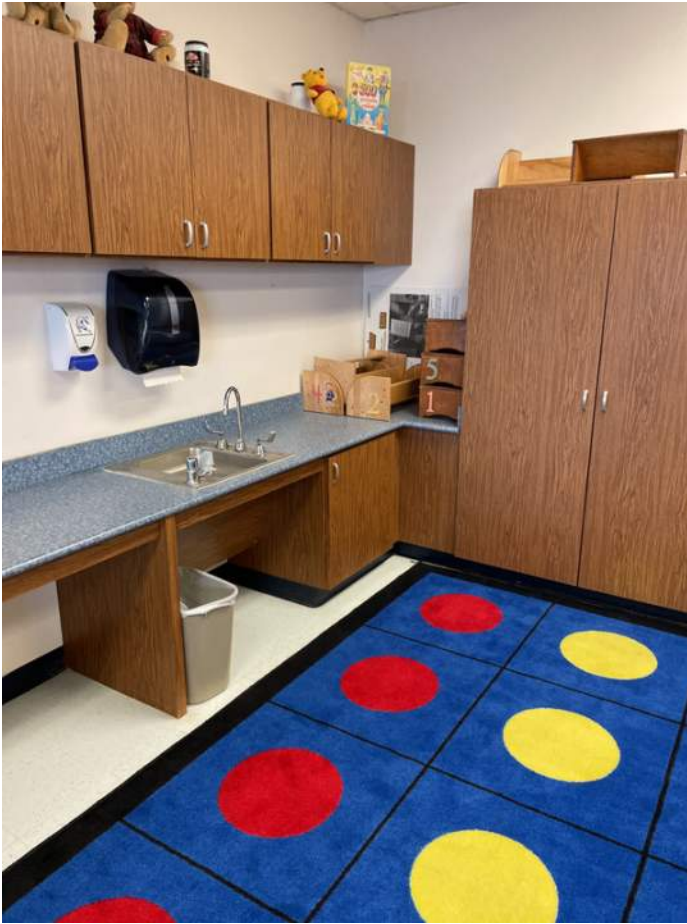
Type Description-Fixed Furnishings	Millwork
Condition Rating-Fixed Furnishings	Good - minimal depreciation, consistent with asset age
Deficiency Category-Fixed Furnishings	No Immediate Action
Quantity-Fixed Furnishings	n/a
Unit-Fixed Furnishings	n/a

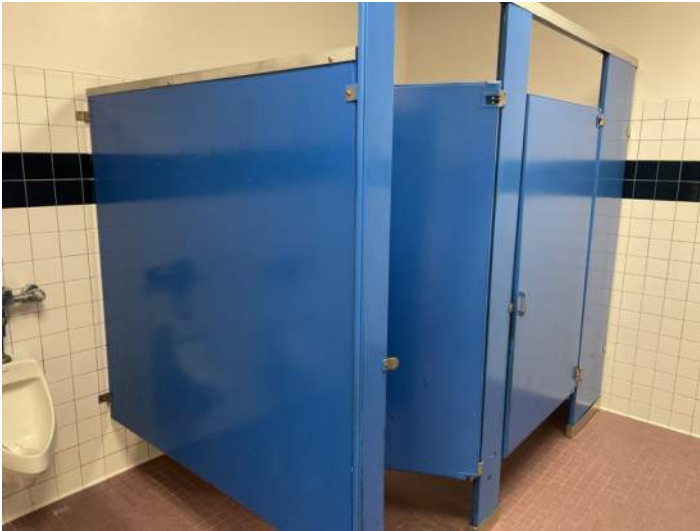
Type Description-Fixed Furnishings	Toilet partitions
---	-------------------

Condition Rating-Fixed Furnishings	Fair - exhibiting deficiencies requiring minor service/repair to extend useful life
---	---

Deficiency Category-Fixed Furnishings	No Immediate Action
--	---------------------

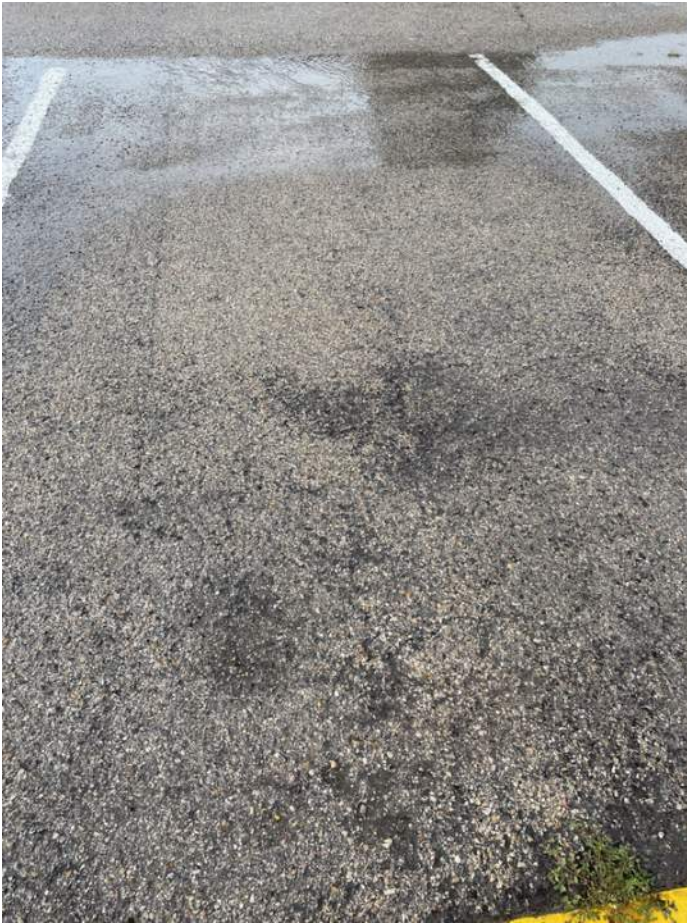
Type Description-Site Development	Parking lot
Condition Rating-Site Development	Good - minimal depreciation, consistent with asset age
Deficiency Category-Site Development	No Immediate Action
Quantity-Site Development	n/a
Unit-Site Development	n/a
Year Installed-Site Development	n/a
Comments-Site Development	n/a

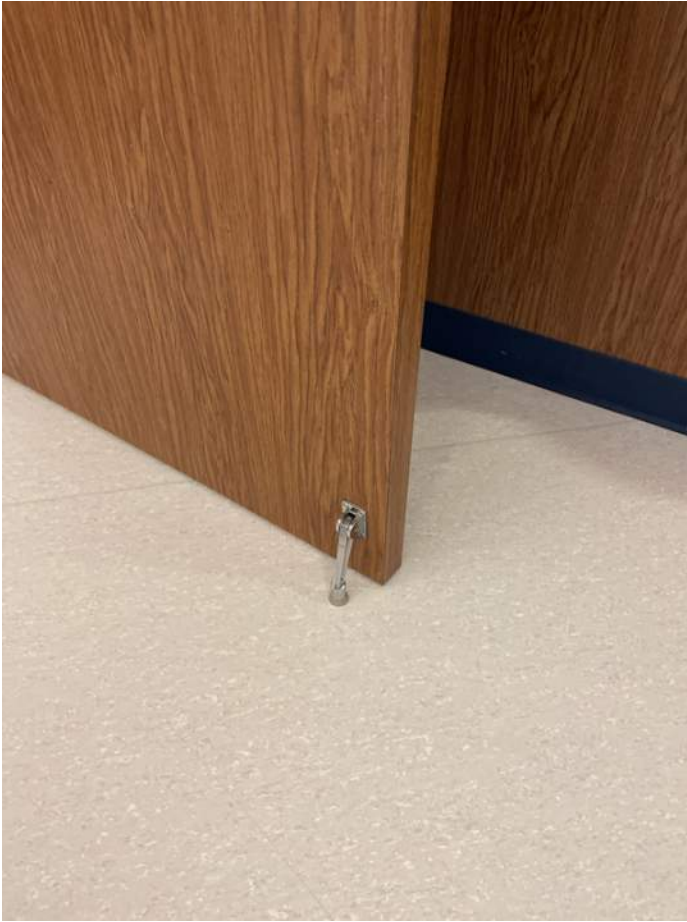
Fire code issue. Corridors are rated but most rated doors have manual hold opens. This building is too new to be grandfathered.

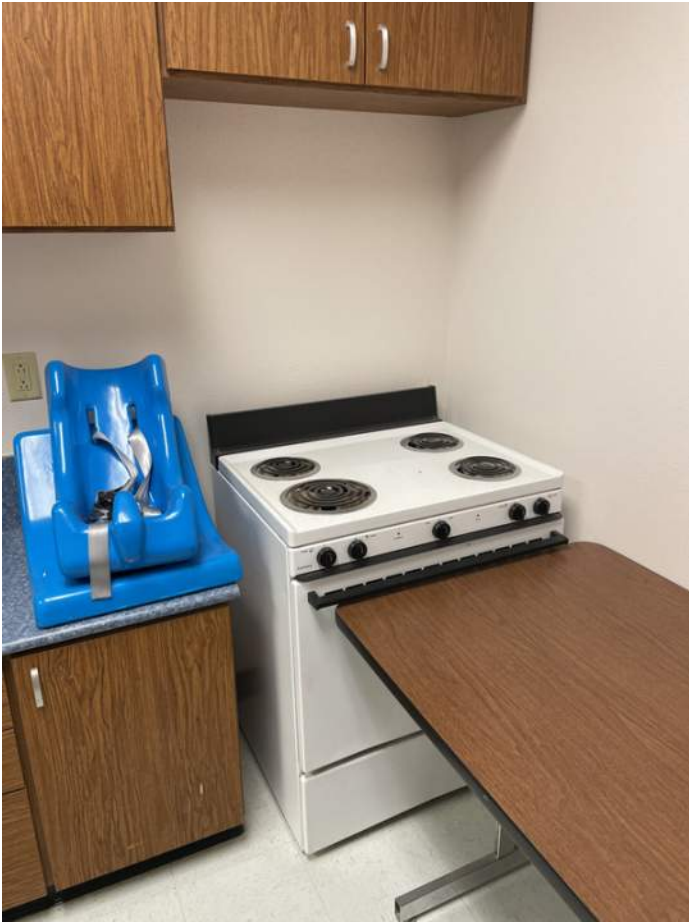
Building Codes - 2. Fire code issue. Cooktop without fire suppression system.

Fire code issue. Cooktop without fire suppression system.

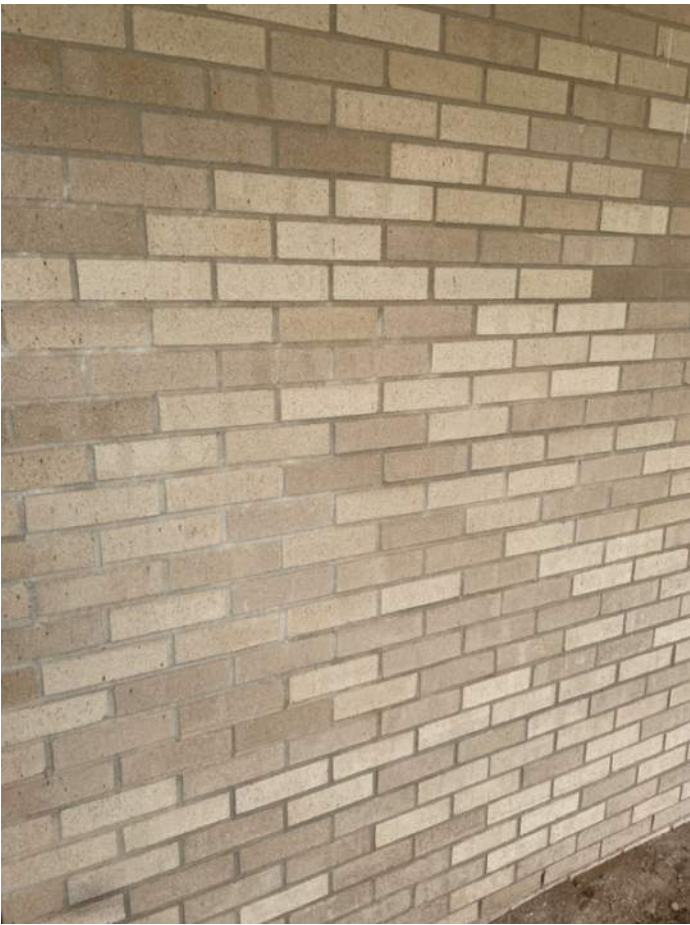
Type Description-Exterior Walls	Brick
Condition Rating-Exterior Walls	Good - minimal depreciation, consistent with asset age
Deficiency Category-Exterior Walls	No Immediate Action
Quantity-Exterior Walls	100
Unit-Exterior Walls	%
Year Installed-Exterior Walls	1975
Comments-Exterior Walls	n/a

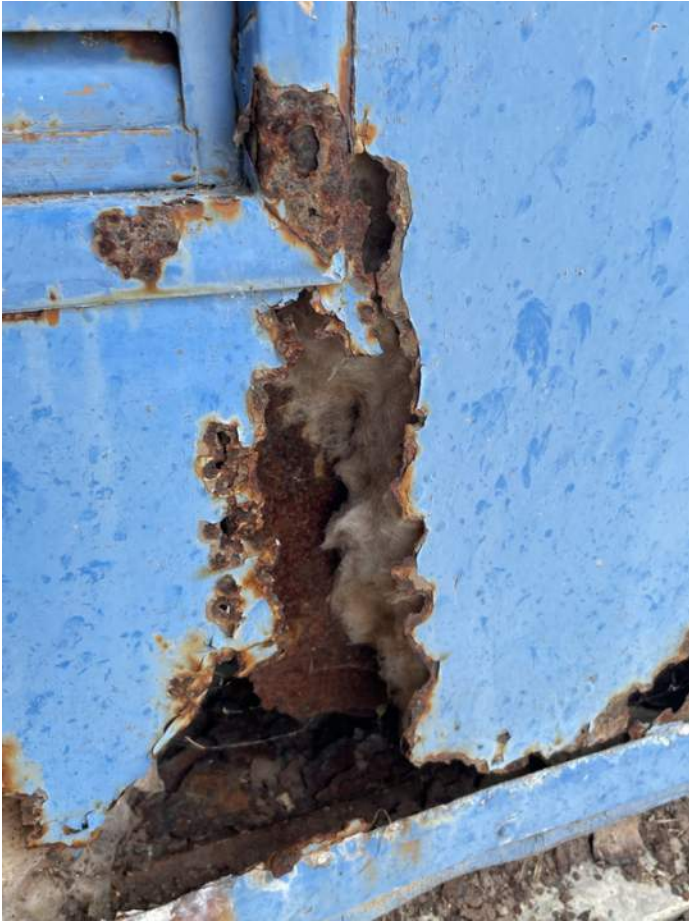
Type Description-Exterior Doors	Hollow Metal
Condition Rating-Exterior Doors	Critical - failed or failing, and beyond useful life requiring immediate attention
Deficiency Category-Exterior Doors	Damaged/Failing

Quantity-Exterior Doors	100
Unit-Exterior Doors	%
Year Installed-Exterior Doors	1975
Comments-Exterior Doors	All doors past lifespan. Some are highly damaged from rust.

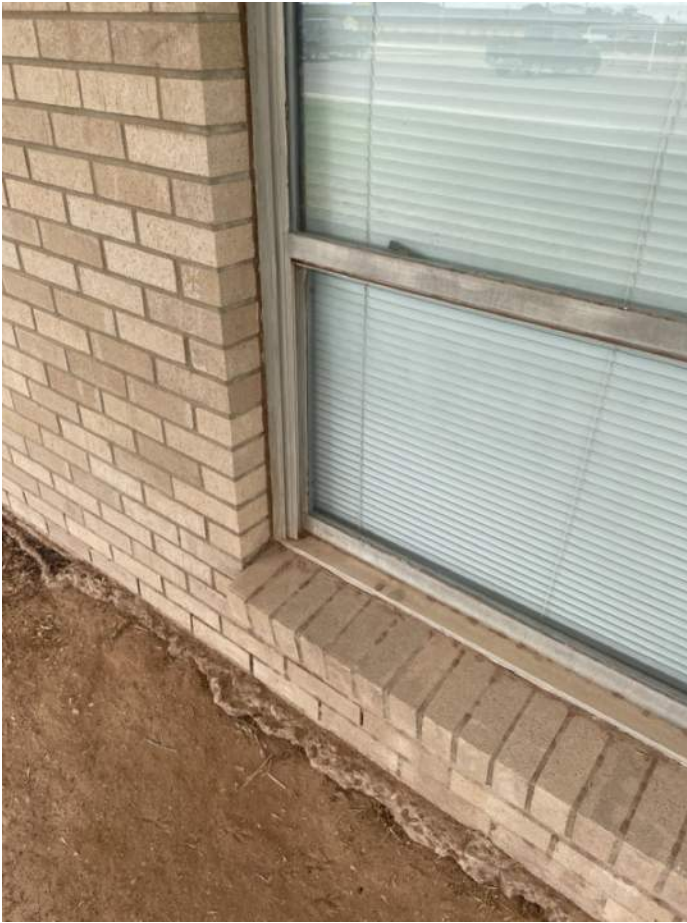
Type Description-Windows	Aluminum
Condition Rating-Windows	Fair - exhibiting deficiencies requiring minor service/repair to extend useful life
Deficiency Category-Windows	No Immediate Action
Quantity-Windows	80
Unit-Windows	%
Year Installed-Windows	1975
Comments-Windows	n/a

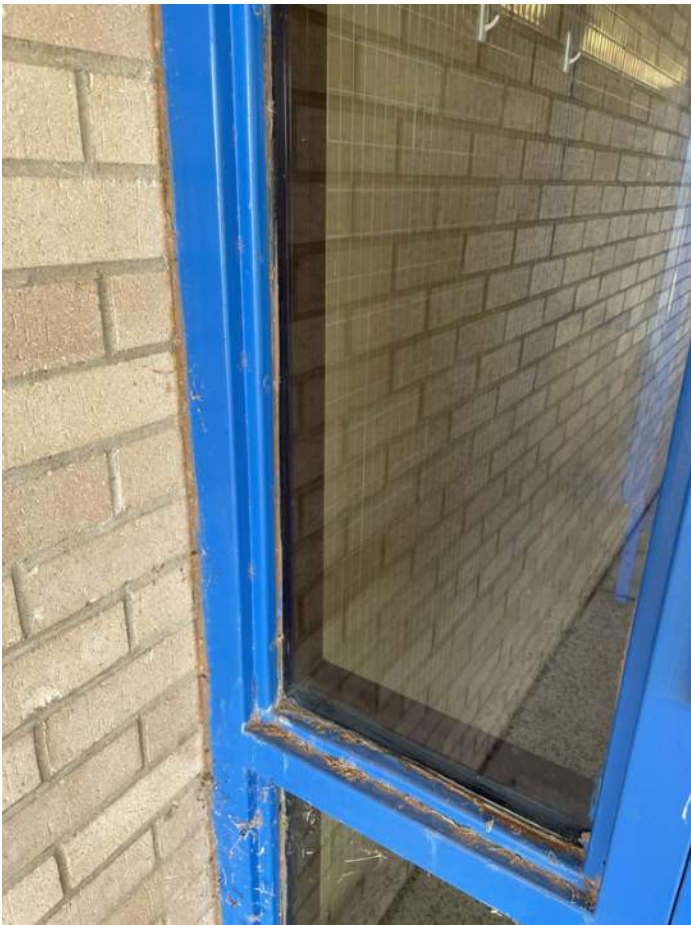
Type Description-Windows	Hollow Metal
Condition Rating-Windows	Fair - exhibiting deficiencies requiring minor service/repair to extend useful life
Deficiency Category-Windows	No Immediate Action
Quantity-Windows	20
Unit-Windows	%
Year Installed-Windows	1975
Comments-Windows	n/a

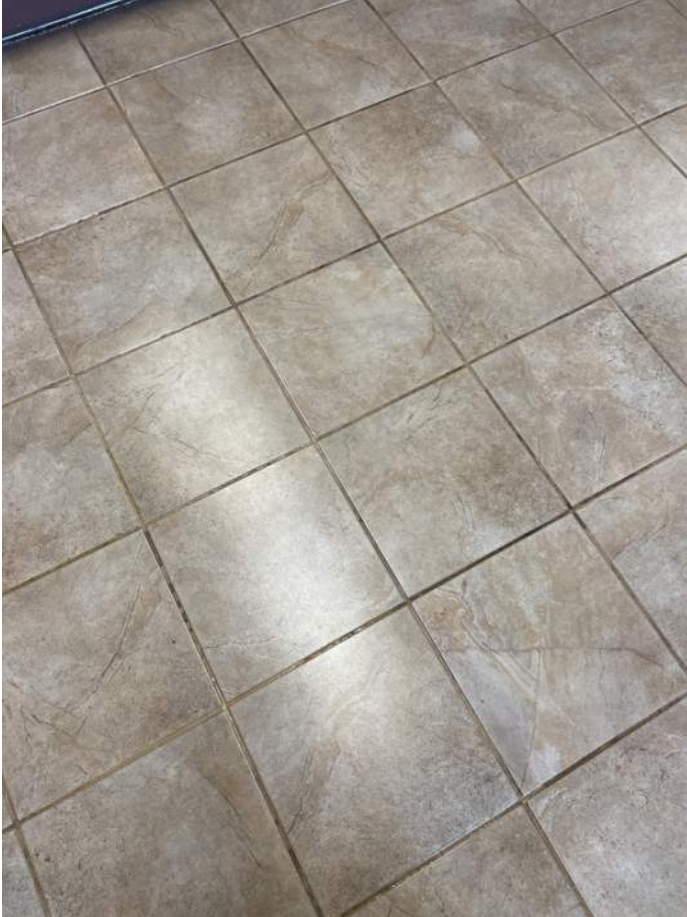
Type Description-Flooring Finishes	Ceramic Tile
Condition Rating-Flooring Finishes	Good - minimal depreciation, consistent with asset age
Deficiency Category-Flooring Finishes	No Immediate Action
Quantity-Flooring Finishes	5
Unit-Flooring Finishes	%
Year Installed-Flooring Finishes	n/a
Comments-Flooring Finishes	Unknown age. Good condition.

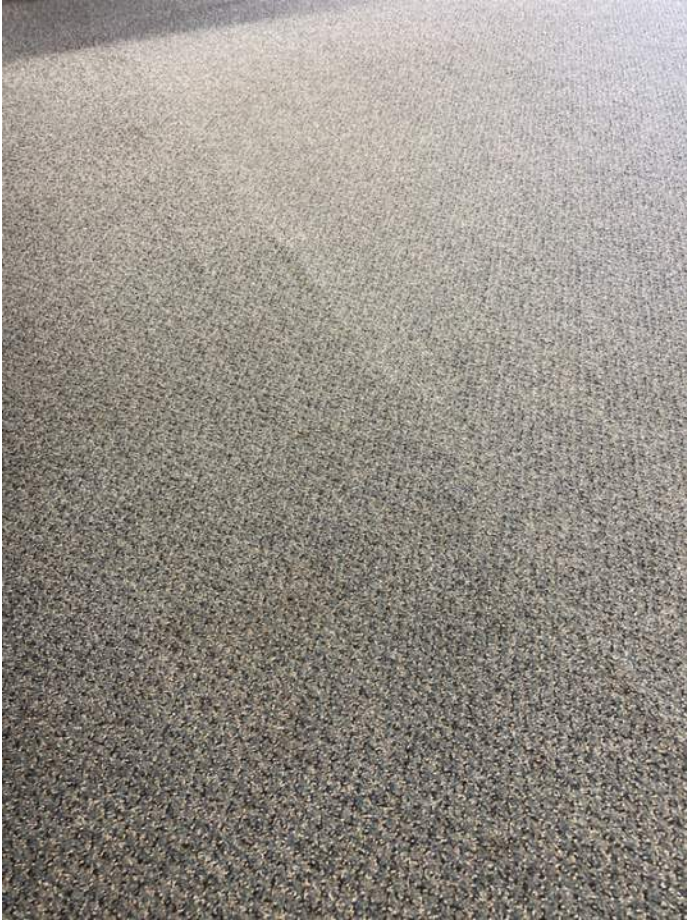
Type Description-Flooring Finishes	Carpet
Condition Rating-Flooring Finishes	Fair - exhibiting deficiencies requiring minor service/repair to extend useful life
Deficiency Category-Flooring Finishes	No Immediate Action
Quantity-Flooring Finishes	70
Unit-Flooring Finishes	%
Year Installed-Flooring Finishes	n/a

Comments-Flooring Finishes | Nearing end of lifespan.

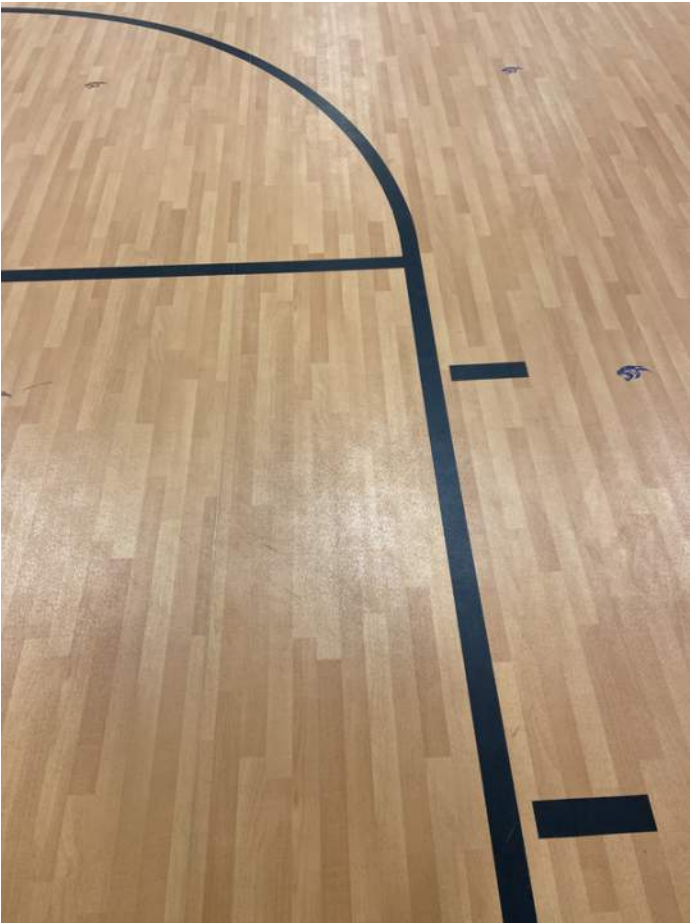
Type Description-Flooring Finishes	Rubber
Condition Rating-Flooring Finishes	Excellent - no known deficiencies or visible depreciation
Deficiency Category-Flooring Finishes	No Immediate Action
Quantity-Flooring Finishes	5
Unit-Flooring Finishes	%
Year Installed-Flooring Finishes	n/a
Comments-Flooring Finishes	n/a

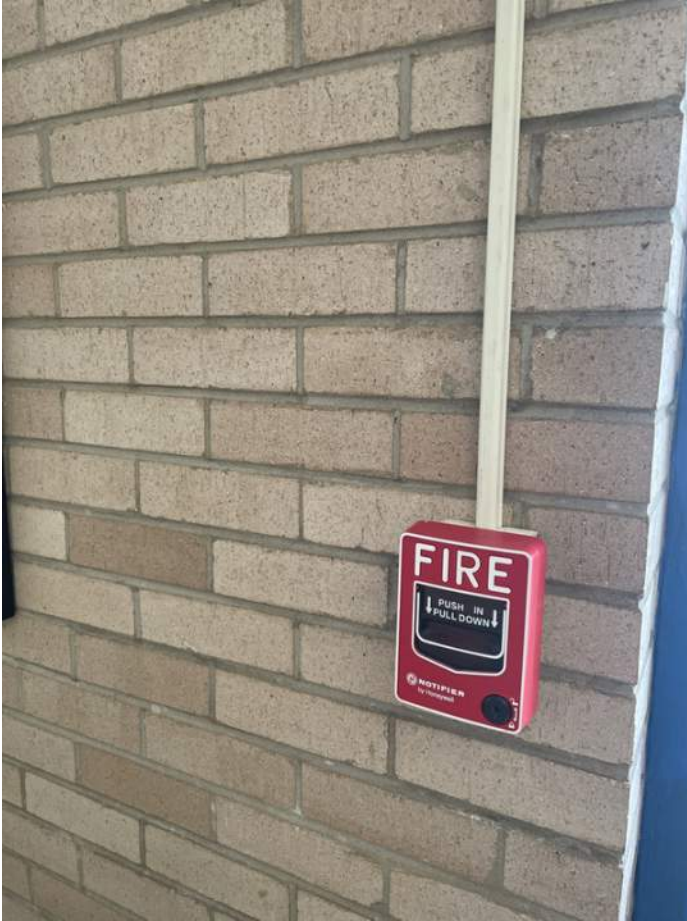
Type Description-Wall Finishes	Brick
Condition Rating-Wall Finishes	Good - minimal depreciation, consistent with asset age
Deficiency Category-Wall Finishes	No Immediate Action
Quantity-Wall Finishes	5
Unit-Wall Finishes	%
Year Installed-Wall Finishes	1975

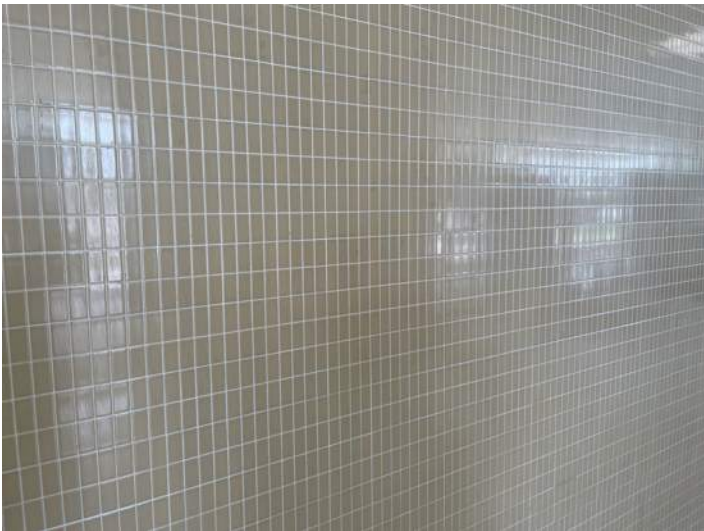
Type Description-Wall Finishes	Ceramic Tile
Condition Rating-Wall Finishes	Good - minimal depreciation, consistent with asset age
Deficiency Category-Wall Finishes	No Immediate Action
Quantity-Wall Finishes	25
Unit-Wall Finishes	%
Year Installed-Wall Finishes	1975
Comments-Wall Finishes	n/a

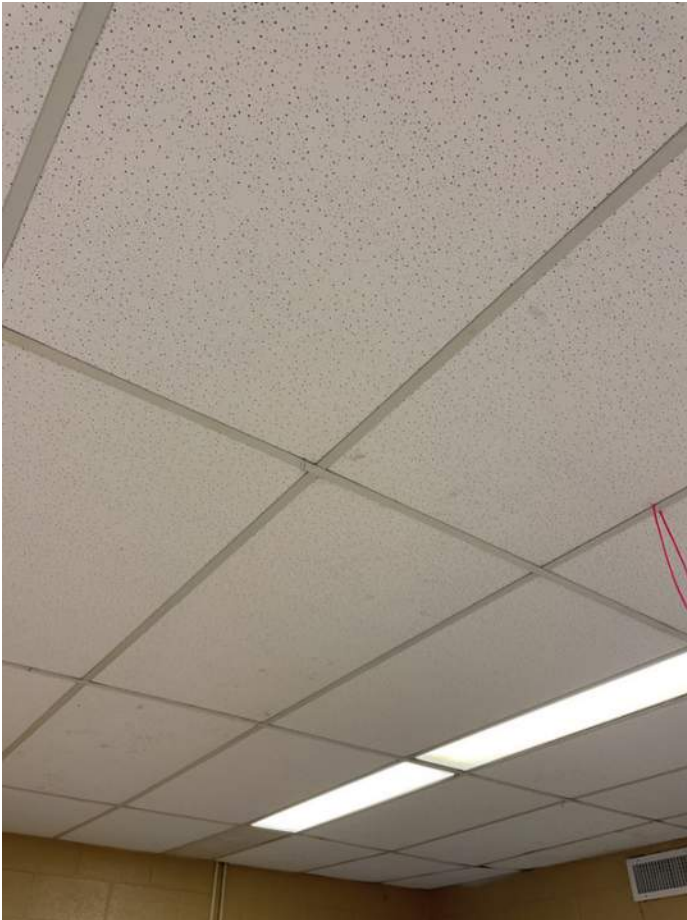
Type Description-Ceiling Finishes	2x4 Acoustical Tile
Condition Rating-Ceiling Finishes	Good - minimal depreciation, consistent with asset age
Deficiency Category-Ceiling Finishes	No Immediate Action
Quantity-Ceiling Finishes	95
