Fort Stockton ISD - Condition Assessment

Alamo Elementary

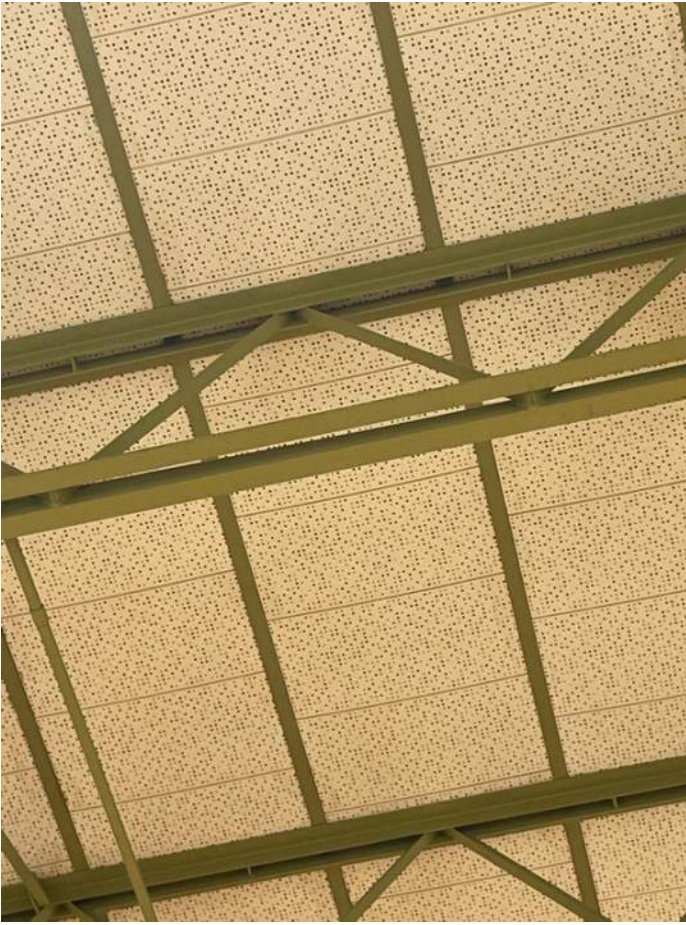
Type Description-Ceiling Finishes	1x1 Acoustical Tile
-----------------------------------	---------------------

Condition Rating-Ceiling Finishes	Good - minimal depreciation, consistent with asset age
-----------------------------------	--

Deficiency Category-Ceiling Finishes	No Immediate Action
--------------------------------------	---------------------

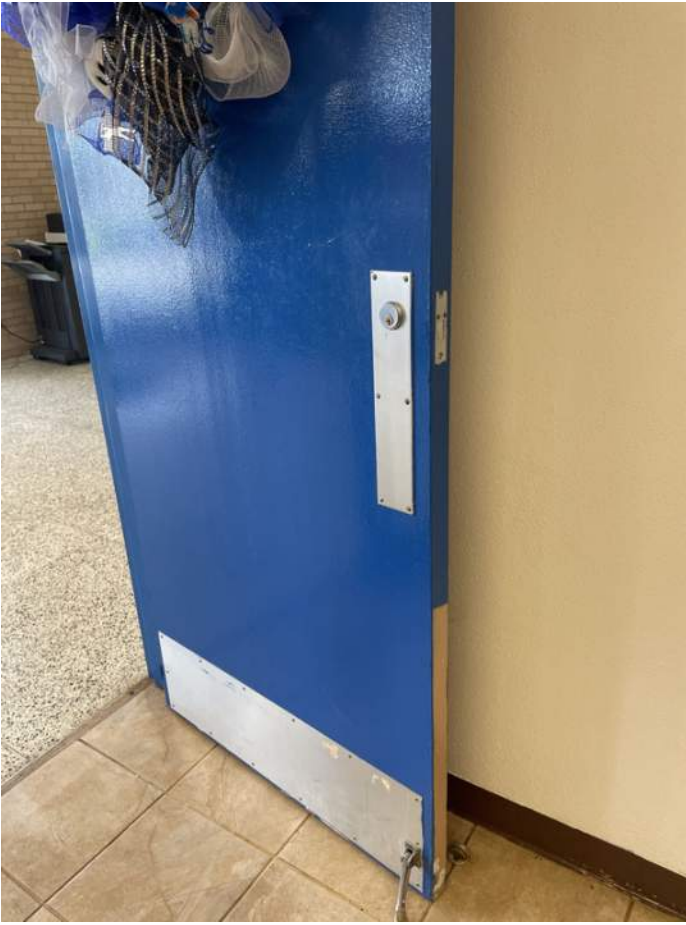
Type Description-Interior Doors	Wood
Condition Rating-Interior Doors	Fair - exhibiting deficiencies requiring minor service/repair to extend useful life
Deficiency Category-Interior Doors	Beyond Useful Life
Quantity-Interior Doors	95
Unit-Interior Doors	%
Year Installed-Interior Doors	1975
Comments-Interior Doors	n/a

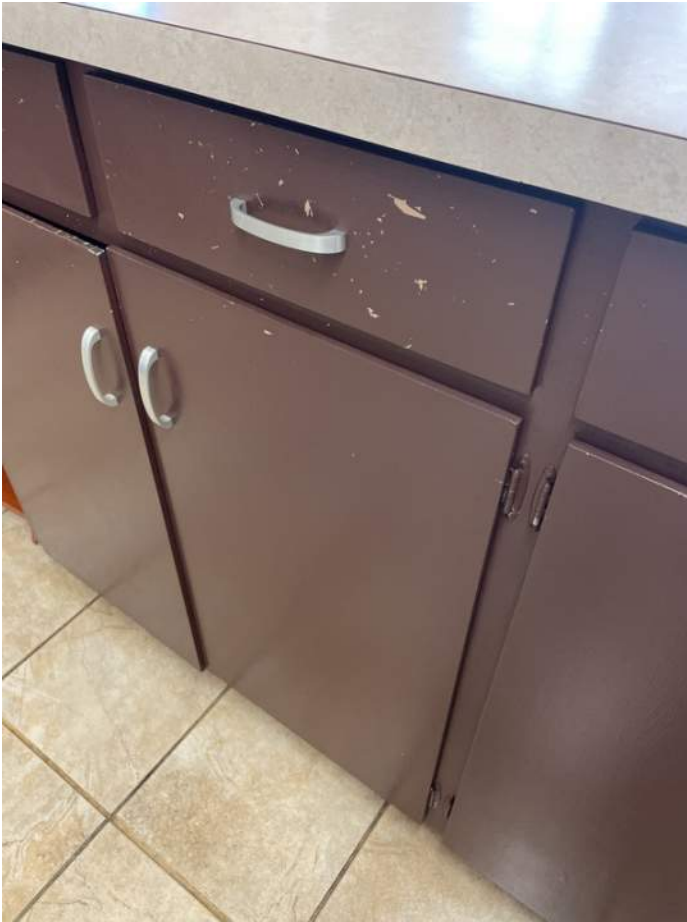
Type Description-Fixed Furnishings	Millwork
Condition Rating-Fixed Furnishings	Fair - exhibiting deficiencies requiring minor service/repair to extend useful life
Deficiency Category-Fixed Furnishings	Beyond Useful Life
Quantity-Fixed Furnishings	n/a

Unit-Fixed Furnishings	n/a
Year Installed-Fixed Furnishings	1975
Comments-Fixed Furnishings	n/a

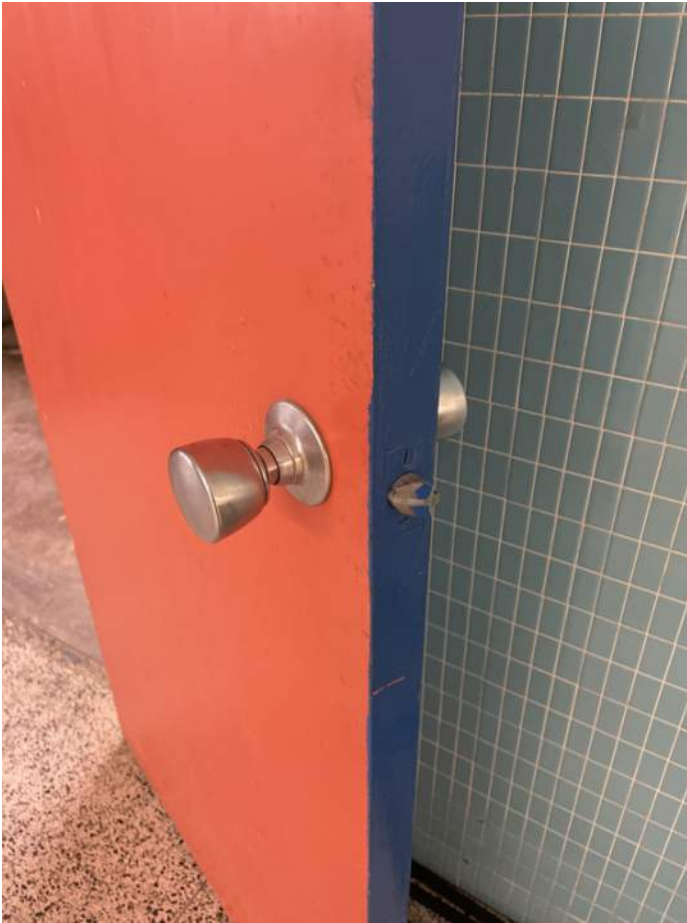
Description-Accessibility	Most doors do not have accessible locks.
---------------------------	--

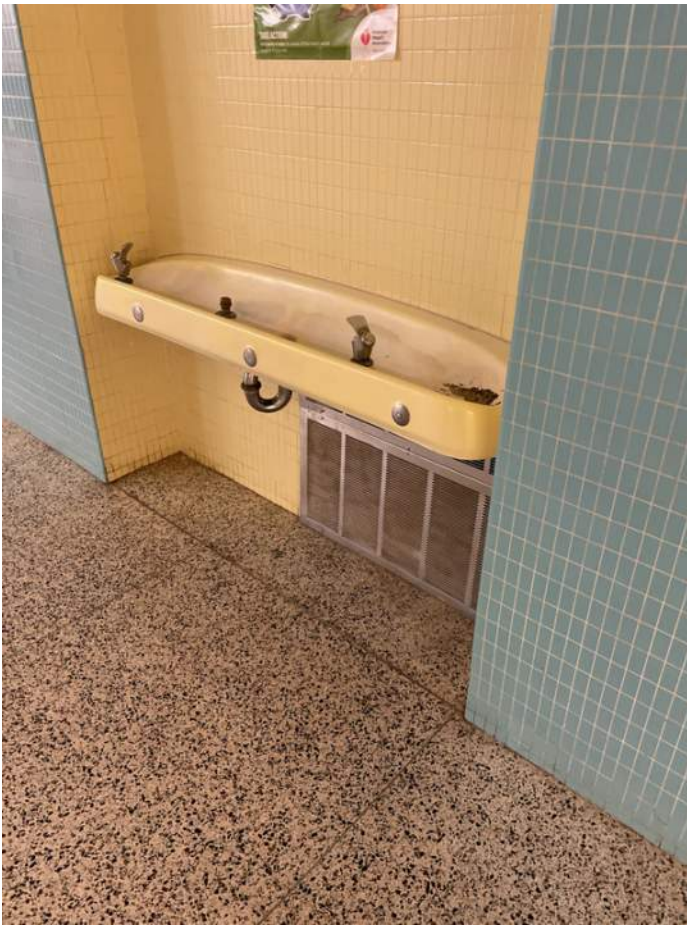
Drinking fountains not accessible

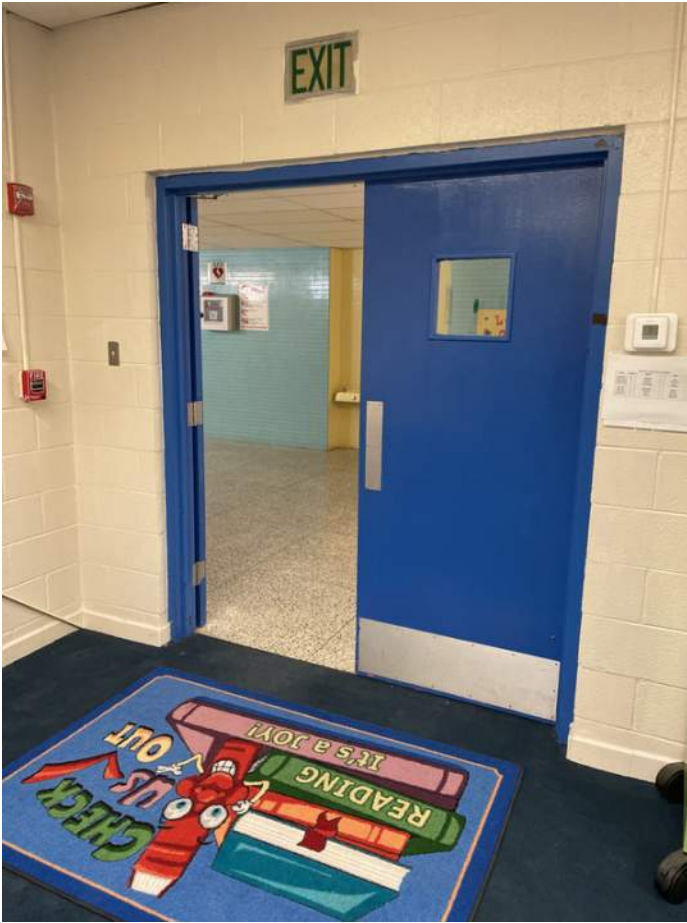
Fire code issue. Library main pair of doors require exit devices.

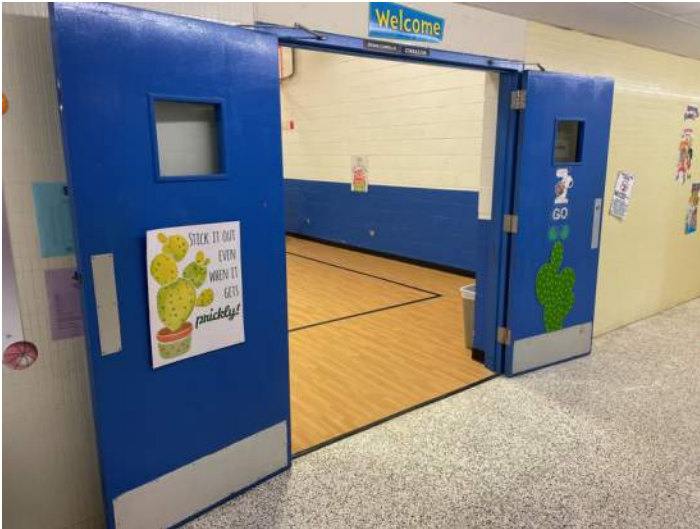
Building Codes - 3. Fire code issue. Current codes require gym to have two exits with exit devices. Gym has one exit without exit devices.

Fire code issue. Current codes require gym to have two exits with exit devices. Gym has one exit without exit devices.

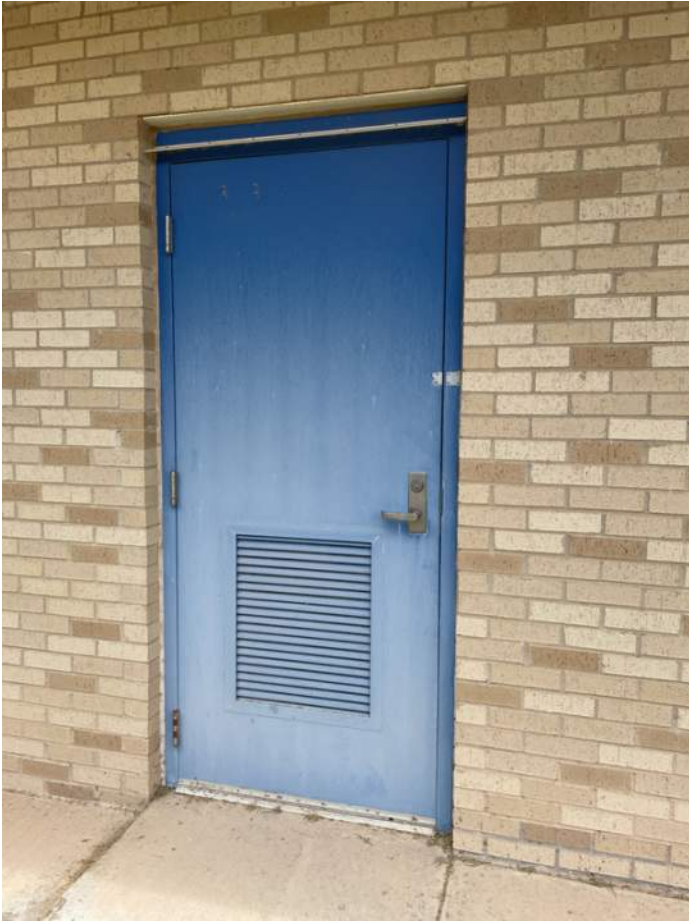
Exterior Doors - 1. Hollow Metal

Type Description-Exterior Doors	Hollow Metal
Condition Rating-Exterior Doors	Fair - exhibiting deficiencies requiring minor service/repair to extend useful life
Deficiency Category-Exterior Doors	Damaged/Failing

Quantity-Exterior Doors	30
Unit-Exterior Doors	%
Year Installed-Exterior Doors	2010
Comments-Exterior Doors	Repainting needed. Replace rusting hinges.

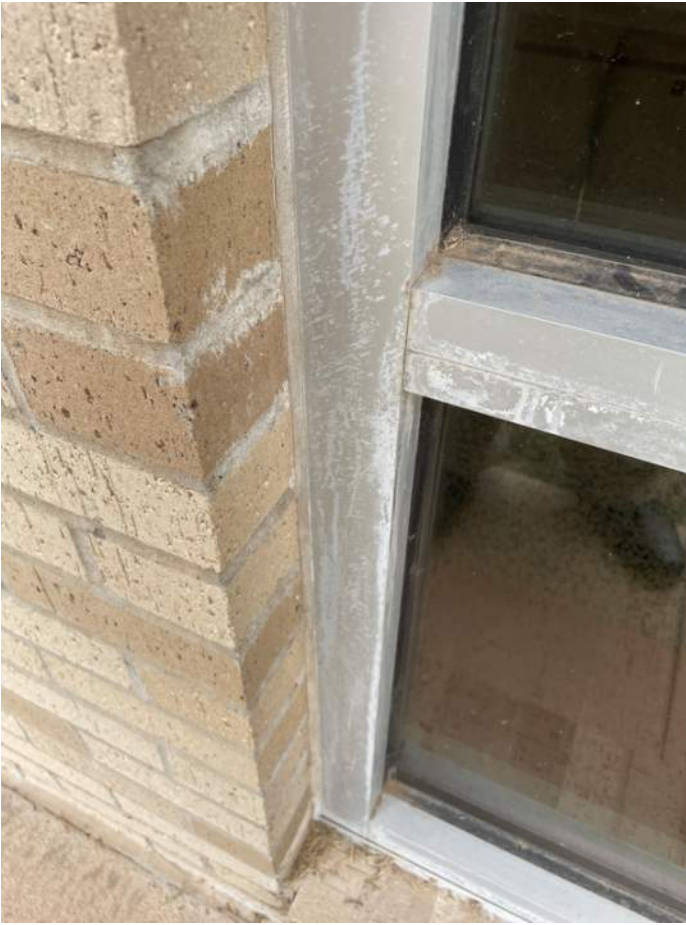
Windows - 1. Aluminum

Type Description-Windows	Aluminum
Condition Rating-Windows	Fair - exhibiting deficiencies requiring minor service/repair to extend useful life
Deficiency Category-Windows	No Immediate Action
Quantity-Windows	100
Unit-Windows	%
Year Installed-Windows	2010
Comments-Windows	Coronation issue, likely irrigation, needs to be identified and removed.

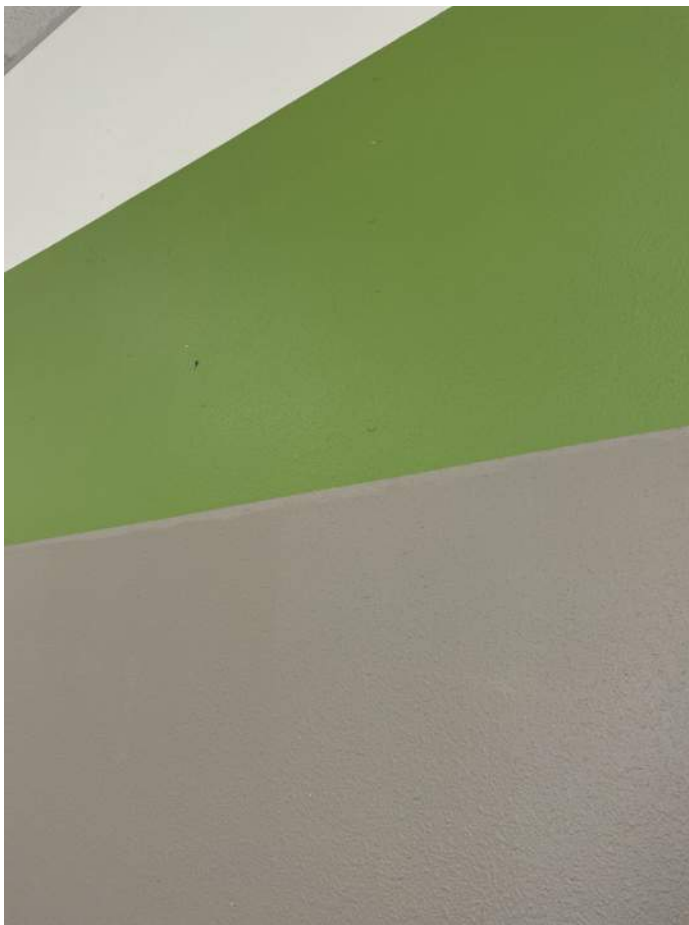
Wall Finishes - 1. Paint

Type Description-Wall Finishes	Paint
Condition Rating-Wall Finishes	Poor - nearing end of useful life, and requiring major service/repair to remain operational
Deficiency Category-Wall Finishes	Beyond Useful Life
Quantity-Wall Finishes	n/a
Unit-Wall Finishes	%
Year Installed-Wall Finishes	2010
Comments-Wall Finishes	n/a

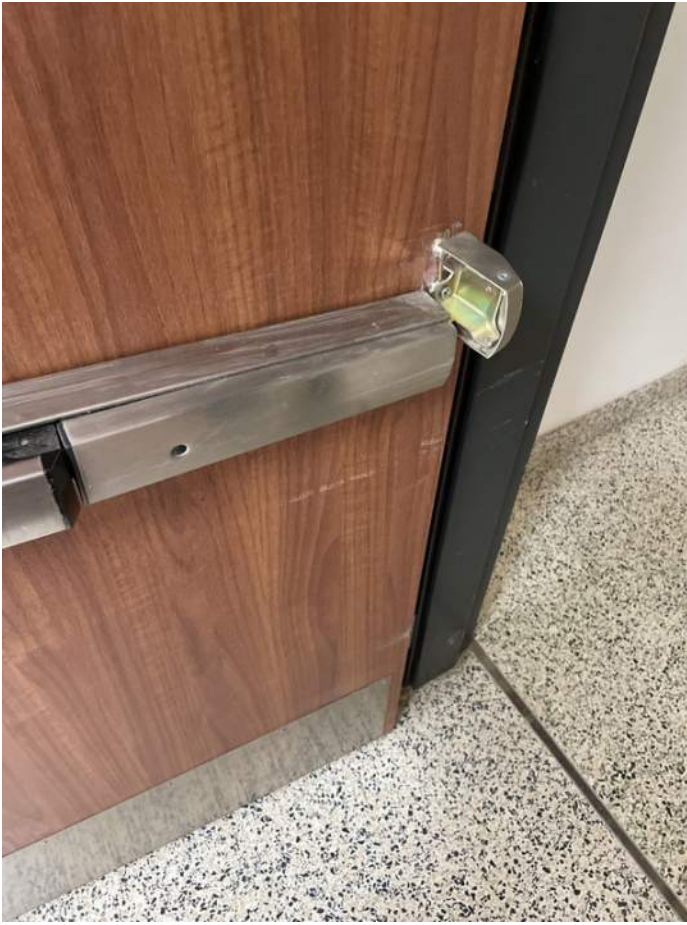
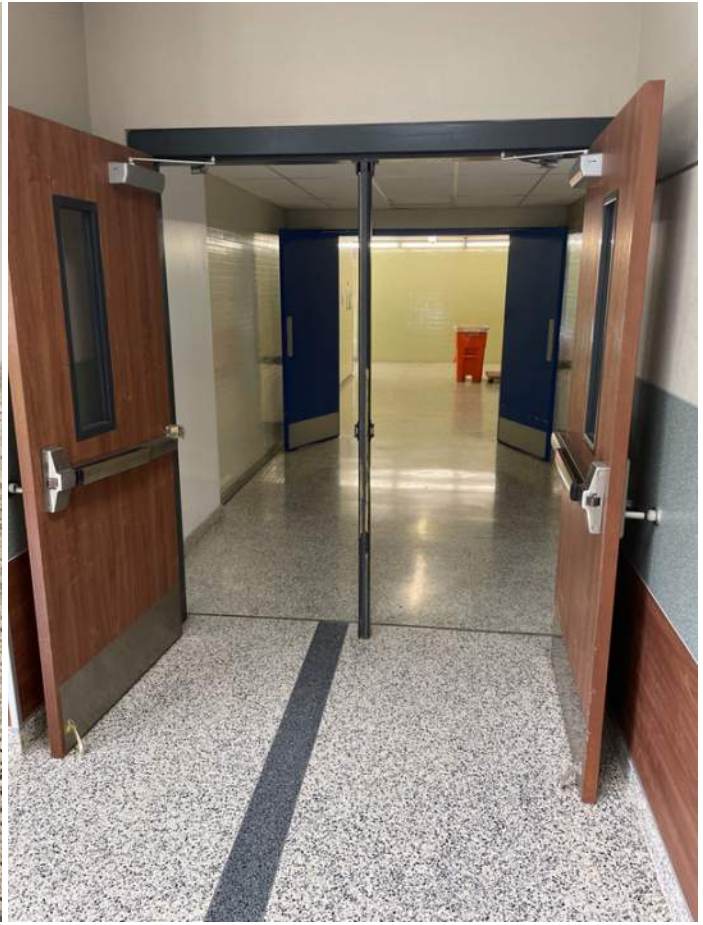
Interior Doors - 1. Fire wall doors

Type Description-Interior Doors	Fire wall doors
Condition Rating-Interior Doors	Critical - failed or failing, and beyond useful life requiring immediate attention
Deficiency Category-Interior Doors	Damaged/Failing
Quantity-Interior Doors	1
Unit-Interior Doors	EA
Year Installed-Interior Doors	2010
Comments-Interior Doors	Doors damaged due to narrow opening with mullion. Replace doors. Provide magnetic door holders

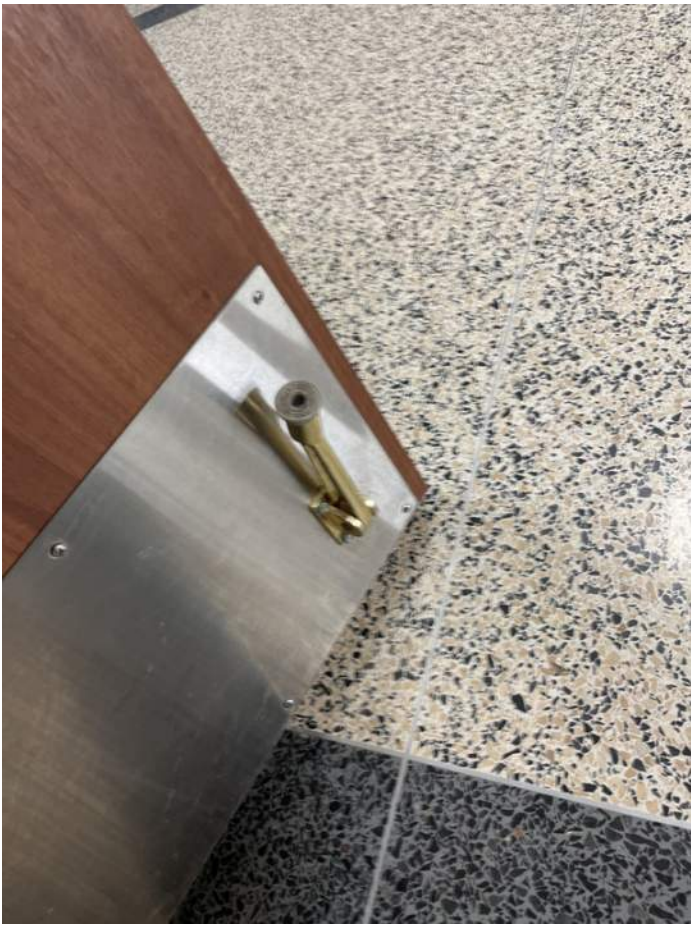
Fire code issue. Corridors are rated. Most rated doors have manual door holders. Addition is too new to be grandfathered.

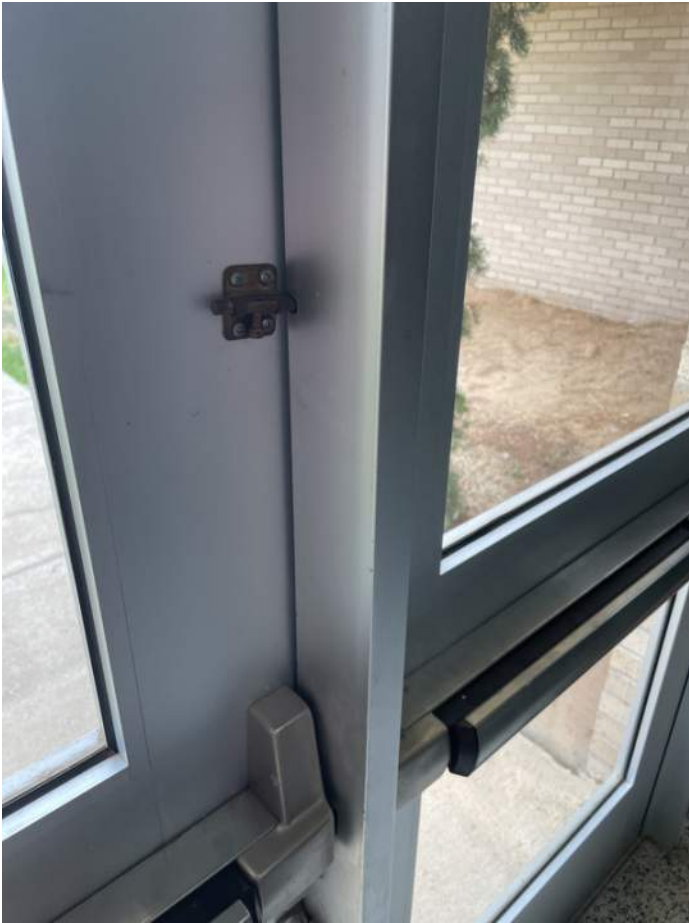
Building Codes - 2. Fire code issue. Secondary lock on egress door. Addition is too new to be grandfathered.

Description-Building Codes	Fire code issue. Secondary lock on egress door. Addition is too new to be grandfathered.
-----------------------------------	--

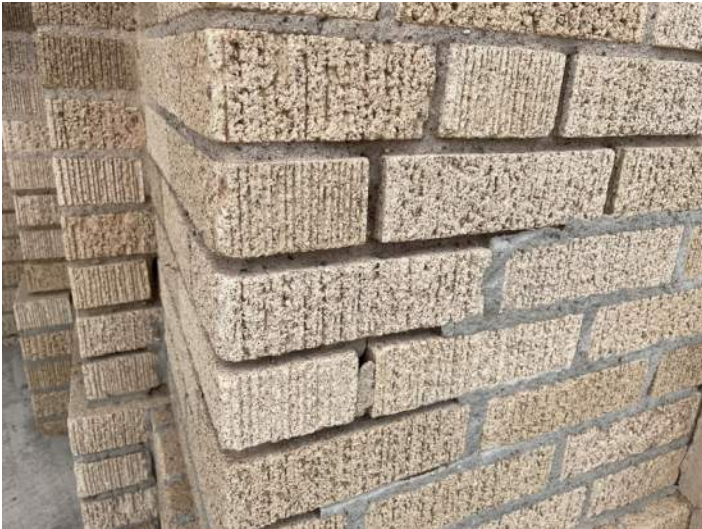
Type Description-Exterior Walls	Brick
Condition Rating-Exterior Walls	Fair - exhibiting deficiencies requiring minor service/repair to extend useful life
Deficiency Category-Exterior Walls	Damaged/Failing
Quantity-Exterior Walls	100
Unit-Exterior Walls	%
Year Installed-Exterior Walls	n/a
Comments-Exterior Walls	Pointing needed in several areas.

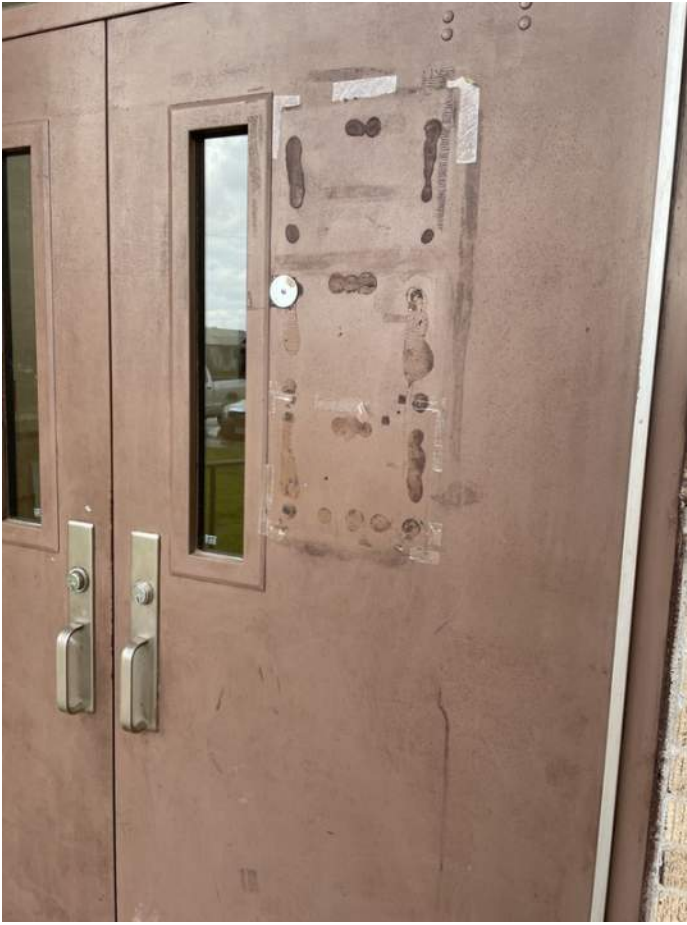
Exterior Doors - 1. Hollow Metal

Type Description-Exterior Doors	Hollow Metal
Condition Rating-Exterior Doors	Poor - nearing end of useful life, and requiring major service/repair to remain operational
Deficiency Category-Exterior Doors	Beyond Useful Life
Quantity-Exterior Doors	100
Unit-Exterior Doors	%
Year Installed-Exterior Doors	n/a
Comments-Exterior Doors	All doors in poor condition. Some doors do not open without excessive force.

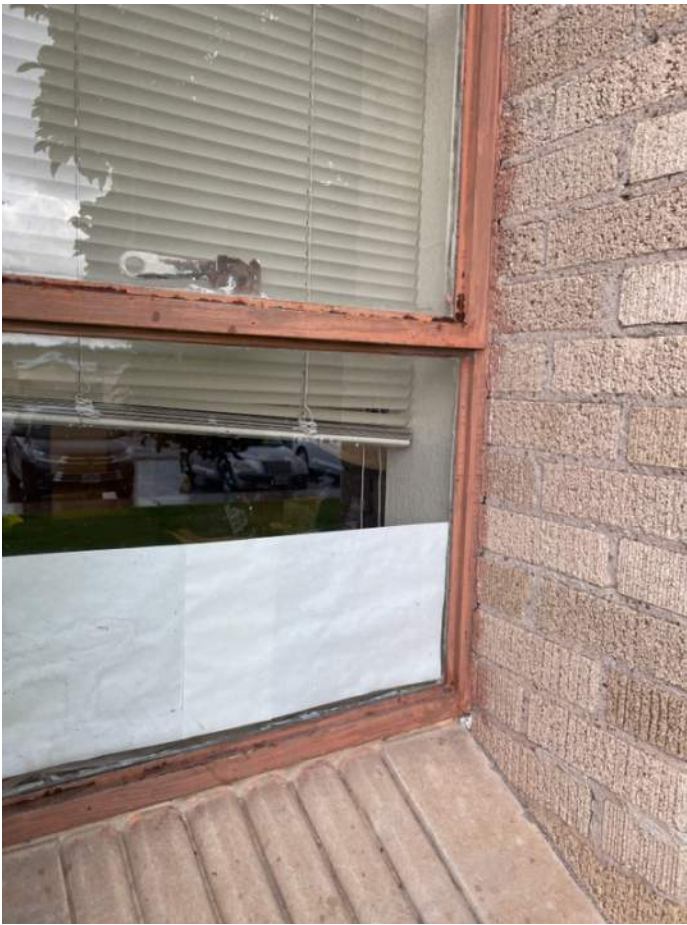
Windows - 1. Steel

Type Description-Windows	Steel
Condition Rating-Windows	Poor - nearing end of useful life, and requiring major service/repair to remain operational
Deficiency Category-Windows	Beyond Useful Life
Quantity-Windows	90
Unit-Windows	%
Year Installed-Windows	1938
Comments-Windows	n/a

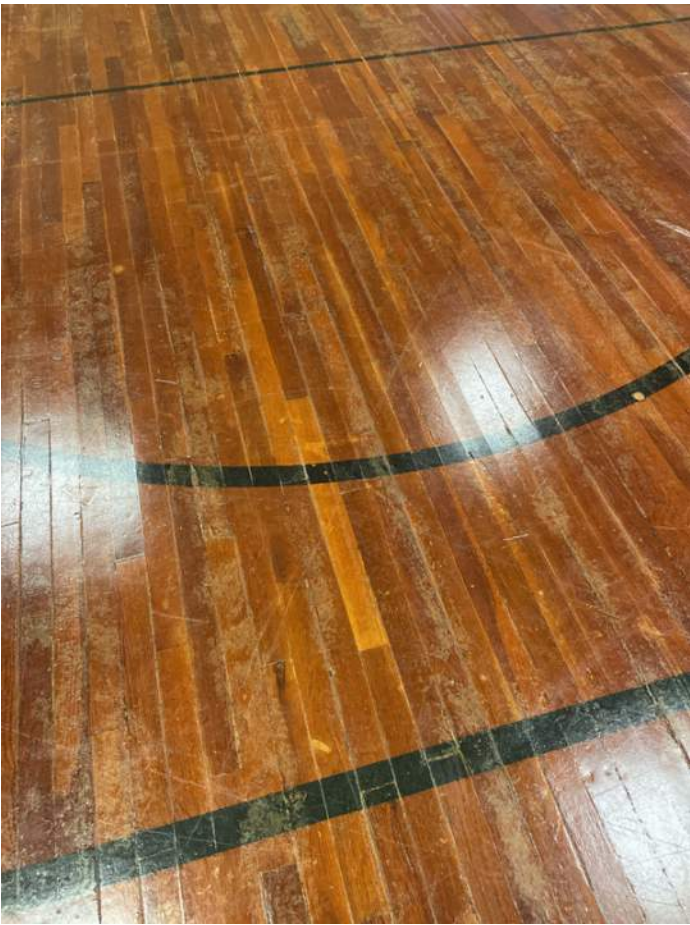
**Flooring Finishes - 5. Wood**

Type Description-Flooring Finishes	Wood
Condition Rating-Flooring Finishes	Poor - nearing end of useful life, and requiring major service/repair to remain operational
Deficiency Category-Flooring Finishes	Beyond Useful Life
Quantity-Flooring Finishes	10
Unit-Flooring Finishes	%
Year Installed-Flooring Finishes	1938
Comments-Flooring Finishes	n/a

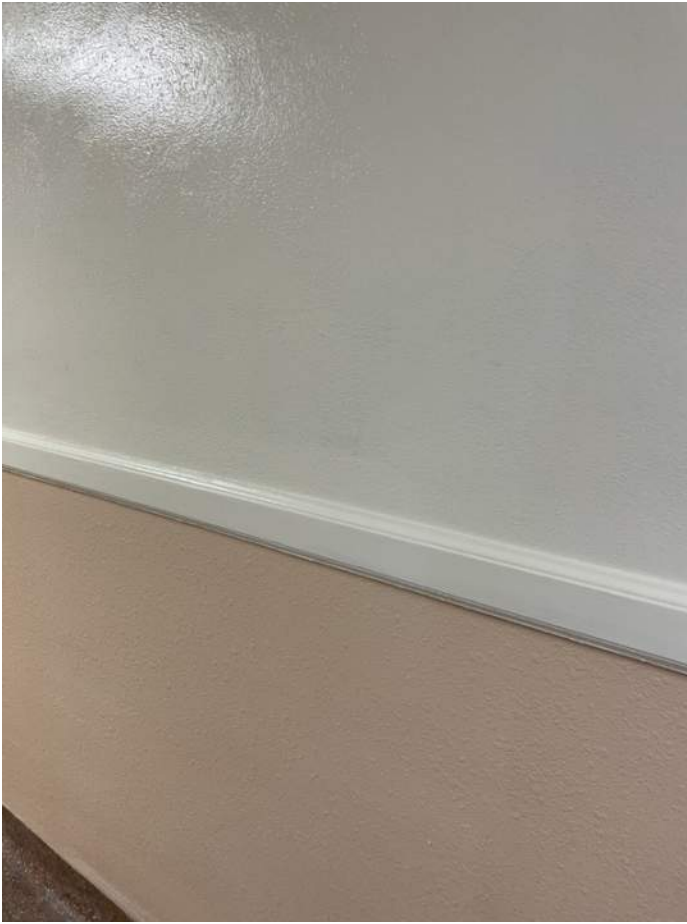
Wall Finishes - 1. Paint

Type Description-Wall Finishes	Paint
Condition Rating-Wall Finishes	Poor - nearing end of useful life, and requiring major service/repair to remain operational
Deficiency Category-Wall Finishes	Beyond Useful Life
Quantity-Wall Finishes	n/a
Unit-Wall Finishes	n/a

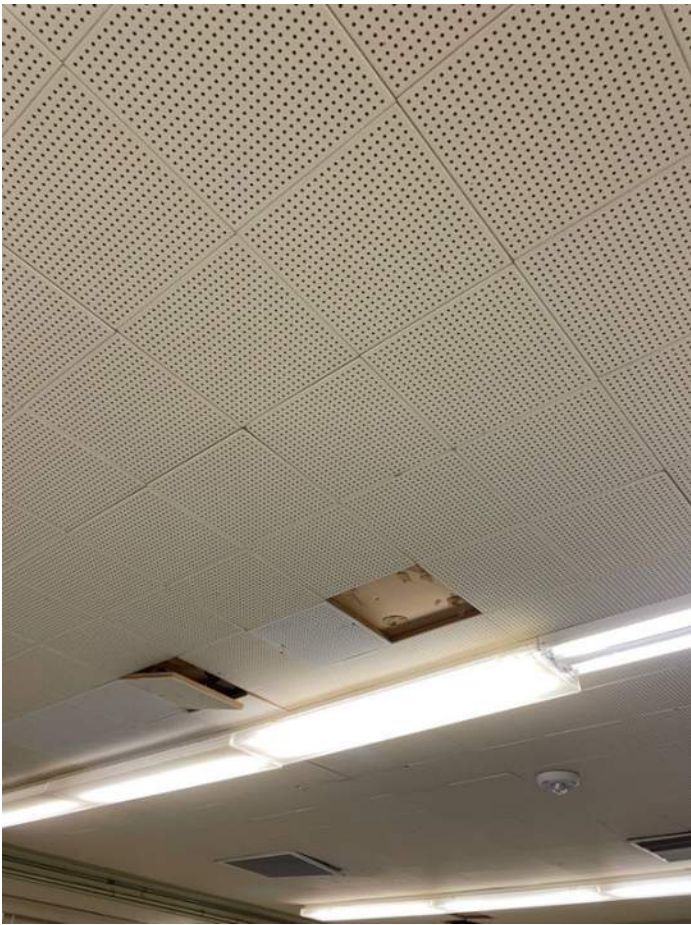
**Ceiling Finishes - 2. 1x1 Acoustical Tile**

Type Description-Ceiling Finishes	1x1 Acoustical Tile
Condition Rating-Ceiling Finishes	Critical - failed or failing, and beyond useful life requiring immediate attention
Deficiency Category-Ceiling Finishes	Damaged/Failing
Quantity-Ceiling Finishes	20
Unit-Ceiling Finishes	%
Year Installed-Ceiling Finishes	1950
Comments-Ceiling Finishes	n/a

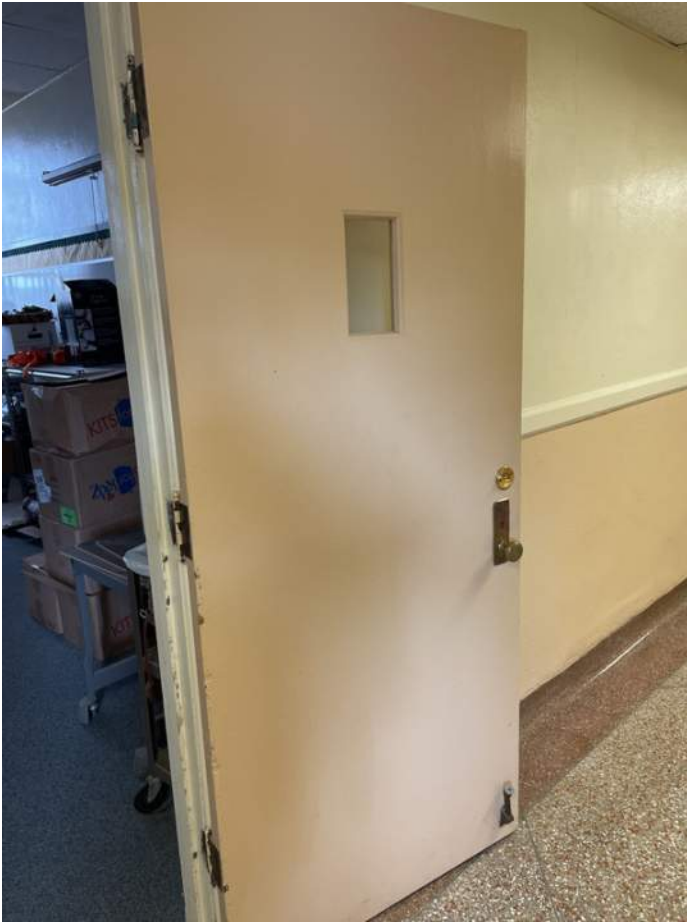
Interior Doors - 1. Wood

Type Description-Interior Doors	Wood
Condition Rating-Interior Doors	Poor - nearing end of useful life, and requiring major service/repair to remain operational
Deficiency Category-Interior Doors	Beyond Useful Life
Quantity-Interior Doors	100
Unit-Interior Doors	%
Year Installed-Interior Doors	1938
Comments-Interior Doors	n/a

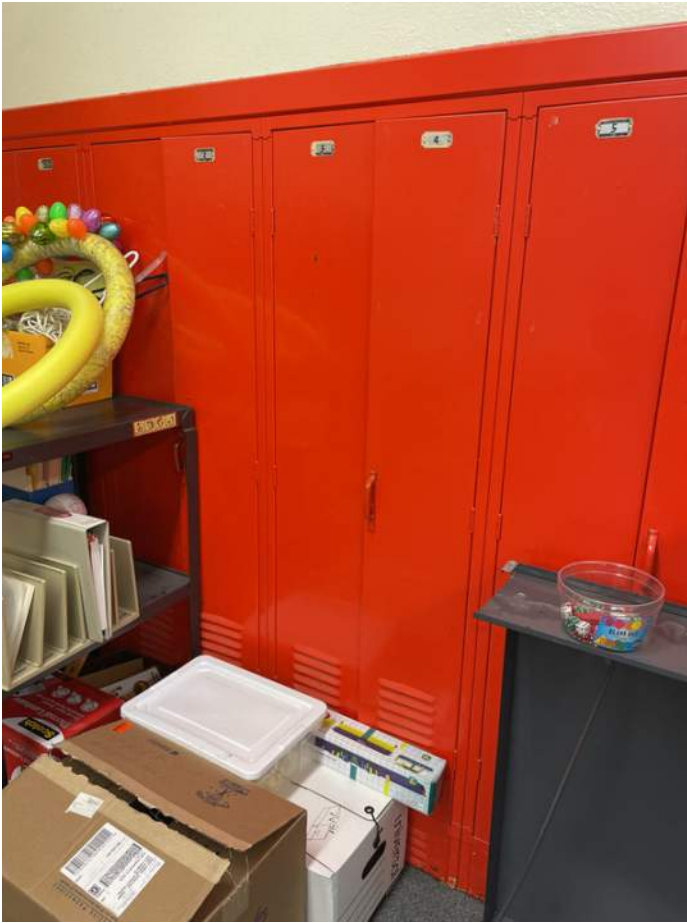
Type Description-Fixed Furnishings	Lockers
Condition Rating-Fixed Furnishings	Good - minimal depreciation, consistent with asset age
Deficiency Category-Fixed Furnishings	No Immediate Action
Quantity-Fixed Furnishings	n/a
Unit-Fixed Furnishings	n/a
Year Installed-Fixed Furnishings	n/a
Comments-Fixed Furnishings	n/a

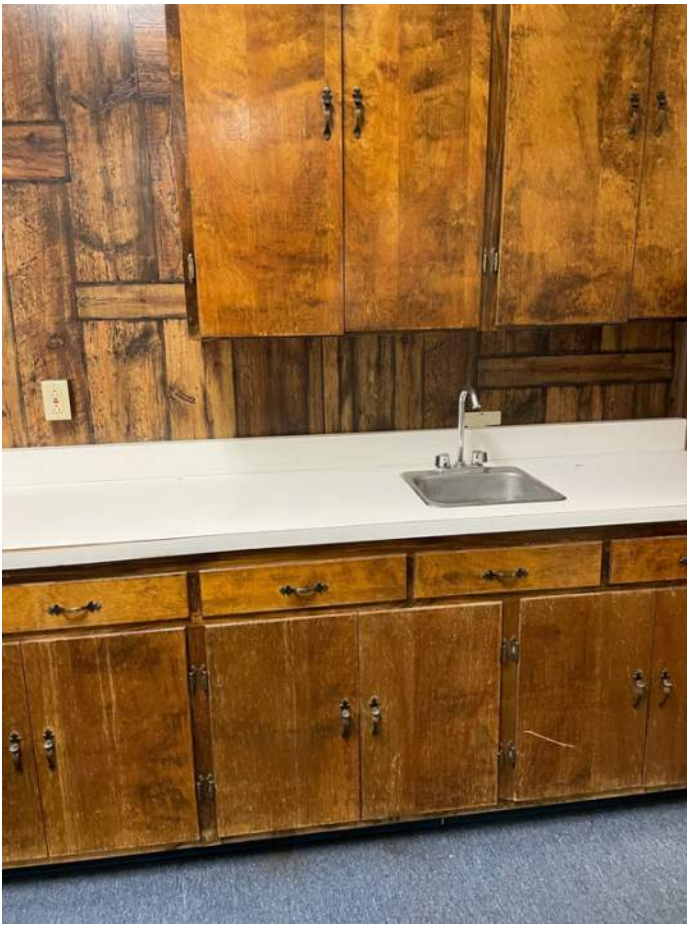
Fixed Furnishings - 2. Millwork

Type Description-Fixed Furnishings	Millwork
Condition Rating-Fixed Furnishings	Poor - nearing end of useful life, and requiring major service/repair to remain operational
Deficiency Category-Fixed Furnishings	Beyond Useful Life
Quantity-Fixed Furnishings	n/a
Unit-Fixed Furnishings	n/a
Year Installed-Fixed Furnishings	n/a
Comments-Fixed Furnishings	n/a

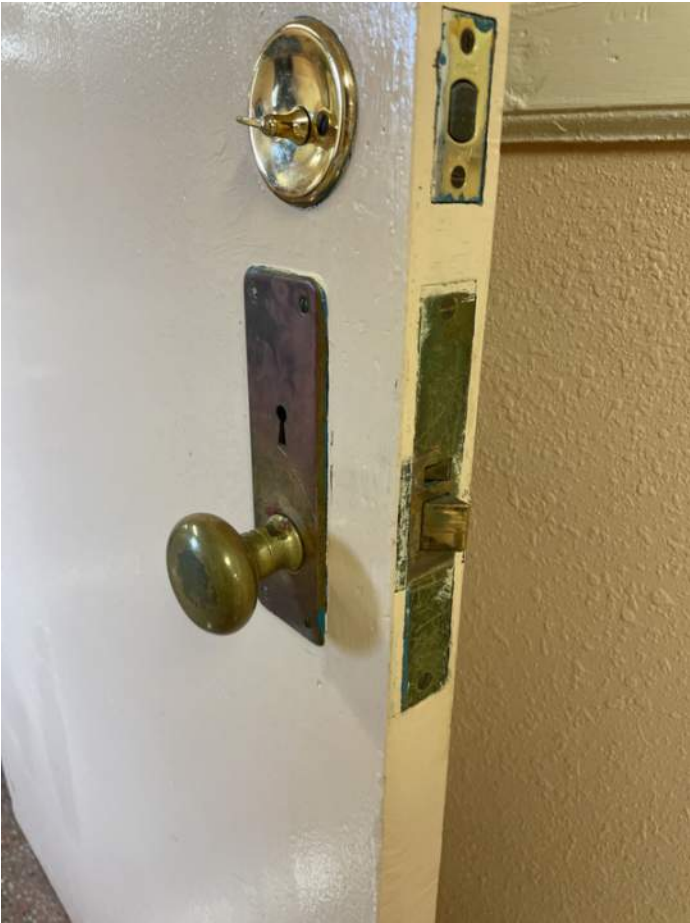
Most doors are not accessible

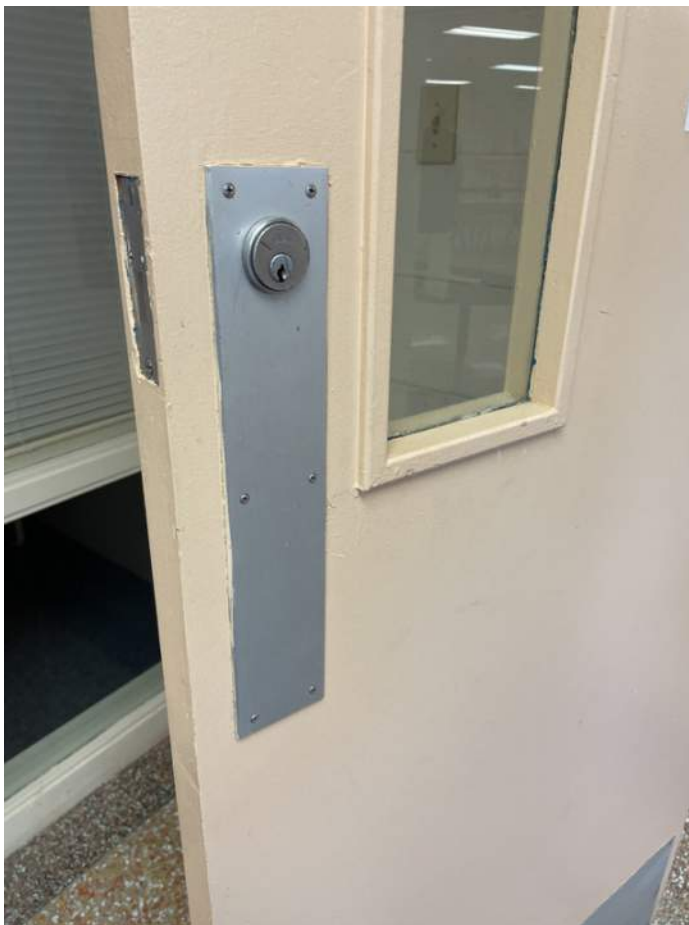
Building Codes - 1. Cafeteria main doors

Description-Building Codes	Cafeteria main doors
----------------------------	----------------------

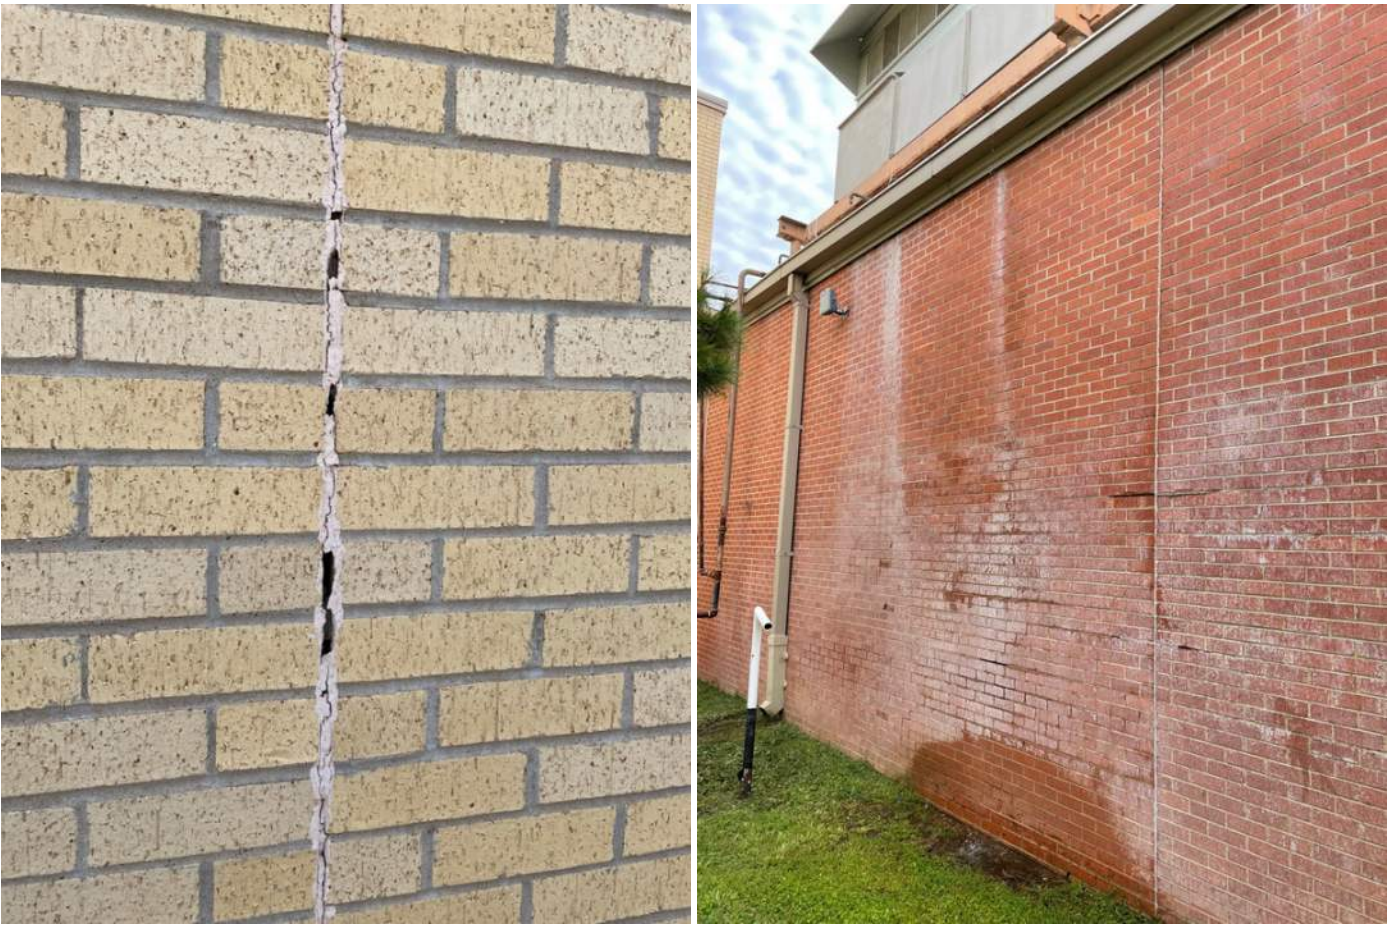
Type Description-Exterior Walls	Brick
Condition Rating-Exterior Walls	Good - minimal depreciation, consistent with asset age
Deficiency Category-Exterior Walls	Damaged/Failing
Quantity-Exterior Walls	100
Unit-Exterior Walls	%
Year Installed-Exterior Walls	1962
Comments-Exterior Walls	Minor pointing needed in isolated areas. Expansion joints need to be replaced. Brick and most grout in good condition. Damage from clogged gutter needs to be repaired.

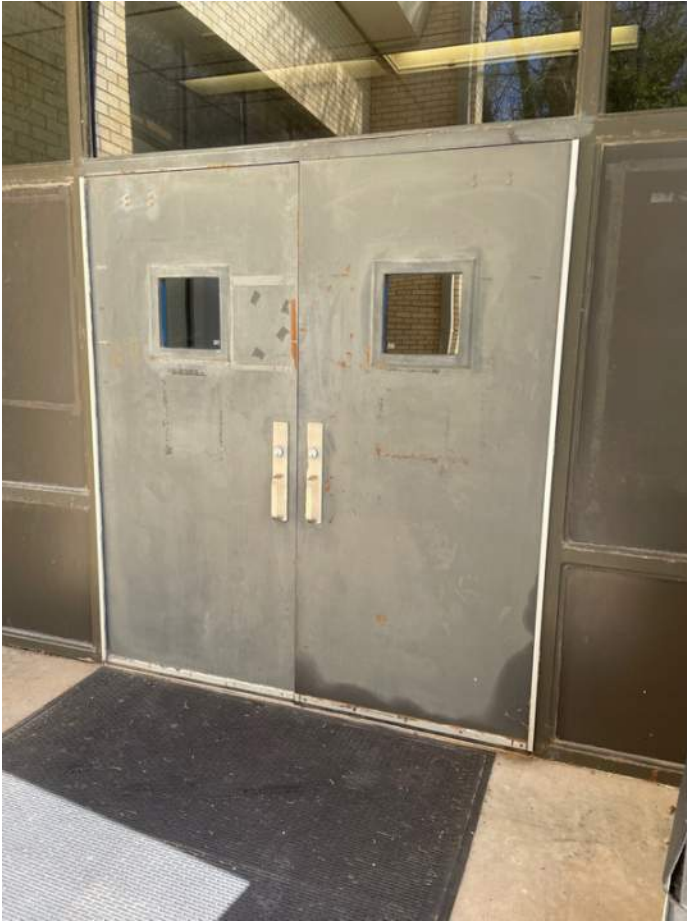
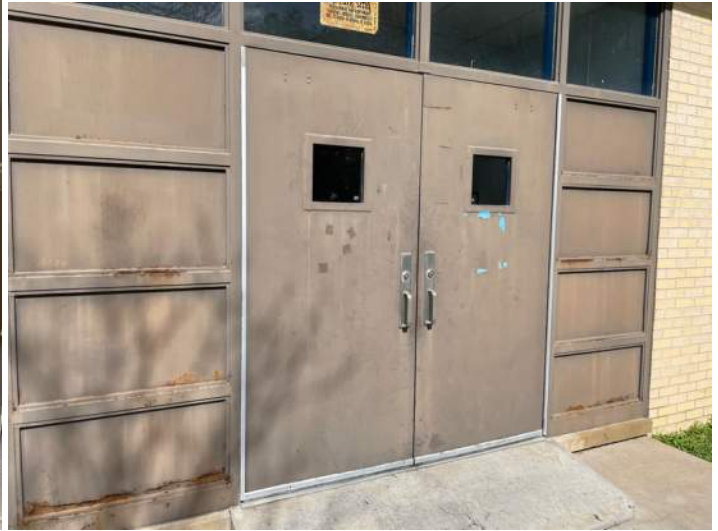
Exterior Doors - 1. Hollow metal doors

Type Description-Exterior Doors	Hollow metal doors
Condition Rating-Exterior Doors	Poor - nearing end of useful life, and requiring major service/repair to remain operational
Deficiency Category-Exterior Doors	Beyond Useful Life

Quantity-Exterior Doors	100
Unit-Exterior Doors	%
Year Installed-Exterior Doors	1977
Comments-Exterior Doors	Rusting.

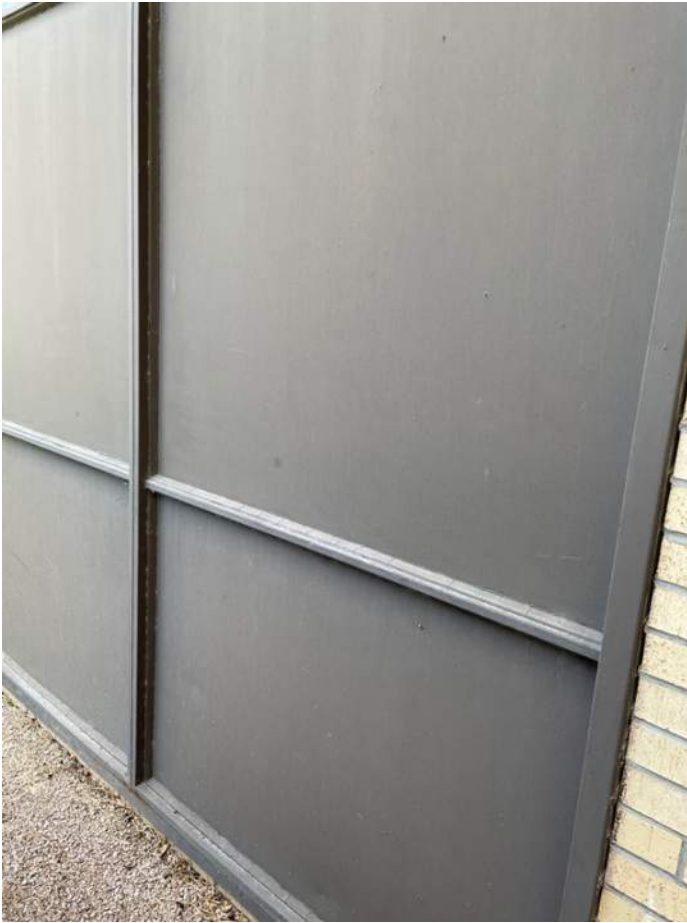
Type Description-Windows	Hollow Metal
Condition Rating-Windows	Poor - nearing end of useful life, and requiring major service/repair to remain operational
Deficiency Category-Windows	Beyond Useful Life
Quantity-Windows	95
Unit-Windows	%
Year Installed-Windows	1962
Comments-Windows	n/a

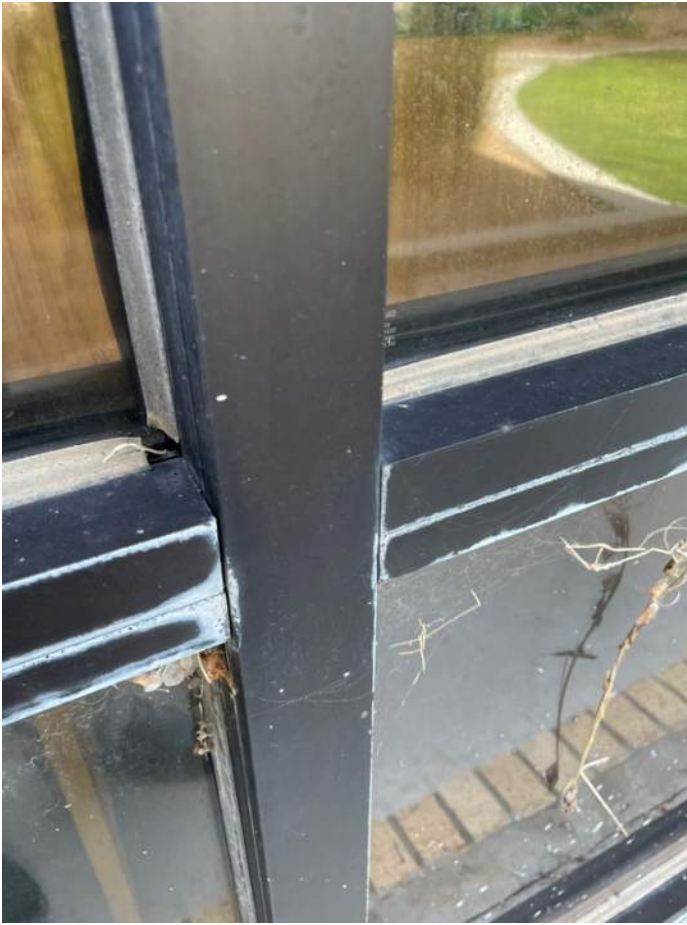
Windows - 2. Aluminum

Type Description-Windows	Aluminum
Condition Rating-Windows	Fair - exhibiting deficiencies requiring minor service/repair to extend useful life
Deficiency Category-Windows	Beyond Useful Life
Quantity-Windows	5
Unit-Windows	%
Year Installed-Windows	1962
Comments-Windows	Cleaning windows could extend life.

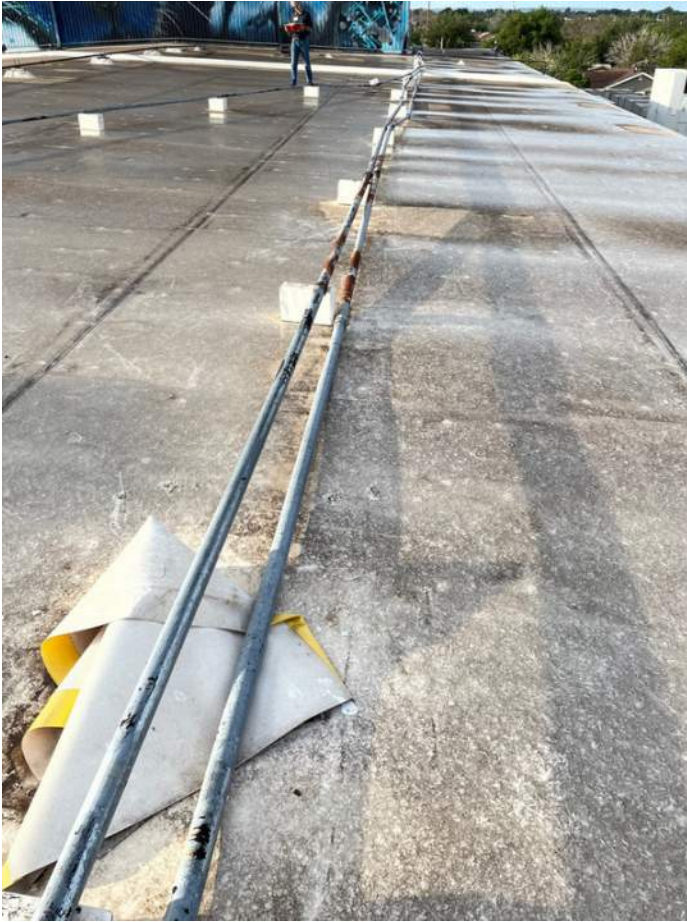
Roofing - 1. TPO

Type Description-Roofing	TPO
Condition Rating-Roofing	Good - minimal depreciation, consistent with asset age
Deficiency Category-Roofing	Inadequate
Quantity-Roofing	95
Unit-Roofing	%
Year Installed-Roofing	2017

Overall roof is good. Widespread issues with conduit falling off supports and on contact with roof. This is due to the condition of the conduit.

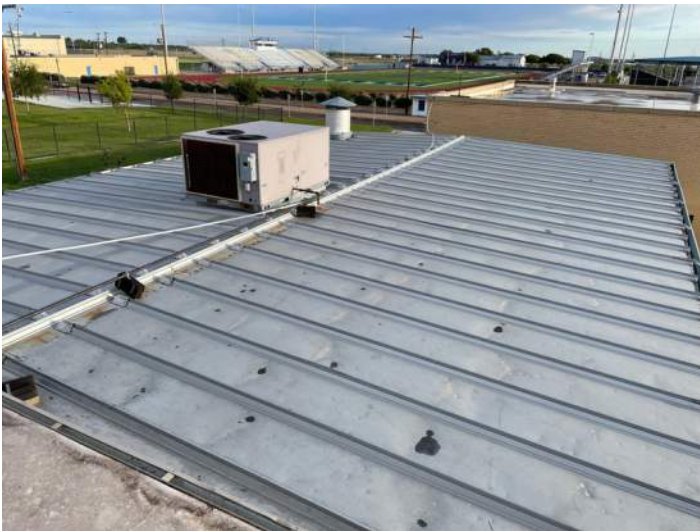
**Roofing - 2. Metal roof.**

Type Description-Roofing	Metal roof.
Condition Rating-Roofing	Good - minimal depreciation, consistent with asset age
Deficiency Category-Roofing	No Immediate Action
Quantity-Roofing	5
Unit-Roofing	%
Year Installed-Roofing	2000
Comments-Roofing	n/a
