Fort Stockton ISD - Condition Assessment

Alamo Elementary

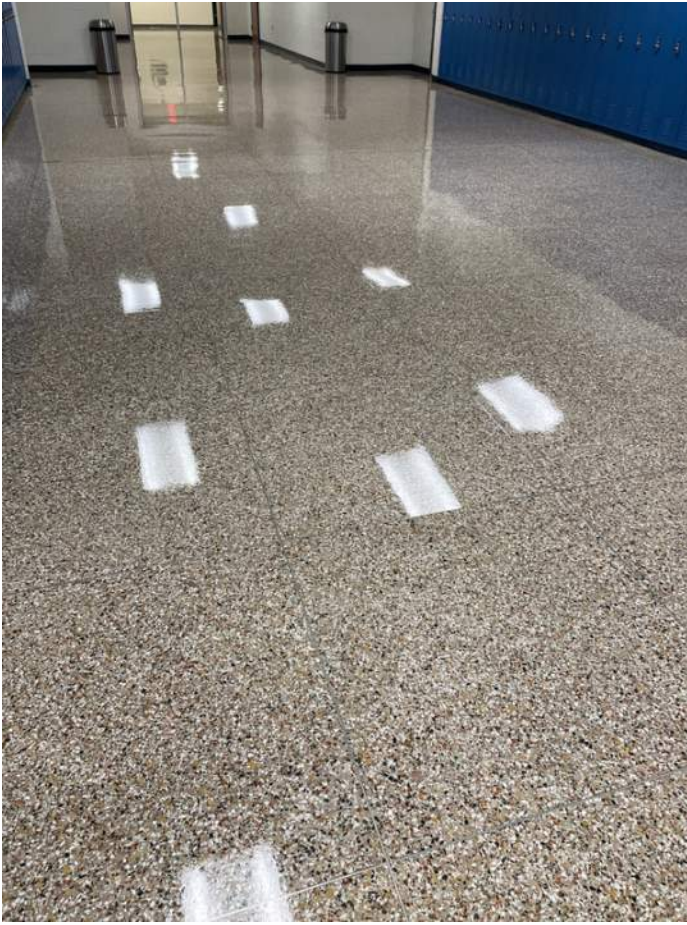
Flooring Finishes - 1. Terrazzo

Type Description-Flooring Finishes	Terrazzo
Condition Rating-Flooring Finishes	Good - minimal depreciation, consistent with asset age
Deficiency Category-Flooring Finishes	No Immediate Action
Quantity-Flooring Finishes	30
Unit-Flooring Finishes	%
Year Installed-Flooring Finishes	1977
Comments-Flooring Finishes	Well maintained. In corridors and some classrooms.

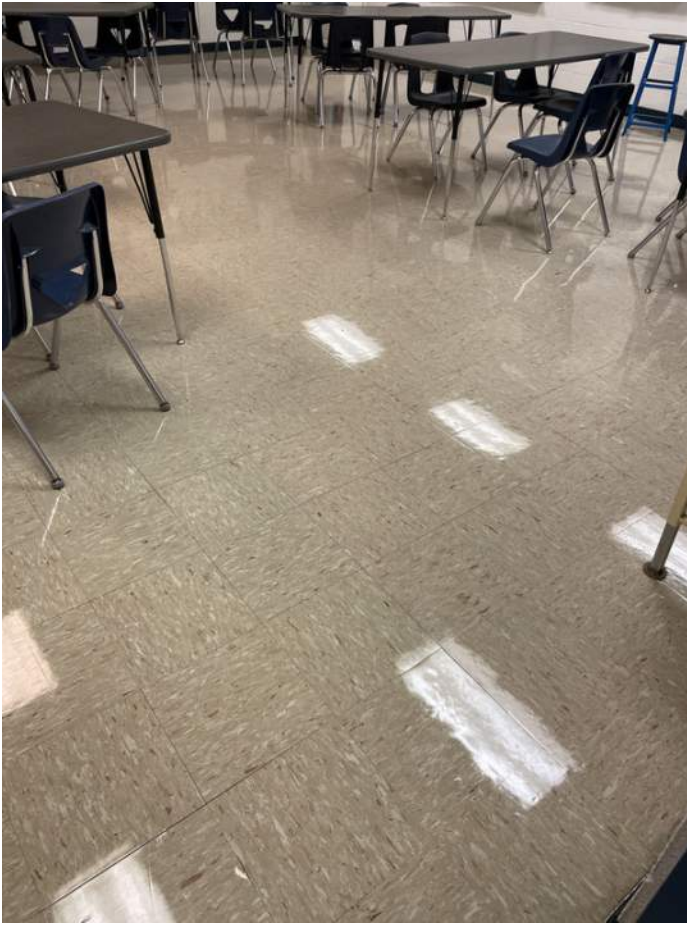
Flooring Finishes - 2. VCT

Type Description-Flooring Finishes	VCT
Condition Rating-Flooring Finishes	Good - minimal depreciation, consistent with asset age
Deficiency Category-Flooring Finishes	No Immediate Action
Quantity-Flooring Finishes	30
Unit-Flooring Finishes	%
Year Installed-Flooring Finishes	1977
Comments-Flooring Finishes	Well maintained. In mot classrooms.

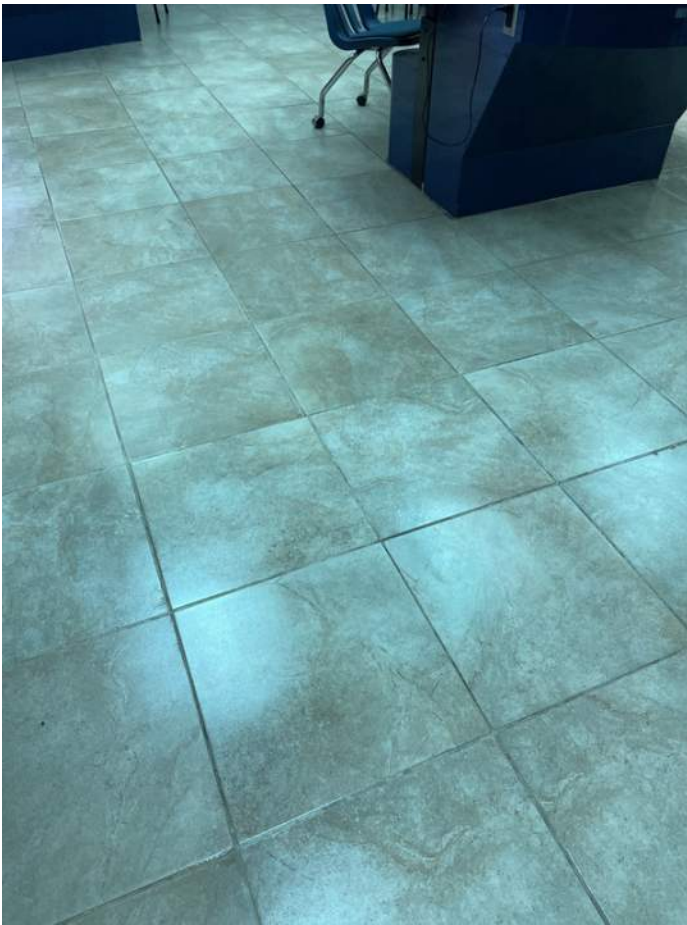
Flooring Finishes - 3. Ceramic tile

Type Description-Flooring Finishes	Ceramic tile
Condition Rating-Flooring Finishes	Good - minimal depreciation, consistent with asset age
Deficiency Category-Flooring Finishes	No Immediate Action
Quantity-Flooring Finishes	5
Unit-Flooring Finishes	%
Year Installed-Flooring Finishes	2010
Comments-Flooring Finishes	In science labs.

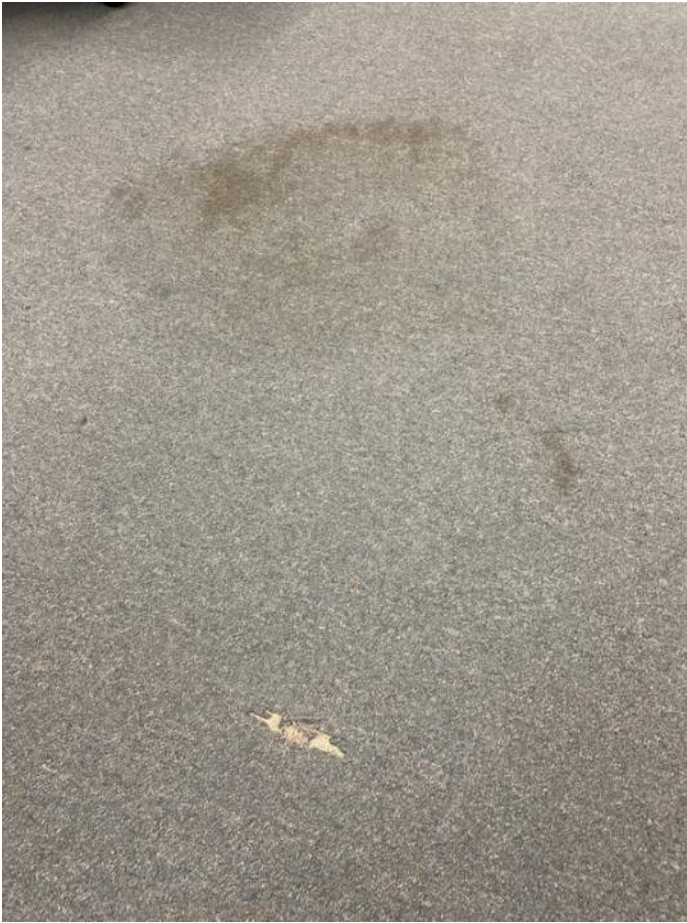
Flooring Finishes - 4. Carpet

Type Description-Flooring Finishes	Carpet
Condition Rating-Flooring Finishes	Poor - nearing end of useful life, and requiring major service/repair to remain operational
Deficiency Category-Flooring Finishes	Beyond Useful Life
Quantity-Flooring Finishes	10
Unit-Flooring Finishes	%
Year Installed-Flooring Finishes	2000
Comments-Flooring Finishes	Torn and stained. Located in several locker rooms.

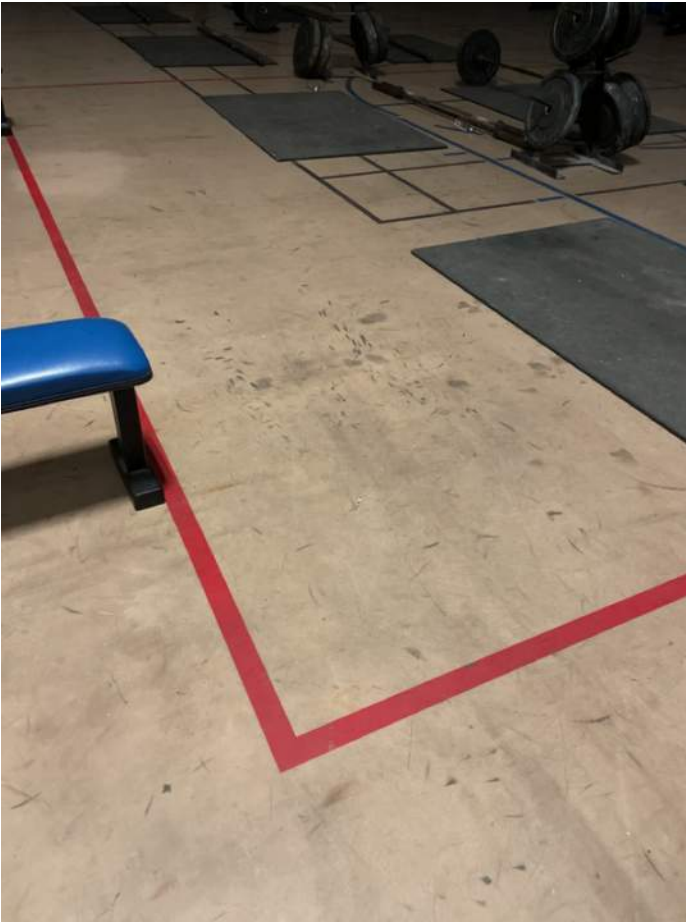
Flooring Finishes - 5. Rubber

Type Description-Flooring Finishes	Rubber
Condition Rating-Flooring Finishes	Fair - exhibiting deficiencies requiring minor service/repair to extend useful life
Deficiency Category-Flooring Finishes	No Immediate Action
Quantity-Flooring Finishes	5
Unit-Flooring Finishes	%
Year Installed-Flooring Finishes	2000
Comments-Flooring Finishes	Located in White Gym used as a weight room. Widespread stains but no damage noted.

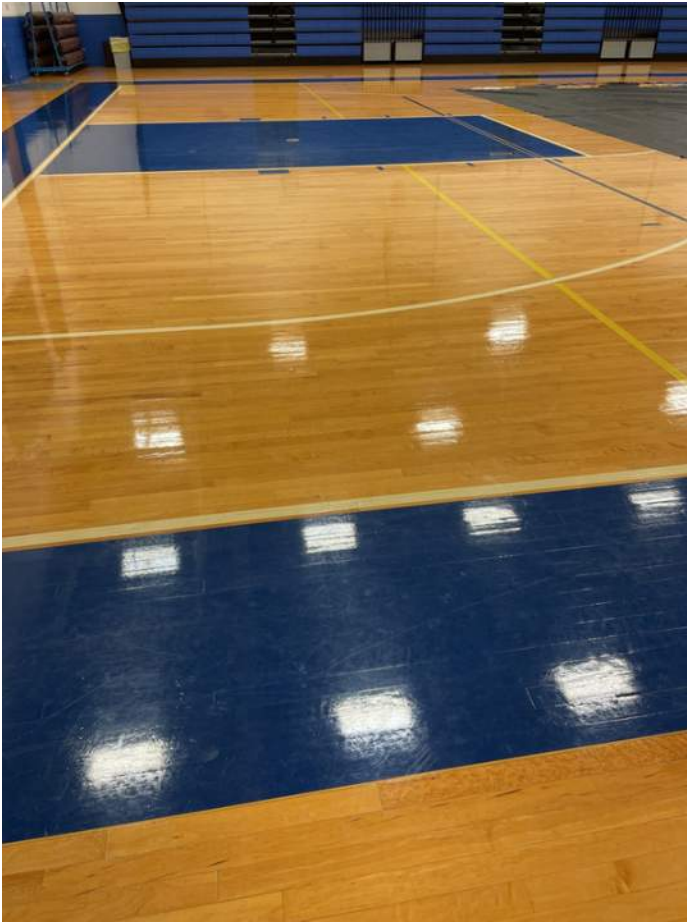
Flooring Finishes - 6. Wood

Type Description-Flooring Finishes	Wood
Condition Rating-Flooring Finishes	Good - minimal depreciation, consistent with asset age
Deficiency Category-Flooring Finishes	No Immediate Action
Quantity-Flooring Finishes	5
Unit-Flooring Finishes	%
Year Installed-Flooring Finishes	n/a
Comments-Flooring Finishes	Unknown age. Good condition.

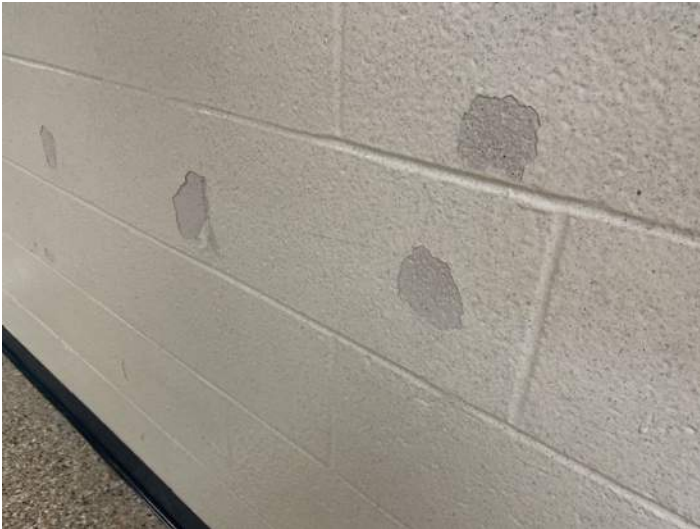
Wall Finishes - 1. Painted CMU

Type Description-Wall Finishes	Painted CMU
Condition Rating-Wall Finishes	Poor - nearing end of useful life, and requiring major service/repair to remain operational
Deficiency Category-Wall Finishes	Beyond Useful Life
Quantity-Wall Finishes	85
Unit-Wall Finishes	%
Year Installed-Wall Finishes	2010
Comments-Wall Finishes	Damage is several areas.

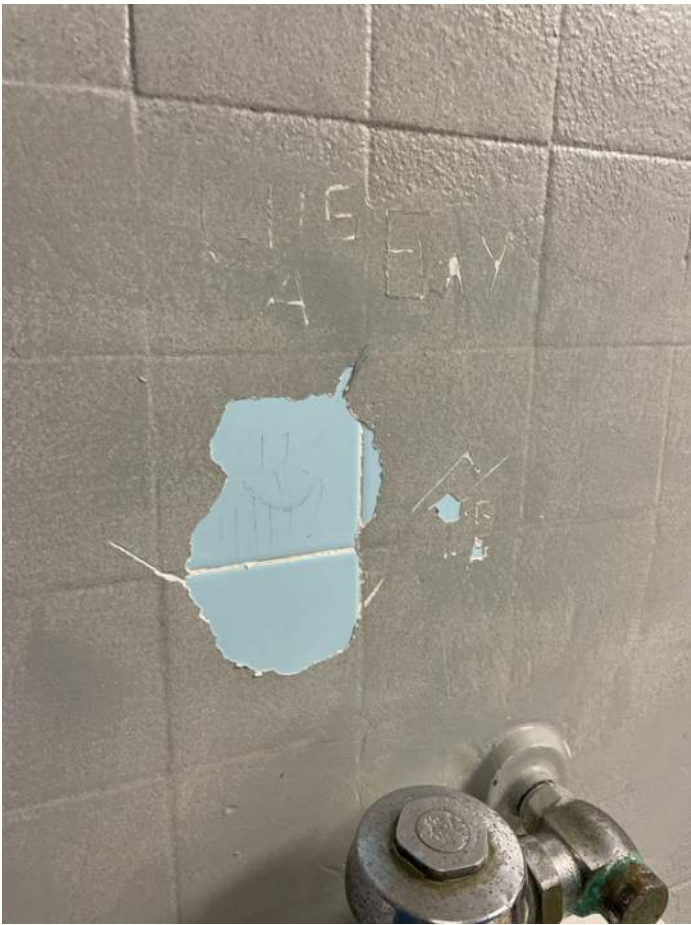
Wall Finishes - 2. Painted ceramic tile

Type Description-Wall Finishes	Painted ceramic tile
Condition Rating-Wall Finishes	Poor - nearing end of useful life, and requiring major service/repair to remain operational
Deficiency Category-Wall Finishes	Beyond Useful Life
Quantity-Wall Finishes	5
Unit-Wall Finishes	%
Year Installed-Wall Finishes	2010
Comments-Wall Finishes	Widespread damage. Located in restrooms.

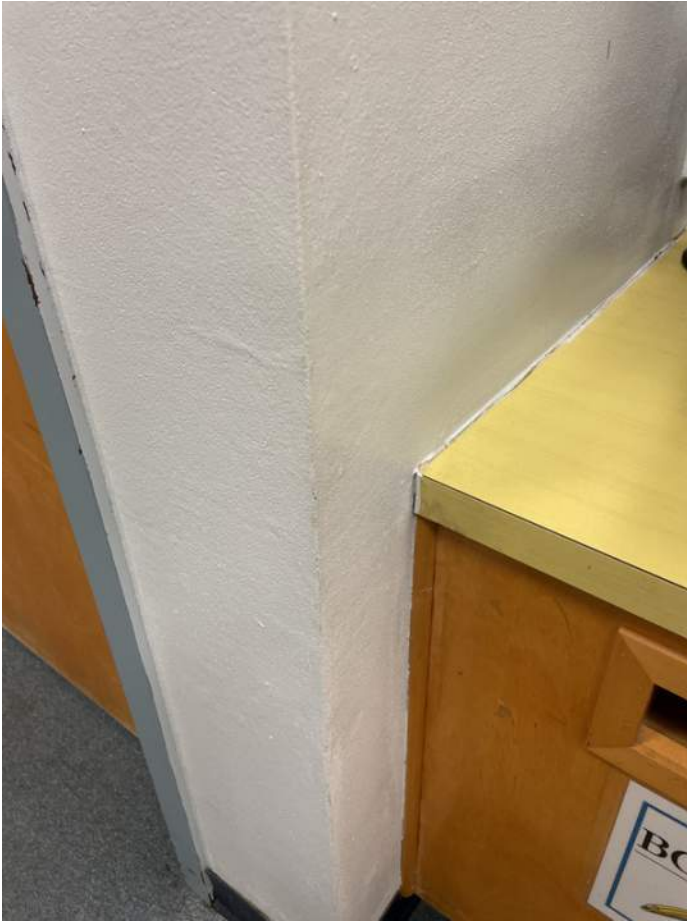
Wall Finishes - 3. Painted gypsum.

Type Description-Wall Finishes	Painted gypsum.
Condition Rating-Wall Finishes	Fair - exhibiting deficiencies requiring minor service/repair to extend useful life
Deficiency Category-Wall Finishes	Beyond Useful Life

Quantity-Wall Finishes	5
Unit-Wall Finishes	%
Year Installed-Wall Finishes	2010
Comments-Wall Finishes	Minor but widespread damage.

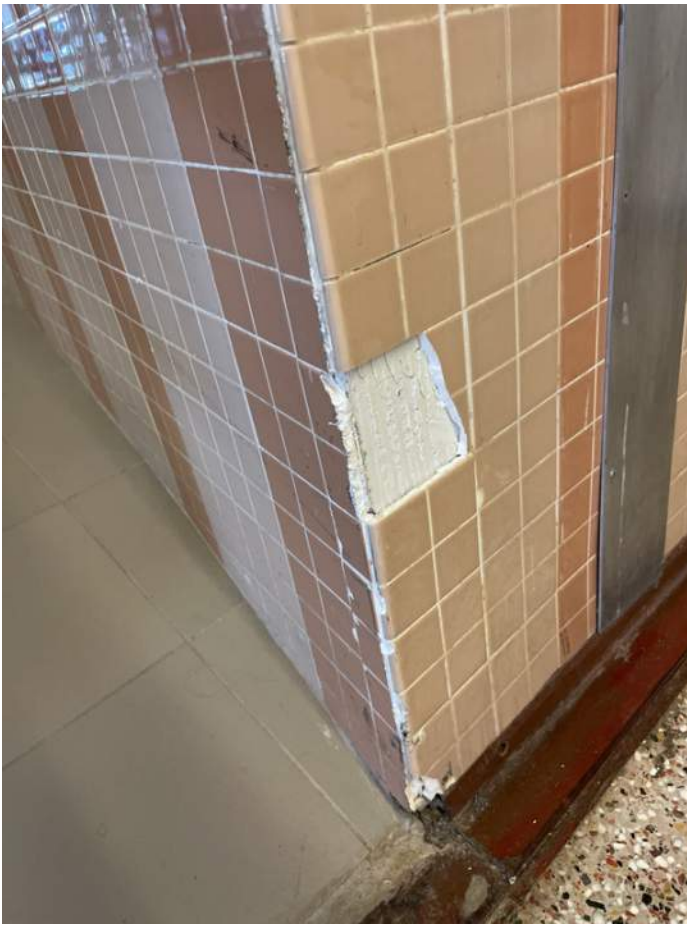
**Wall Finishes - 4. Ceramic Tile**

Type Description-Wall Finishes	Ceramic Tile
Condition Rating-Wall Finishes	Poor - nearing end of useful life, and requiring major service/repair to remain operational
Deficiency Category-Wall Finishes	Damaged/Failing
Quantity-Wall Finishes	5
Unit-Wall Finishes	%
Year Installed-Wall Finishes	1962
Comments-Wall Finishes	Most tiles in good condition. Isolated damage.

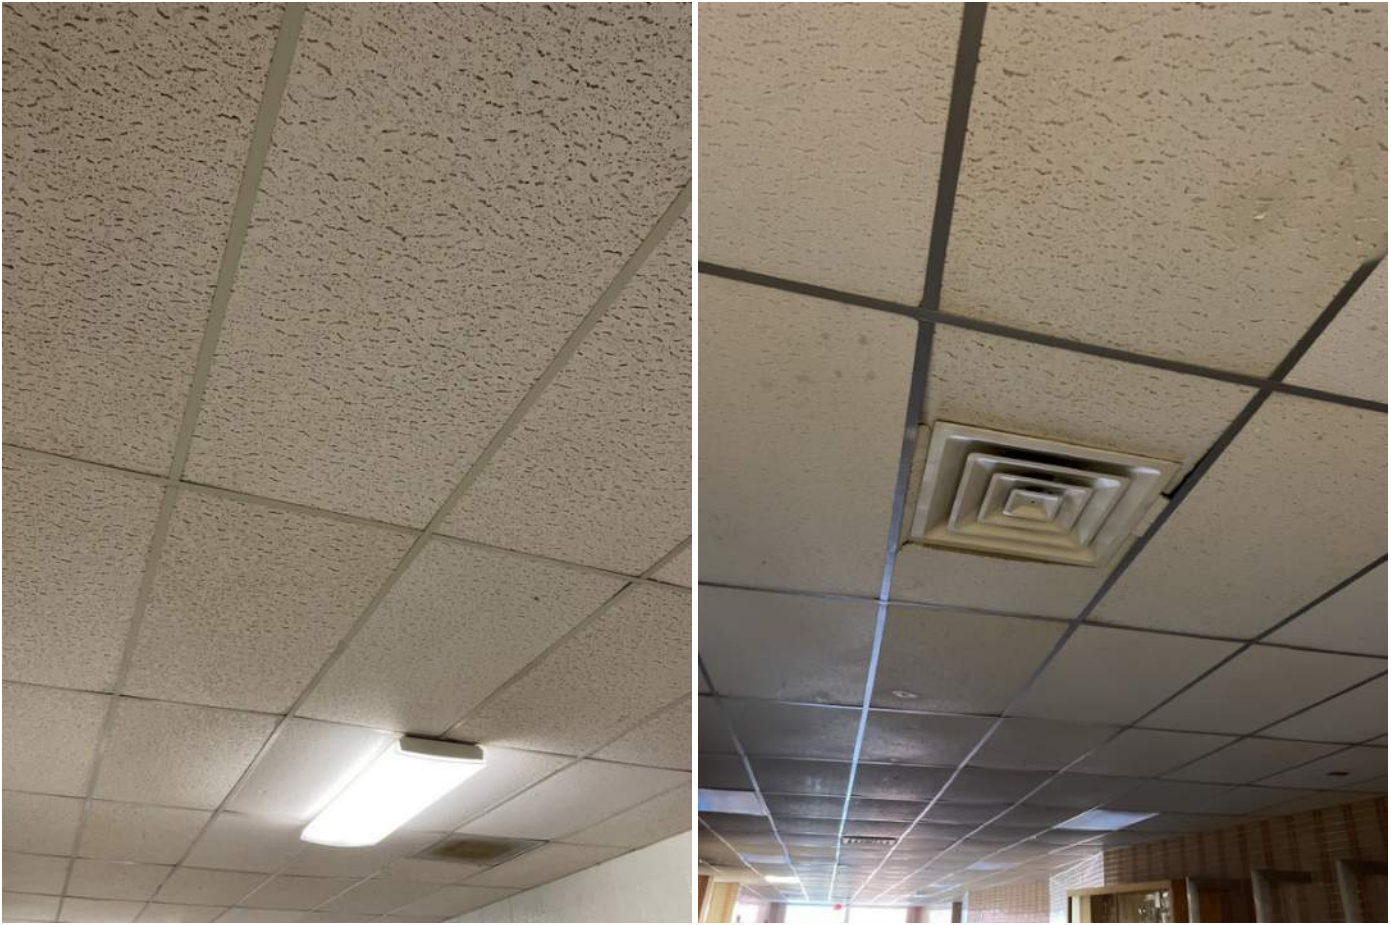
Ceiling Finishes - 1. 2x4 Acoustical Tile

Type Description-Ceiling Finishes	2x4 Acoustical Tile
Condition Rating-Ceiling Finishes	Poor - nearing end of useful life, and requiring major service/repair to remain operational
Deficiency Category-Ceiling Finishes	Beyond Useful Life
Quantity-Ceiling Finishes	90
Unit-Ceiling Finishes	%
Year Installed-Ceiling Finishes	1977
Comments-Ceiling Finishes	n/a

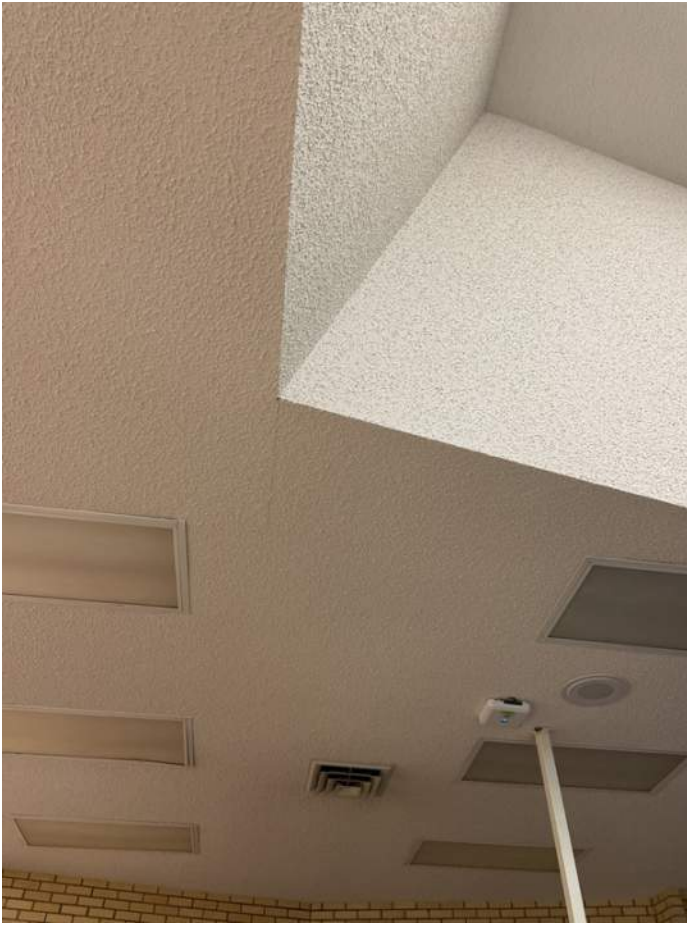
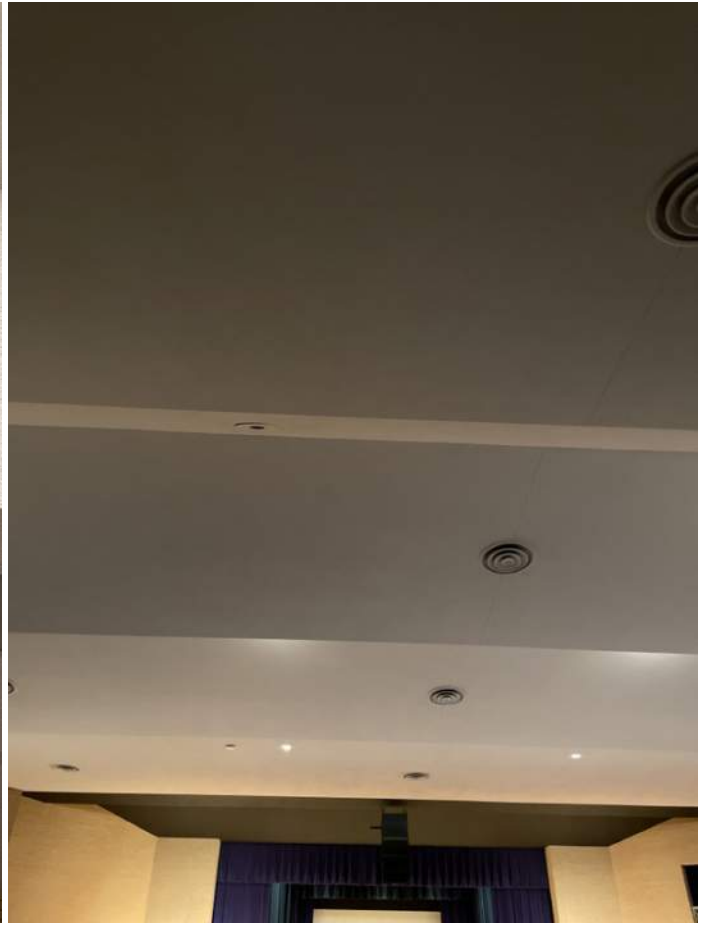
Ceiling Finishes - 2. Hard Ceilings

Type Description-Ceiling Finishes	Hard Ceilings
Condition Rating-Ceiling Finishes	Good - minimal depreciation, consistent with asset age
Deficiency Category-Ceiling Finishes	No Immediate Action
Quantity-Ceiling Finishes	5
Unit-Ceiling Finishes	%
Year Installed-Ceiling Finishes	1977
Comments-Ceiling Finishes	Well maintained but old. Minor cosmetic damage.

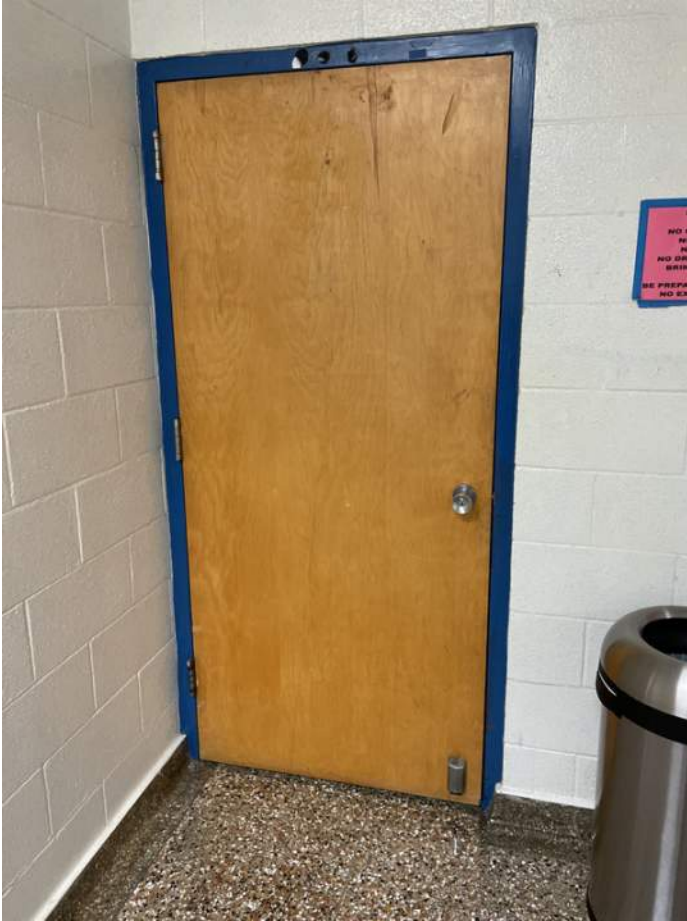
Interior Doors - 1. Classroom Wing Wood

Type Description-Interior Doors	Classroom Wing Wood
Condition Rating-Interior Doors	Fair - exhibiting deficiencies requiring minor service/repair to extend useful life
Deficiency Category-Interior Doors	No Immediate Action
Quantity-Interior Doors	50
Unit-Interior Doors	%
Year Installed-Interior Doors	1977

Well maintained but old.

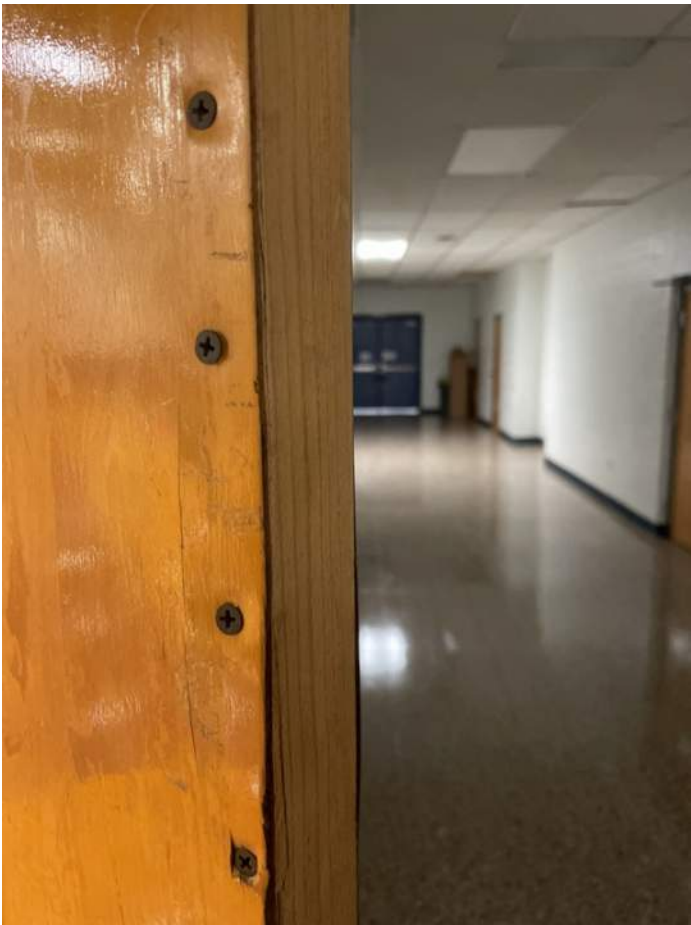
Interior Doors - 2. Gym and Auditorium Wing Wood

Type Description-Interior Doors	Gym and Auditorium Wing Wood
Condition Rating-Interior Doors	Poor - nearing end of useful life, and requiring major service/repair to remain operational
Deficiency Category-Interior Doors	Damaged/Failing
Quantity-Interior Doors	50
Unit-Interior Doors	%
Year Installed-Interior Doors	1977
Comments-Interior Doors	Screws used to hold finish to the door.

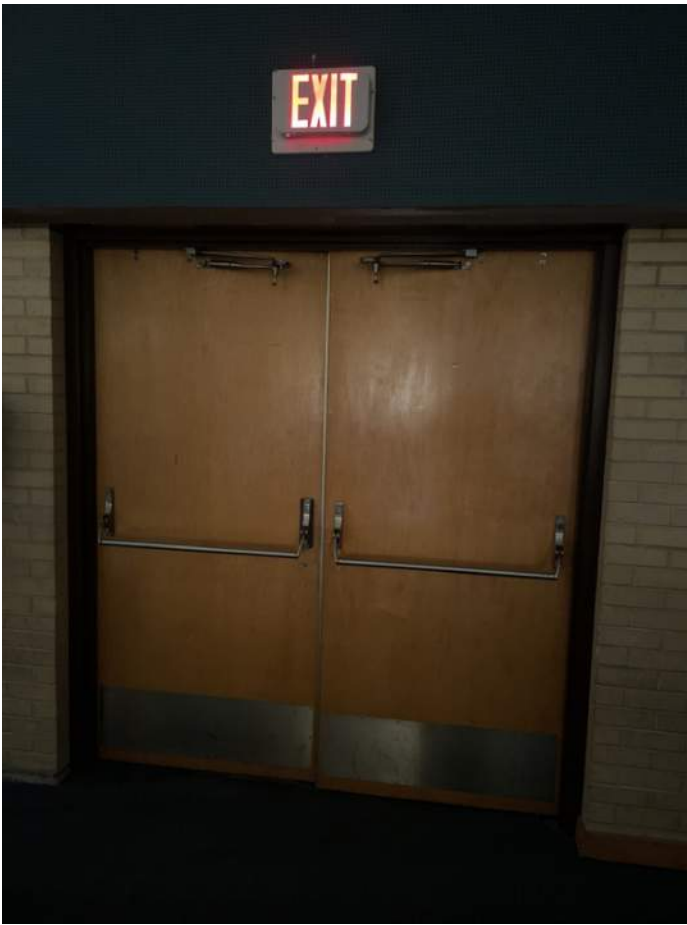
Interior Doors - 3. Auditorium Wood Pair of Doors

Type Description-Interior Doors	Auditorium Wood Pair of Doors
Condition Rating-Interior Doors	Critical - failed or failing, and beyond useful life requiring immediate attention
Deficiency Category-Interior Doors	Code Compliance
Quantity-Interior Doors	3
Unit-Interior Doors	EA
Year Installed-Interior Doors	1962
Comments-Interior Doors	Doors require excessive force and repeated attempts to unlatch from the inside. Could not get one door lead to open at all.

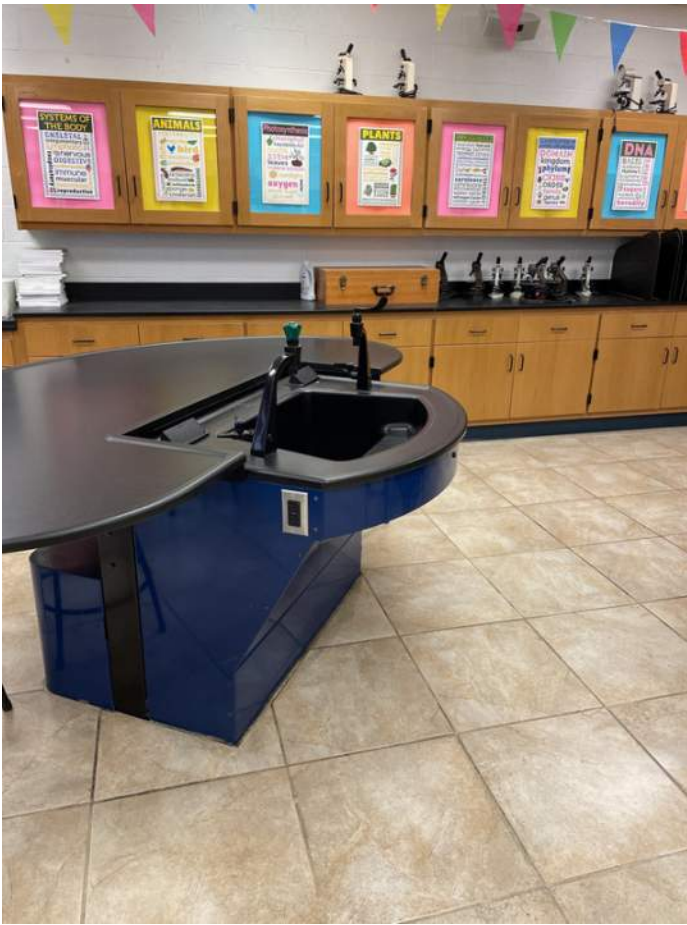
Fixed Furnishings - 1. Science lab millwork.

Type Description-Fixed Furnishings	Science lab millwork.
Condition Rating-Fixed Furnishings	Excellent - no known deficiencies or visible depreciation
Deficiency Category-Fixed Furnishings	No Immediate Action
Quantity-Fixed Furnishings	20
Unit-Fixed Furnishings	%
Year Installed-Fixed Furnishings	2015
Comments-Fixed Furnishings	Great shape

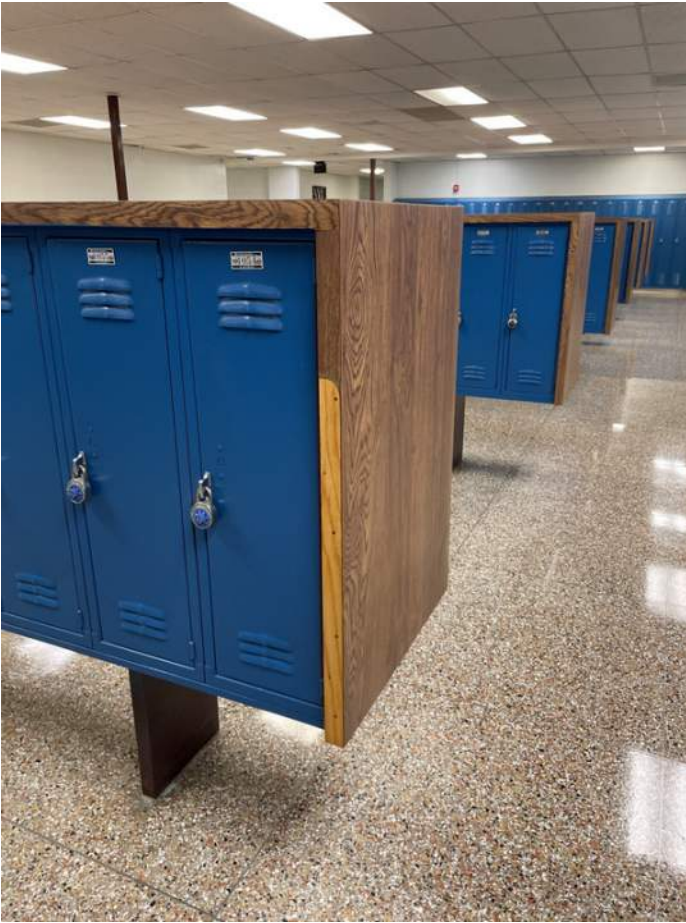
Fixed Furnishings - 2. Lockers

Type Description-Fixed Furnishings	Lockers
Condition Rating-Fixed Furnishings	Good - minimal depreciation, consistent with asset age
Deficiency Category-Fixed Furnishings	No Immediate Action
Quantity-Fixed Furnishings	30
Unit-Fixed Furnishings	%
Year Installed-Fixed Furnishings	1977
Comments-Fixed Furnishings	Well maintained but old. Some minor damage.

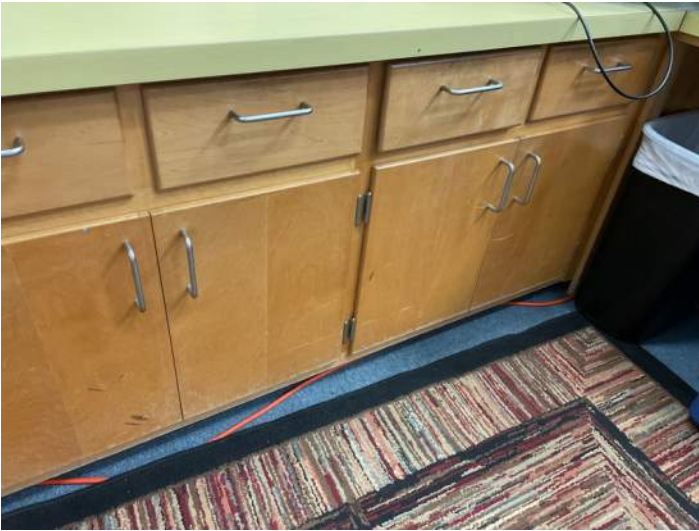
Fixed Furnishings - 3. Wood Millwork

Type Description-Fixed Furnishings	Wood Millwork
Condition Rating-Fixed Furnishings	Fair - exhibiting deficiencies requiring minor service/repair to extend useful life
Deficiency Category-Fixed Furnishings	Beyond Useful Life
Quantity-Fixed Furnishings	20
Unit-Fixed Furnishings	%
Year Installed-Fixed Furnishings	1977
Comments-Fixed Furnishings	Fair condition for age by very old. Mainly in library.

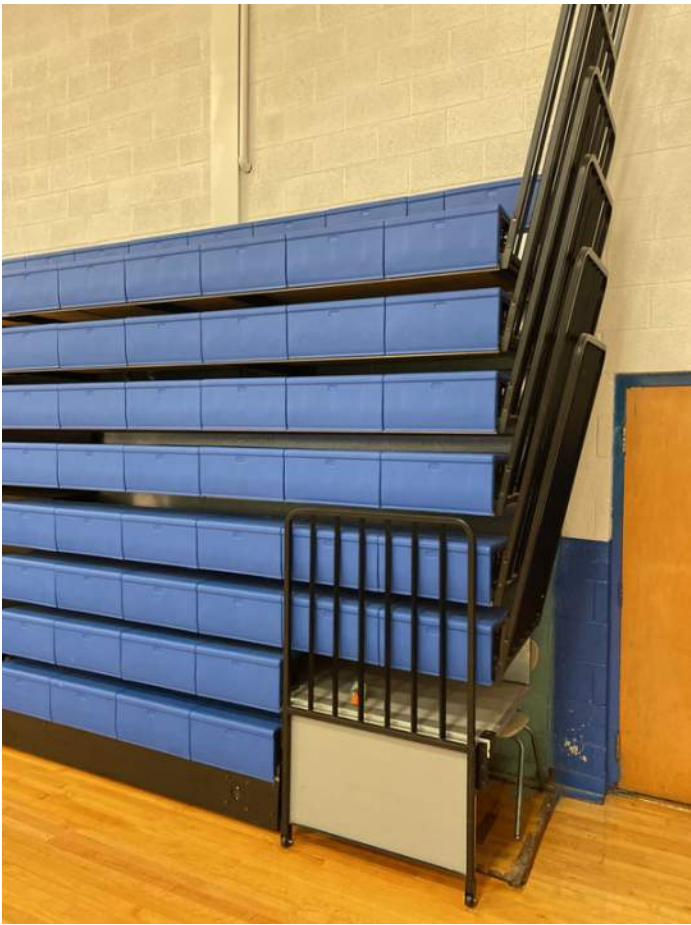
Fixed Furnishings - 4. Bleachers

Type Description-Fixed Furnishings	Bleachers
Condition Rating-Fixed Furnishings	Excellent - no known deficiencies or visible depreciation
Deficiency Category-Fixed Furnishings	No Immediate Action
Quantity-Fixed Furnishings	10
Unit-Fixed Furnishings	%
Year Installed-Fixed Furnishings	n/a
Comments-Fixed Furnishings	Unknown age. Looks new.

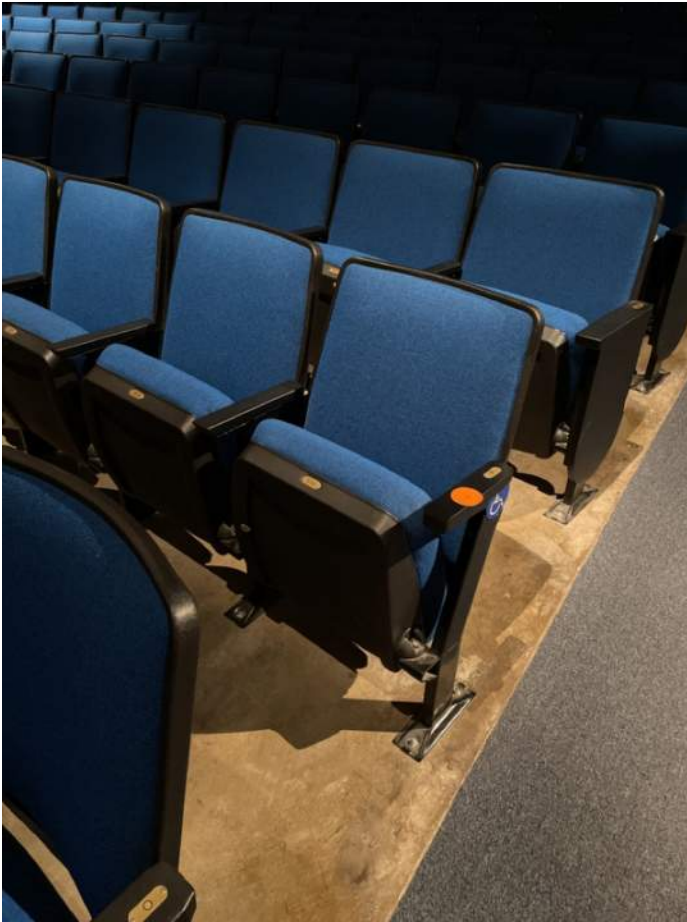
Fixed Furnishings - 5. Theater Seating

Unit-Fixed Furnishings	%
Year Installed-Fixed Furnishings	n/a
Comments-Fixed Furnishings	Unknown age. Looks new.

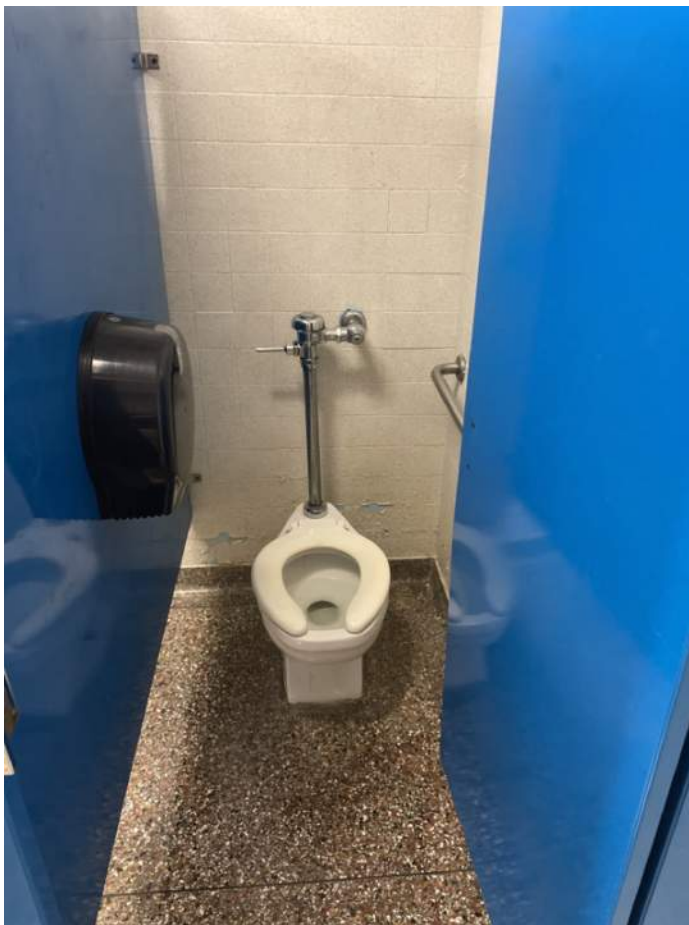
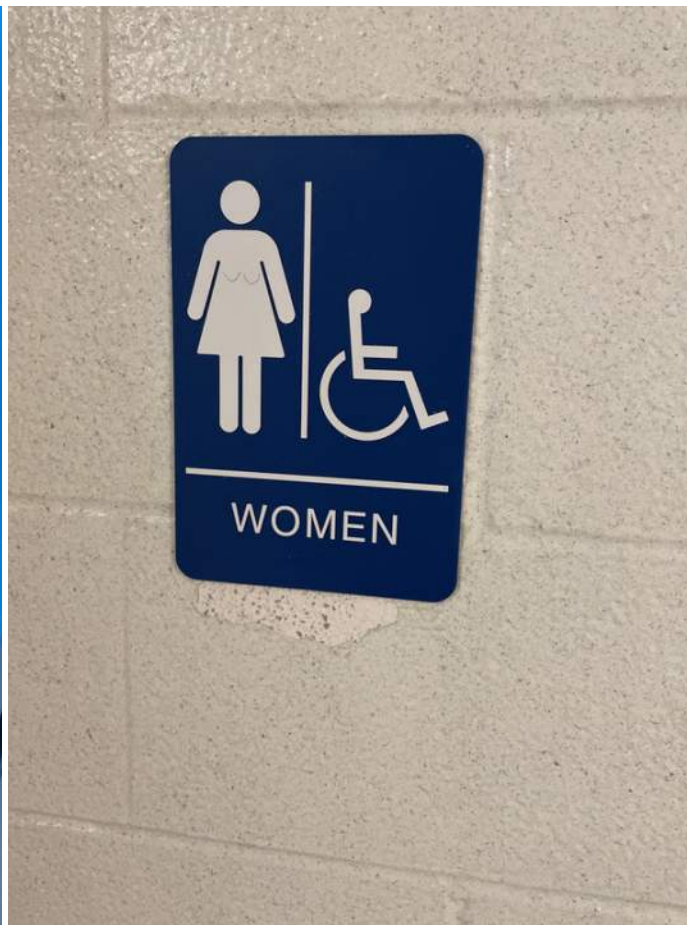
Description-Accessibility	Restrooms next to room 16 are not accessible. Marked as accessible. No signage directing to accessible restrooms. Accessibility is not required at these restrooms but signage needs to be corrected.
---------------------------	---

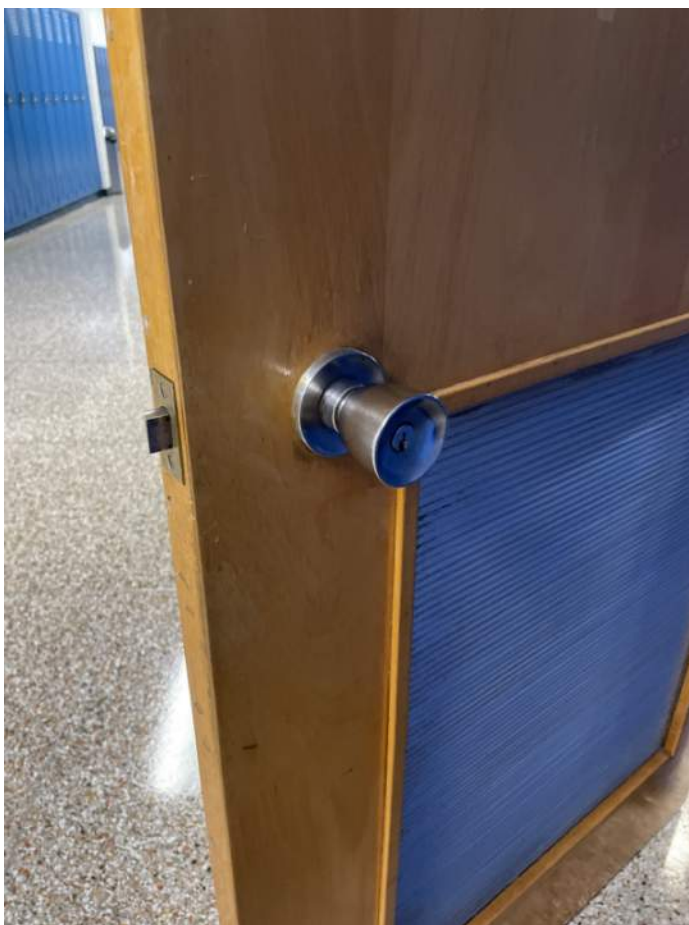
Accessibility Standards - 2. No accessible turns.

No accessible turns.

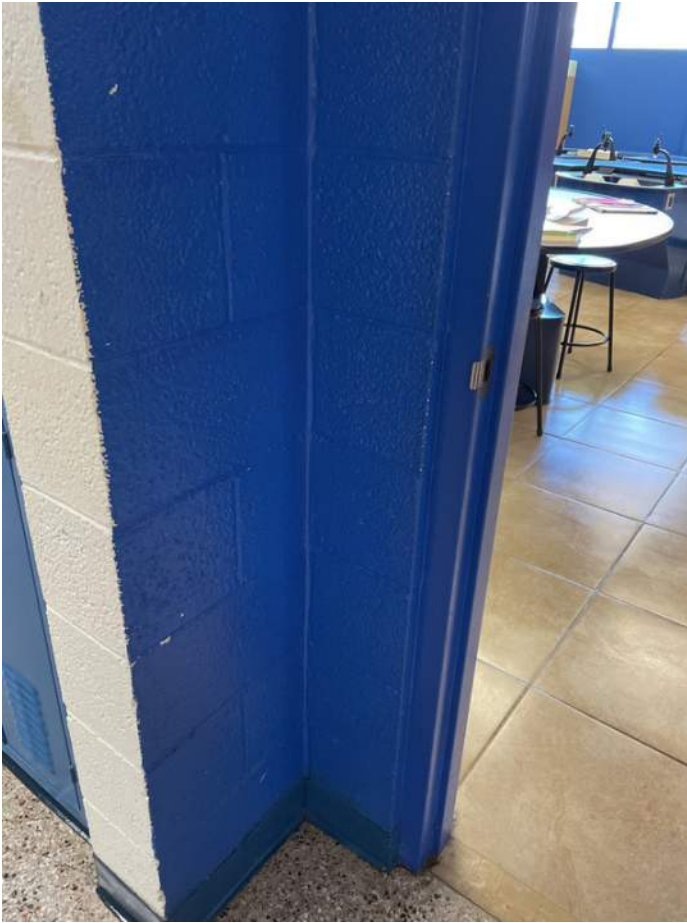
Accessibility Standards - 3. Door floor clearance do not meet ADA/TAS on 30% of doors.

Door floor clearance do not meet ADA/TAS on 30% of doors.

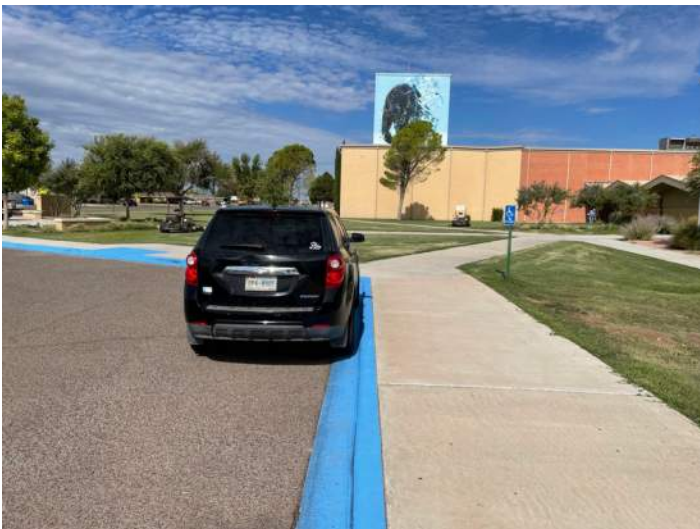
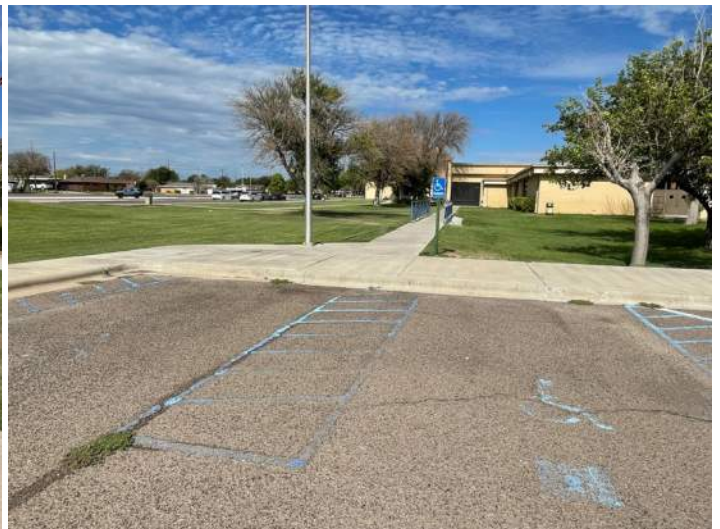
Accessibility Standards - 4. 3 ADA parking spaces do not meet current codes.

3 ADA parking spaces do not meet current codes.

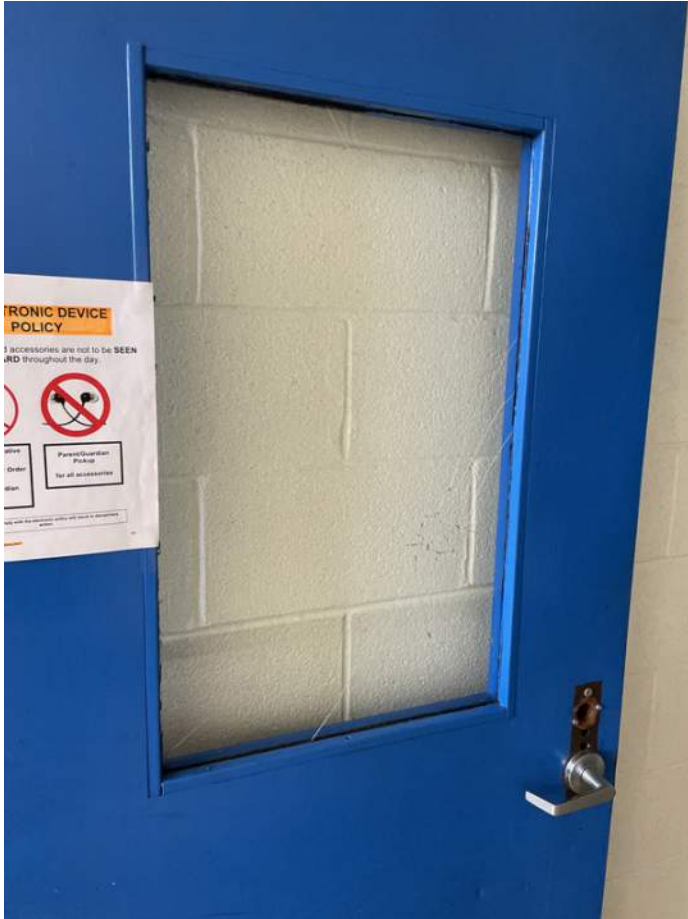
Non-safety glass in doors.

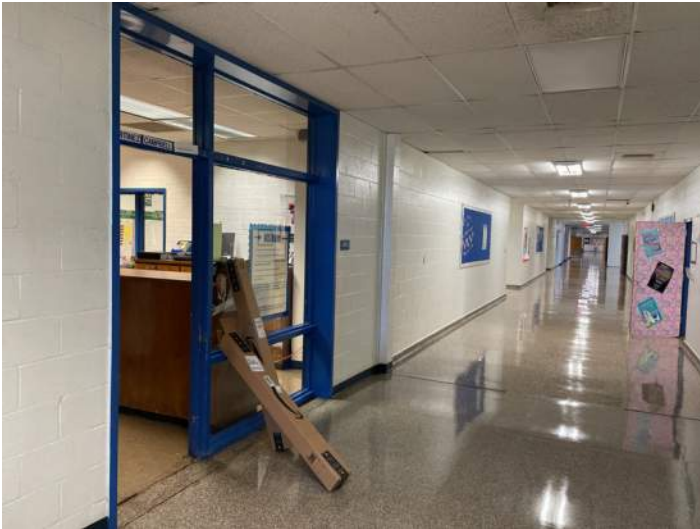
Building Codes - 2. No sprinkler system and corridors are not rated.

No sprinkler system and corridors are not rated.

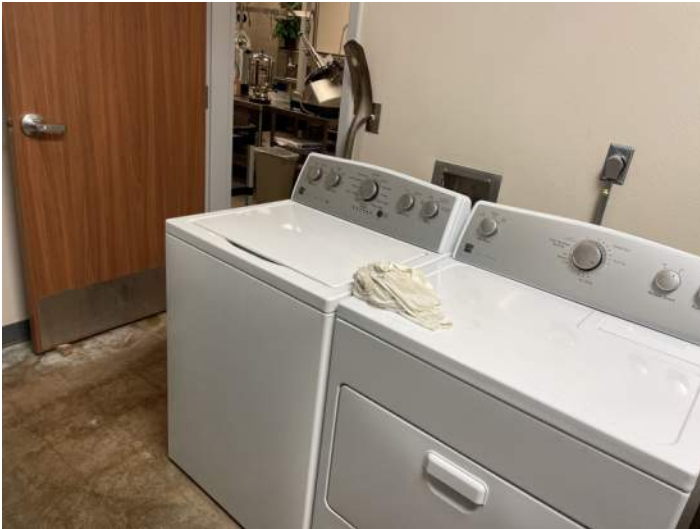
In kitchen, laundry equipment in unrated room.

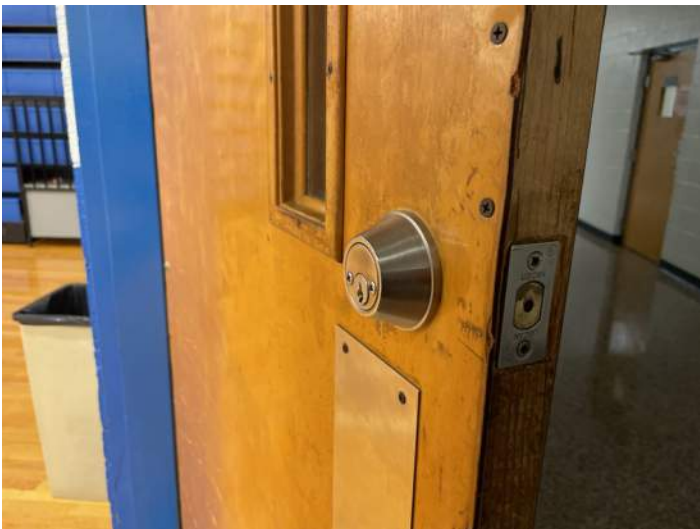
Building Codes - 5. Fire code issue. Deadbolts on gym doors. Fire and building code do not allow deadbolts on these doors. 4 single doors and 4 pairs of doors with this issue.

Fire code issue. Deadbolts on gym doors. Fire and building code do not allow deadbolts on these doors. 4 single doors and 4 pairs of doors with this issue.

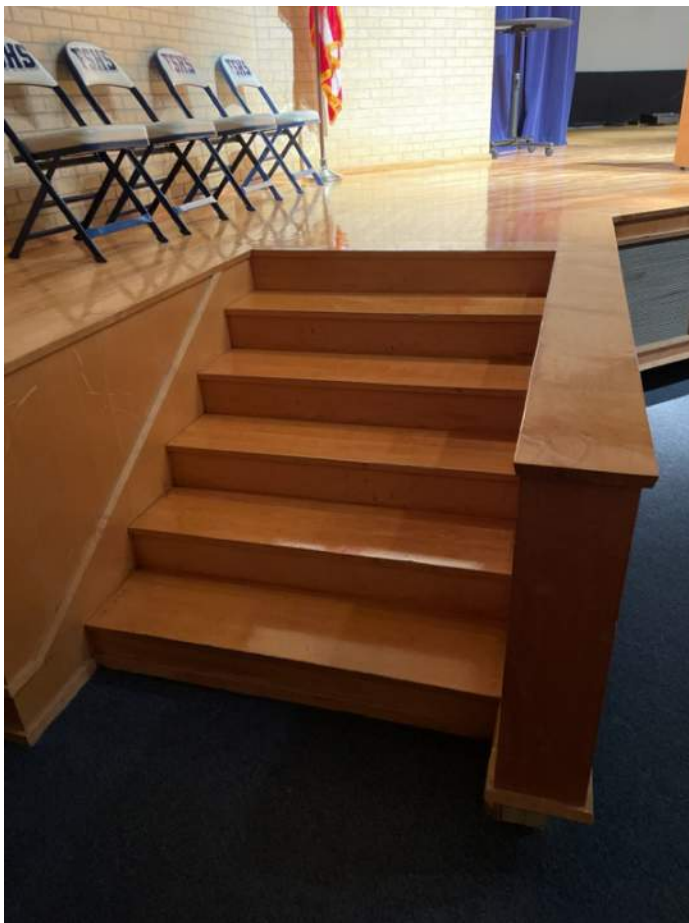
Building Codes - 6. Stairs to stage missing handrails.

Stairs to stage missing handrails.

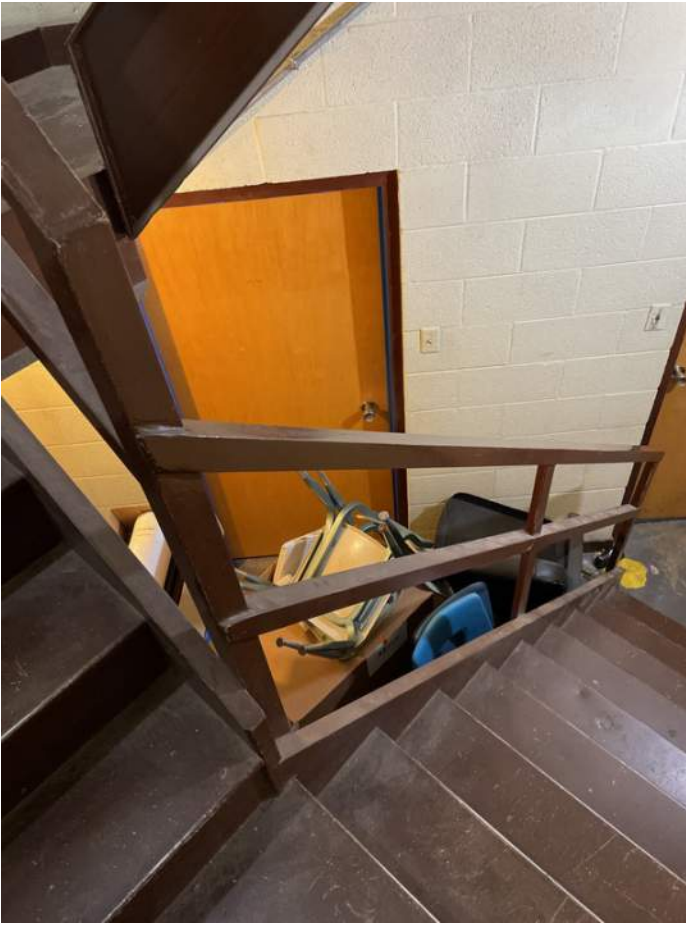
OSHA, building and fire code issue. Stairs to stage balcony do not meet current requirements for catwalk guardrails.

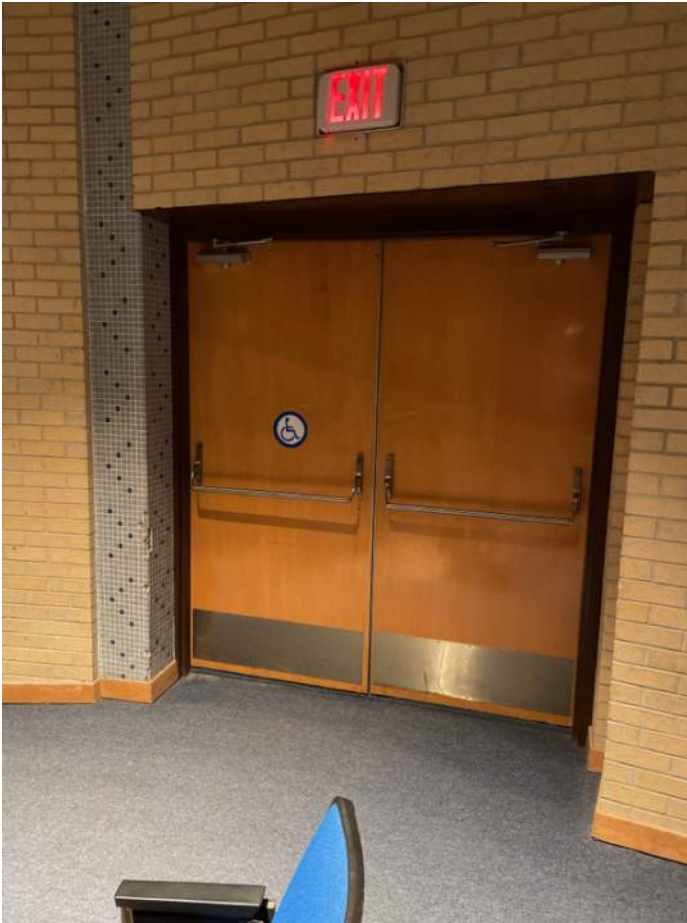
Building Codes - 9. Major fire code issue. 3 interior pairs of doors with concealed vertical rod exit devices do no unlatch from the inside reliability.

Major fire code issue. 3 interior pairs of doors with concealed vertical rod exit devices do no unlatch from the inside reliability.
