Fort Stockton ISD - Condition Assessment

Alamo Elementary

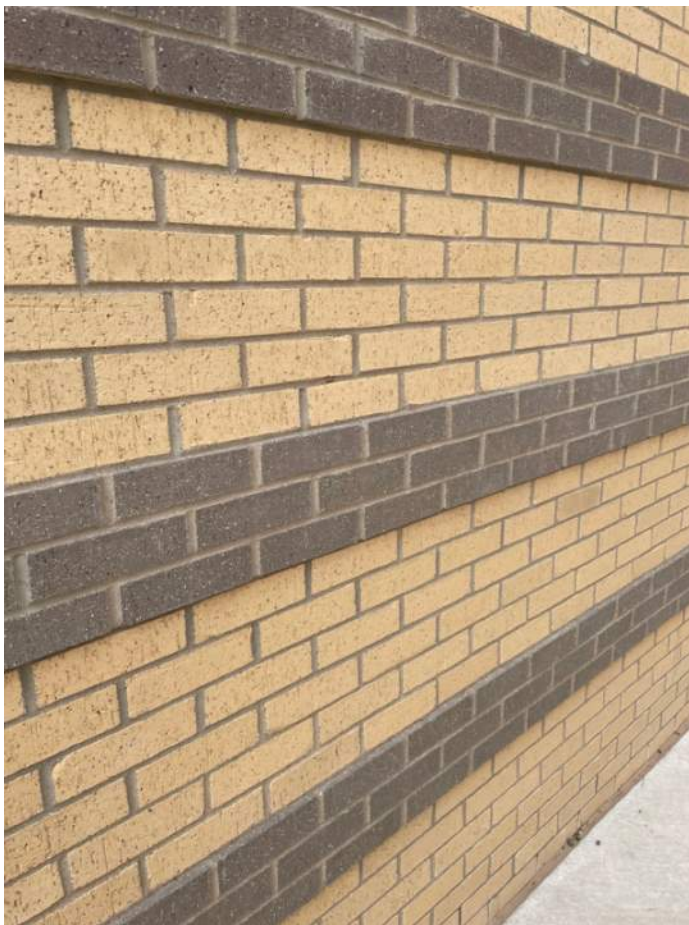
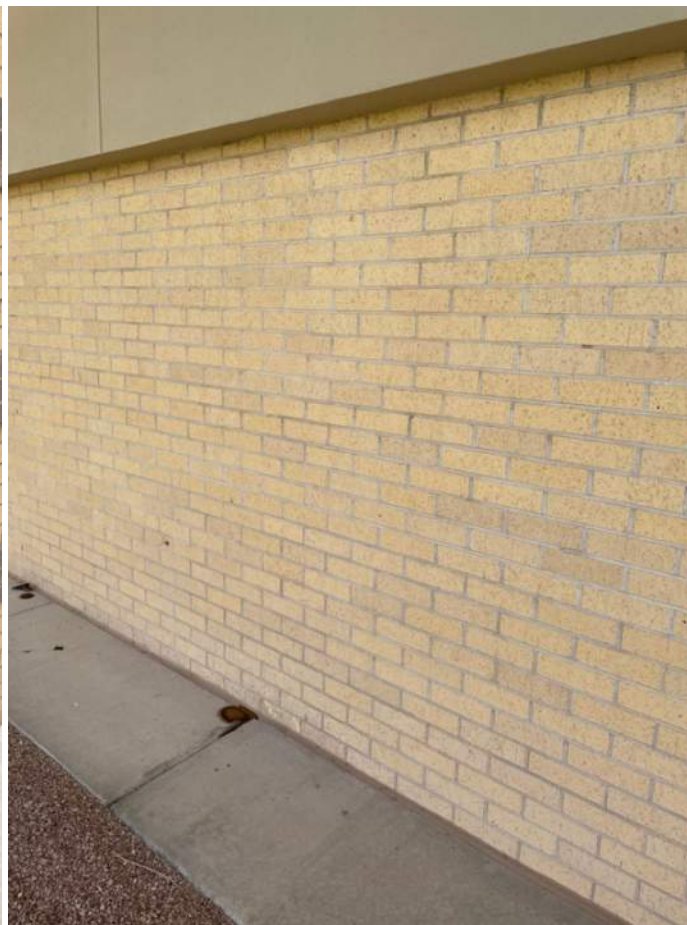
Type Description-Exterior Walls	Brick
Condition Rating-Exterior Walls	Excellent - no known deficiencies or visible depreciation
Deficiency Category-Exterior Walls	No Immediate Action
Quantity-Exterior Walls	50
Unit-Exterior Walls	%
Year Installed-Exterior Walls	1962
Comments-Exterior Walls	Old brick pointed in 2017. New brick installed for band addition in 2017. All brick in good condition.

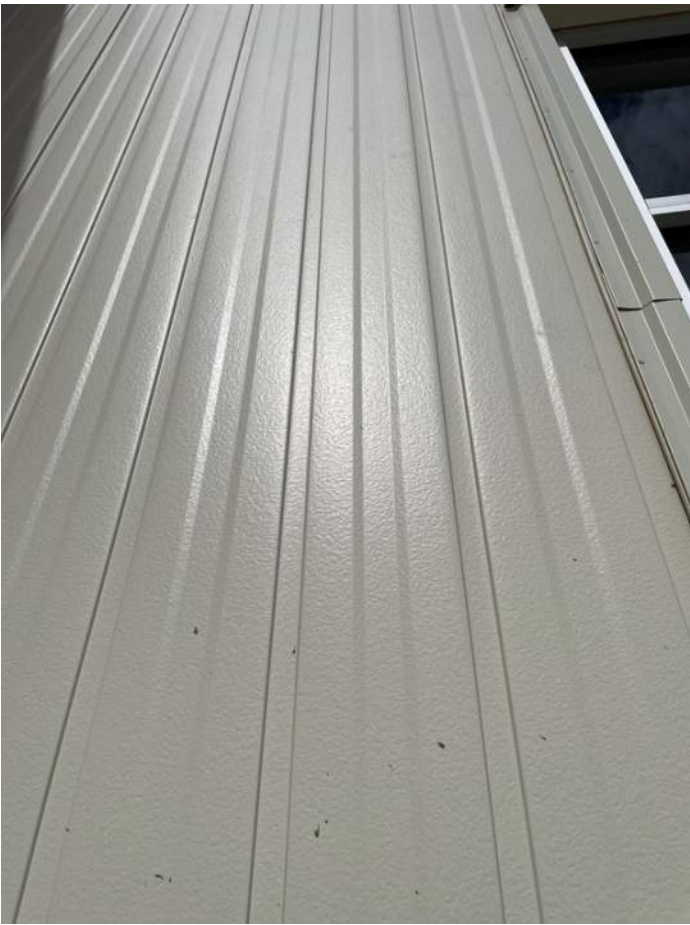
Exterior Walls - 3. Metal Wall Panels

Type Description-Exterior Walls	Metal Wall Panels
Condition Rating-Exterior Walls	Excellent - no known deficiencies or visible depreciation
Deficiency Category-Exterior Walls	No Immediate Action
Quantity-Exterior Walls	30
Unit-Exterior Walls	%
Year Installed-Exterior Walls	2017
Comments-Exterior Walls	Installed on natatorium.

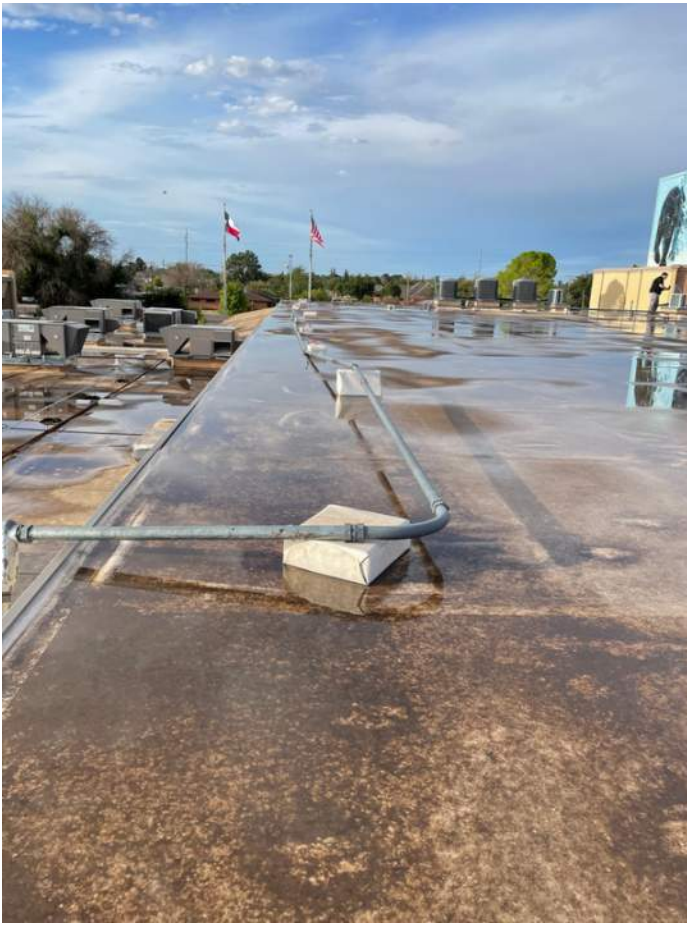
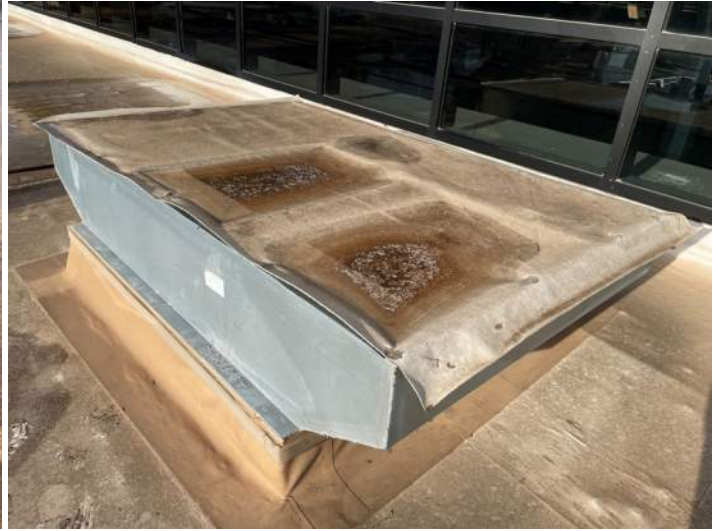
Roofing - 1. TPO

Type Description-Roofing	TPO
Condition Rating-Roofing	Good - minimal depreciation, consistent with asset age
Deficiency Category-Roofing	Inadequate
Quantity-Roofing	100
Unit-Roofing	%
Year Installed-Roofing	2017
Comments-Roofing	Overall great roof, issues limited or with adjacent construction. Limited issue with old rooftop unit curb was not sealed correctly. Widespread issues with conduit falling off supports and in contact with roof. This is due to the poor condition of the conduit. No noted roof issues with the conduit, but if conduit remains there will be problems with the roof.

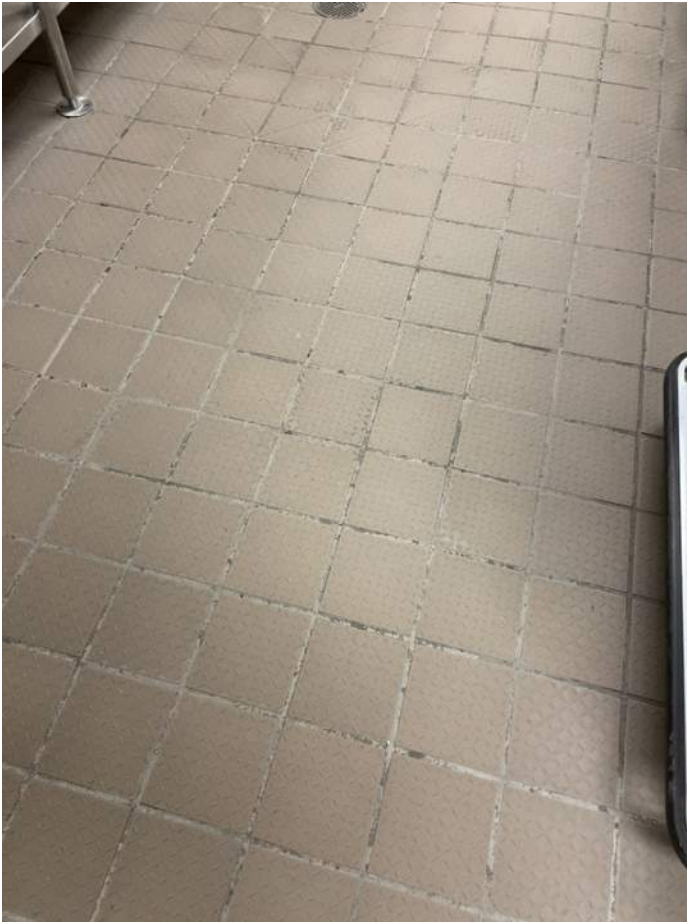
Flooring Finishes - 1. Kitchen Ceramic Tile

Type Description-Flooring Finishes	Kitchen Ceramic Tile
Condition Rating-Flooring Finishes	Fair - exhibiting deficiencies requiring minor service/repair to extend useful life
Deficiency Category-Flooring Finishes	No Immediate Action
Quantity-Flooring Finishes	10
Unit-Flooring Finishes	%
Year Installed-Flooring Finishes	2017
Comments-Flooring Finishes	Tile good. Grout has widespread staining.

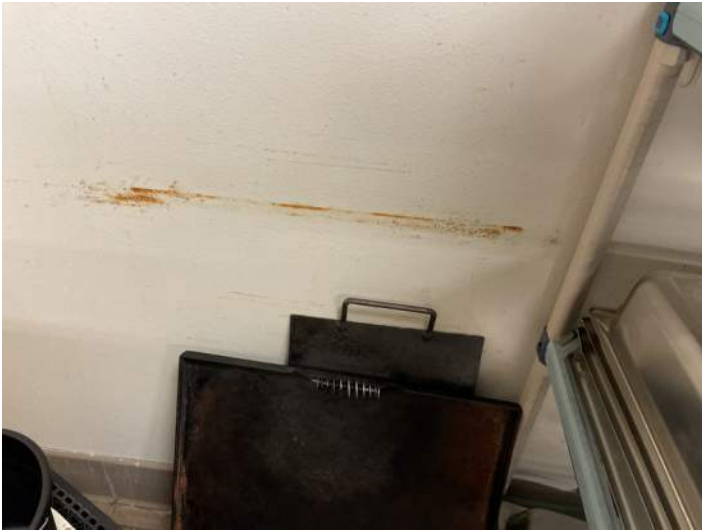
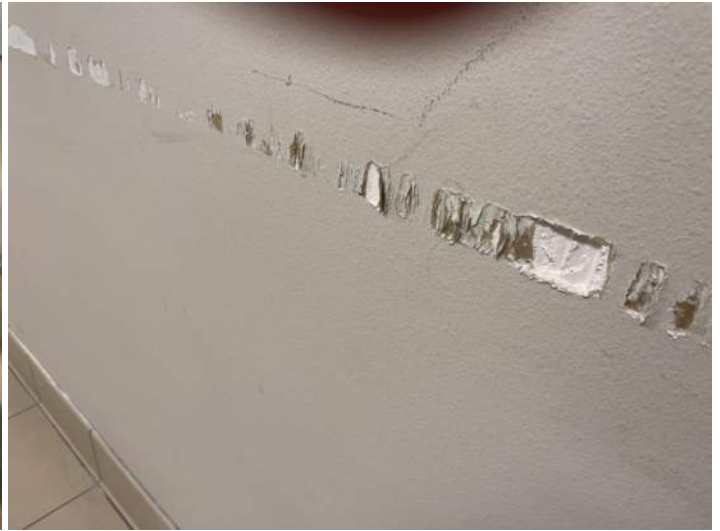
Wall Finishes - 1. Painted Gypsum in Kitchen and Servery

Type Description-Wall Finishes	Painted Gypsum in Kitchen and Servery
Condition Rating-Wall Finishes	Poor - nearing end of useful life, and requiring major service/repair to remain operational
Deficiency Category-Wall Finishes	Damaged/Failing
Quantity-Wall Finishes	15
Unit-Wall Finishes	%
Year Installed-Wall Finishes	2017
Comments-Wall Finishes	Paint past useful life. Several highly damaged but isolated areas in kitchen and servery. Add a more durable finish to the damaged areas and repaint.

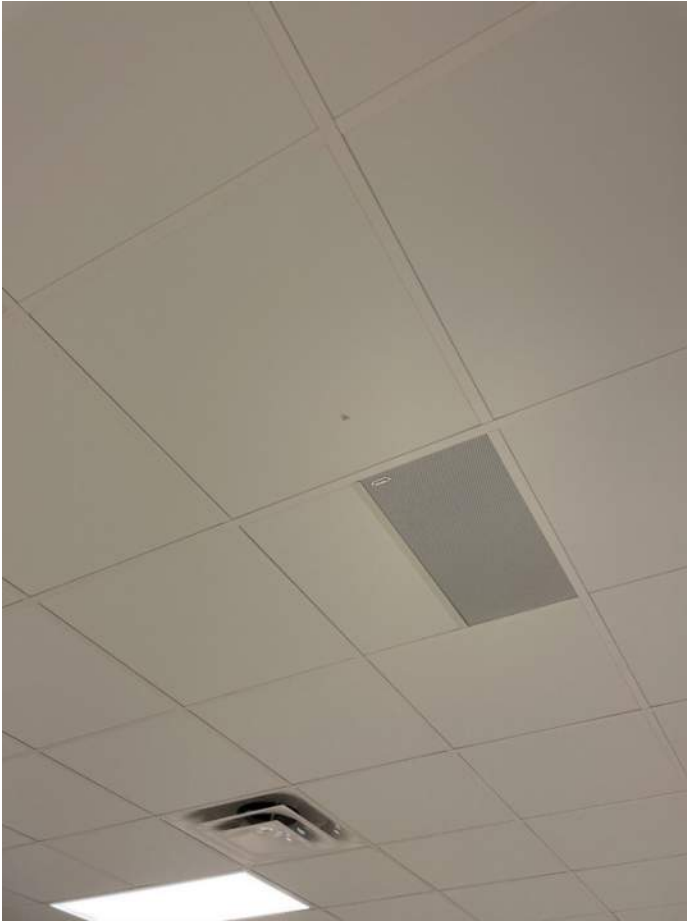
Ceiling Finishes - 1. 2x2 Acoustical Tile

Type Description-Ceiling Finishes	2x2 Acoustical Tile
Condition Rating-Ceiling Finishes	Excellent - no known deficiencies or visible depreciation
Deficiency Category-Ceiling Finishes	No Immediate Action
Quantity-Ceiling Finishes	95
Unit-Ceiling Finishes	%
Year Installed-Ceiling Finishes	2017
Comments-Ceiling Finishes	Minor damage

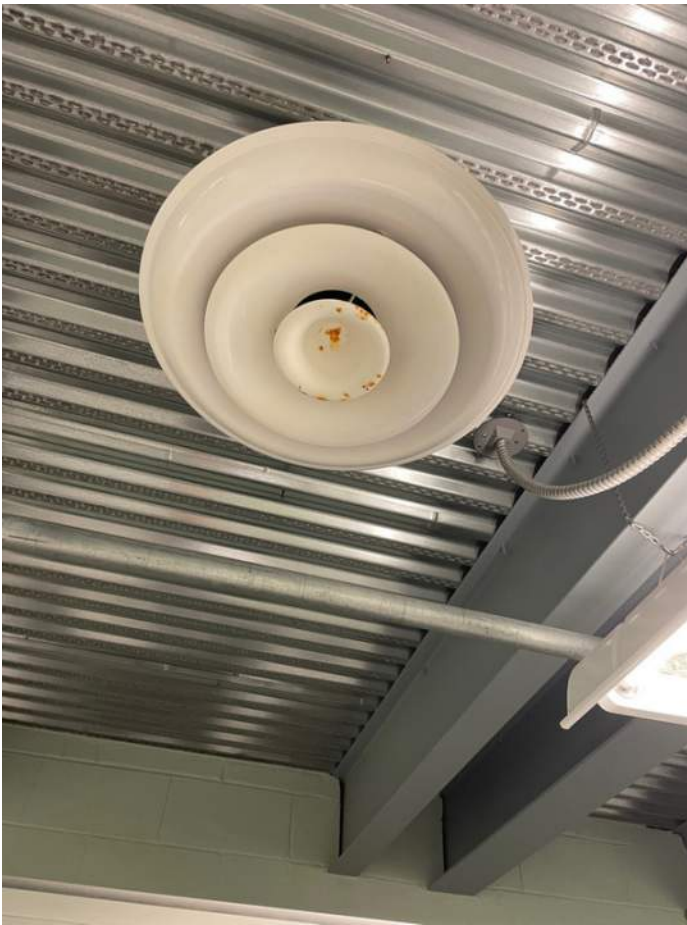
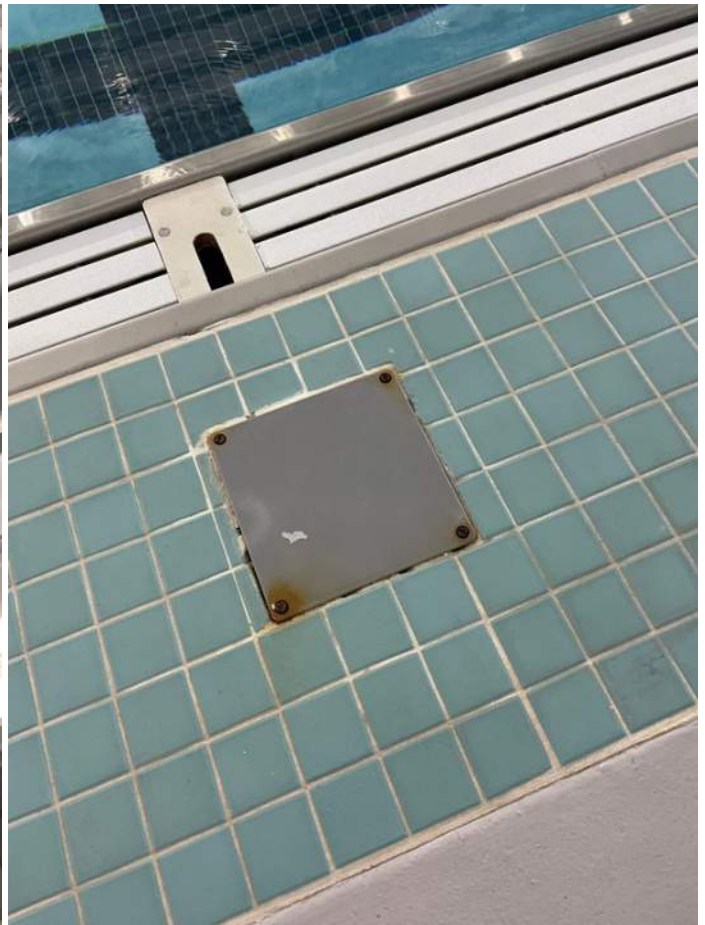
Fixed Furnishings - 2. Mix equipment

Type Description-Fixed Furnishings	Mix equipment
Condition Rating-Fixed Furnishings	Poor - nearing end of useful life, and requiring major service/repair to remain operational
Deficiency Category-Fixed Furnishings	Damaged/Failing
Quantity-Fixed Furnishings	n/a
Unit-Fixed Furnishings	n/a
Year Installed-Fixed Furnishings	2017
Comments-Fixed Furnishings	Several items rusting and need to be replaced. All in natatorium.

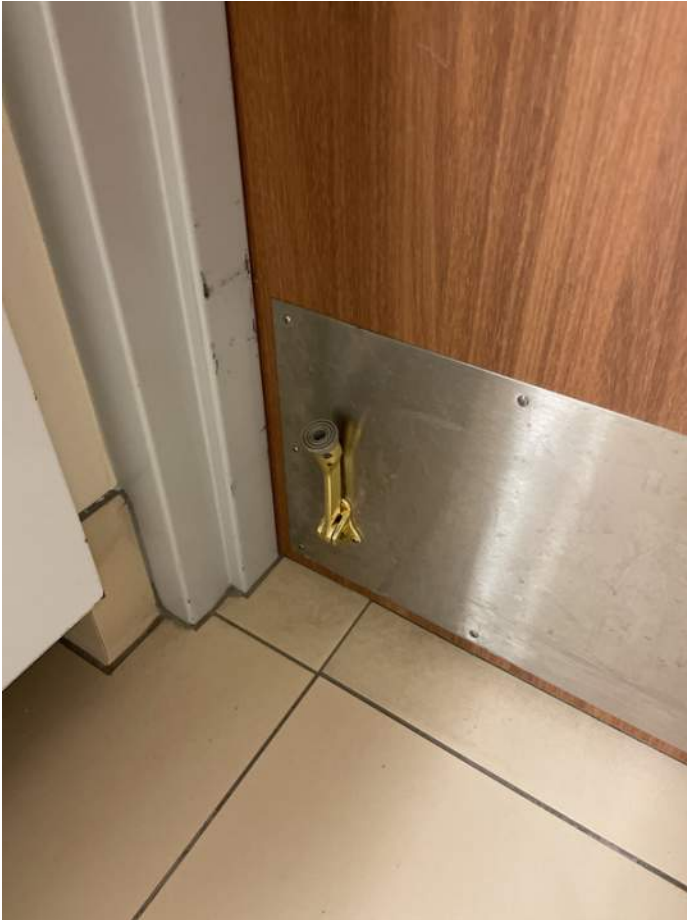
Added kick stop violates ADA and TAS

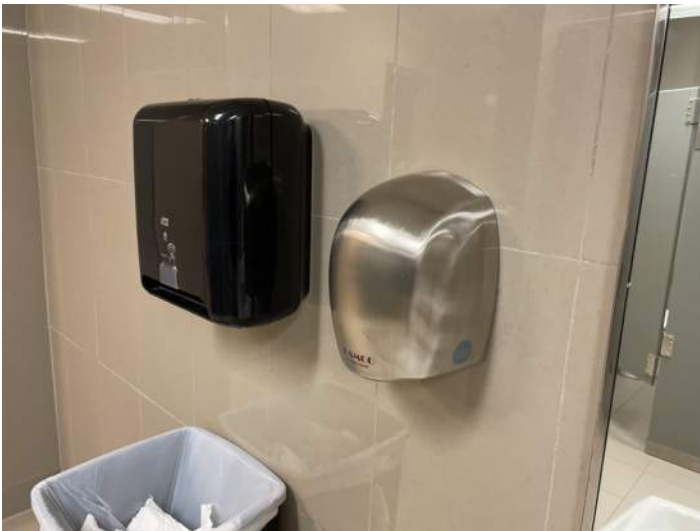
Accessibility Standards - 2. Equipment in restrooms extended more than 4 inches from wall.

Equipment in restrooms extended more than 4 inches from wall.

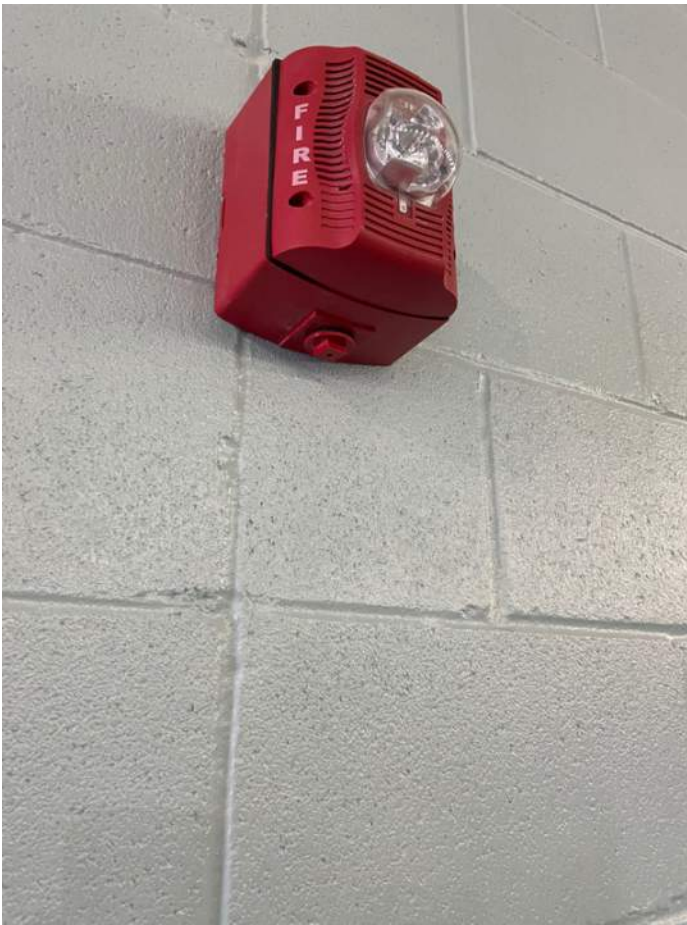
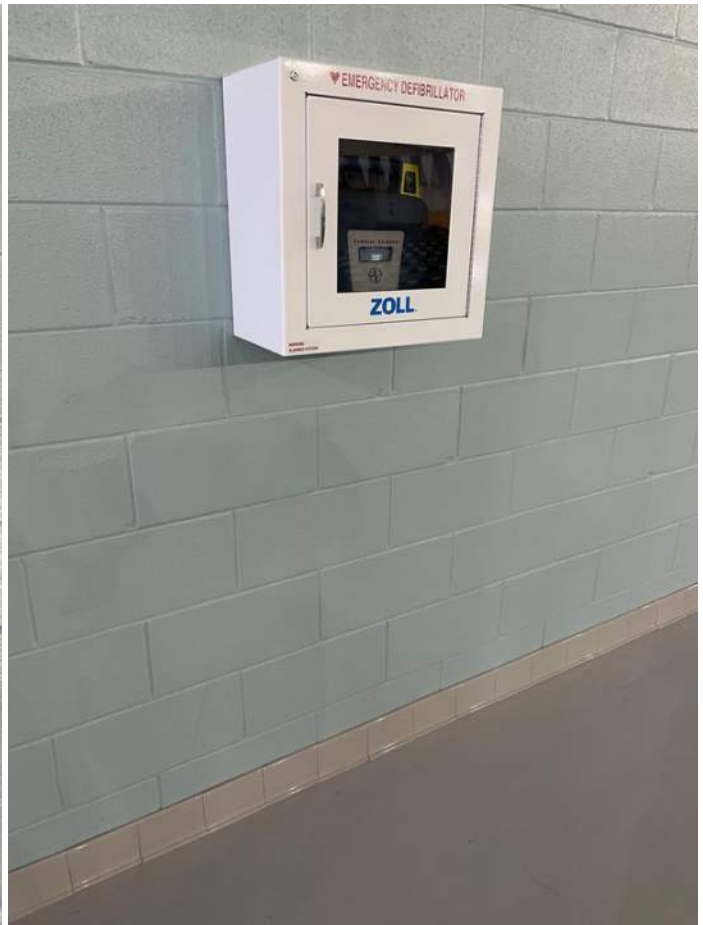
Accessibility Standards - 3. Equipment throughout natatorium extends more than 4 inches from wall

Equipment throughout natatorium extends more than 4 inches from wall

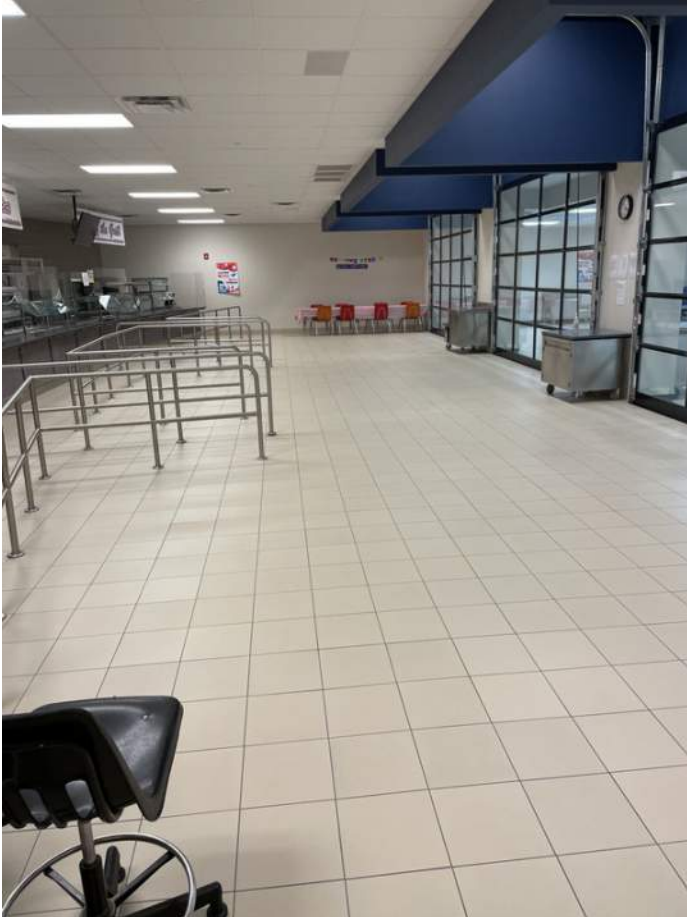
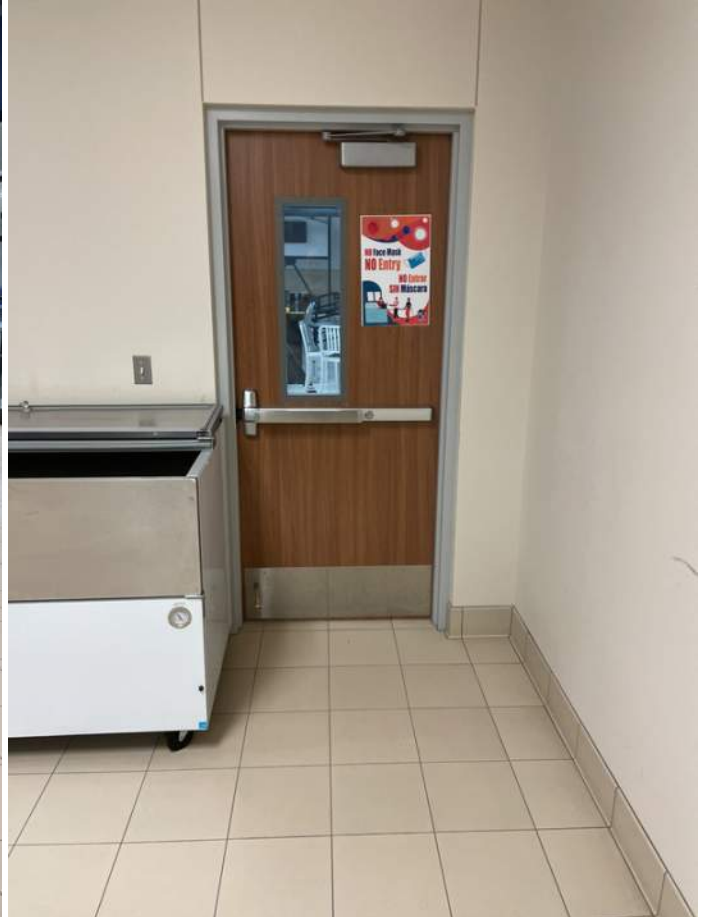
Building Codes - 1. Fire code issue. Student cafeteria lines have an occupant load over 50 but the area only has one swing door exit. Cannot egress through the cafeteria.

Fire code issue. Student cafeteria lines have an occupant load over 50 but the area only has one swing door exit. Cannot egress through the cafeteria.

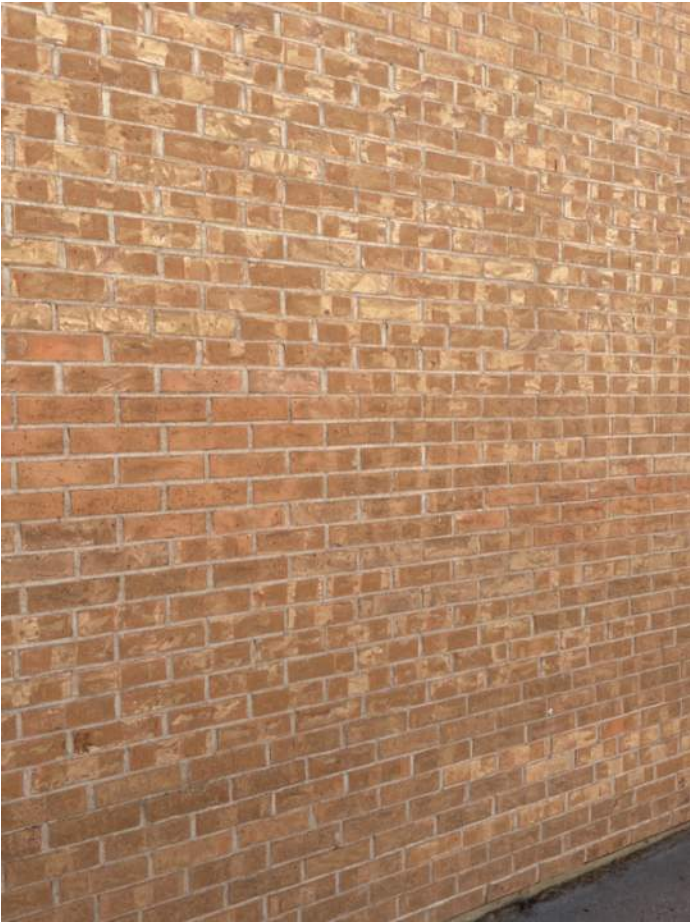
Photos-Exterior Walls

Type Description-Exterior Walls	Brick
Condition Rating-Exterior Walls	Good - minimal depreciation, consistent with asset age
Deficiency Category-Exterior Walls	No Immediate Action
Quantity-Exterior Walls	100
Unit-Exterior Walls	%
Year Installed-Exterior Walls	1980
Comments-Exterior Walls	n/a

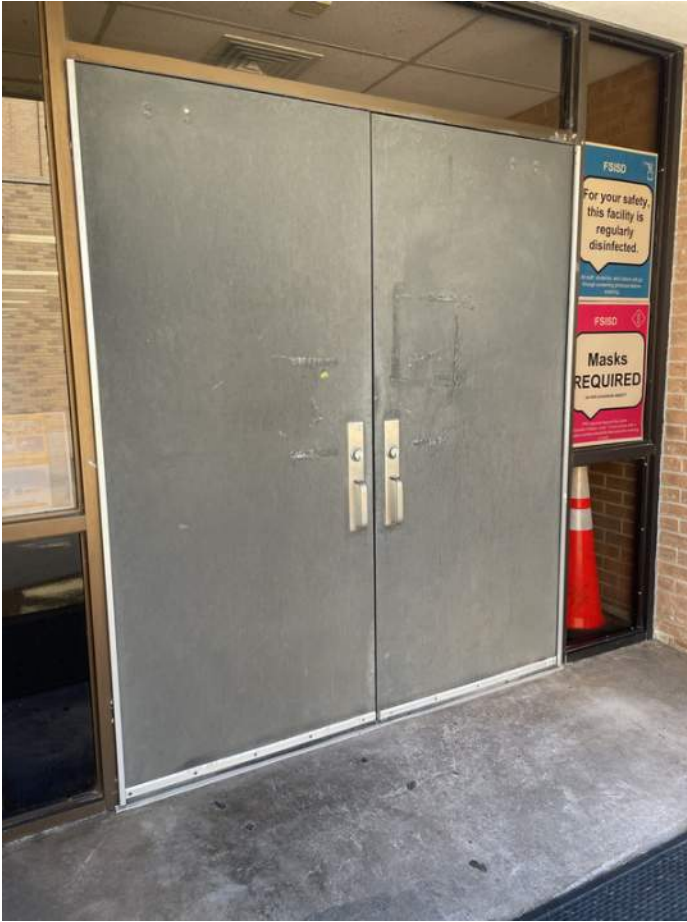
Photos-Exterior Doors

Type Description-Exterior Doors	Hollow Metal
Condition Rating-Exterior Doors	Fair - exhibiting deficiencies requiring minor service/repair to extend useful life
Deficiency Category-Exterior Doors	No Immediate Action

Quantity-Exterior Doors	100
Unit-Exterior Doors	%
Year Installed-Exterior Doors	1980
Comments-Exterior Doors	Repainting will extend life.

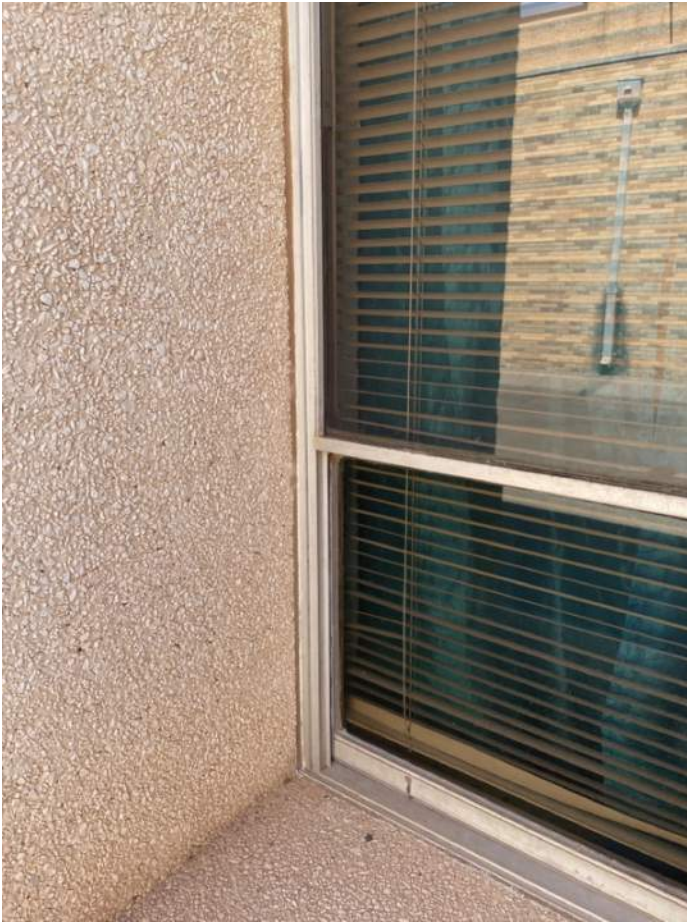
Photos-Windows

Type Description-Windows	Aluminum
Condition Rating-Windows	Good - minimal depreciation, consistent with asset age
Deficiency Category-Windows	No Immediate Action
Quantity-Windows	100
Unit-Windows	%
Year Installed-Windows	1980
Comments-Windows	n/a

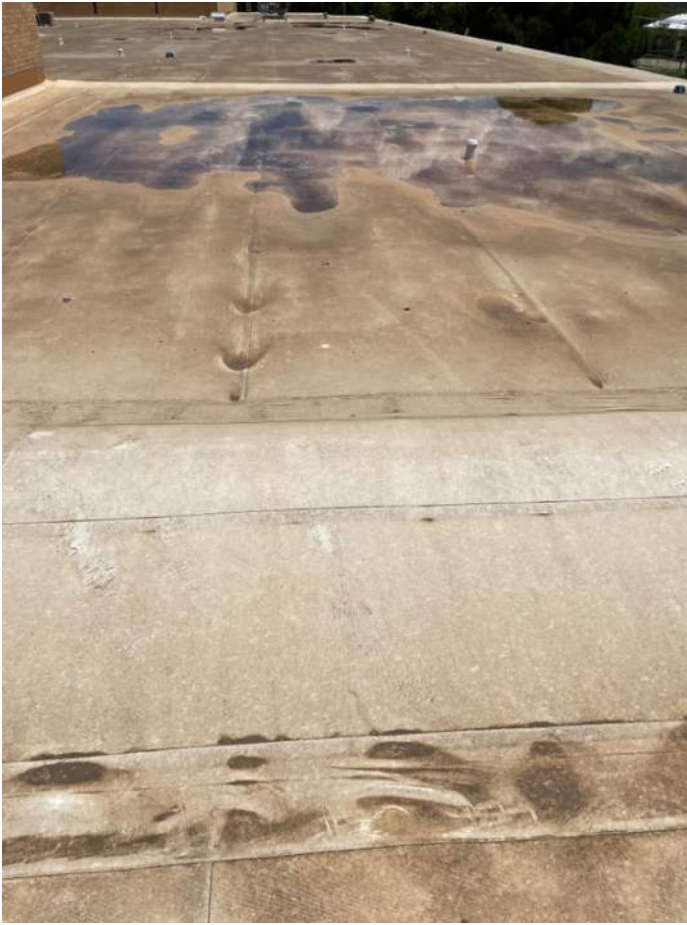
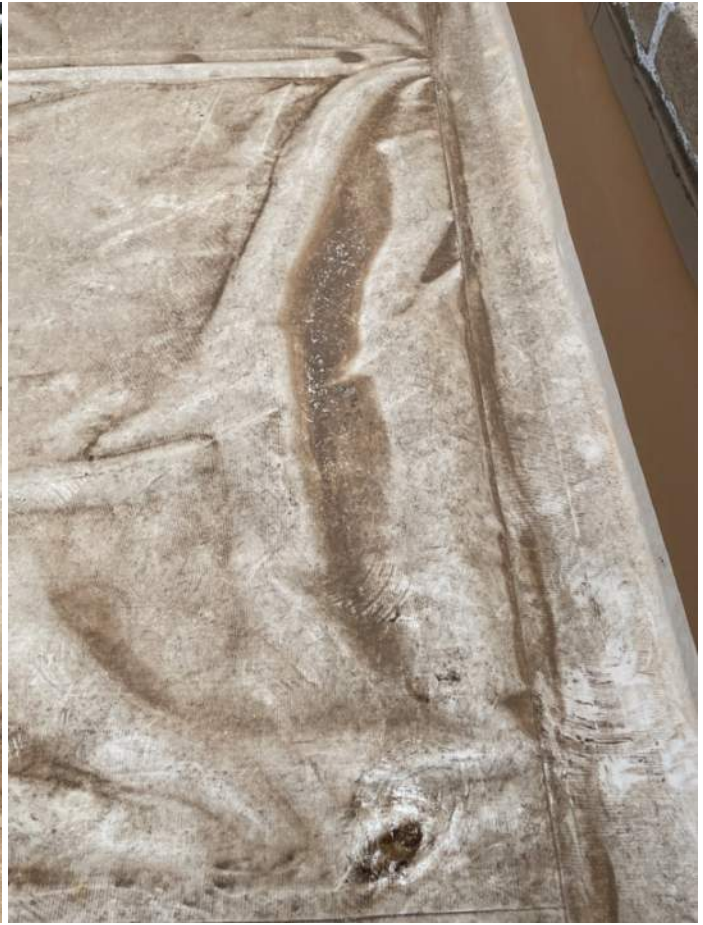
Photos-Roofing

Type Description-Roofing	TPO
Condition Rating-Roofing	Good - minimal depreciation, consistent with asset age
Deficiency Category-Roofing	n/a
Quantity-Roofing	n/a
Unit-Roofing	n/a
Year Installed-Roofing	2017
Comments-Roofing	Roof in good shape now. Not fully adhered. No sloping when installed. Would have been easier to

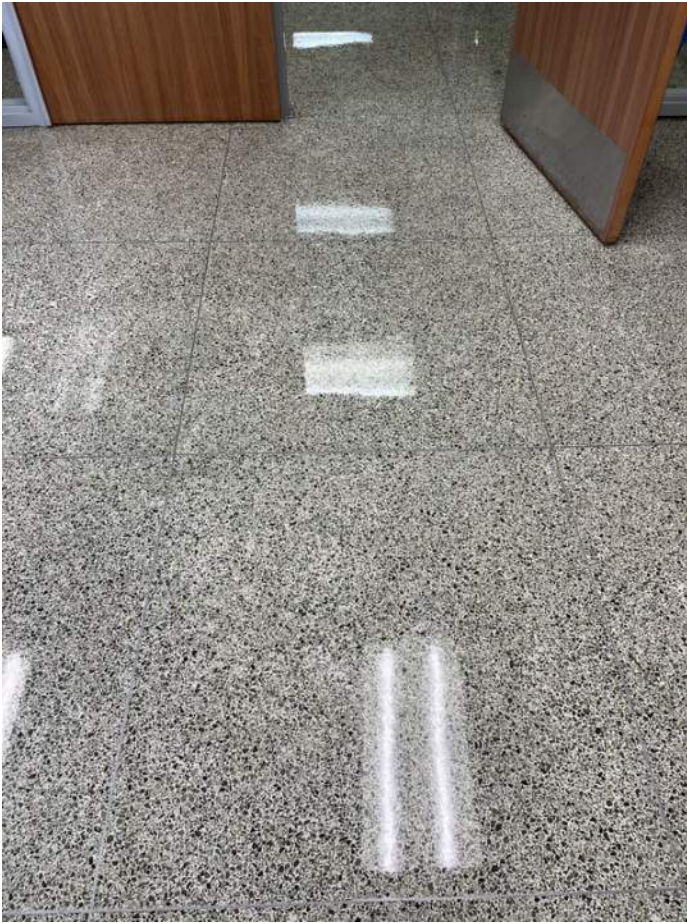
Photos-Flooring Finishes

Type Description-Flooring Finishes	Terrazzo
Condition Rating-Flooring Finishes	Good - minimal depreciation, consistent with asset age
Deficiency Category-Flooring Finishes	n/a
Quantity-Flooring Finishes	80
Unit-Flooring Finishes	%
Year Installed-Flooring Finishes	1980
Comments-Flooring Finishes	n/a

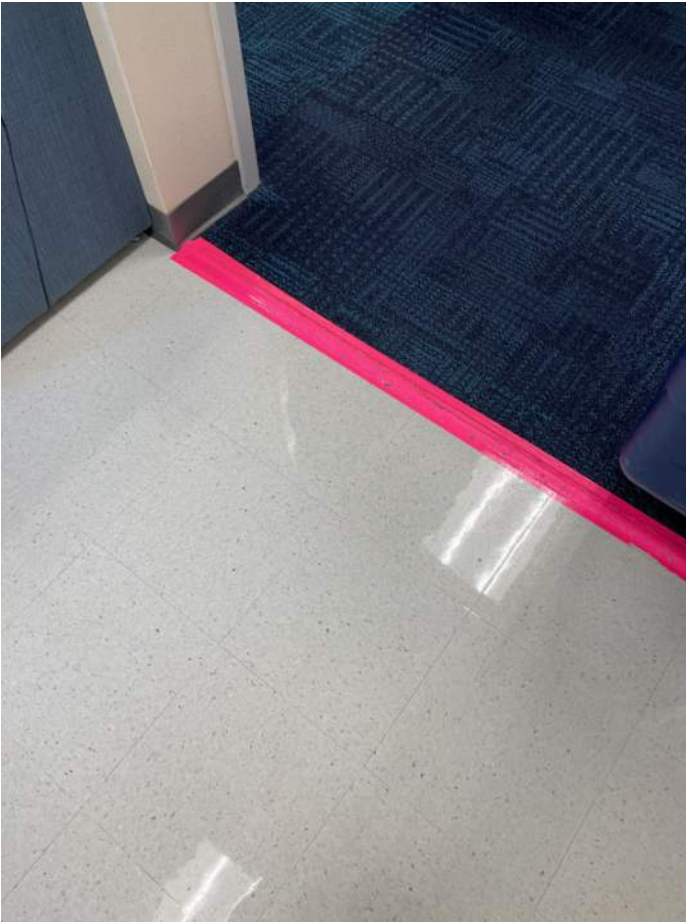
Photos-Flooring Finishes

Type Description-Flooring Finishes	New flooring transitions
Condition Rating-Flooring Finishes	Critical - failed or failing, and beyond useful life requiring immediate attention
Deficiency Category-Flooring Finishes	Damaged/Failing
Quantity-Flooring Finishes	15
Unit-Flooring Finishes	LF
Year Installed-Flooring Finishes	2015
Comments-Flooring Finishes	Flooring transitions in office area is not installed correctly. It has become a tripping hazard. Staff has installed duct tape over the transitions to keep them down.

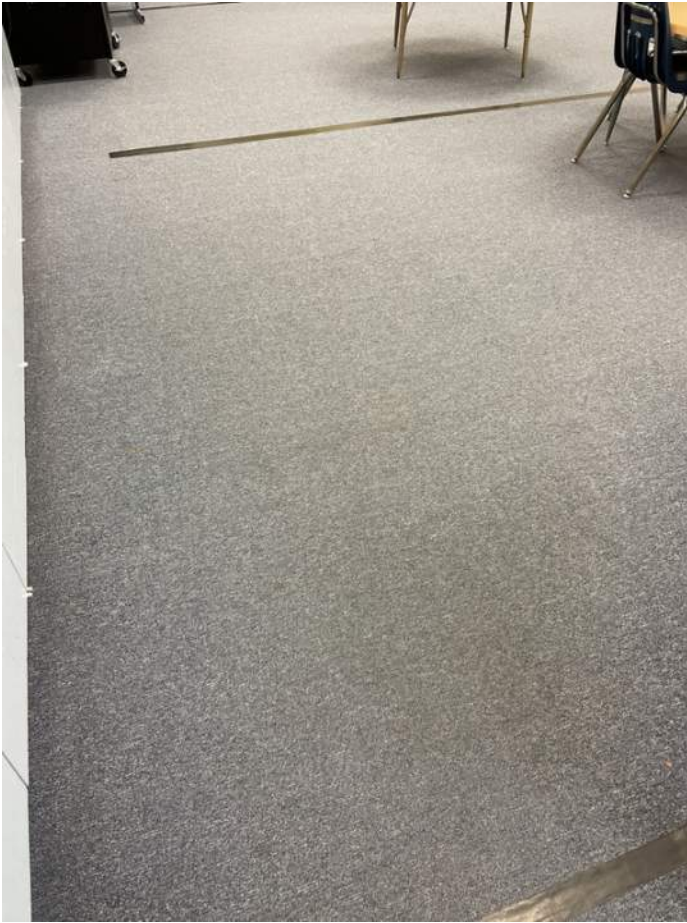
Photos-Flooring Finishes

Type Description-Flooring Finishes	Older Carpet
Condition Rating-Flooring Finishes	Fair - exhibiting deficiencies requiring minor service/repair to extend useful life
Deficiency Category-Flooring Finishes	Beyond Useful Life
Quantity-Flooring Finishes	10
Unit-Flooring Finishes	%
Year Installed-Flooring Finishes	1990
Comments-Flooring Finishes	Older flooring in good condition for age.

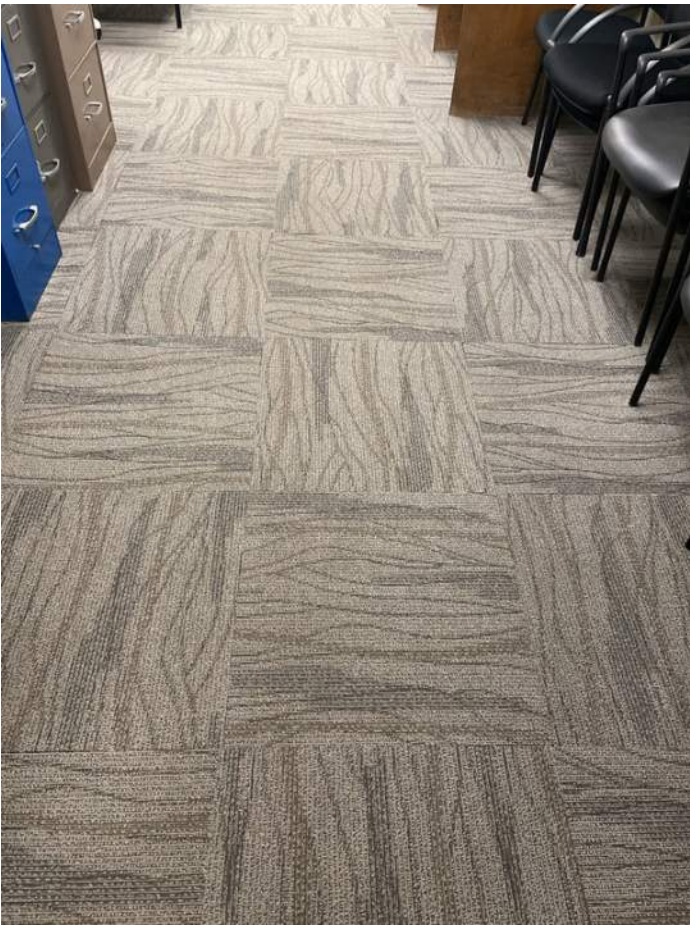
Photos-Flooring Finishes

Type Description-Flooring Finishes	New Carpet
Condition Rating-Flooring Finishes	Excellent - no known deficiencies or visible depreciation
Deficiency Category-Flooring Finishes	No Immediate Action
Quantity-Flooring Finishes	10
Unit-Flooring Finishes	%
Year Installed-Flooring Finishes	2017
Comments-Flooring Finishes	n/a

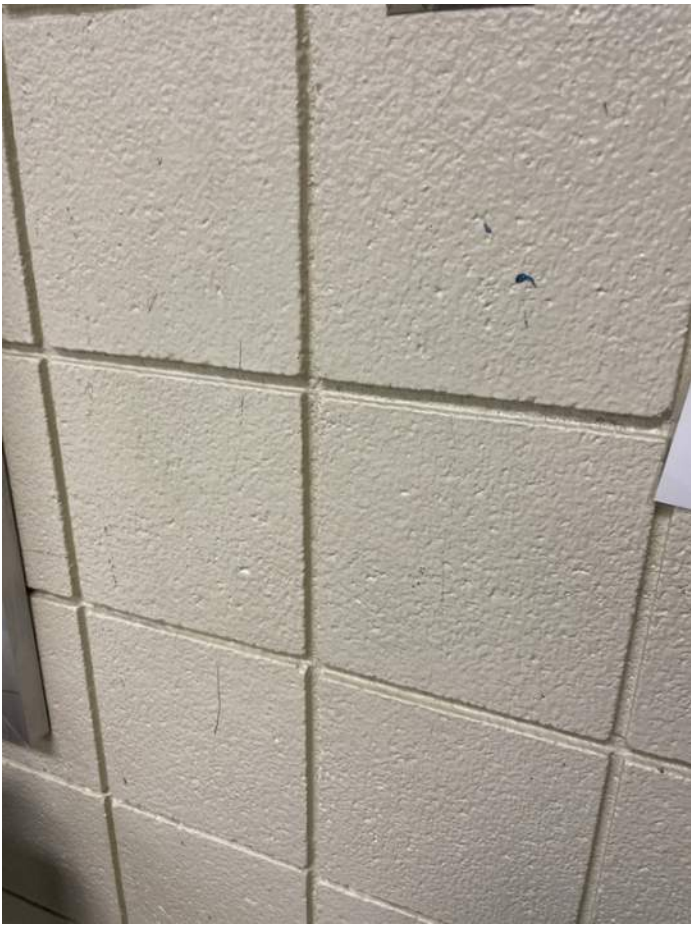
Photos-Wall Finishes

Type Description-Wall Finishes	Paint
Condition Rating-Wall Finishes	Poor - nearing end of useful life, and requiring major service/repair to remain operational
Deficiency Category-Wall Finishes	Beyond Useful Life
Quantity-Wall Finishes	n/a
Unit-Wall Finishes	n/a
Year Installed-Wall Finishes	n/a
Comments-Wall Finishes	n/a

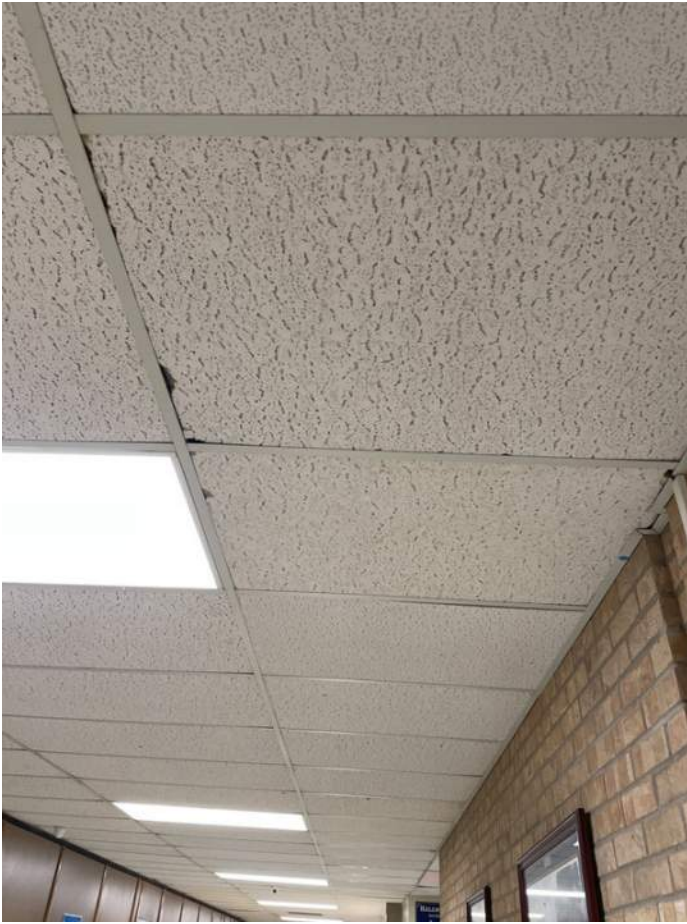
Photos-Ceiling Finishes

Type Description-Ceiling Finishes	2x4 Acoustical Tile
Condition Rating-Ceiling Finishes	Fair - exhibiting deficiencies requiring minor service/repair to extend useful life
Deficiency Category-Ceiling Finishes	n/a
Quantity-Ceiling Finishes	n/a
Unit-Ceiling Finishes	n/a

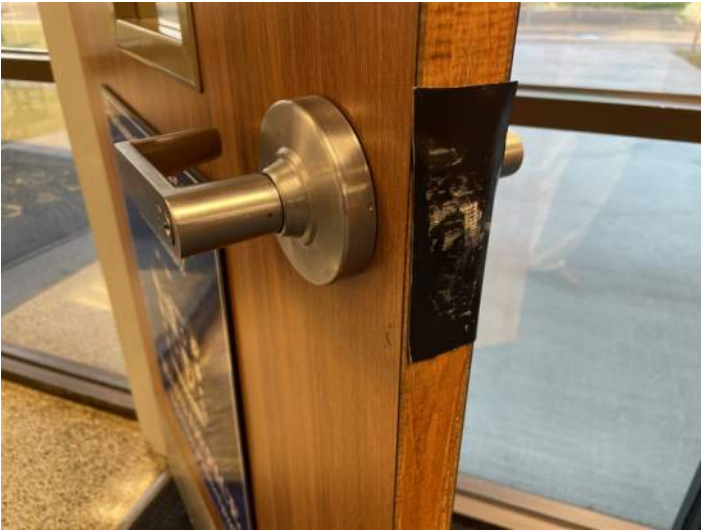
Photos-Interior Doors

Type Description-Interior Doors	Electrified lockset
Condition Rating-Interior Doors	Critical - failed or failing, and beyond useful life requiring immediate attention
Deficiency Category-Interior Doors	Inadequate
Quantity-Interior Doors	1
Unit-Interior Doors	EA
Year Installed-Interior Doors	2017
Comments-Interior Doors	Electrified lockset installation was never completed. Staff uses tape to unlatch the door. Lockset mechanically damaged.

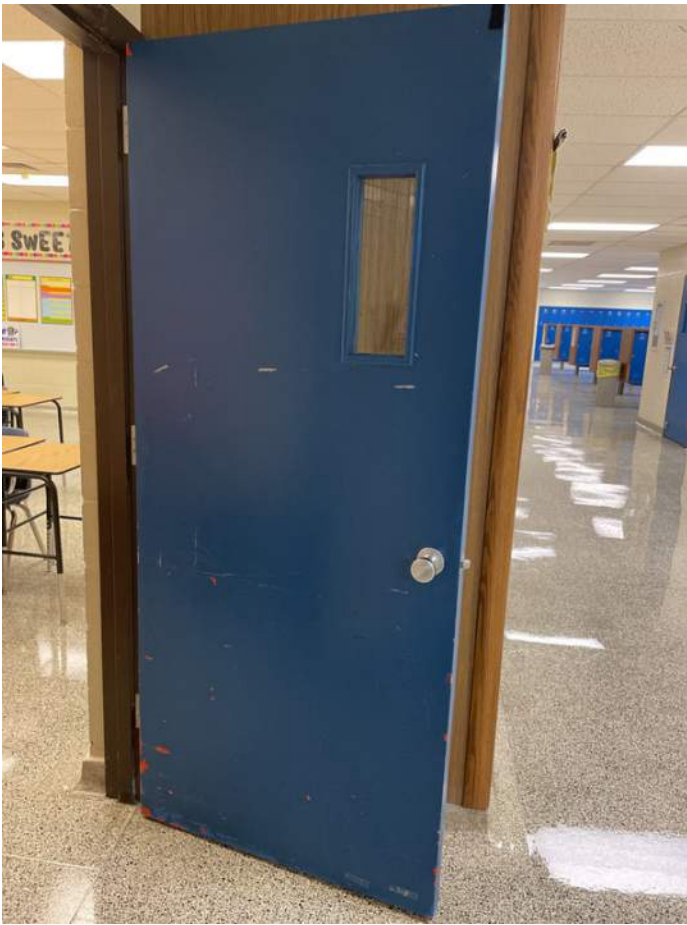
Photos-Interior Doors

Type Description-Interior Doors	Wood
Condition Rating-Interior Doors	Poor - nearing end of useful life, and requiring major service/repair to remain operational
Deficiency Category-Interior Doors	Beyond Useful Life
Quantity-Interior Doors	95
Unit-Interior Doors	%
Year Installed-Interior Doors	n/a
Comments-Interior Doors	n/a

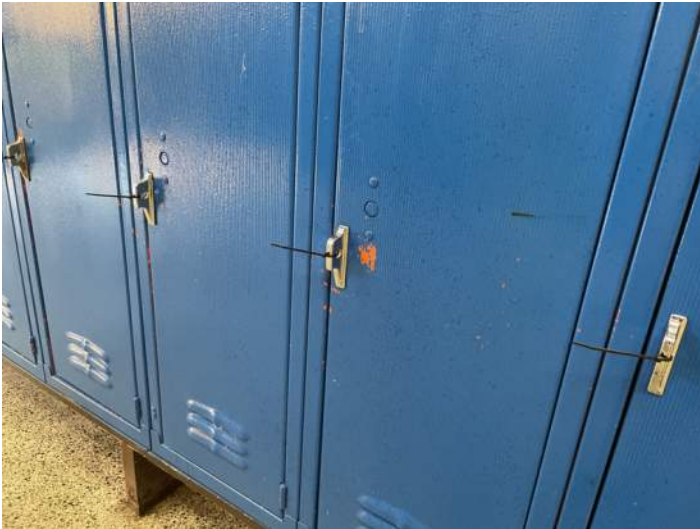
Photos-Fixed Furnishings

Type Description-Fixed Furnishings	Lockers
Condition Rating-Fixed Furnishings	Fair - exhibiting deficiencies requiring minor service/repair to extend useful life
Deficiency Category-Fixed Furnishings	No Immediate Action
Quantity-Fixed Furnishings	n/a
Unit-Fixed Furnishings	n/a
Year Installed-Fixed Furnishings	1980
Comments-Fixed Furnishings	Not using. Paint needed.

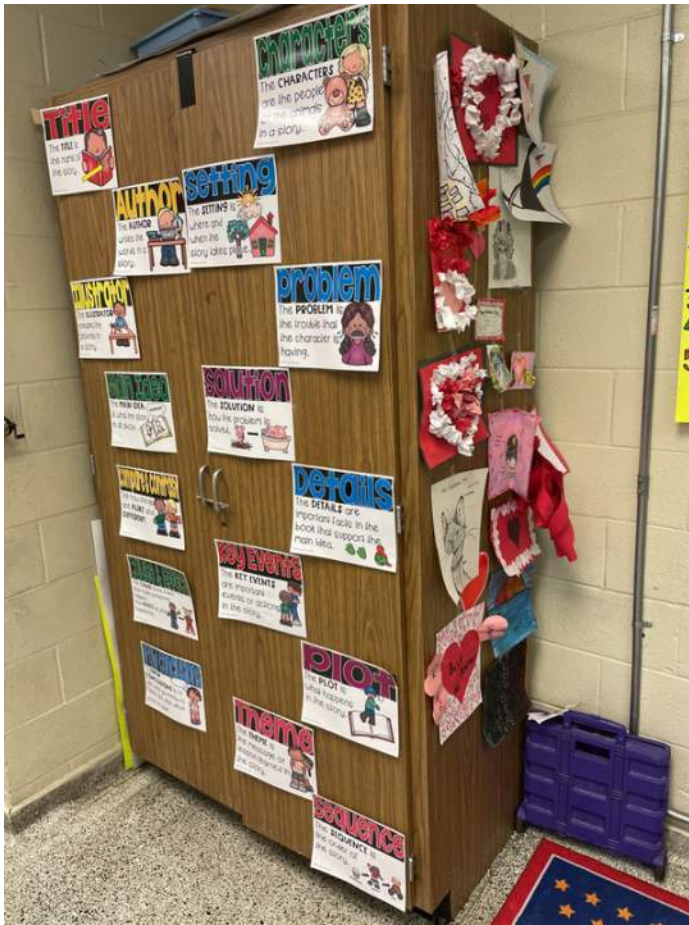
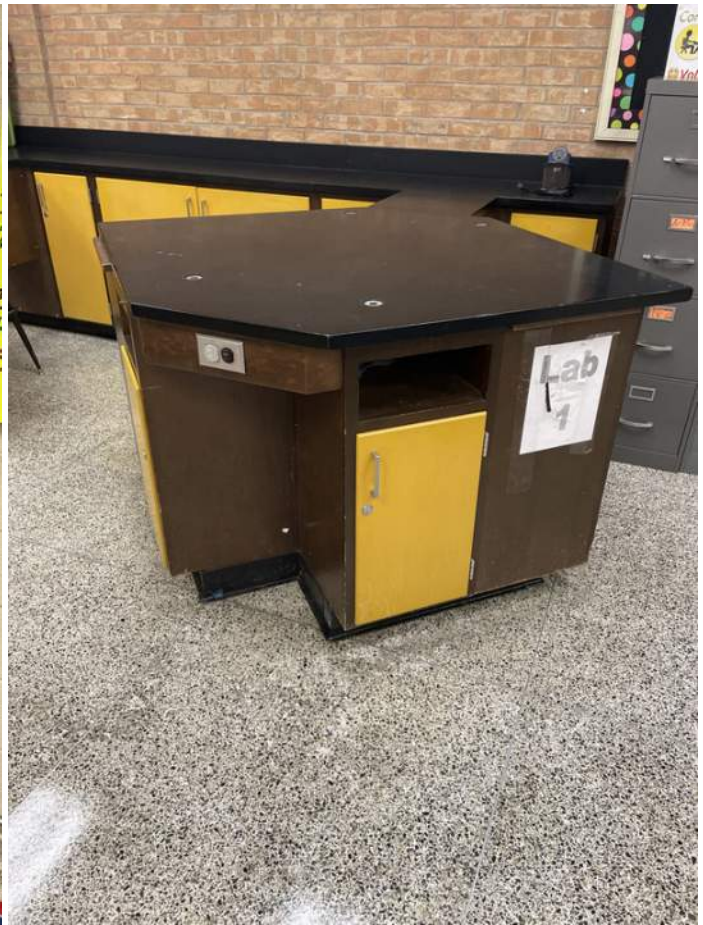
Photos-Fixed Furnishings

Type Description-Fixed Furnishings	Millwork
Condition Rating-Fixed Furnishings	Fair - exhibiting deficiencies requiring minor service/repair to extend useful life
Deficiency Category-Fixed Furnishings	Beyond Useful Life
Quantity-Fixed Furnishings	n/a
Unit-Fixed Furnishings	n/a
Year Installed-Fixed Furnishings	1980
Comments-Fixed Furnishings	n/a

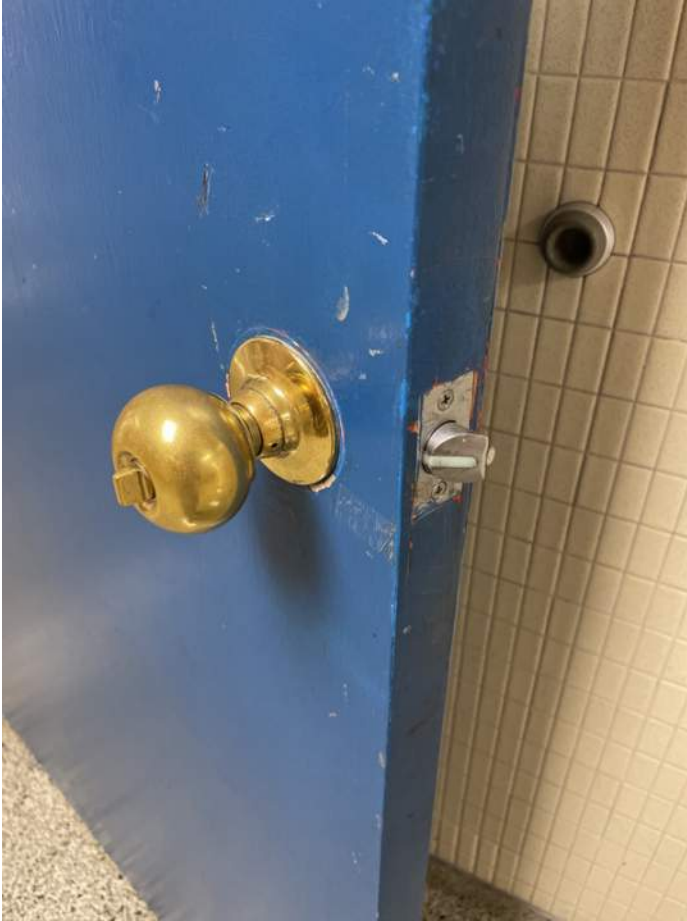
Photos-Accessibility

Most doors do not have accessible locks.
