Fort Stockton ISD - Condition Assessment

Alamo Elementary

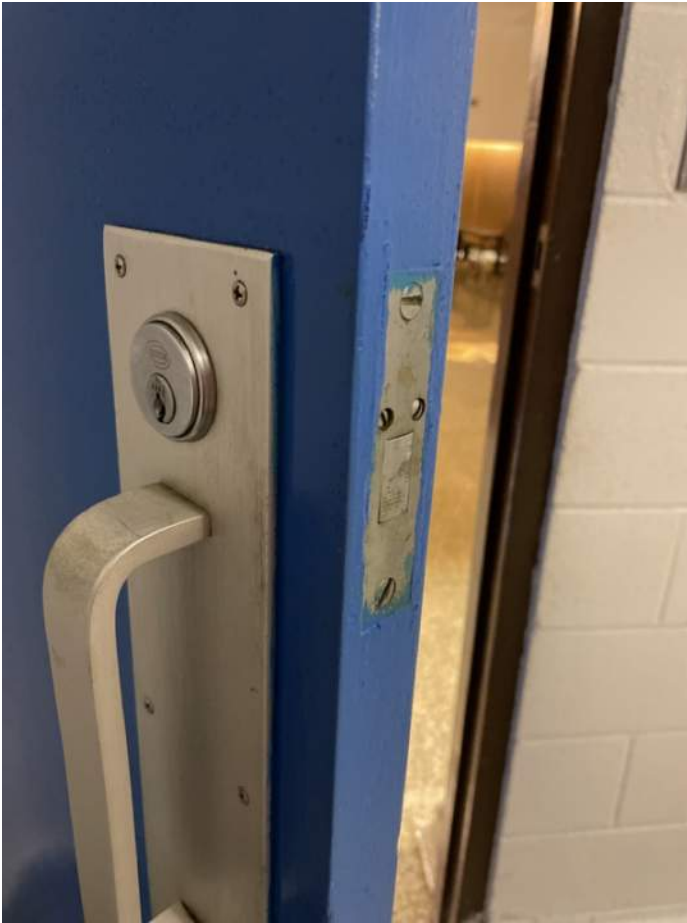
Photos-Building Codes

Building Codes - 1. Fire code issue. Non-egress deadbolts on 2 serving line doors. Fire and building code do not allow non-egress deadbolts on these doors. Deadbolts can be replaced without replacing doors.

Fire code issue. Non-egress deadbolts on 2 serving line doors. Fire and building code do not allow non-egress deadbolts on these doors. Deadbolts can be replaced without replacing doors.

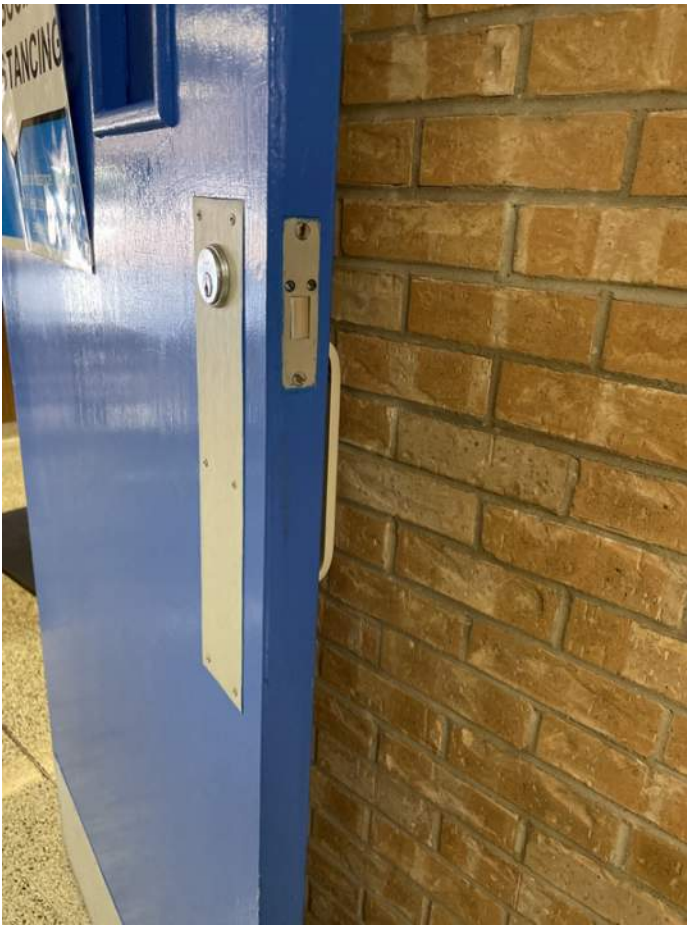
Photos-Building Codes

Building Codes - 2. Fire code issue. 3 pair of doors in the cafeteria have deadbolts. Fire and building codes do not allow deadbolts on these doors.

Fire code issue. 3 pair of doors in the cafeteria have deadbolts. Fire and building codes do not allow deadbolts on these doors.

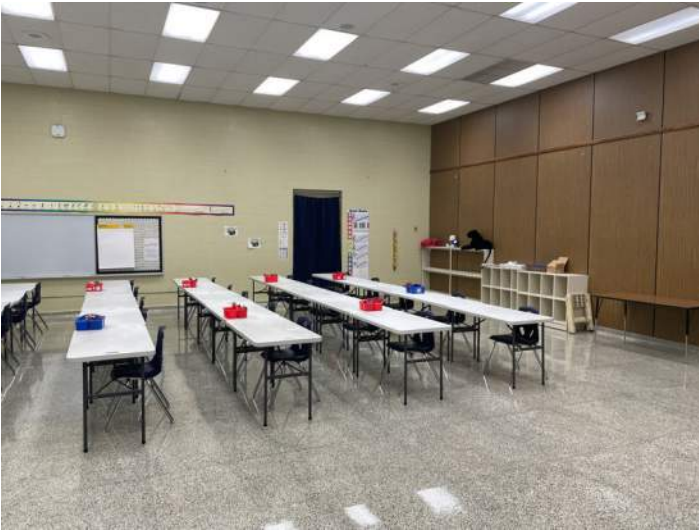
Photos-Building Codes

Building Codes - 3. Fire code issue. Rooms 1 and 17 are larger than 1,000 SF. They need two exits each with exit devices. A door between the rooms can be adjusted to allow dual egress.

Fire code issue. Room 17 is larger than 1,000 SF and the Library has an occupant load higher than 49. These spaces have only one exit and no panic devices. Building and fire codes require these spaces to have two exits with exit devices.

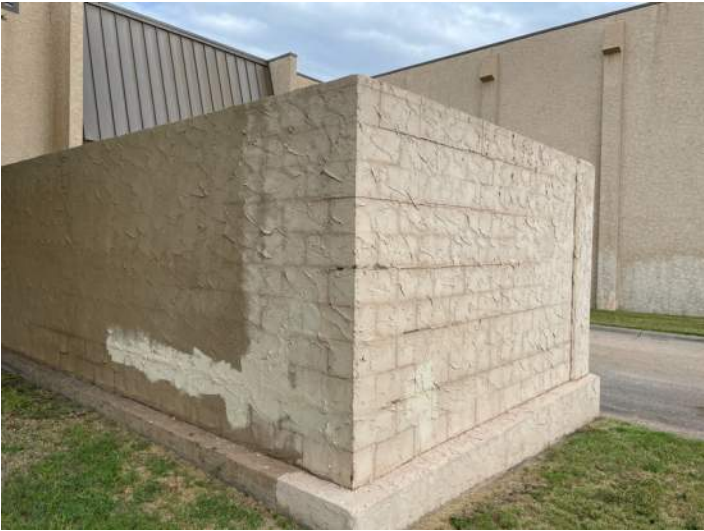
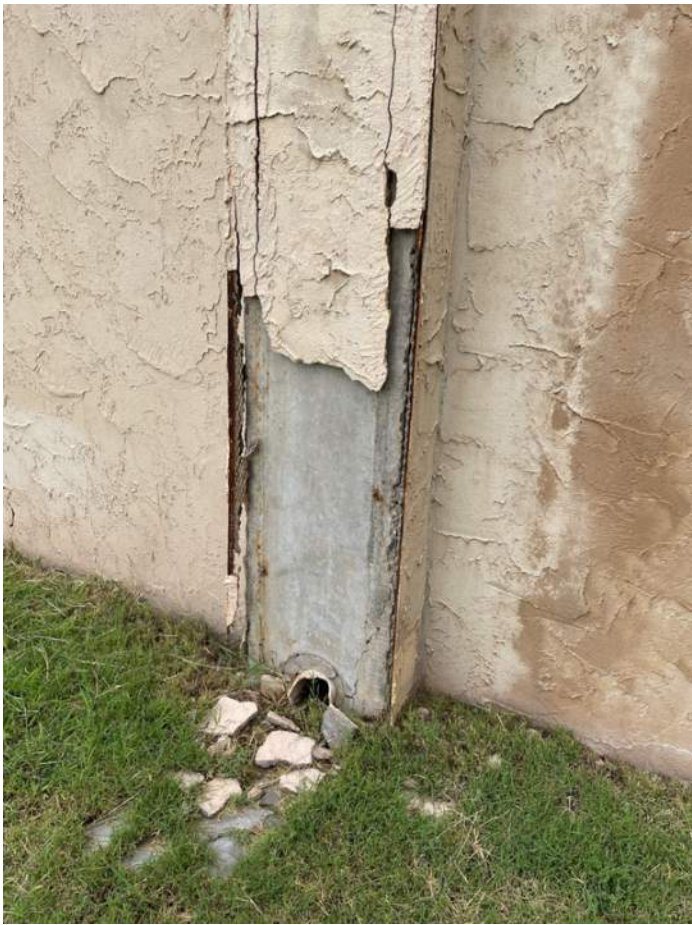
Photos-Exterior Walls

Type Description-Exterior Walls	Stucco
Condition Rating-Exterior Walls	Poor - nearing end of useful life, and requiring major service/repair to remain operational
Deficiency Category-Exterior Walls	Damaged/Failing
Quantity-Exterior Walls	100
Unit-Exterior Walls	%
Year Installed-Exterior Walls	1980
Comments-Exterior Walls	Widespread damage all around the building.

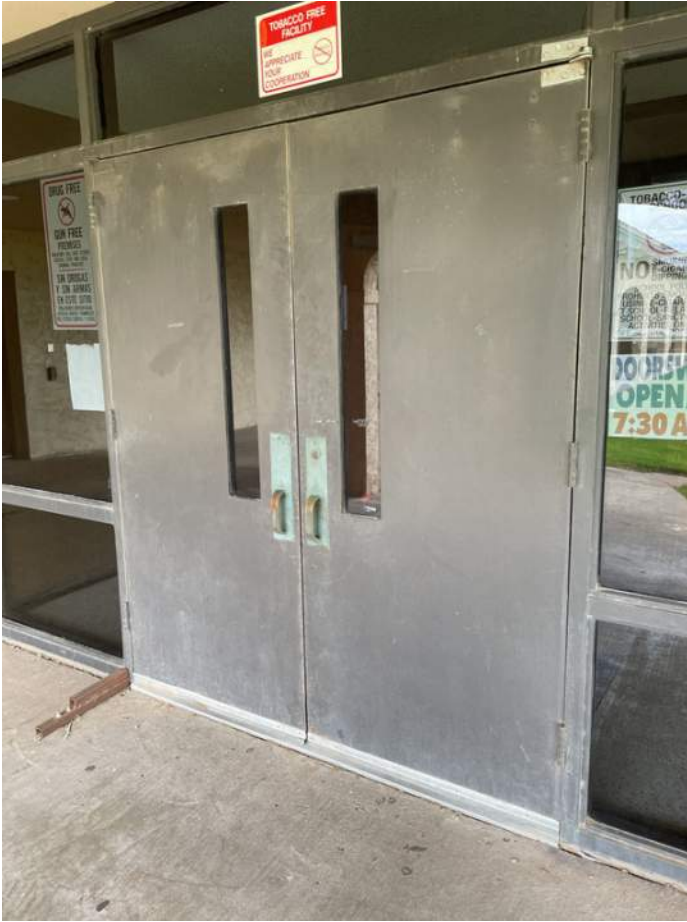
Photos-Exterior Doors

Type Description-Exterior Doors	Hollow metal
Condition Rating-Exterior Doors	Poor - nearing end of useful life, and requiring major service/repair to remain operational
Deficiency Category-Exterior Doors	Damaged/Failing

Quantity-Exterior Doors	100
Unit-Exterior Doors	%
Year Installed-Exterior Doors	1980
Comments-Exterior Doors	Most doors do not latch correctly and required secondary locks.

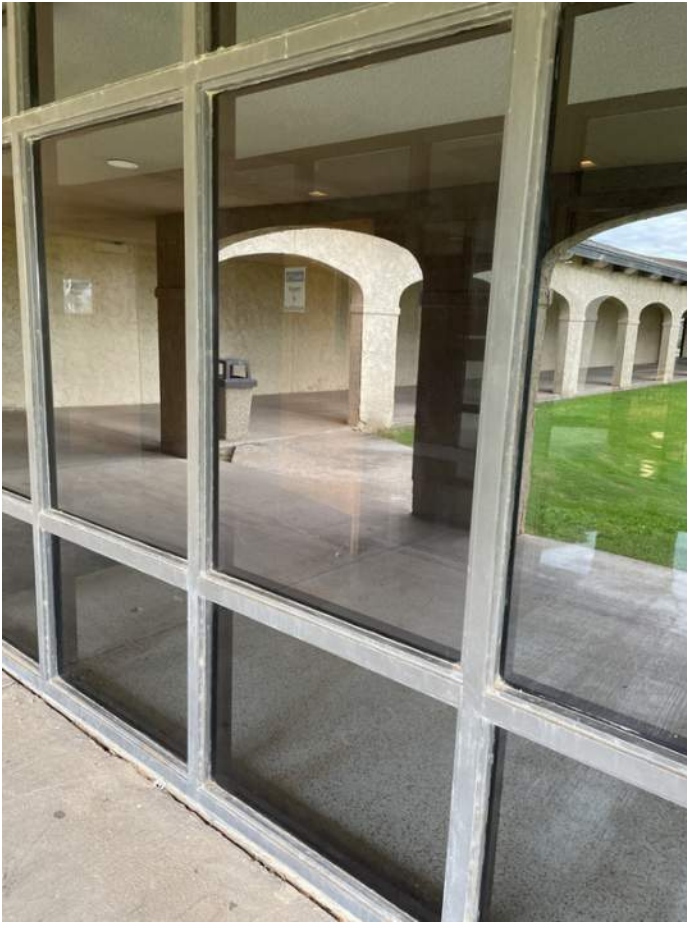
Photos-Windows

Type Description-Windows	Hollow metal
Condition Rating-Windows	Fair - exhibiting deficiencies requiring minor service/repair to extend useful life
Deficiency Category-Windows	Beyond Useful Life
Quantity-Windows	100
Unit-Windows	%
Year Installed-Windows	1980
Comments-Windows	In good shape for age. Painting will extend life.

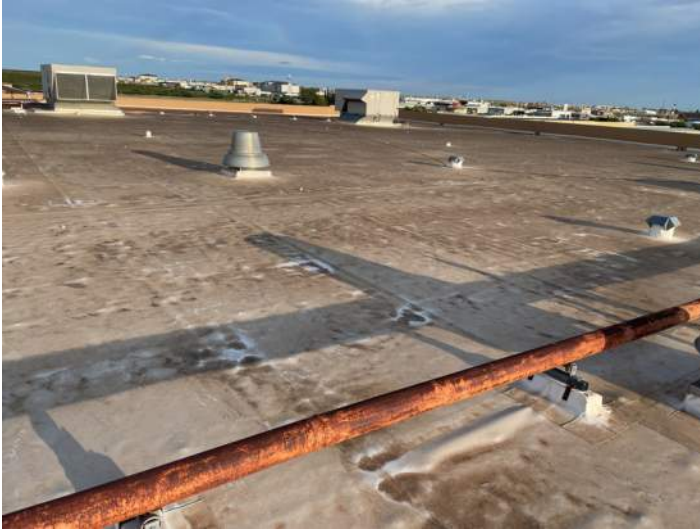
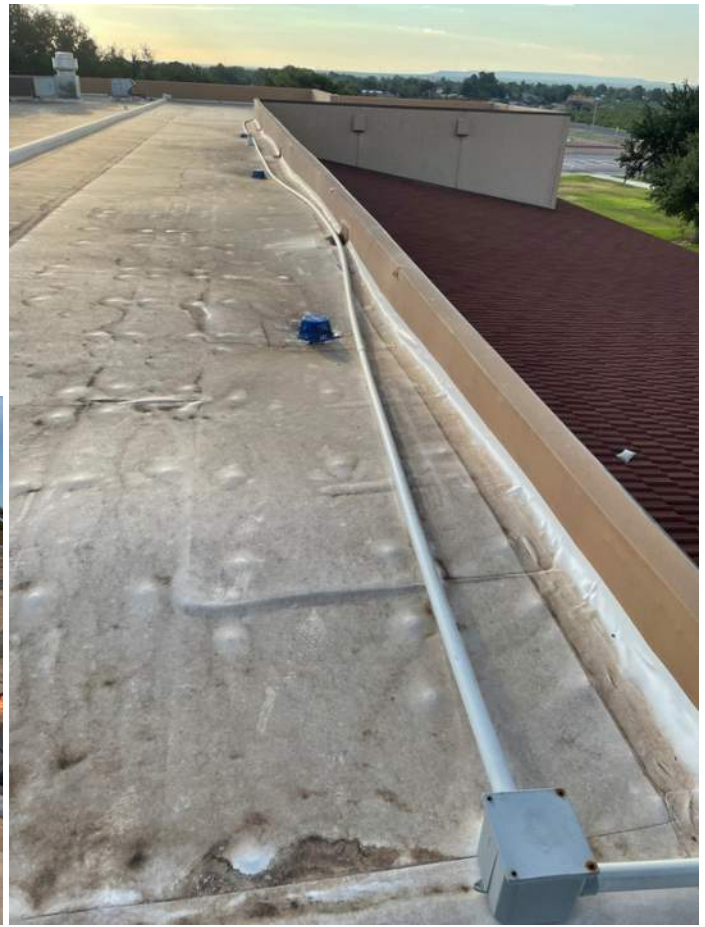
Photos-Roofing

Type Description-Roofing	Single Ply
Condition Rating-Roofing	Good - minimal depreciation, consistent with asset age
Deficiency Category-Roofing	Missing
Quantity-Roofing	85
Unit-Roofing	%
Year Installed-Roofing	n/a
Comments-Roofing	Unknown age. Looks new. A lot of rocks on the roof. If stepped on , the rocks can create leaks. Conduit in contact with roof in several areas. Missing supports for conduit in a few areas.

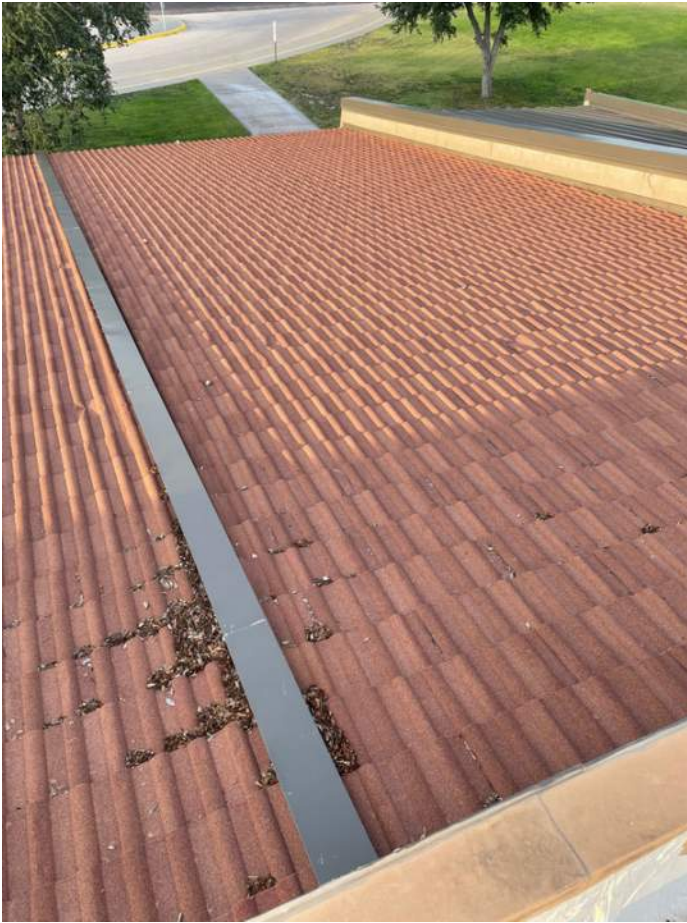
Photos-Roofing

Type Description-Roofing	Metal Tile
Condition Rating-Roofing	Good - minimal depreciation, consistent with asset age
Deficiency Category-Roofing	No Immediate Action
Quantity-Roofing	10
Unit-Roofing	%
Year Installed-Roofing	n/a
Comments-Roofing	Unknown age. Good condition.

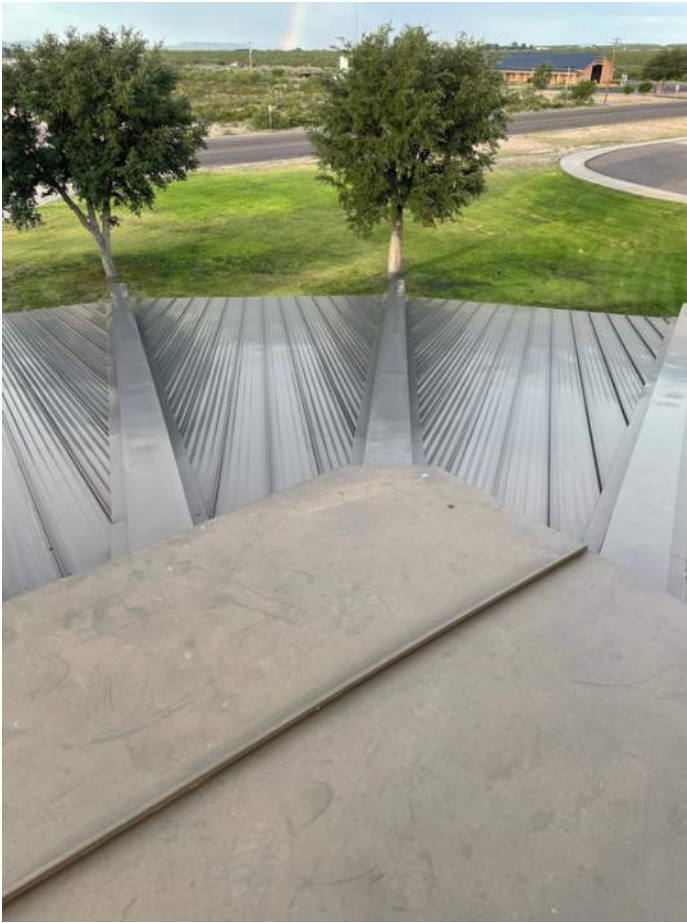
Photos-Roofing

Type Description-Roofing	Metal
Condition Rating-Roofing	Good - minimal depreciation, consistent with asset age
Deficiency Category-Roofing	No Immediate Action
Quantity-Roofing	5
Unit-Roofing	%
Year Installed-Roofing	n/a
Comments-Roofing	Unknown age. Good condition.

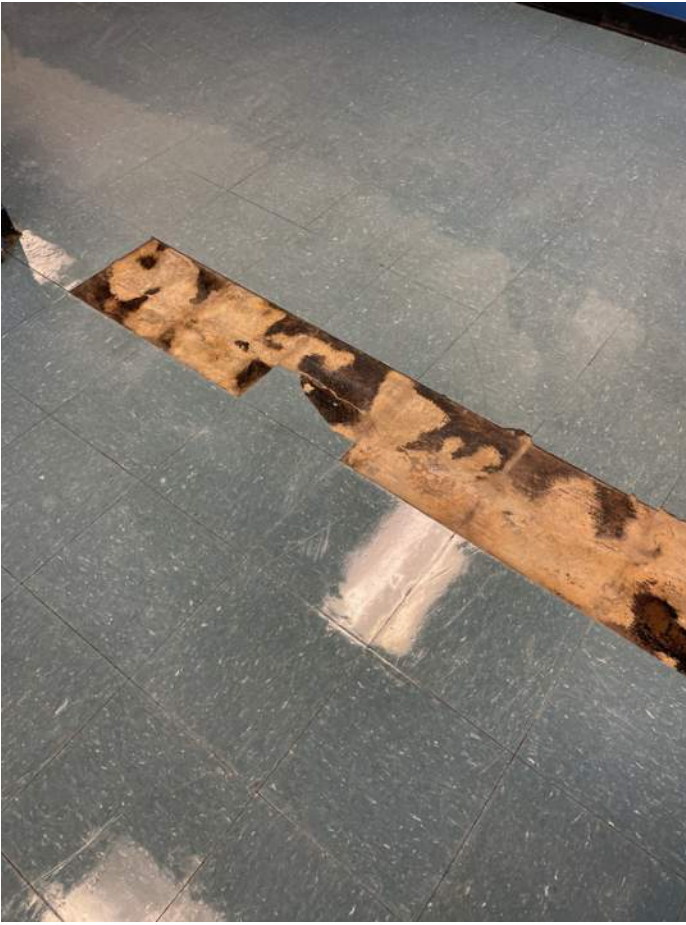
Photos-Flooring Finishes

Type Description-Flooring Finishes	12x12 VCT in locker rooms.
Condition Rating-Flooring Finishes	Critical - failed or failing, and beyond useful life requiring immediate attention
Deficiency Category-Flooring Finishes	Damaged/Failing
Quantity-Flooring Finishes	10
Unit-Flooring Finishes	%
Year Installed-Flooring Finishes	1980
Comments-Flooring Finishes	Tile cracks when waking on. Several tiles missing.

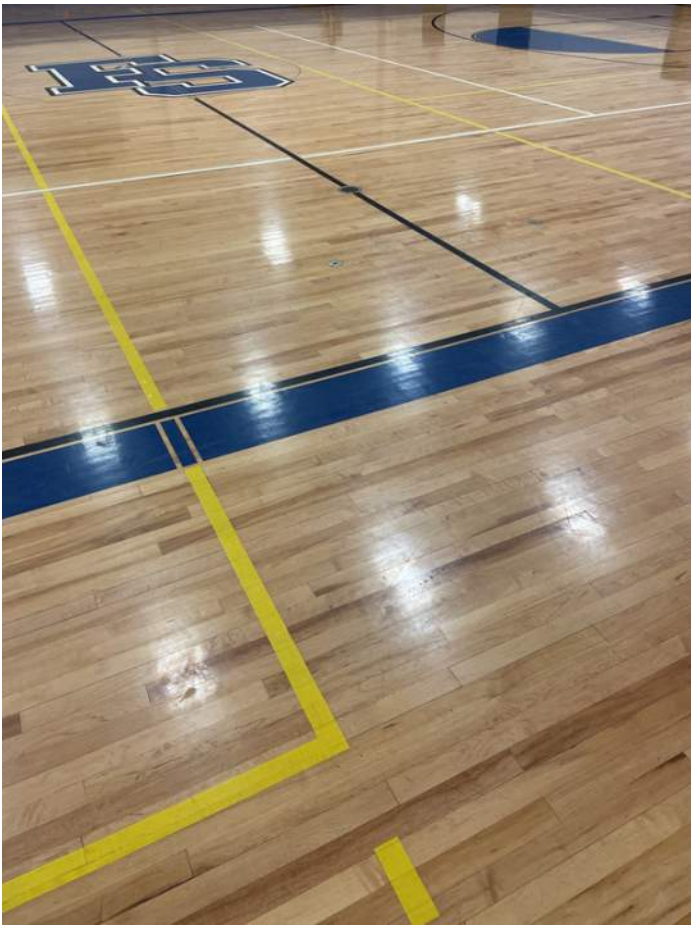
Photos-Flooring Finishes

Type Description-Flooring Finishes	Wood
Condition Rating-Flooring Finishes	Good - minimal depreciation, consistent with asset age
Deficiency Category-Flooring Finishes	No Immediate Action
Quantity-Flooring Finishes	10
Unit-Flooring Finishes	%
Year Installed-Flooring Finishes	n/a
Comments-Flooring Finishes	n/a

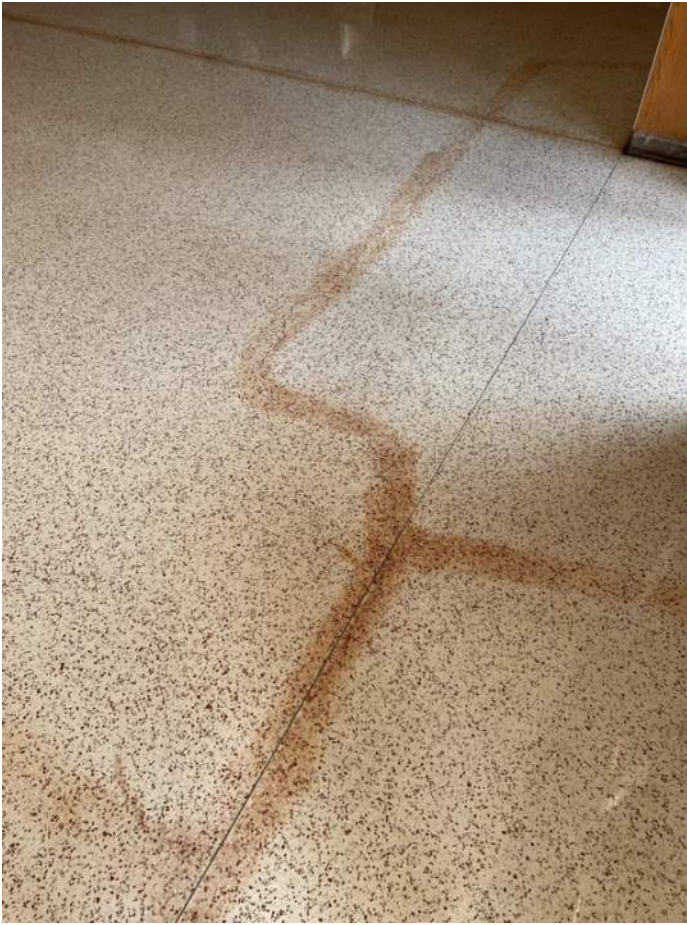
Photos-Flooring Finishes

Type Description-Flooring Finishes	Terrazzo
Condition Rating-Flooring Finishes	Fair - exhibiting deficiencies requiring minor service/repair to extend useful life
Deficiency Category-Flooring Finishes	Damaged/Failing
Quantity-Flooring Finishes	15
Unit-Flooring Finishes	%
Year Installed-Flooring Finishes	1980
Comments-Flooring Finishes	Craking in several locations. A treatment for the cracks stained the floor.

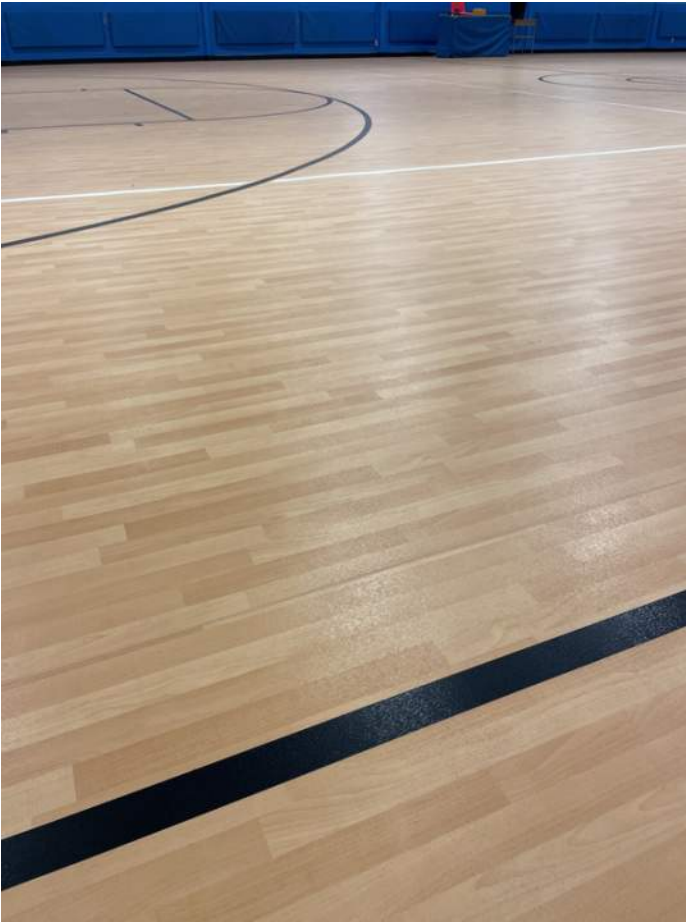
Photos-Flooring Finishes

Type Description-Flooring Finishes	Rubber
Condition Rating-Flooring Finishes	Excellent - no known deficiencies or visible depreciation
Deficiency Category-Flooring Finishes	No Immediate Action
Quantity-Flooring Finishes	5
Unit-Flooring Finishes	%
Year Installed-Flooring Finishes	n/a
Comments-Flooring Finishes	Unknown age. Looks new.

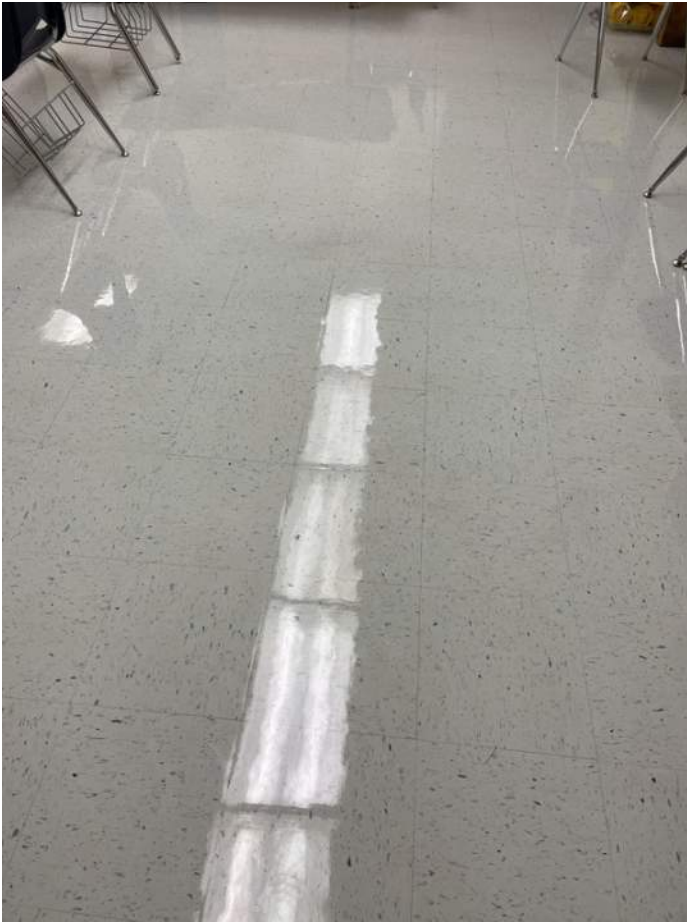
Photos-Flooring Finishes

Type Description-Flooring Finishes	12x12 VCT
Condition Rating-Flooring Finishes	Good - minimal depreciation, consistent with asset age
Deficiency Category-Flooring Finishes	No Immediate Action
Quantity-Flooring Finishes	20
Unit-Flooring Finishes	%
Year Installed-Flooring Finishes	n/a
Comments-Flooring Finishes	n/a

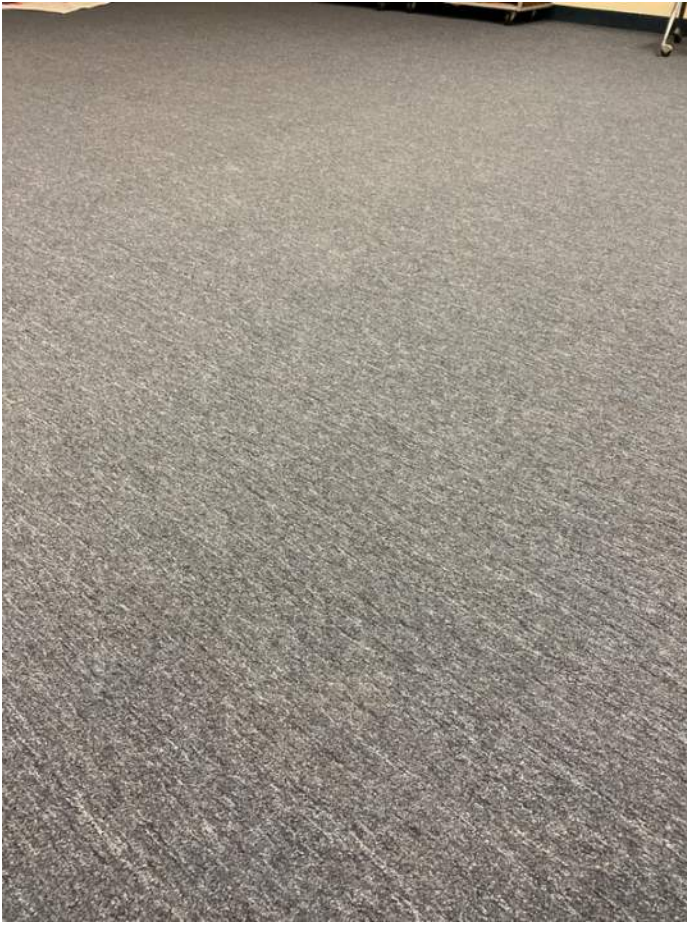
Photos-Flooring Finishes

Type Description-Flooring Finishes	Carpet
Condition Rating-Flooring Finishes	Good - minimal depreciation, consistent with asset age
Deficiency Category-Flooring Finishes	No Immediate Action
Quantity-Flooring Finishes	15
Unit-Flooring Finishes	%
Year Installed-Flooring Finishes	n/a
Comments-Flooring Finishes	n/a

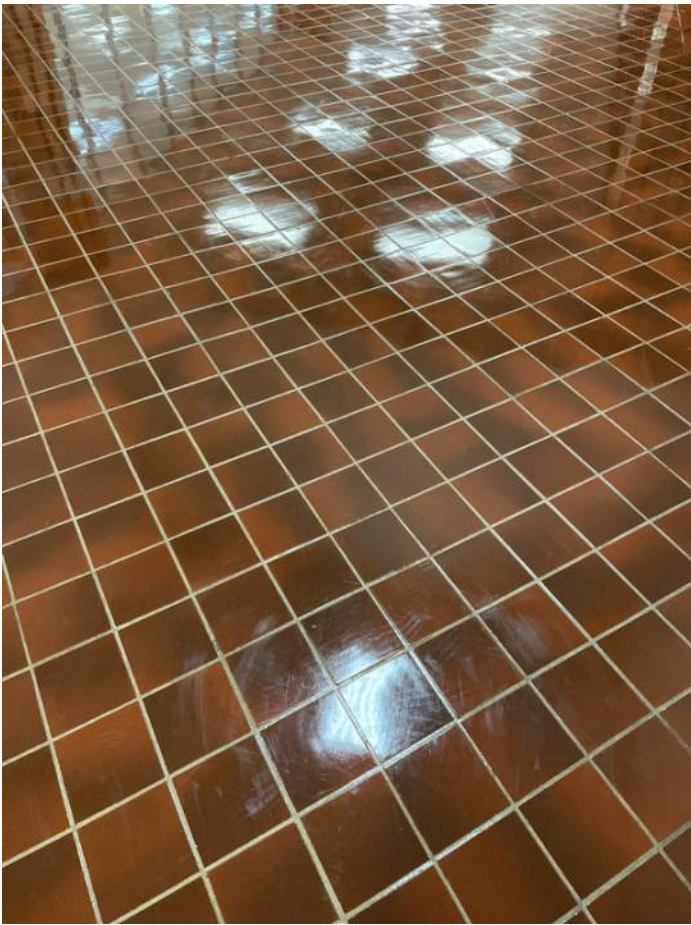
Type Description-Flooring Finishes	Ceramic tile
Condition Rating-Flooring Finishes	Good - minimal depreciation, consistent with asset age
Deficiency Category-Flooring Finishes	No Immediate Action
Quantity-Flooring Finishes	5
Unit-Flooring Finishes	%
Year Installed-Flooring Finishes	1980
Comments-Flooring Finishes	n/a

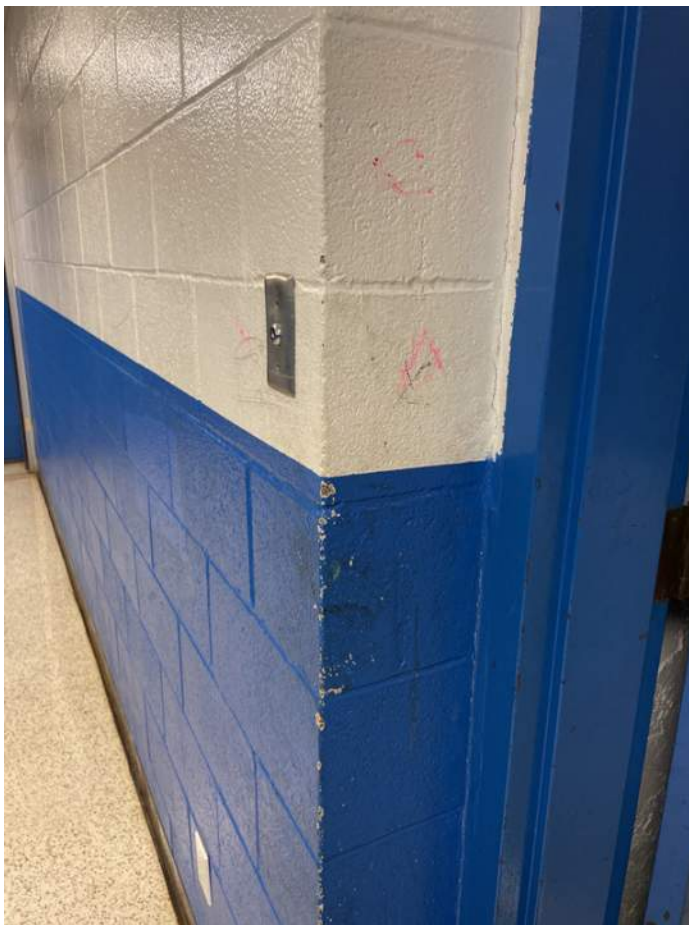
Wall Finishes - 1. Paint

Type Description-Wall Finishes	Paint
Condition Rating-Wall Finishes	Fair - exhibiting deficiencies requiring minor service/repair to extend useful life
Deficiency Category-Wall Finishes	Beyond Useful Life
Quantity-Wall Finishes	80
Unit-Wall Finishes	%
Year Installed-Wall Finishes	n/a
Comments-Wall Finishes	Paint damage in several areas.

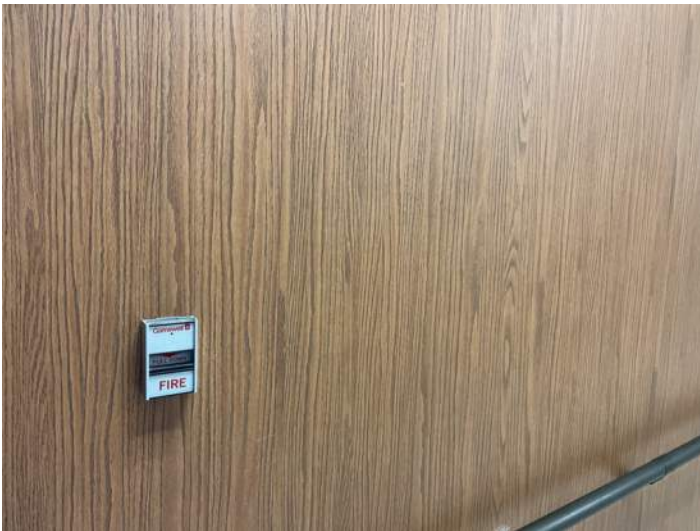
Wall Finishes - 2. PLAM

Type Description-Wall Finishes	PLAM
Condition Rating-Wall Finishes	Good - minimal depreciation, consistent with asset age
Deficiency Category-Wall Finishes	No Immediate Action
Quantity-Wall Finishes	15
Unit-Wall Finishes	%
Year Installed-Wall Finishes	1980
Comments-Wall Finishes	n/a

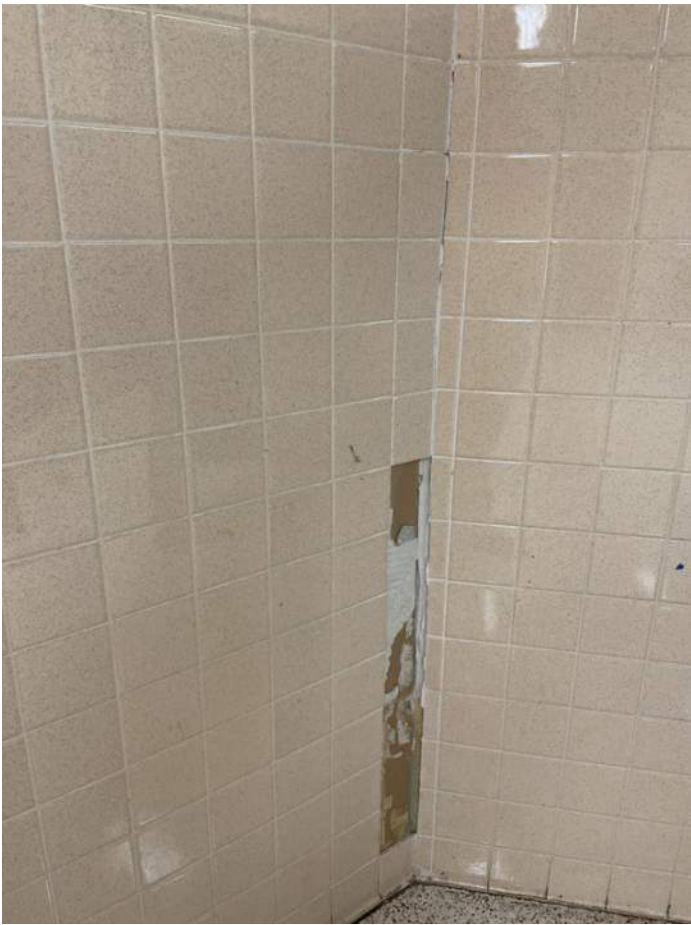
Wall Finishes - 3. Ceramic tile

Type Description-Wall Finishes	Ceramic tile
Condition Rating-Wall Finishes	Poor - nearing end of useful life, and requiring major service/repair to remain operational
Deficiency Category-Wall Finishes	Damaged/Failing
Quantity-Wall Finishes	5
Unit-Wall Finishes	%
Year Installed-Wall Finishes	1980
Comments-Wall Finishes	Tiles missing.

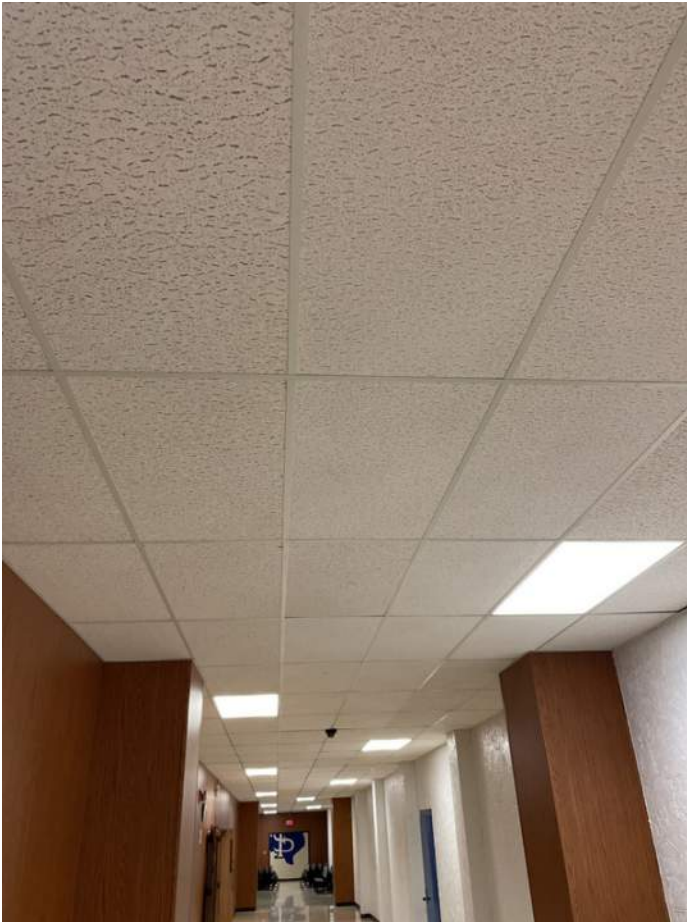
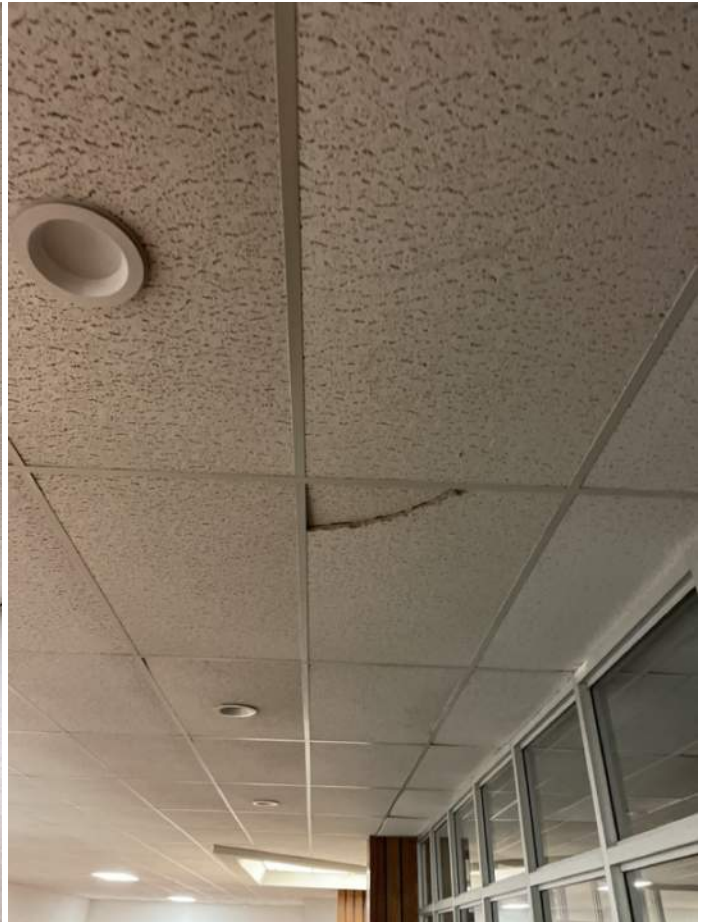
Ceiling Finishes - 1. 2x4 Acoustical Tile

Condition Rating-Ceiling Finishes	Fair - exhibiting deficiencies requiring minor service/repair to extend useful life
Deficiency Category-Ceiling Finishes	No Immediate Action
Quantity-Ceiling Finishes	100
Unit-Ceiling Finishes	%
Year Installed-Ceiling Finishes	1980
Comments-Ceiling Finishes	Some damage that could be easily replaced.

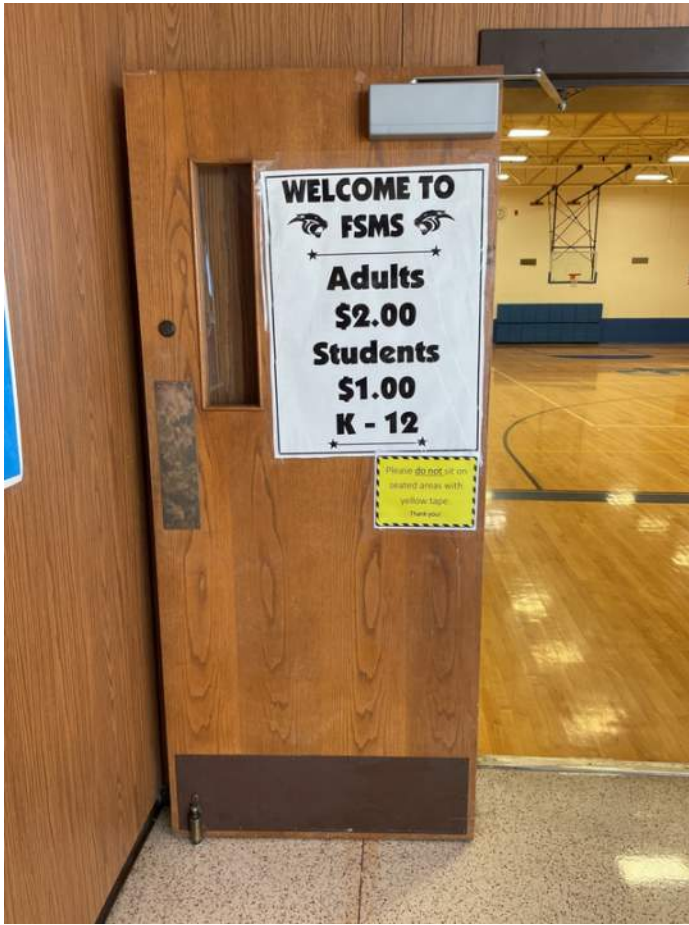
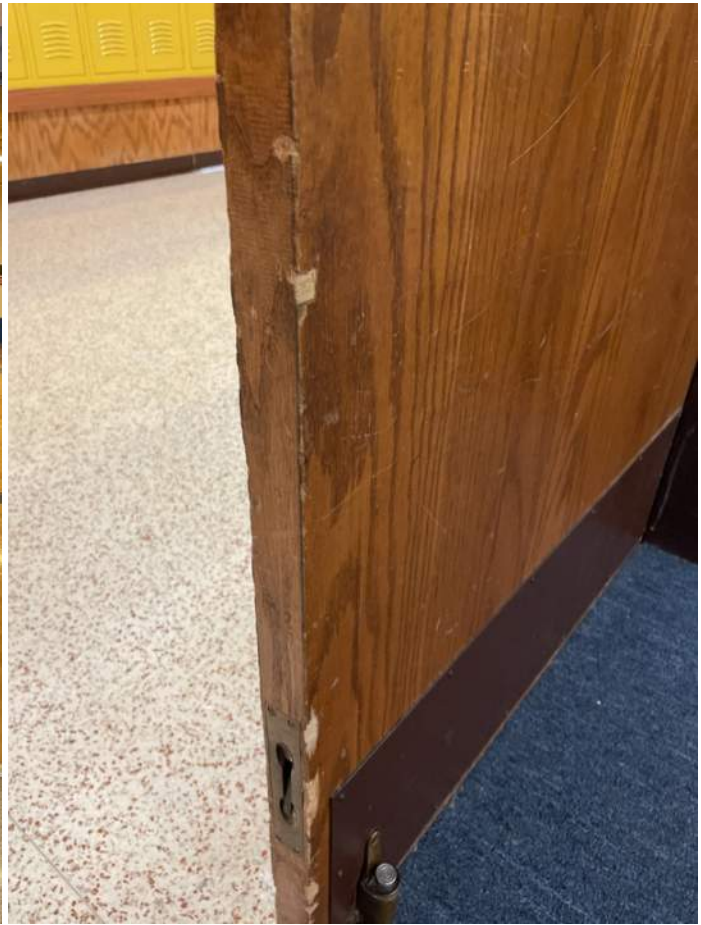
Interior Doors - 1. Wood

Type Description-Interior Doors	Wood
Condition Rating-Interior Doors	Poor - nearing end of useful life, and requiring major service/repair to remain operational
Deficiency Category-Interior Doors	Beyond Useful Life
Quantity-Interior Doors	90
Unit-Interior Doors	%
Year Installed-Interior Doors	1980
Comments-Interior Doors	Some doors are highly damaged. All in poor condition.

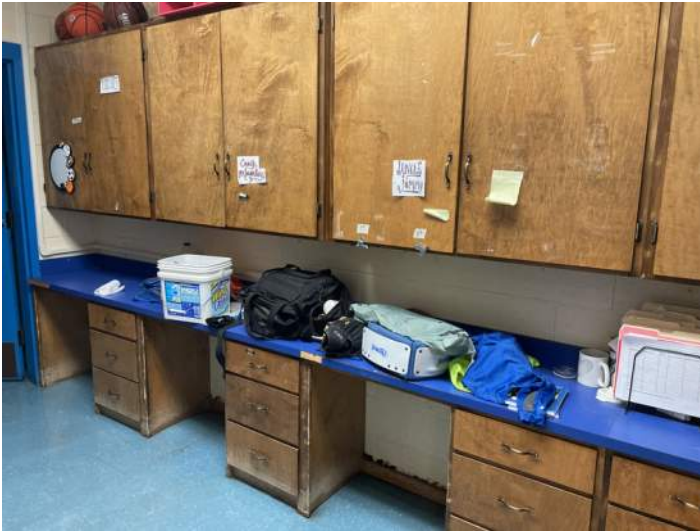
Type Description-Fixed Furnishings	Millwork
Condition Rating-Fixed Furnishings	Poor - nearing end of useful life, and requiring major service/repair to remain operational
Deficiency Category-Fixed Furnishings	Damaged/Failing
Quantity-Fixed Furnishings	n/a

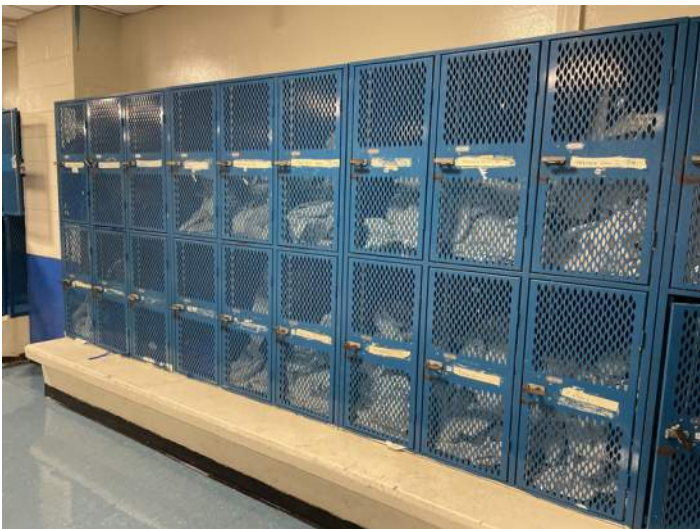
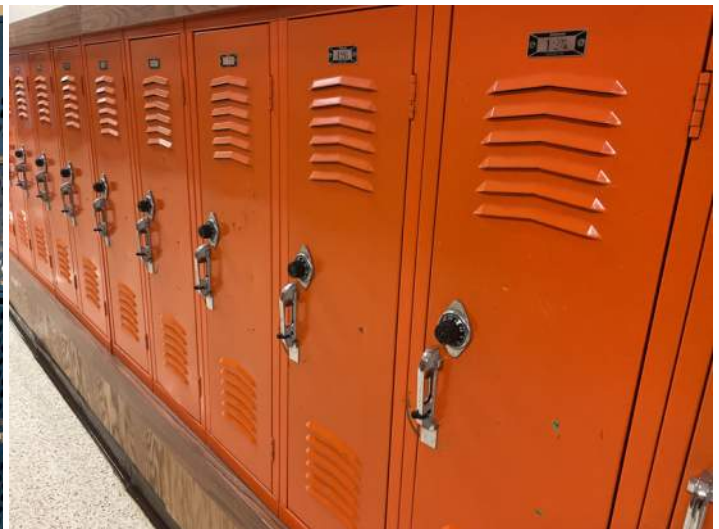
**Fixed Furnishings - 2. Lockers**

Type Description-Fixed Furnishings	Lockers
Condition Rating-Fixed Furnishings	Fair - exhibiting deficiencies requiring minor service/repair to extend useful life
Deficiency Category-Fixed Furnishings	No Immediate Action
Quantity-Fixed Furnishings	n/a
Unit-Fixed Furnishings	%
Year Installed-Fixed Furnishings	1980
Comments-Fixed Furnishings	Still operational. Painting will extend life.

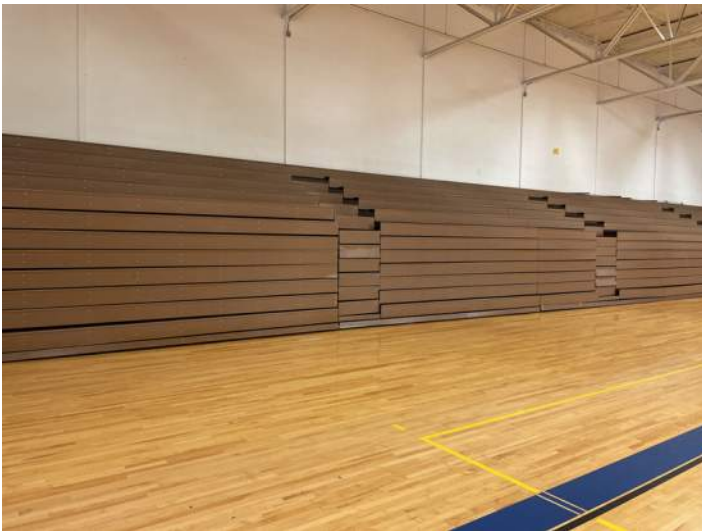
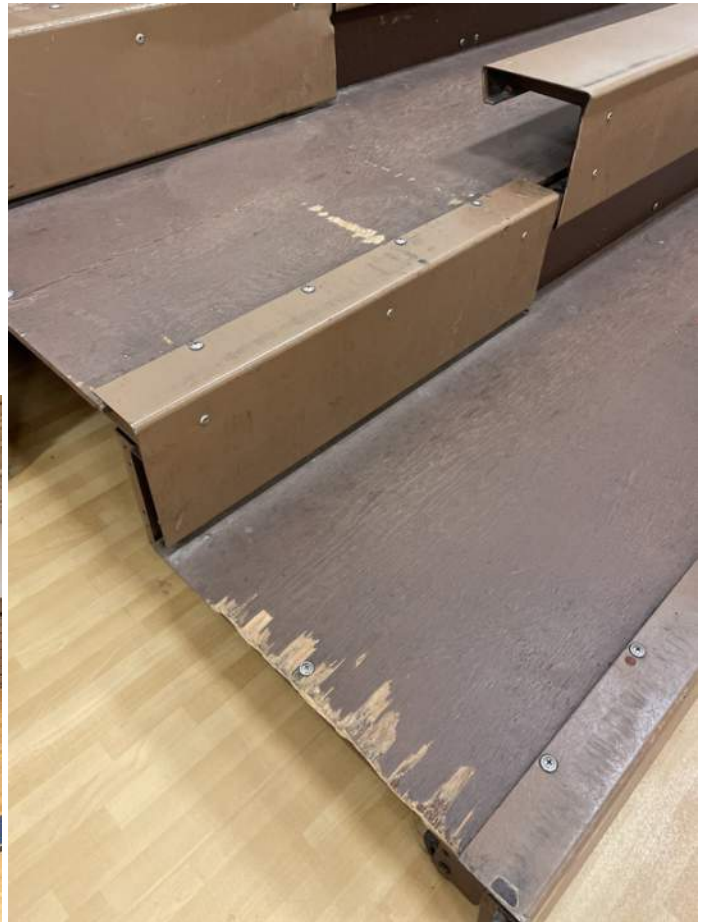
Fixed Furnishings - 3. Bleachers

Type Description-Fixed Furnishings	Bleachers
Condition Rating-Fixed Furnishings	Poor - nearing end of useful life, and requiring major service/repair to remain operational
Deficiency Category-Fixed Furnishings	Beyond Useful Life
Quantity-Fixed Furnishings	n/a
Unit-Fixed Furnishings	%
Year Installed-Fixed Furnishings	1980
Comments-Fixed Furnishings	n/a

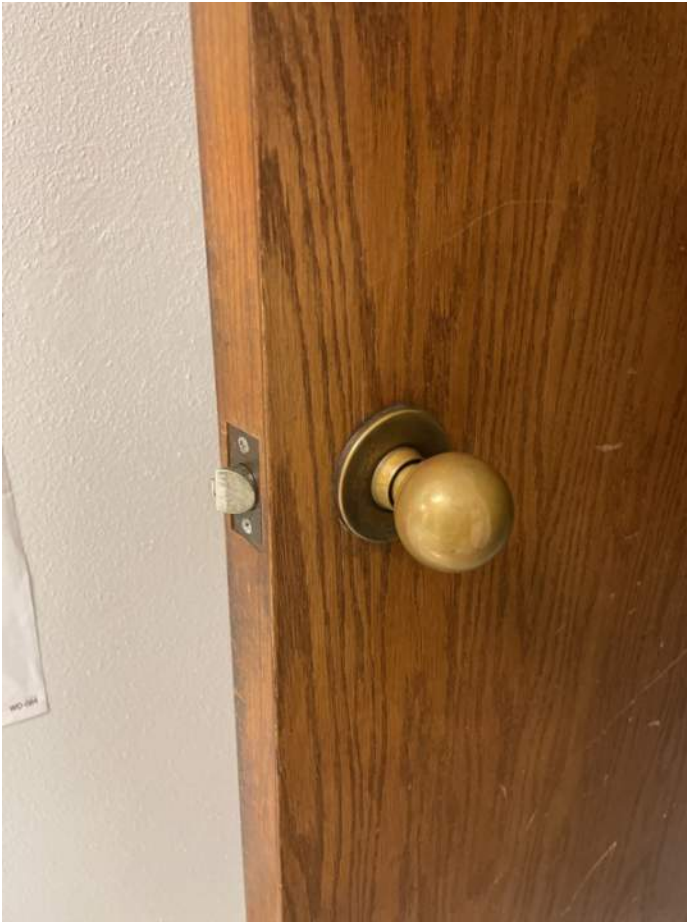
Description-Accessibility | No accessible door turns.

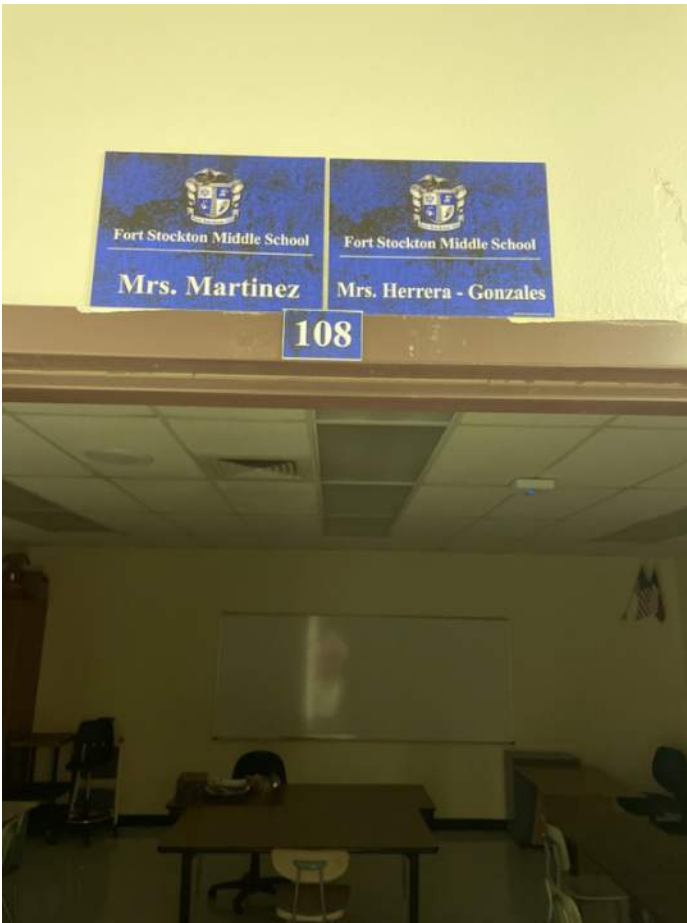
Description-Accessibility | No accessible signage.

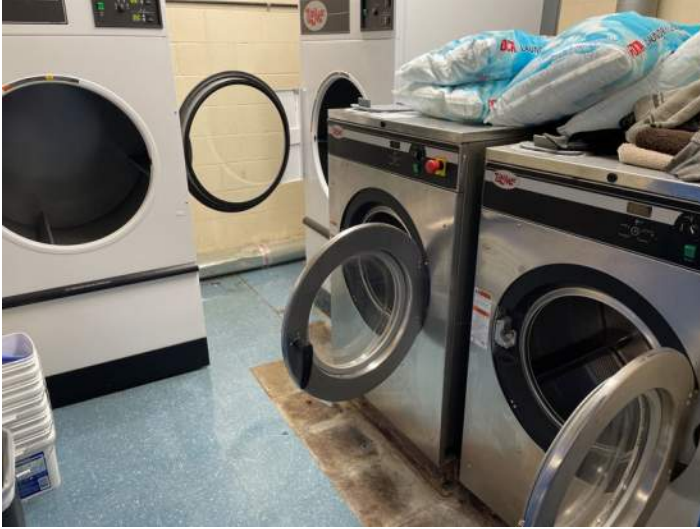
Description-Building Codes | Laundry equipment in unrated room.

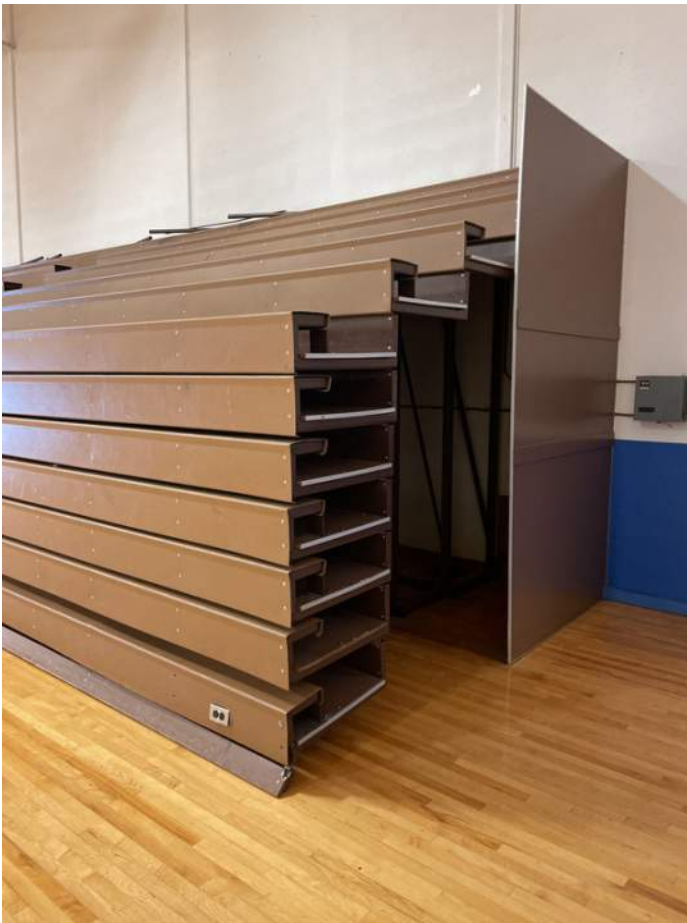
Building Codes - 2. Bleachers have no guards. Falling hazard.

Description-Building Codes | Bleachers have no guards. Falling hazard.

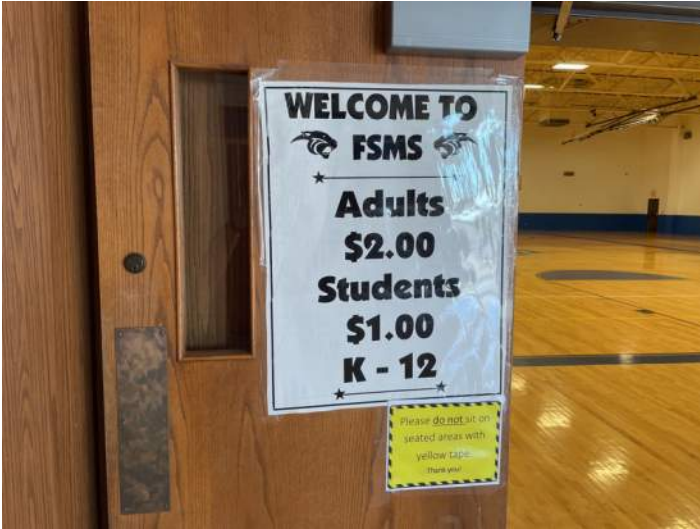
Building Codes - 3. Fire code issue. 19 pairs for doors and 4 single leaf doors to the gyms, cafeteria, room 144, theater, library, and cross corridor doors have deadbolts. Fire and building codes do not allow deadbolts on these doors.

Fire code issue. 19 pairs for doors and 4 single leaf doors to the gyms, cafeteria, room 144, theater, library, and cross corridor doors have deadbolts. Fire and building codes do not allow deadbolts on these doors.

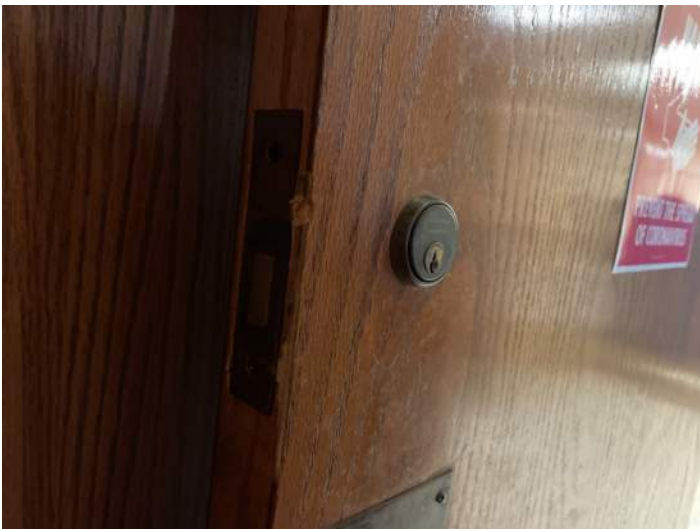
Building Codes - 4. Fire code issue. 3 restroom doors have non-egress deadbolts. Egress deadbolts required in current code. Classroom function recommended. Deadbolts can be replaced without replacing doors.

Fire code issue. 3 restroom doors have non-egress deadbolts. Egress deadbolts required in current code. Classroom function recommended. Deadbolts can be replaced without replacing doors.
