Fort Stockton ISD - Condition Assessment

Alamo Elementary

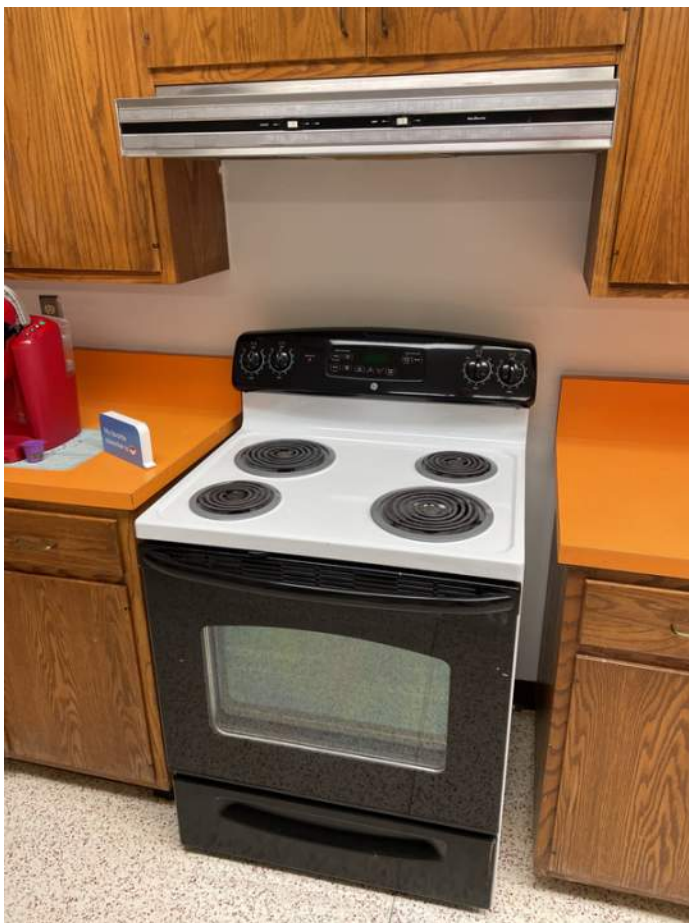
Building Codes - 5. Fire code issue. 2 cooktops without fire suppression in Room 151

Fire code issue. 2 cooktops without fire suppression in Room 151

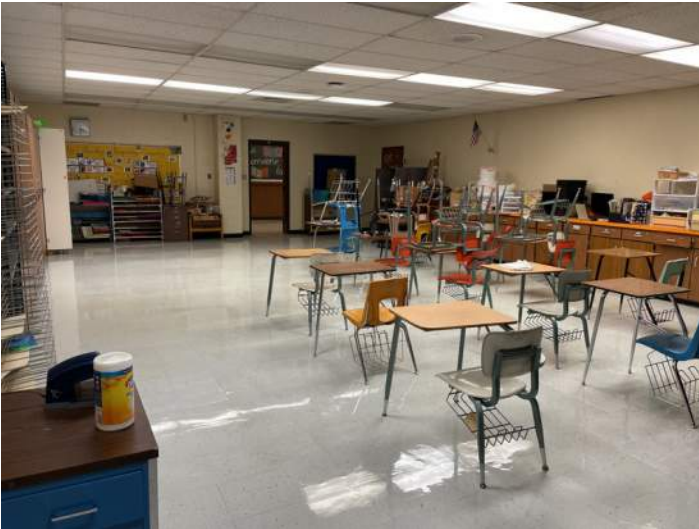
Building Codes - 6. Fire code issue. Classrooms 131, 132, 133, 134, 145, 148, and 149 are each larger than 1000 net SF with only one exit and no exit devices. Classrooms over 1000 net SF need two exits with exit devices.

Fire code issue. Classrooms 131, 132, 133, 134, 145, 148, and 149 are each larger than 1000 net SF with only one exit and no exit devices. Classrooms over 1000 net SF need two exits with exit devices.

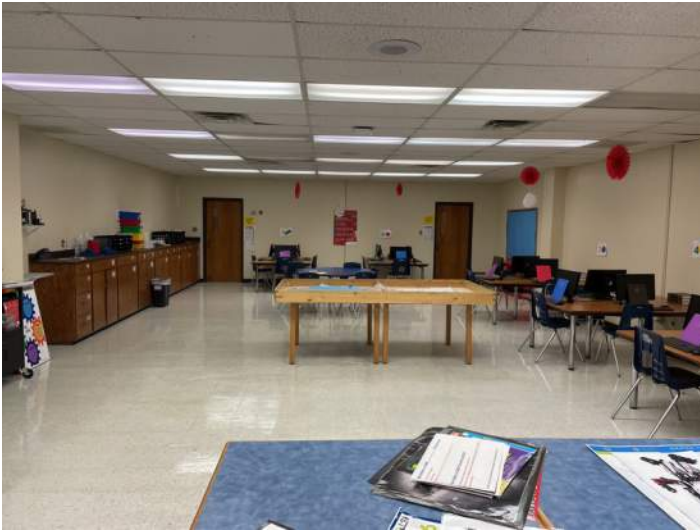
Fire code issue. Two exits from room 126 are too close together. No exit devices.

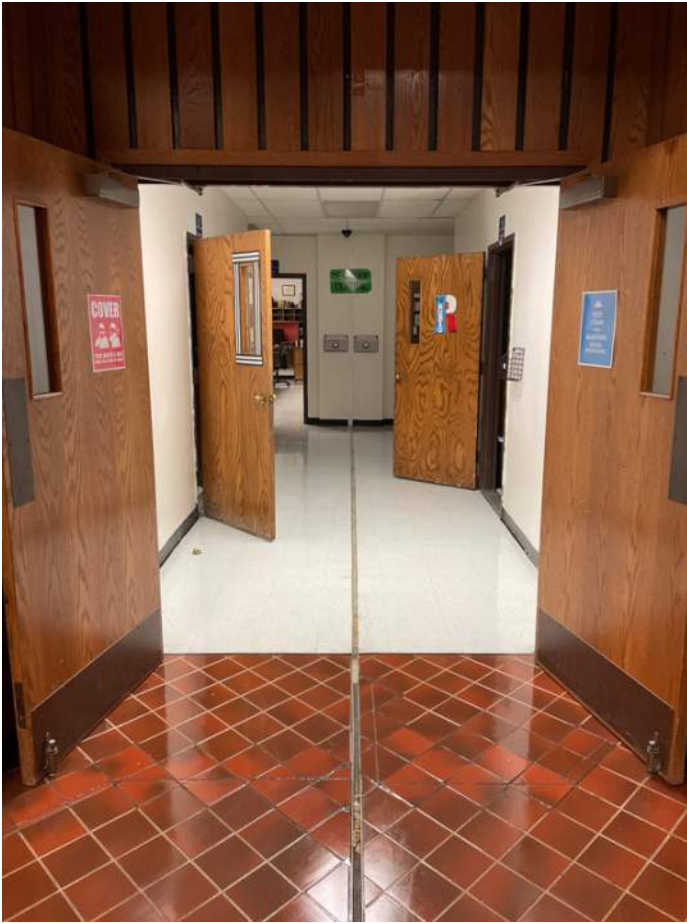
Fire code issue. 4 dead end corridors longer than 20 feet. 5 corridors have occupant loads higher than 50 with only one exit.

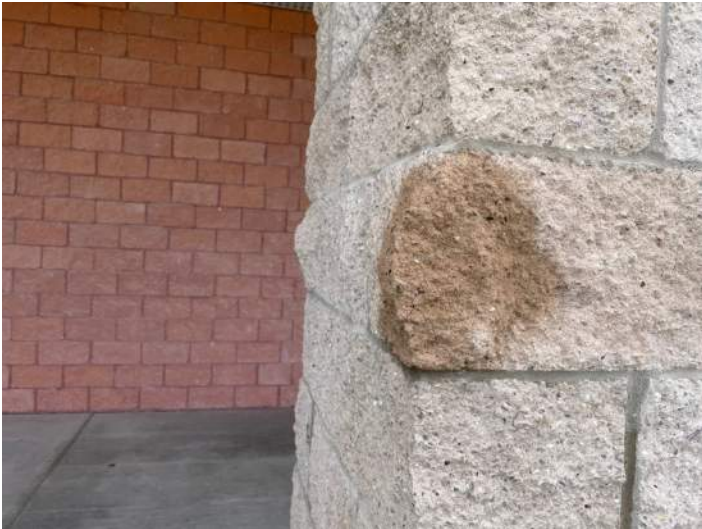
Type Description-Exterior Walls	CMU
Condition Rating-Exterior Walls	Good - minimal depreciation, consistent with asset age
Deficiency Category-Exterior Walls	No Immediate Action
Quantity-Exterior Walls	100
Unit-Exterior Walls	%
Year Installed-Exterior Walls	2000
Comments-Exterior Walls	n/a

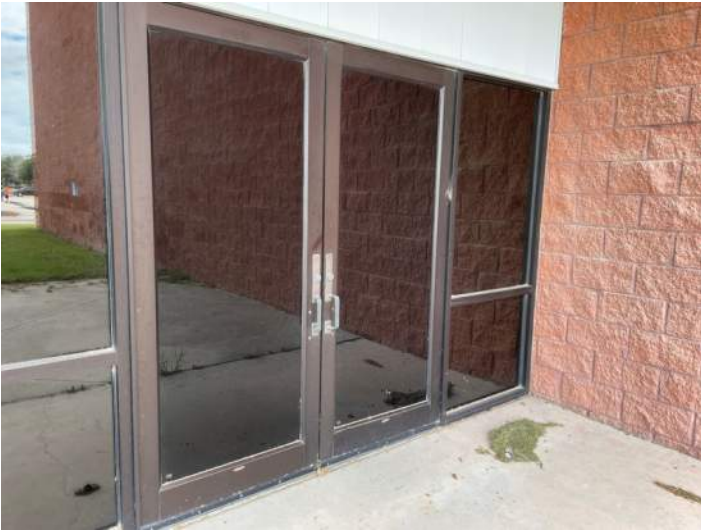
Exterior Doors - 1. Aluminum

Type Description-Exterior Doors	Aluminum
Condition Rating-Exterior Doors	Good - minimal depreciation, consistent with asset age
Deficiency Category-Exterior Doors	No Immediate Action
Quantity-Exterior Doors	100
Unit-Exterior Doors	%
Year Installed-Exterior Doors	2000
Comments-Exterior Doors	n/a

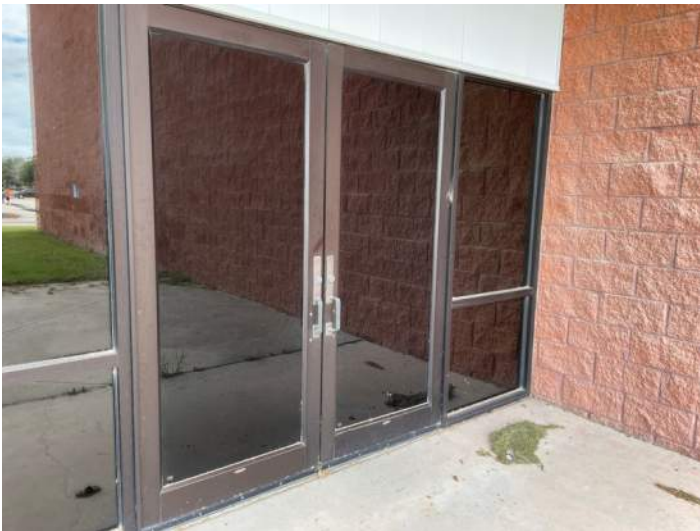
Windows - 1. Aluminum

Type Description-Windows	Aluminum
Condition Rating-Windows	Good - minimal depreciation, consistent with asset age
Deficiency Category-Windows	No Immediate Action
Quantity-Windows	100
Unit-Windows	%
Year Installed-Windows	n/a
Comments-Windows	n/a

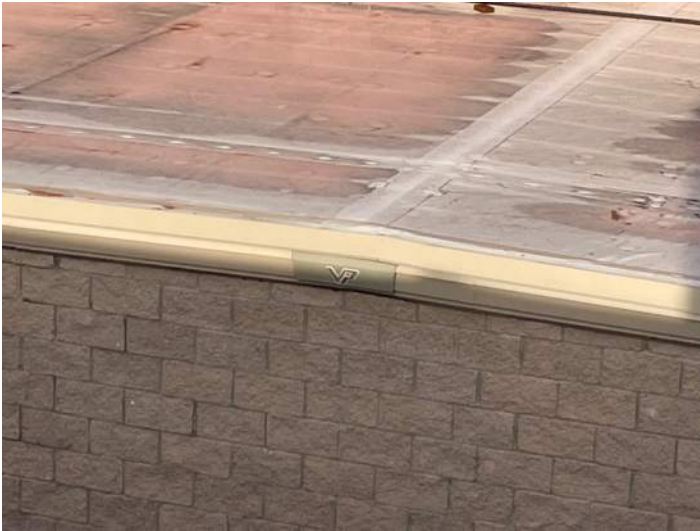
Roofing - 1. TPO

Type Description-Roofing	TPO
Condition Rating-Roofing	Excellent - no known deficiencies or visible depreciation
Deficiency Category-Roofing	No Immediate Action
Quantity-Roofing	100
Unit-Roofing	%
Year Installed-Roofing	2017
Comments-Roofing	n/a

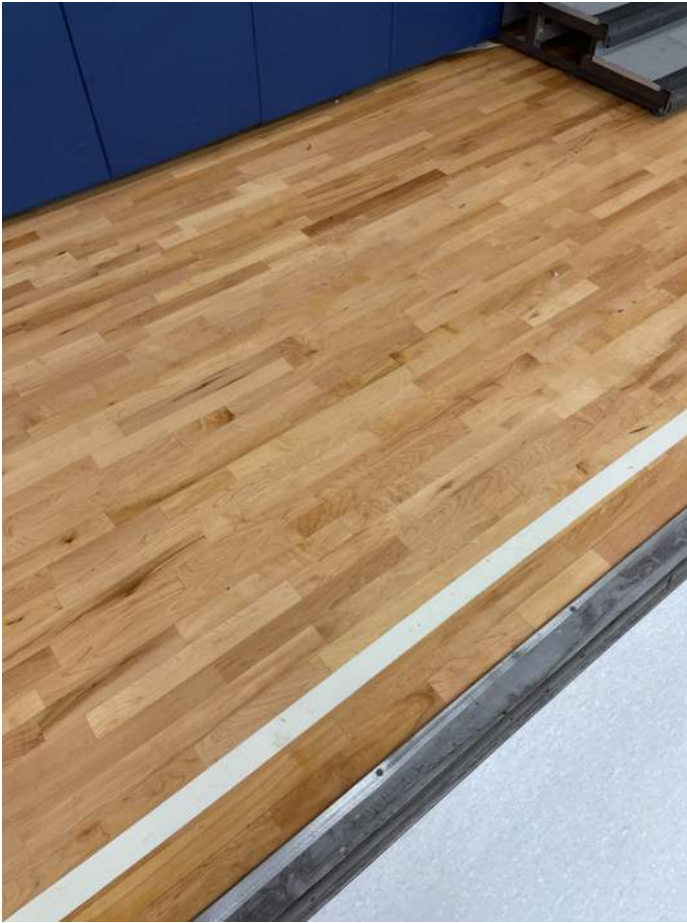
Flooring Finishes - 1. Wood

Type Description-Flooring Finishes	Wood
Condition Rating-Flooring Finishes	Good - minimal depreciation, consistent with asset age
Deficiency Category-Flooring Finishes	No Immediate Action
Quantity-Flooring Finishes	40
Unit-Flooring Finishes	%
Year Installed-Flooring Finishes	2000
Comments-Flooring Finishes	n/a

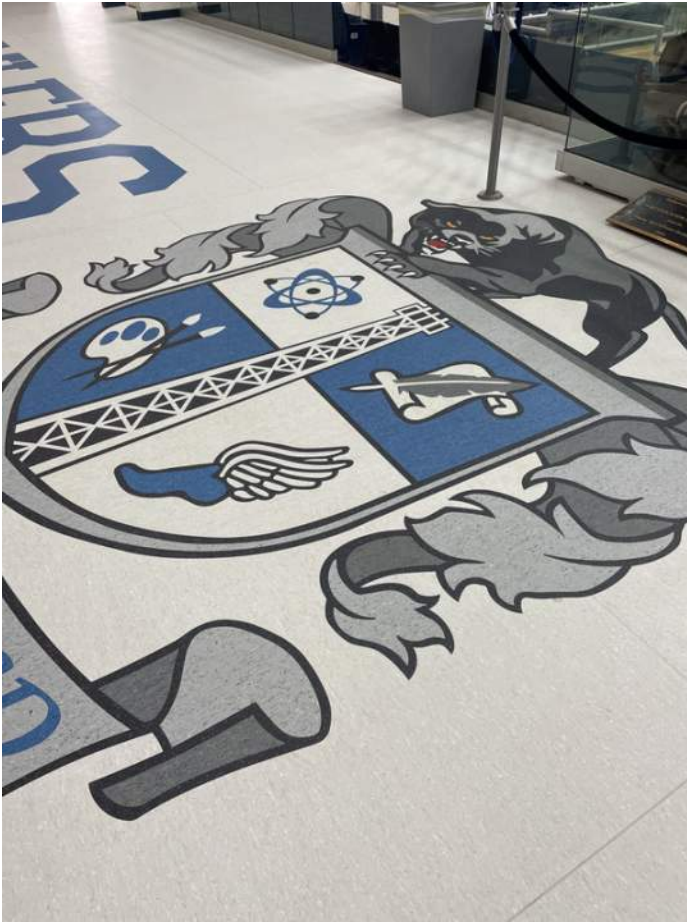
Flooring Finishes - 2. Rubber

Type Description-Flooring Finishes	Rubber
Condition Rating-Flooring Finishes	Excellent - no known deficiencies or visible depreciation
Deficiency Category-Flooring Finishes	No Immediate Action
Quantity-Flooring Finishes	60
Unit-Flooring Finishes	%

Year Installed-Flooring Finishes	n/a
Comments-Flooring Finishes	Has been replaced unknown age. Looks new.

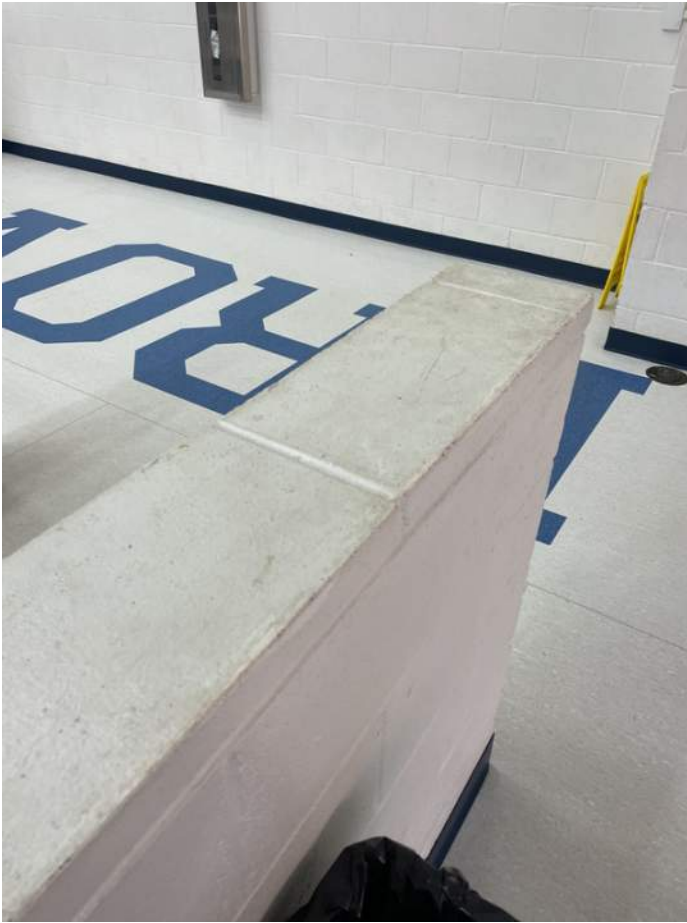
**Wall Finishes (1 Item)****Wall Finishes - 1. Paint**

Type Description-Wall Finishes	Paint
Condition Rating-Wall Finishes	Poor - nearing end of useful life, and requiring major service/repair to remain operational
Deficiency Category-Wall Finishes	Beyond Useful Life
Quantity-Wall Finishes	100
Unit-Wall Finishes	%
Year Installed-Wall Finishes	n/a
Comments-Wall Finishes	Repaint needed.

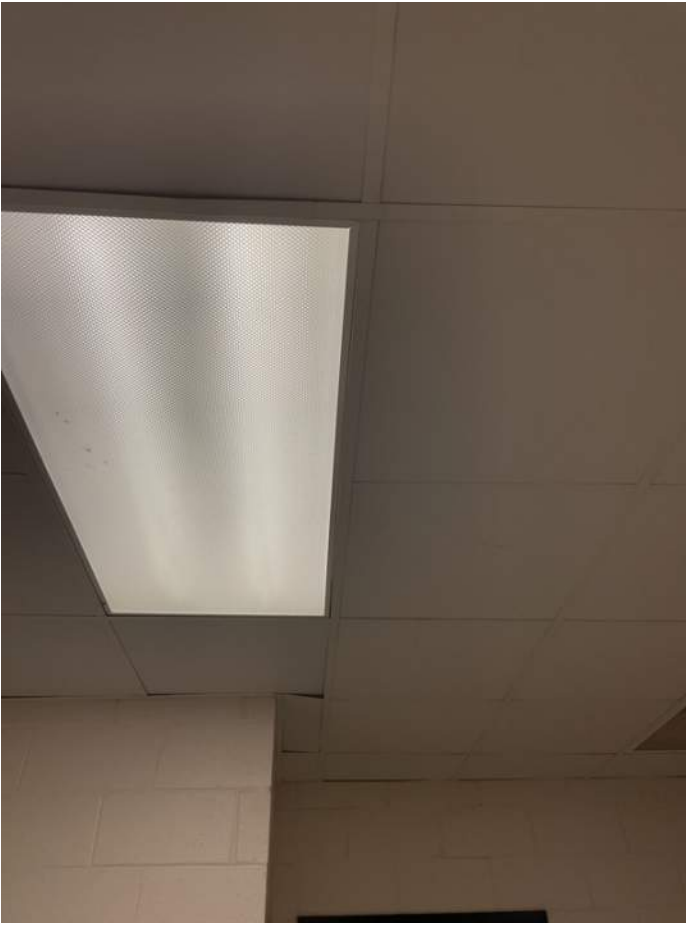
Ceiling Finishes - 1. 2x2 acoustical tile

Type Description-Ceiling Finishes	2x2 acoustical tile
Condition Rating-Ceiling Finishes	Good - minimal depreciation, consistent with asset age
Deficiency Category-Ceiling Finishes	No Immediate Action
Quantity-Ceiling Finishes	15
Unit-Ceiling Finishes	%
Year Installed-Ceiling Finishes	2000
Comments-Ceiling Finishes	n/a

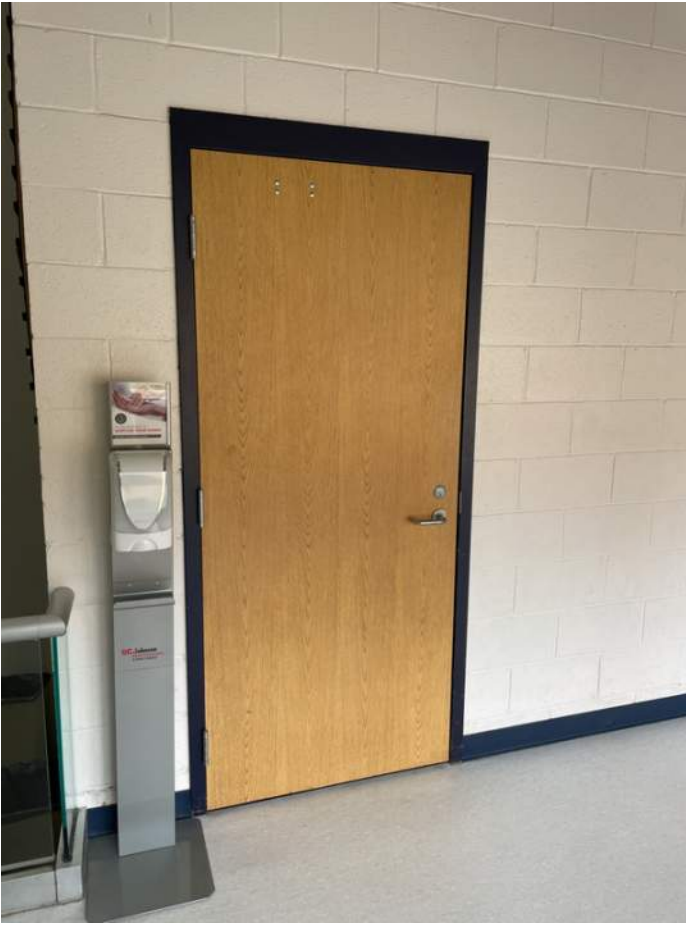
Interior Doors - 1. Wood

Type Description-Interior Doors	Wood
Condition Rating-Interior Doors	Good - minimal depreciation, consistent with asset age
Deficiency Category-Interior Doors	No Immediate Action
Quantity-Interior Doors	100
Unit-Interior Doors	%
Year Installed-Interior Doors	n/a
Comments-Interior Doors	n/a

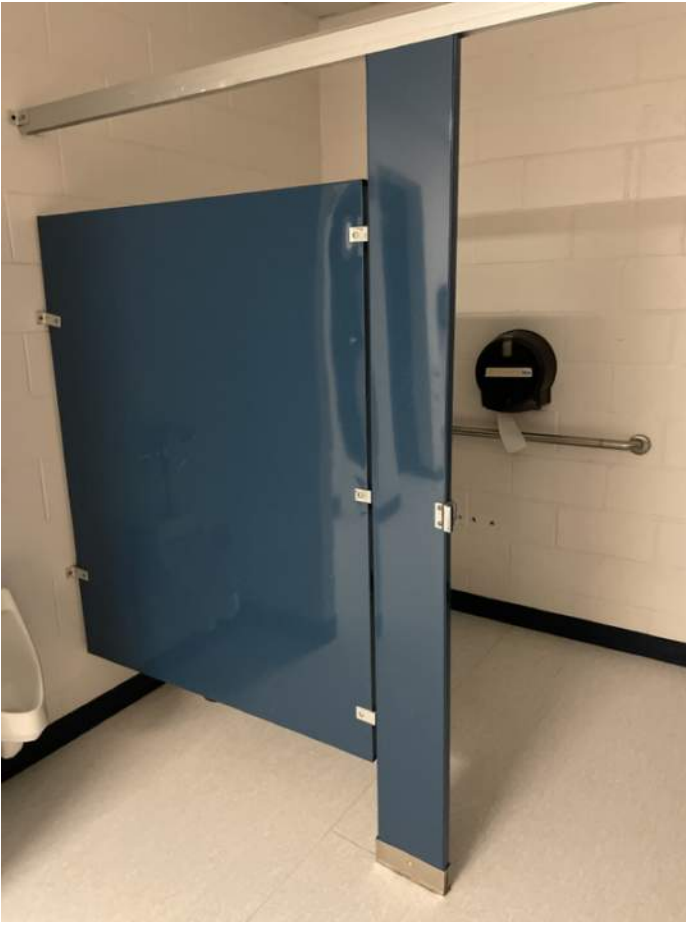
Fixed Furnishings - 1. Toilet partitions

Type Description-Fixed Furnishings	Toilet partitions
Condition Rating-Fixed Furnishings	Good - minimal depreciation, consistent with asset age
Deficiency Category-Fixed Furnishings	No Immediate Action
Quantity-Fixed Furnishings	n/a
Unit-Fixed Furnishings	n/a
Year Installed-Fixed Furnishings	n/a
Comments-Fixed Furnishings	n/a

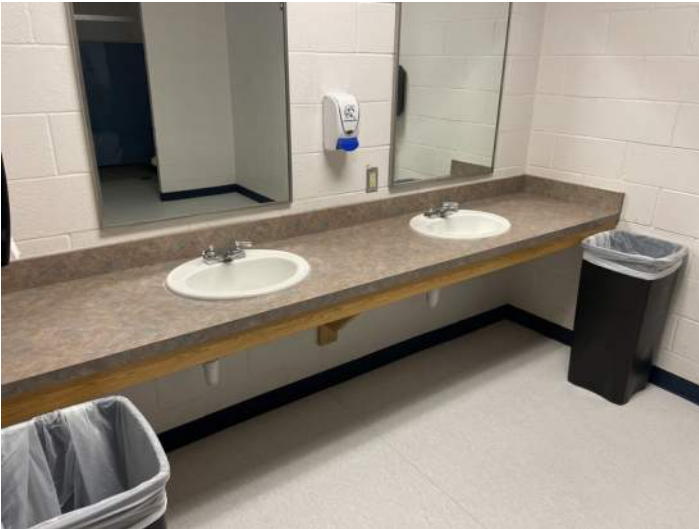
Fixed Furnishings - 2. Millwork

Type Description-Fixed Furnishings	Millwork
Condition Rating-Fixed Furnishings	Good - minimal depreciation, consistent with asset age
Deficiency Category-Fixed Furnishings	No Immediate Action
Quantity-Fixed Furnishings	n/a
Unit-Fixed Furnishings	n/a
Year Installed-Fixed Furnishings	n/a
Comments-Fixed Furnishings	n/a

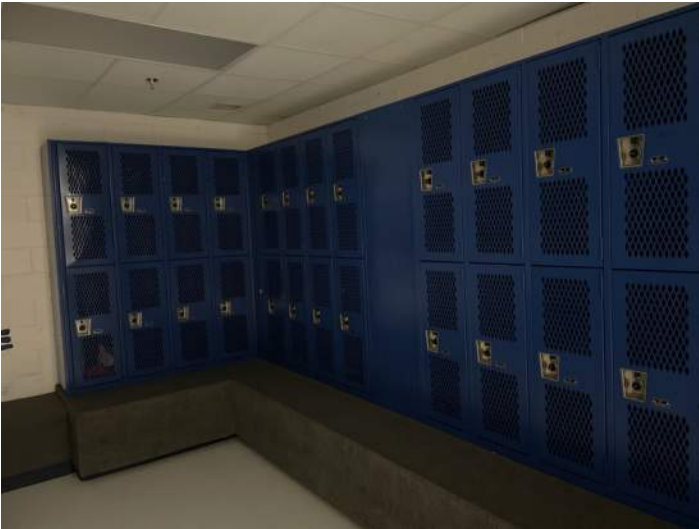
**Fixed Furnishings - 3. Lockers**

Type Description-Fixed Furnishings	Lockers
Condition Rating-Fixed Furnishings	Good - minimal depreciation, consistent with asset age
Deficiency Category-Fixed Furnishings	No Immediate Action
Quantity-Fixed Furnishings	n/a
Unit-Fixed Furnishings	n/a
Year Installed-Fixed Furnishings	n/a
Comments-Fixed Furnishings	n/a

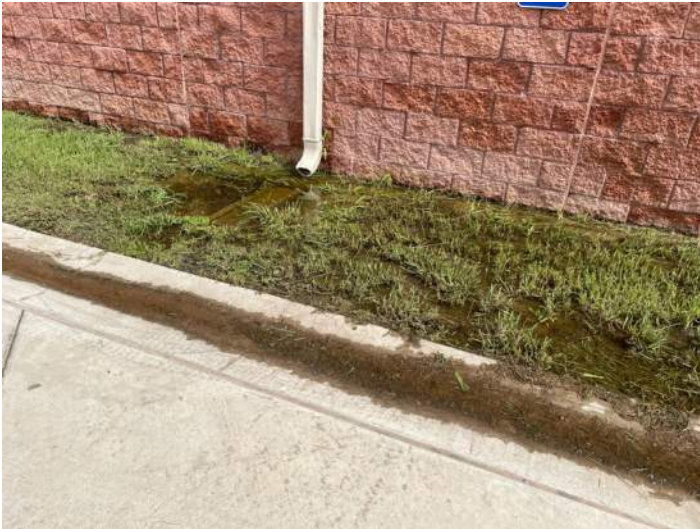
Site Development - 1. Site Drainage

Type Description-Site Development	Site Drainage
Condition Rating-Site Development	Poor - nearing end of useful life, and requiring major service/repair to remain operational
Deficiency Category-Site Development	Inadequate
Quantity-Site Development	25
Unit-Site Development	%
Year Installed-Site Development	2000
Comments-Site Development	Areas between buildings do not drain well.

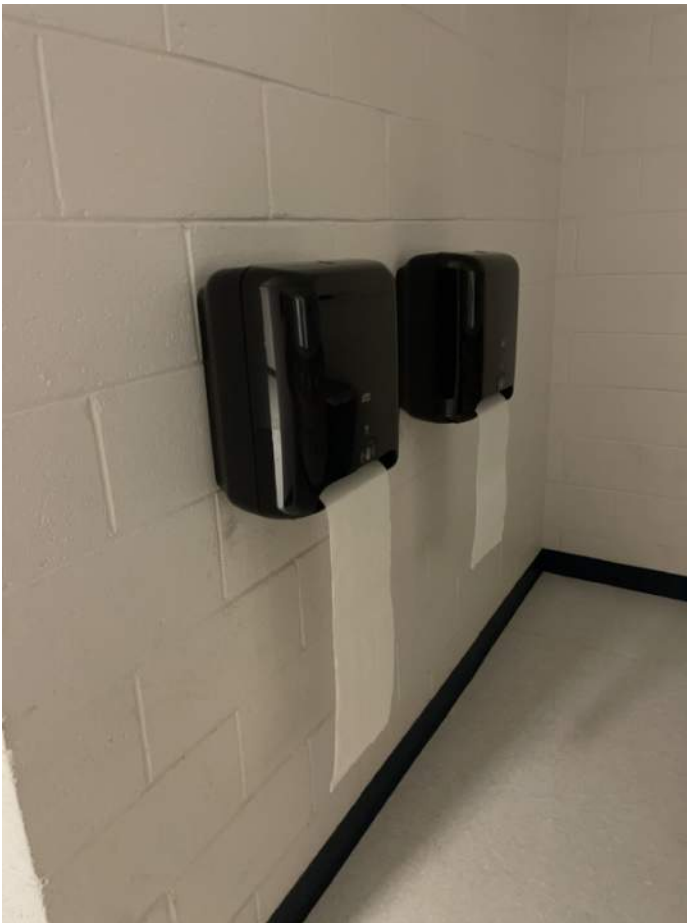
Description-Accessibility	Toilet accessories extend more than 4 inches from wall.
----------------------------------	---

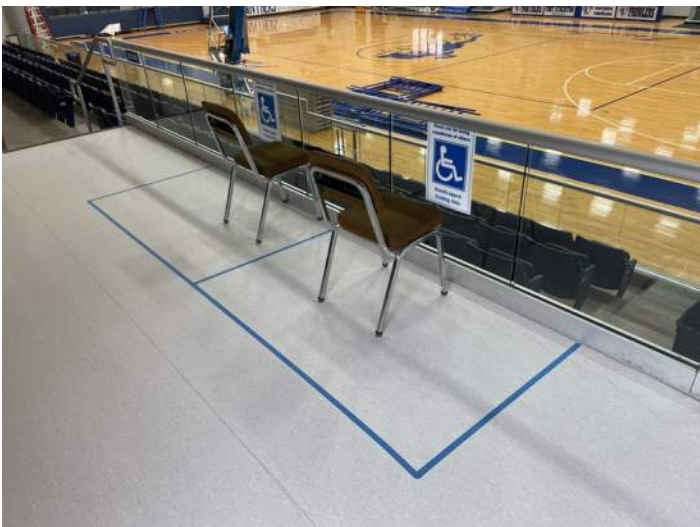
Accessibility Standards - 2. Companion seating way removed an not replaced when rubber flooring was replaced.

Companion seating way removed an not replaced when rubber flooring was replaced.

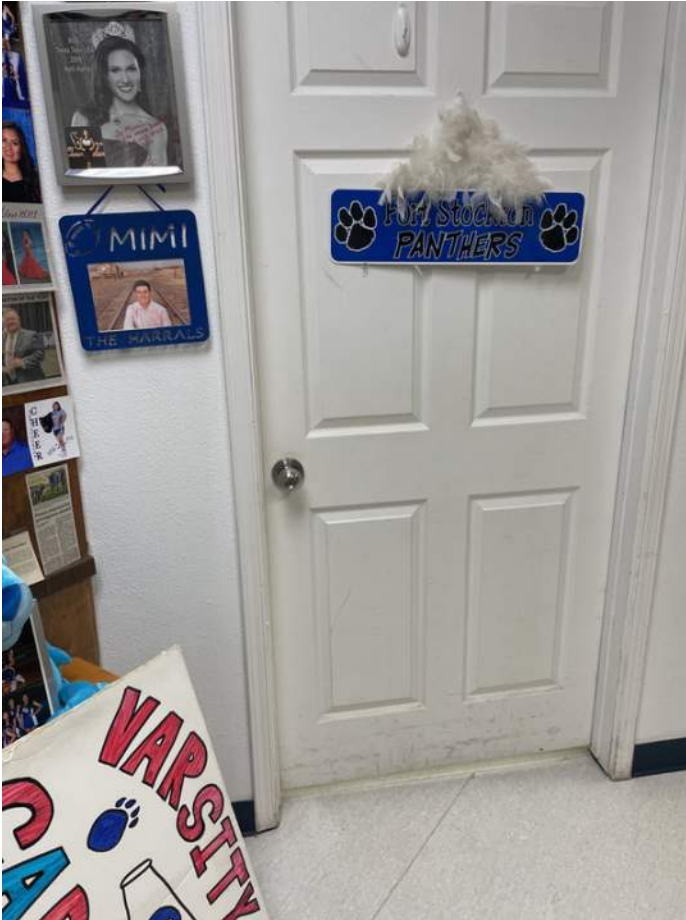
Conversion of film room to offices was not built to accessibility codes. To meet code: One door needs to be relocated. Door lock on that door and another needs to be replaced.

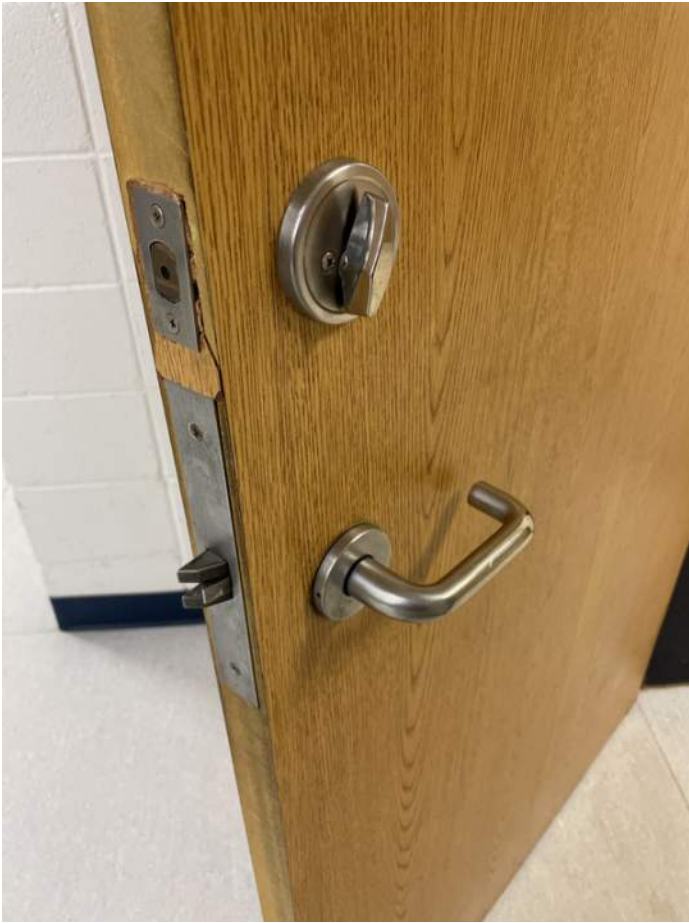
Fire fire issue. 6 doors have two locks.

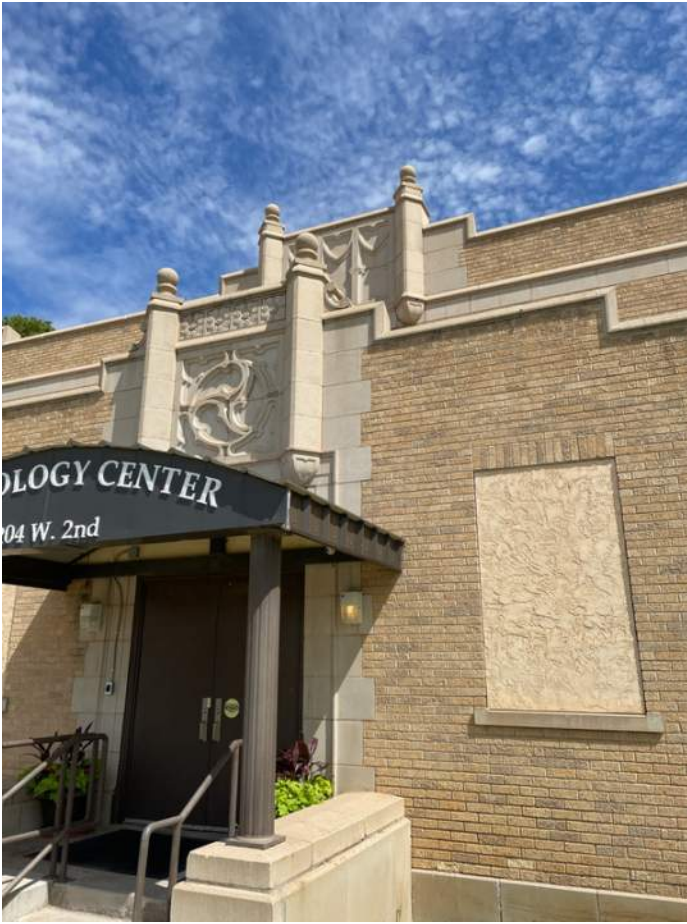
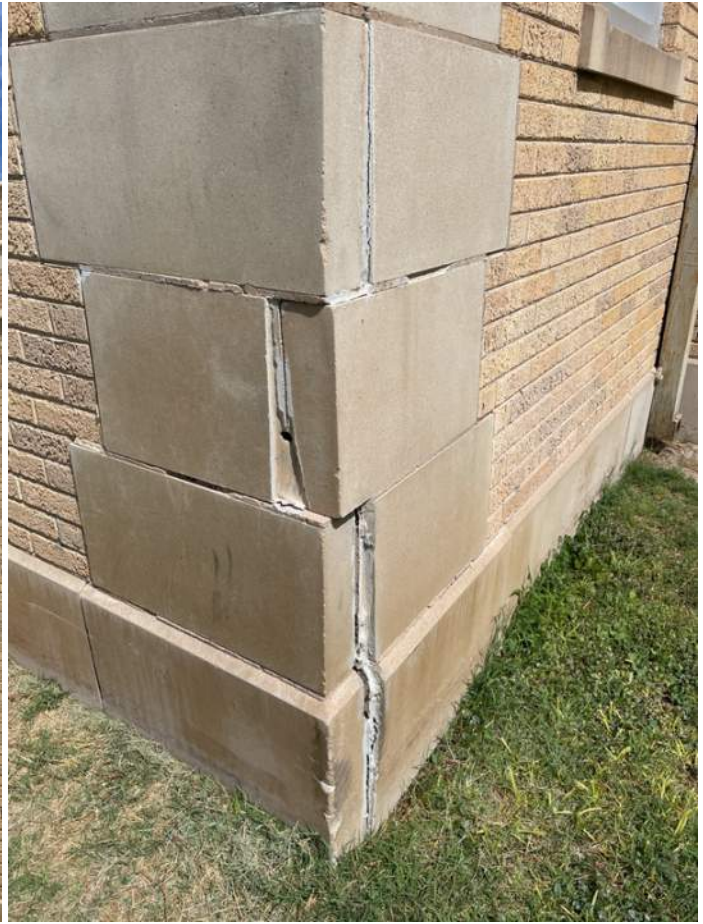
Exterior Walls - 2. Cast Stone

Type Description-Exterior Walls	Cast Stone
Condition Rating-Exterior Walls	Fair - exhibiting deficiencies requiring minor service/repair to extend useful life
Deficiency Category-Exterior Walls	Damaged/Failing
Quantity-Exterior Walls	10
Unit-Exterior Walls	%

Year Installed-Exterior Walls	1931
Comments-Exterior Walls	Most cast stone in good condition. Isolated damage

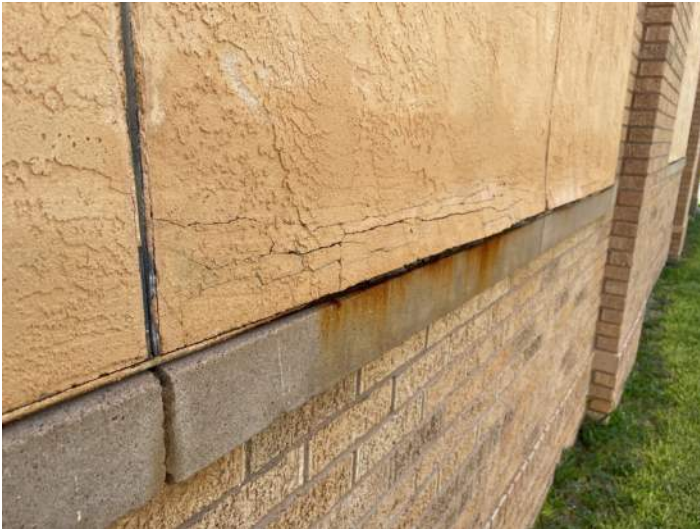
**Exterior Walls - 3. Stucco**

Type Description-Exterior Walls	Stucco
Condition Rating-Exterior Walls	Fair - exhibiting deficiencies requiring minor service/repair to extend useful life
Deficiency Category-Exterior Walls	Damaged/Failing
Quantity-Exterior Walls	10
Unit-Exterior Walls	%
Year Installed-Exterior Walls	n/a
Comments-Exterior Walls	Most stucco in good condition. Two 12'x10' panels need to be replaced.

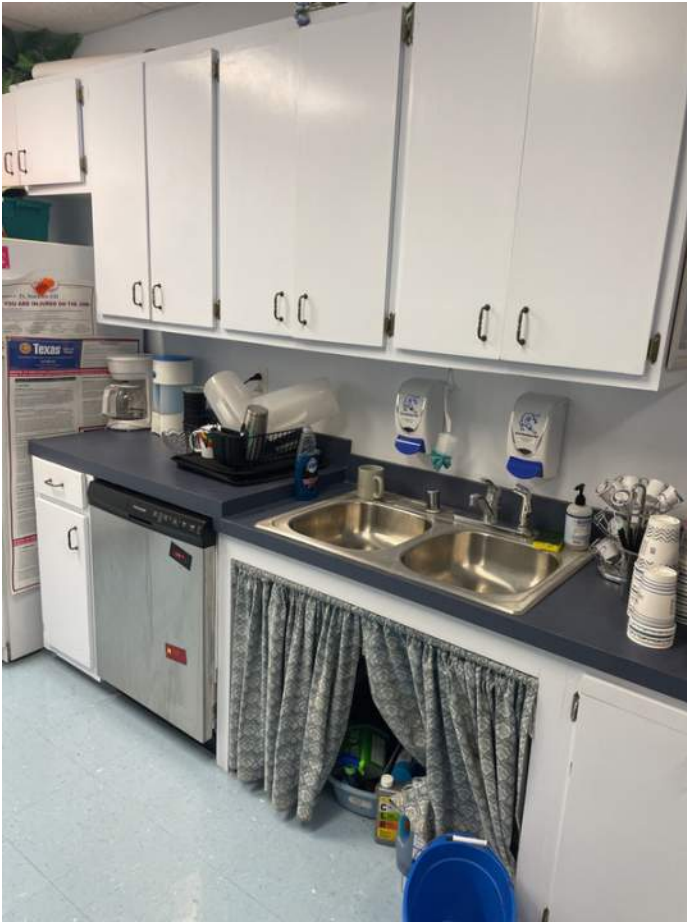
Fixed Furnishings - 2. Millwork Painted Wood

Type Description-Fixed Furnishings	Millwork Painted Wood
Condition Rating-Fixed Furnishings	Fair - exhibiting deficiencies requiring minor service/repair to extend useful life
Deficiency Category-Fixed Furnishings	No Immediate Action
Quantity-Fixed Furnishings	n/a
Unit-Fixed Furnishings	n/a
Year Installed-Fixed Furnishings	2002
Comments-Fixed Furnishings	Poor quality in the first place but doesn't experience much abuse here.

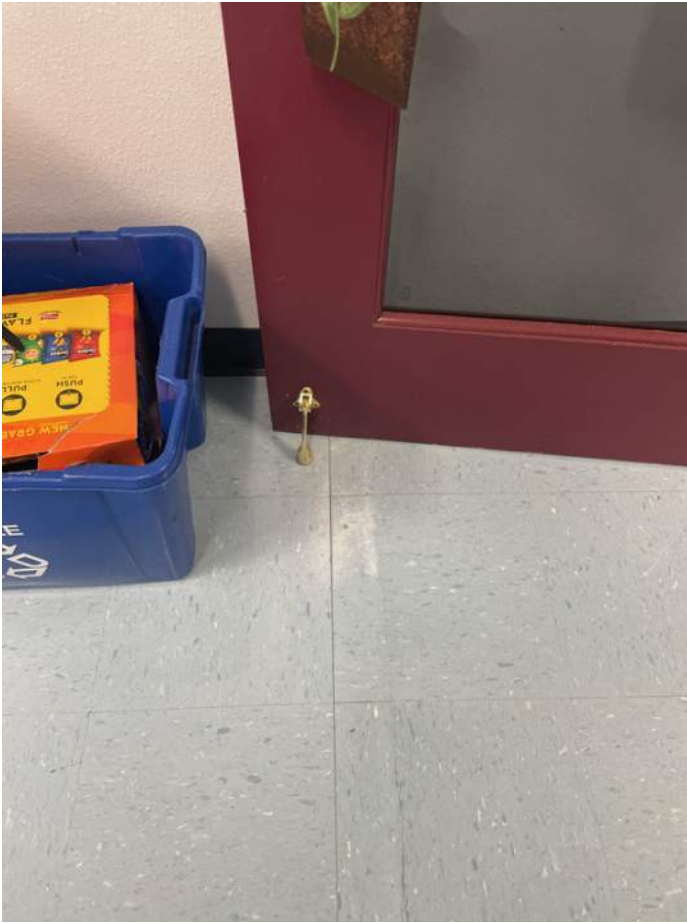
Fire code issue. Corridor doors are rated. All have door props added.

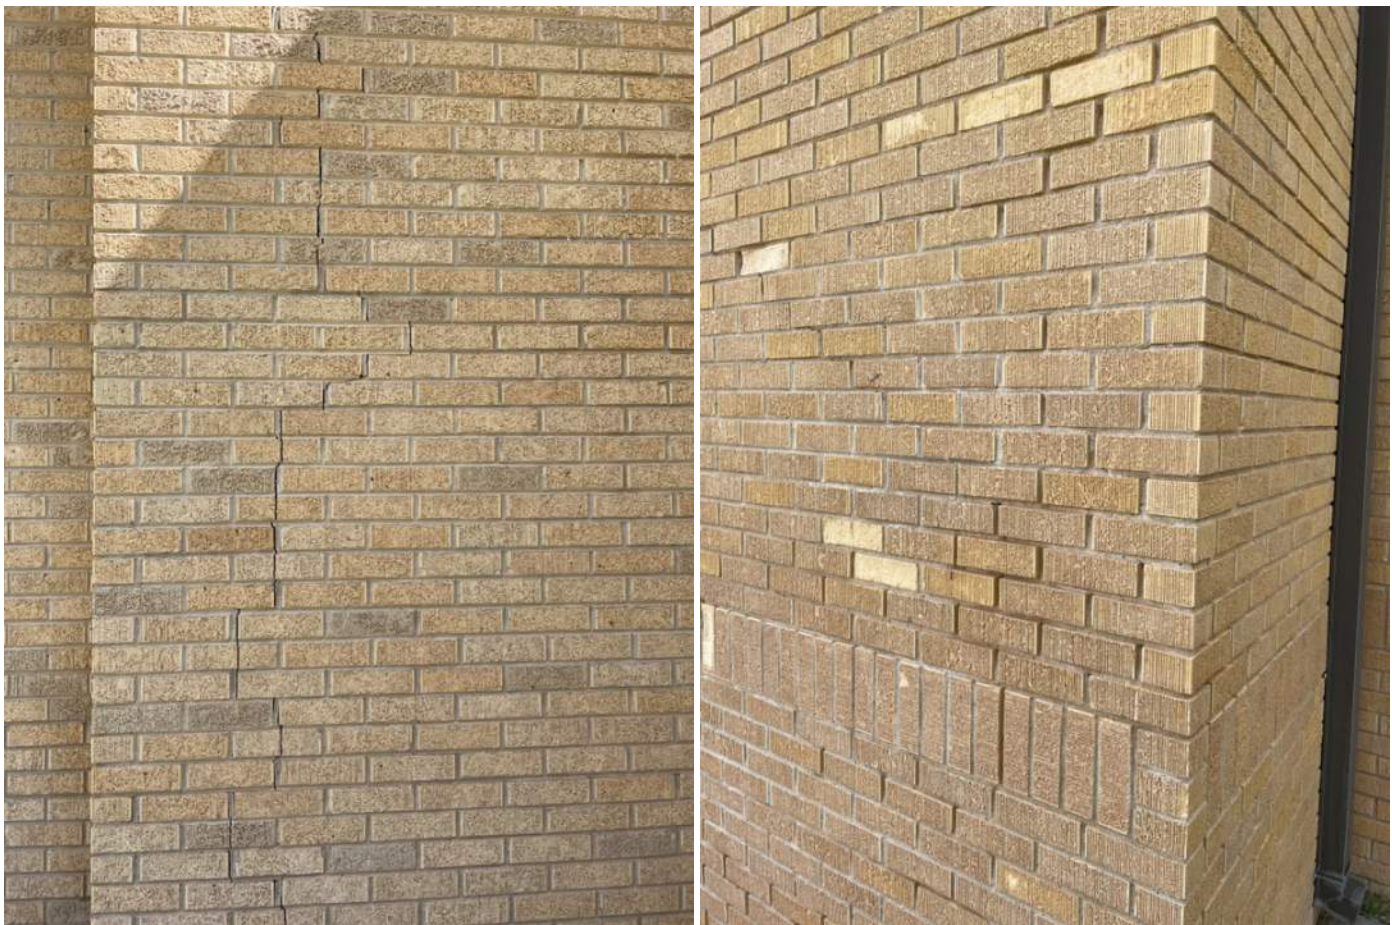
Type Description-Exterior Walls	Brick
Condition Rating-Exterior Walls	Fair - exhibiting deficiencies requiring minor service/repair to extend useful life
Deficiency Category-Exterior Walls	Damaged/Failing
Quantity-Exterior Walls	80
Unit-Exterior Walls	%
Year Installed-Exterior Walls	1931
Comments-Exterior Walls	Some crack repair and pointing needed. Most brick in good condition.

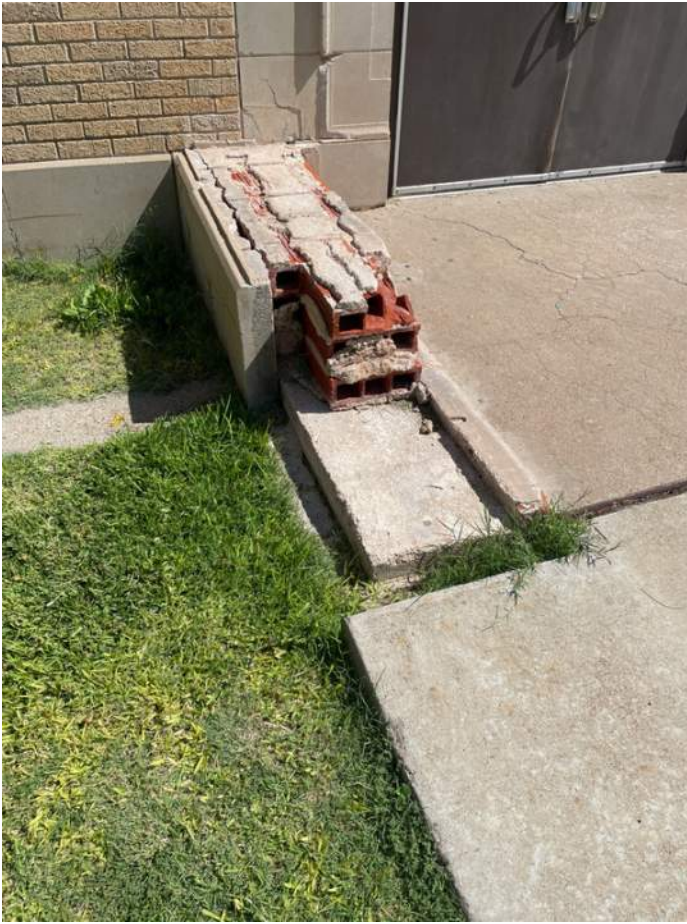
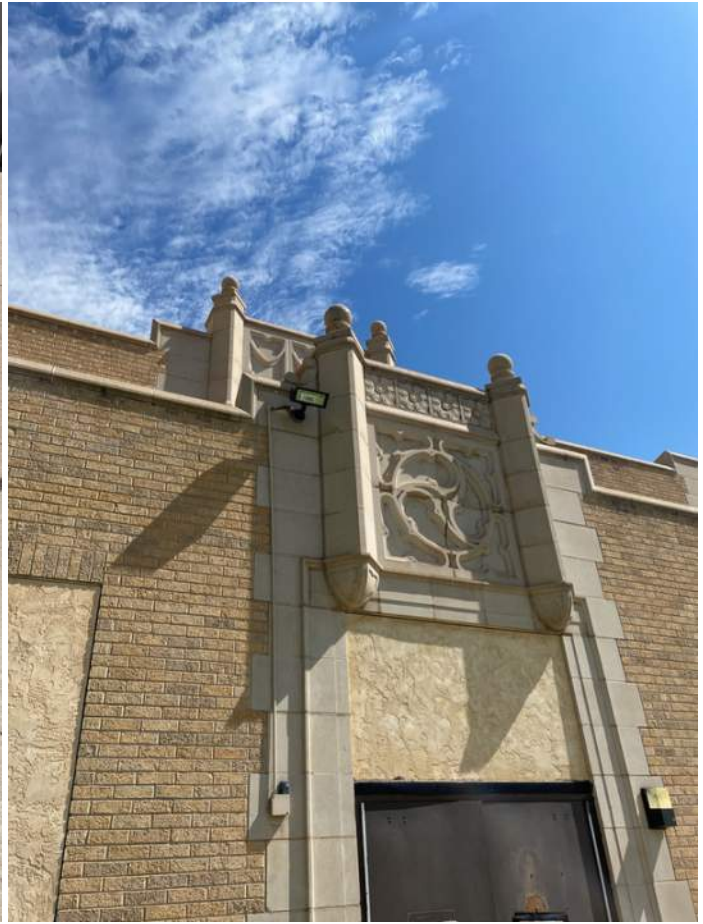
Exterior Walls - 2. Cast Stone

Type Description-Exterior Walls	Cast Stone
Condition Rating-Exterior Walls	Fair - exhibiting deficiencies requiring minor service/repair to extend useful life
Deficiency Category-Exterior Walls	Damaged/Failing
Quantity-Exterior Walls	10
Unit-Exterior Walls	%

Comments-Exterior Walls | Most stone in good condition. Some pointing required. Missing stone at girls gym entrance.

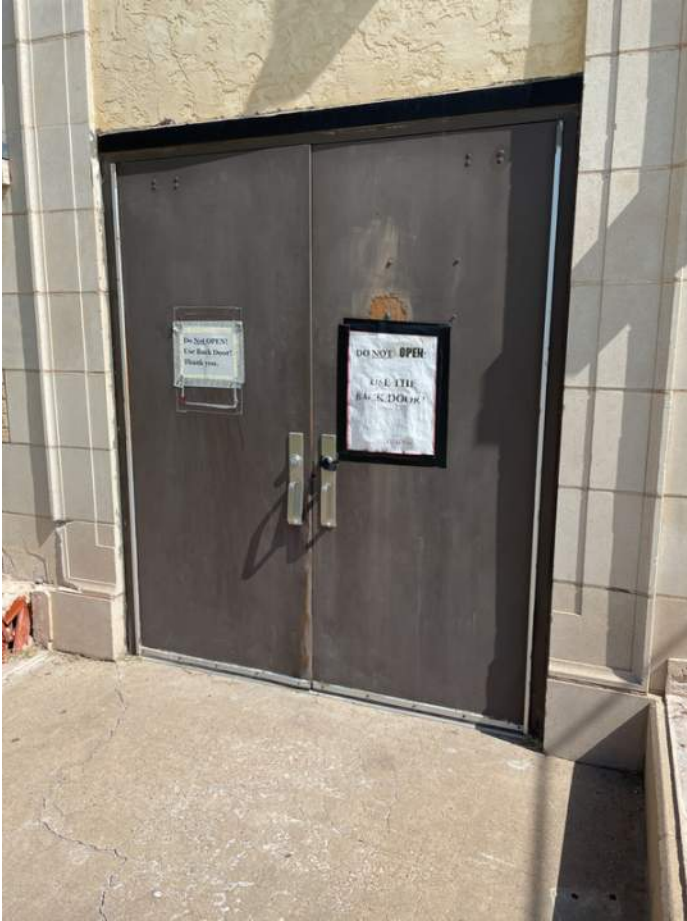
Exterior Doors - 1. Hollow Metal

Type Description-Exterior Doors	Hollow Metal
Condition Rating-Exterior Doors	Poor - nearing end of useful life, and requiring major service/repair to remain operational
Deficiency Category-Exterior Doors	Damaged/Failing
Quantity-Exterior Doors	100
Unit-Exterior Doors	%
Year Installed-Exterior Doors	n/a

Unknown age but not original. Need to be replaced.

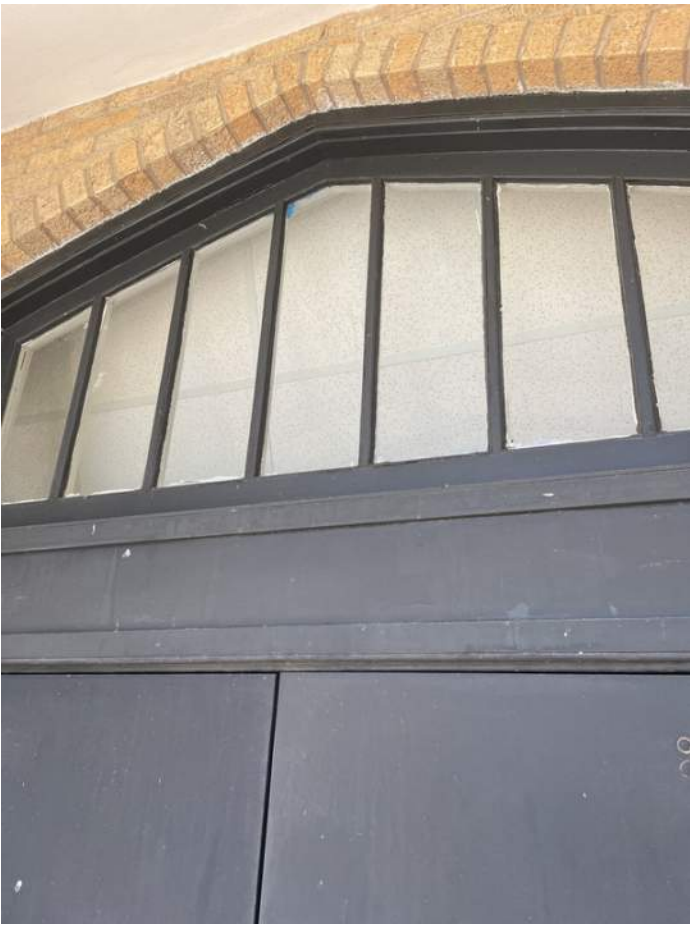
Windows - 2. Wood

Type Description-Windows	Wood
Condition Rating-Windows	Fair - exhibiting deficiencies requiring minor service/repair to extend useful life
Deficiency Category-Windows	No Immediate Action
Quantity-Windows	1
Unit-Windows	EA
Year Installed-Windows	1931
Comments-Windows	In a protected location. Repainting will extend life.

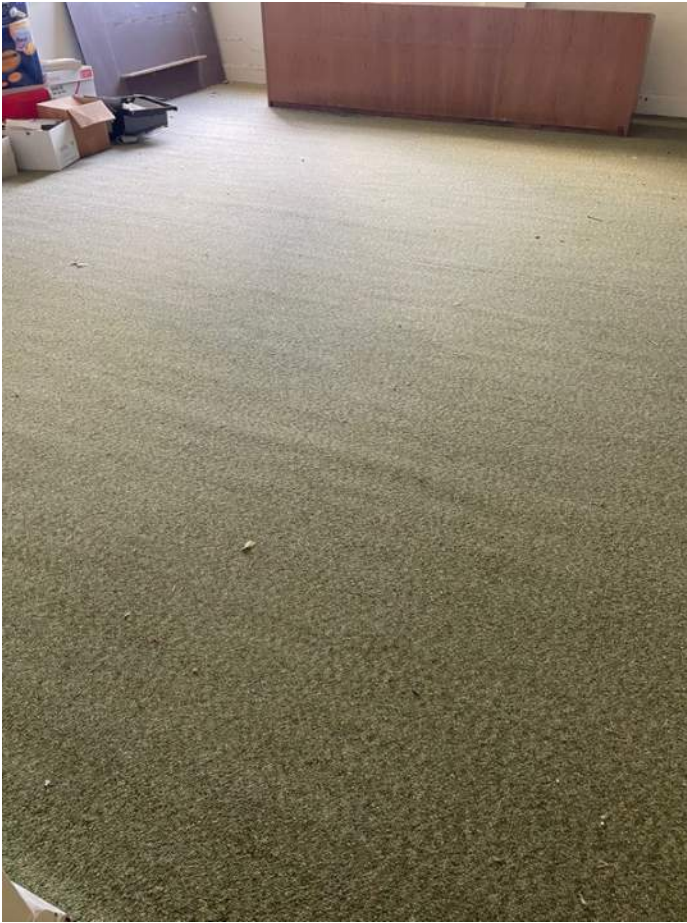
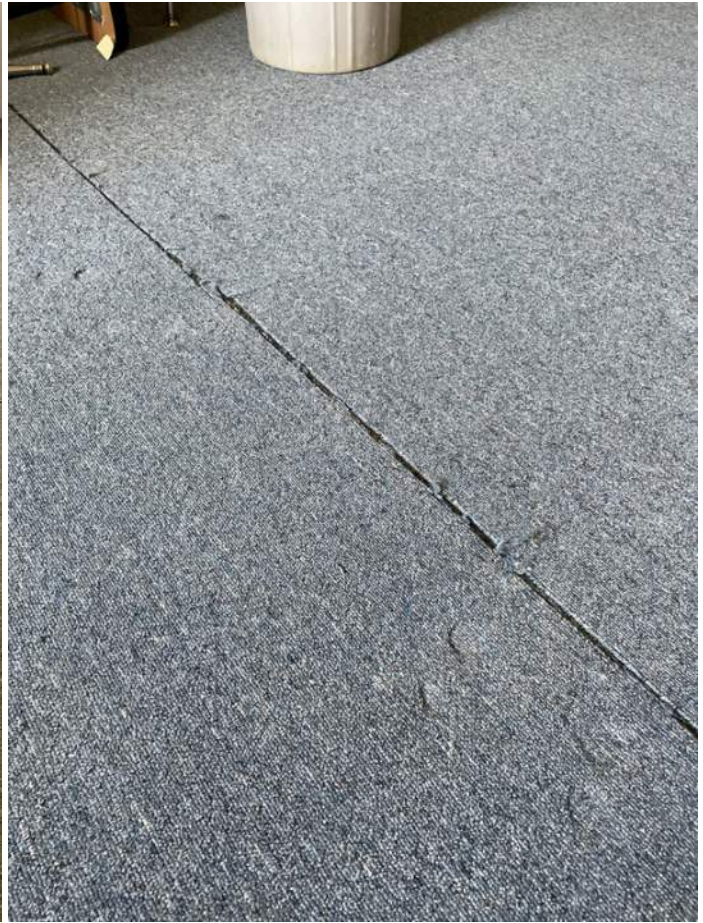
Flooring Finishes - 4. 2nd and 3rd Floor Carpet

Type Description-Flooring Finishes	2nd and 3rd Floor Carpet
Condition Rating-Flooring Finishes	Poor - nearing end of useful life, and requiring major service/repair to remain operational
Deficiency Category-Flooring Finishes	Beyond Useful Life
Quantity-Flooring Finishes	35
Unit-Flooring Finishes	%
Year Installed-Flooring Finishes	n/a
Comments-Flooring Finishes	Well past life span.

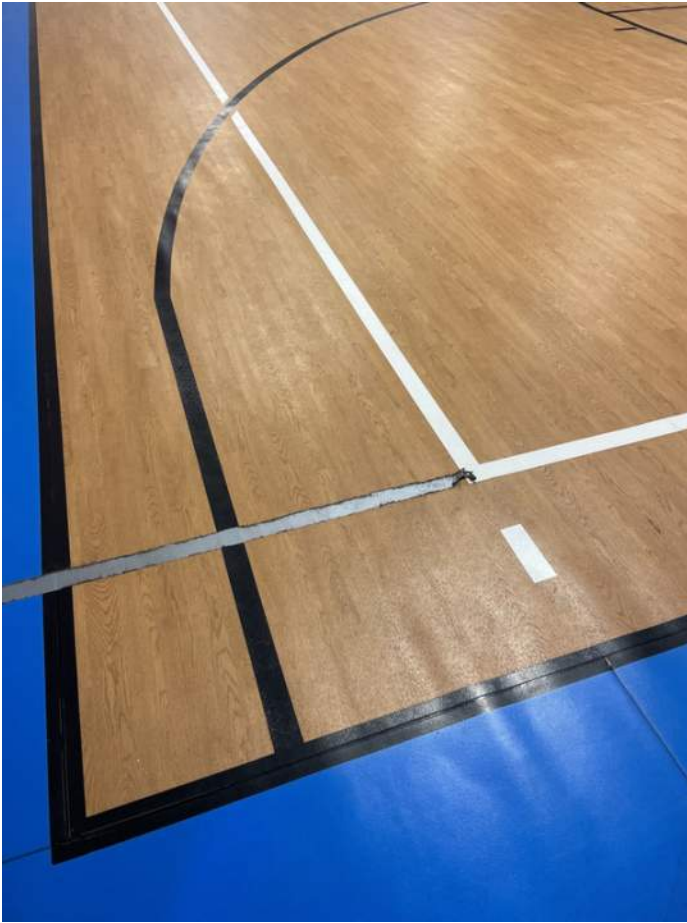
Flooring Finishes - 6. Rubber

Type Description-Flooring Finishes	Rubber
Condition Rating-Flooring Finishes	Fair - exhibiting deficiencies requiring minor service/repair to extend useful life
Deficiency Category-Flooring Finishes	No Immediate Action
Quantity-Flooring Finishes	5
Unit-Flooring Finishes	%
Year Installed-Flooring Finishes	n/a
Comments-Flooring Finishes	Some of issues with bubbles.

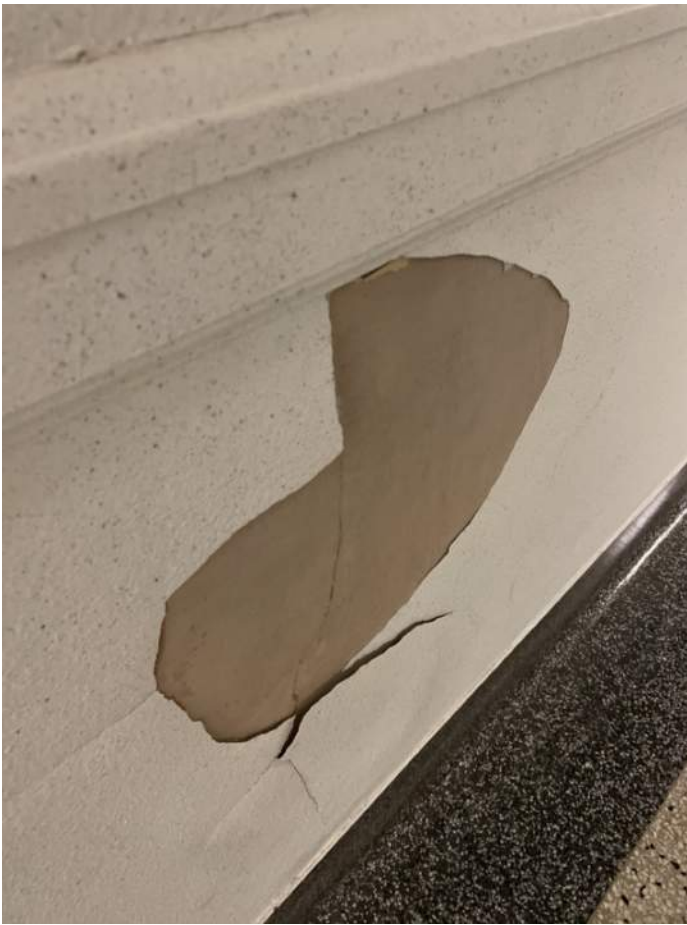
Type Description-Wall Finishes	Plaster
Condition Rating-Wall Finishes	Fair - exhibiting deficiencies requiring minor service/repair to extend useful life
Deficiency Category-Wall Finishes	Damaged/Failing
Quantity-Wall Finishes	90
Unit-Wall Finishes	%
Year Installed-Wall Finishes	n/a
Comments-Wall Finishes	Unknown age. Most in good condition but some isolated damage needs repair.
