Fort Stockton ISD - Condition Assessment

Alamo Elementary

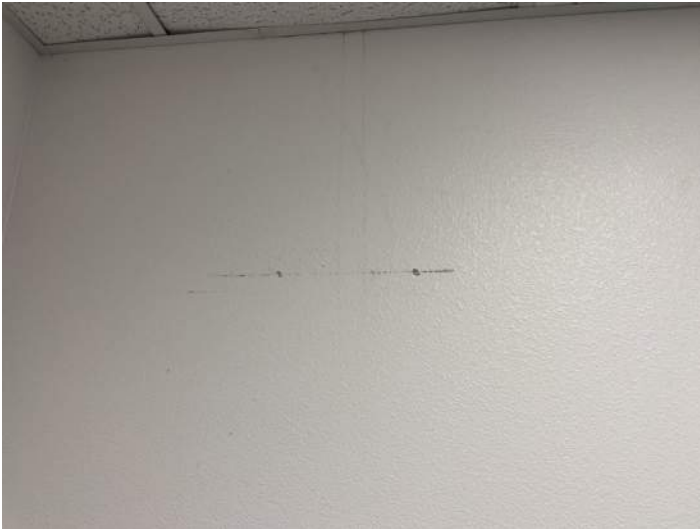
Wall Finishes - 2. Paint

Type Description-Wall Finishes	Paint
Condition Rating-Wall Finishes	Poor - nearing end of useful life, and requiring major service/repair to remain operational
Deficiency Category-Wall Finishes	Beyond Useful Life
Quantity-Wall Finishes	10
Unit-Wall Finishes	%
Year Installed-Wall Finishes	n/a
Comments-Wall Finishes	n/a

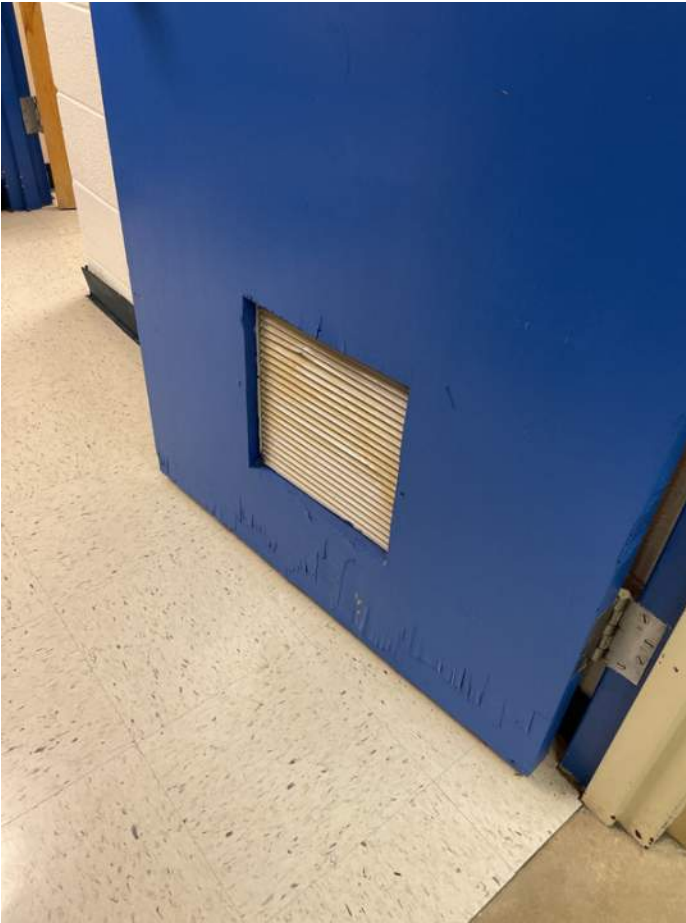
Interior Doors - 2. Gym doors

Type Description-Interior Doors	Gym doors
Condition Rating-Interior Doors	Poor - nearing end of useful life, and requiring major service/repair to remain operational
Deficiency Category-Interior Doors	Damaged/Failing
Quantity-Interior Doors	10
Unit-Interior Doors	%
Year Installed-Interior Doors	n/a
Comments-Interior Doors	Gym doors in poor condition. Unknown age but not original.

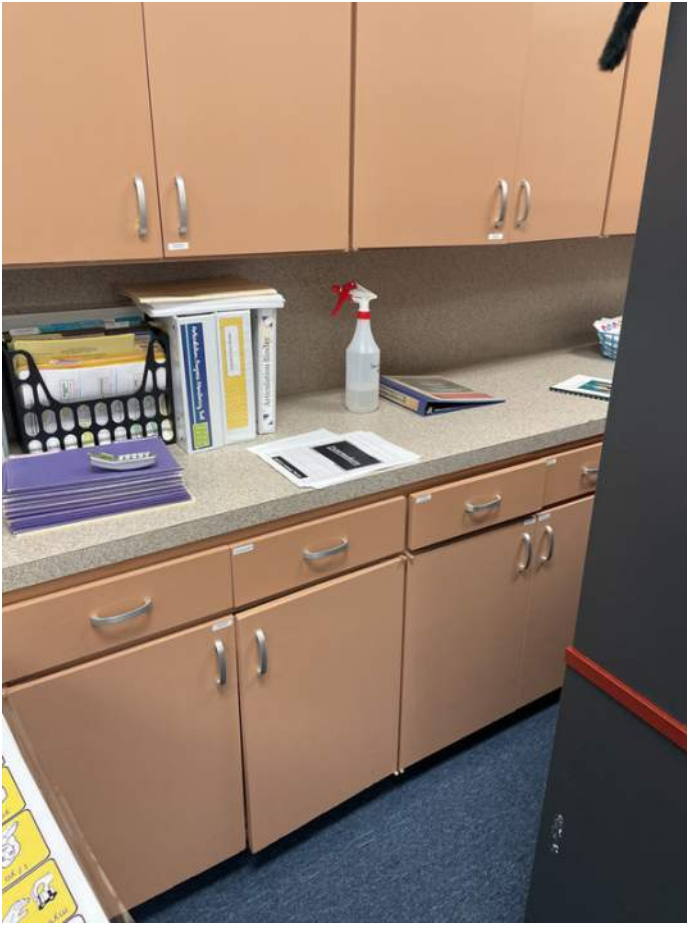
Type Description-Fixed Furnishings	Millwork
Condition Rating-Fixed Furnishings	Good - minimal depreciation, consistent with asset age
Deficiency Category-Fixed Furnishings	No Immediate Action
Quantity-Fixed Furnishings	n/a
Unit-Fixed Furnishings	n/a
Year Installed-Fixed Furnishings	n/a
Comments-Fixed Furnishings	Unknown age. Good condition.

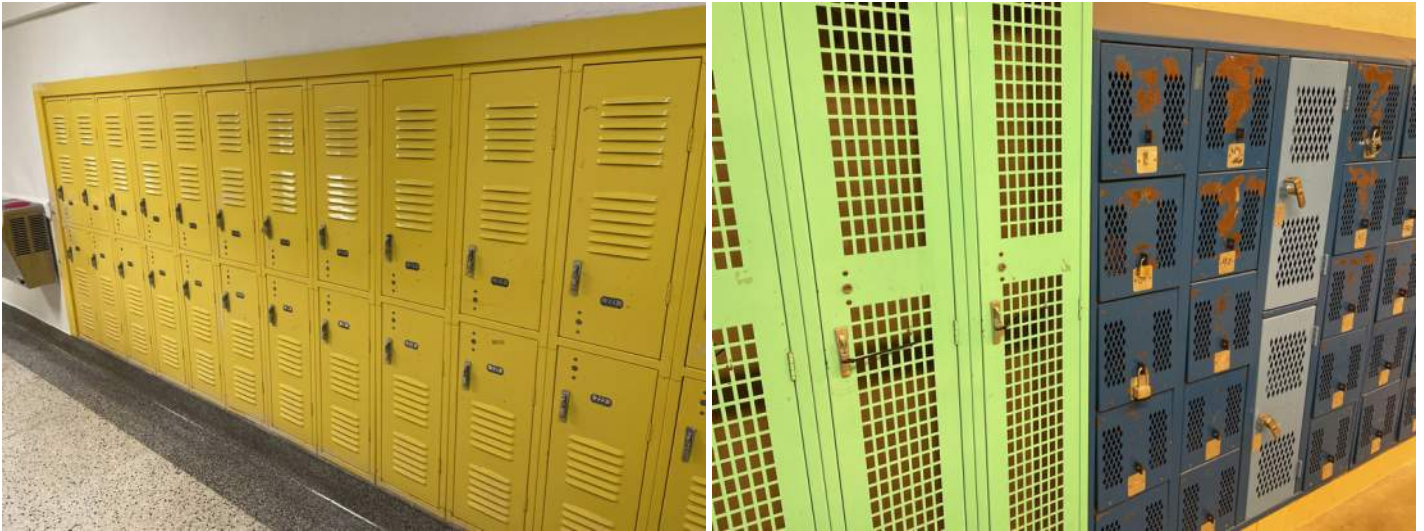
Fixed Furnishings - 3. Lockers

Type Description-Fixed Furnishings	Lockers
Condition Rating-Fixed Furnishings	Good - minimal depreciation, consistent with asset age
Deficiency Category-Fixed Furnishings	n/a
Quantity-Fixed Furnishings	n/a
Unit-Fixed Furnishings	n/a
Year Installed-Fixed Furnishings	n/a
Comments-Fixed Furnishings	Some lockers need paint.

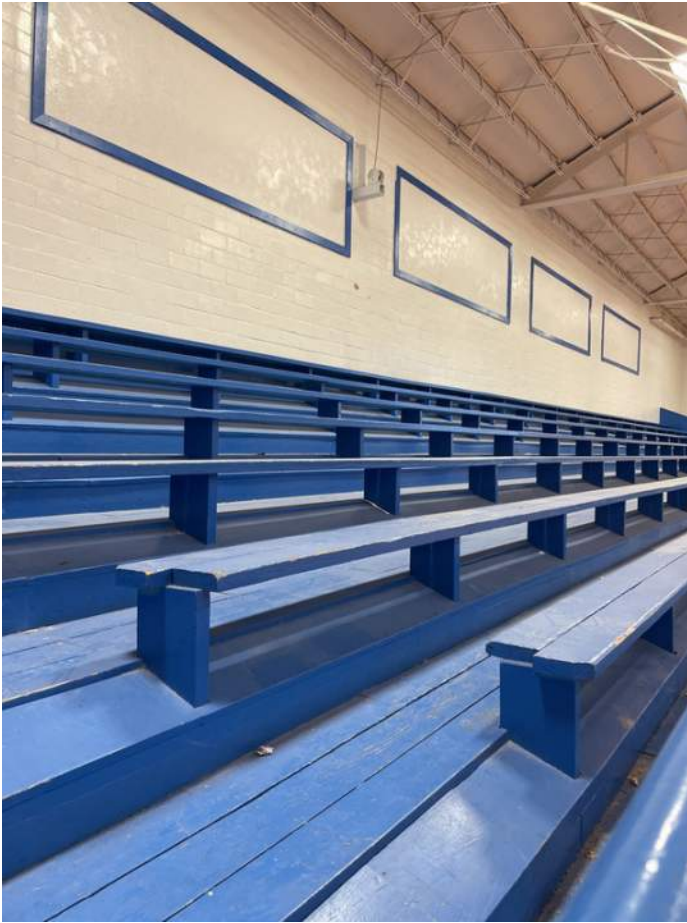
Fixed Furnishings - 4. Bleachers

Type Description-Fixed Furnishings	Bleachers
Condition Rating-Fixed Furnishings	Poor - nearing end of useful life, and requiring major service/repair to remain operational
Deficiency Category-Fixed Furnishings	Beyond Useful Life
Quantity-Fixed Furnishings	n/a
Unit-Fixed Furnishings	n/a
Year Installed-Fixed Furnishings	n/a
Comments-Fixed Furnishings	n/a

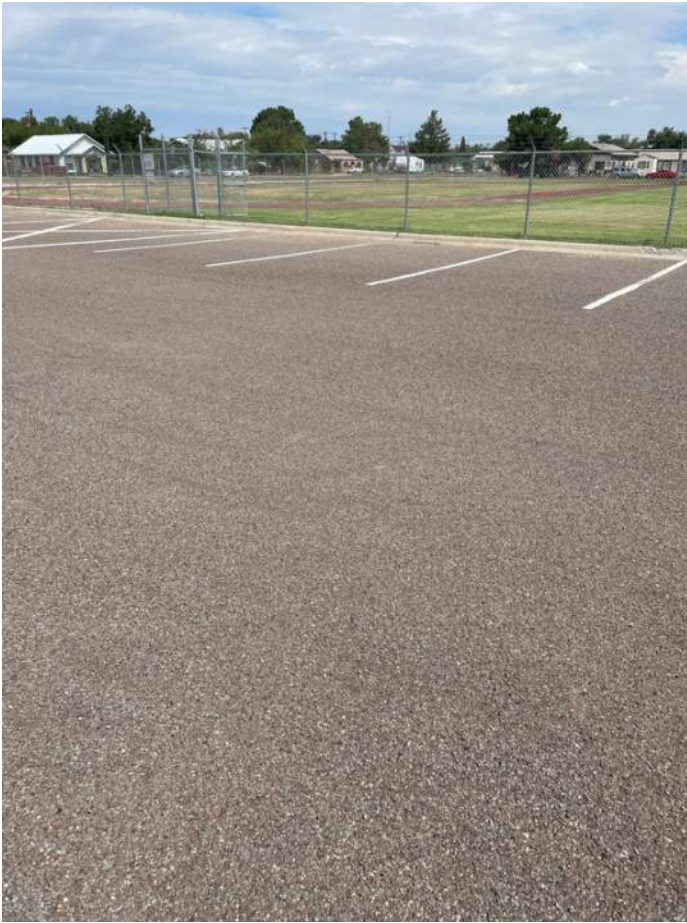
Site Development - 1. Parking lot

Type Description-Site Development	Parking lot
Condition Rating-Site Development	Good - minimal depreciation, consistent with asset age
Deficiency Category-Site Development	No Immediate Action
Quantity-Site Development	n/a
Unit-Site Development	n/a
Year Installed-Site Development	n/a
Comments-Site Development	n/a

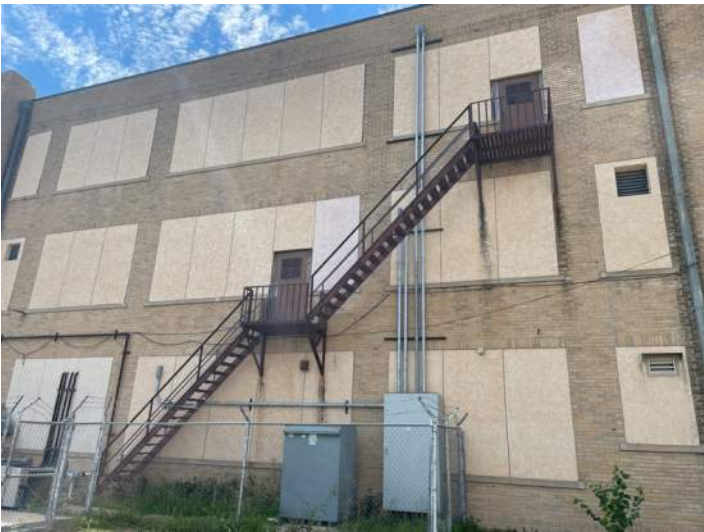
**Site Development - 2. Exterior metal stairs**

Type Description-Site Development	Exterior metal stairs
Condition Rating-Site Development	Critical - failed or failing, and beyond useful life requiring immediate attention
Deficiency Category-Site Development	Damaged/Failing
Quantity-Site Development	1
Unit-Site Development	EA
Year Installed-Site Development	n/a
Comments-Site Development	Stairs unsafe due to extensive rusting. Recommend removing. Better to fire rate the interior stairs then to replace exterior stair.

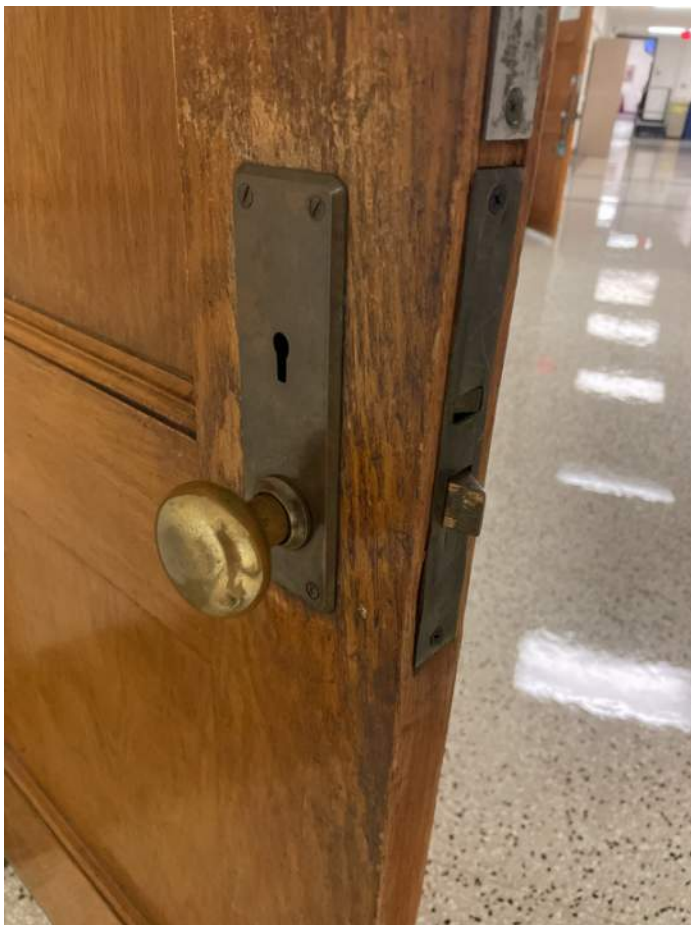
Description-Accessibility	No accessible turns on majority of doors.
---------------------------	---

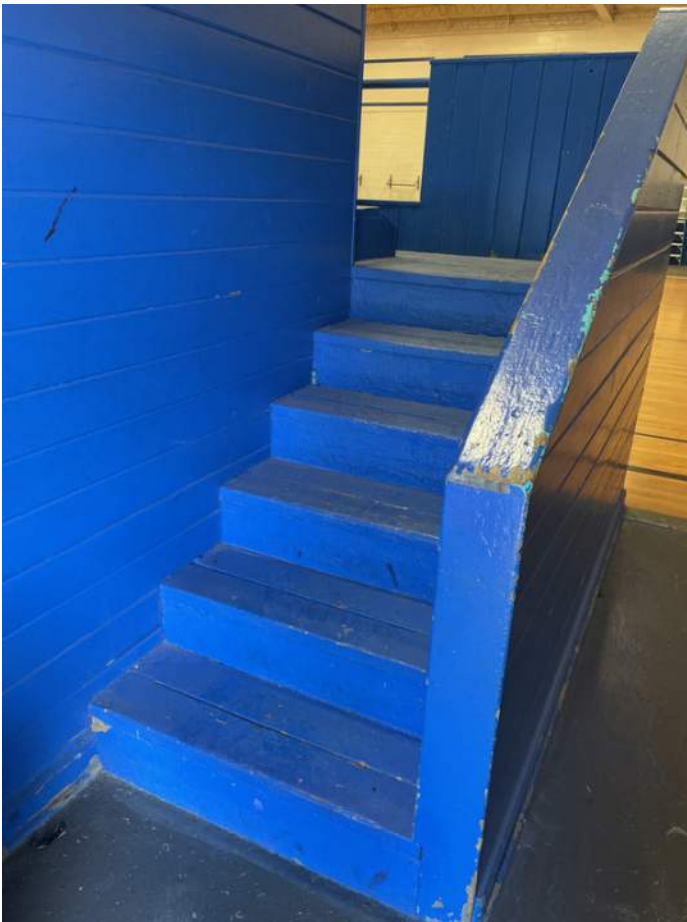
Description-Accessibility | Bleachers are not accessible

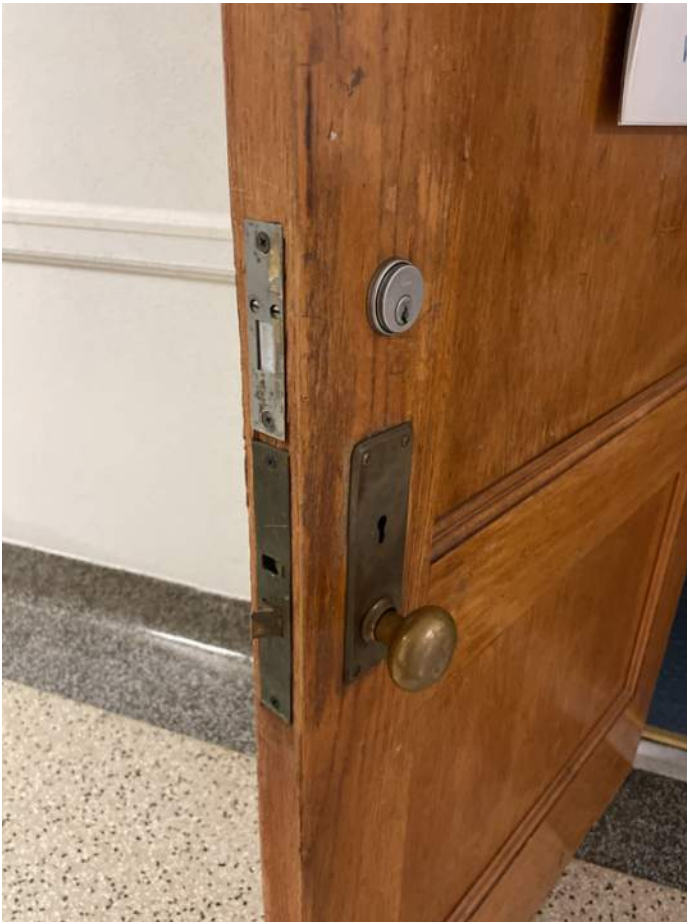
Building Codes - 1. Fire code issue. Two locks on most doors.

Fire code issue. Two locks on most doors.

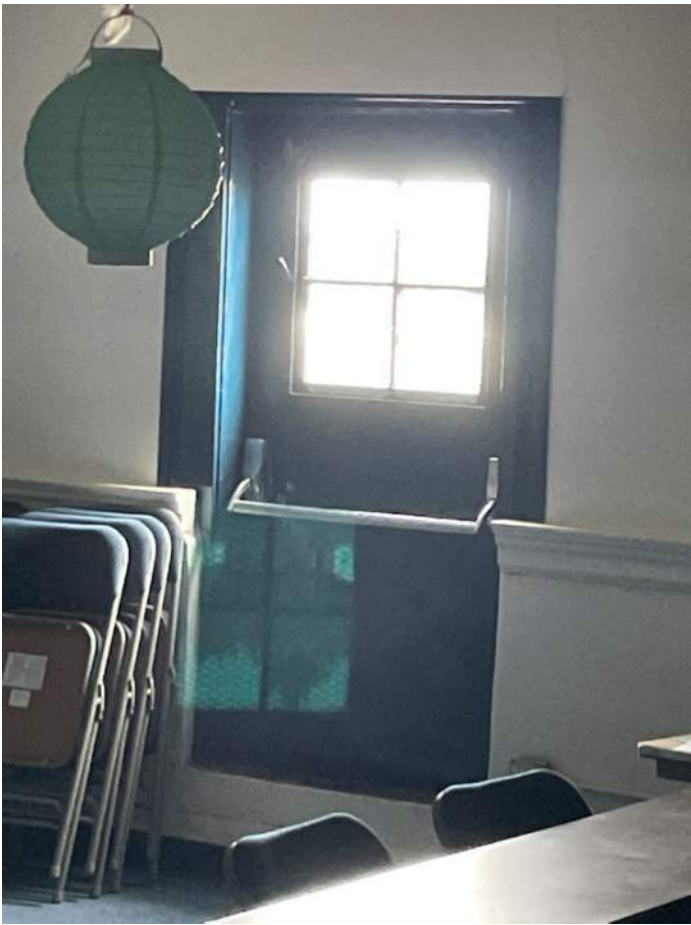
Fire code issue. Room 39/40 is larger than 1,000 SF. It does have 3 exits. One has an exit device, but the step at the door doesn't meet current code requirements. The other two doors could meet code if exit devices are added.

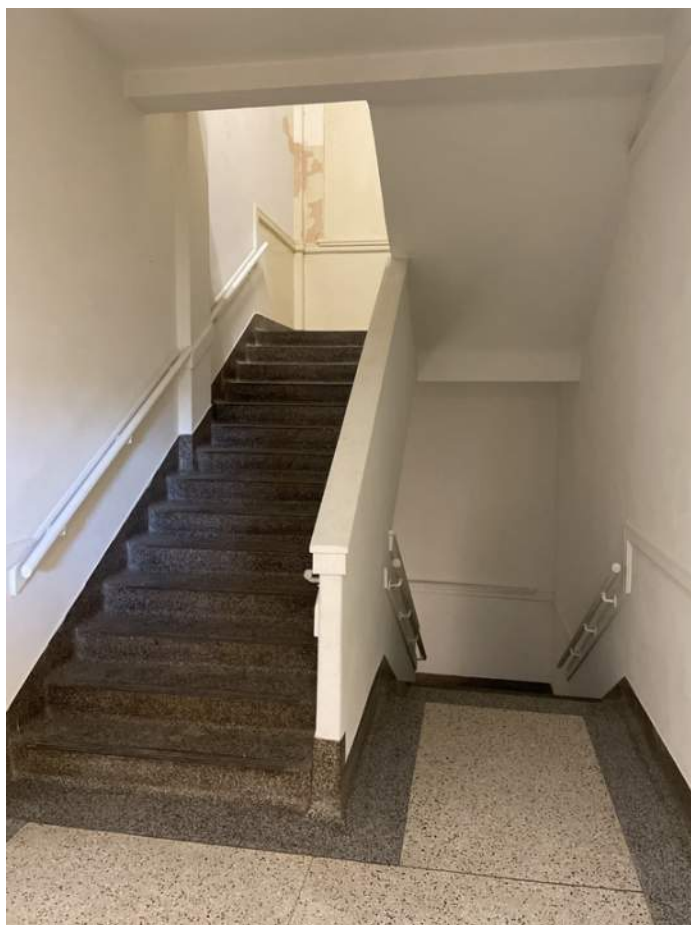
Building Codes - 4. Fire code issue. 2 stairs connect all 3 floors without fire sedation.

Fire code issue. 2 stairs connect all 3 floors without fire sedation.
