District-Wide Facilities Study May 3, 2019

## LOWER MORELAND TOWNSHIP SCHOOL DISTRICT DISTRICT-WIDE FACILITIES FEASIBILITY STUDY May 3, 2019

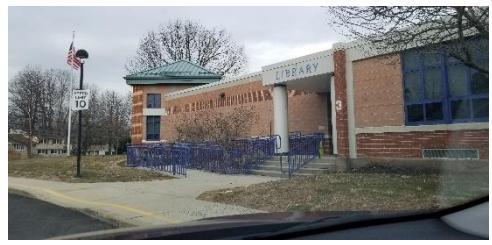
Exterior ramp and stairs

The sidewalks and site stairs around the site are old but in decent condition. In some areas, joints are coming up and curbs are crumbling. The balustrade and handrails at the ramp and stairs by the library are in good condition. The main parking lot was renovated, milled, and resurfaced in 2010. The access road and additional parking lot also was added in 2010. Lion paw prints are painted on the access road entrance from Pine Road, which guides visitors to the front entrance and visitor parking.

Repair areas of sidewalk and curbing where the joints are coming up and curbs are crumbling.

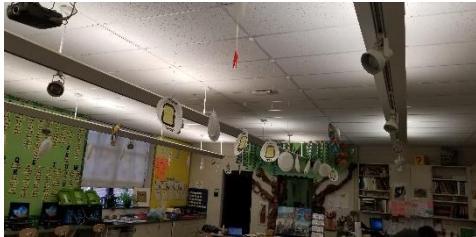
Ceiling in classroom that was art room

acoustical ceiling tiles all were replaced when sprinklers were installed during the 2010 addition and renovation and are in good condition. A couple of rooms that were reconfigured for a different classroom type should have the lighting fixtures revised in that room. This specifically occurs in the old art room, which became a classroom. The track lighting installed for the old art room is still in the now-classroom and is not conducive to learning.

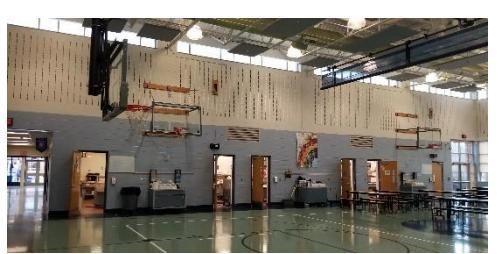
Entry and exit into serving lines

Overall the building meets code compliance, though there are some minor issues. A key compliance issue is door clearances at many locations. To be code compliant, each door needs 18" on the pull side of a door and 12" on the push side of a door. There are a few instances where the doors do not meet this requirement. Another compliance issue are the water fountains, which project into the corridor. Code states that items cannot

All corridor water fountains should be replaced with fixtures compliant with current ADA and code requirements.

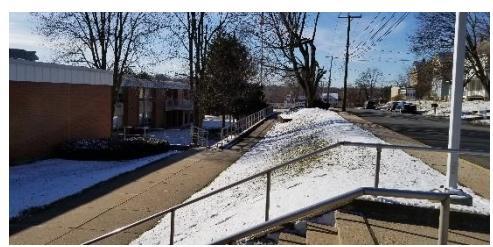
Sidewalk looking down Murray Avenue

A sidewalk along Murray Avenue and one along the entrance driveway to the gymnasium provide pedestrian access to the site. A bridge connects the Murray Avenue sidewalk to the upper entrance of the building. There also is a sidewalk along the pick-up/drop-off lane. Finally, sidewalks from the rear of the building connect the school to the stadium. All sidewalks are in good condition, except for the deteriorating exterior stairs that provide access to the stadium.

Replace stairs from the school to the stadium.

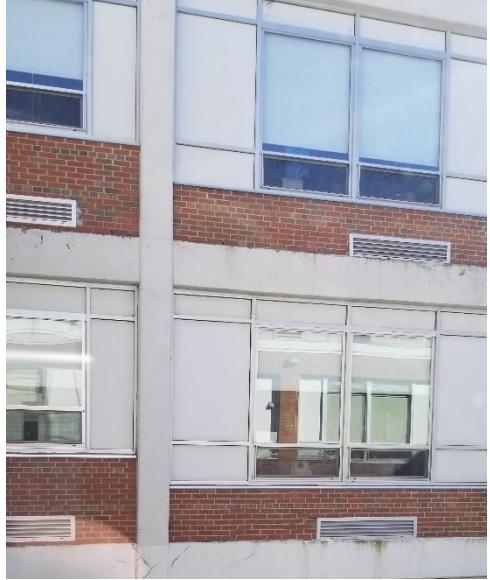
Exterior windows

Most of the windows throughout the building have aluminum storefront frames. Some windows in the original gymnasium are casement windows while others have been replaced with aluminum storefront frames. The windows are in good condition, though the caulking on some windows needs to be replaced.

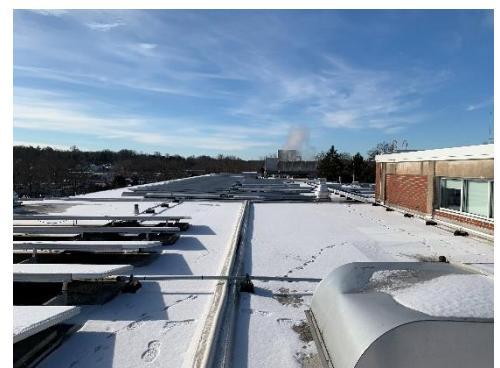
Flat roof with solar array

The main school building has a thermoplastic polyolefin (TPO) finish, and the original gymnasium has a high sloped roof with asphalt shingles. There are solar arrays on the main portion of the building. Currently, there are no reported roof leaks on the building. The asphalt roof's warranty expires in 2019, and all other roof areas are under warranty until 2022.

Replace the asphalt shingles with a system in warranty, and prepare to replace the remaining roof systems in 2022.

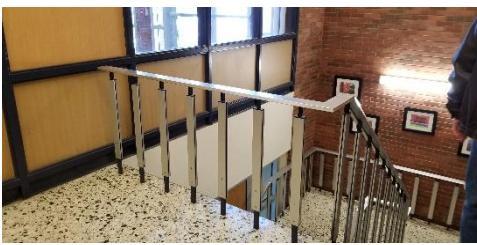
Not compliant stair handrail / guard

Stair railings should be replaced to meet modern building safety codes.

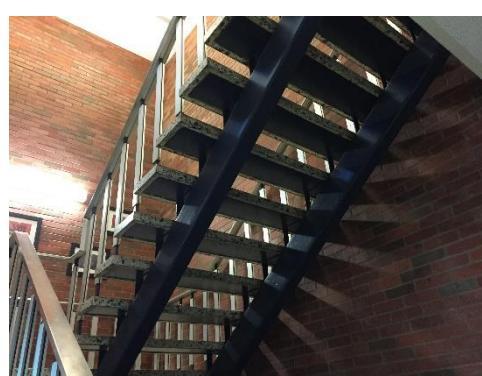
Open risers in main stair

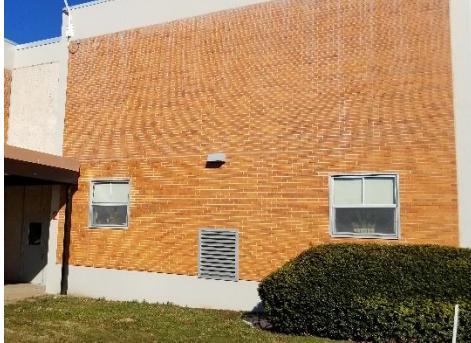
Efflorescing on brick veneer

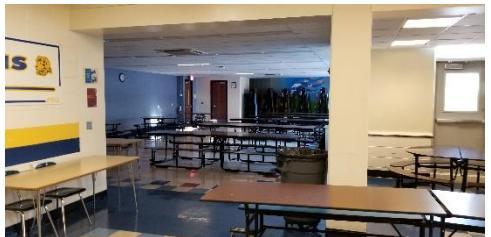
The cafeteria was recently expanded. Two classrooms adjacent to the cafeteria were renovated to create more seating. Unfortunately, the cafeteria and seating annex combined is still too small a space to accommodate the number of students it serves. Seating and flexibility are limited.

View to cafeteria expansion

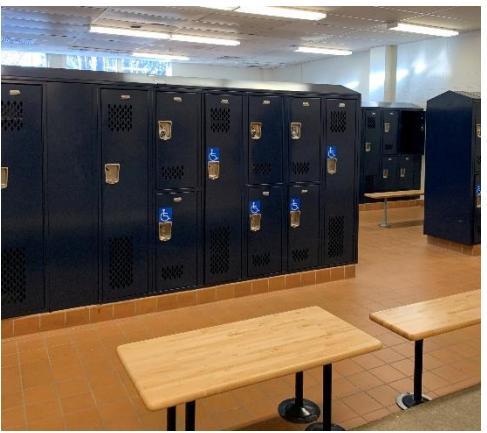
Boys locker room

The physical education program spaces are sufficient for the program. The main gymnasium, fitness center, and locker rooms are on the opposite side of the building from the auxiliary gymnasium. As a result, the auxiliary gym is underutilized. The gymnasium, fitness center, and auxiliary gym have wood floors that are old but in good condition. The district recently replaced the lockers in the locker room. However, other areas in the locker room still need attention: bathrooms are not ADA compliant and the tile floors are showing signs of wear and tear.

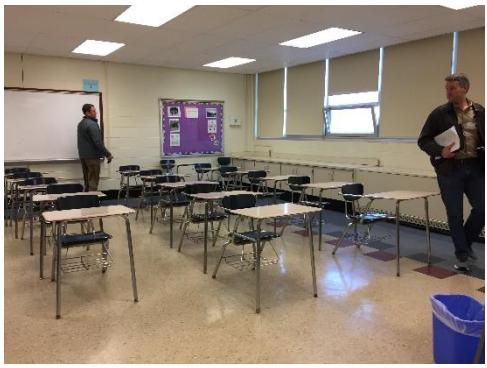
Typical classroom

Flexible furniture should replace the older desk-with-chair units currently in use.

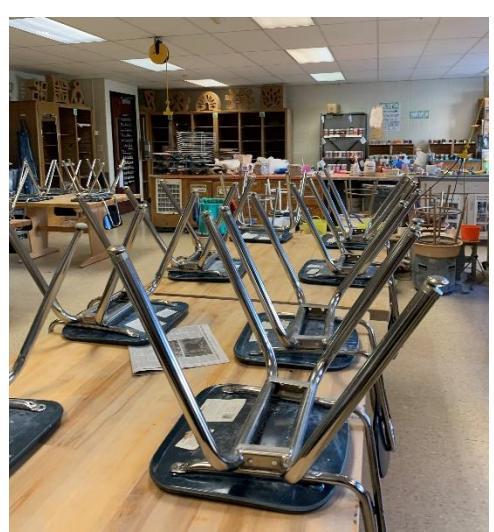
There are three art rooms in the building. One of the classrooms is dedicated to ceramics and has two large kilns and one small kiln that are all aged and in need of replacement. The other art rooms provide instructional space for painting, drawing, and computer art. Ample storage is available for the art program, but it is not efficient. Some of the storage is accessed off the corridor in small closets not connected to the art rooms. Also, there is a desire to integrate more of the technology and engineering programs into the art program.

Ceramics classroom

Replace existing kilns.

Renovate art classrooms to provide more efficient storage in classroom and flexibility for additional collaboration.

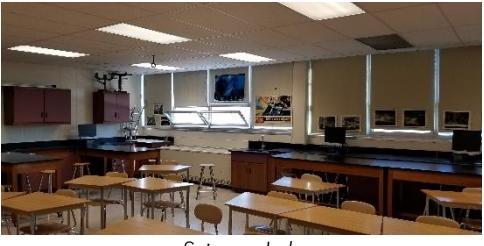
The science labs, renovated in 1997, are in good condition. However, they are limited in flexibility because the lab tables are affixed to the walls. Most of the labs are connected to a prep room. There is desire from the district to add additional lab spaces.

Science Lab

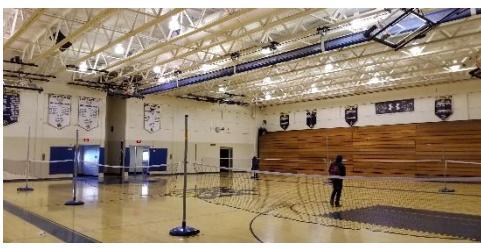
The physical education program is supported a gymnasium, wrestling room, fitness center, natatorium, and locker rooms. The main gymnasium has one main court and two side courts. It has a wood floor that is nearing the end of its lifespan. Also, there are no volleyball standards in the floor. Players on the main court have minimal run-off space on one side and run off space that goes into a hallway on the other side. The bleachers, which can hold up to 1,500 occupants, are old, not ADA compliant, and are repaired often. There are no aisles in the bleachers, which is not code compliant.

"Upper Gym" – Main Gymnasium

Renovate gymnasium with a gym floor replacement and new bleachers to meet athletic standards and code.

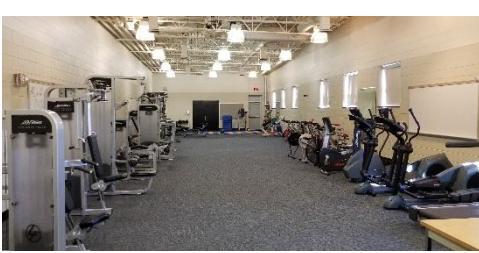
The fitness center and wrestling room can only be accessed by walking through the gymnasium. Yet the fitness room does not have any interior windows to connect it visually with the gym. The floor has carpet, which is not ideal for a fitness environment. The wrestling room wall pads are showing signs of wear.

Fitness Lab

Schedule wrestling room wall pads for replacement in the next five to ten years.

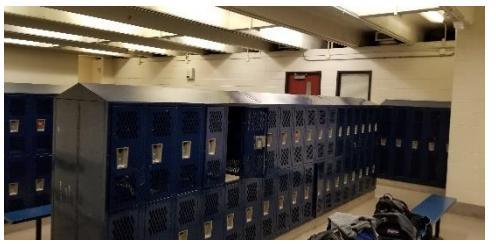
Locker Room

Aspects of the locker room were recently renovated. The lockers and floor were replaced, as was the floor in the trainer's room. The floor finish in both spaces was not installed correctly, and this makes it difficult to clean. The floor in the trainer's room is separating from the wall base. There are not enough lockers to accommodate current number of students in the gym classes. There are no team rooms. The locker rooms are only accessible through the gym or the pool deck.

Replace locker room floor and add more lockers to increase capacity.
