FACILITIES NEEDS ASSESSMENT

BORONDA MEADOWS

PREPARED BY BELLI ARCHITECTURAL GROUP

2022

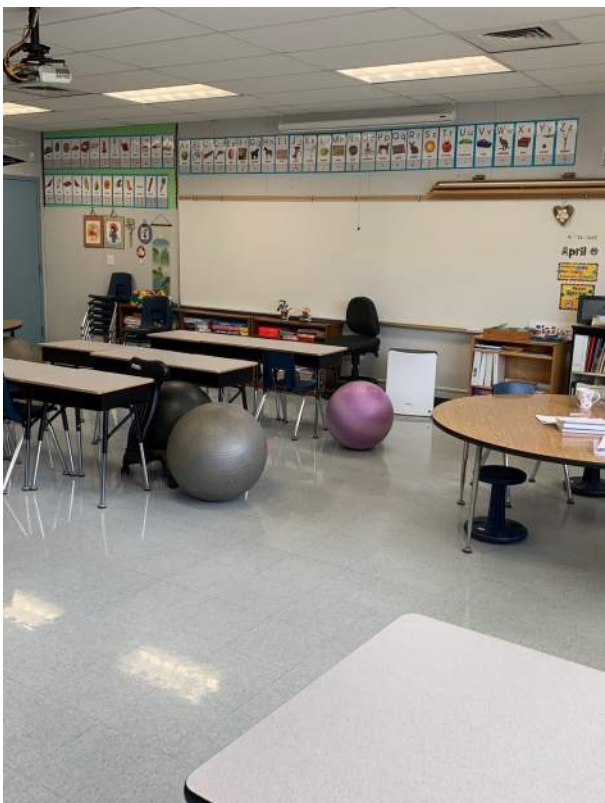
Image 2.3.6 Existing classroom furniture. Taken on 04/26/2022 by Belli Architectural Group.

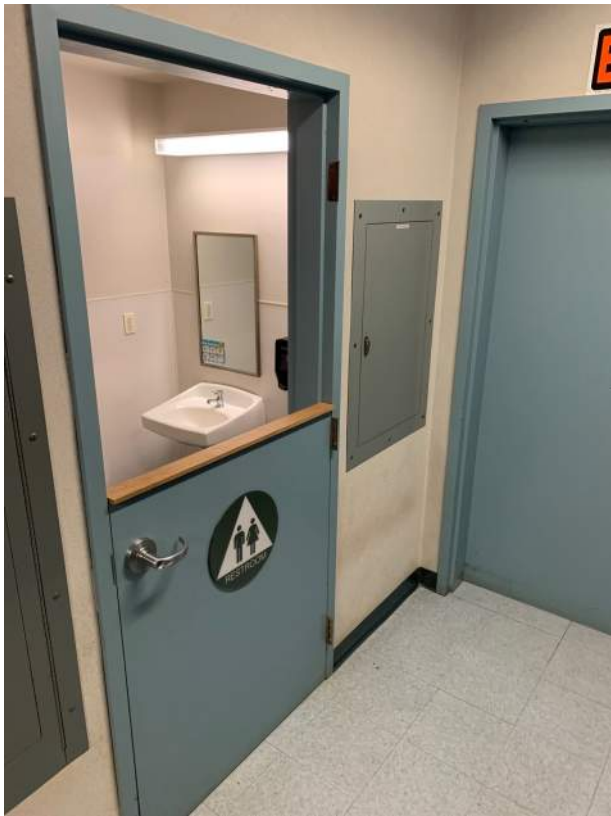
Image 2.4.2 Kindergarten restroom doors. Taken on 04/26/2022 by Belli Architectural Group.

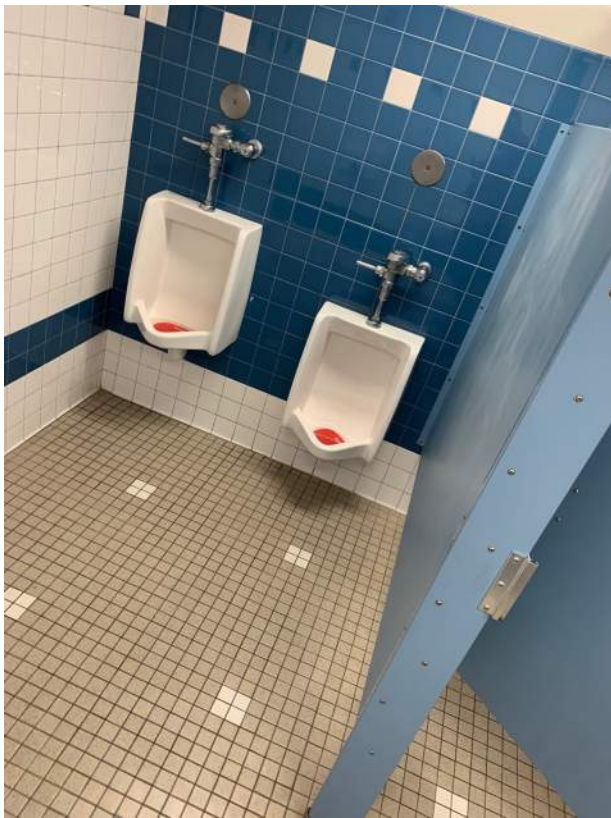
Image 2.4.3 Accessible urinals. Taken on 04/26/2022 by Belli Architectural Group.

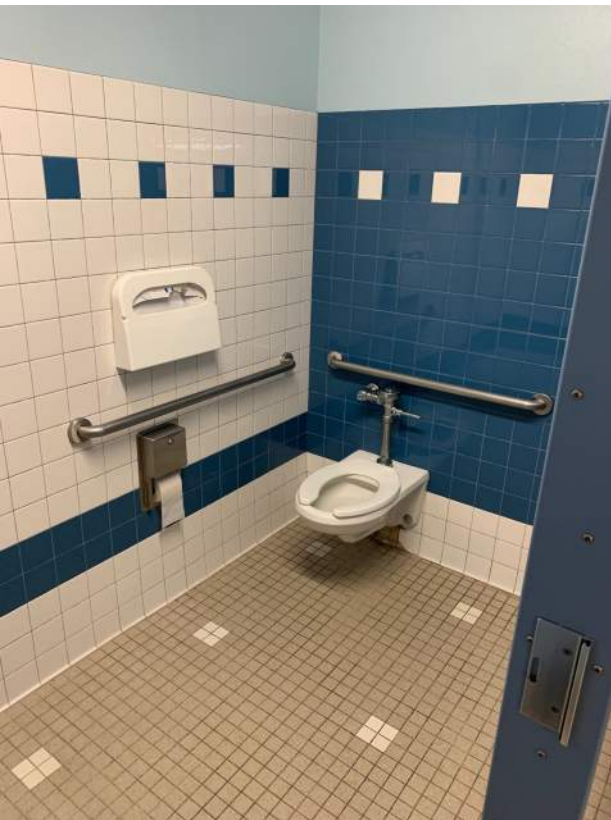
Image 2.4.4 Accessible toilets. Taken on 04/26/2022 by Belli Architectural Group.

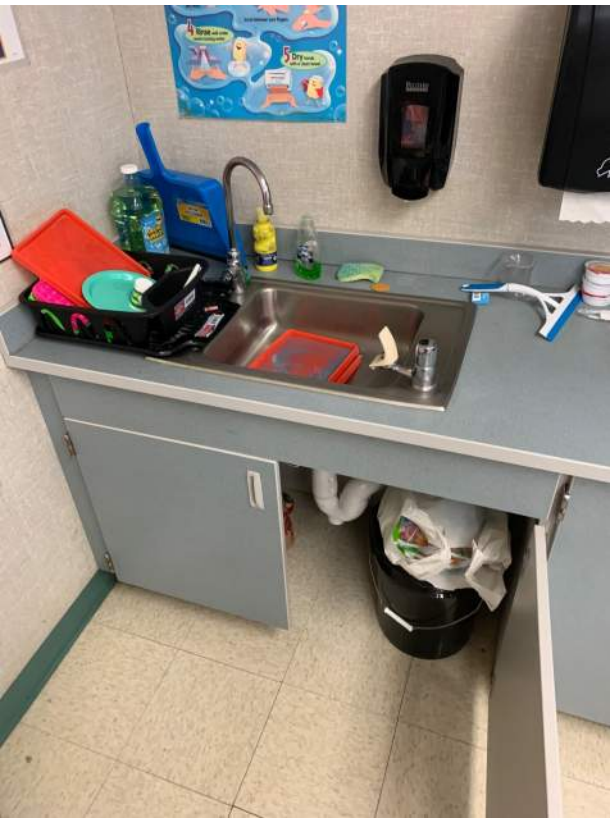
Image 2.4.5 Accessible sinks. Taken on 04/26/2022 by Belli Architectural Group.

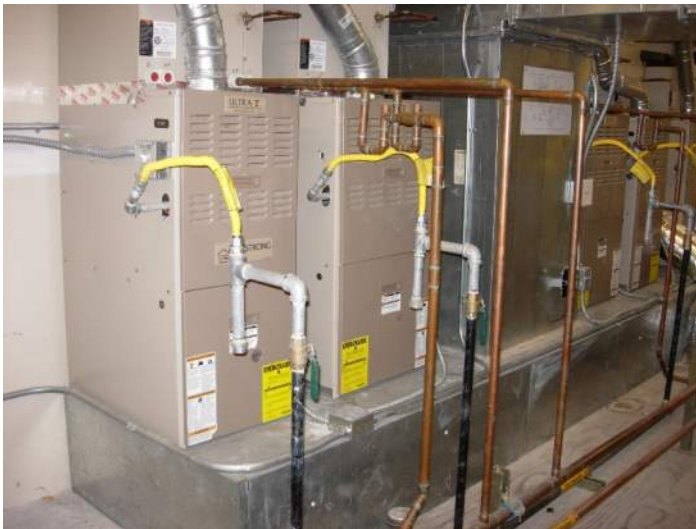
Administration Building:

The heating system for the administration building consist of five (5) Armstrong up-flow gas-fired furnaces. These furnaces are original and appear to be in good condition and operating satisfactory. These units have cooling (air conditioning).

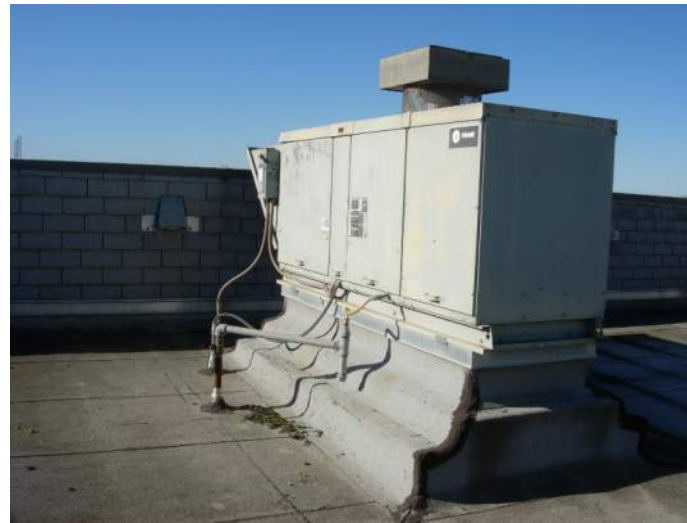
Multi-Purpose/Cafeteria Building A and B:

The heating system for this building consist of four (4) Trane rooftop gas-fired heating only units. These are original and appear to be in good condition and operating satisfactory. A horizontal gas-fired furnace located above the ceiling of the stage provides heating for this area. The food service area has CaptiveAire Type 1 hoods that are in very good condition. The food service equipment in Building A is presently not in use

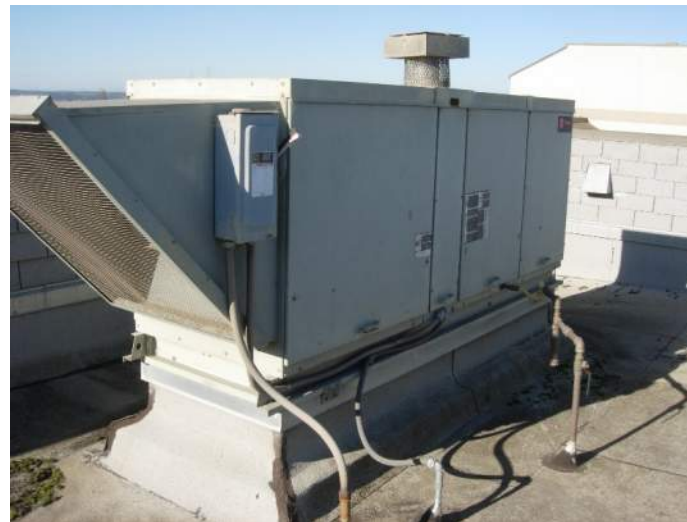
Kindergarten Building:

The heating system for this building consist of three (3) Trane rooftop gas-fired heating only units. These are original and appear to be in good condition and operating satisfactory.

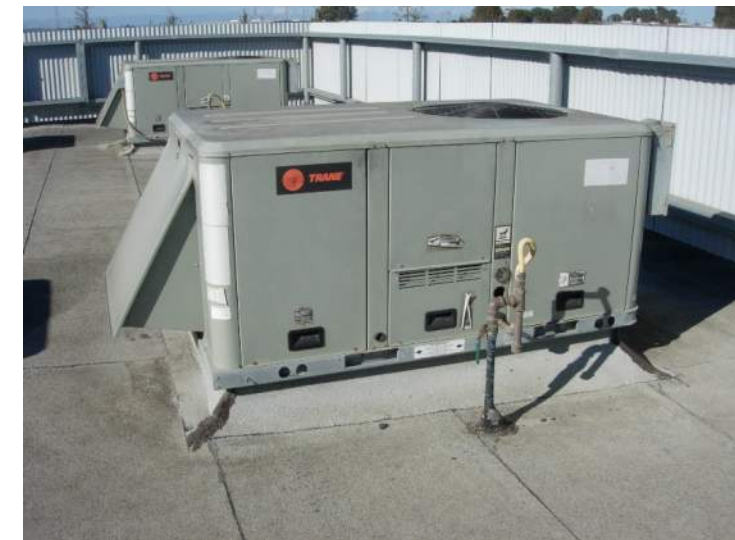
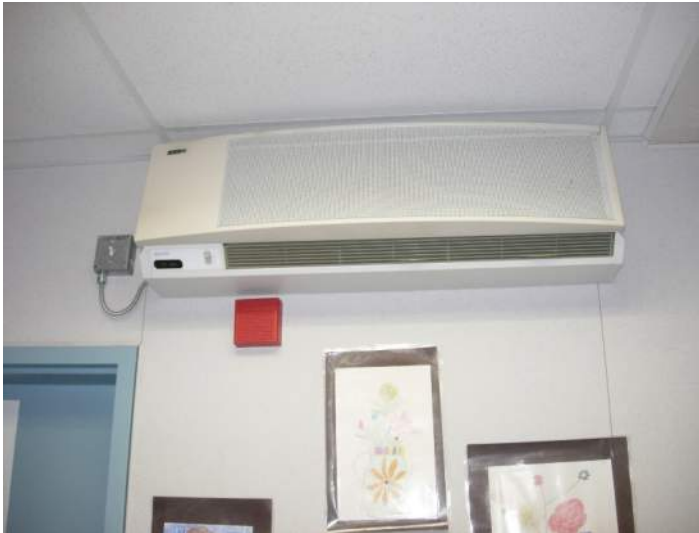
Classroom (Classrooms 5 thru 28) Building:

These buildings (there are four of them) are heated and cooled with six (6) Trane rooftop mounted packaged gas heat/electric cooling units. Each classroom (there are six classrooms in each building) has its own HVAC unit. These are original and appear to be in good condition and operating satisfactory. Each Teachers Resource Room have a wall mounted EMI heating/cooling unit.

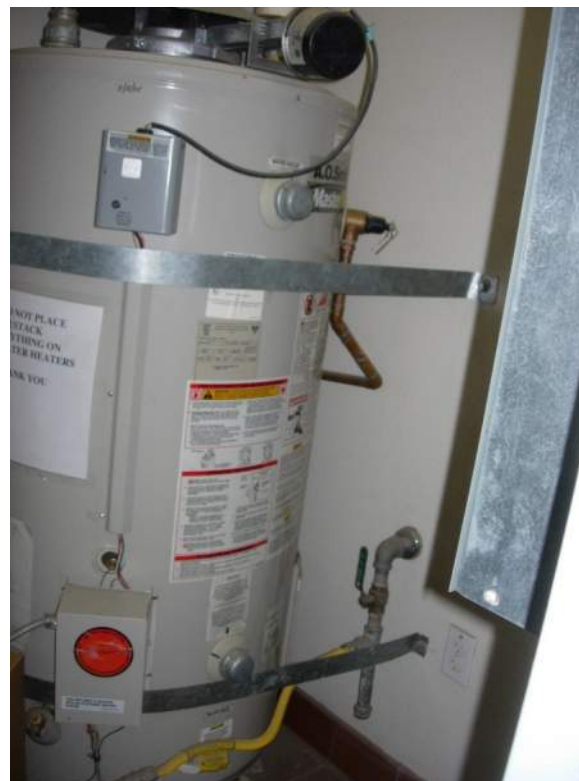
Multi-Purpose/Cafeteria Building A and B:

A gas-fired tank type water heater serves the food service kitchen. The required DSA approved seismic bracing is present.

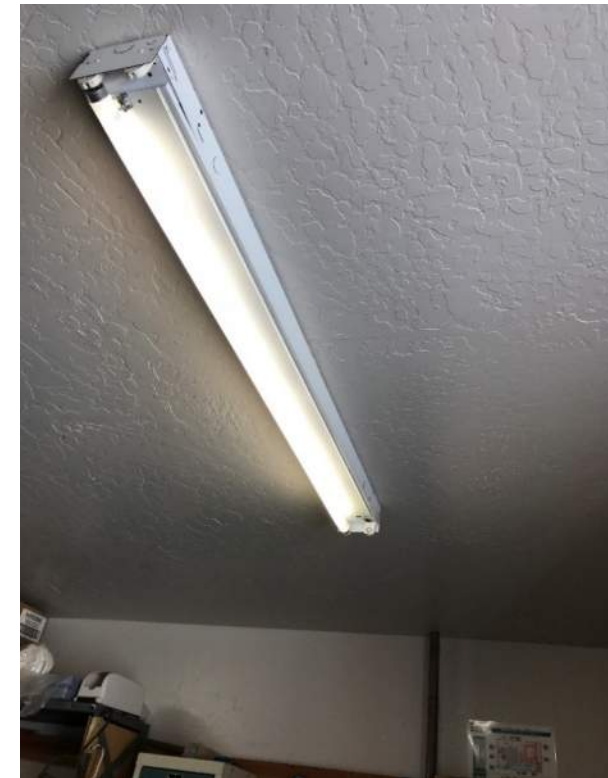
Interior Lighting is primarily fluorescent with T8 or T12 lamps at interior spaces that were observed. Most, if not all the lighting throughout the school campus is old and although there was no mention of complete failure, some light fixtures seemed original to the spaces, so they are likely near their “end of life”, especially with regards to efficiency. A few light fixtures were found to have missing lenses/diffusers and lamps, see attached photo LTG1. Most of the rooms have energy code compliant controls such as occupancy sensors. Emergency lighting with integrated battery back-up were found in common areas, offices and in the library building. In the multi-purpose building, classrooms and hallways, bug-eye type stand-alone emergency light fixtures were installed. However, no emergency lighting was found at the exterior landings. Multi-level switching/dimming necessary for energy conservation is almost non-existent. Expected life; Unknown. It is recommended to retrofit or replace campus wide lighting system with new LED technology in the near future. This would be a good opportunity for reduction in energy use from more efficient lighting fixtures, improved classroom lighting, smart lighting controls, daylight harvesting and would also reduce maintenance costs. See photo attached LTG2.
