# FACILITIES NEEDS ASSESSMENT

LAUREL WOOD

PREPARED BY BELLI ARCHITECTURAL GROUP

2022

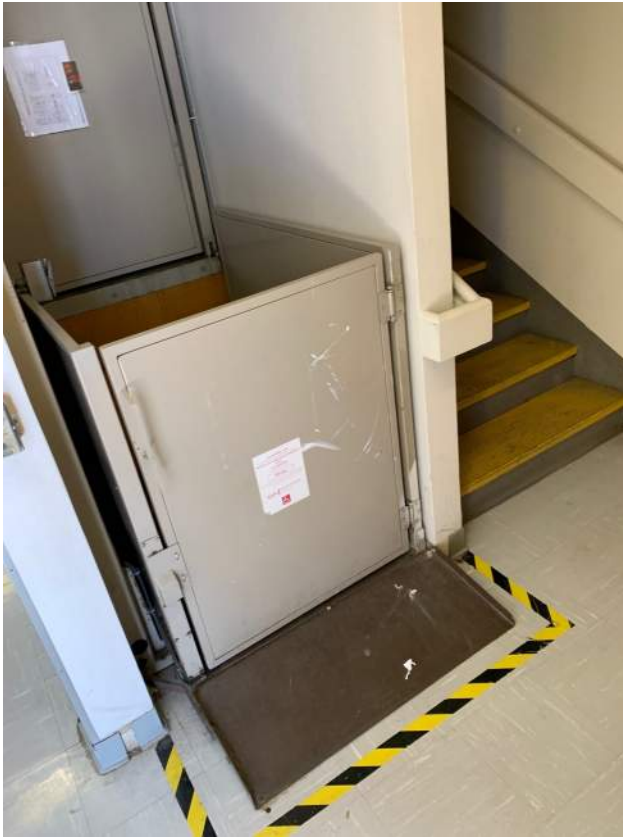
*Image 2.4.4 Accessible chair lift to stage. Taken on 04/26/2022 by Belli Architectural Group.*

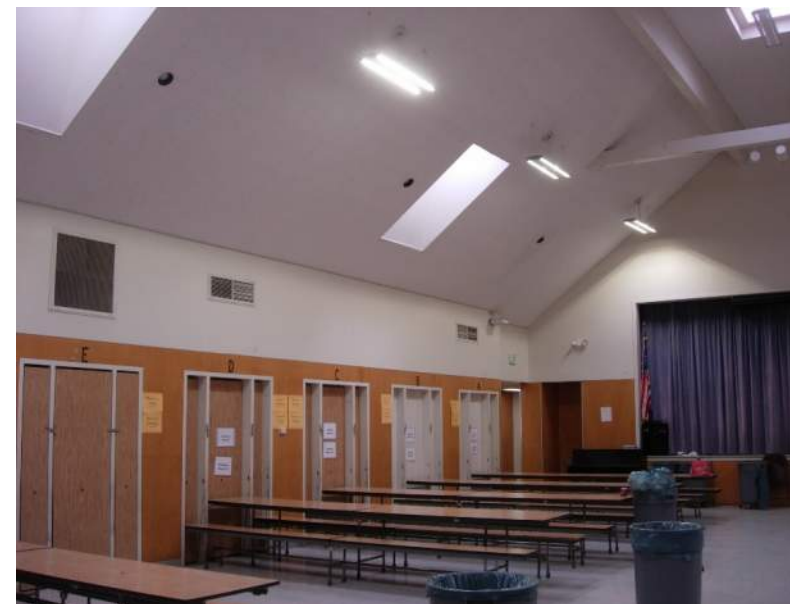
This building is heated with two (2) Reznor horizontal gas-fired heating units with blower fans located in the attic. These are original units from 1986 and should be replaced. These units have outside air inlets for ventilation.

The photo below is inside the cafeteria.
