FACILITIES NEEDS ASSESSMENT

LOS PADRES

PREPARED BY BELLI ARCHITECTURAL GROUP

2022

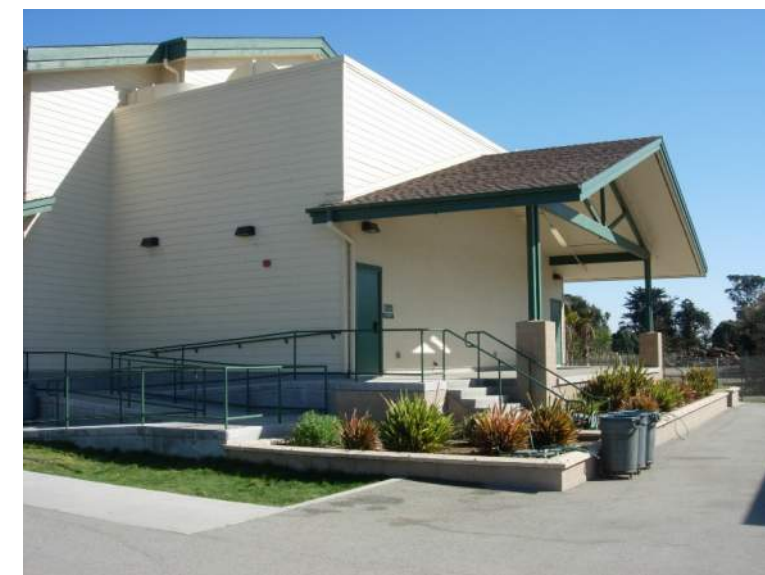
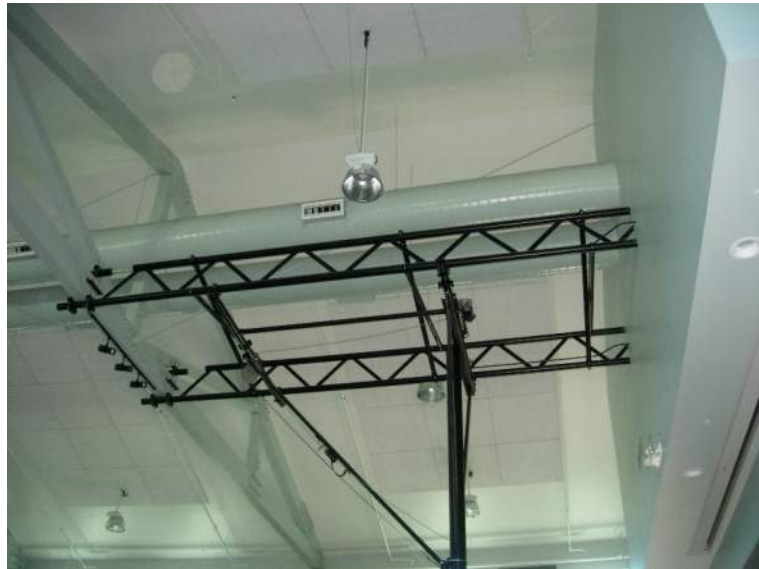
Multi-Purpose Building:

This building was constructed in 2013. The HVAC and plumbing systems appear to be in very good condition and operating.
