FACILITIES NEEDS ASSESSMENT

UNIVERSITY PARK

PREPARED BY BELLI ARCHITECTURAL GROUP

2022

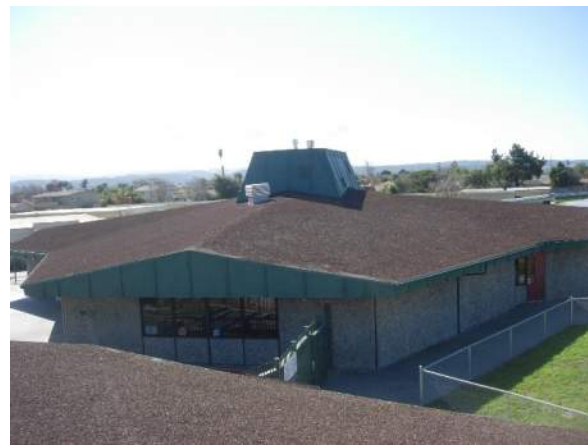
The findings from a site visit conducted on April 27, 2022. It appears the last significant HVAC/Plumbing modernization was done in 2003. The three (3) main school buildings appear to be 1960's era and are unlike any others in the district. These three building just had new roofs installed in 2022. The wood enclosure on the roofs that house the HV equipment were also repaired. It is desired to install a Pelican Wireless Control System to allow the district maintenance staff to control all HVAC equipment.
