**SITE ASSESSMENT  
FOR  
ADA COMPLIANCE**

**Red Hill Sports Complex  
Shaw Drive  
San Anselmo**

January 18, 2022

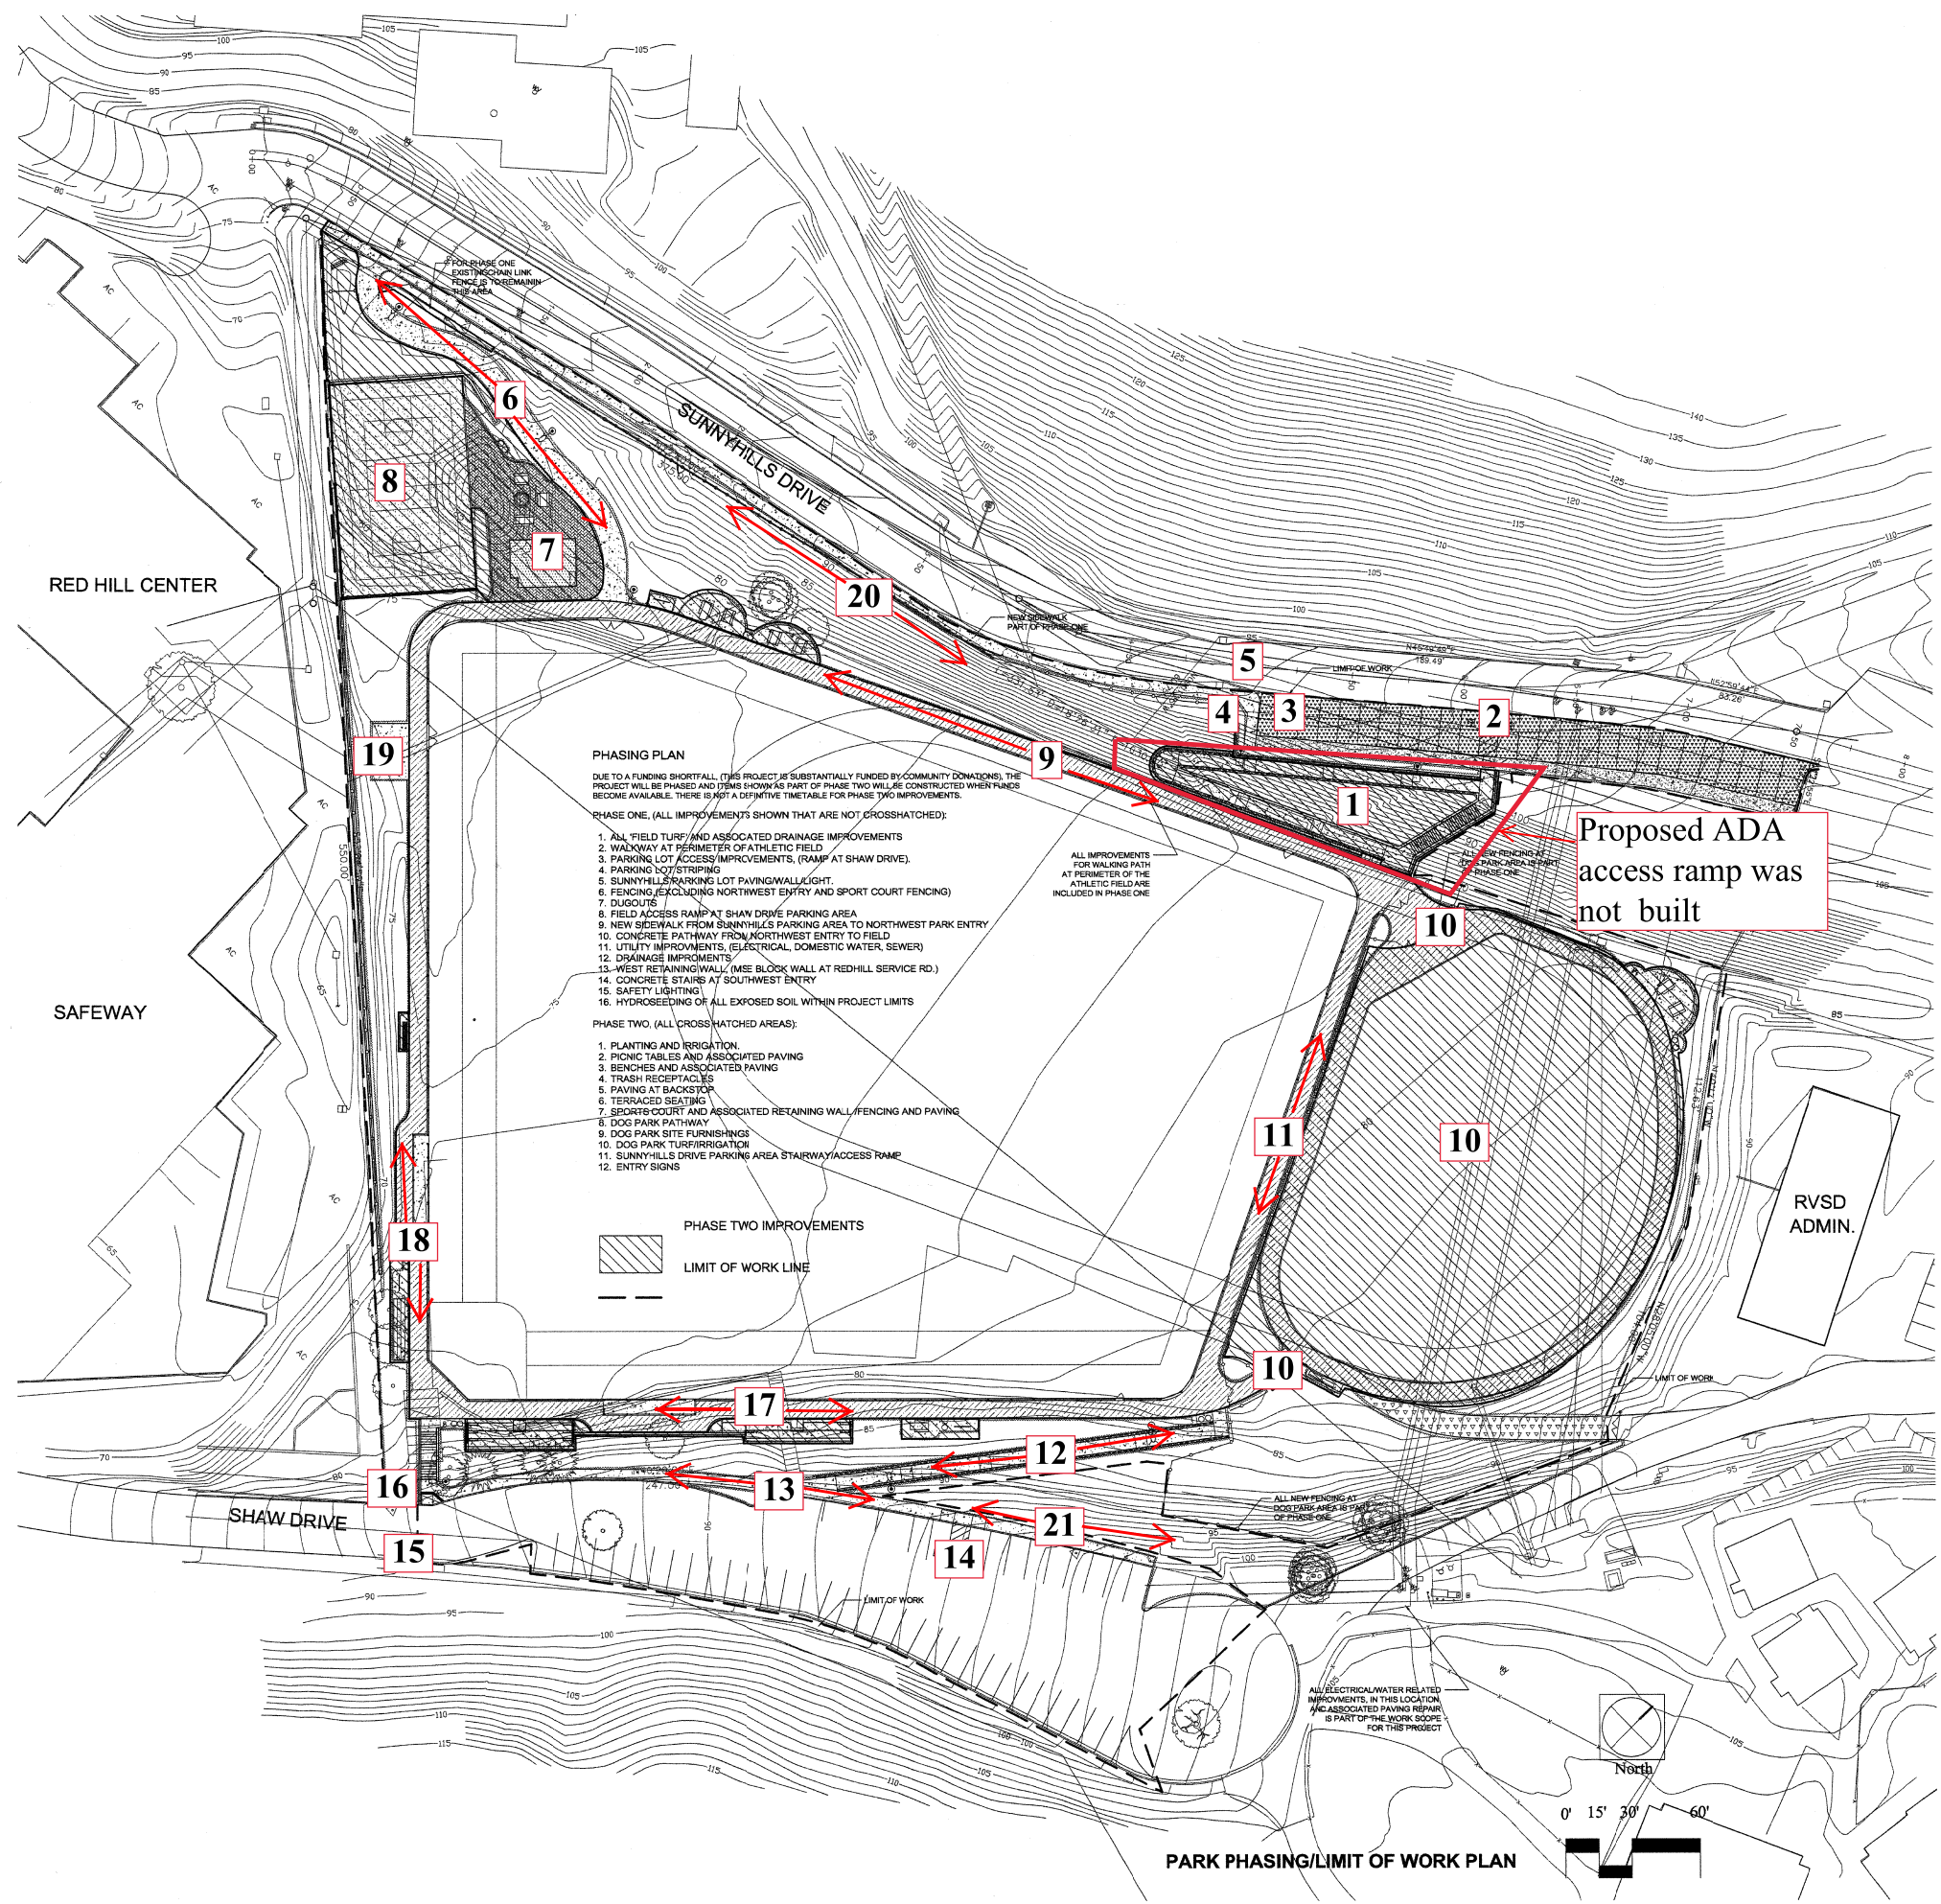
# PH1.1

### PHASING PLAN

DUE TO A FUNDING SHORTFALL, THIS PROJECT IS SUBSTANTIALLY FUNDED BY COMMUNITY DONATIONS. THE PROJECT WILL BE PHASED AND THIS SHOWS PART OF PHASE TWO WILL BE CONSTRUCTED WHEN FUNDS BECOME AVAILABLE. THERE IS NOT A DEFINITIVE TIMETABLE FOR PHASE TWO IMPROVEMENTS.
