# FACILITY CONDITION ASSESSMENT

**Alum Rock Unified School District**  
2930 Gay Avenue  
San Jose, California 95127  
Kolvira Chheng

Adelante II / Arbuckle  
1970 Cinderella Lane  
San Jose, California 95116

*January 19, 2023*

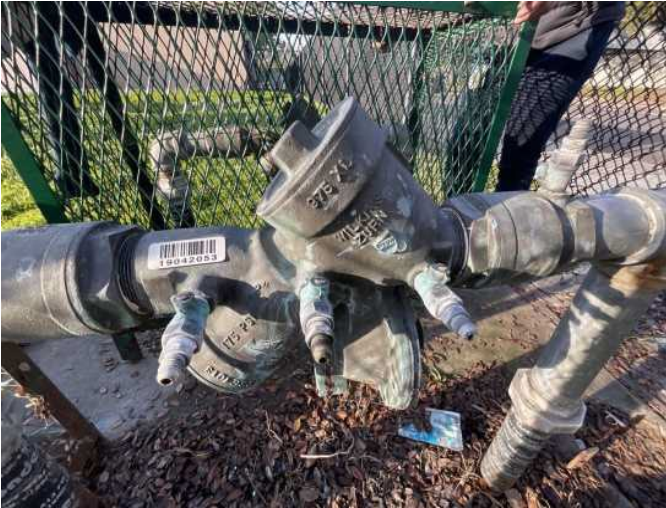
1 - BACKFLOW PREVENTER

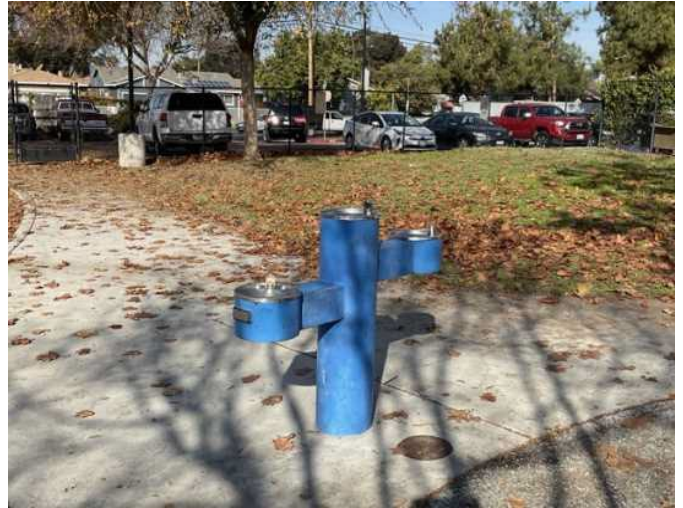
2 - DRINKING FOUNTAIN

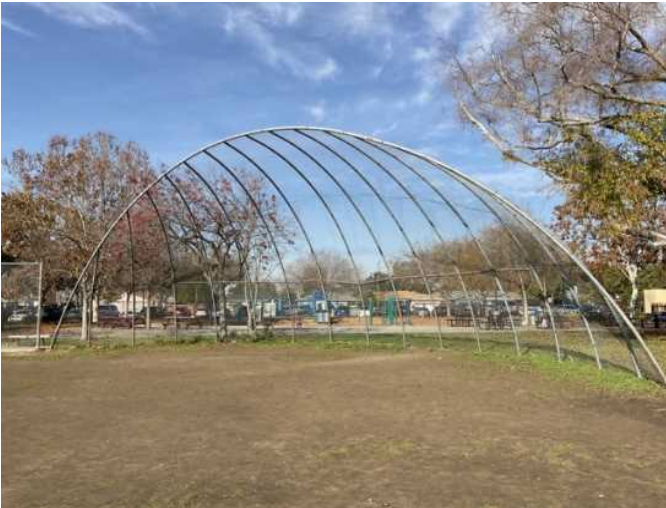
3 - SPORTS APPARATUS

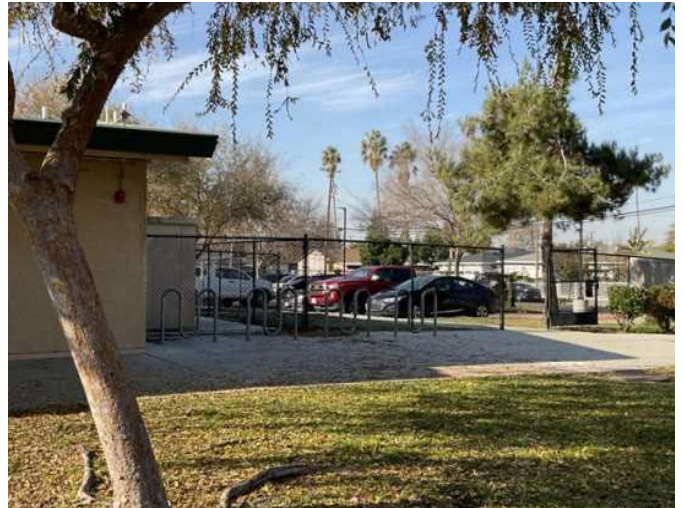
4 - BIKE RACK

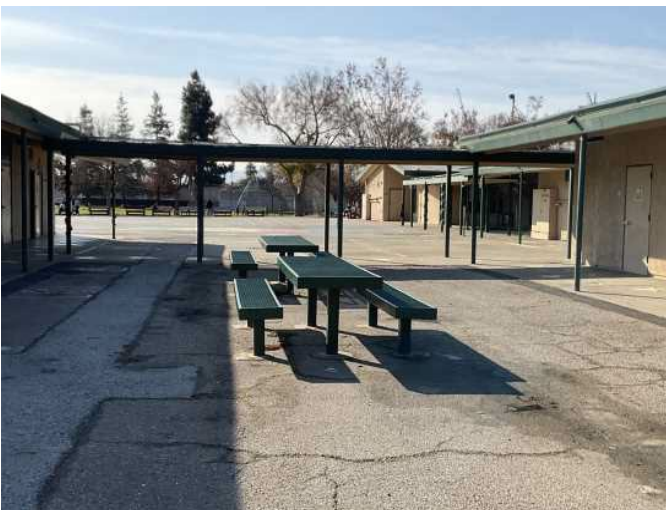
5 - PARK BENCH

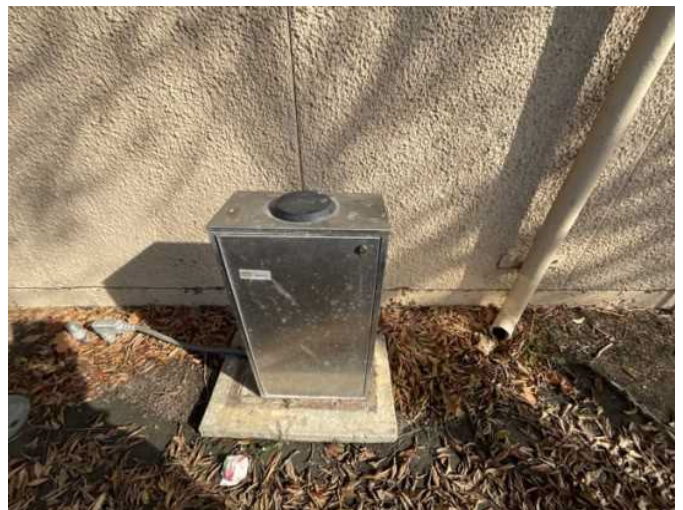
6 - IRRIGATION SYSTEM

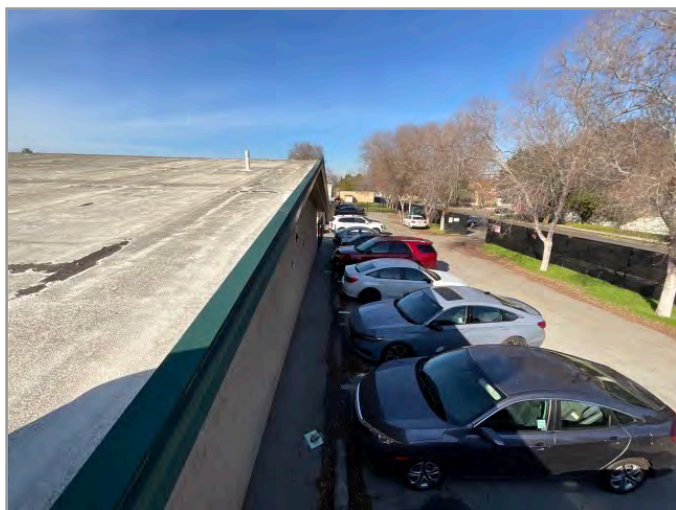
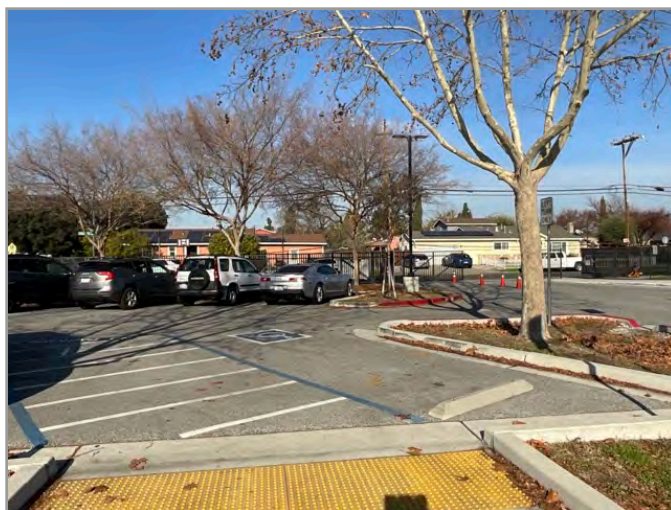
OVERVIEW OF ACCESSIBLE PARKING AREA

SECOND AREA OF ACCESSIBLE PARKING

Question		Yes	No	NA	Comments
1	Does the required number of standard ADA designated spaces appear to be provided ?	✗			
2	Does the required number of van-accessible designated spaces appear to be provided ?	✗			
3	Are accessible spaces on the shortest accessible route to an accessible building entrance ?	✗			
4	Does parking signage include the International Symbol of Accessibility ?	✗			
5	Does each accessible space have an adjacent access aisle ?	✗			
6	Do parking spaces and access aisles appear to be relatively level and without obstruction ?	✗

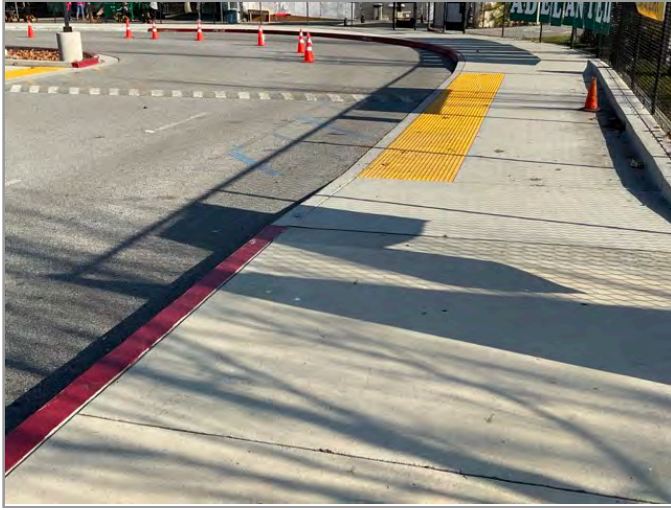
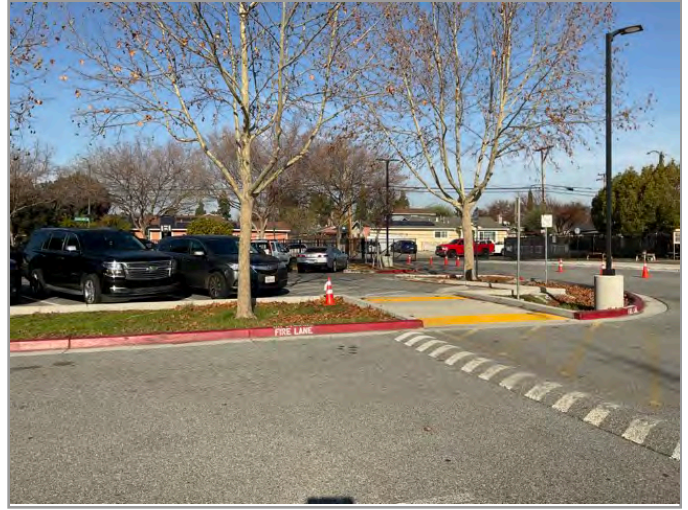
ACCESSIBLE PATH

SECOND PATHWAY

Question		Yes	No	NA	Comments
1	Is an accessible route present from public transportation stops and municipal sidewalks on or immediately adjacent to the property ?	✗			
2	Does a minimum of one accessible route appear to connect all public areas on the exterior, such as parking and other outdoor amenities, to accessible building entrances ?	✗			
3	Are curb ramps present at transitions through raised curbs on all accessible routes?			✗	
4	Do curb ramps appear to have compliant slopes for all components ?			✗	
5	Do ramp runs on an accessible route appear to have compliant slopes ?			✗	
6	Do ramp runs on an accessible route appear to have a compliant rise and width ?			✗

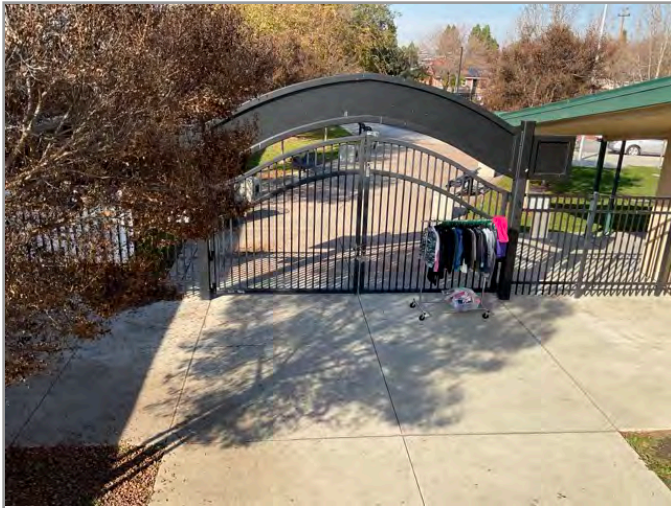
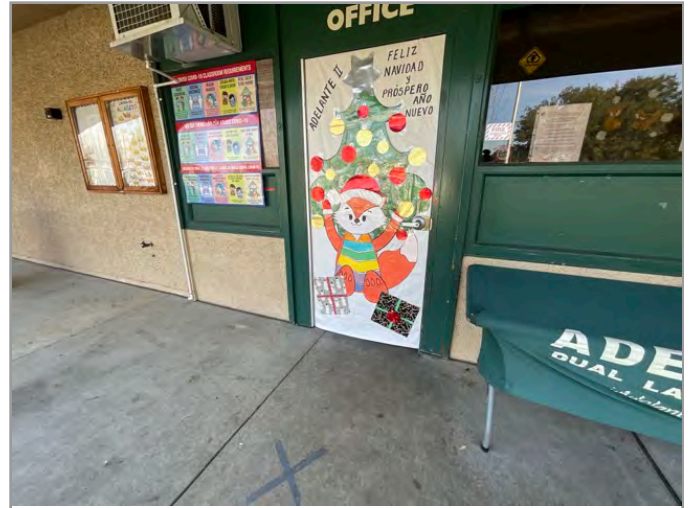
MAIN ENTRANCE

ADDITIONAL ENTRANCE

Question		Yes	No	NA	Comments
1	Do a sufficient number of accessible entrances appear to be provided ?	✗			
2	If the main entrance is not accessible, is an alternate accessible entrance provided?	✗			
3	Is signage provided indicating the location of alternate accessible entrances ?			✗	
4	Do doors at accessible entrances appear to have compliant maneuvering clearance area on each side ?	✗			
5	Do doors at accessible entrances appear to have compliant hardware ?	✗			
6	Do doors at accessible entrances appear to have a compliant clear opening width ?	✗

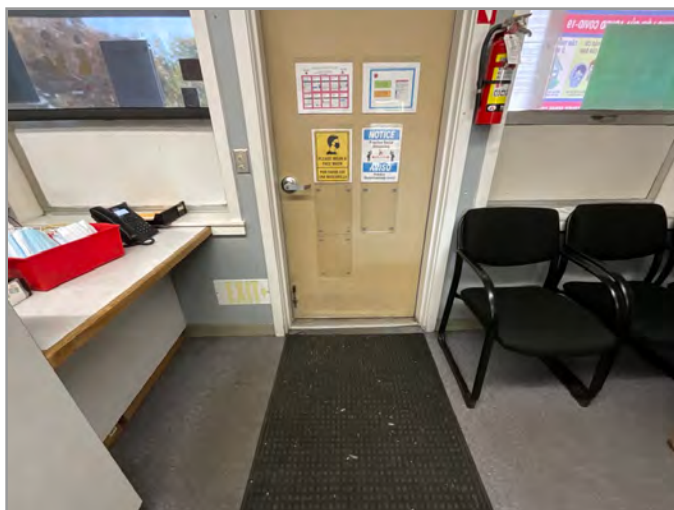
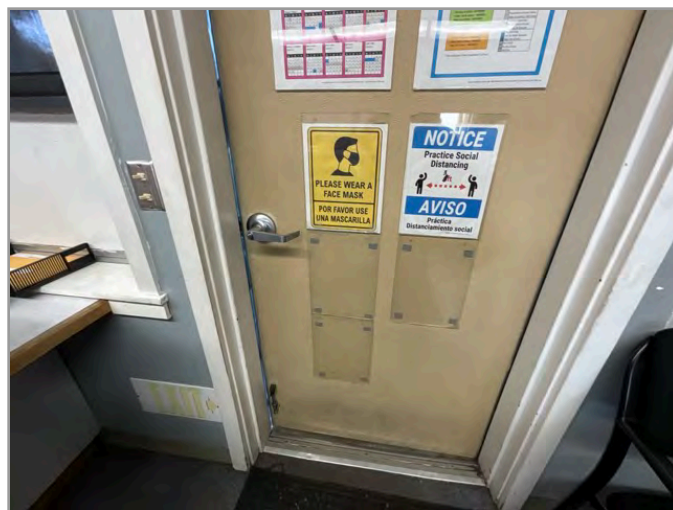
ACCESSIBLE INTERIOR PATH

DOOR HARDWARE

Question		Yes	No	NA	Comments
1	Does an accessible route appear to connect all public areas inside the building ?	✗			
2	Do accessible routes appear free of obstructions and/or protruding objects ?	✗			
3	Do ramps on accessible routes appear to have compliant slopes ?			✗	
4	Do ramp runs on an accessible route appear to have a compliant rise and width ?			✗	
5	Do ramps on accessible routes appear to have compliant end and intermediate landings ?			✗	
6	Do ramps on accessible routes appear to have compliant handrails ?			✗

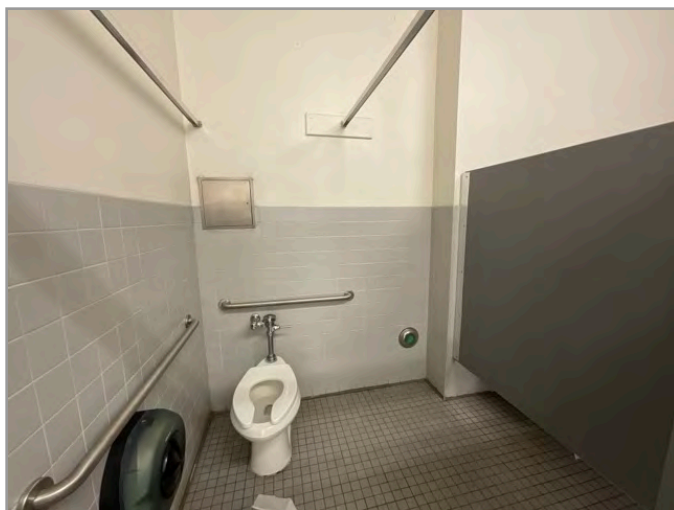
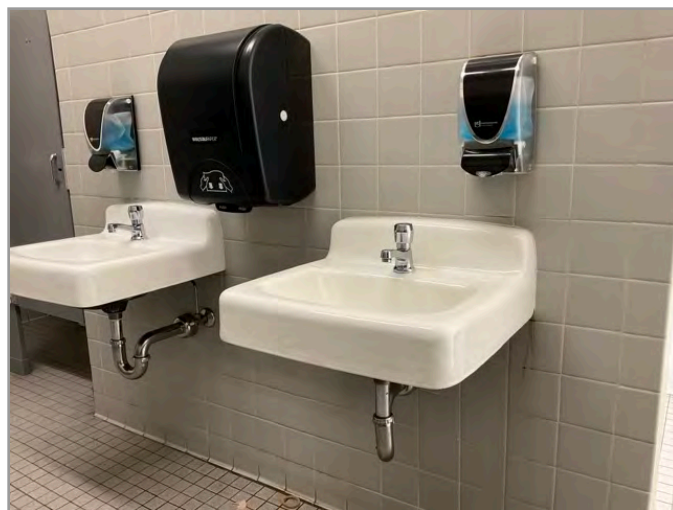
TOILET STALL OVERVIEW

SINK, FAUCET HANDLES AND ACCESSORIES

Question		Yes	No	NA	Comments
1	Do publicly accessible toilet rooms appear to have a minimum compliant floor area ?	✗			
2	Does the lavatory appear to be mounted at a compliant height and with compliant knee area ?	✗			
3	Does the lavatory faucet have compliant handles ?	✗			
4	Is the plumbing piping under lavatories configured to protect against contact ?	✗			
5	Are grab bars provided at compliant locations around the toilet ?	✗			
6	Do toilet stall doors appear to provide the minimum compliant clear width ?	✗

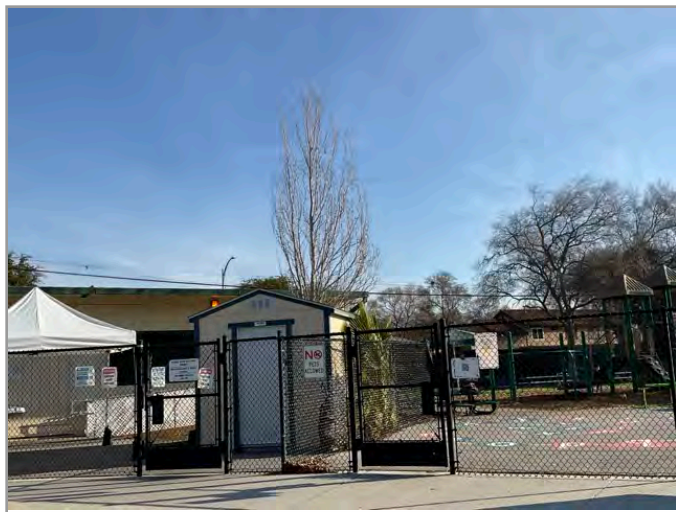
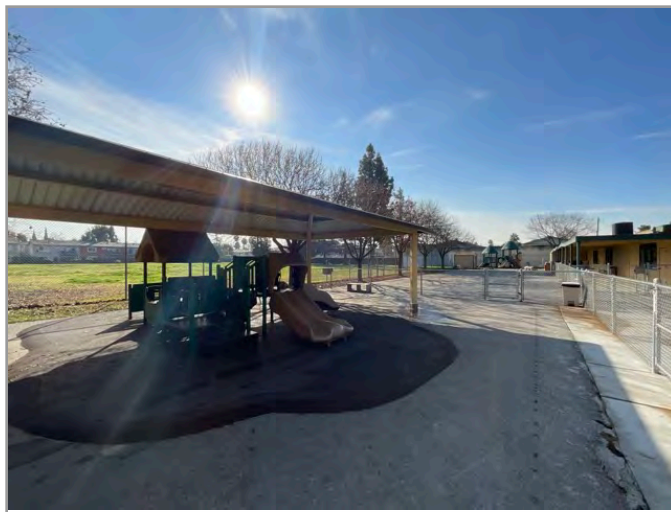
ACCESSIBLE ROUTE

OVERVIEW OF PLAYGROUND

Question		Yes	No	NA	Comments
1	Is there an accessible route to the play area / s?	✗			
2	Has the play area been reviewed for accessibility ?			✗	
3	Are publicly accessible swimming pools equipped with an entrance lift ?			✗
