FACILITY CONDITION ASSESSMENT

Lyndale Elementary
13901 Nordyke Drive
San Jose, California 95127

159228.22R000-009.354

January 25, 2023

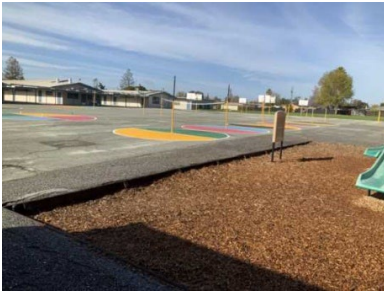
The play component is not accessible, the entire school should be reviewed. - AssetCALC ID: 4797430

**ADA Miscellaneous**

Level III Study, Includes Measurements
Site Lyndale Elementary Throughout building

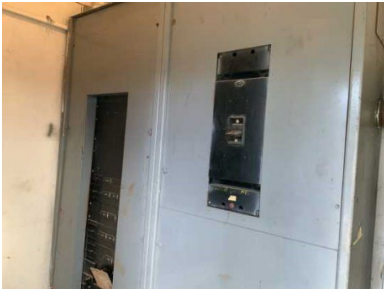
**Switchboard**

120/208 V
Multi-Use/Cafeteria Building Lyndale Elementary
Electrical room

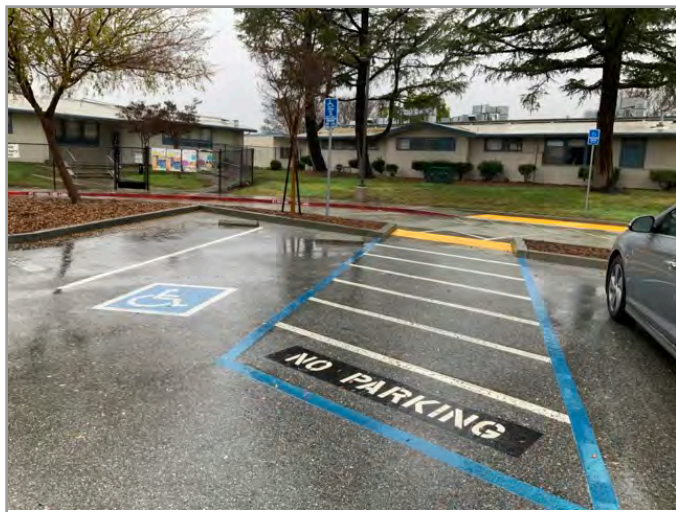
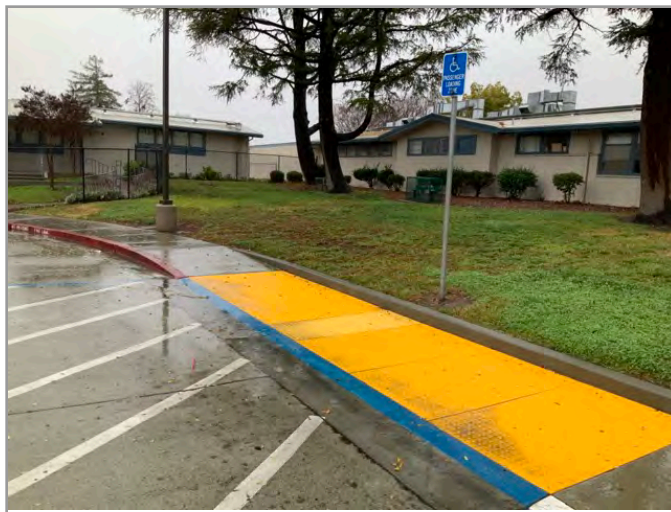
Question		Yes	No	NA	Comments
1	Does the required number of standard ADA designated spaces appear to be provided ?	✗			
2	Does the required number of van-accessible designated spaces appear to be provided ?	✗			
3	Are accessible spaces on the shortest accessible route to an accessible building entrance ?	✗			
4	Does parking signage include the International Symbol of Accessibility ?	✗			
5	Does each accessible space have an adjacent access aisle ?	✗			
6	Do parking spaces and access aisles appear to be relatively level and without obstruction ?	✗

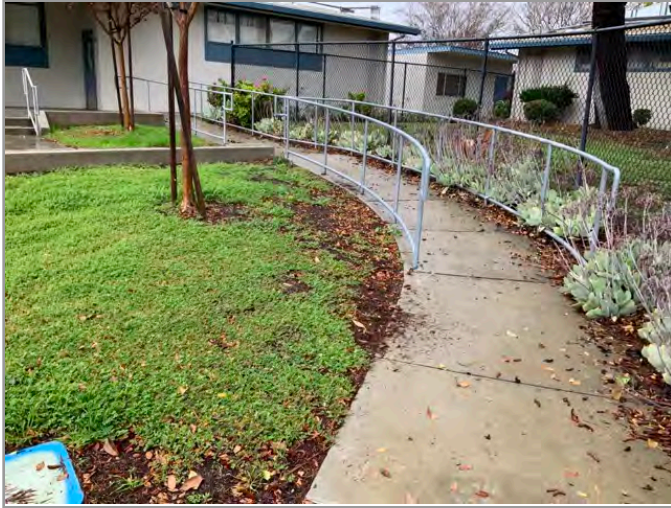
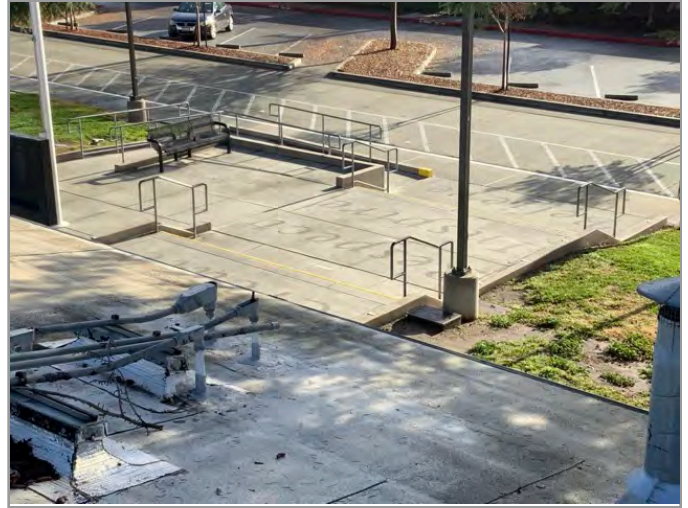
Question		Yes	No	NA	Comments
1	Is an accessible route present from public transportation stops and municipal sidewalks on or immediately adjacent to the property ?	✗			
2	Does a minimum of one accessible route appear to connect all public areas on the exterior, such as parking and other outdoor amenities, to accessible building entrances ?	✗			
3	Are curb ramps present at transitions through raised curbs on all accessible routes?	✗			
4	Do curb ramps appear to have compliant slopes for all components ?	✗			
5	Do ramp runs on an accessible route appear to have compliant slopes ?	✗			
6	Do ramp runs on an accessible route appear to have a compliant rise and width ?	✗

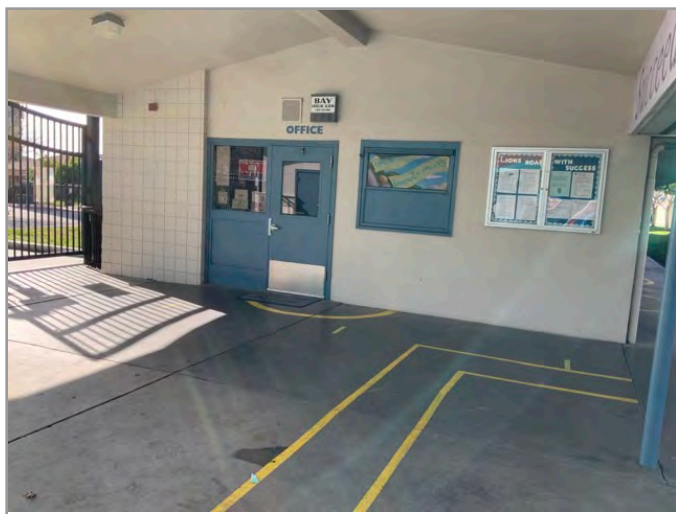
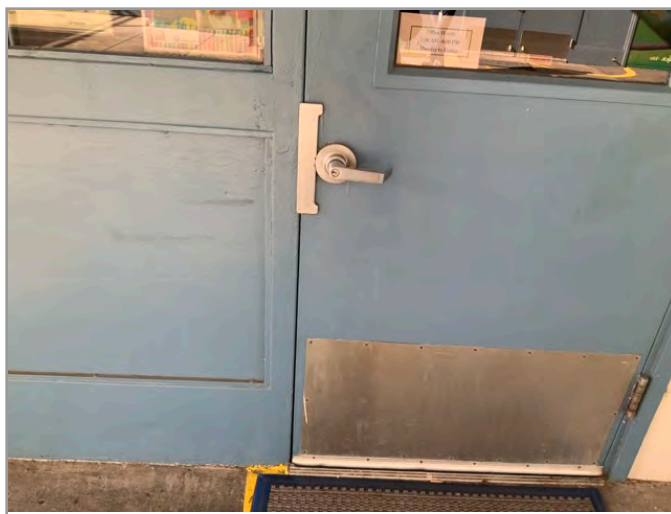
Question		Yes	No	NA	Comments
1	Do a sufficient number of accessible entrances appear to be provided ?	✗			
2	If the main entrance is not accessible, is an alternate accessible entrance provided?	✗			
3	Is signage provided indicating the location of alternate accessible entrances ?			✗	No alternate entry
4	Do doors at accessible entrances appear to have compliant maneuvering clearance area on each side ?	✗			
5	Do doors at accessible entrances appear to have compliant hardware ?	✗			
6	Do doors at accessible entrances appear to have a compliant clear opening width ?	✗

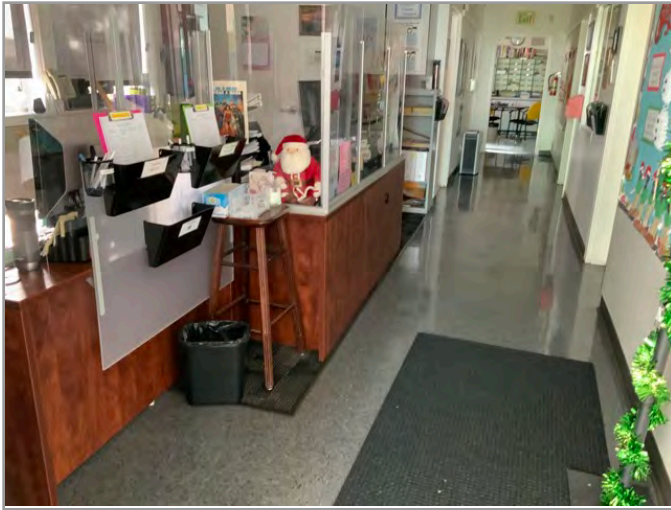
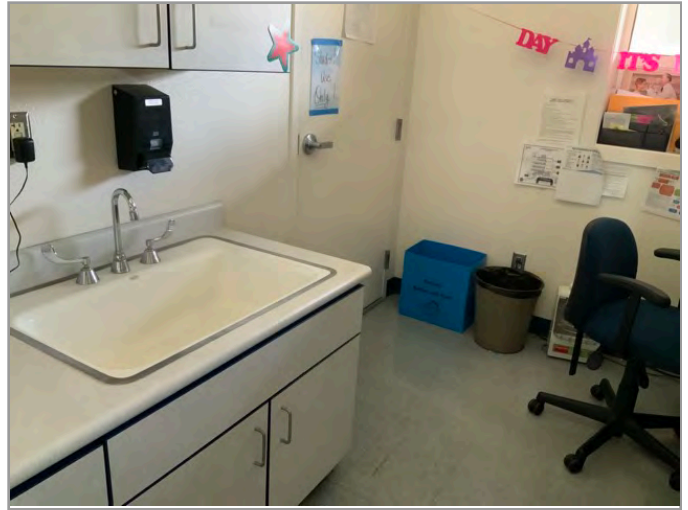
Question		Yes	No	NA	Comments
1	Does an accessible route appear to connect all public areas inside the building ?	✗			
2	Do accessible routes appear free of obstructions and/or protruding objects ?	✗			
3	Do ramps on accessible routes appear to have compliant slopes ?			✗	No interior ramps
4	Do ramp runs on an accessible route appear to have a compliant rise and width ?			✗	No interior ramps
5	Do ramps on accessible routes appear to have compliant end and intermediate landings ?			✗	No interior ramps
6	Do ramps on accessible routes appear to have compliant handrails ?			✗	No interior ramps

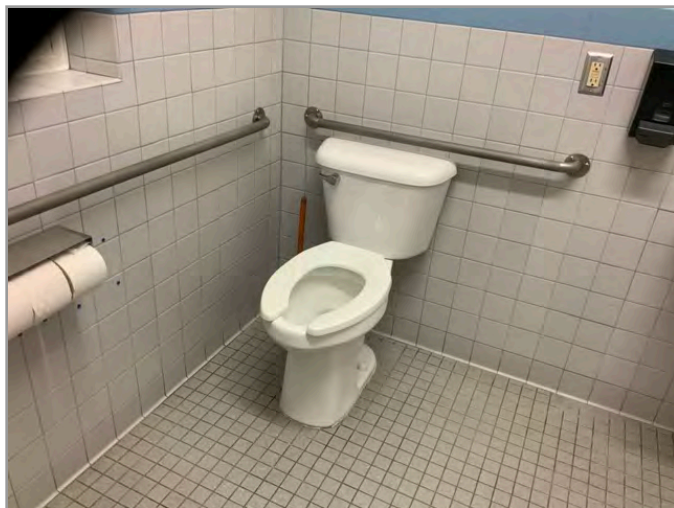
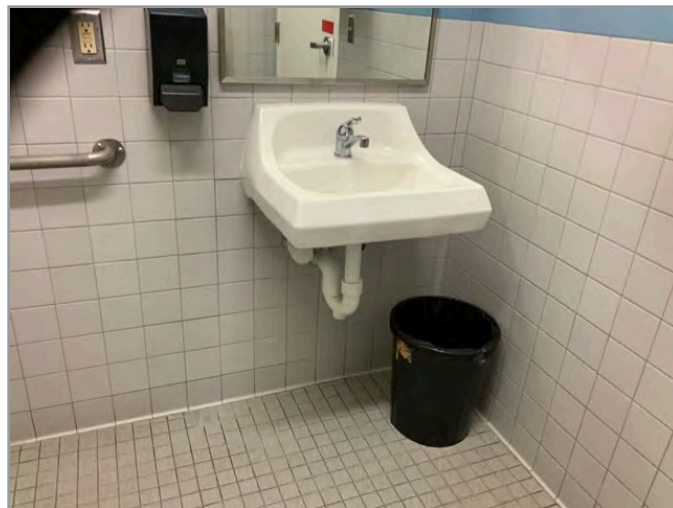
Question		Yes	No	NA	Comments
1	Do publicly accessible toilet rooms appear to have a minimum compliant floor area ?	✗			
2	Does the lavatory appear to be mounted at a compliant height and with compliant knee area ?	✗			
3	Does the lavatory faucet have compliant handles ?	✗			
4	Is the plumbing piping under lavatories configured to protect against contact ?	✗			
5	Are grab bars provided at compliant locations around the toilet ?	✗			
6	Do toilet stall doors appear to provide the minimum compliant clear width ?	✗

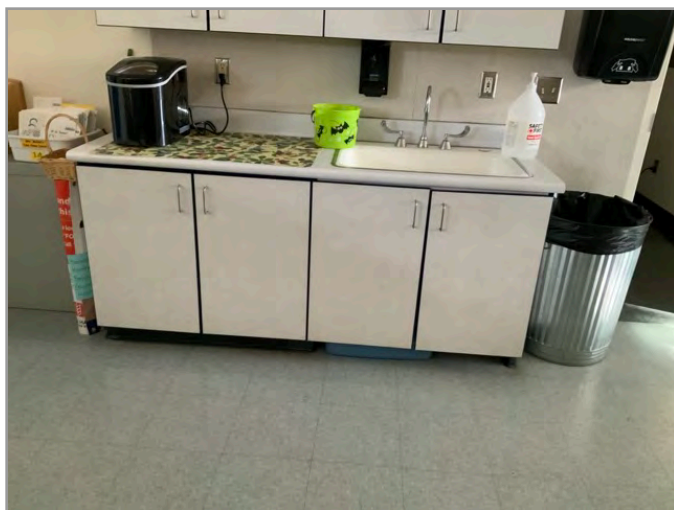
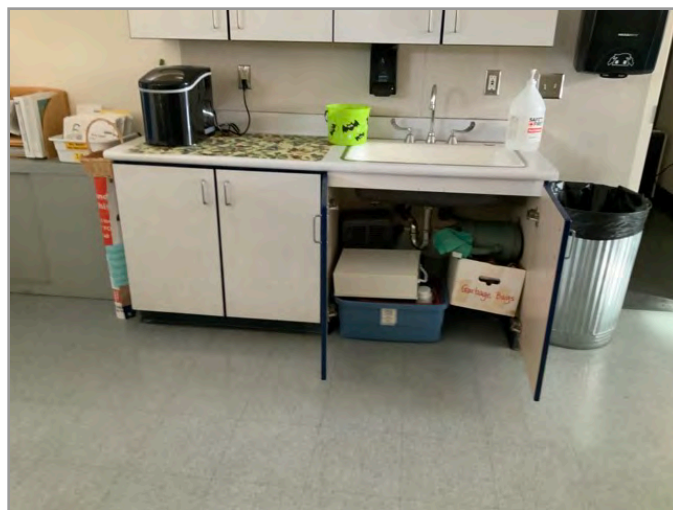
Question		Yes	No	NA	Comments
1	Do kitchens/kitchenettes appear to have a minimum compliant path of travel or area of maneuverability ?	✗			
2	Are the appliances centered for a parallel or forward approach with adequate clear floor space ?			✗	No appliances
3	Is there an accessible countertop/preparation space of proper width and height ?	✗			
4	Is there an accessible sink space of proper width and height ?	✗			
5	Does the sink faucet have compliant handles ?	✗			
6	Is the plumbing piping under the sink configured to protect against contact ?		✗

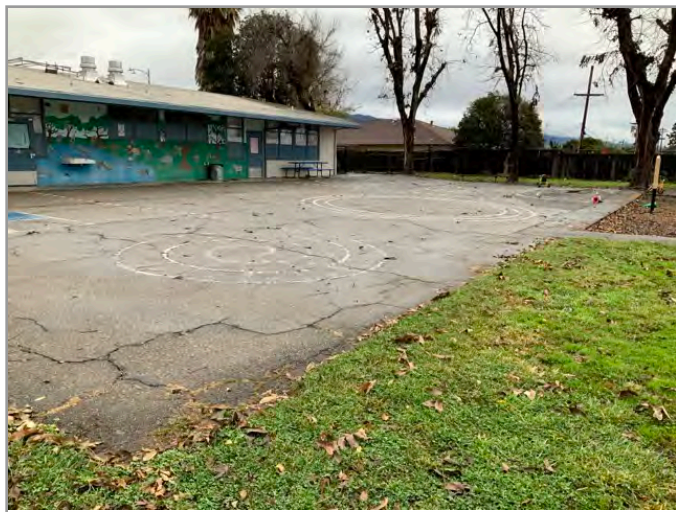
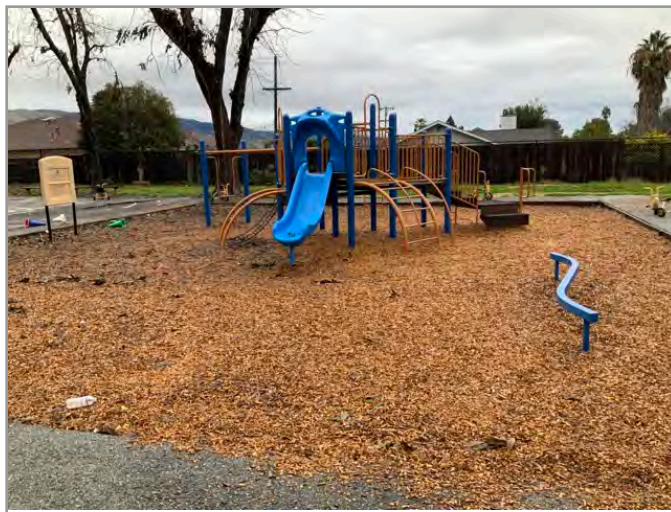
Question		Yes	No	NA	Comments
1	Is there an accessible route to the play area / s?		✗		
2	Has the play area been reviewed for accessibility ?				Unknown
3	Are publicly accessible swimming pools equipped with an entrance lift ?			✗	No pool
