Appendix D
Environmental Audits Item 'iii'
Playground Review

Riverside Building

900 Albion Avenue

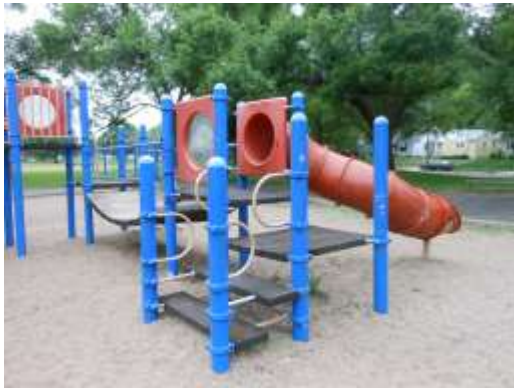
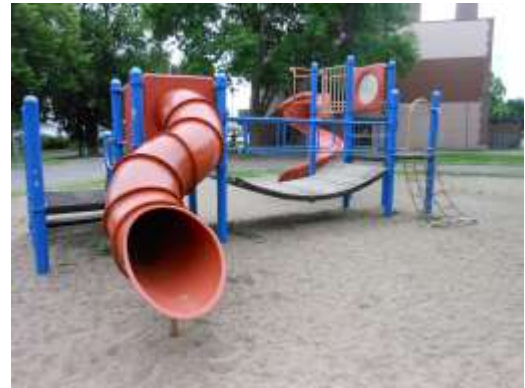
Location A1: Composite

View of composite. There are multiple features of the composite structure that do not comply with ASTM or CPSC requirements.

Area of entrapment.

Priority 1- Remove this composite structure.

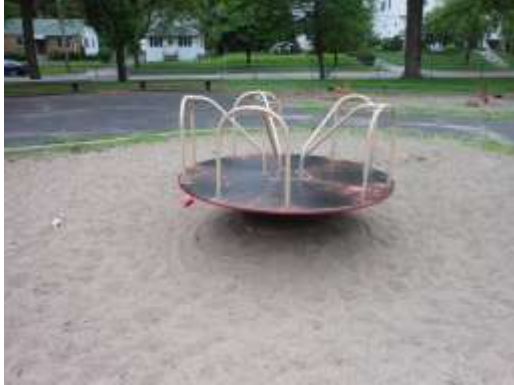
Location A2: Merry-Go-Round

View of merry-go-round.

There are no recommendations at this time.

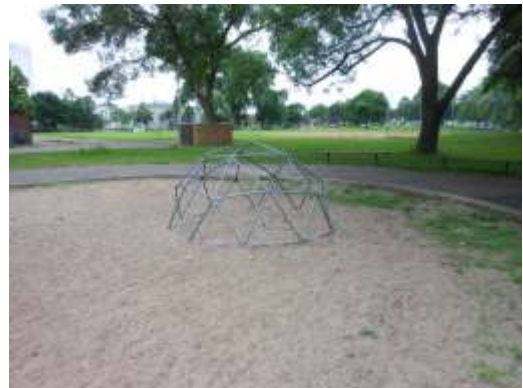
Geodesic Dome

The concrete footing of the geodesic dome is currently exposed.

Priority 2- Add surface material to cover the exposed concrete footing.
