ROOFING AND HVAC PLANNING STUDY

at Chimacum School District

studio Meng Strazzara

October 11, 2023

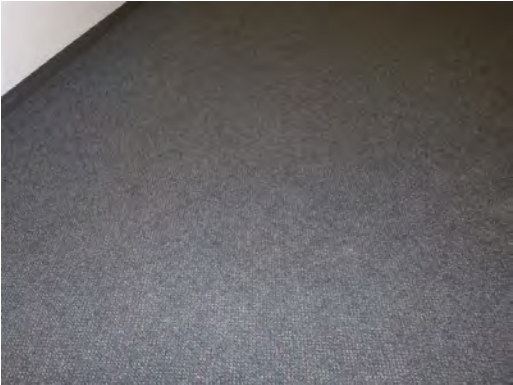
Deficient Material: Carpet
Carpet shows signs of wear and tear.

Remedial Action:
Remove and replace carpet.

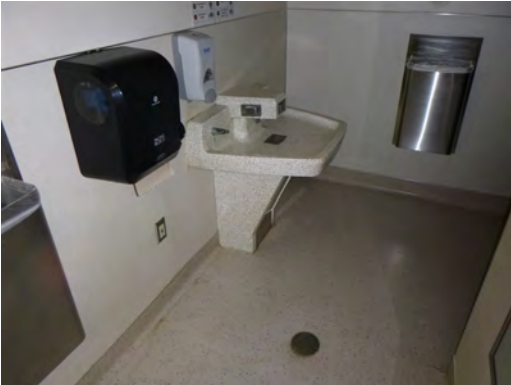
Deficient Material: Trim
Trim approaching end of life, with some already failing, specifically gang lavatory push-buttons.

Remedial Action:
Renew fixture trim; especially gang lavatory push-buttons.

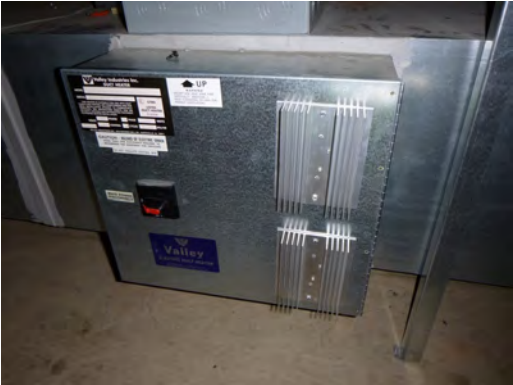
Deficient Material: **Controllers**
Past reports of duct heater controllers (SCRs) failing.

Remedial Action:
Replace controllers as they fail.

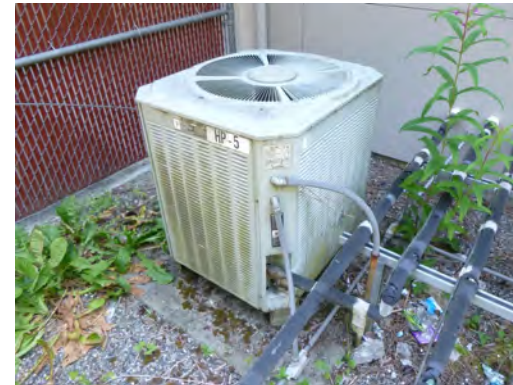
Deficient Material: **Condensing Units**

Outside condensing units at end of life, with some compressors already failing. Marginal refrigerant tubing support with failing outside insulation. All existing heat pumps are R-22 refrigerant based; R-22 is obsolete and increasingly difficult and/or expensive to obtain.

Replace heat pumps with modern refrigerant-based technology as they fail; alternately as one large project for improved economy of scale and consistency. Assume both inside and outside units will need replacement due to needed change in refrigerant.

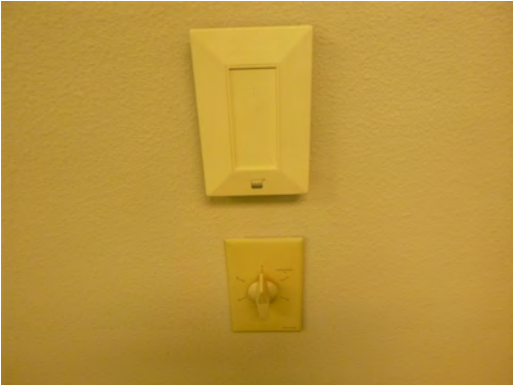
Deficient Material: Controls
Obsolete controls with unknown energy use.

Remedial Action:
Replace controls with District standard meeting current energy code requirements.

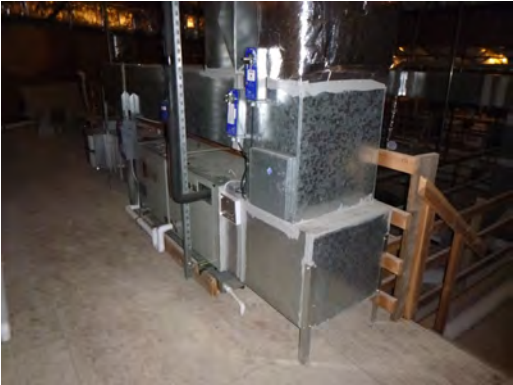
Deficient Material: Defrost controls
Defrost cycle controls not interlocked, resulting occupant thermal discomfort during defrost cycles.

Remedial Action:
Complete defrost cycle interlock retrofit on remaining 75% of heat pump systems.

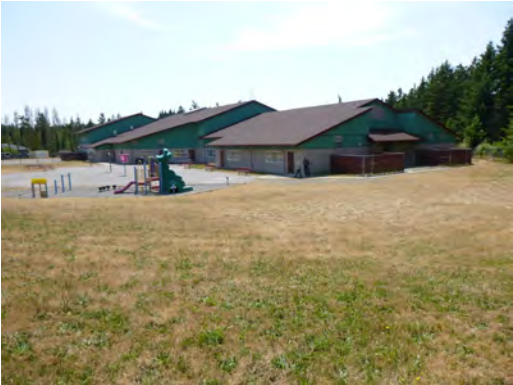
Deficient Material: Septic system
The existing drain field is reportedly soon due for redevelopment.

Remedial Action:
Clean, flush, test, and repair the existing drain field as needed per inspection report.

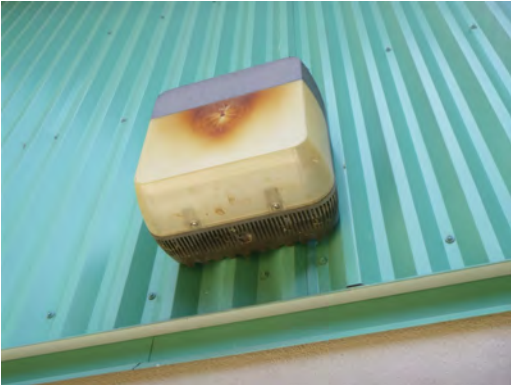
Deficient Material: Site lighting
Many building exterior wall packs have yellowed, cracked, broken, or damaged lenses.

Remedial Action:
Replace with LED wall packs or sconces.

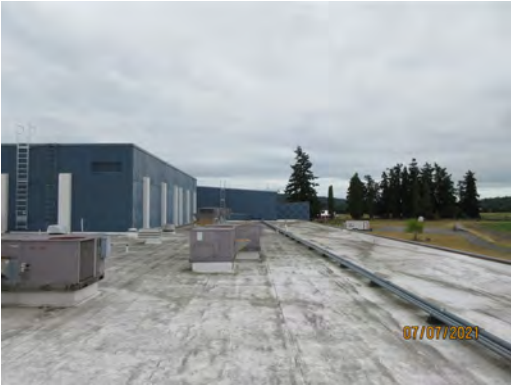
Deficient Material: Membrane Roof
Membrane roof near end of life. 2015 sealer failing in some areas. Insulation soft in many areas.

Remedial Action:
Remove and replace roof with new membrane roofing. Consider adding insulation to increase building thermal performance.

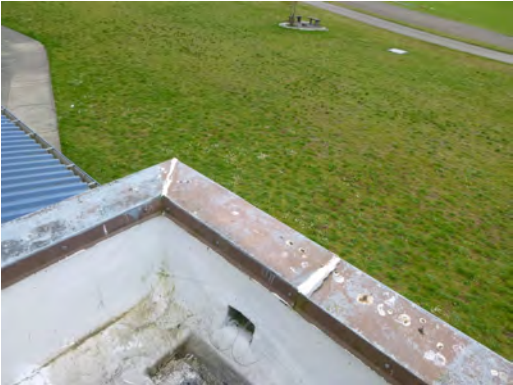
Deficient Material: Parapet Flashing
Parapet flashing in places, aged, faded, showing rust, sealant cracks.

Remedial Action:
Remove and replace flashing with new, prefinished and seal joints.

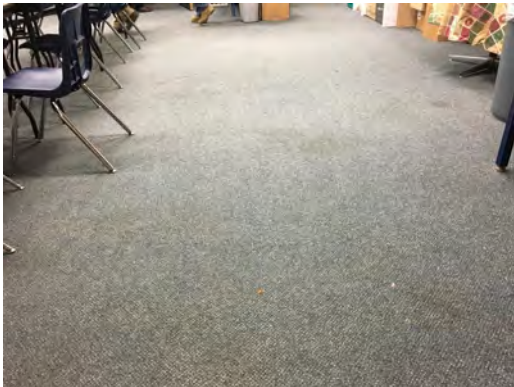
Deficient Material: Carpet
Carpet shows wear, some stains.

Remedial Action:
Remove and replace carpet in corridors, classrooms and offices.

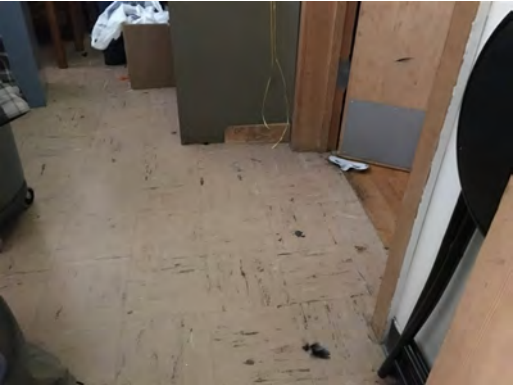
Deficient Material: VCT Hazzard
VCT with reported hazardous material present at auditorium green room areas.

Remedial Action:
Abate and remove flooring, replace with new VCT.

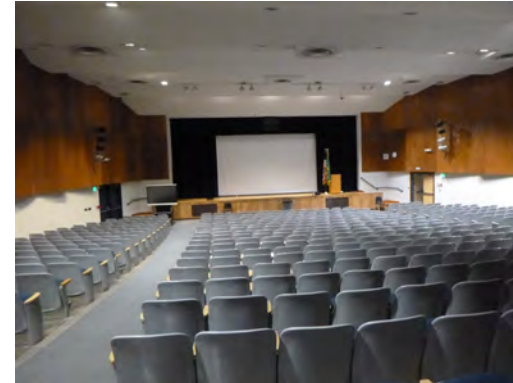
Deficient Material: Lift
No ADA lift at auditorium stage.

Remedial Action:
Install ADA lift.

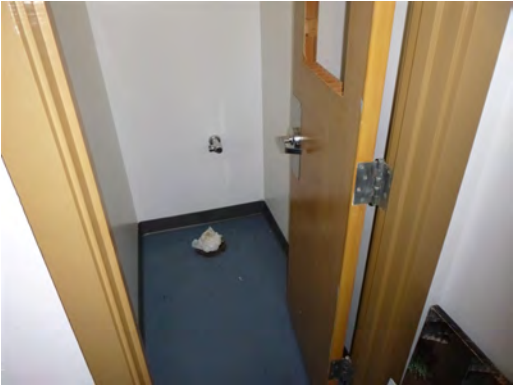
Deficient Material: Green room fixtures
The two green room restrooms serving the auditorium stage are missing fixtures.

Remedial Action:
Install flush fixtures and lavatory.

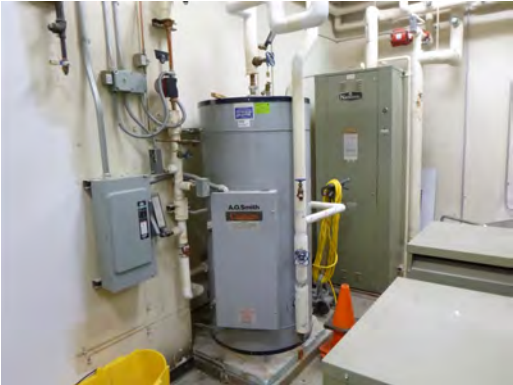
Deficient Material: Water Distribution
Older galvanized pipe in some locations. Mostly older hot water heaters. Little or no backflow prevention and no pressure control.

Remedial Action:
Replace old galvanized pipe with copper. Replace older hot water heaters, especially those already failing. Provide backflow prevention and pressure control per code.

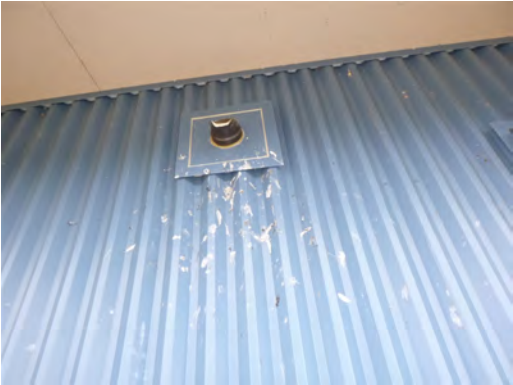
Deficient Material: **Roof Drainage**
Several issues including poorly draining flat roof, previously reported uninsulated roof drain bodies and piping, and excessive bird nesting in overflow roof drain cow tongue points of discharge.

Remedial Action:
Add roof drains to fully drain roof, insulate roof drain bodies and piping where missing, remove birds nests from overflow roof drains, and install anti-bird nesting feature.

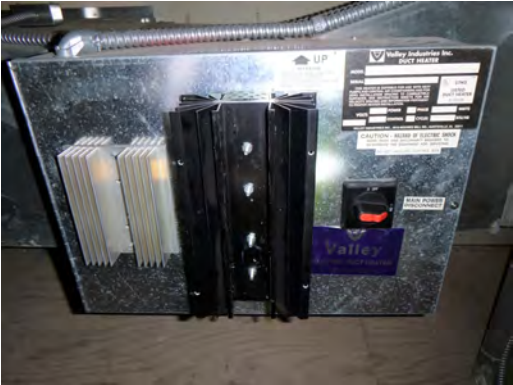
Deficient Material: Duct heaters
North classroom wing electric duct heater controllers approaching end of life.

Remedial Action:
Replace upon failure.

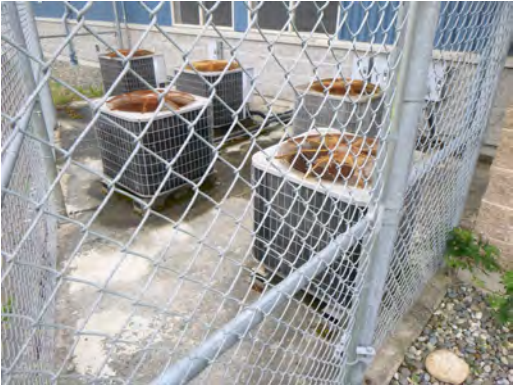
Deficient Material: Condensing Units
North classroom wing split heat pump condensing units CU-101 to -105 approaching end of life with rust, corrosion, and compressor failures.

Remedial Action:
Replace condensing units with new, including reinsulating outside refrigerant tubing.

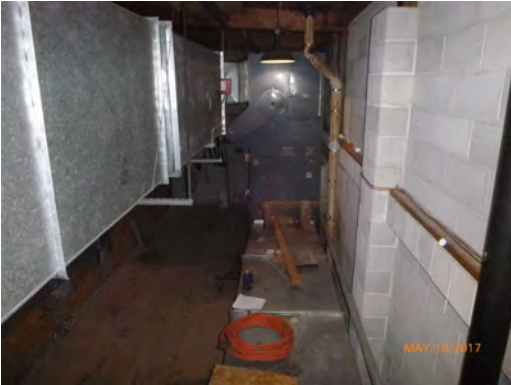
Deficient Material: Air Handling Units
North classroom wing heat pump inside air handling units aging. Gym and auditorium systems similarly aging.

Remedial Action:
Renew north classroom inside units when outside condensing units are replaced. Renew gym and auditorium systems to maintain in reliable condition.

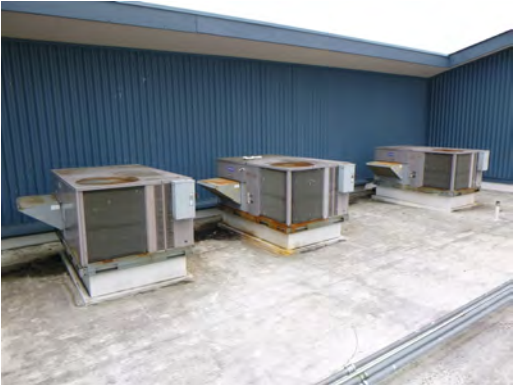
Deficient Material: Roof Top Units
1999 rooftop units at end of life with failing compressors, rusty housings, and unclear economizer (free cooling) operation.

Remedial Action:
Replace with new roof heat pumps units including full economizer per code.

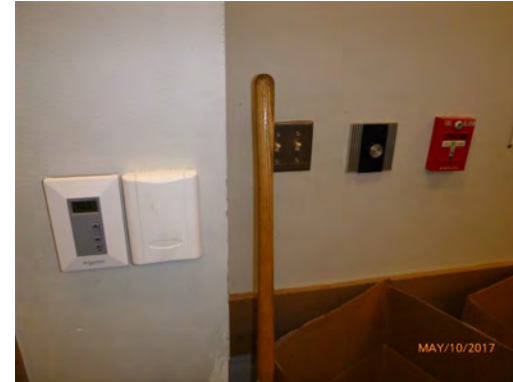
Deficient Material: Controls

Replace with new control system meeting code and District standards.

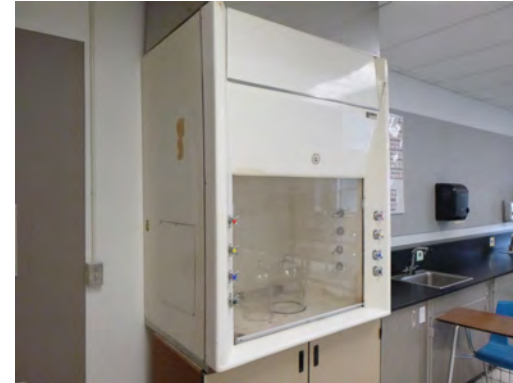
Deficient Material: Fume hoods
One aged fume hood with damaged housing.

Remedial Action:
Replace with modern high-efficiency fume hood.

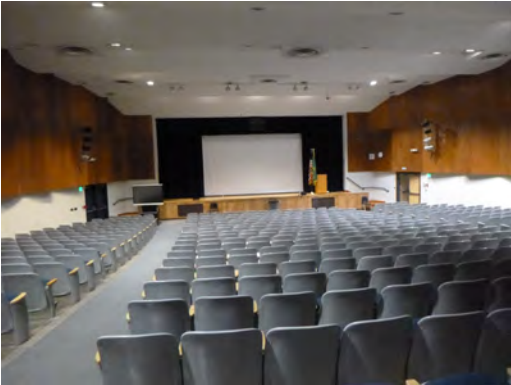
Deficient Material: Fire Sprinkler
No fire sprinkler for gym and auditorium areas.

Remedial Action:
Install fire sprinkler in gym and auditorium areas.

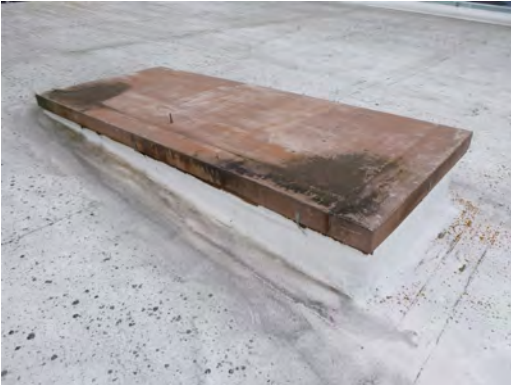
Deficient Material: Stage heat relief
Stage heat relief is strapped shut and disabled.

Remedial Action:
Restore stage heat relief function.

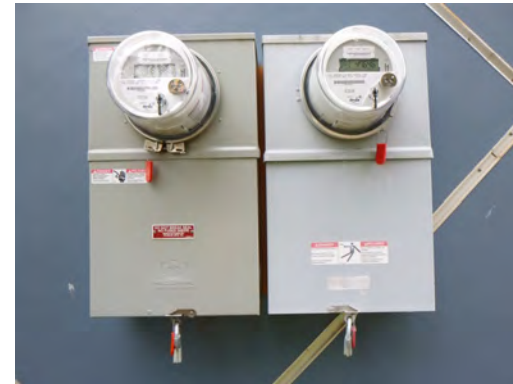
Deficient Material: Electrical Service Monitoring

Campus power submetering for each of the two services to Building 100A reportedly not functioning properly. MDP-1 switchboard power quality monitoring display is failed. MDP-1 surge suppression for Phase B is failed.

Make submetering operational for MDP-1 and -2 services. Repair or replace MDP-1 power quality monitoring and surge suppression for Phase B.

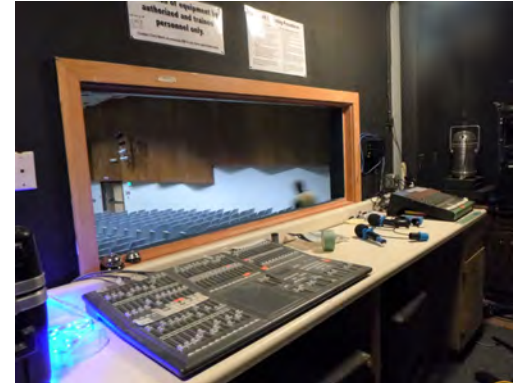
Deficient Material: Audio/video

Replace with modern digital A/V system.

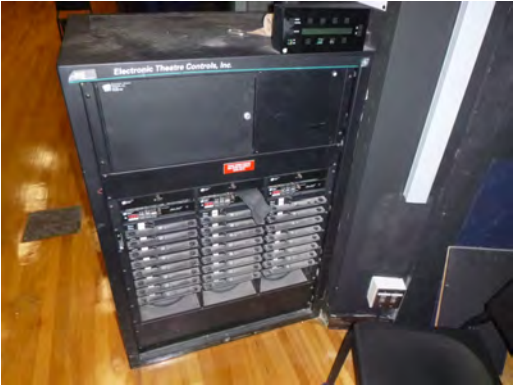
Deficient Material: Stage lighting
The old apparent analog stage lighting system controller and incandescent lighting system is failed and obsolete.

Remedial Action:
Replace with modern digital system with LED technology in conjunction with the reported new A/V system being installed separately.

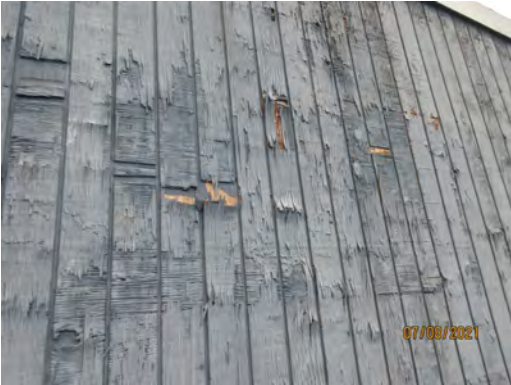
Deficient Material: Wood Siding
Wood siding aged, damaged, and paint faded.

Remedial Action:
Remove siding and upgrade building envelope system (see Building 100A B2010 Exterior Wall deficiency).

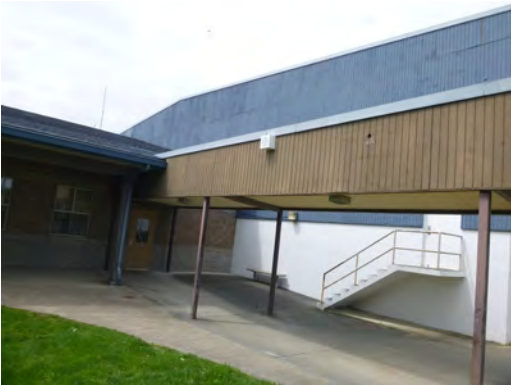
Deficient Material: Wood Siding
Wood siding aged, damaged, and paint faded.

Remedial Action:
Replace damaged siding, prep, and repaint.

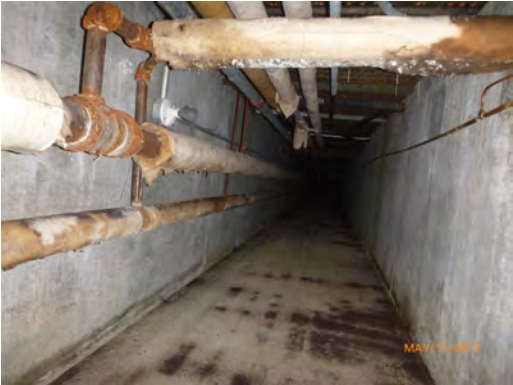
Deficient Material: Domestic Water System
Some original galvanized piping; no backflow prevention; no pressure regulation.

Remedial Action:
Replace original galvanized piping with copper or PEX; install backflow prevention and pressure regulation per code.

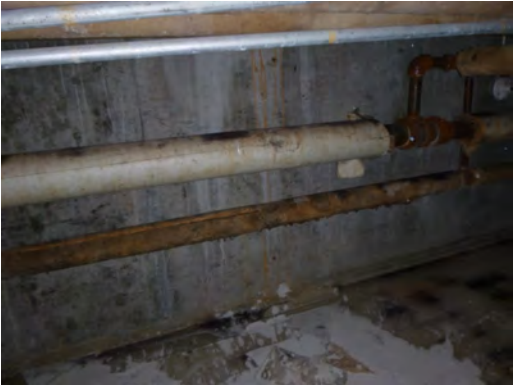
Deficient Material: Asbestos insulation
Reported original asbestos-insulated pipe in tunnel system, which may interconnect with other buildings.

Remedial Action:
Remediate asbestos insulation and demolish abandoned piping in tunnel network.

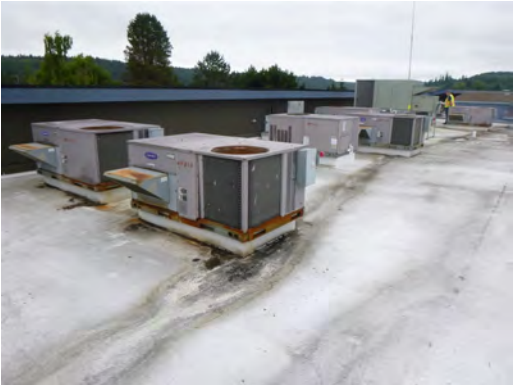
Deficient Material: Rooftop Units
Carrier heat pumps units near end of life.

Remedial Action:
Plan for rooftop unit replacement prior to failure; ensure new units provide economizer relief if not integral to building; consider upgrade to high-efficiency units including demand control ventilation (DCV) and/or heat recovery ventilation (HRV).

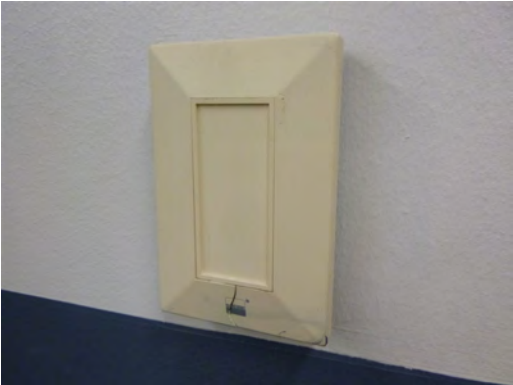
Deficient Material: Controls
1999 control system all but obsolete.

Remedial Action:
Renew control system per energy code and District standards.

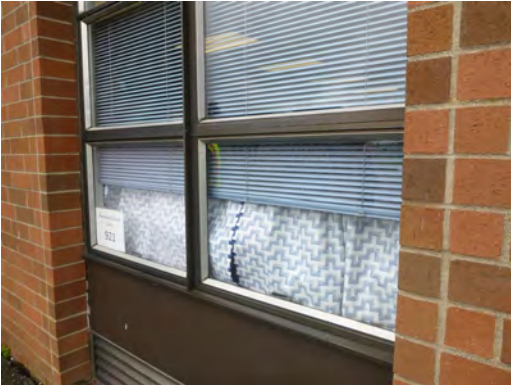
Deficient Material: Windows
Single-glazed windows.

Remedial Action:
Remove and replace with new fiberglass, dual-glazed windows.

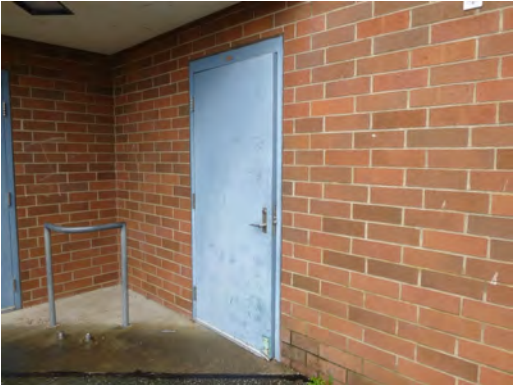
Deficient Material: Exterior Doors
Hollow metal doors and frames in need of paint.

Remedial Action:
Prep, patch as necessary, repaint doors and frames.

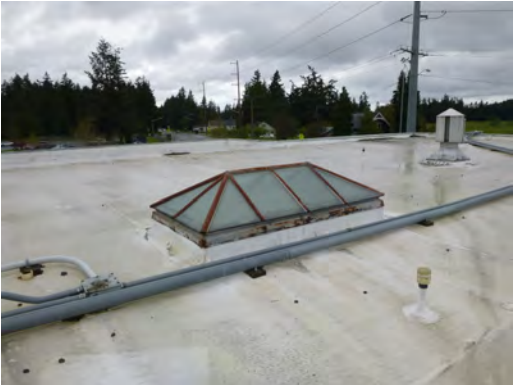
Deficient Material: Skylights
Skylights original and past useful life.

Remedial Action:
Remove and replace skylights.

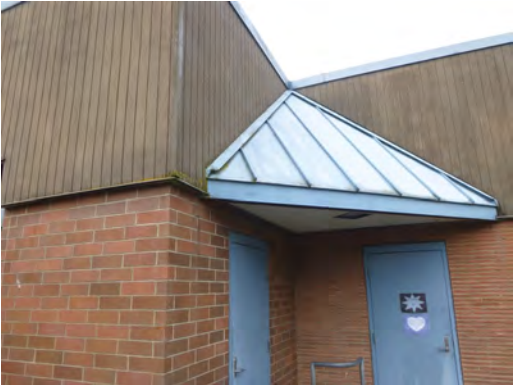
Deficient Material: Canopy
Wood framed canopy adjacent to groups of exterior doors.

Remedial Action:
Replace damaged roofing and fascia, prep and repaint, replace wood soffit.

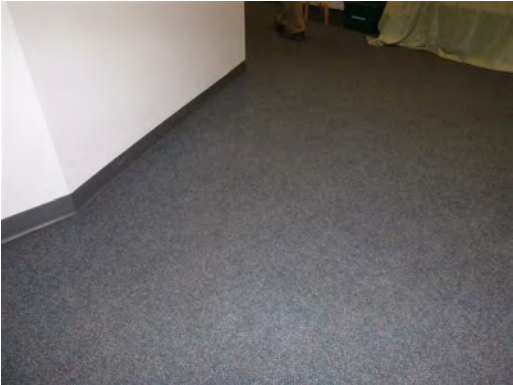
Deficient Material: Carpet
Carpet shows signs of wear, some staining.

Remedial Action:
Remove and replace with new carpet.

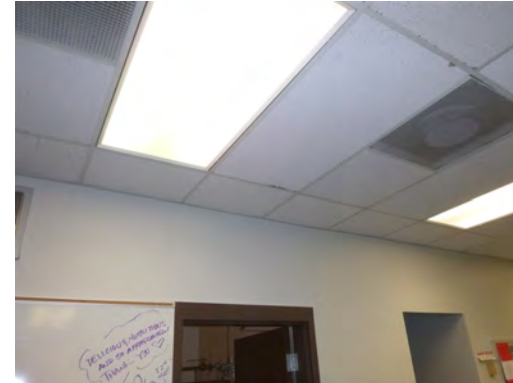
Deficient Material: Ceiling Finish

Ceiling finish is 2x4 ACT and some 12x12 tiles, in fair condition due to age, minor damage.

Remove areas of ACT tiles and replace with new, keep T-grid in place. Remove older 12x12 tiles and replace with new tiles.

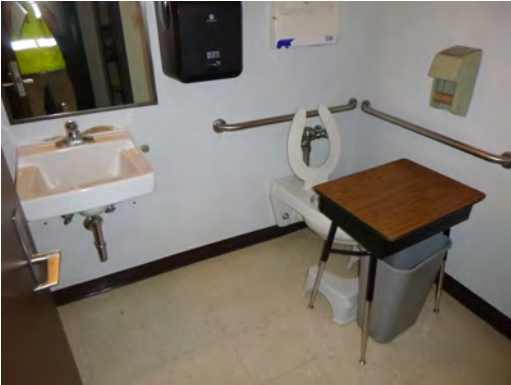
Deficient Material: Fixtures & Trim
Some fixtures with minor damage; many faucets and some flush valves in poor condition.

Remedial Action:
Repair or replace damaged fixtures; renew or replace poorly operating fixture trim (flush valves and especially faucets).

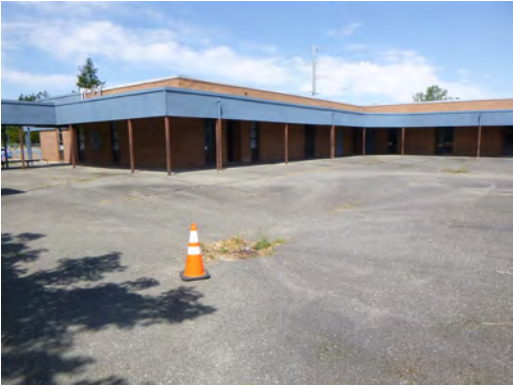
Deficient Material: Galvanized pipe
Original underground galvanized water lines with reports of possible leaks.

Remedial Action:
Replace water service with modern pipe material, such as heavy copper.

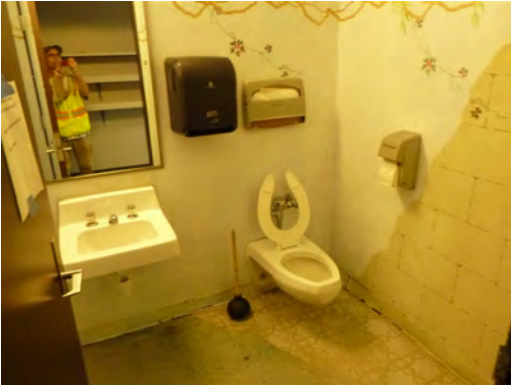
Deficient Material: Waste Piping
Several fixtures slow to drain; unclear Studor island vent devices and caps at roof with unclear purpose. Reports of increasing back-ups prior to abandonment of the building.

Remedial Action:
Clean, test, and repair or replace any blocked lines. Address issue related to Studor vents and covers.

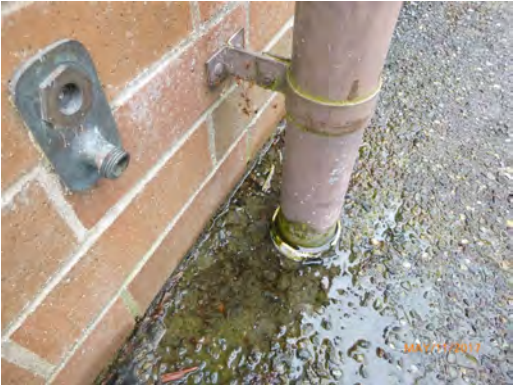
Deficient Material: Roof Drainage
Roof drain back-ups, ponding, damaged downspouts, and drywells backing up to sidewalks causing safety hazard.

Remedial Action:
Reconfigure roof drains, repair damaged downspouts, redevelop drywells.

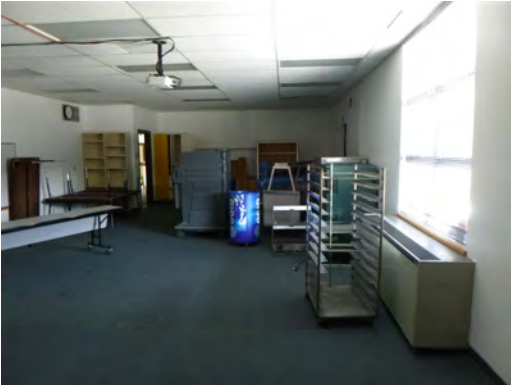
Deficient Material: Ductwork
Poor air distribution and ventilation, with some larger classrooms short-circuiting unit ventilator outside air to nearby ceiling relief grilles without ventilating most the space.

Remedial Action:
Reconfigure ductwork to provide adequate ventilation air distribution.

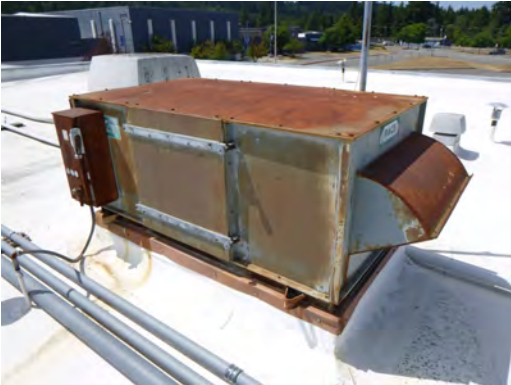
Deficient Material: **Roof Top Units**
Admin rooftop units (RTUs) are rusted and at end of life.

Remedial Action:
Replace current RTUs with new RTUs.

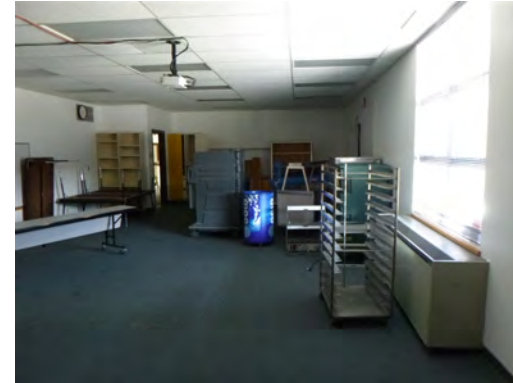
Deficient Material: Unit ventilators
Classroom unit ventilators aging and noisy.

Remedial Action:
Refurbish classroom unit ventilators.

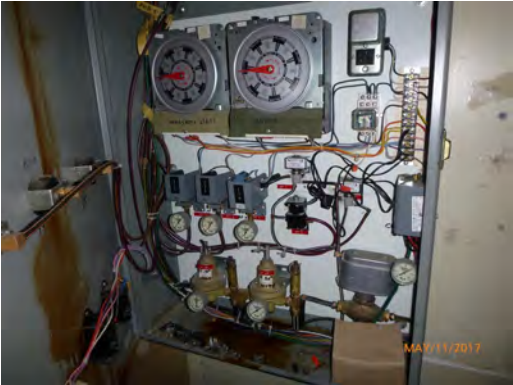
Deficient Material: HVAC Controls
Obsolete pneumatic controls with failing compressor in adjacent Building 500.

Remedial Action:
Replace controls with modern digital (DDC) system per code and District standards.

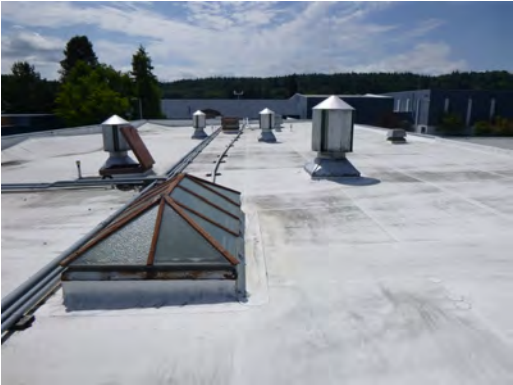
Deficient Material: Relief Hoods
Economizer relief hoods abandoned in place, some beginning to leak rain water. Reportedly, high winds pressurize membrane roof, causing it to inflate.

Remedial Action:
Confirm vertical relief hoods are abandoned in place and no longer needed, then remove, cap, and seal roof openings and insulate curb.

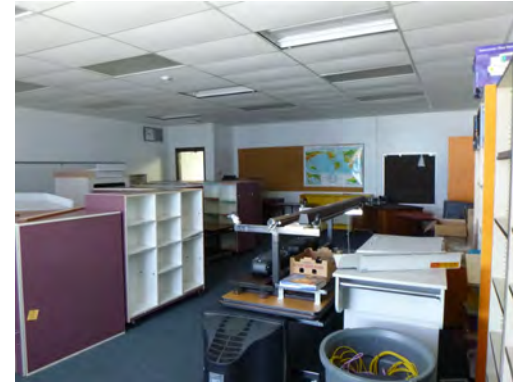
Deficient Material: Fire sprinkler

No fire sprinkler; with fire hazard increased by excessive storage of surplus combustible materials such as furniture.

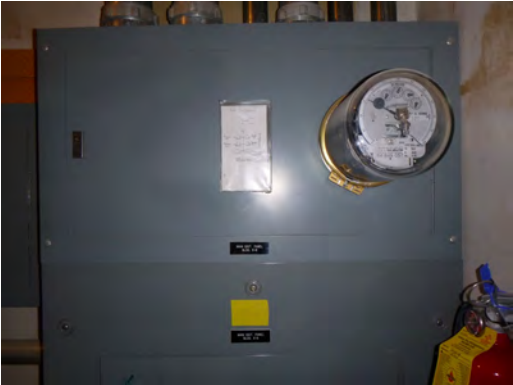
Deficient Material: Main Switchgear
Reaching end of useful life expectancy and has limited capacity.

Remedial Action:
Provide new switchgear.

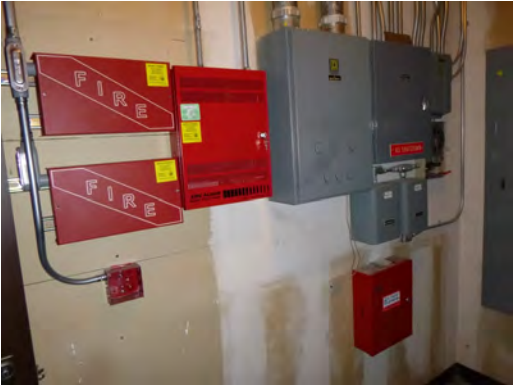
Deficient Material: Fire Alarm Panel
Fire alarm panel will not support newer devices and existing parts are no longer available.

Remedial Action:
Replace fire alarm panel.

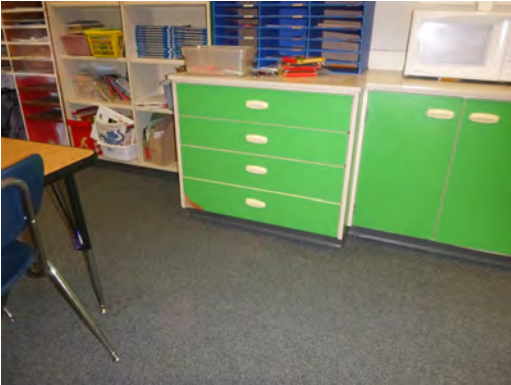
Deficient Material: Casework
Original wood casework is aged and worn.

Remedial Action:
Remove and replace with modern, ADA-compliant casework.

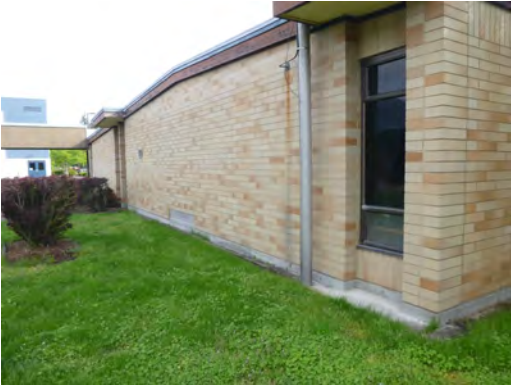
Deficient Material: Masonry Wall
Masonry wall is not sealed.

Remedial Action:
Clean and reseal exterior walls.

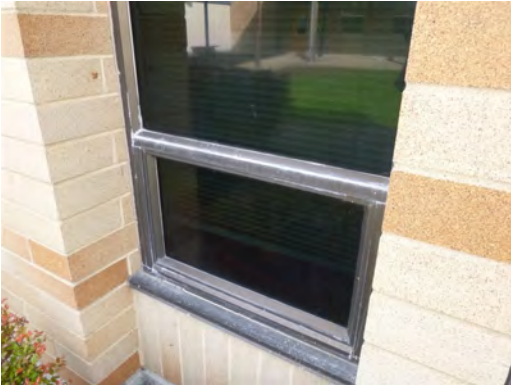
Deficient Material: Windows
Single-glazed windows.

Remedial Action:
Remove and replace with new fiberglass, dual-glazed windows.

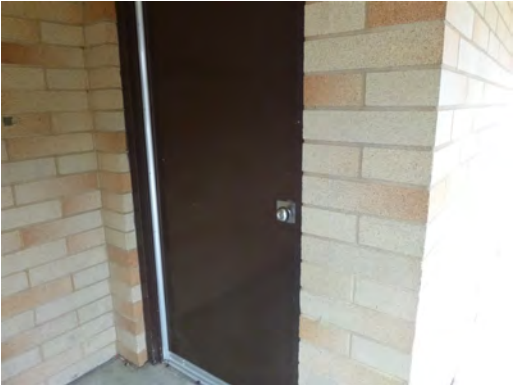
Deficient Material: Exterior Doors
Doors are aged, missing ADA-compliant hardware.

Remedial Action:
Prep and repaint doors and frames, replace hardware with new ADA accessible hardware where necessary.

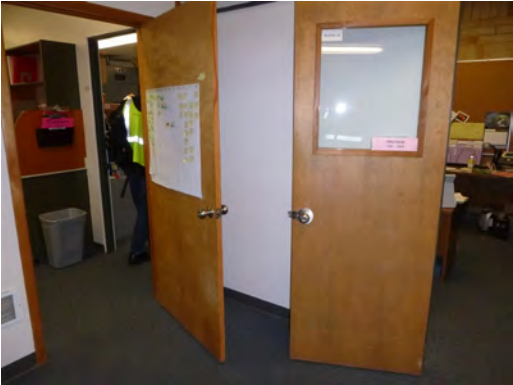
Deficient Material: Door Hardware
Door hardware is not ADA-compliant.

Remedial Action:
Remove and replace hardware to be ADA-compliant.

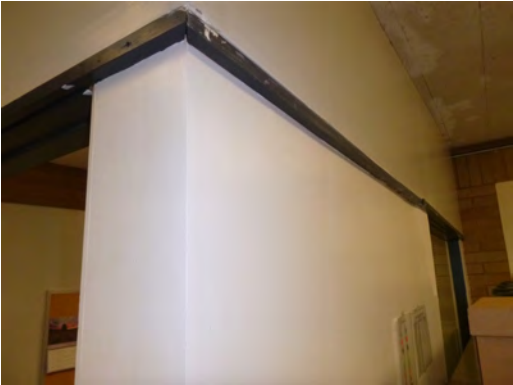
Deficient Material: Wall Finishes
Wall finishes are aged, some signs of damage.

Remedial Action:
Repaint and replace wall finishes where damaged.

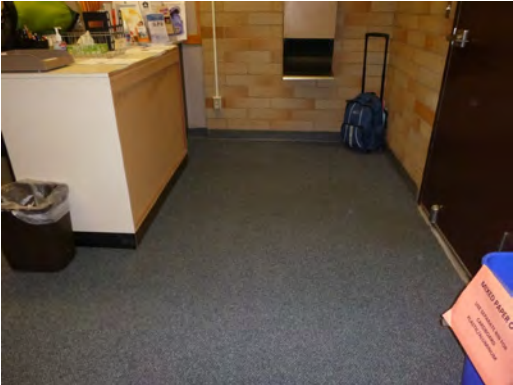
Deficient Material: Carpet
Carpet aged, worn some staining.

Remedial Action:
Remove and replace carpet.

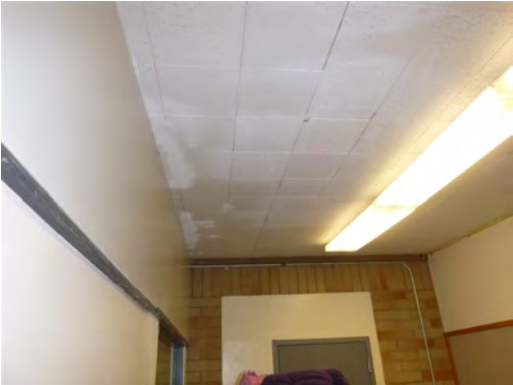
Deficient Material: ACT
12x12 ceiling tiles aged and worn.

Remedial Action:
Remove ceiling tiles and ACT, replace with new.

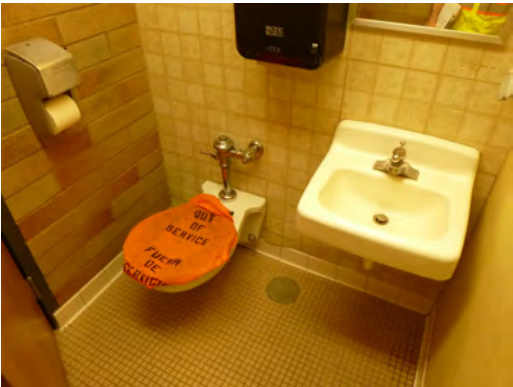
Deficient Material: Plumbing Fixtures
Original fixtures past useful life and wasting water.

Remedial Action:
Replace with new code compliant fixtures.

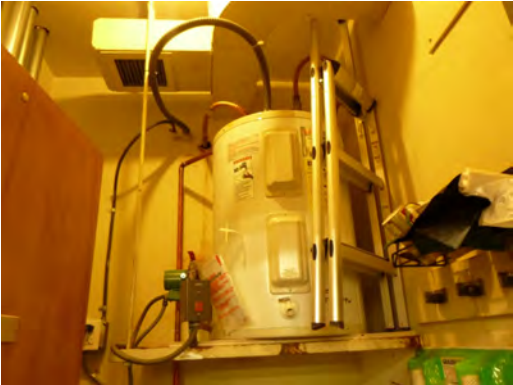
Deficient Material: Domestic Water System
Galvanized pipe.

Remedial Action:
Replace with copper or PEX.

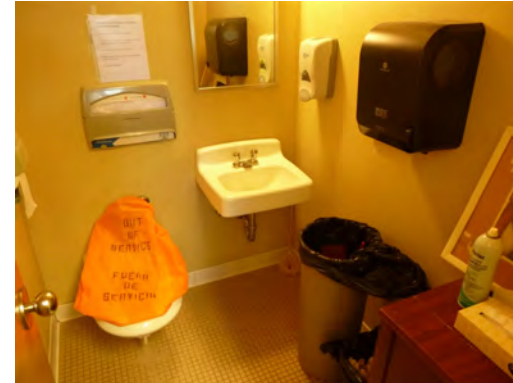
Deficient Material: Waste System
Original waste system near end of life.

Remedial Action:
Clean, test, inspect and renew waste system as needed.

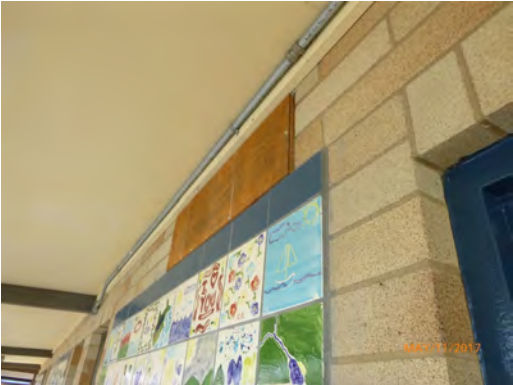
Deficient Material: HVAC Distribution
Little or no ventilation for office areas; original system removed or boarded over. No relief air path from Room 35 to roof relief in main library space.

Remedial Action:
Provide HVAC service to office area. Provide relief air path for Room 35.

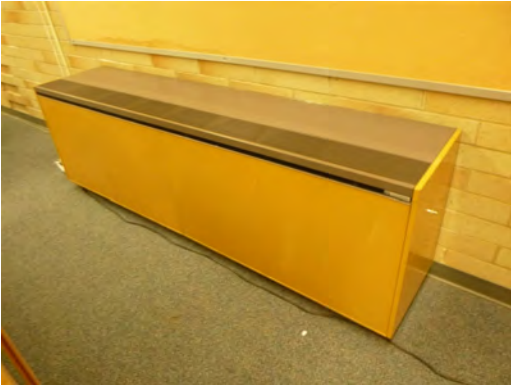
Deficient Material: Unit Ventilators
1968 unit ventilators in poor to fair condition.

Remedial Action:
Refurbish unit ventilators.

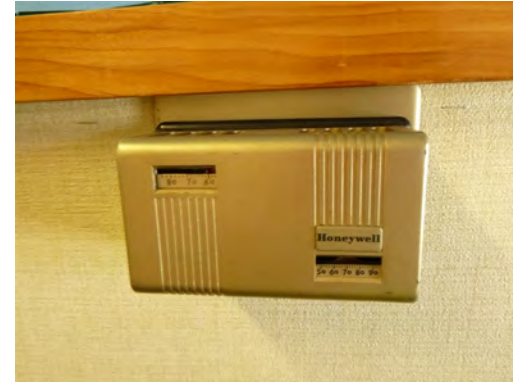
Deficient Material: HVAC Controls
Obsolete pneumatic and local manual t-stat control.

Remedial Action:
Replace with modern (DDC) controls per code and District standards.

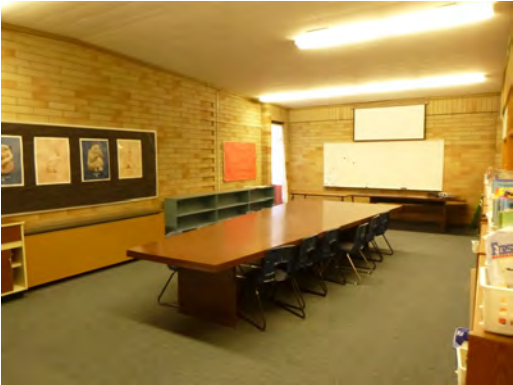
Deficient Material: Fire Sprinkler
No fire sprinkler system.

Remedial Action:
Install fire sprinkler per code.

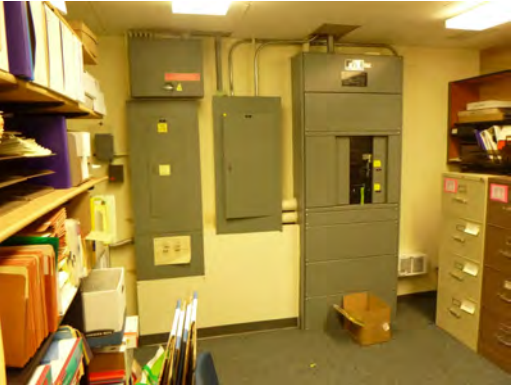
Deficient Material: Main Switchgear
Switchgear has multiple service disconnects that are not code compliant, and reaching end of useful life.

Remedial Action:
Replace switchgear with new single service disconnect gear.

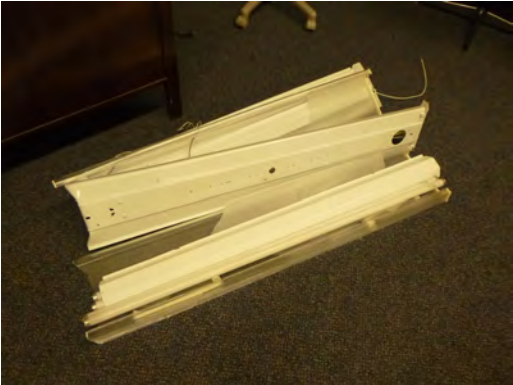
Deficient Material: Light fixtures
Aged light fixtures are inefficient fluorescent with some falling off the ceiling, potentially injuring occupants below.

Remedial Action:
Replace with modern LED fixtures and ensure fixtures are secure to the building structure; after first confirming the building structure is sound.

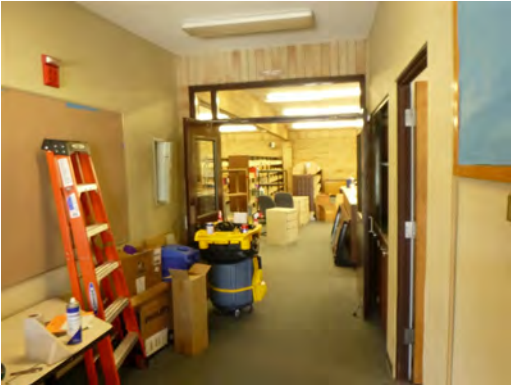
Deficient Material: Fire alarm
Obsolete, non-addressable fire alarm system.

Remedial Action:
Renew with full detection and addressable devices.

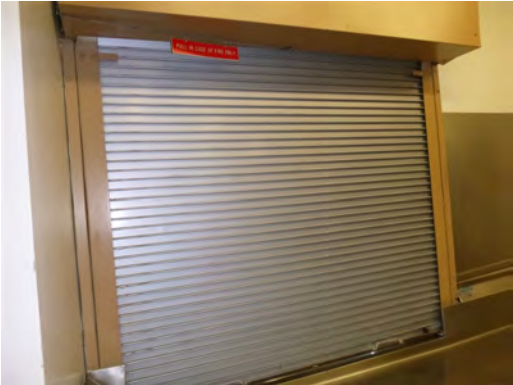
Deficient Material: Coiling Doors
Metal coiling fire doors not able to pass fire inspection.

Remedial Action:
Remove and replace with new, functional doors.

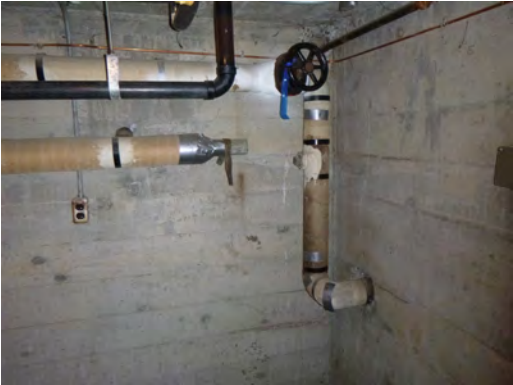
Deficient Material: HVAC System
Aging HVAC system.

Remedial Action:
Renew prior to component failures, such as electric resistance heaters.

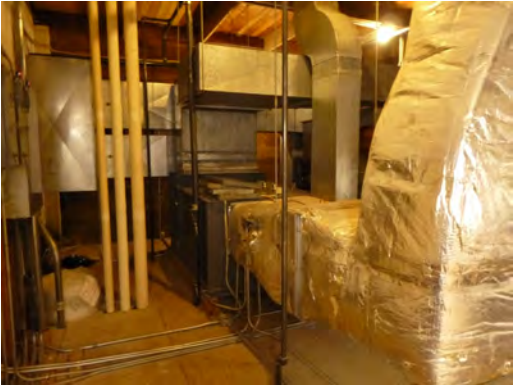
Deficient Material: HVAC Controls
Obsolete electro-pneumatic controls.

Remedial Action:
Replace with digital (DDC) controls per code and District standards.

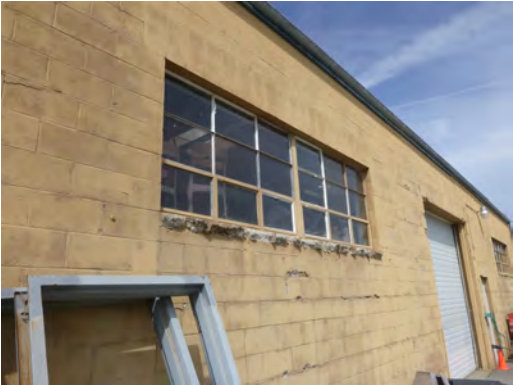
Deficient Material: Windows
Single-glazed, wood framed windows, deteriorated, seals failed, wood exposed, some panes broken.

Remedial Action:
Remove and replace with new fiberglass, dual-glazed windows.

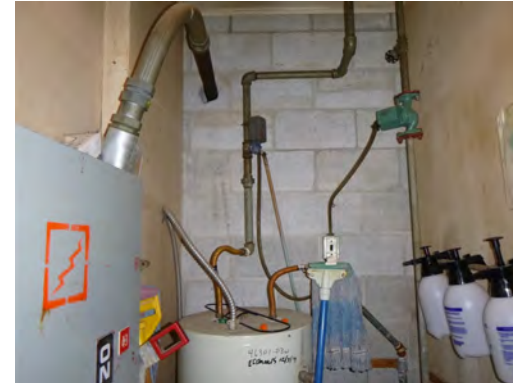
Deficient Material: Waste Piping
Original waste piping at end of life with several fixtures draining slow.

Remedial Action:
Clean, test, inspect, and repair or replace as needed.

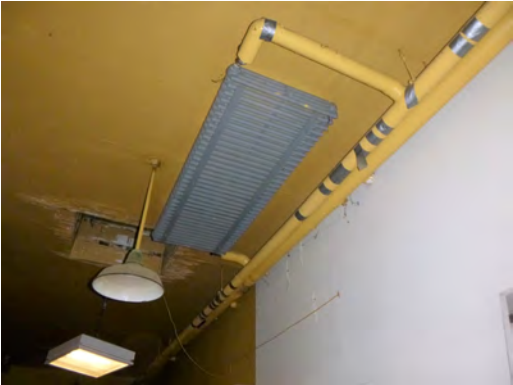
Deficient Material: HVAC
No HVAC system for office and shop areas.

Remedial Action:
Provide HVAC per code.

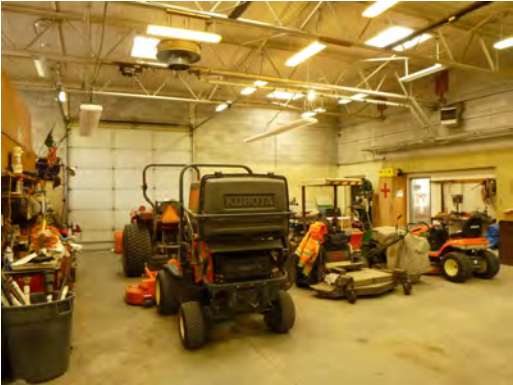
Deficient Material: Unit Heaters
No heat to some spaces, hence portable heaters are used.

Remedial Action:
Install permanent heating system in unheated spaces.

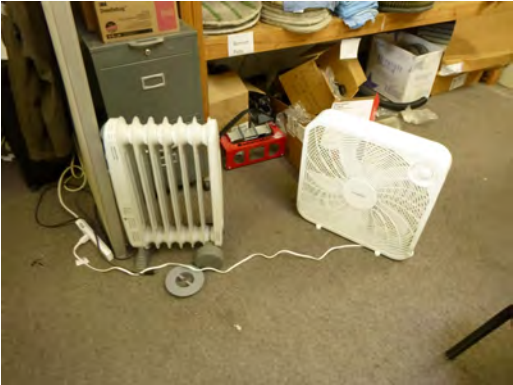
Deficient Material: Controls
No building automation system.

Remedial Action:
Install building automation system per code and District standards.

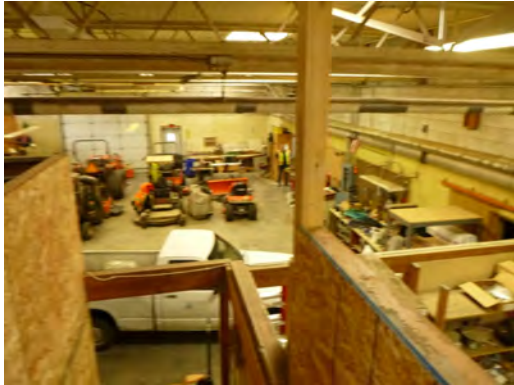
Deficient Material: Fire Sprinkler
No fire sprinkler system.

Remedial Action:
Install fire sprinkler per code.

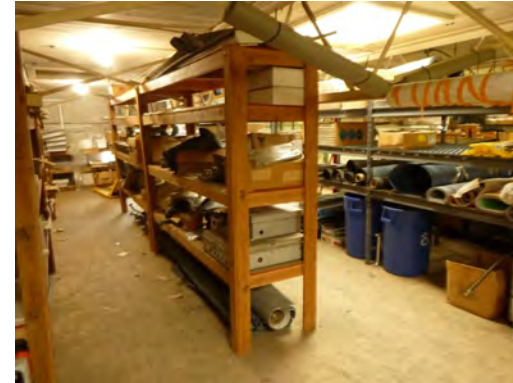
Deficient Material: Flammable and Combustible Liquid Storage

No apparent flammable, combustible, and hazardous material storage locker system.

Provide flammable, combustible, and/or hazardous material storage lockers, vented to outside per code; alternately, a packaged hazmat storage unit outside.

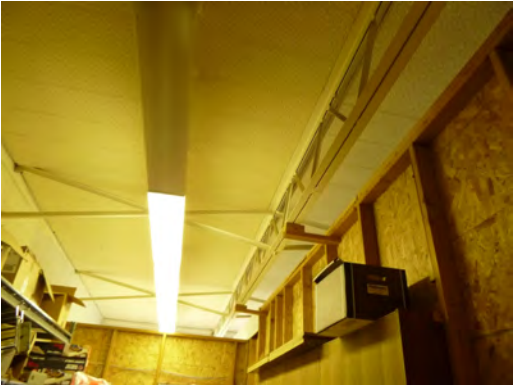
Deficient Material: Fire Alarm System

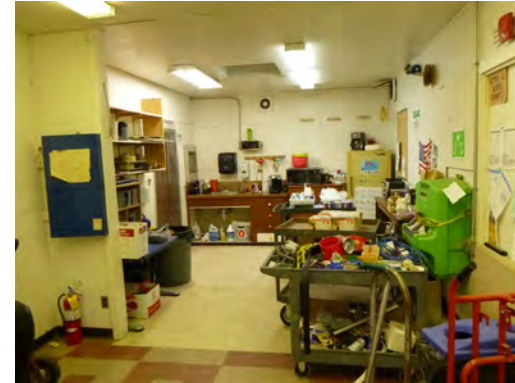
Deficient Material: Security
Only one CCTV camera observed covering a small portion of the yard.

Remedial Action:
Install CCTV to monitor the front and back sides of the building, plus inside main shop and entry corridor area as a minimum.

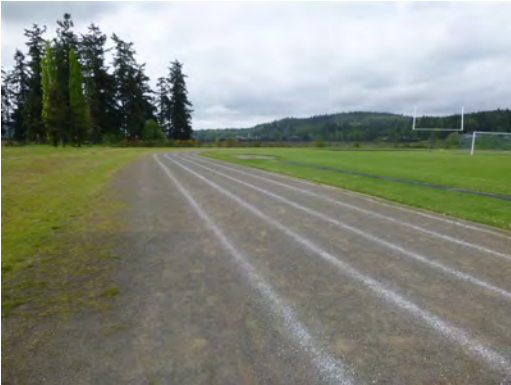
Deficient Material: Running Track
Running track is aged, gravel thin.

Remedial Action:
Remove and replace track with new gravel running surface, regrade surface. Repair edge as required.

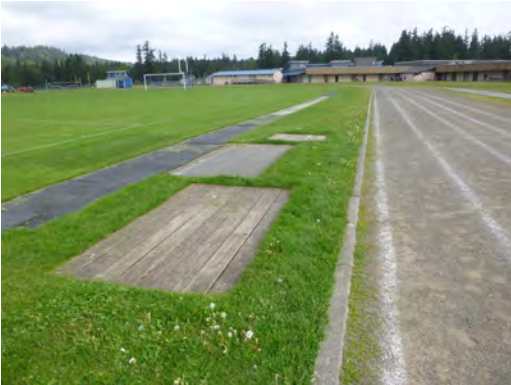
Deficient Material: Track and Field
Track and field fixtures are worn and aged.

Remedial Action:
Remove and replace fixtures with new: pole vault box and standards, shot put pad, ring and cinders, long jump box, sand and takeoff boards, discus pad and cage.

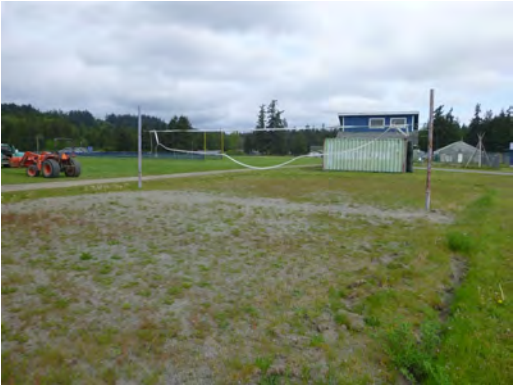
Deficient Material: Volley Ball Court
Sand volleyball court is damaged and unusable.

Remedial Action:
Replace standards and net, regrade and place new sand, repair court boundary, allowance.

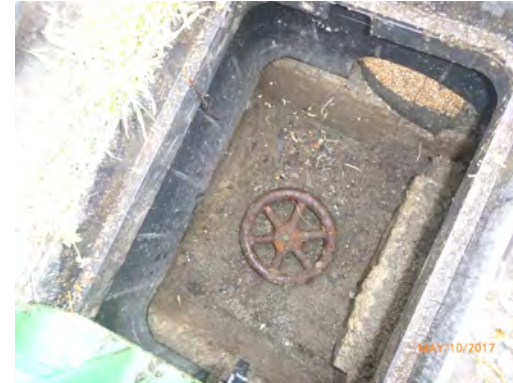
Deficient Material: Water Supply

Older service lines assumed buildings, little or no backflow prevention, unknown as-built condition for many lines, failed or failing isolation valves.

Determine as-built condition (line locations), provide backflow prevention per code, replace older lines and isolation valves.

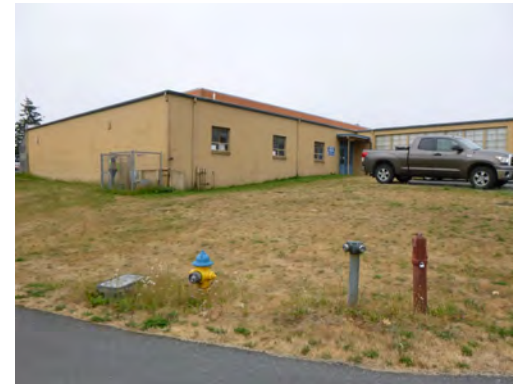
Deficient Material: On-Site Sewage System

Little or no as-built drawings, other than 2014 O&M Manual with schematic diagrams. Minor repairs needed from time to time. System renewed in 1999 and approaching mid-life service. Recent inspection calls for drain field flushing.

Locate and mark all drain field end points; back-flush drain field and take other corrective and maintenance action as recommended in the current large on-site sewage system (LOSS) inspection report.

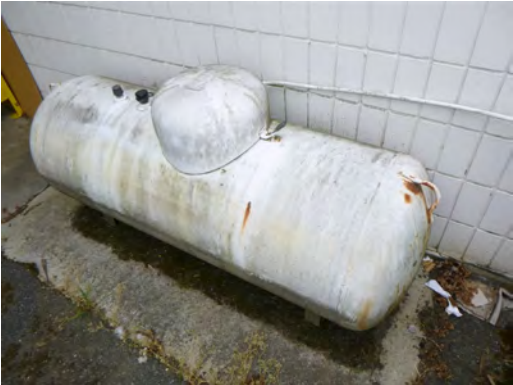
Deficient Material: Propane Tanks
Original/older propane fuel tanks.

Remedial Action:
Replace propane tanks.

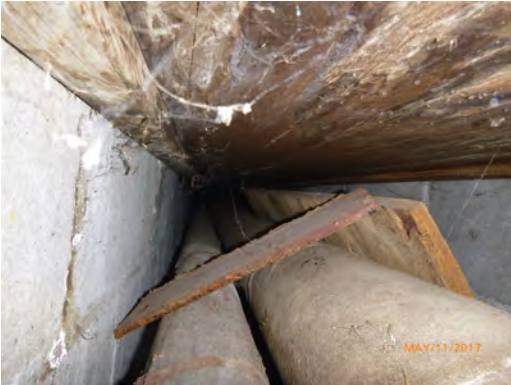
Deficient Material: Asbestos
Asbestos containing material (ACM) in tunnels.

Remedial Action:
Remediate asbestos and repurpose tunnels.

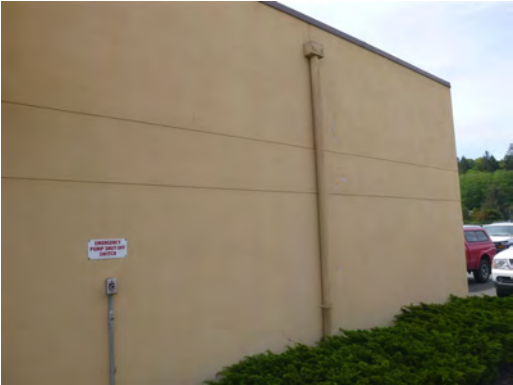
Deficient Material: Exterior Wall
Wall paint is worn, faded.

Remedial Action:
Prep and repaint exterior walls.

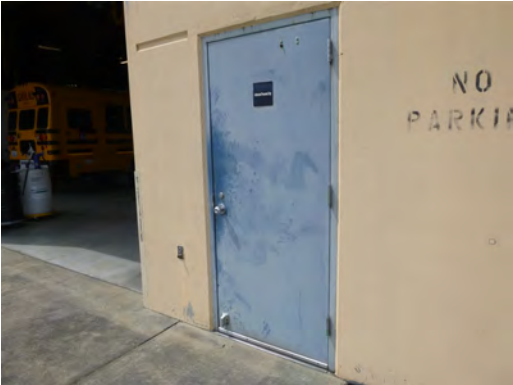
Deficient Material: Exterior Doors
Doors are damaged and need paint, rust showing, dents, no ADA-compliant hardware.

Remedial Action:
Remove and replace doors.

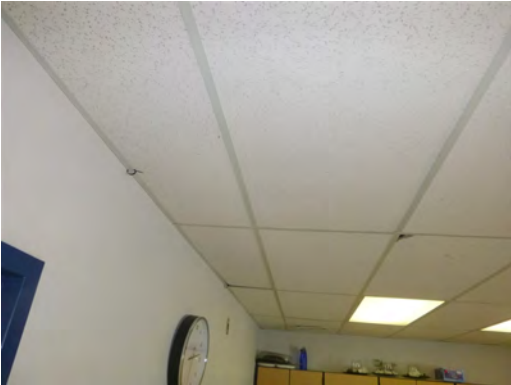
Deficient Material: Wall Paint
Paint shows wear and tear.

Remedial Action:
Prep and repaint walls.
