ROOFING AND HVAC PLANNING STUDY

at Chimacum School District

studio Meng Strazzara

October 11, 2023

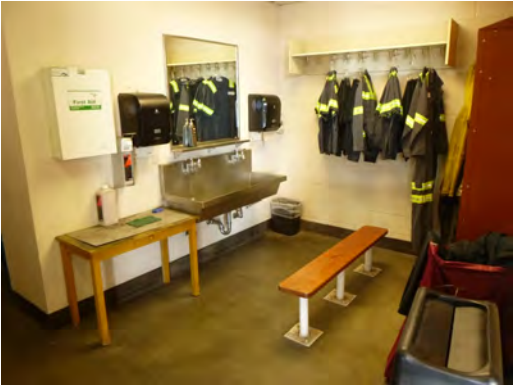
Deficient Material: Plumbing Fixtures & Trim
Original fixtures nearing end of life.

Remedial Action:
Replace fixtures and trim.

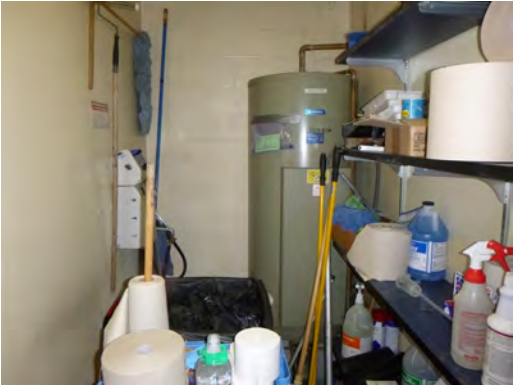
Deficient Material: Water Distribution System
Original water service, galvanized distribution pipe and original water heater.

Remedial Action:
Renew system.

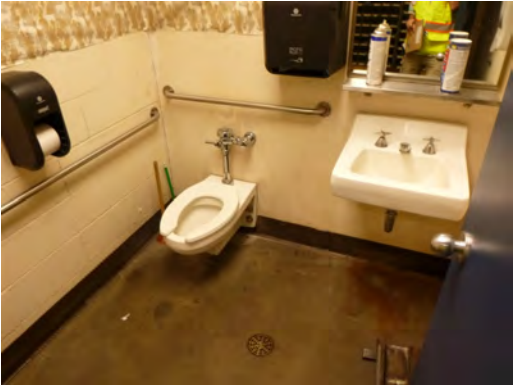
Deficient Material: Waste System
Original waste piping approaching end of life with some fixtures slow to drain or flush.

Remedial Action:
Clean, test, inspect, and repair or replace as needed.

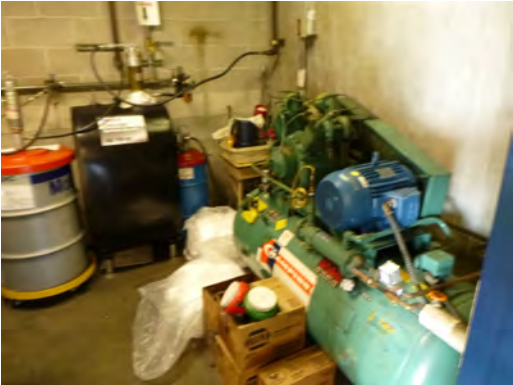
Deficient Material: Shop Plumbing Systems
Compressed air, shop fluids, waste oil, and similar systems near end of life.

Remedial Action:
Renew shop plumbing systems.

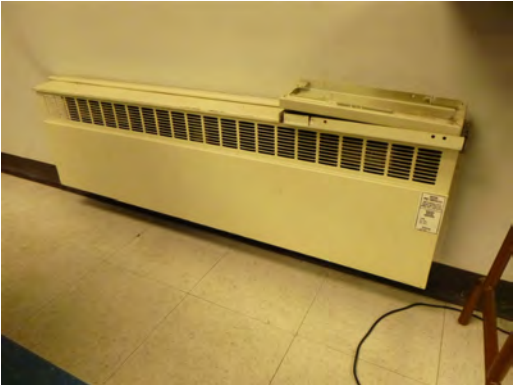
Deficient Material: Electric Heaters
Electric baseboard, wall, and ceiling heaters failing.

Remedial Action:
Replace with new.

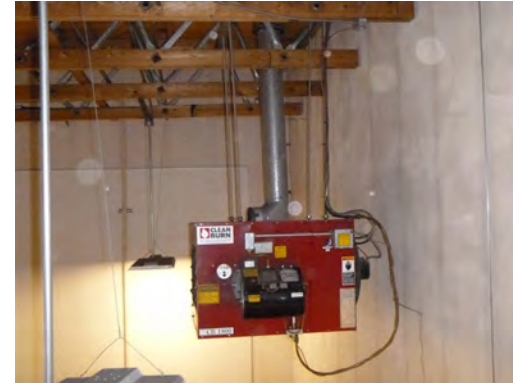
Deficient Material: Waste oil furnace

The small waste oil furnace is failed or failing needing replacement soon. The larger unit is aging and may need replacement in several years.

Replace waste oil furnaces upon failure.

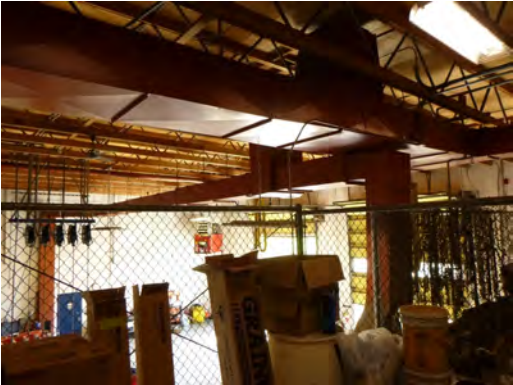
Deficient Material: Shop HVAC System
Original shop HVAC system rooftop air handling unit removed and not replaced, leaving shop ductwork abandoned in place, not compliant with code.

Remedial Action:
Renew or replace shop HVAC system to meet code.

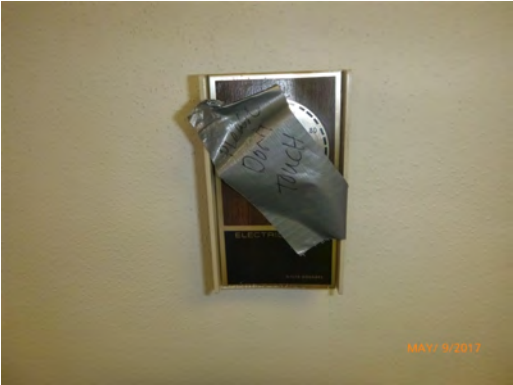
Deficient Material: HVAC Controls
Little or no automatic controls and no remote monitoring.

Remedial Action:
Install programmable controls per code and District standards.

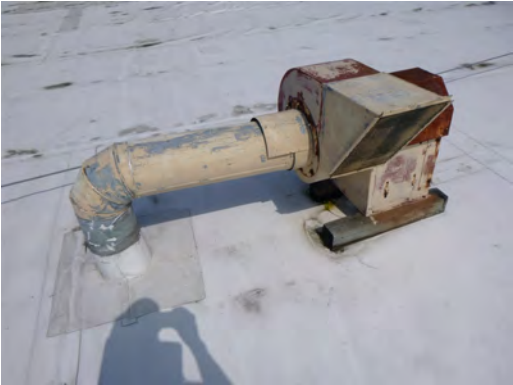
Deficient Material: Industrial Ventilation
Industrial ventilation systems largely inoperable or obsolete.

Remedial Action:
Renew or replace per code.

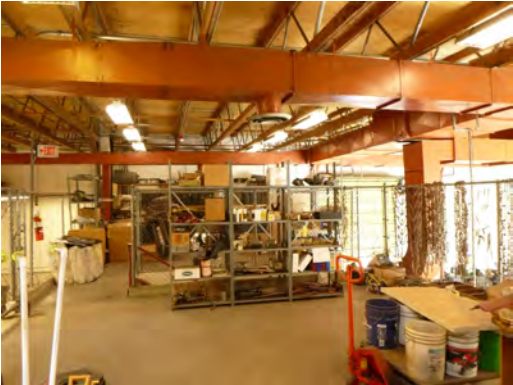
Deficient Material: Fire Sprinkler
No fire sprinkler system.

Remedial Action:
Install fire sprinkler system.

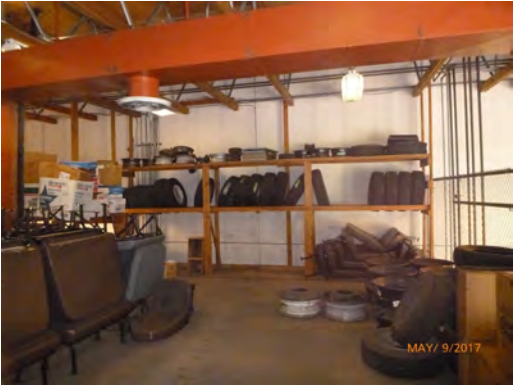
Deficient Material: Deluge System
No fire protection for tire storage, flammable liquid, and other combustible storage.

Remedial Action:
Provide deluge fire suppression per code.

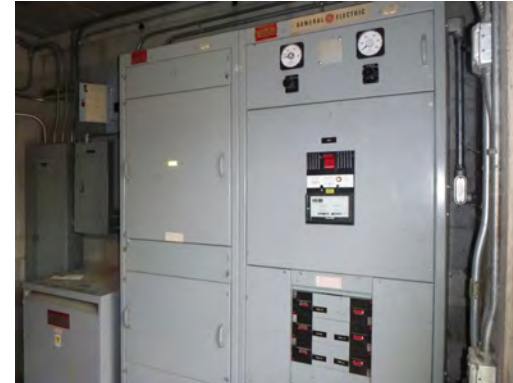
Deficient Material: Main Switchgear.

Provide new switchgear; increase capacity from 400A to 600A or 800A in conjunction with other planned upgrades, such as addition of air conditioning to office wing to north, or to accommodate future electric vehicle charging stations.

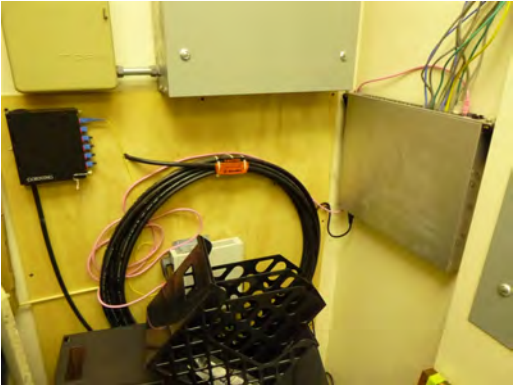
Deficient Material: Data System
Costly, unreliable, purveyor-provided fiber-optic data service.

Remedial Action:
Route data from adjacent District main campus to the transportation IDF.

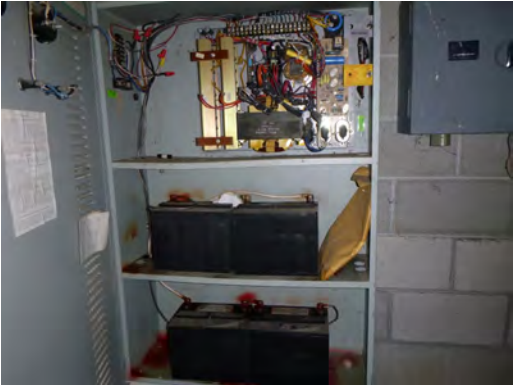
Deficient Material: UPS Lighting System
Existing UPS is non functional.

Remedial Action:
Provide new UPS system.

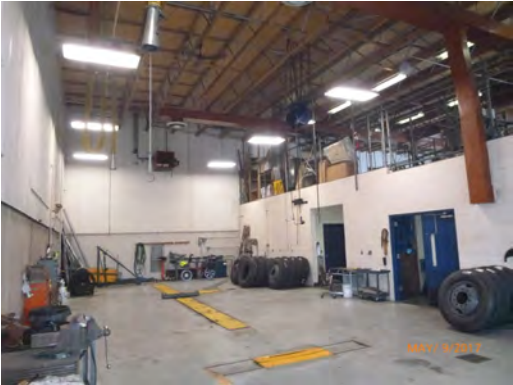
Deficient Material: Lifts
Original lifts should be renewed.

Remedial Action:
Renew lifts.

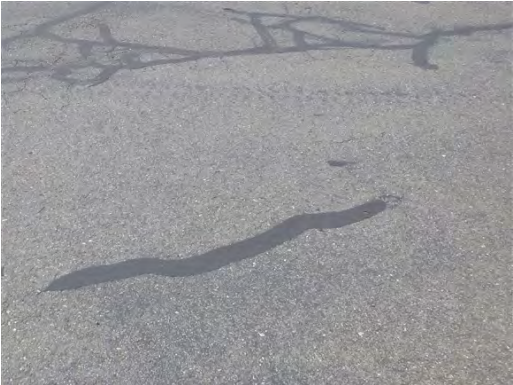
Deficient Material: AC Paving
Paving shows wear and tear, some cracking.

Remedial Action:
Clean, repair cracks, surface with AC top coat and restripe.
