FACILITY CONDITION ASSESSMENT

James K. Polk Elementary
5000 Polk Avenue
Alexandria, Virginia 22302

148303.21R000-009.354

December 17, 2021

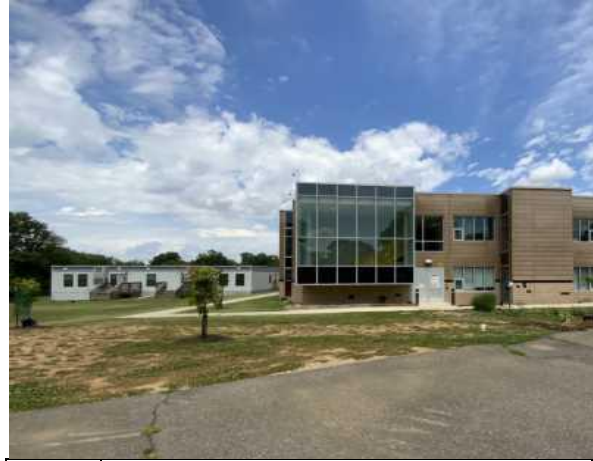
#2: LEFT ELEVATION

Siding on rear and left elevation of the building is failing (broken) and exposing foundation to the elements. - AssetCALC ID: 3148332

Uniformat Code: B2011
Recommendation: **Replace in 2021**
