FACILITY CONDITION ASSESSMENT

Mount Vernon Community School
2601 Commonwealth Avenue
Alexandria, Virginia 22302

148303.21R000-011.354

December 20, 2021

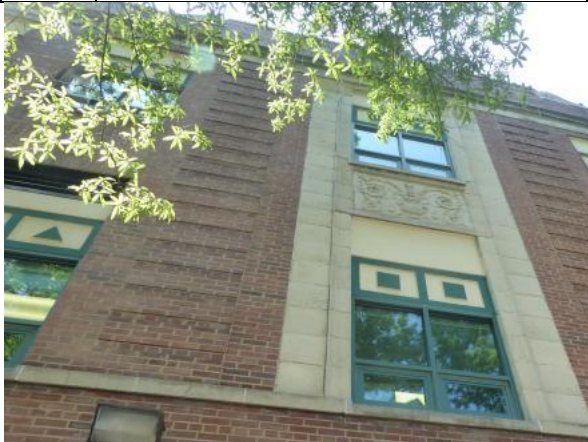
#6:	BRICK FACADE AND ALUMINUM WINDOWS
-----	-----------------------------------

The school is a three-story CMU and reinforced concrete structure with the third level being much smaller than the first and second levels. Exterior façade consists of brick veneer with double-glazed aluminum framed windows. The windows were installed quite some time ago but remain adequate, due to havewindow system modifications and repairs in 2016, 2018 and 2021. Exterior doors are swinging steel units with a small amount of glazing. The roof is primarily a TPO membrane, which was installed in recent years. There is damaged interior wall finishes along the north façade, reportedly due to prior roof leaks. This is evident in multiple rooms along the north side of the building.

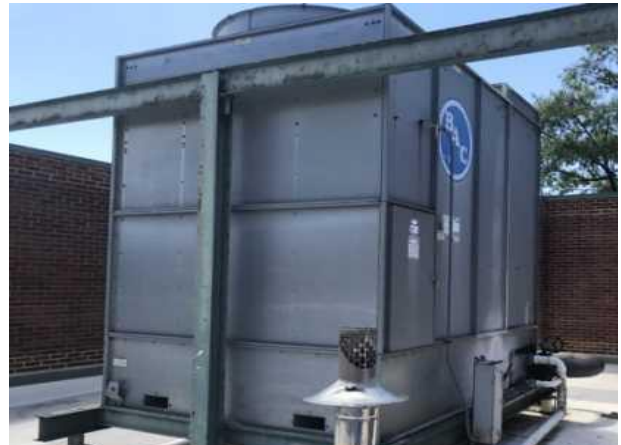
#20: COOLING TOWER

The school is primarily condition by a chilled water loop and a series of boilers. The chilled water loop consists of a water-cooled chiller and rooftop cooling tower. The cooling tower is scheduled for replacement in November and the chiller is nearing the end of its useful and maintenance is becoming an issue. It should be replaced soon as well. Classrooms, hallways and offices are primarily conditioned by ventilators. There is also a series of rooftop packaged units and split system units. The electrical distribution system appears to be older for the most part with some components replaced as needed. Unclear if some components are original or not. Lighting appears to be T-8 fixtures in large part. The plumbing is widespread as many of the classrooms have single occupancy restrooms, in addition to, the larger restrooms located on the lower two levels. Fire protection includes an integrated fire alarm system which includes horn strobes, pull stations and smoke detectors, as well as addressable fire alarm control panel. The exit lighting was observed to be poor. Fire suppression is limited to a network of extinguishers throughout the building. A small system is in the kitchen over the range.
