FACILITY CONDITION ASSESSMENT

Samuel W. Tucker Elementary
435 Ferdinand Day Drive
Alexandria, Virginia 22302

148303.21R000-012.354

December 20, 2021

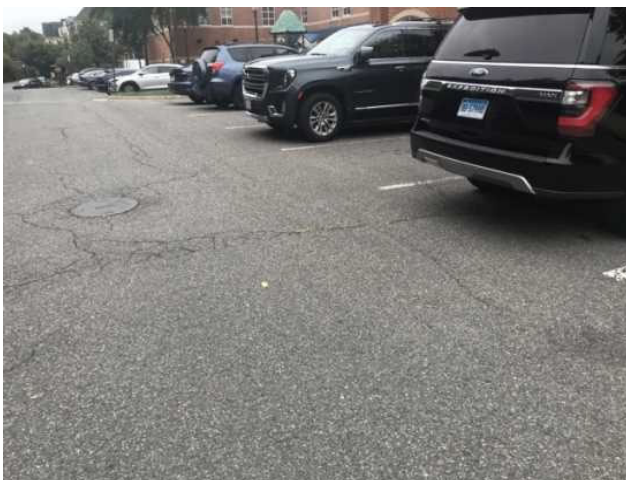
5 - PARKING LOTS, PAVEMENT

Parking Lots in Failed condition.

Uniformat Code: G2021
Recommendation: **Seal and Stripe in 2021**

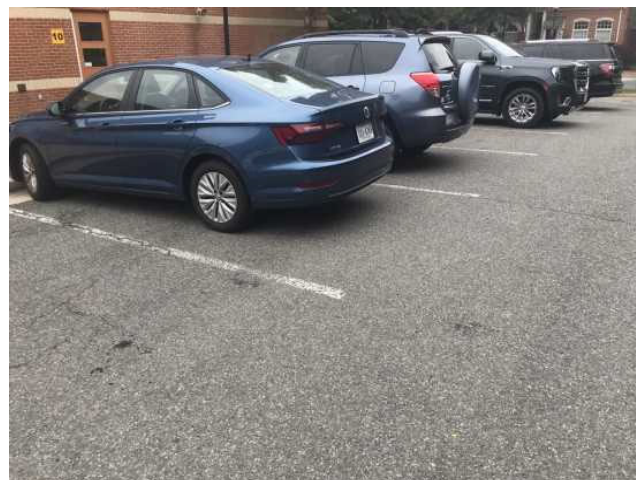
6 - PARKING LOTS, PAVEMENT

Parking Lots in Failed condition.

Uniformat Code: G2021
Recommendation: **Mill and Overlay in 2021**

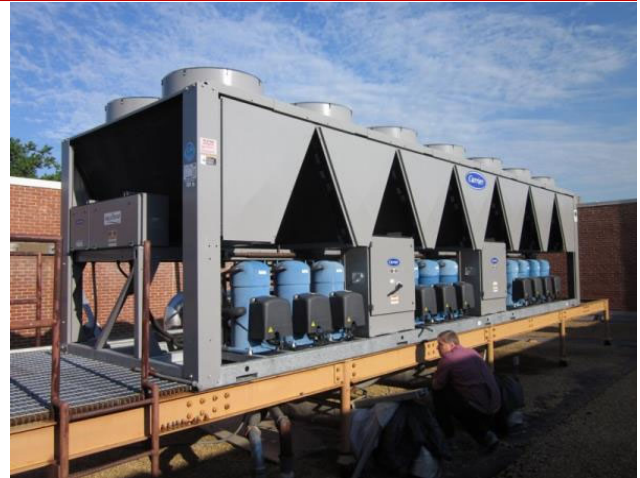
20 - AIR-COOLED CHILLER

The HVAC systems and components appear to have been well maintained during recent years, with ongoing replacements over the years as needed. In general, the plumbing systems are reportedly adequate to serve the facility, with equipment and fixtures updated as needed. Chiller replacement is scheduled for November 2021.
