2021 School District of Onalaska Long Range Planning Study

PART 1 - Facilities Condition Assessment

2021 SCHOOL DISTRICT OF ONALASKA: LONG RANGE PLANNING STUDY FACILITIES CONDITION ASSESSMENT

School District of Onalaska

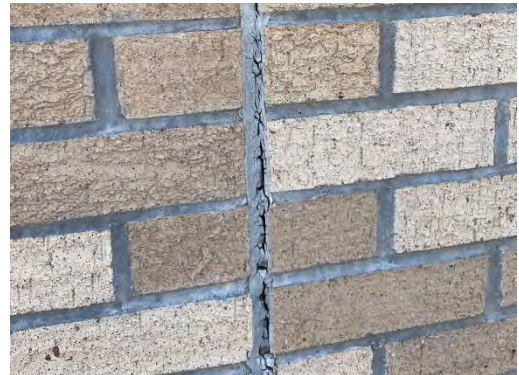
Multiple control joints demonstrate signs of aging and cracking

1. In general, the exterior face brick remains in very good condition. Two locations on the west end of the building exhibit minor cracking that could easily be repaired. Mortar joints appear to be in satisfactory condition with various locations requiring re-pointing.
2. The brick walls constructed as part of the 1988 addition utilized a particular plastic tube weep vent at the bottom of the wall, which appear to be partially (if not totally) plugged limiting the moisture weep capabilities. There were no indications that the plugged weep vents are problematic but may warrant a future project to clean out the weep vents.
3. Overall, control joints are in good condition. A number of brick expansion joints demonstrate aging and cracking. At some of the expansion joints, the caulking has been partially 'squeezed' out of the brick head joints likely due to brick expansion.

1. Various control joints should be cut out and re-caulked. Control joints that display brick expansion should be monitored on an annual basis to ensure they maintain a waterproof joint.
2. The District may want to consider re-coating the acrylic stucco with a new flexible elastomeric coating that will reinforce the weather-tightness of these wall areas.
3. Flashing above arches or sealant in head stones need to be considered at South entrance 'P' in order to minimize ongoing water damage.

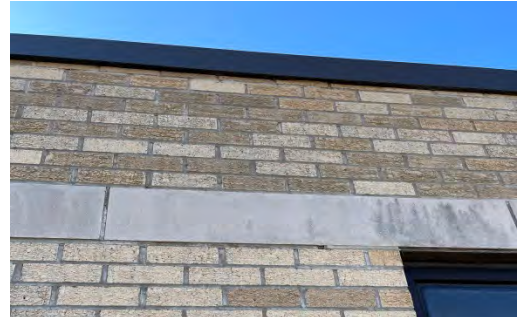
Tuck point and joint repair required at stone band above windows

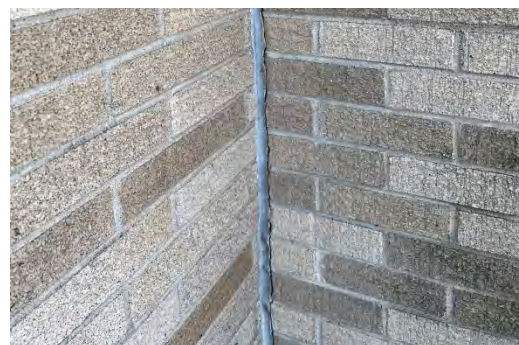
Soft joint replacement is required at various existing joints

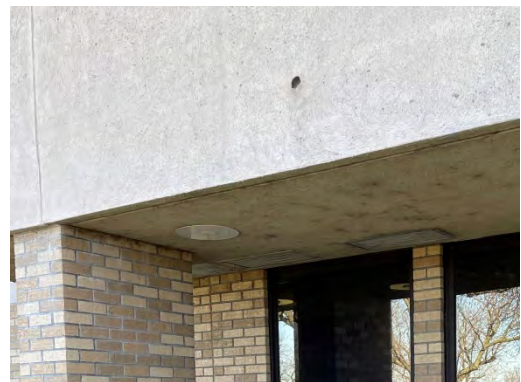
4. Metal roof edge fascia, flashings and wall caps also appear to be in relatively good condition and do not warrant any immediate action.
5. Limited wall areas of the 1988 addition were clad with an exterior acrylic stucco surface. The surface appears to be functioning as a weather barrier but shows some signs of aging, to be expected. A couple of hairline cracks were observed that may be a result of seasonal expansion and shrinkage cycles.
6. South entrance 'P' displays ongoing moisture leaks from open joints in stone and lack of flashing. Interior water damage has occurred in adjacent classroom ceilings.

Multiple breakages in EIFS surface

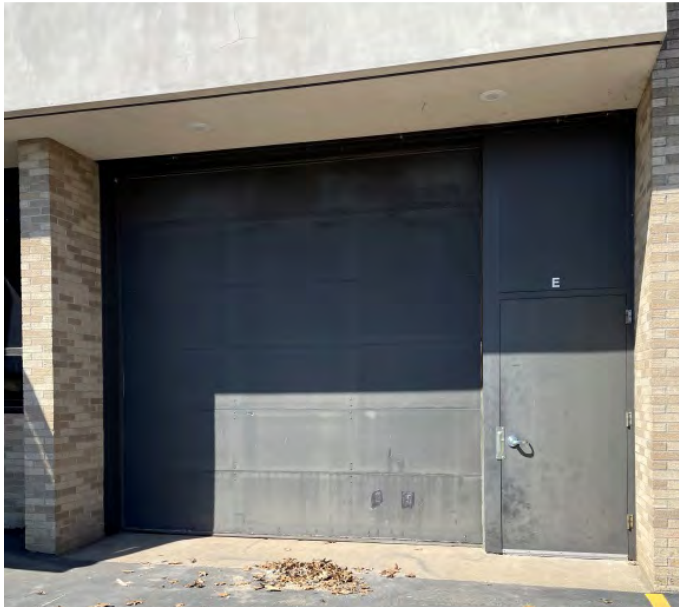
1. All aluminum entrance doors and hollow metal doors and frames were replaced in 2018.
2. All gym doors and the Building & Grounds entry door were replaced with fiberglass doors and frames.
3. O.H. Doors and accompanying man doors outside Tech Ed. have not been updated.

Existing O.H. door & man door

1. The age and efficiency of existing O.H. Doors and man doors should be considered for future replacement.

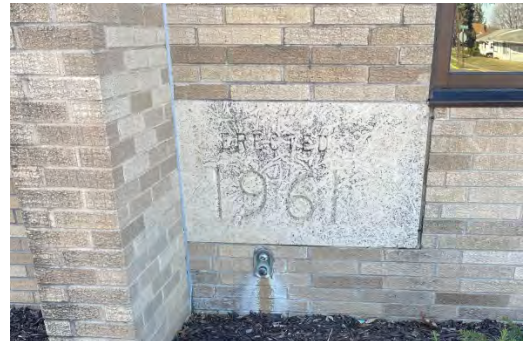
1. A number of hose bibs show ongoing leakage or separation from exterior walls.
2. Stone planter caps have shifted in areas and begun separating from the building. Aluminum covers show age and wear.
3. Grade at multiple areas have washed away from building perimeter.
4. Various areas show separation between exterior walls and concrete stoops.

Sealant required at various hose bibs

1. Hose bibs require sealant and monitoring to prevent continuing water damage to exterior masonry.
2. Planter maintenance does not require immediate repair and could be addressed over time. Stone planter caps need mortar removed and need to be re-caulked. Aluminum covers could be replaced or rust removed and re-painted.
3. Areas where grade is low does not require immediate attention. Grade could be raised to cover exposed insulation or membrane.
4. Tectum panels are recommended to be repainted.

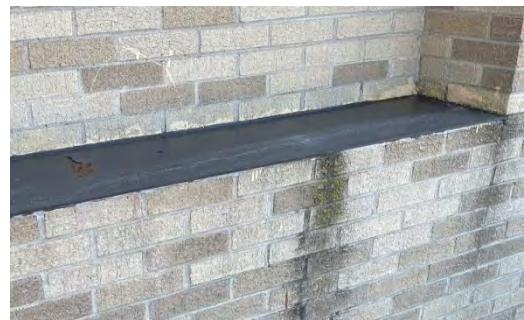
Existing aluminum planter covers

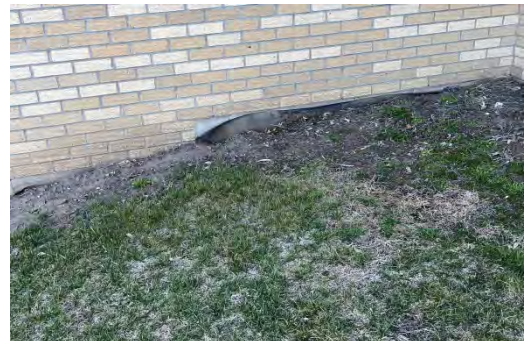
Grade washed away from building

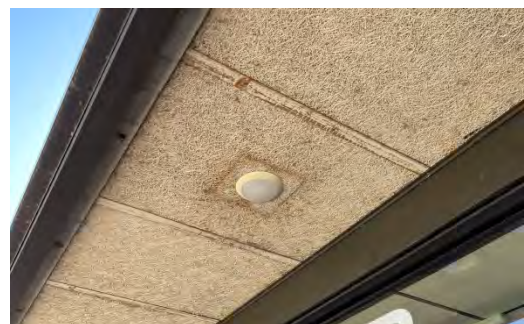
Tectum panels above entry 'B'

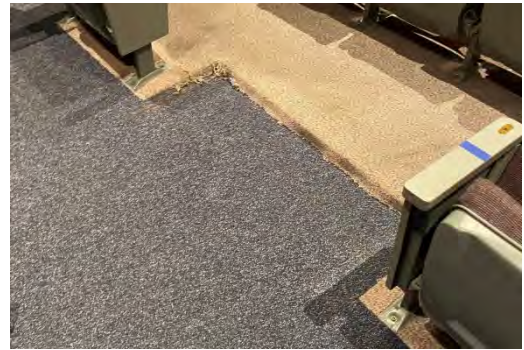
PAC: Area where carpet is detached

1. At vinyl composition tile, various floor expansion joints need to be inspected for potential trip hazards.
2. PAC carpet should be replaced entirely.

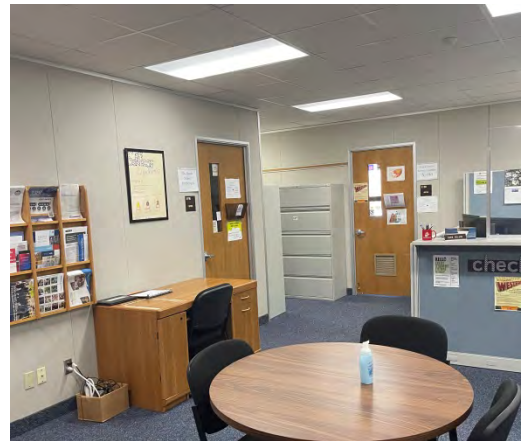
Student Services – Demountable partitions

1. Overall, concrete block walls are in satisfactory condition.
2. Fabric on demountable walls shows wear and tears in multiple areas.
3. Demountable partitions do not provide adequate sound control between rooms.

1. Demountable walls are recommended to be replaced with standard wall construction and sound insulation to minimize noise bleeds between classrooms and hallways.

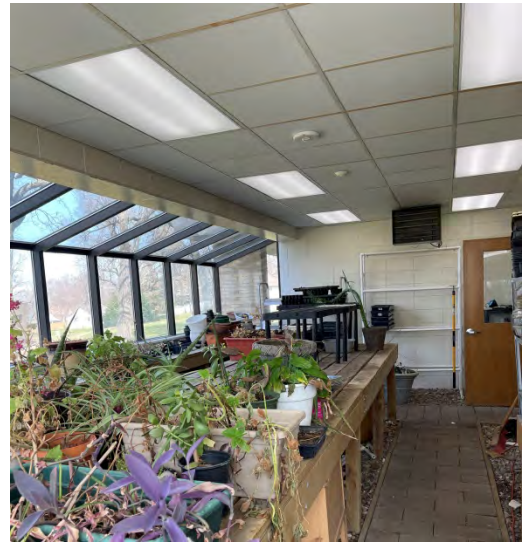
1. Island and peninsula chemistry work stations appear to be in good condition with minimal signs of damage. Salvaged storage cabinets are also used in the science prep rooms. These cabinets appeared to be well built and should have several years of service left.
2. The perimeter countertop work surfaces and student tables in the three biology and physics lab also appear to be in satisfactory condition given their age of 27 years. The student tables were originally movable and positioned in conjunction with floor pedestal type electrical receptacles. The tables were then anchored to the floor and conduit routed to the table aprons with receptacles.
3. Botany shows sign of moisture damage at walls and ceiling grid system rusting.

Botany adjacent to Science

1. In Chemistry room 119, it is recommended that the eyewash sinks and showers be re-plumbed to add mixing valves to the water service to temper the water temperature.
2. Instructor demonstration tables could be changed out with new ADA compliant demonstration tables.
3. Conduct a detailed study of the high school lab facilities to update for current trends, ADA compliance, AV equipment, HVAC (fume hoods), plumbing, and electrical systems.
2. Botany block walls could be repainted. Moisture is causing paint to peel.

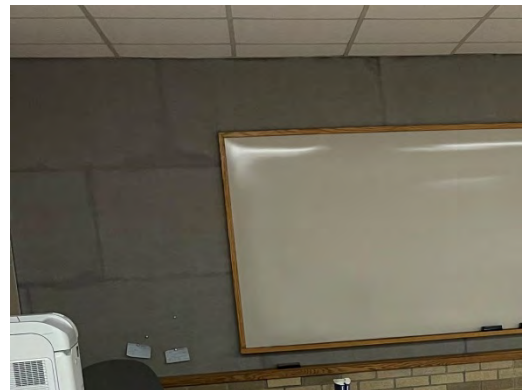
Acoustical wall carpet

1. Some rooms display more wear on finishes than others.
2. Minimal sagging of 2x4 acoustical ceiling tiles occurring. Moisture damage can be found near Entry 'R', within the field house and miscellaneous areas in the school.
4. Acoustical wall carpet is detaching and adhesive is bleeding through in various areas.

1. Selected finishes could be slowly replaced over time based on priority level.
2. Damaged acoustical ceiling tiles shall be replaced.
3. Acoustical wall carpet should be replaced with acoustical wall panels.

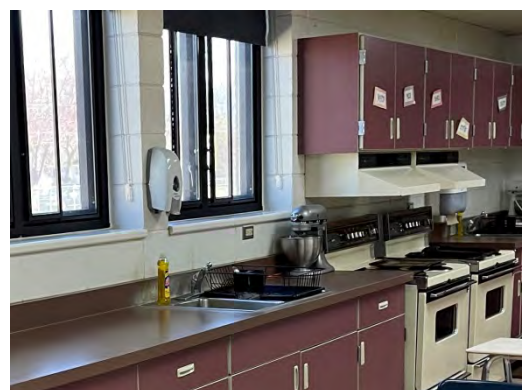
Aged finishes and worn areas

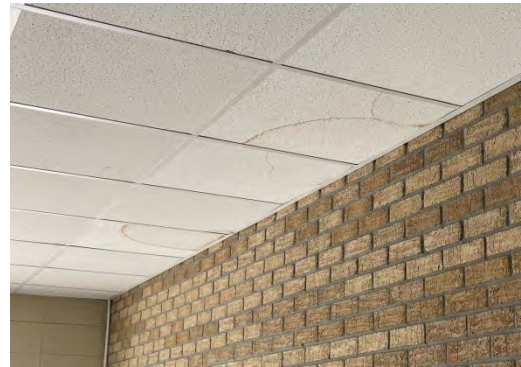
Damaged ceiling tiles to be replaced

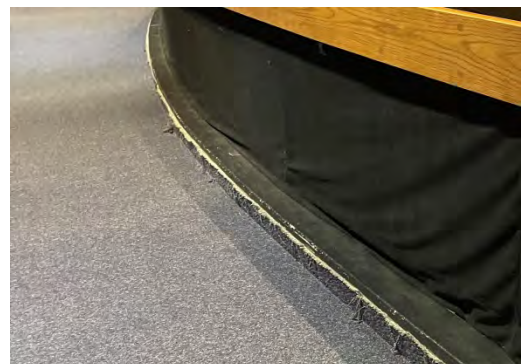
1. Overall, finishes in the PAC are aged and worn. Floor carpet is pulling up and detached in areas. Wall carpet displays moisture damage.
2. Mezzanine is accessed by stairs. Space is used for storage of props and scenery. Movability of materials appears difficult due to size of items and access to space.
3. ADA access to the stage is limited to the rear hallway and non-existent to the orchestra pit. Sound booth is not ADA accessible.
4. Stage does not have sufficient wing space or fly space for theater performances.
5. Full band of 130 students does not fit on the stage.

Carpet detaching in multiple areas

1. All finishes need updating. Carpet needs full replacement. Acoustical wall carpet should be replaced with proper acoustical panels.
2. Shortcomings of this area will be reviewed with the overall design study for the high school.

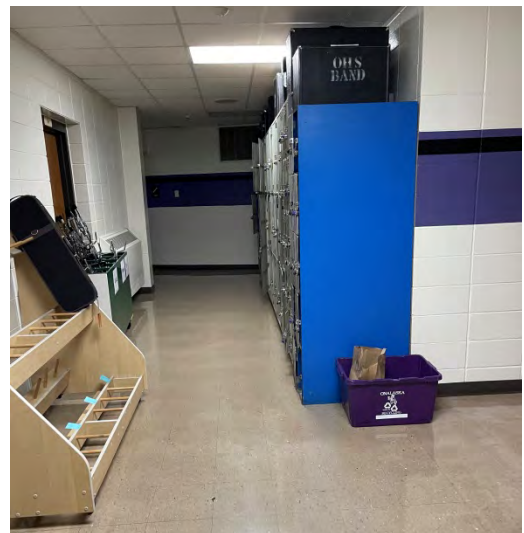
1. Classroom is undersized for the amount of students in the program. The perimeter of the room is utilized for instruments or storage of chairs/stands.
2. Instrument storage is inadequate in both the classroom and separate storage room. Instruments overflow into the hallways.
3. Room does not have appropriate acoustical treatment or height to accommodate proper sound distribution.

Overflow of instrument storage in hallway

1. Shortcomings of this area will be reviewed with the overall design study for the high school.

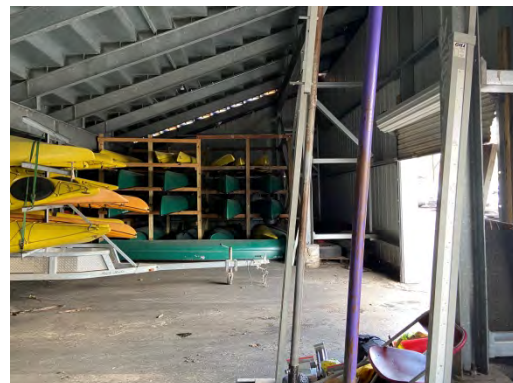
1. With exception of the press box, the main structure and seating assemblies appear to be in satisfactory condition.
2. O.H. Doors are coming off the track which creates an operating concern and safety hazard.
3. Storage is shared amongst several programs.

Storage beneath bleachers

1. Replacement of the light-duty push-up coiling garage doors with heavier-duty overhead sectional doors. The door jambs at the overhead doors also show some damage, likely from moving items in and out of the enclosed storage areas. A recommendation would be to add concrete filled steel bollards at the sides of the door openings.

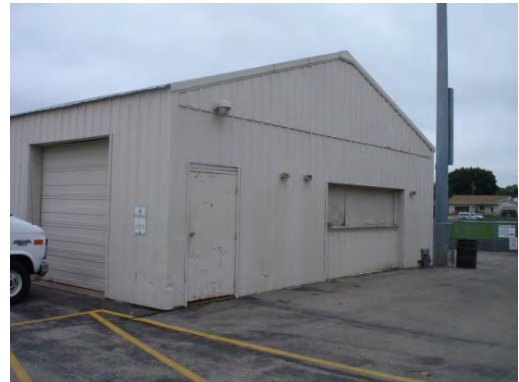
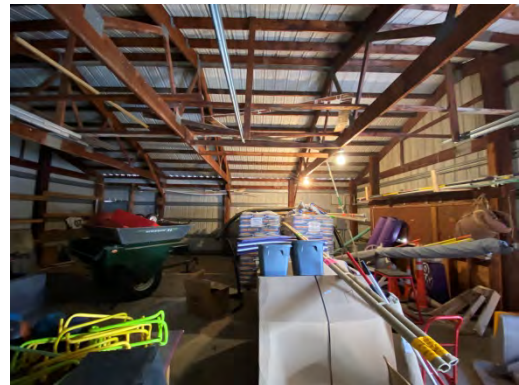
1. The garage structure shows signs of wear and corrosion but can likely be used indefinitely. Overhead doors and swinging doors can be replaced; however, the building in general appears to have deteriorated to the point of total replacement.
2. Building is currently filled with materials and equipment.

Vehicle storage building

Interior of vehicle storage building

1. Building can continue to be used in its current condition. Updates should be considered as part of a district wide maintenance project.

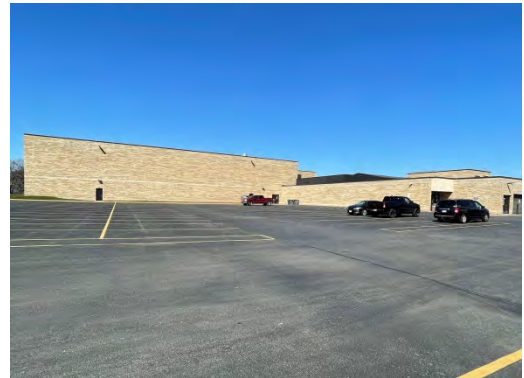
1. Where parking is provided, accessible parking spaces shall be provided as follows:
 - a. Total Parking Spaces Provided: 301 to 400
 - b. Required Number of Accessible Spaces: 8
2. Van accessible spaces shall be provided for every eight accessible stalls. The existing parking lot includes a total of 325 spaces. There are currently five designated handicap parking stalls.

Rear parking lot

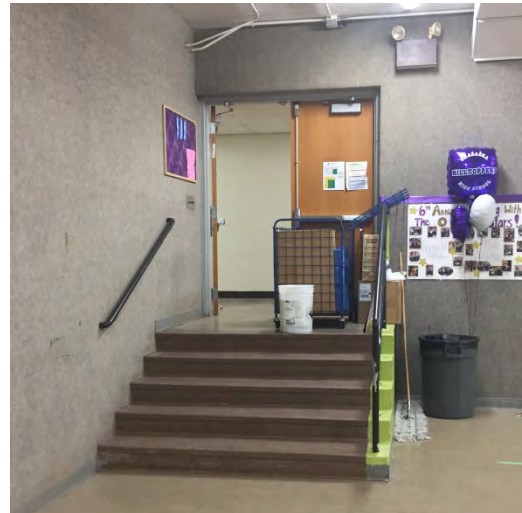
Dance room access from hallway

1. Handicap access should be considered for the Dance Studio if the room is to function as the one and only room for the dance studio.
2. Access to the upper mezzanine will be reviewed with the overall design study for the high school.

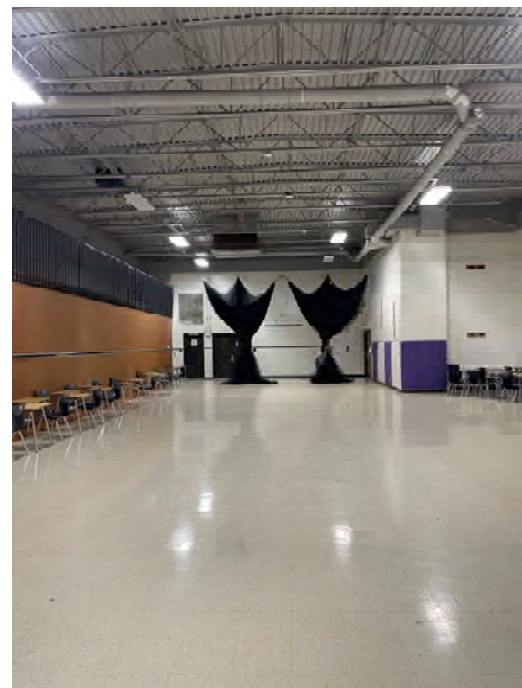
No elevator access to upper mezzanine

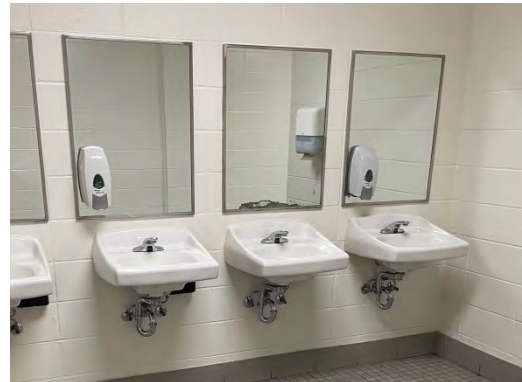
Exposed pipes at lavatories

1. Toilet rooms are not completely compliant with current ADA guidelines.
2. Grab bars and size of stalls do not meet current ADA guidelines.
3. Lavatories do not have proper covers or insulation over exposed pipes.

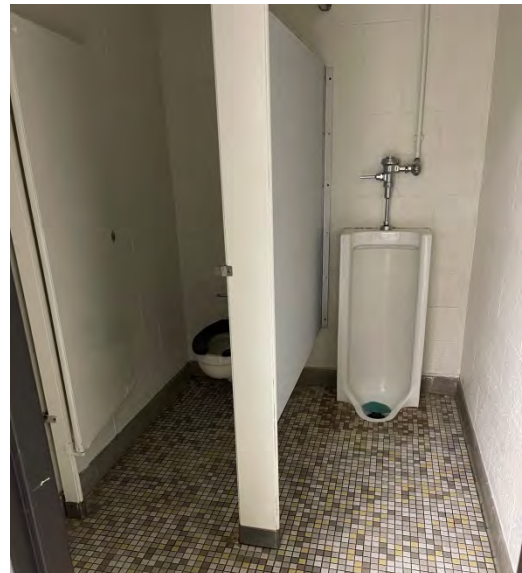
Locker room toilet stalls

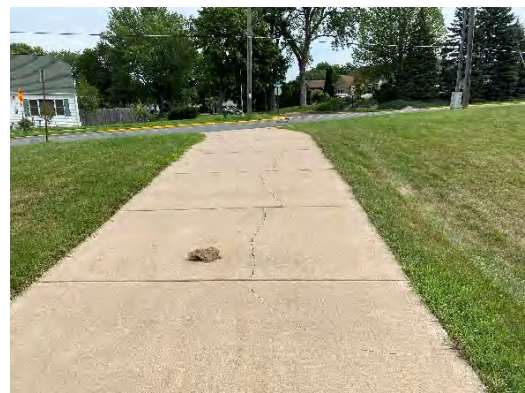
Sidewalk at Door S – map grid H4

1. Continue to monitor and note any cracked or lifted sidewalks.
2. Replace sidewalk sections (6 required) in front of door S (grid H4) this should be 6" reinforced on aggregate base.

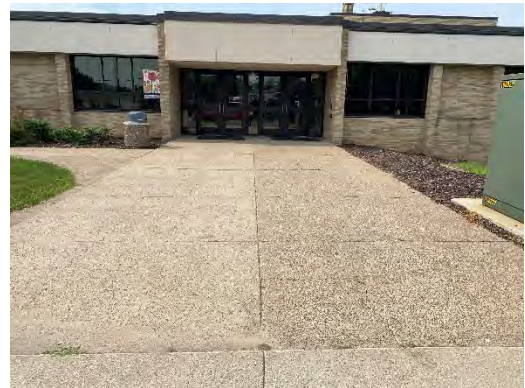
North Main Entrance – map grid H6

3. Replace large area in front of the North Main Entrance (approximately 22x40) (grid H6).
4. Replace section previously "mud-jacked" (grid H8) tripping hazard.

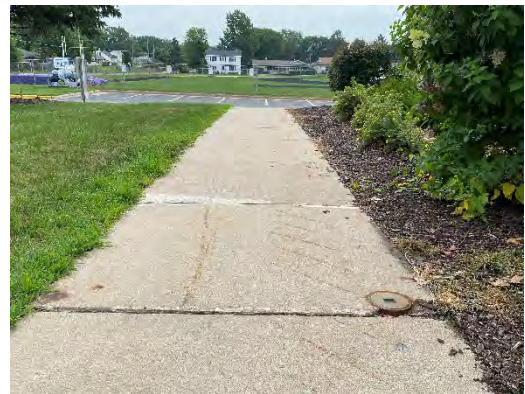
Tripping hazard – map grid H8

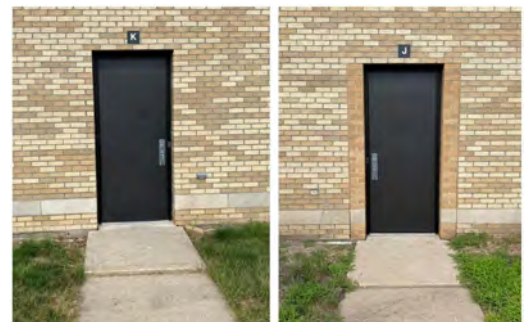
Door stoops – map grid D7 and E7

5. Replace approach to stoop at doors J and K trip hazard (grid E7 and D7) and door G (grid E9).
6. Replace broken sidewalk at door P (grid F5).
7. Replace broken concrete sidewalk at ramp crossing (grid B5).

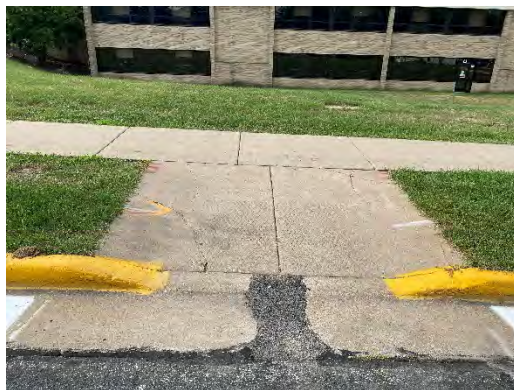
Replace ramp – map grid I5

11. Replace ADA ramps at Crosswalk and at drop-off entrance (grid I-5).
12. Replace broken curb at drop-off area (grid I5).
13. Accessible route curb openings require detectable warning fields (grid E4 and E5).

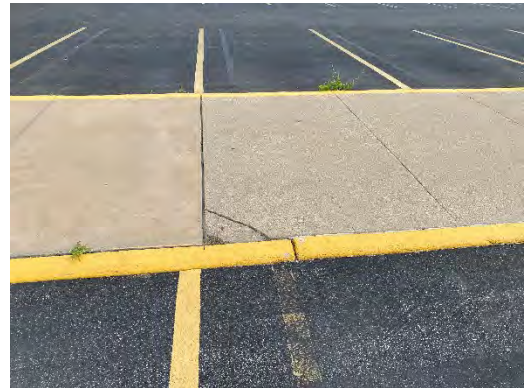
Broken sidewalk – map grid C8

8. Patch broken sidewalk corner (grid C8).
9. Waste units near door J should be on concrete slabs (grid E7).
10. Reinstall joint seals at Doors E, N, and O (grid D5, C6, and C7).

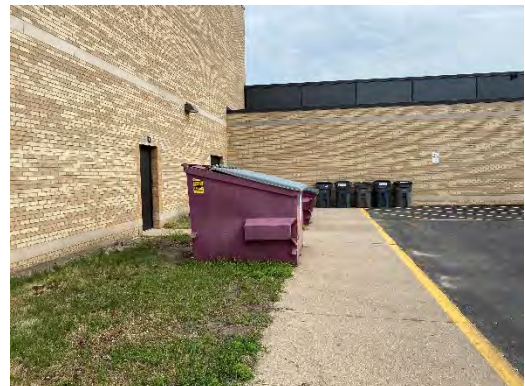
Concrete slabs needed – map grid E7

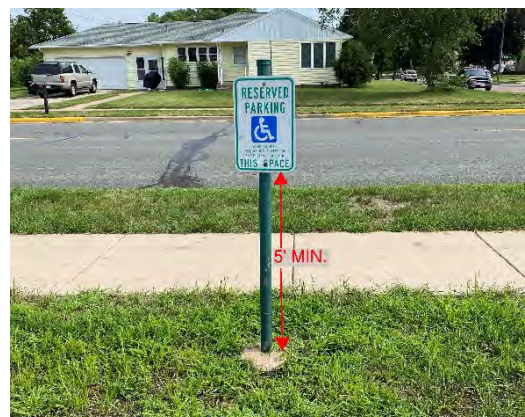
1. Signs are too low.

North Entry Drop-off Area –
low ADA signs, map grid

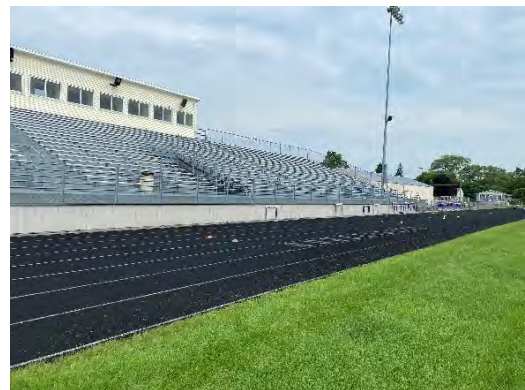
1. Drainage from the football field runs across the track. The stadium drainage also falls on the track and then leaks under the stadium enclosed spaces. This condition causes a high level of concern for water damage and in the late winter freezing and thawing conditions occur frequently. Installing a trench drain at both edges of the track would alleviate some of this concern and would certainly extend the life of the track surface and reduce (but probably not completely eliminate) the problem.

Football field drainage – map grid D-E10

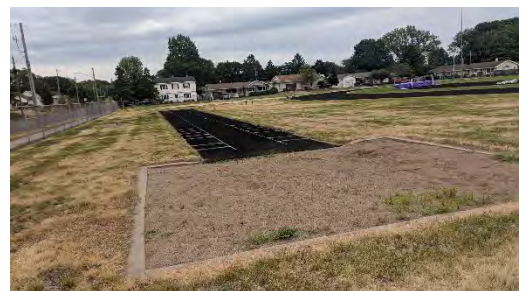
Long jump – map grid H10-11

1. Long jump pits meet rule requirements but are probably 10-15' too short for practical use. These should be extended when feasible to do so. Additionally, the space between runways should be increased by 4-6' if the pits are going to be reconstructed to allow for simultaneous use.
2. Several locations along the south and east side enclosing fence have the top rail displaced. These should be repaired.
3. Considerable effort has been made to remove trees from the property fence lines. This practice should be continued annually to keep the operation from becoming a major event.

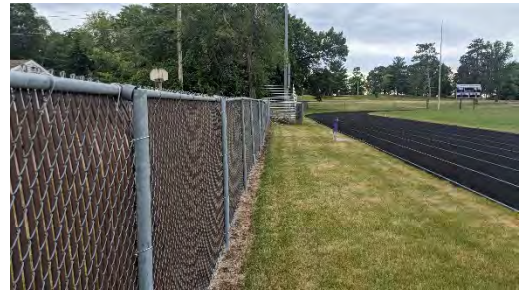
Repair top rail – map grid B12, C10, E13

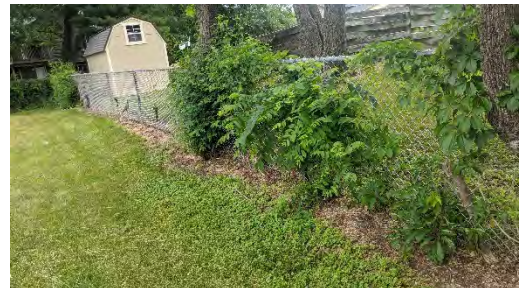
Vegetation in fence (east practice field)

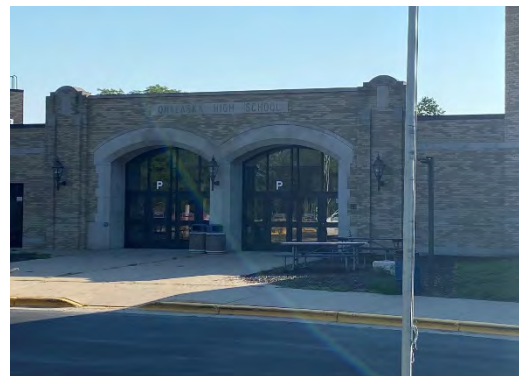
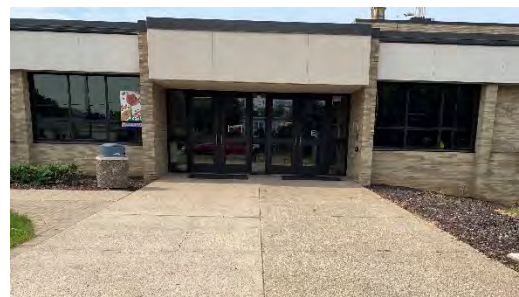
1. The existing landscape is Spartan but not messy.
2. Some smaller areas near main entrances could be refreshed or replaced with more interesting and complex plantings. This would have to be followed by additional maintenance to ensure the investment is kept up.

Entrance landscaping – map grid E-F5

Entrance landscaping – map grid H6

1. Continue to monitor landscaping and remove dead or diseased branches or plants/trees.
2. Update entrance area landscapes.

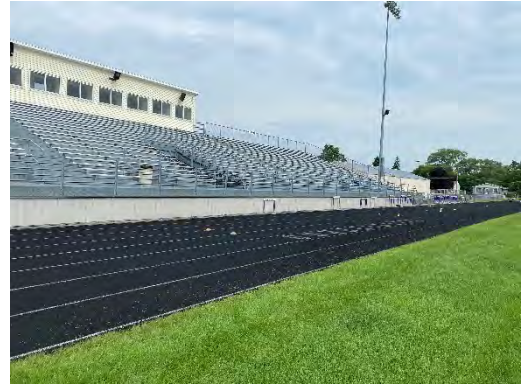
1. No deficiencies were seen in existing facilities.
2. Track area lacks surface drainage which causes continued storm water and ice problems in the areas around the facility.

Track/football field drainage – map grid D-E10

1. Add drainage at the edges of both sides of the track. This would intercept field runoff and capture drainage from the stadium seating.

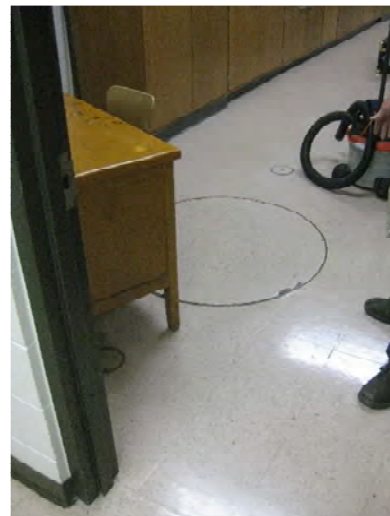
Chemical neutralization basin

4. Other Equipment will require an annual review of condition and minor on-going maintenance as needed.
5. Add HW and a tempering valve to all of the emergency eyewashes and showers.
6. Disconnect MB from Chemical neutralization basin or discontinue usage.

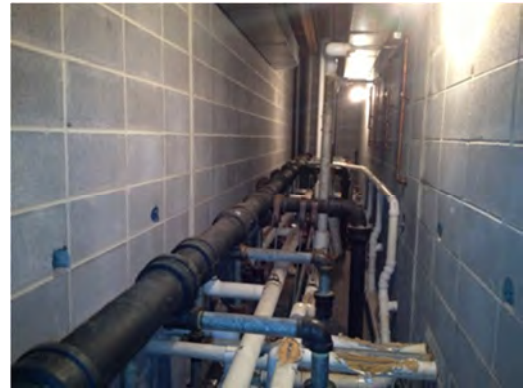
Typical chase in 1960 & 1968 areas

1. Galvanized water piping should be scheduled for replacement, original valves should also be replaced.
2. Soften the CW domestic system.
3. A camera should be used to review the condition of the CI sanitary drain piping in the Team area and Field house areas of the building to determine the condition of piping

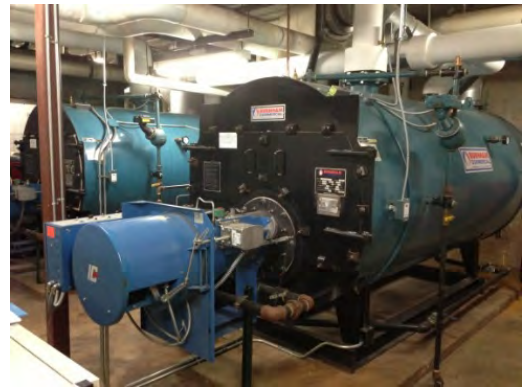
Hot water boilers

1. The high-efficiency boiler is in good condition and, with a proper maintenance program, should continue to serve the building for another 15 years or more. The Burnham firetube boilers are in marginal condition with one of the boilers in poor condition due to an on-going condensing issue that has basically ruined the boiler.

1. Provide additional VAV boxes as needed to the classroom spaces that have been partitioned in the past without HVAC revisions.
2. Remove the aging Burnham firetube boilers and install a new high-efficiency condensing boiler plant with a variable speed pumping system to serve the entire building.
3. Replace the existing hot water system air separator with a new magnetic air and dirt separator to remove unwanted contaminants and metal particulates from the system that can damage control valves and other devices.
4. Install hot water heating coils in existing air handling units AHU-2, AHU-3, and AHU-10 to provide improved discharge air temperature control for each system.
5. Continue to maintain the existing digital control system by keeping the software current.
6. Continue to replace all duct board as needed.

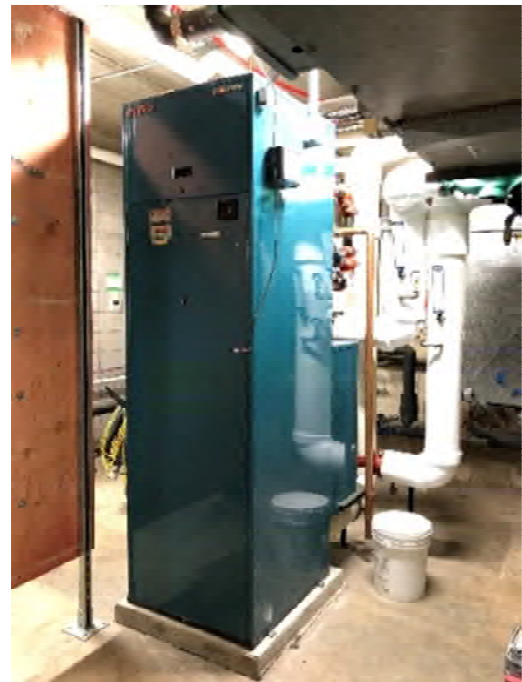
High-efficiency Boiler

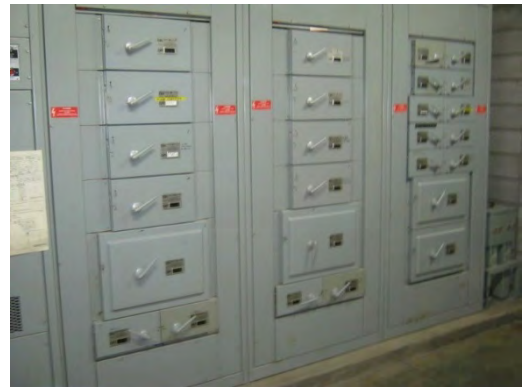
Main switchboard

1. The main Switch Board is in good working condition with no issues reported by Maintenance Staff.
2. The main service switchboard does not have a surge protection device.
3. The existing 1960 Switchboard located in what is referred to as the 'Laundry Room #211C should be removed and replaced with new. This switchboard feeds an existing air handling unit, woods and Metals Shop Panelboards, Panel LCF-2 and unlabeled Panels. Switchboard is fed from the 1988 Switchboard.

1. Provide surge protection device on main service. \$4,400.
2. Provide a new 600 amp. (minimum) distribution panelboard to replace 1960 switchboard. \$16,500.

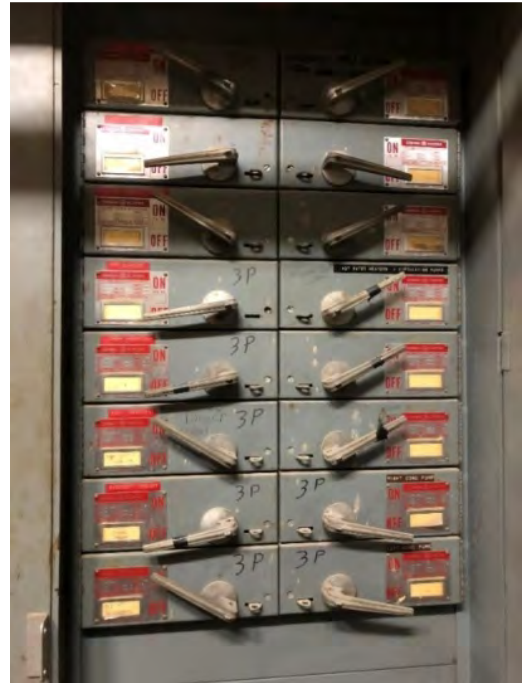
Old distribution Panelboard

1. All existing panelboards are generally full and do not have space for additional circuit breakers.
2. The panelboards that were installed in 1968 are at the end of their useful life due to the operating lifespan of circuit breakers.
3. The panelboards that were installed in 1988 are in good working order. However as noted above are full and have minimal space for additional circuit breakers.
4. In the Kitchen by the Service Line, the panelboard is full and should be replaced with a new larger panelboard. It is also the opinion of this writer; the existing panelboard should be relocated to a better location. \$4,000.

1. The expected remaining lifespan of the 1968 panelboards is about 0 - 5 more years and should be replaced as soon as possible.
2. The expected remaining lifespan of the 1988 panelboards is about 15-20 more years.

1. Replace the 1968 panelboards and feeder wire with new. New circuit breakers will allow for a safer and more expandable installation. \$7,700 EA for a Total of \$154,000.
2. Provide one additional panelboard located adjacent to each 1988 panelboard. Observed a minimum of Seven (7) additional panelboards required. \$4,400 Each for a Total of \$31,000.

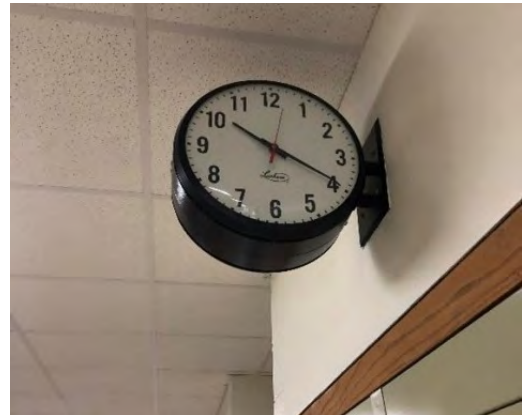
Wall clock

1. The clock system is in adequate working order. Some of the clocks are approaching or have exceeded end of expected life cycle.
2. Additional clocks can be added to the system.
3. The School District has begun to replace clocks.

1. Recommend budgeting for wall clock replacement, \$150 per clock depending on power option. The master clock is already upgraded. Total budget \$21,000.

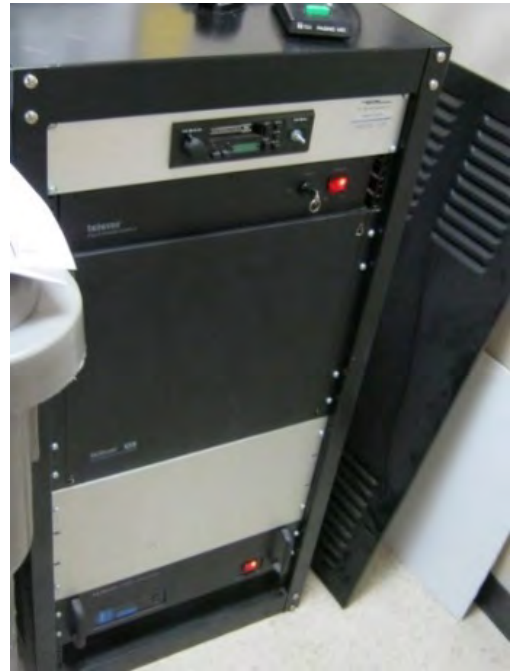
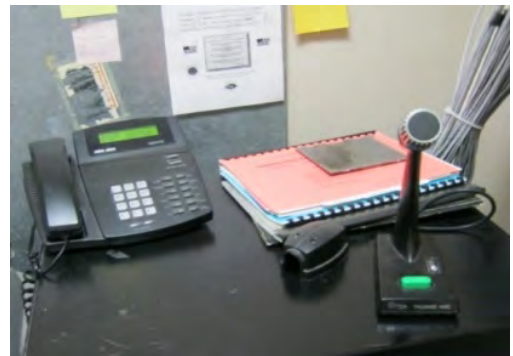
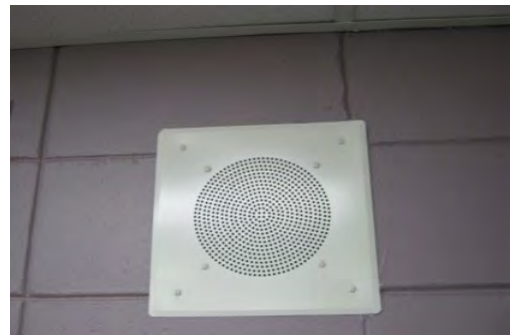
Public address system

2. The expected remaining lifespan of the replaced CPU and Controller is about 10 -15 more years. The speakers and wiring have reached end of life expectancy.

1. Replace with a new modernized system. Consider a system to integrate with modern technology such as mobile communication, pre-recorded messaging, etc. Budget allowance of \$90,000.

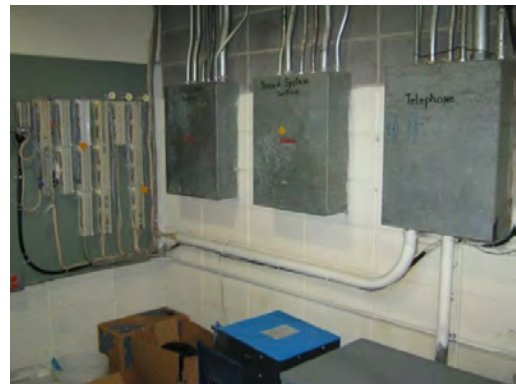
Telephone system

1. Remove all CAT 3 wiring and replace with new CAT 6. Budget \$50,000.

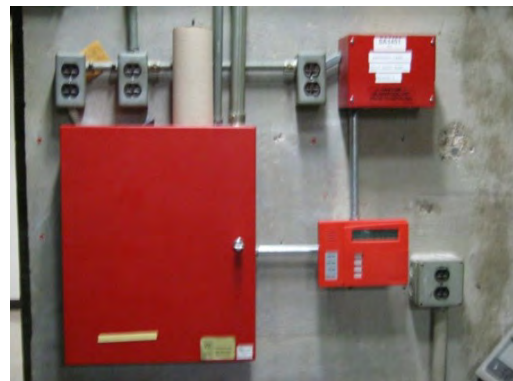
1. There are exterior door contact switches on all exterior doors.
2. Security system is in good working order.
3. Additional security devices can be added.

Security system equipment

1. Due to advance age of the system, consideration should be given to replace the security system head-end equipment with a new modernized, programmable, software based, system which could be integrated with CCTV Cameras, Fire Alarm and Electronic Door Access Systems. Budget \$15,000.

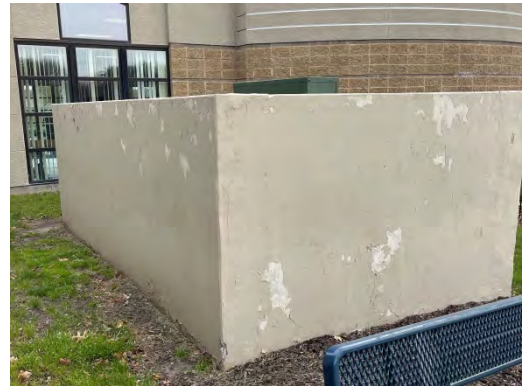
Stucco walls at transformer require repair

1. Stucco walls at the transformer should be refinished.
2. Ground face CMU at commons requires tuck pointing and should be resealed to prevent further moisture damage.
3. Ribbed panels should be refastened.
4. Insulation of exterior walls needs to be improved and will be reviewed as part of the middle school design study.

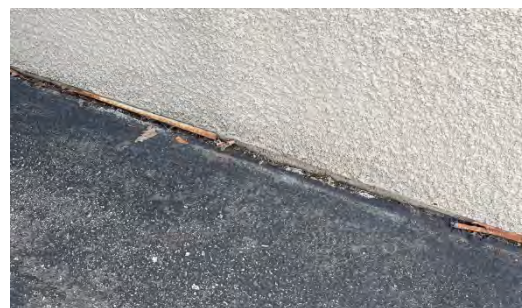
Drip flashing rusted and deteriorated

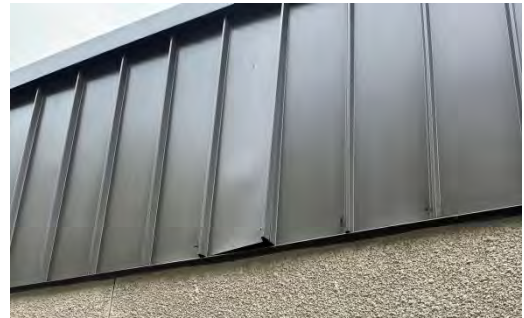
Metal ribbed panels detached

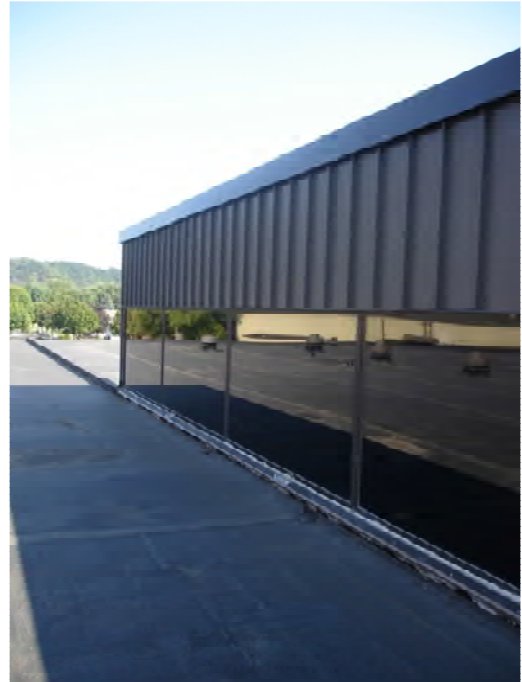
Clerestory windows at LMC

1. If the decision is made to replace the aluminum framed clerestory windows in the sloped shed roof areas, it is recommended that the sill conditions be raised and re-flashed per current recommendations of the roof membrane manufacturer.

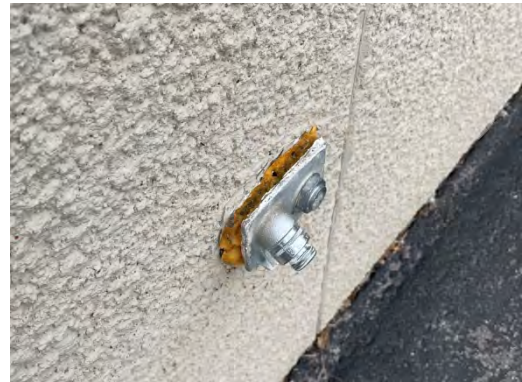
1. Hose bibs are protruding out from exterior walls and appear to be sealed with spray foam.
2. Multiple downspouts do not direct drainage away from the building.
3. Entry soffits appear to be in satisfactory condition.

Hose bibs

1. Hose bibs should be routinely monitored for proper sealant at the perimeter.
2. Downspout drainage should be redirected to prevent water damage at building perimeter.

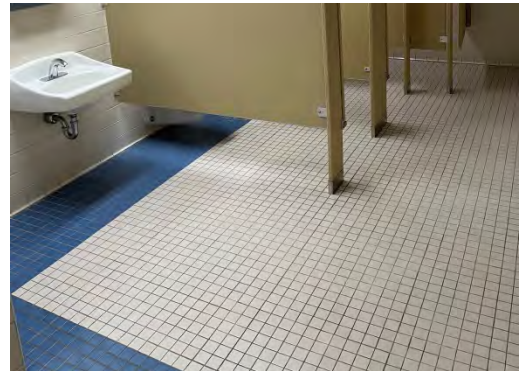
Ceramic tile in toilet rooms outdated

1. Flooring needs to be updated throughout the building and will be reviewed as part of the middle school design study.
2. Flooring may be replaced as needed through an ongoing district maintenance project.

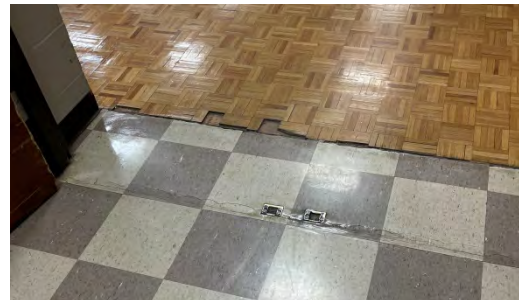
1. Overall, flooring is outdated and worn in various areas.
2. VCT flooring in the commons displays cracks along windows most likely from building settlement over time. This can also be seen in other areas of the school.
3. VCT flooring in multipurpose room does not meet the needs of programs.
4. Parquet flooring at door thresholds damaged.
5. Recently replaced carpet is in good condition.

Maple gymnasium flooring and VCT display damage and cracks at threshold

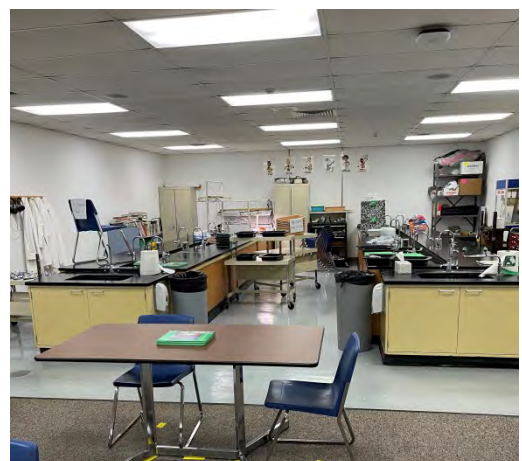
7th grade science classroom with gooseneck faucets not removed

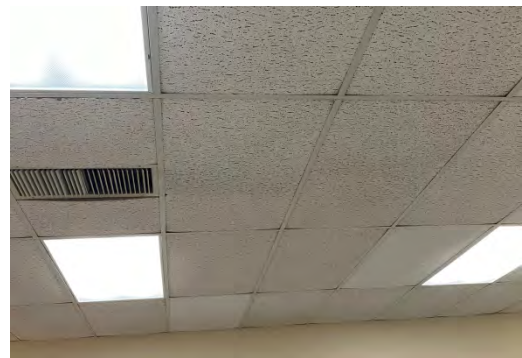
Acoustical tile sagging, typical

1. Ceiling tile and grid in the science labs are stained and corroded.
2. Ceilings in all classrooms are 2x4 and show extreme deterioration and sagging.
2. Plastic laminate casework and counter tops are outdated and worn in various areas.

1. Replace worn areas of acoustical ceiling tile and vinyl faced ceiling panels (toilet rooms).
2. Replace all 2x4 tiles with 2x2 tiles in all areas.
3. General finishes will be reviewed as part of the middle school design study.
4. The district may replace finishes as needed as part of a district maintenance project.

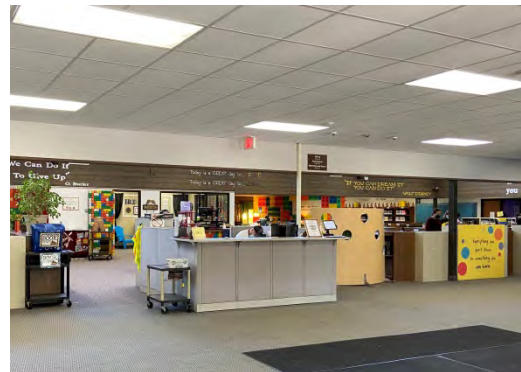
Visitor check-in located in front of LMC

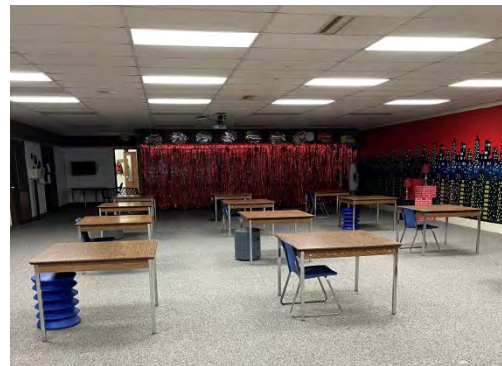
Student services and principals office adjacent to LMC student workspace which lacks privacy

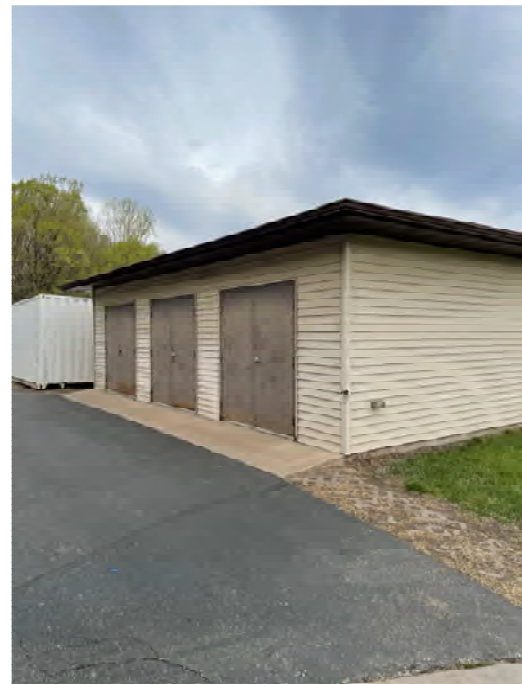
Middle school garage

1. In general, the garage structure appears to be in satisfactory condition.
2. Vinyl siding is aged with multiple damaged areas.
3. The asphalt shingles should provide several more years before it becomes necessary to replace the shingles.
4. Doors are rusted and deteriorating.

1. The hollow metal doors should be scheduled for refinishing or replaced.

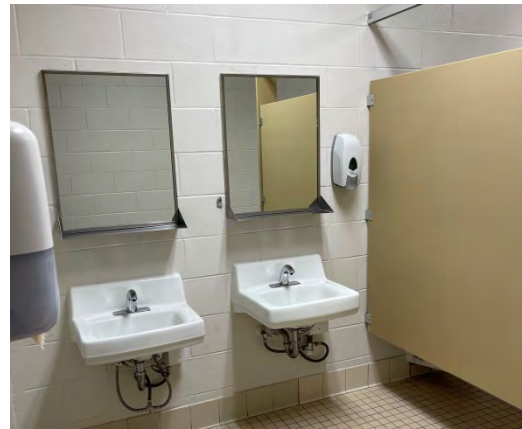
Exposed pipes at lavatories

1. In general, toilet rooms will be reviewed with the overall design study for the middle school to see where renovations are applicable.

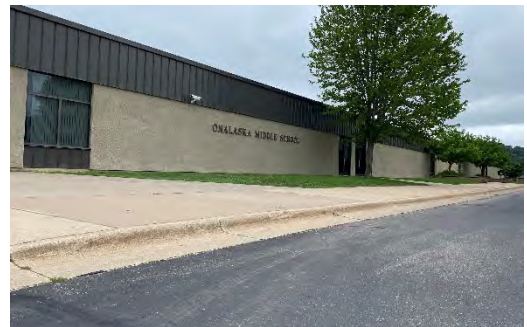
Sidewalks at OMS

1. In general, the sidewalks are in good condition.

1. Continue to monitor and note any cracked or lifted sidewalks.

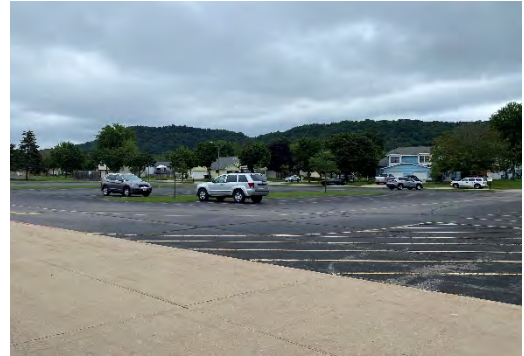
Parking at OMS

1. The asphalt paving and curb and gutter are still in good condition.

1. Continue to monitor conditions of paving and make any needed corrections.

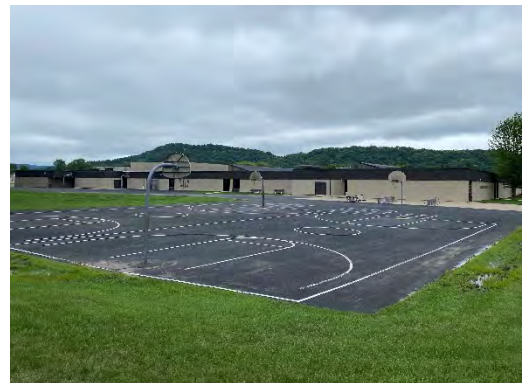
Playgrounds at OMS

1. In general, the playground paving and components are in good condition.

1. Continue to monitor conditions of paving and make any needed corrections.
2. Continue to inspect basketball hoops annually for broken or worn equipment. Repair, replace or remove equipment that is unsafe.

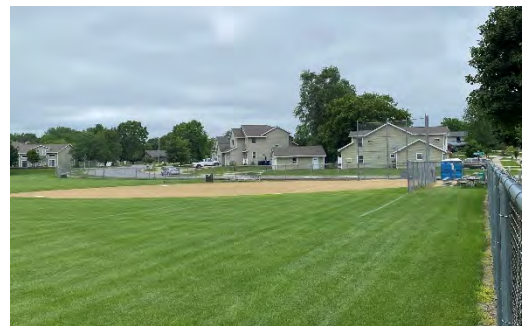
Fields at OMS

1. The ball field backstops and fencing appear to be in good condition.

1. Continue to inspect backstops and fencing and repair/replace anything broken or unsafe.

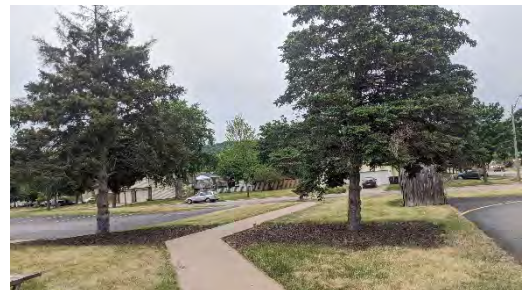
Spruce tree – map grid E8

1. Landscaping in general appears to be in good condition.
2. There is a spruce tree with multiple dead branches (map grid E8).

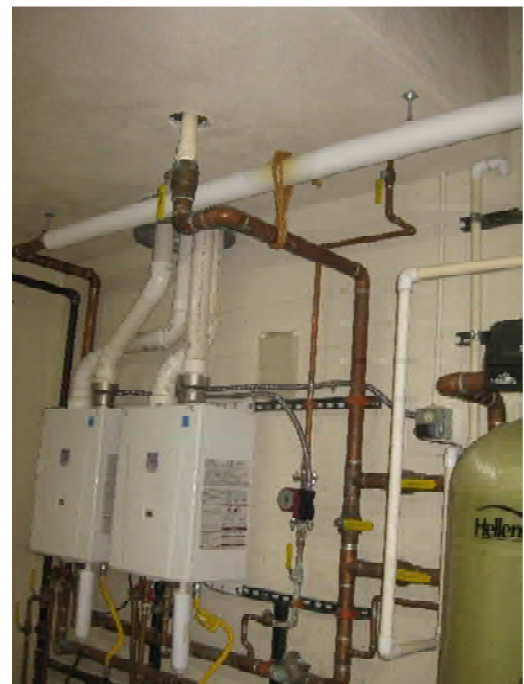
Water heaters and softener

1. Water heating equipment is gas fired instantaneous water heating equipment. Currently 2 units provide adequate hot water for building. The units are good condition and are operating well.
2. The sanitary, storm and water piping systems are functioning properly.
3. Water piping system is functioning properly, Valves will need to be replaced as system ages.
4. Water service would not be large enough for a fire protection system.
5. There is a single water softener, it is for Domestic HW only.

1. Galvanized water piping should be scheduled for replacement, original valves should also be replaced.
2. Entire building should be on softened water.
3. Other Equipment will require an annual review of condition and minor on-going maintenance as needed.

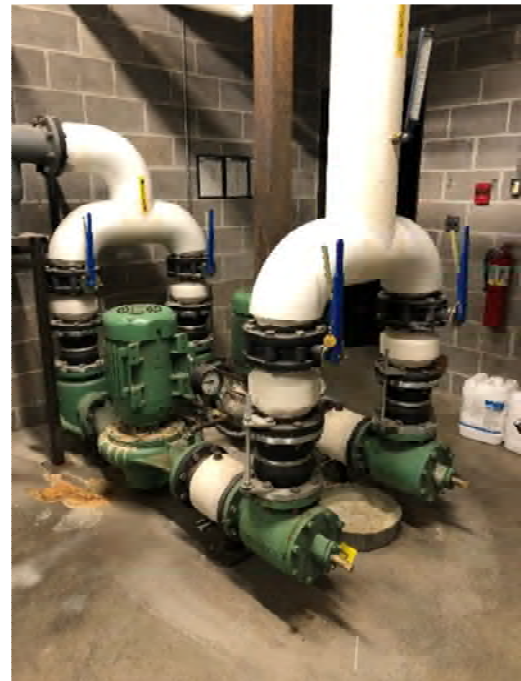
Hot water pumps

1. The boiler is in good condition and, with a proper maintenance program, should continue to serve the building for another 15-20 years.
2. The Taco hot water system pumps have experienced problems with leaking seals. The seals have been replaced previously and are leaking again.
3. The Owner reported that the gymnasium has had difficulty delivering proper airflow even after having the heating and cooling coils cleaned. Both the gym and commons areas have difficulty reaching setpoint on hot/humid days when the spaces are occupied.
4. The Owner also reported that the kitchen experiences pressure issues when the exhaust hoods are in operation. This is likely due to a lack of makeup air.
5. There have been numerous complaints of systems not maintaining proper temperatures throughout the building in both summer and winter. Air distribution and zoning appear to be a significant problem.

1. The hot water and chilled water systems serving the building are overall in good operating condition. However, the constant flow pumping systems serving the hot water and chilled water systems are inefficient from an energy standpoint. Revise the hot water system to a primary-secondary variable flow pumping system by utilizing variable frequency drives and pressure reset control sequences to optimize operation and more closely match the actual building loads. Revise the chilled water system to a variable primary flow system with a similar approach. At that time, the existing Taco hot water system pumps should be replaced.
