2021 School District of Onalaska Long Range Planning Study

PART 1 - Facilities Condition Assessment

2021 SCHOOL DISTRICT OF ONALASKA: LONG RANGE PLANNING STUDY FACILITIES CONDITION ASSESSMENT

School District of Onalaska

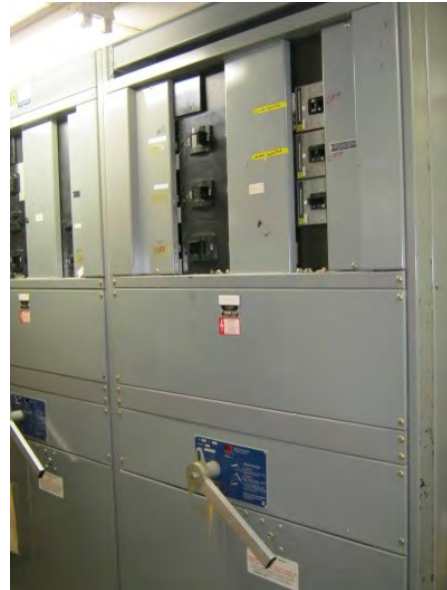
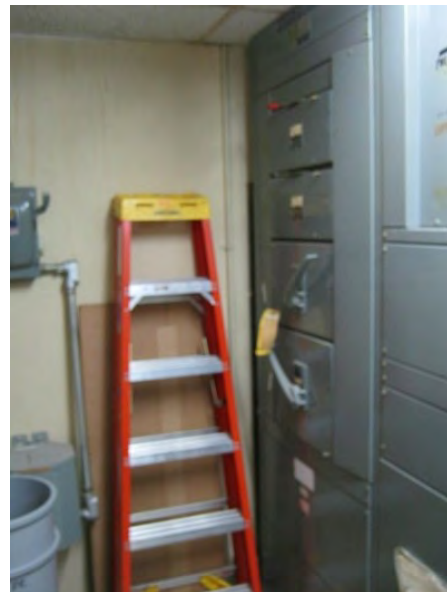
Main switchboard

1. Provide surge protection device on main service. \$4,500.

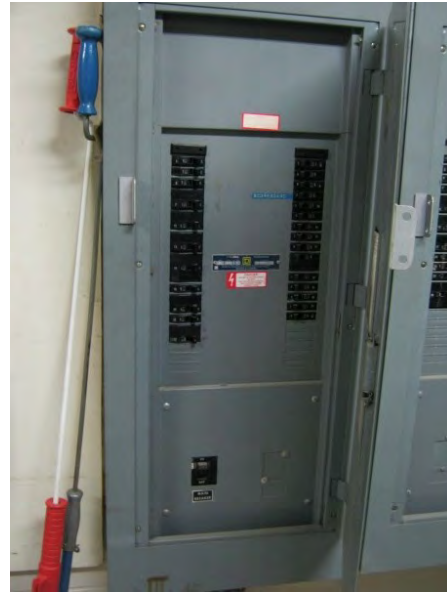
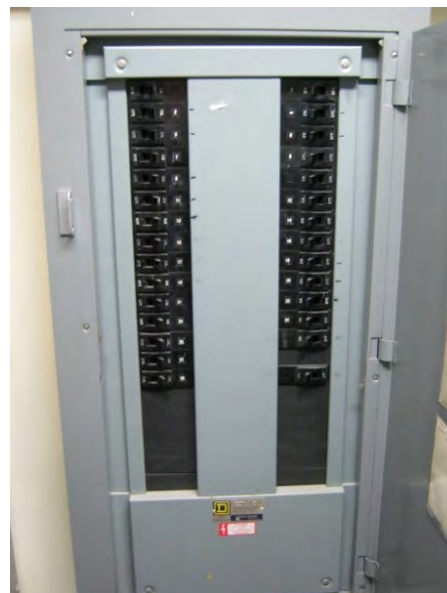
1. The expected remaining lifespan of the panelboards is about 10 - 15 more years.

Panelboard

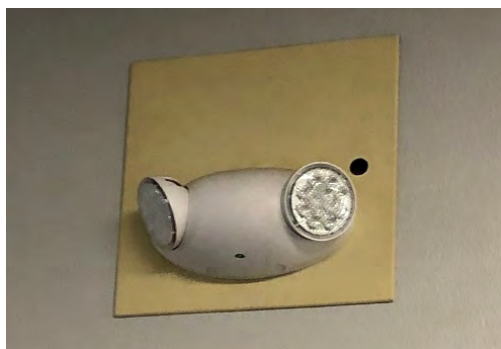
1. There is no automatic control for the parking lot lighting.
2. There is no emergency lighting in the corridors with the exception of one corridor.

Emergency lighting

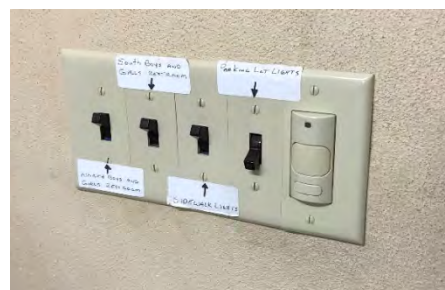
Manual exterior lighting control

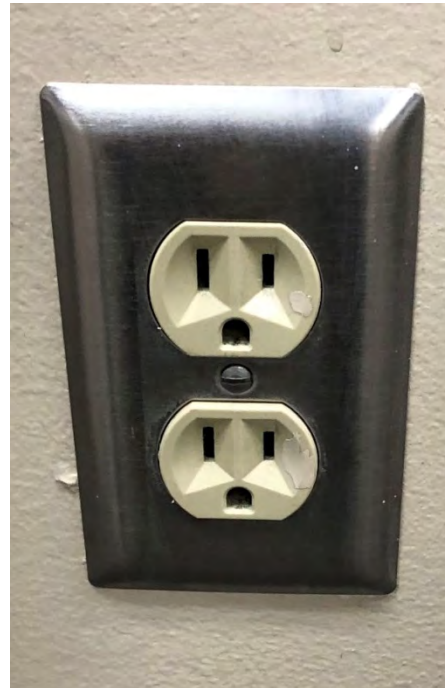
1. Switches and receptacles are in good working order.
2. Many receptacle circuits are shared between two classrooms which can lead to the circuit becoming overloaded. It was noted that especially the Science Rooms need additional branch-circuits.

15 amp. duplex receptacle

1. Replace any broken switches and receptacles. \$35 EA
2. Add additional branch-circuits and receptacles to classrooms as required. \$420 EA
3. Recommend a minimum of one branch-circuit per classroom.

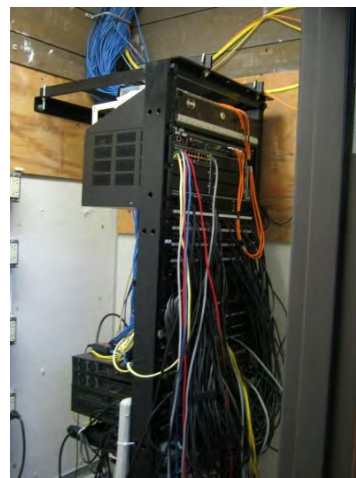
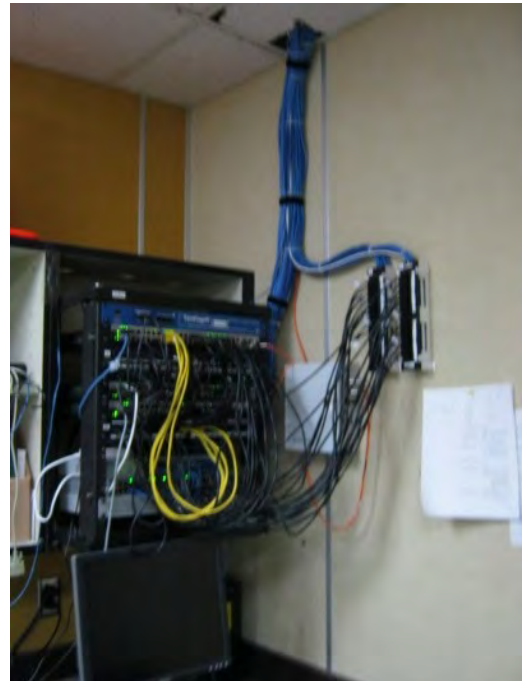
Network equipment

1. The expected remaining lifespan of the CAT6 data cabling is about 12-15 more years.
2. The expected remaining lifespan of the CAT5 data cabling is about 0-5 more years.
3. The expected remaining lifespan of the network equipment is about 7-10 more years

1. Replace the old existing CAT3 and CAT5 cable, jacks and patch panels with new CAT6 plus, add additional equipment racks, patch panels and switches. Budget \$82,000
2. Install additional Wireless Access Points as required. Budget \$1,000/Each
3. Provide Single-mode fiber optic cable between MDF closet and IDF closets. Budget \$6,000 per closet.

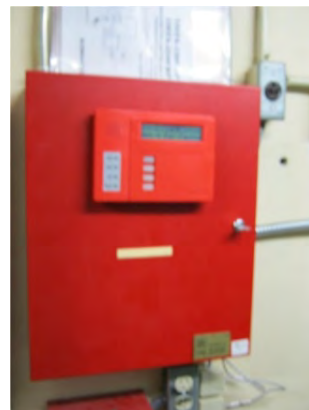
1. The expected remaining lifespan of the security system is about 2 - 5 more years.

Security system keypad/control panel

1. Upgrade system head-end equipment and devices.
2. Security system replacement cost. \$550/security device.

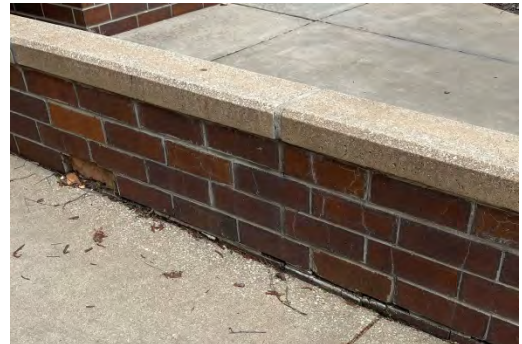
1. The exterior face brick remains in very good condition with limited areas that should be cleaned of stains.
2. Caulked exterior brick expansion joints are also in good condition with a few exceptions.
3. Brick at partial high walls near the main entrance and dumpster enclosure show areas of moisture damage and several cracks. Stone caps have shifted in place.
4. The colored precast concrete sills have weathered and faded from exposure to UV.
5. Membrane flashing at base of walls is beginning to deteriorate.
6. Lintels above doors show signs of wear.

Repairs required at low seat walls

2. Brick partial high walls should be considered for future replacement. Soft joints shall be provided at stone caps. Ongoing repairs may be considered as part of a district maintenance project in lieu of replacement.
3. The colored precast concrete sills shall be monitored for maintenance and could be cleaned from stains. Sills may be re-sealed with prefinished metal flashing as part of a district maintenance project. Priority is not high at this time.
4. Door lintels may be repainted and monitored for maintenance.

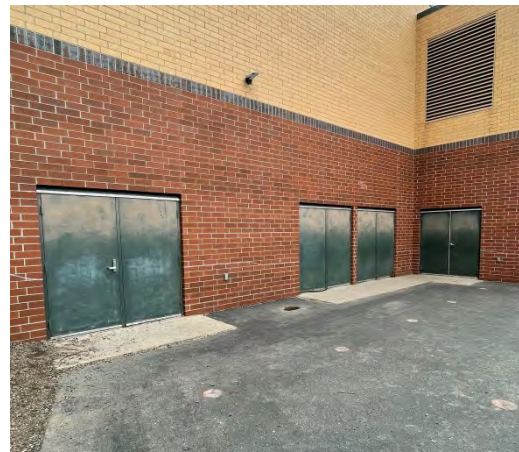
1. Aluminum entrances remain in good condition.
2. Hollow metal doors and O.H. door and jambs show signs of wear from aging and UV exposure.
3. Right hand gym doors are beginning to deteriorate at base. Door sweeps are beginning to detach from gym doors.
4. Bollards adjacent to receiving doors show wear from exposed elements.

Hollow metal doors at gym and storage

1. Future maintenance related projects should be considered to include refinishing (painting) of the exterior hollow metal doors, frames, and any steel lintels above the doors. Door sweeps shall be replaced as needed.

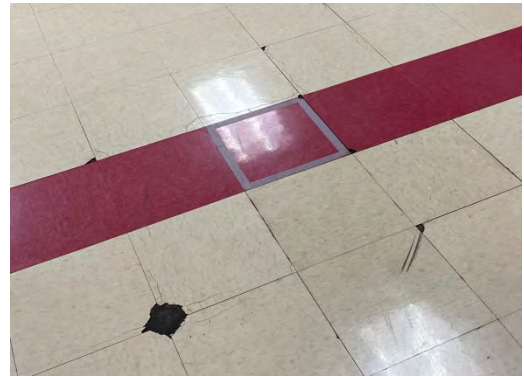
1. In general, various floorings are well maintained with some areas requiring repairs or replacement.
2. Carpet in the multipurpose room shows age and wear. Carpet has been replaced in various classrooms.
3. Resilient flooring displays wear and cracking in multiple areas within shared corridors. Cracking is typical outside toilet rooms and near brick columns.
4. There are signs of movement (floor settlement) of plumbing clean-outs in some of the corridors.

Various repairs required in resilient floors

1. Selected finishes could be slowly repaired or replaced over time based on priority level.
2. Clean outs shall be monitored over time for additional floor movement.

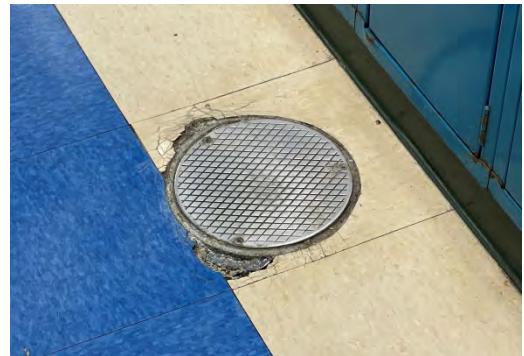
Movement of plumbing clean-outs

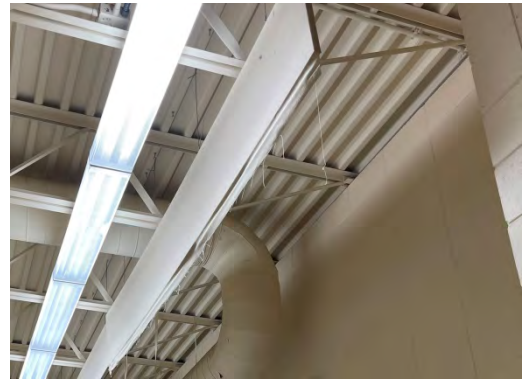
1. With the exception of the suspended ceiling in the kitchen area, all suspended ceilings appear in good condition.
2. Fabric bulletin boards are detaching from the walls in multiple areas.
3. Fabric is detaching from suspended acoustical panels in art room.

Suspended acoustical panels require repair

1. Selected finishes such as bulletin boards could be slowly replaced over time based on priority level.
2. Damaged ceiling tiles shall be replaced.
3. Ceiling T-grid in kitchen areas should be monitored for any signs of corrosion.
4. Fabric on suspended acoustical panels requires repair/reattachment.

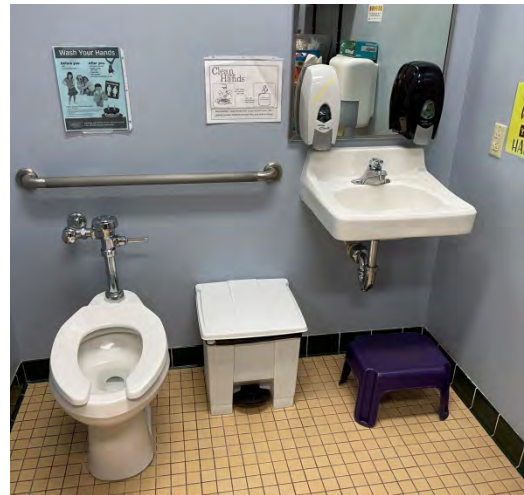
1. Toilet rooms are not completely compliant with current ADA guidelines.
2. Vertical 18" grab bar missing in ADA stall.
3. Lavatories do not have proper covers or insulation over exposed pipes.

1. Toilet rooms comply with previous ADA guidelines when building was completed. No work is recommended at this time to update toilet facilities.

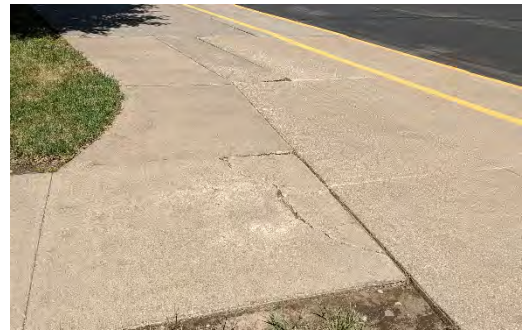
Broken sidewalk – map grid G5

1. In general, the sidewalks are in good condition.
2. Broken sidewalk (map grid G5)
3. Drainage problem at the bottom of stairs at building entrance (map grid I3)

1. Replace broken sidewalk (map grid G5)
2. Pave area at the bottom of the stairs to help with the drainage issues (map grid I3)
3. Continue to monitor and repair any cracked or lifted sidewalks.

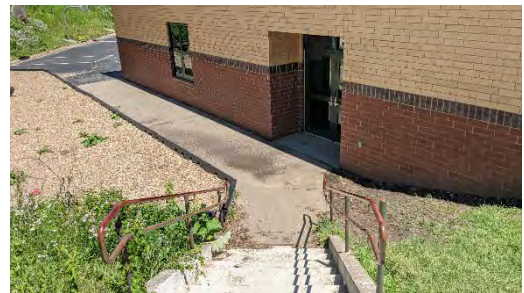
Drainage problem – map grid I3

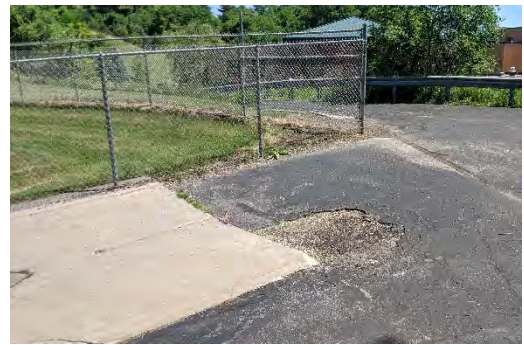
1. ADA signage installation has not been completed (map grid F-G6).
2. Pavement failure (map grid J3)
3. Standing water in pavement (map grid J3)
4. Erosion is occurring to the east of the driveway entering the upper paved play area (map grid J3-4)
5. Post and fence have been removed, but foundation remains (map grid J3)
6. Concrete area designed for bike parking is being used for vehicular parking and the concrete has been damaged (map grid E3)
7. Broken curb section (map grid C4)

Pavement failure – map grid J3

1. Complete the ADA signage installation (map grid F-G6)
2. Replace pavement (map grid J3)
3. Add a drain to correct the area of standing water (map grid J3)

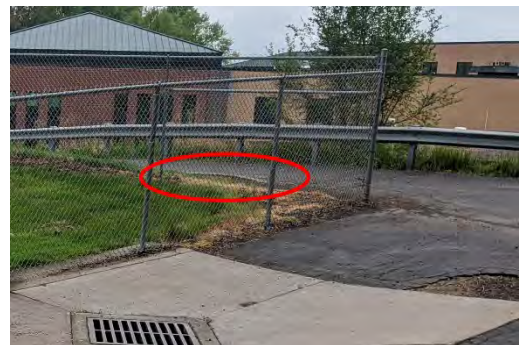
Standing water – map grid J3

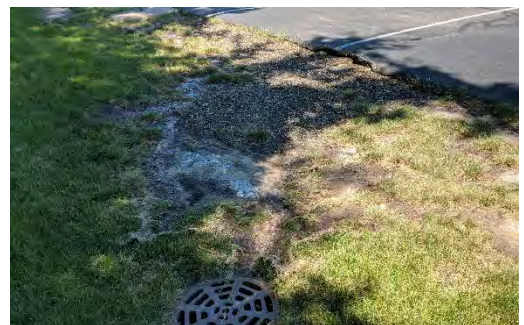
Erosion at upper play area – map grid J3-4

4. Add a paved gutter and paved apron to address the erosion problems (map grid J3-4)
5. Replace post and fence or remove the foundation (map grid J3)
6. Replace the damaged 4" concrete and replace with 6" concrete on gravel base (map grid E3)
7. Replace broken curb section (C4)
8. Continue to monitor conditions of paving and make any needed corrections.

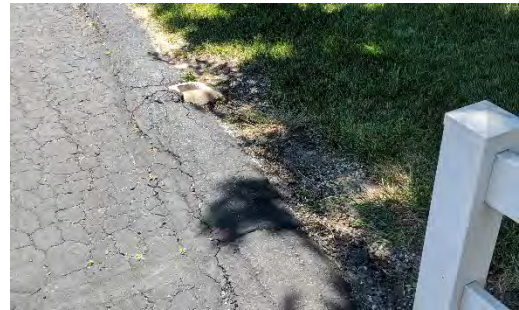
Fence post foundation – map grid J3

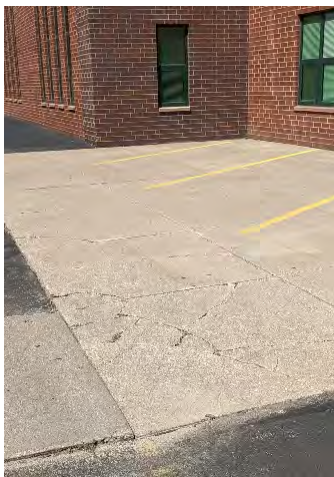
Concrete pavement failure – map grid E3

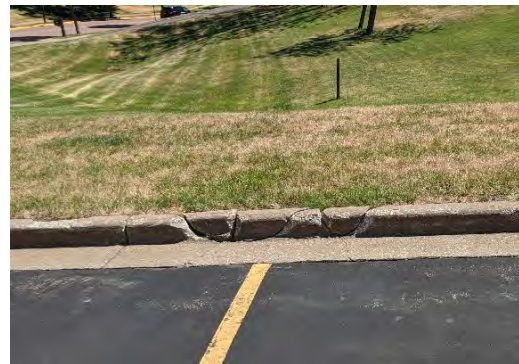
Broken curb – map grid C4

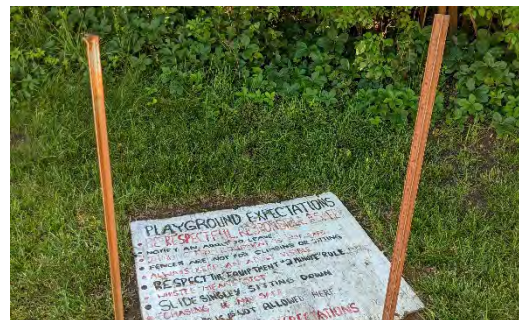
1. Damaged playground sign (map grid I2)
2. Broken post cap and damaged gate (map grid F2)
3. Missing post cap (map grid E2)

Damaged sign – map grid I2

1. Remove or replace playground sign (map grid I2)
2. Repair/replace post cap and gate (map grid F2)
3. Replace missing post cap (map grid E2)
4. Continue to inspect playground components for broken and worn equipment. Repair, replace or remove equipment that is unsafe.

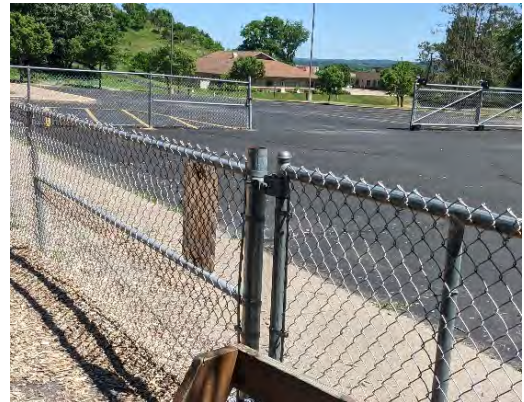
Missing post cap – map grid E2

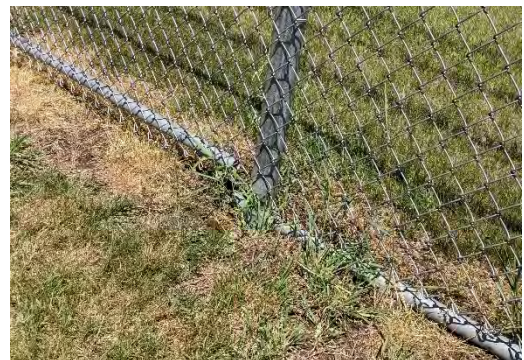
1. Backstop bracket not attached (map grid L7)
2. See “Paving” section for erosion concerns at south end of field.

Backstop bracket – map grid L7

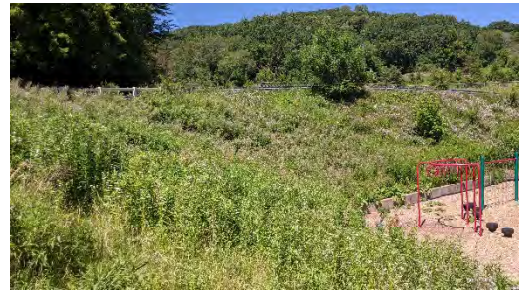
1. Dying Ash tree at trail (map grid F9)
2. Tree walk sign posts in general are rotting off (map grid F7)
3. Volunteer Black Walnut and Black Locust trees (map grid F7)
4. Volunteer Elm, Walnut, and Boxelder at paved trail switchback, and west and east of bench (G7).
5. Volunteer Black Locust trees (map grid F7 and E7).
6. Debris has accumulated at end of paved trail bench area and is causing an erosion issue (map grid E7)
7. Branches of River Birch are impacting the building (map grid G5)
8. Trees are growing in the prairie (map grid I4-6 and J4-6)
9. Numerous Thistle (map grid I3)
10. Trees growing on steep slopes (map grid E-F1)

Thistle and trees in prairie – map grid I3-6 and J4-6

1. Remove dying Ash tree (map grid F9)
2. Replace tree walk sign posts (map grid F7).
3. Remove Black Walnut and Black Locust trees (map grid F7)
4. Remove volunteer Elm, Walnut and Boxelder trees (map grid G7)
5. Remove volunteer Black Locust trees (map grid F7 and E7).
6. Clear debris from under the benches at the end of the paved trail bench area so drainage can go to the west instead of the northwest. Drainage should follow along the east side of the trail and go south of the bench area (map grid E7)
7. Trim River Birch branches away from building (map grid G5).
8. Remove all trees from prairie slope *except* Maple near the gate for the driveway (map grid I4-6 and J4-6)

9. Kill Thistle and replant with native vegetation (map grid I3)
10. Remove trees from steep slopes (map grid E-F1).
11. Replace shade tree. Recommend Hackberry or Cutleaf Silver Maple (map grid F4)

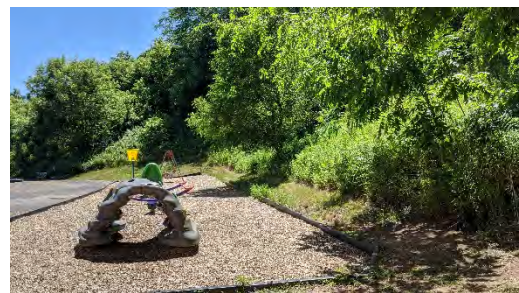
Trees growing on steep slopes – map grid E-F1

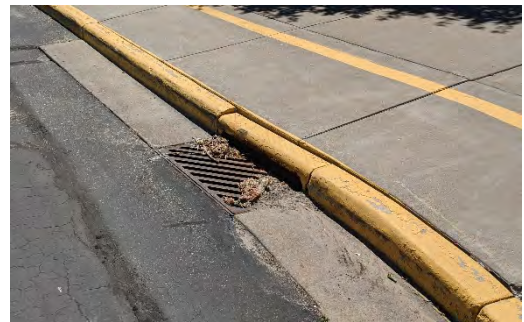
Reset curb inlet – map grid G5

1. Reset curb inlet (map grid G5).
2. Fill to ensure drainage goes to the inlet (map grid I3).
3. Keep debris cleared from the inlet (map grid G2).

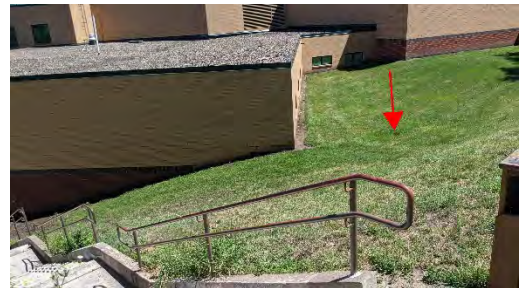
Drainage not going to inlet – map grid I3

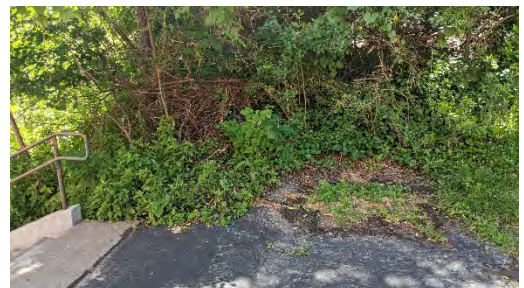
Debris in inlet – map grid G2

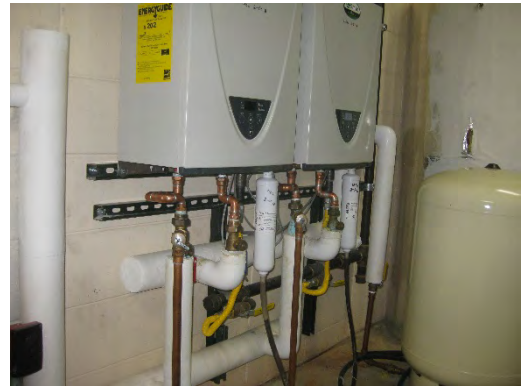
1. Water heating equipment is gas fired instantaneous water heating equipment. Currently 2 units provide adequate hot water for building. The units are good condition and are operating well.
2. The Sanitary, storm and water piping systems are functioning properly.
3. Water piping system is functioning properly. Valves will need to be replaced as they age.

Water heaters

1. Instantaneous water heating equipment is required to be maintained for scale build up on a regular basis.
2. Other Equipment will require an annual review of condition and minor ongoing maintenance as needed.

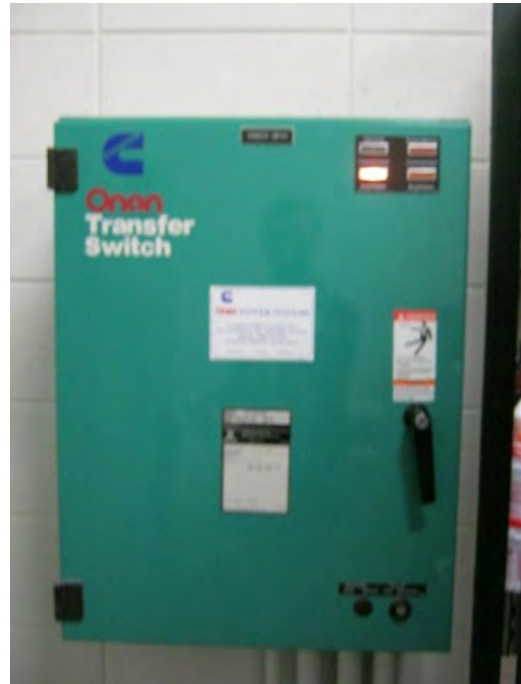
1. The generator and transfer switch need repair or replacement.

Transfer switch

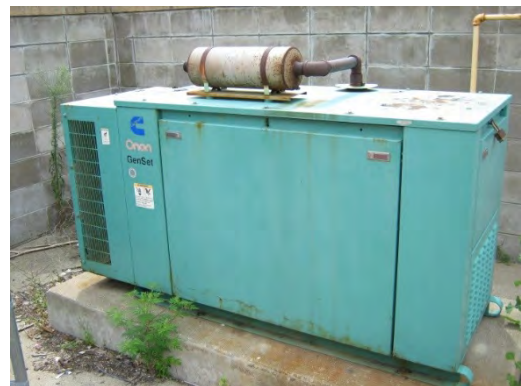
Emergency generator

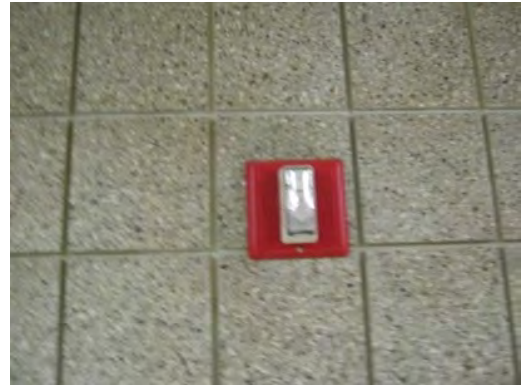
Fire alarm notification device

1. Consider upgrading to an audio evacuation fire alarm system.
2. Audio Evac Fire Alarm Systems are now the normal design practice for any size school.
3. This building is not sprinklered.
4. The Onalaska School District has made strides and have developed a new standard for fire alarm systems, for example the Northern Hills Elementary School has an audio evacuation fire alarm system. Recommend continuing on this path for all schools in the district.
5. Budget estimate to upgrade to audio evacuation system installation - \$93,500.

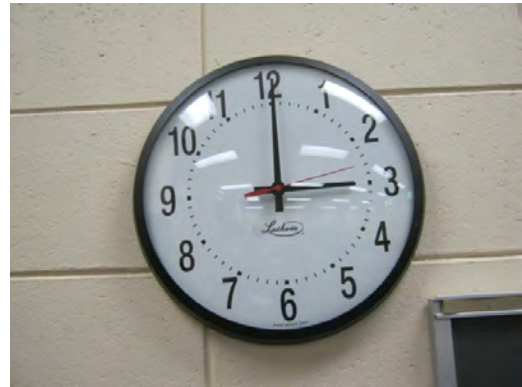
Lathem analog clock

1. Replace the entire master clock system with new low voltage hard-wired Point-Over-Ether (POE) system or with line-voltage AC powered synchronized wireless system.
2. Budget \$22,000.

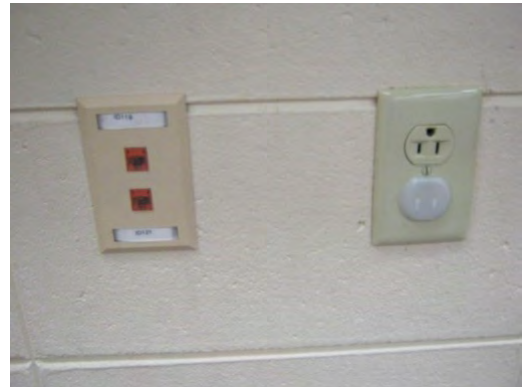
Data jacks

1. Replace the old existing CAT5e cable with new CAT6-plus cable. \$165/data jack

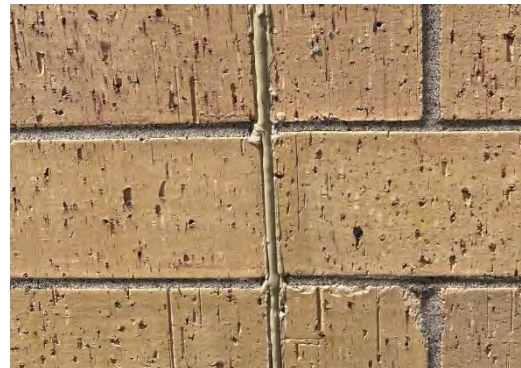
1. The exterior face brick remains in good condition. Brick mortar joints show minimal signs of any significant deterioration. Expansion joint sealants are in good condition.
2. Expansion joints at the south wall of the gym display signs of brick expansion.
3. Lintels above windows are in good condition overall. Slight movement can be seen on the building west side.

Brick expansion at gym south wall

1. Control joints that display brick expansion should be monitored on an annual basis to ensure they maintain a waterproof joint.

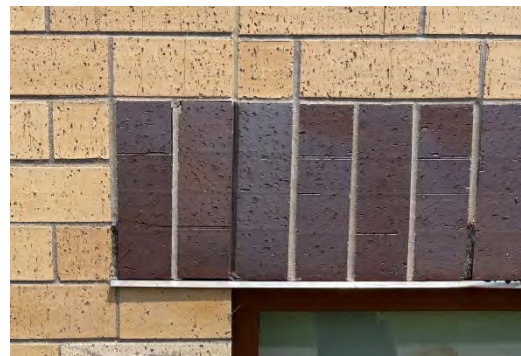
Slight movement at window lintel on left

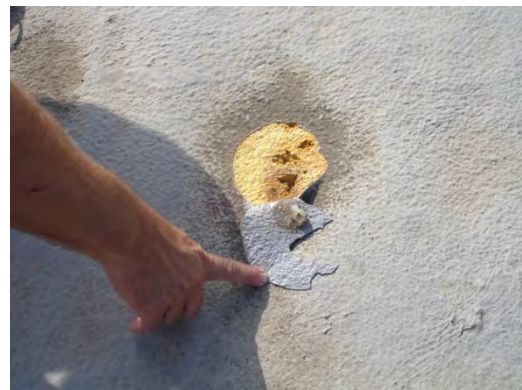
1. In general, the ballasted roof areas appear to be in satisfactory condition. Perimeter of the rubber membrane roofs will likely continue pulling away from any parapet or raised roof curbs from ongoing shrinkage.
2. The foam roofs above the 1966 classroom/gymnasium wing will continue to require frequent inspections for holes thru the foam that will contribute to leakage into the interior. The foamed roof surface is irregular and allows water to pond before finding its way to the roof drains and scuppers. Damage from birds is often the source of creating holes in the foam which can expand over time. This roof was recoated in 2013.
3. Sheet metal fascia appears in satisfactory condition. The original fascia at the 1966 south end addition appears worn and deteriorating.

Example of holes created in foam causing deterioration

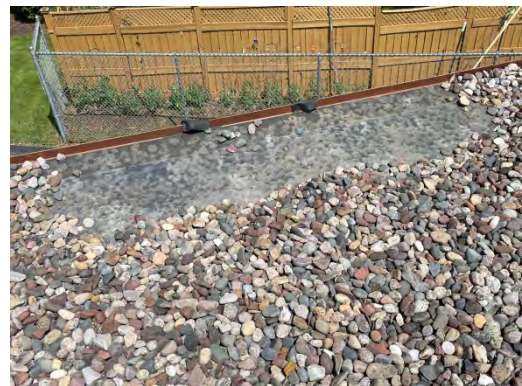
Roof membrane/coping repair in progress

1. For purposes of extending the lifespan of the ballasted single ply rubber membrane roof, it is recommended that the perimeters be cut out and re-flashed with reinforced perimeter strip as needed. Membrane seams should also be reviewed/stripped on a scheduled annual basis. The maintenance work should extend the life of the ballasted roofing indefinitely.
2. The urethane foam roofs can continue to be re-coated and repaired indefinitely with the understanding that frequent inspections and repairs will likely be necessary. Total tear-off and replacement with a single-ply membrane (EPDM or PVC) remains an option when conditions justify the cost of maintaining versus total replacement.

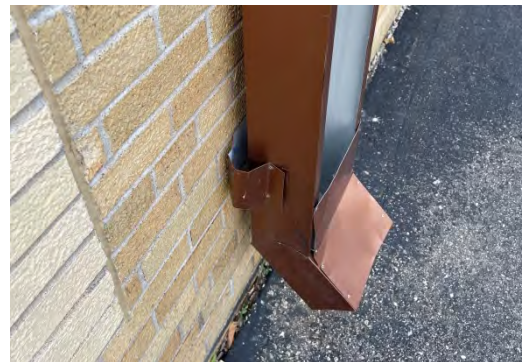
1. Multiple downspouts at the playground display signs of damage.
2. Wood soffits at the playground dumpster refuge area display signs of damage.
3. Wood soffits on the building west side show signs of moisture damage.

Damaged downspout at playground

1. Downspouts and wood soffit repairs may be part of an ongoing district maintenance project based on priority level.
2. Moisture damage at wood soffits should be monitored and repaired as needed.

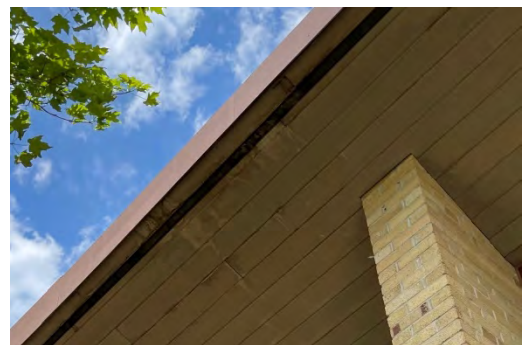
Moisture damage at wood soffit

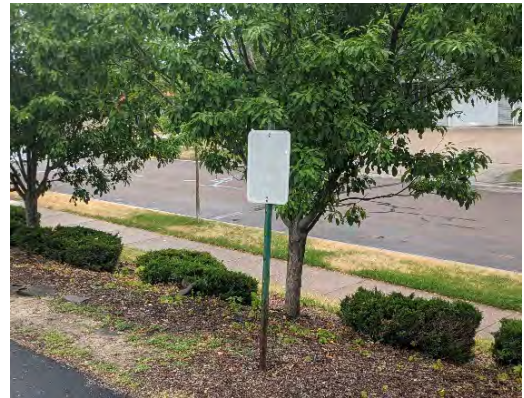
Replace sign – map grid H5

1. Replace sign with legible one (map grid H5)
2. Continue to monitor conditions of paving and make any needed corrections.

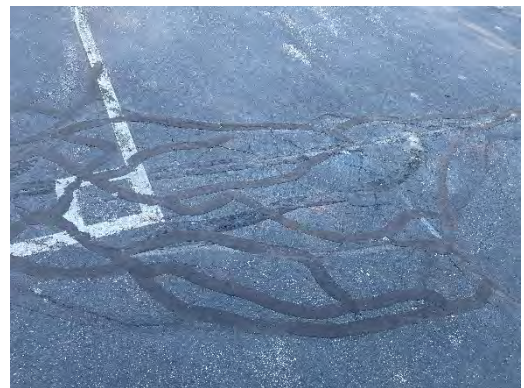
Areas of pavement failure (map grid D-E5 and D3)

1. Asphalt is showing some signs of small area failure, but still serviceable (map grid D-E5 and D3)
2. Playground edging is broken (map grid D5)
3. Play structure's stairs and landing areas have cracked/peeling coating and metal beneath is rusting (map grid C5)
4. Concrete fish paint is peeling (D4)

1. Consider repaving entire play area in the 10 year plan (map grid D-E5 and D3).
2. Replace broken playground edging (map grid D5).
3. Consult with playground manufacturer for repairs or replacement of landing and stair areas (map grid C5).
4. Consult with professional painting company for proper surface preparation, and base/surface coat of paint for concrete fish (map grid D4).

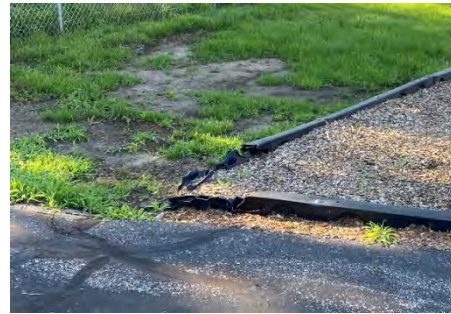
Broken playground edging (map grid D5)

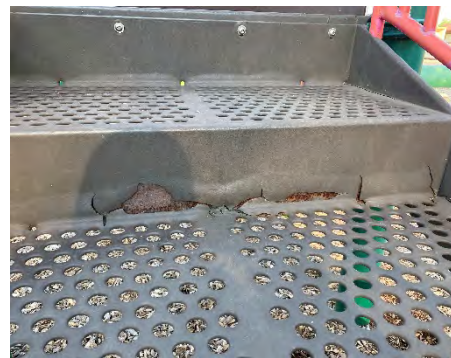
Play structure surfacing (map grid C5)

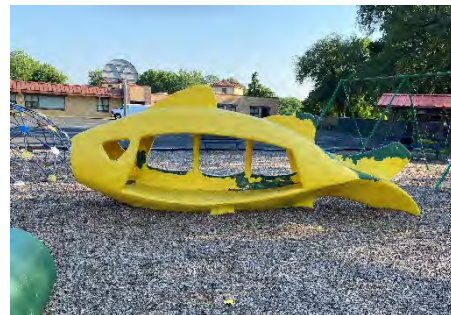
Peeling paint (map grid D4)

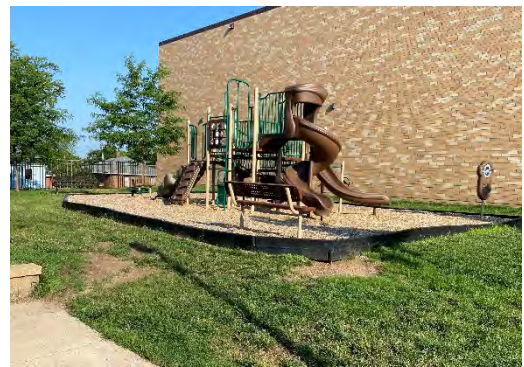
Bare areas of turf – map grid B3

1. There are bare areas of the lawn in the pre-K/K play area (map grid B3).
2. There are some large dead branches in the Siberian Elm (map grid B5)
3. Dead branches in the spruce trees (map grid F6)
4. Trees growing in the fragrant sumac (map grid G6)

1. Reseed bare areas of lawn in the pre-K/K play area (map grid B3).
2. Prune the dead branches from the Siberian Elm (map grid B5).
3. Prune the dead branches from the spruce trees (map grid F6)
4. Remove trees growing in the fragrant sumac (map grid G6)

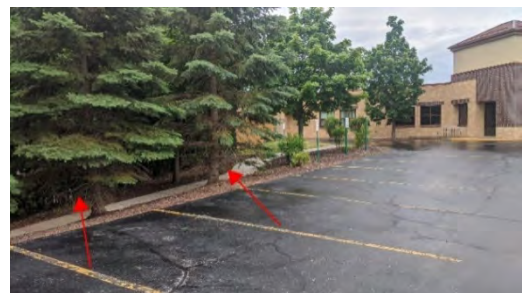
Dead branches in spruce (map grid F6)

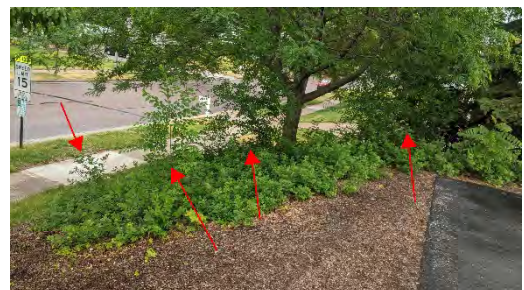
Trees growing in fragrant sumac (map grid G6)

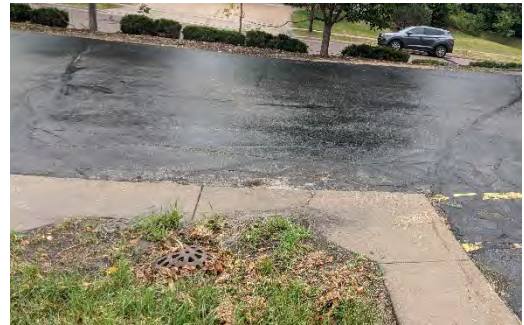
1. Most utility structures that could be observed appeared to be in good working order.
2. Inlet appears to be plugging and there are signs of erosion across the driveway (map grid G5)
3. Inlet apron partially cracked and damaged (map grid D3).

Plugged inlet – map grid G5

1. Replace inlet frame and grate with Neenah model R-2560 or equal to keep from plugging (map grid G5).
2. Replace concrete inlet (map grid D3).

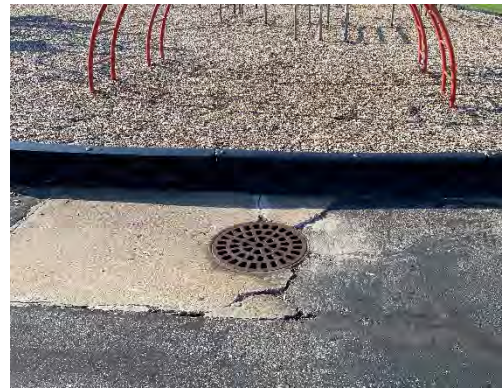
Damaged apron – map grid D3

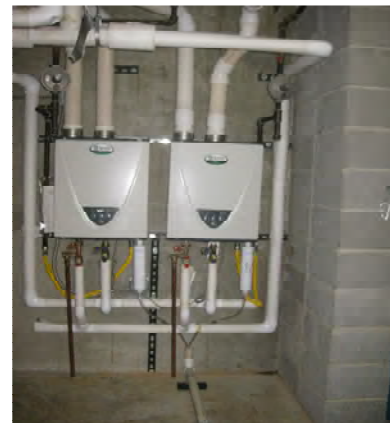
Water heaters

1. Water heating equipment is gas fired instantaneous water heating equipment. Currently 2 units provide adequate hot water for building. The units are good condition and are operating well.
2. The sanitary, storm and water piping systems are functioning properly.
3. Water piping system is functioning properly, Valves will need to be replaced as system ages.

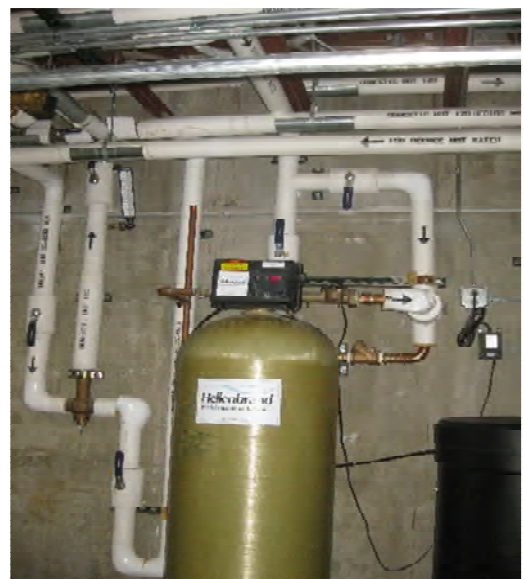
2. The building is served by a single Hillenbrand water softener in the 2014 addition. The water softener is softening domestic HW only.
3. Plumbing fixtures are in good operational condition. WCs are wall hung flush valve are a mix of sensor operated and manual, URs are floor mount with sensor and manual flush valves, Lavs have manual faucets.

Water softener

1. Install a Duplex water softening system at the domestic water service to soften water to the entire building.
2. Other Equipment will require an annual review of condition and minor ongoing maintenance as needed.

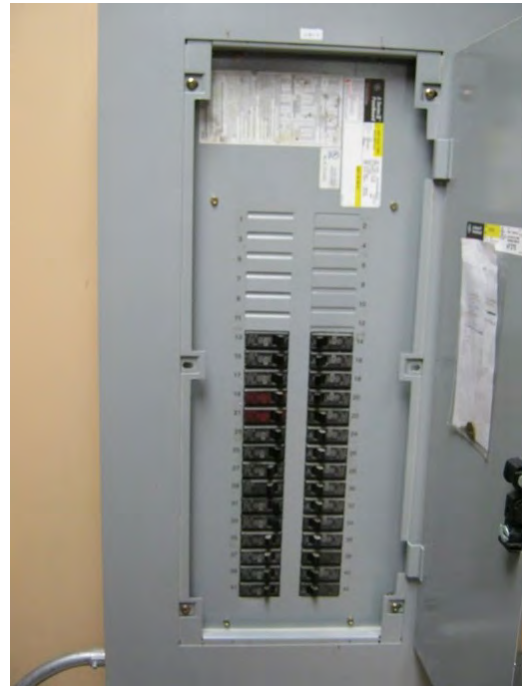
1. The expected remaining lifespan of the 1960 panelboards is less than 0-5 more years.
2. The expected remaining lifespan of the 2006 panelboards is about 25 - 30 more years.

Panelboard

1. Replace the 1960 panelboards and feeder with new. New circuit breakers will allow for a safer and more expandable installation.
\$8,000 EA

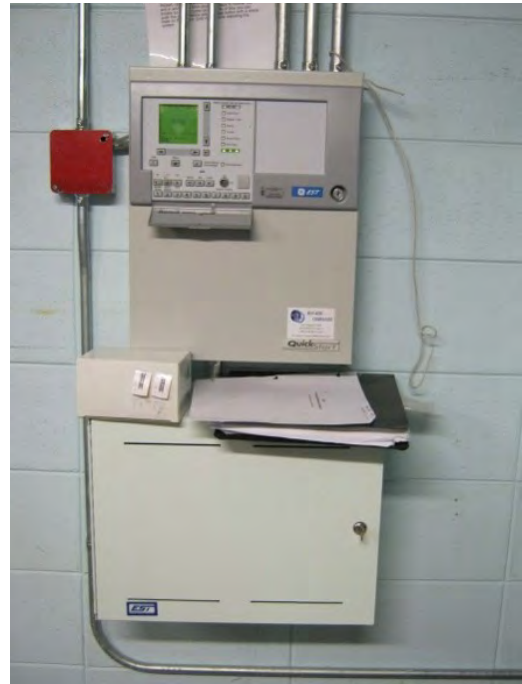
1. The expected remaining lifespan of the fire alarm system is about 10 - 12 more years. However, it has been reported that replacement parts for the system are difficult to obtain.

Fire alarm control panel

1. Consider upgrading to an audio evacuation fire alarm system:
2. Audio Evac Fire Alarm Systems are now the normal design practice for any size school.
3. This building is not sprinklered.
4. The Onalaska School District has made strides and have developed a new standard for fire alarm systems, for example the Northern Hills Elementary
5. School has an audio evacuation fire alarm system. Recommend continuing on this path for all schools in the district.
6. Budget estimate to upgrade to audio evacuation system installation - \$93,500.

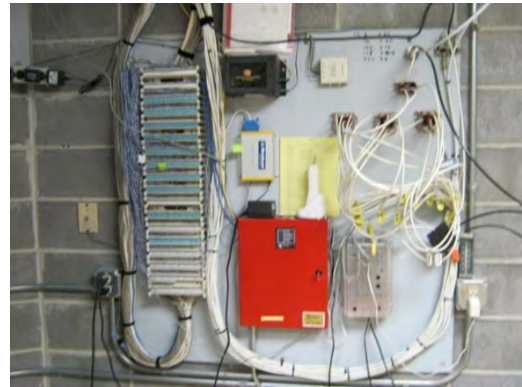
Phone system wiring

1. There is a recently installed Mitel 3300 IP (Internet Protocol) phone system. This system was installed in 2015 – 2016. New IP phones have been installed through-out the school.
2. The phone cabling is CAT3 and is routed back to wall mounted voice wiring blocks. The voice wiring blocks are located in the main IT room.

1. Remove all CAT 3 wiring and replace with new CAT 6 Plus. Budget \$35,000.

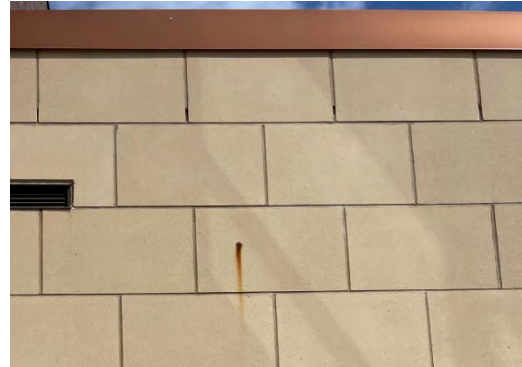
1. Overall, exterior face brick, stone and metal panels are in good condition with limited areas requiring monitoring or repair.
2. Various areas at manufacture stone veneer display rust spots. It is likely there are mixed metals within the stone causing rust to occur.
3. Slight movement in manufactured stone has occurred on the south end of the building.
4. Multiple areas display damage to building masonry.
5. Mortar is missing in a couple locations such as the SE corner beyond the commons and adjacent to entry 'C' under the classroom windows.
6. Masonry columns at mechanical enclosure show signs of moisture damage.
7. Lintel at south stair is not painted.

Rust spots occurring in various areas

1. Rusted areas in stone should be continuously monitored and assessed for patch and repair. Ongoing repairs may be considered as part of a district maintenance project.
2. Shifting of stone shall be monitored.
3. Mortar should be added in areas where missing.
4. Stone caps at mechanical enclosure should be properly sealed to prevent continuous moisture damage in columns.

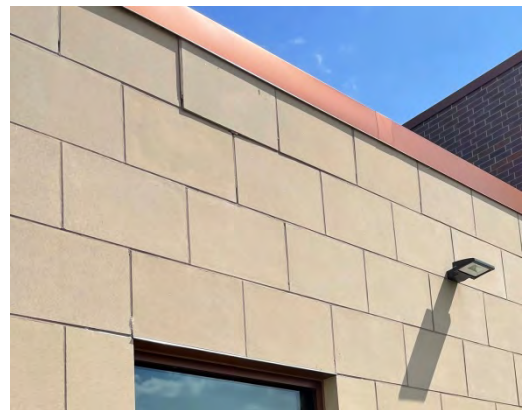
Movement of stone below parapet; south end of building outside office

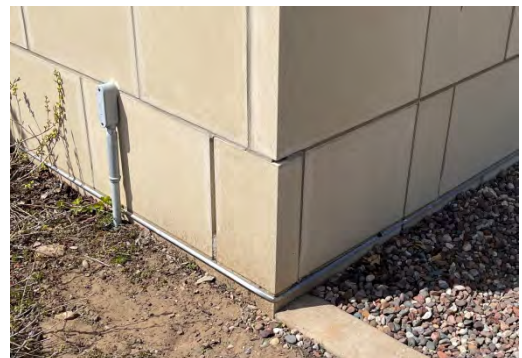
Mortar missing from manufactured stone

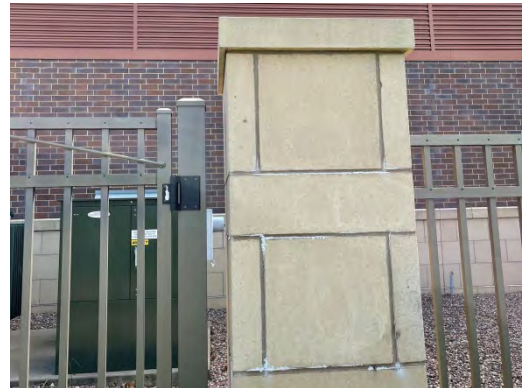
Moisture damage at mechanical enclosure

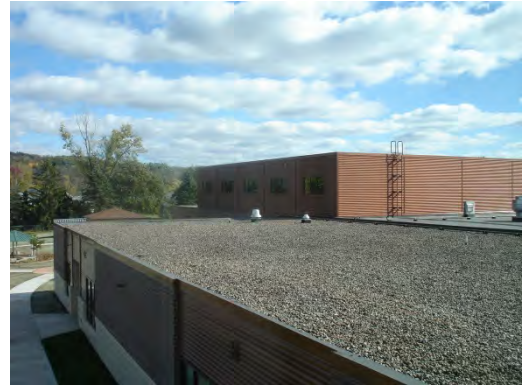
Ballasted roof at 1071 and 1991 building

1. The 2003 roof sections have outlasted the warranty however the roof appear in satisfactory condition
2. The 2014 sections appear in good condition.

1. Monitor roof conditions on an annual basis and repair as needed. It is expected that although the warranty has expired on portions of the roof the life expectancy can be extended.

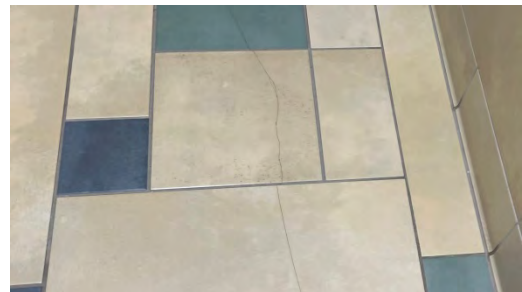
1. In general, various floorings are well maintained throughout the building with few areas to be monitored.
2. Multiple tiled areas in toilet rooms display cracks in floor likely due to concrete floor shrinkage.
3. Metal base trim adjacent to kitchen cooler/freezer is damaged at the corner.

Toilet tile floor cracking

1. Tile floor should be monitored. No recommendations at this time.
2. Metal trim should be repaired.

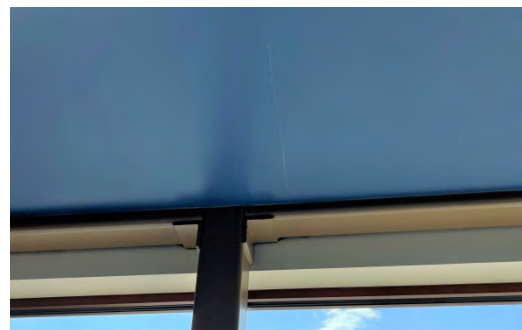
Upper atrium bulkhead

1. Walls remain in satisfactory condition overall with limited areas to be monitored.
2. Upper atrium shows cracks in drywall joints due to movement in the building. A few other areas in classrooms/spaces display similar conditions.

1. Drywall cracks should be monitored. If increasing shrinkage occurs, joints may be replaced with expansion joints.

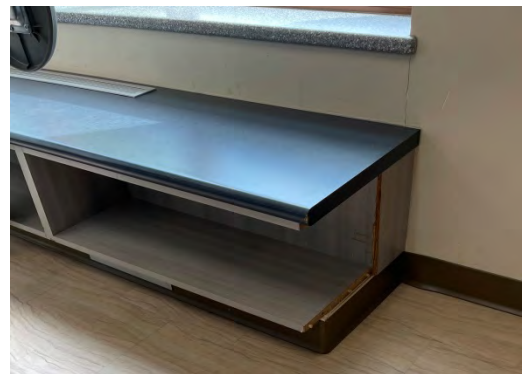
1. Cafeteria bench is missing end panel.

1. End panel needs to be replaced at bench.
2. No other recommendations at this time

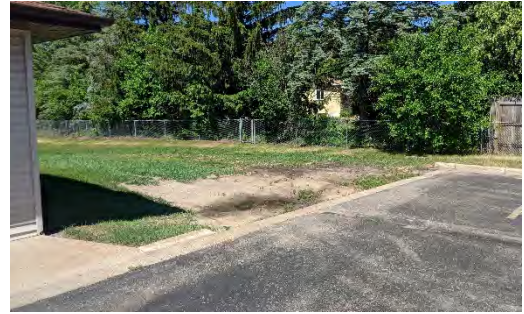
Area of dead lawn – map grid D6

1. The asphalt paving and curb and gutter are still in good condition.
2. There is an area of dead lawn (map grid D6) that appears to be where the snow from the parking lot is stored.

1. Consider installing an apron in the snow storage area with a drain connected to the storm sewer (approx. 100' of storm sewer).
2. Continue to monitor conditions of paving and make any needed corrections.

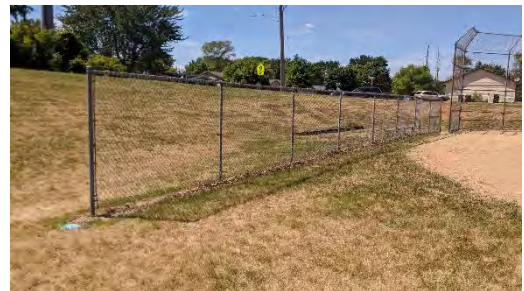
1. The softball field backstop and fencing have some broken or missing components.

Missing end brace rail – map grid G2

1. Repair/replace missing end brace rail on fence (map grid G2).
2. Repair backstop bottom rail (map grid H2).
3. Repair bottom fence fabric (map grid H3).

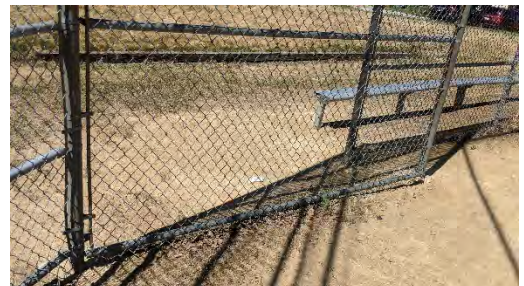
Repair backstop bottom rail – map grid H2

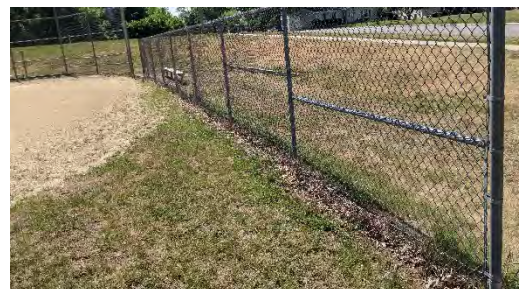
Repair fence fabric – map grid H3

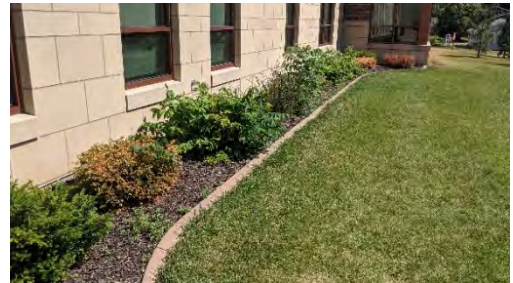
1. Landscaping that was installed as part of the construction project has had minimal maintenance. Pruning and removal/replacement of dead plants should be addressed.

Replace dead shrubs – map grid B2

1. Replace dead shrubs (map grid B2)
2. Remove Walnut trees from the landscape bed(s) (map grid B3).
3. Prune Ginkgo tree in front of transformer fenced area. No branch lower than 7'. Cut off stubs of old branches (map grid D4).

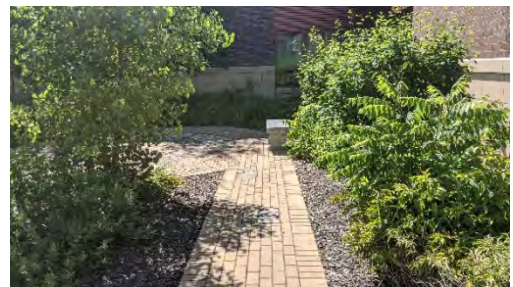
Remove Walnut trees – map grid B3

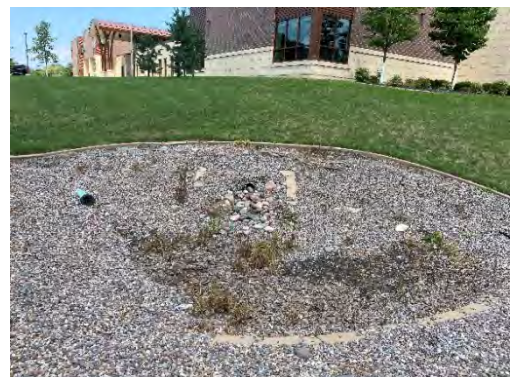
Biofilter – map grid A1

2. The biofilter by the sign was originally not constructed correctly and has continued to degrade (map grid A1).
3. The drainage swale that directs the stormwater from the south parking area to the biofilter tends to hold water and grass is difficult to establish (map grid A4).

1. Rebuild biofilter.
2. Install 36" concrete gutter in drainage swale area to improve drainage and ease maintenance.

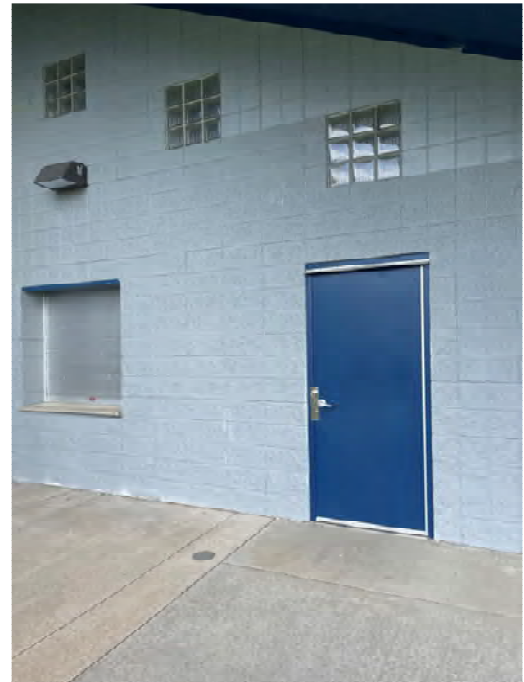
1. Overhead coiling counter doors have minimal damage.
2. Rain drip edge is coming off at storage double doors.

Hollow metal doors and O.H. coiling doors

1. Continue use of overhead coiling counter doors but consider installation of protective steel grilles to reduce the potential ongoing damage.
2. Rain drip needs to be reattached.

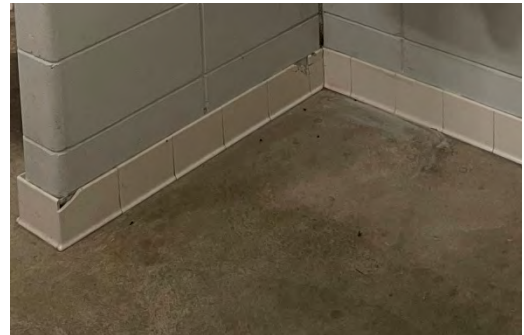
Tile base chipped in various areas

1. Floor could be re-sealed but does not require immediate attention.
2. No other recommendations at this time.

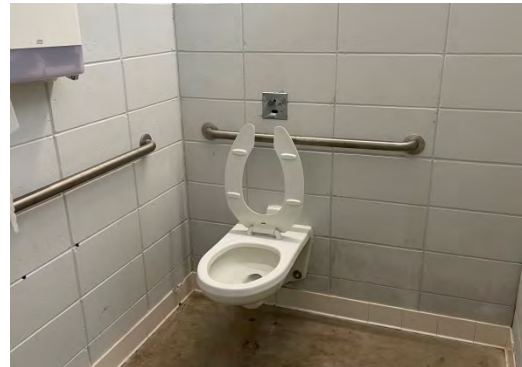
1. Toilet rooms are not completely compliant with current ADA guidelines.
2. Vertical 18" grab bar missing in ADA stall.

ADA toilet stall

1. Toilet rooms comply with previous ADA guidelines when building was completed. No work is recommended at this time to update toilet facilities.

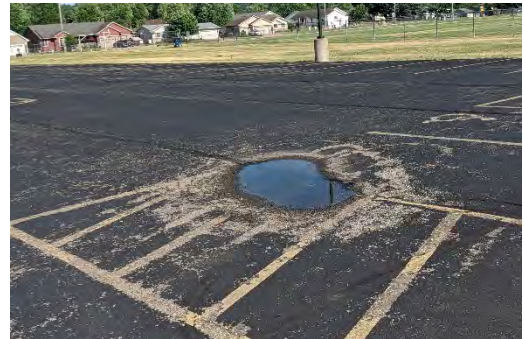
1. There are two low areas in the paving. (map grid I11)
2. ADA parking requires signage (map grid I10)

Low spot in paving – map grid I11

1. Cut out and replace base/paving in the two low areas (map grid I11).
2. Install ADA signage (map grid I10)

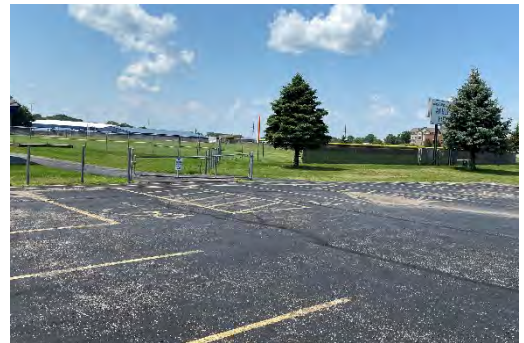
No ADA signage – map grid I10

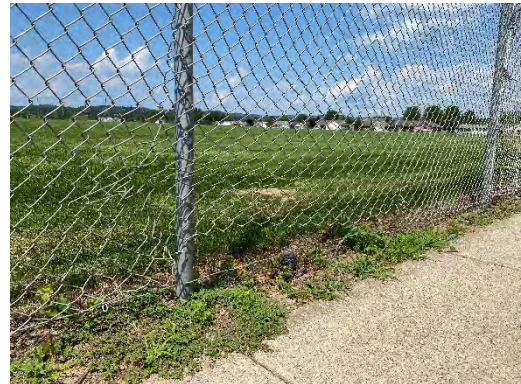
Example of damaged fence

1. There are quite a few areas along both Riders Club Rd. and East Ave. N. where the fence needs to be repaired and wire ties are missing from posts (map grid D6-12 and D-H14)
2. There are end caps missing from end posts and most of the gates (map grid D6, E14, H14, H12, H11, H9, H8)
3. Eastern baseball field – the back (west) side of the 3rd base dugout wall is in need of repair (map grid J6)

1. Repair fence and replace wire ties that are missing from posts map grid (D6-12 and D-H14)
2. Replace missing end caps (map grid map grid D6, E14, H14, H12, H11, H9, H8)
3. Repair dugout wall (map grid J6)
