2021 School District of Onalaska Long Range Planning Study

PART 1 - Facilities Condition Assessment

2021 SCHOOL DISTRICT OF ONALASKA: LONG RANGE PLANNING STUDY FACILITIES CONDITION ASSESSMENT

School District of Onalaska

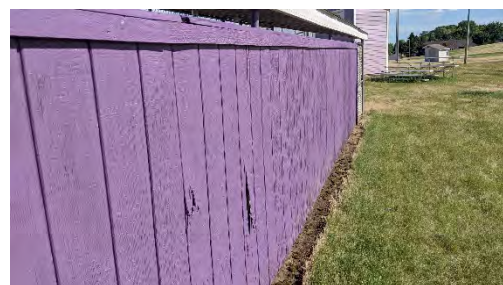
1. There are quite a few areas along both Riders Club Rd. and East Ave. N. where the fence needs to be repaired and wire ties are missing from posts (map grid D6-12 and D-H14)
2. There are end caps missing from end posts and most of the gates (map grid D6, E14, H14, H12, H11, H9, H8)
3. Eastern baseball field – the back (west) side of the 3rd base dugout wall is in need of repair (map grid J6)

Dugout wall – map grid J6

1. Repair fence and replace wire ties that are missing from posts map grid (D6-12 and D-H14)
2. Replace missing end caps (map grid map grid D6, E14, H14, H12, H11, H9, H8)
3. Repair dugout wall (map grid J6)

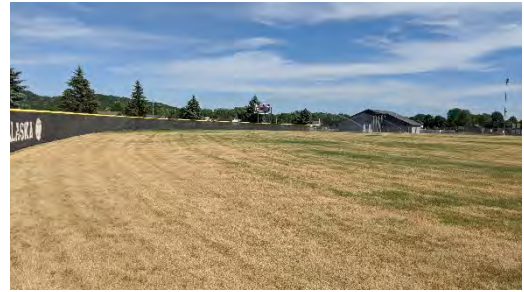
1. There are several locations where there are broken valve box covers (map grid H12 and G12)
2. There are multiple areas where it appears the irrigation system is not working correctly (map grid H13, D12, and L9)
3. Light pole is missing light fixture (map grid H6)

Irrigation system problems

1. Replace broken valve box covers (map grid H12 and G12).
2. Check the irrigation system in the above noted areas. Verify heads are popping up. Repair or readjust areas (map grid H13, D12, and L9).
3. Replace fixture on light pole (map grid H6).

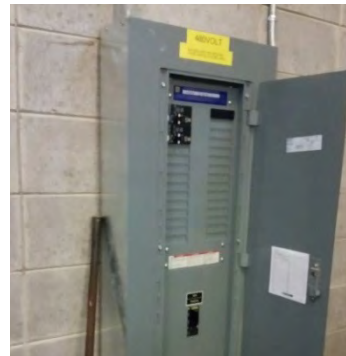
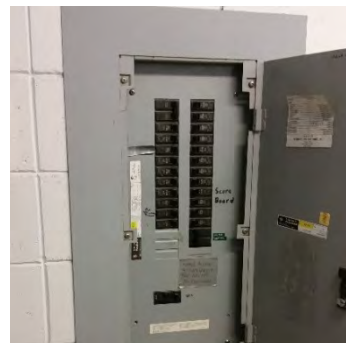
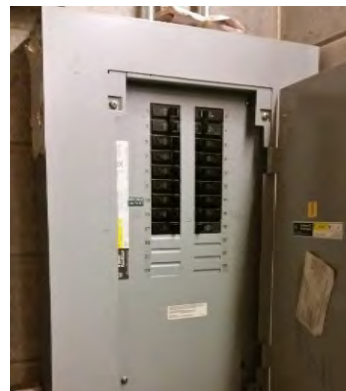
1. The panelboards are in good operating condition.

Panelboard

1. None

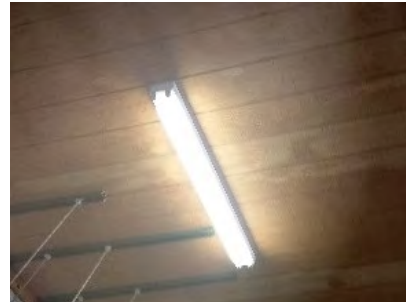
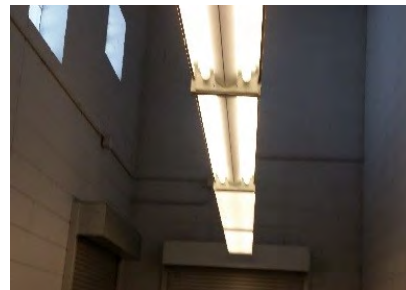
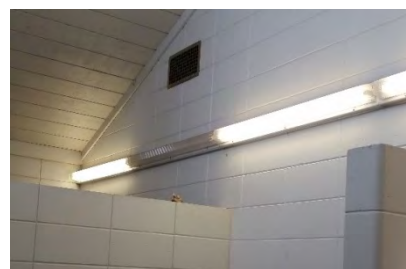
1. The exterior lighting fixtures are LED and are in excellent working condition.
2. The interior lighting fixtures are fluorescent and installed with the original building construction.
3. There are occupancy sensors in the Restrooms.

Storage room

Concession area

Toilet room

1. Replace interior fluorescent lighting fixtures with new energy efficient LED lighting fixtures. Budget - \$7,000.

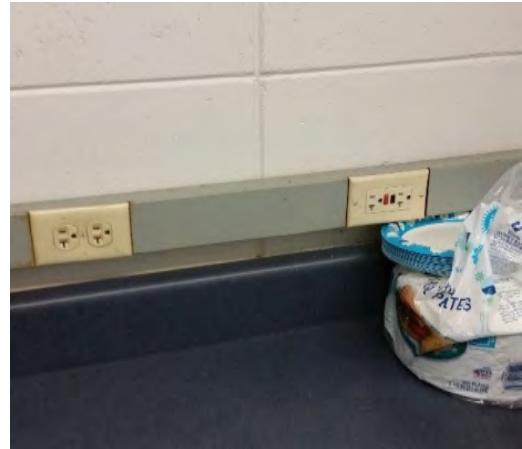
1. The receptacles and toggle switches are adequate and in good working condition.
2. The Concession Area has G.F.C.I. protection.

Outlets

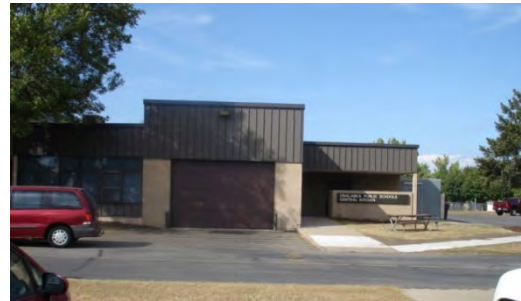
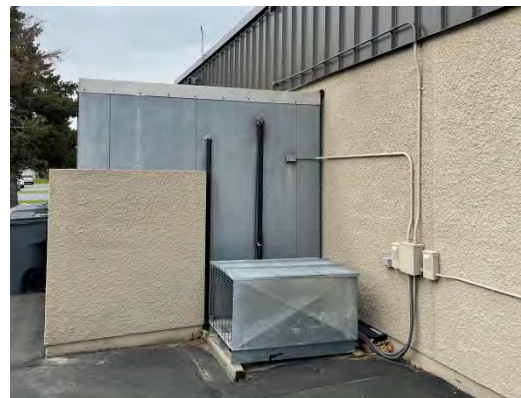
1. In general, the exterior cladding (stucco and metal panels) is in satisfactory condition.

Building exterior

Textured stucco exterior walls

1. None at this time

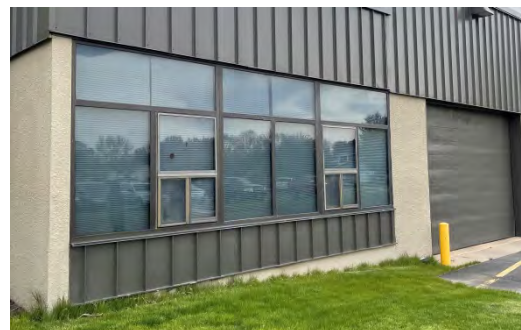
1. The windows in the kitchen consist of a thermally broken aluminum storefront framing with 1 inch insulated glass.

Aluminum storefront framing

1. Windows are in need of replacement.

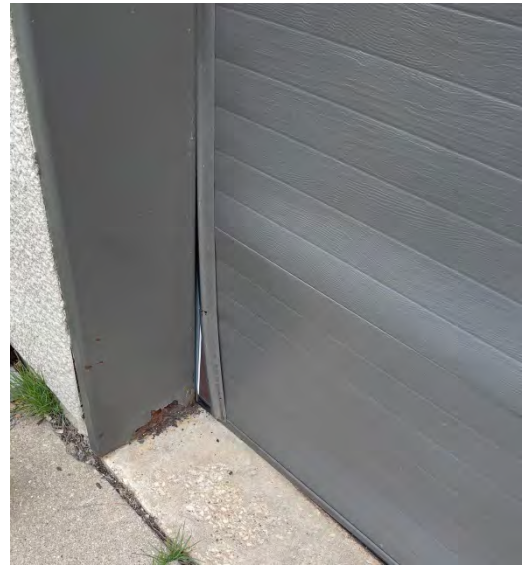
1. With the exception of the main entrance door, all other hollow metal doors and frames are in satisfactory condition.
2. The south O.H door is showing some signs of corrosion and typical wear.

Kitchen O.H. Door

1. O.H. door needs repainting and new weather stripping; provide galvanized metal jambs.
2. Rain drip above side double doors needs to be replaced.

CK-0019	7/12/21	O.H. Door Maintenance Replace rain drip on storage double doors	Maintenance	Repaint O.H. door, install new weather stripping, provide new galvanized metal jambs, and replace rain drips	\$2,200		2
---------	---------	-----------------------------------------------------------------------	-------------	--------------------------------------------------------------------------------------------------------------------	---------	--	---

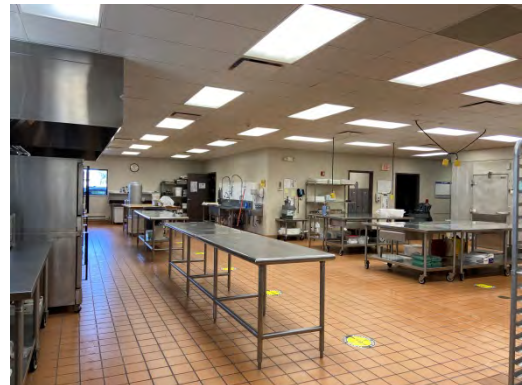
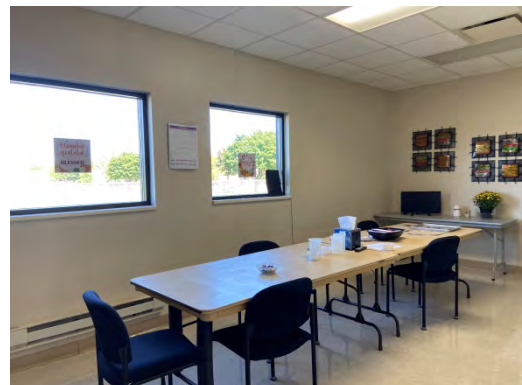
1. Flooring appears to be well maintained with no apparent immediate need to replace or upgrade.

Main food prep area

Break room

1. None at this time

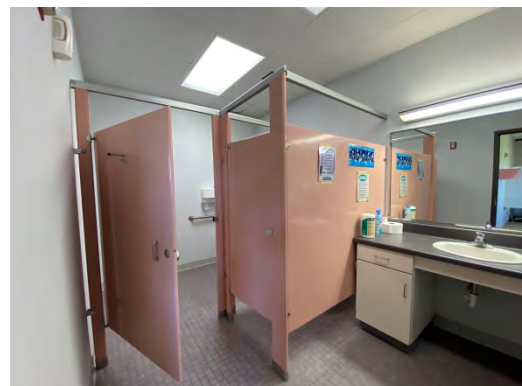
1. The majority of the rooms have suspended acoustical tile. The prep kitchen area has a suspended 2' x 4' vinyl-face gypsum panel. Break room and offices have standard acoustical tile. The main storage room along the east side of the building has no suspended acoustical tile ceiling.
2. Toilet partitions in the women's toilet room are metal.

Women's toilet room

1. Ceiling tile and grid appear to be in satisfactory condition.
2. Metal toilet stall partitions show typical signs of years of usage.

1. Monitor T-grid in food prep areas for any signs of corrosion.
2. Partitions can continue to be used but can be changed out to solid plastic as part of any toilet room remodeling project.

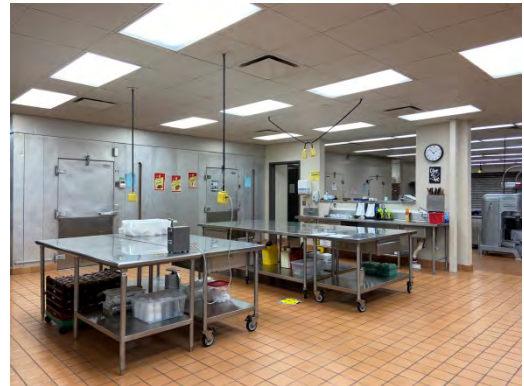
Main food prep area

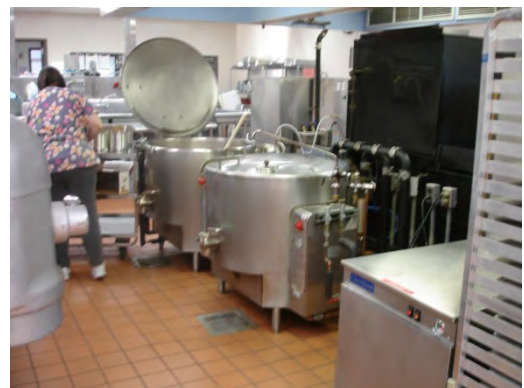
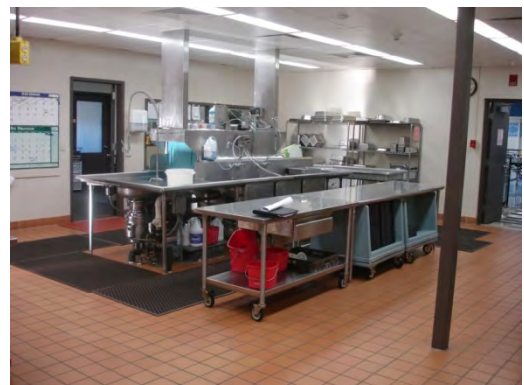
1. Overall, kitchen equipment is aging.
2. Other old equipment that will need to be considered for replacement includes the 5-door steamer, two ovens, 2-burner stove, mixer and bread slicer.
3. Dishwasher and grease interceptor were recently replaced in 2014.
4. Cooler and freezer functions well.

Steam equipment

Hobart dishwasher

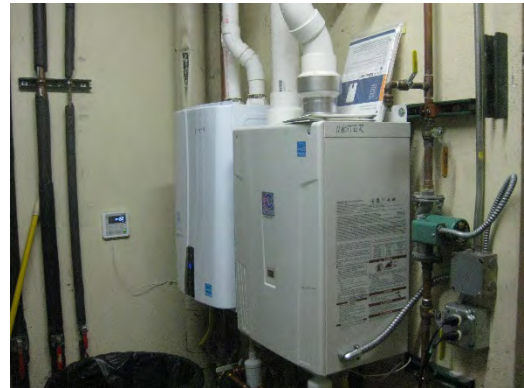
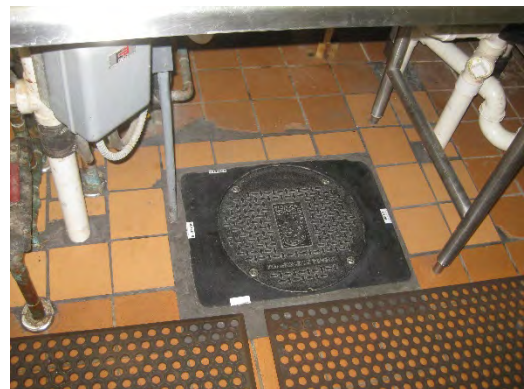
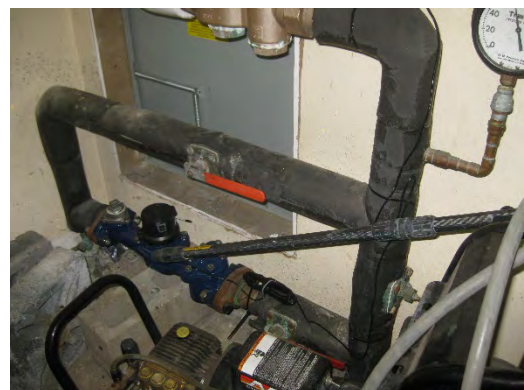
1. Water heating equipment is gas fired instantaneous water heating equipment. 2 units provide adequate hot water for building. The units are good condition and are operating well.
2. The building is served by a small single Diamond water softener. The water softener is softening domestic HW and CW.
3. Water service is 2" K copper with a 2" meter.
4. Water piping is fed underground to the fixtures.
5. Water piping is copper.
6. This building has its own gas meter.
7. Gas is fed to the Cook line from underground.
8. Plumbing fixtures are in good operational condition.
9. There is a small in-ground grease interceptor. I do not think there is a grease interceptor for the large dishwasher.
10. There is a mix of PVC and Cast Iron drain and vent piping.

1. The Sanitary, storm and water piping systems are functioning properly.
2. Water piping system is functioning properly. Valves will need to be replaced as they age.
3. CI drain/vent piping in kitchen has a shortened usable lifetime due to kitchen wastes, it it typically 10-15 yrs.

Water heaters

Grease interceptor

Water meter

1. Instantaneous water heating equipment is required to be maintained for scale build up on a regular basis.
2. Other Equipment will require an annual review of condition and minor ongoing maintenance as needed.
3. Gas piping underground in a building is not a good idea, it should be installed above ground.
4. Current code requires the large DW to flow thru a grease interceptor.
5. There does not appear to be an emergency shut-off for the gas to the equipment under the Hood.

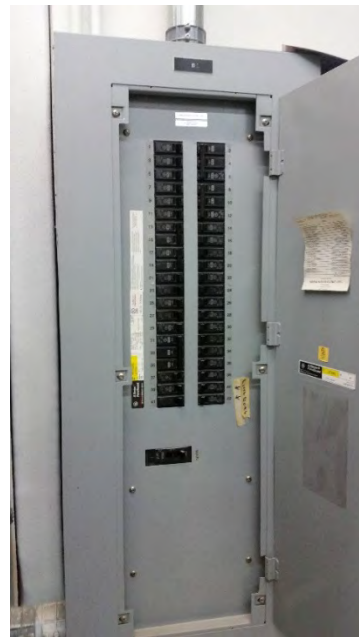
1. The expected remaining lifespan of the panelboards is about 20-30 more years.

Panelboard

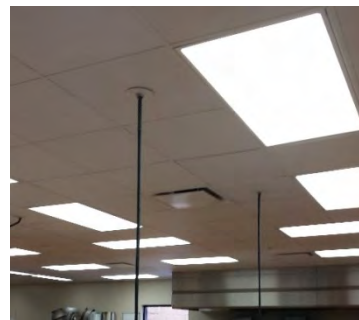
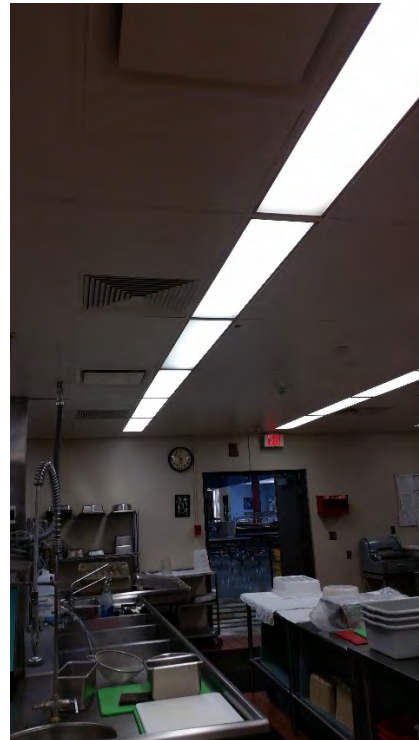
1. The kitchen has a combination of 2x4 acrylic lens 2-lamp fluorescent fixtures and 1x4 acrylic lens 2-lamp fluorescent fixtures. The lamps are T8 with a color temperature of 5000K. The ballasts are electronic. The light fixtures are on 8' centers in a variety of patterns.
2. The offices have 2x4 fluorescent fixtures. The lamps are T8 with a color temperature of 5000K. The ballasts are electronic.

2x4 light fixtures

1. The expected remaining lifespan of the interior light fixtures is about 10-15 more years.

1x4 light fixtures

1. Replace existing interior fluorescent lighting fixtures with LED upon failure or during future remodel projects. \$200 for each fixture.
2. Replace all existing interior fluorescent lighting fixtures with LED and install new programmable digital computer network lighting controls to meet current energy codes and industry standards. Budget – \$30,000

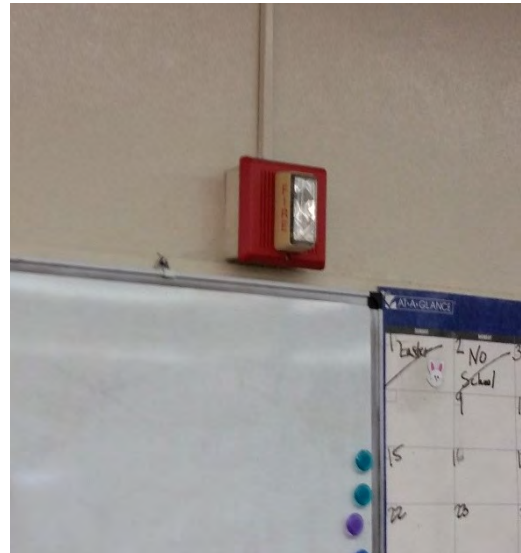
1. The majority of the system has reached its expected life expectancy and should be replaced with new.

Fire alarm

1. Consider upgrading to an audio evacuation fire alarm system:
 - a. Audio Evac Fire Alarm Systems are now the normal design practice for any size school.
 - b. This building is not sprinklered.
 - c. The Onalaska School District has made strides and have developed a new standard for fire alarm systems, for example the Northern Hills Elementary
 - d. School has an audio evacuation fire alarm system. Recommend to continue on this path for all schools in the district.
 - e. Budget estimate to upgrade to audio evacuation system installation - \$10,000.

CK-0017	4/03/2018 7/12/2021	Upgrade fire alarm control system to Voice Evac	System Upgrade	Upgrade existing fire alarm system to Voice Evac to match what is installed at Northern Hills Elementary School.	\$11,500		3
CK-0018	7/12/21	Window Replacement	Replacement	Replace with new aluminum windows	\$12,000		2

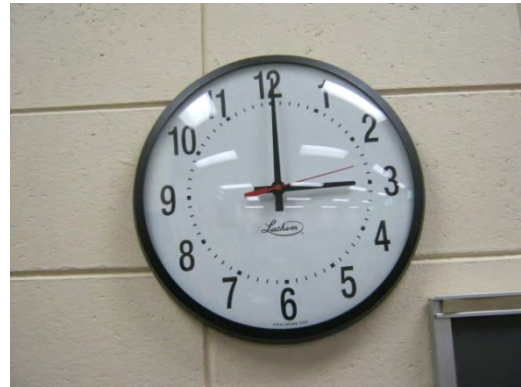
1. The clocks are new and recently installed.
2. Additional clocks can be added to the system.

Wall clock

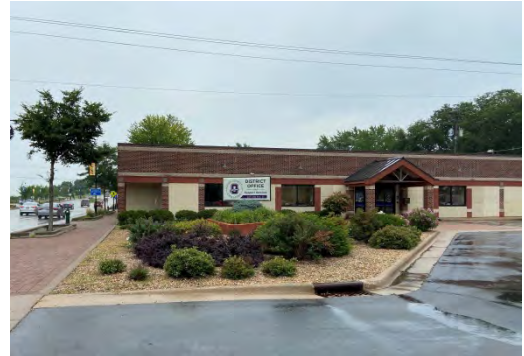
1. Exterior walls appear to be in satisfactory condition except the northeast and east wall where there is a lack of insulation and wall/foundation cracking.

Building exterior

1. Repair northeast and east walls that show deterioration and cracking, as well as reinsulate.

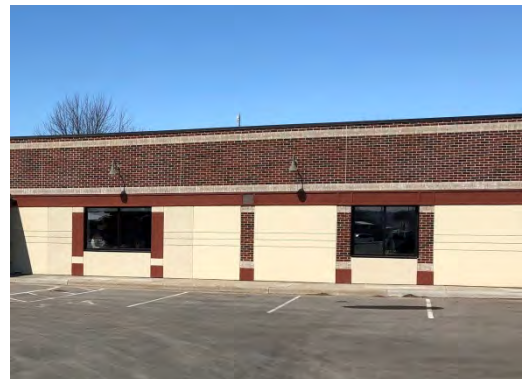
1. Windows remain in good condition.

Aluminum storefront windows - new

1. None at this time

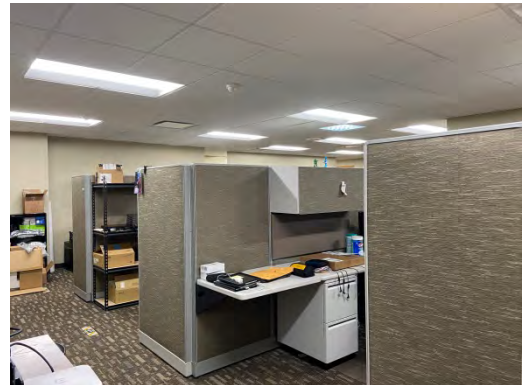
Current Data Services space

1. Shortcomings of this area will be reviewed with the overall design study for the district office to provide additional office space for staff.

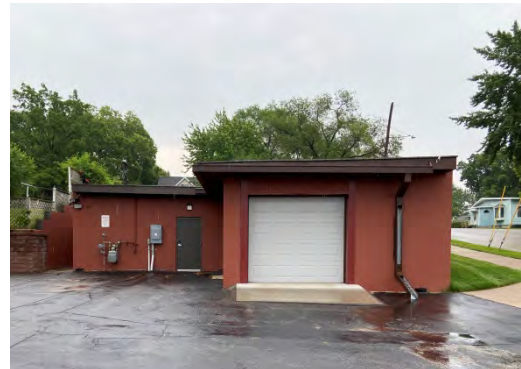
Building exterior

1. It is suggested that a closer structural examination be considered to evaluate the lateral pressure on the east wall as a result of building back into the site embankment. Structural corrections may dictate reinforcing and buttressing the east wall if the lateral load pressures appear to be exerting soil pressure on the masonry foundation wall.
2. Continue to monitor walls for corrective action that may require immediate attention (ex: wall cracks).

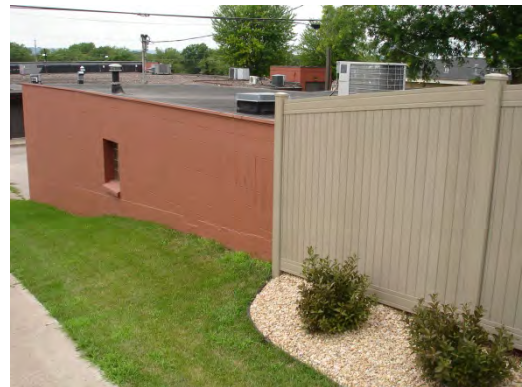
1. Following the 2017 office renovation a proposal to replace the roof system was previously submitted to the District for all work associated with the re-roofing of the annex building. The work involved included removing the existing membrane down to the wood deck, raising of HVAC curbs, plumbing, vents and electrical work. The proposed action was to install a new fully-adhered rubber membrane over EPS insulation.
2. Metal roof edge cap flashing and gravel stop flashing would have been fabricated of standard 24-ga, prefinished galvanized metal.

Existing roof

1. Continue to monitor roof system for corrective action that may require attention (ex: roof leaks).

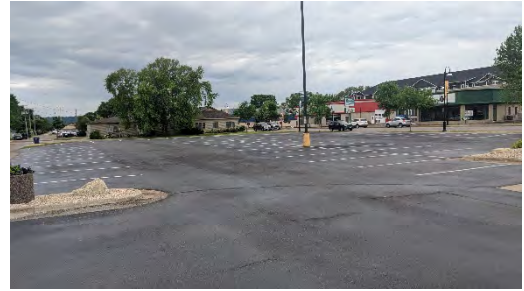
White Striping

1. The paved areas appear to be in serviceable condition at this time.
2. The striping in the main parking lot is white, which is difficult to see in the winter months.
3. The retaining wall adjacent to the paved area by the annex is failing.

1. When the parking lot is restriped next, yellow striping is preferred for visibility.
2. Continue to monitor conditions of paving and make any needed corrections.
3. Replace retaining wall by the annex.

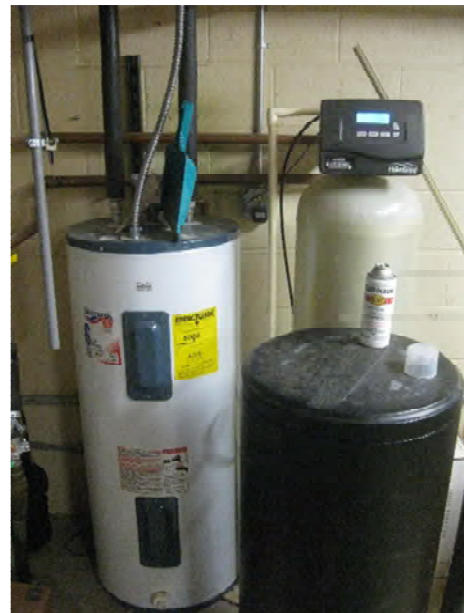
1. Water heating equipment a tank type electric unit, it provides adequate hot water for the building. The unit is good condition and is operating well.
2. The building is served by a single H125 Hillenbrand water softener. The water softener is softening domestic HW and CW.
3. Plumbing fixtures are in good operational condition.
4. Water service is 1 ½" K copper.
5. Water Piping is copper.

Water heater and softener

1. Equipment/fixtures will require an annual review of condition and minor ongoing maintenance as needed.

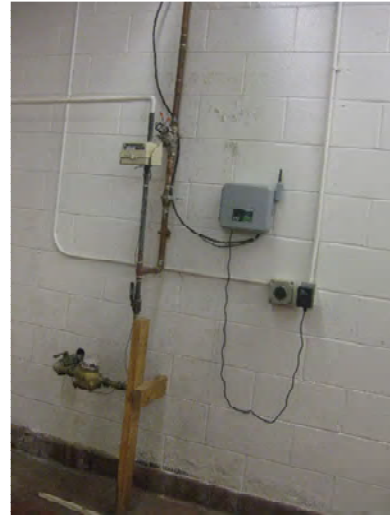
1. Plumbing systems are past their useful life, they will require replacement if remodeling is done.
2. Water piping system is functional properly, Valves will need to be replaced as they age.

Water meter and irrigation

1. Replacement of existing plumbing will be required if remodeling is done.

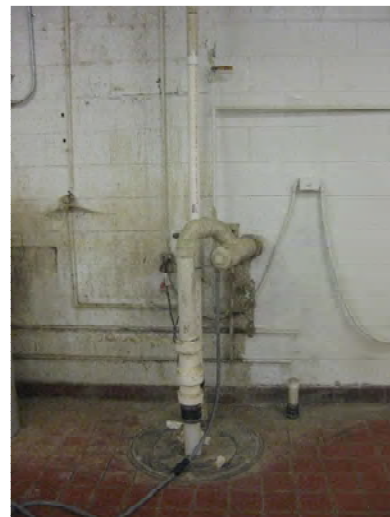
Sanitary sump and pump

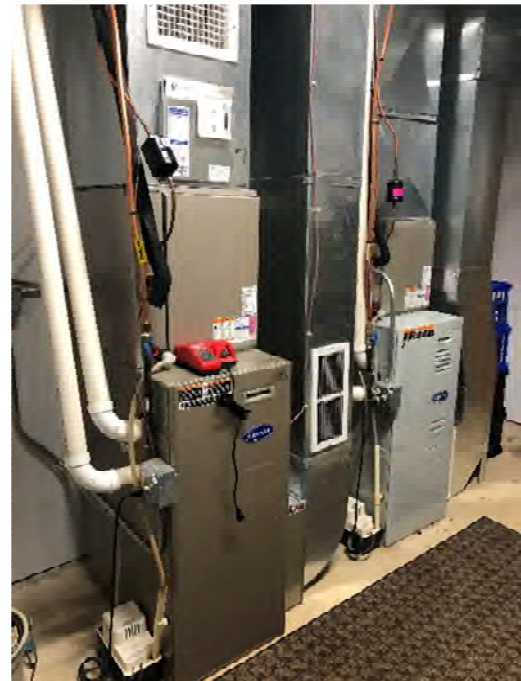
Gas-Fired furnaces

1. The existing RTU's and forced air systems appear to be 15-25 years old and close to, or just past, their life expectancy. It was reported that the ability to control temperatures and humidity in the building is poor.

1. Remove the existing HVAC systems and serve the entire building utilizing two (2) VAV packaged rooftop units with hot water reheat VAV boxes served by a high-efficiency condensing boiler plant with variable flow pumping. A new digital control system would be utilized to control the building to be consistent with the current district standards.
2. Replace all HVAC equipment in Annex if this building is to be utilized.

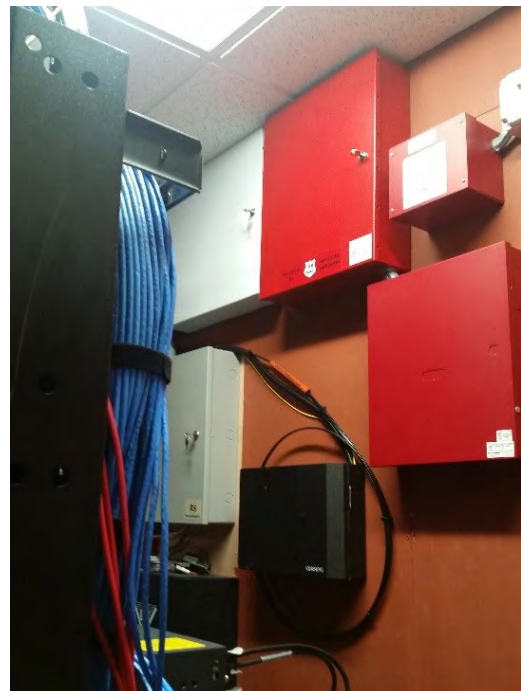
1. The fire alarm system is new and in good working condition.

Fire alarm

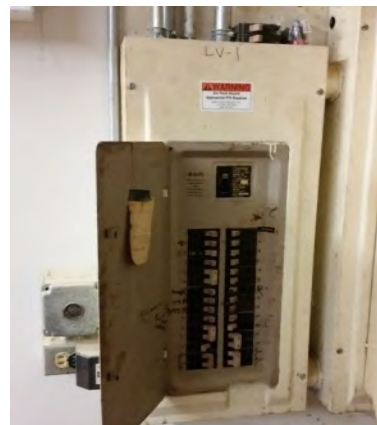
1. These panelboards are outdated and should be replaced with new during future remodel projects.

Panelboard

1. Replace with new panelboards.

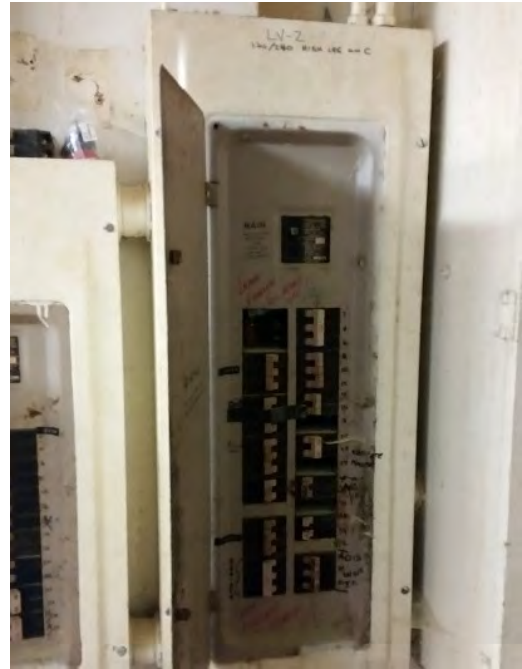
1. These panelboards have exceeded their useful life and should be replaced.

Panelboard

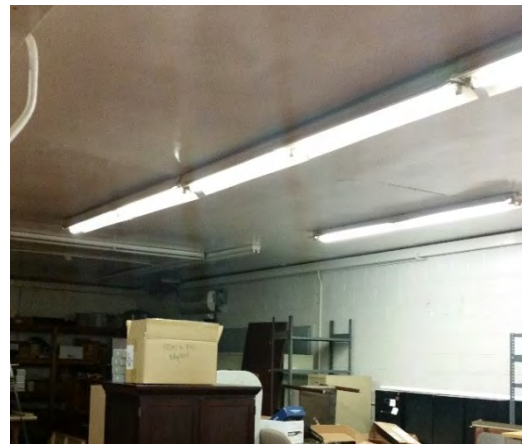
1. The existing interior and exterior light fixtures are outdated and should be replaced with future remodel projects.

Interior light fixtures

1. Replace with new energy efficient LED lighting fixtures and controls.

1. 0 – 3 years.

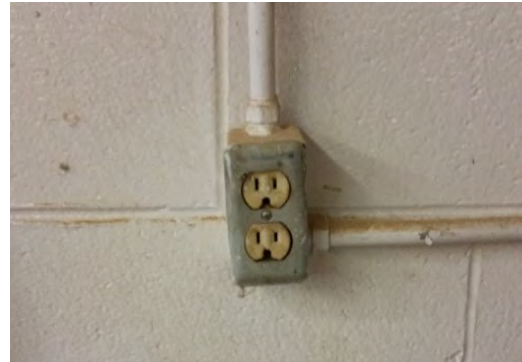
1. The receptacles and toggle switches are outdated and should be replaced with new. A few receptacles are broken.

1. The wiring devices have exceeded their expected useful life.

Wiring device

1. Replace with new.

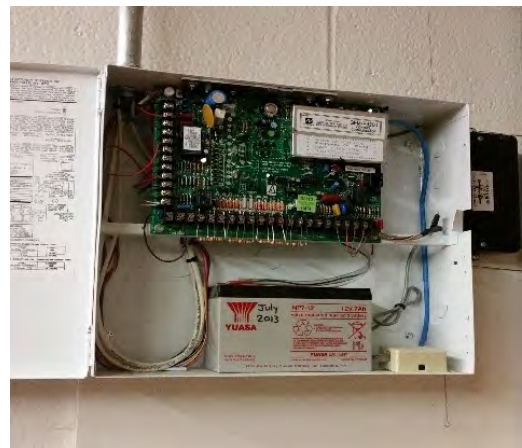
1. 15 – 20 years.

Fire alarm system

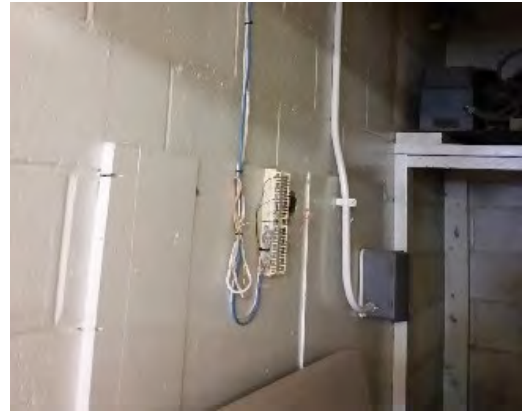
1. 0 - 5 years

Phone and data system

1. Replace with new.

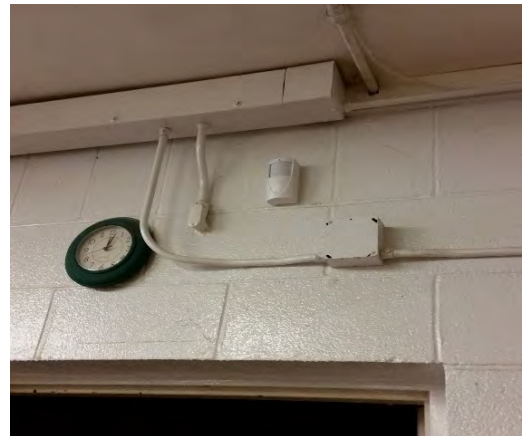
1. 10 – 15 years.

Security system

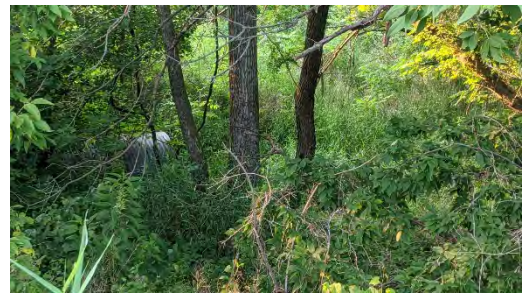
Large Storm Sewer Inlet

1. None as the current drainage system is working at expected levels.
