# School District of Onalaska 2018 Facilities Condition Assessment April 24, 2018 - Final

# FACILITIES CONDITION ASSESSMENT Onalaska School District Onalaska, WI 54650

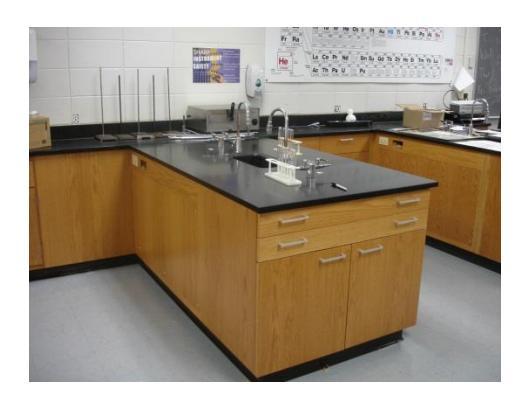
The high school science department was included under the 1988 project and consists of six (6) lab/classrooms located in the lower level at the west end. Each of the science labs has wood cabinetry with epoxy resin worksurfaces. The two chemistry labs have demonstration type fume hoods. Both chemistry labs also have emergency eyewash sinks and overhead emergency drench showers. Is is recommended that the eyewash sinks and showers be replumbed to add mixing valves to the water service to temper the water temperature. Chemistry room 119 was updated approximately 15 years ago with new faucets and gas turrets. All other gas turrets and gooseneck faucets are original (1989) and appear to be in good condition with a couple of exceptions.

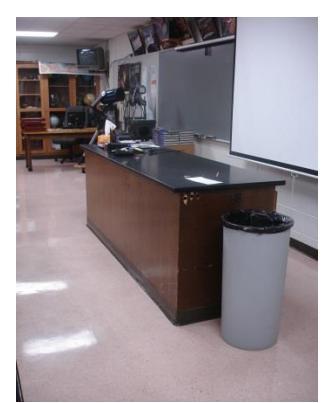
The instructor's demonstration tables were salvaged at the time of the 1989 construction from the previous school's laboratories. These tables could be changed out with new ADA compliant demonstration tables. All other island and peninsula chemistry workstations appear to be in good condition with minimal signs of damage. Salvaged storage cabinets are also used in the science prep rooms. These cabinets appeared to be well built and should have several years of service left.

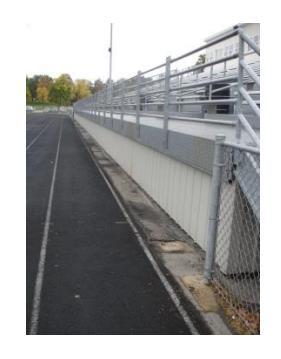
Storm water run-off from the perimeter of the bleacher facility had been an ongoing problem. Run-off from all four directions were basically intended to be collected in a single and undersized catch basin out from the west side of the bleachers. Maintenance staff described that the ponding water around the catch basin can reach depths of 18 inches or more. Run-off passing under the bleachers and through the enclosed equipment storage areas will often freeze during cold conditions.

- Run-off from the football field passes unimpeded over the running track and then though the storage rooms under the bleachers collecting at a low point catch basin.

- Water run-off flows around the north end of the bleachers and continues to the catch basin off the west side of the bleachers.

Stormwater run-off management needs to be re-designed to prevent the water from passing through the enclosed under-bleacher storage areas This will involve a comprehensive plan that collects run-off from the football field and running track, routing it to an enlarged storm sewer system. Another consideration would be to create a storm water detention area in the lawn area to the south of the bleachers.

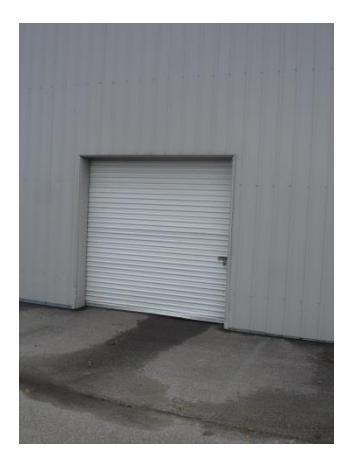
Also included on the list of improvements would be replacement of the light-duty push-up coiling garage doors with heavier-duty overhead sectional doors. The door jambs at the overhead doors also show some damage, likely from moving items in and out of the enclosed storage areas. A recommendation would be to add concrete filled steel bollards at the sides of the door openings.

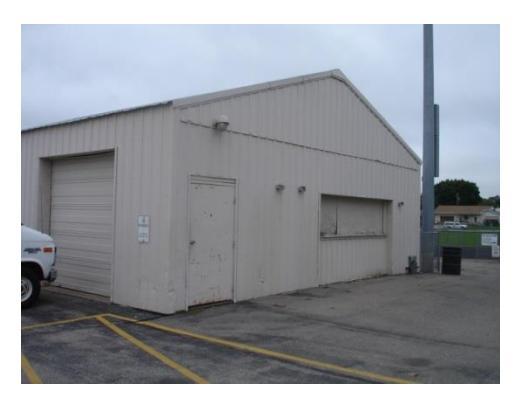
The vehicle garage building located just north of the grandstands was constructed as a simple pole barn structure, wood framed with corrugated metal siding and roofing.

The garage structure shows signs of wear and corrosion but can likely be used indefinitely. Overhead doors and swinging doors can be replaced, however the building in general appears to have deteriorated to the point of total replacement.

Continue usage of the building but schedule future building replacement when funds are available.

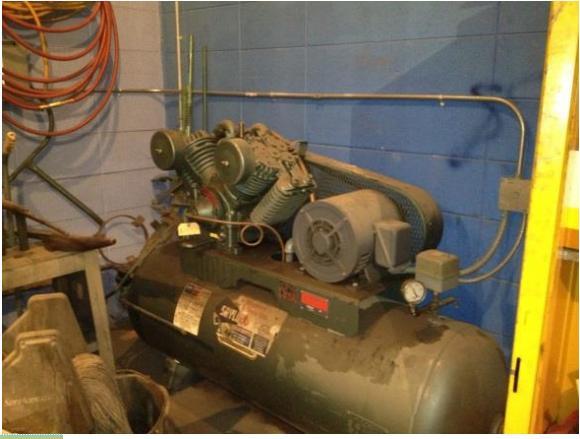
- Water heating equipment is gas fired instantaneous water heating equipment. Currently 4 units provide adequate hot water for the building. The units are in good condition and are operating well.
- 2. The building is served by a duplex water softener. The water softener is softening all domestic water and some cold water serving equipment.
- The Tech ED air compressor is an older model however it is operating well. The daily demand on the unit is relatively low. Would expect it to function properly for years to come.

1. Water heating equipment is expected to last 10 years. Water softening equipment should be viable for another 15 years.

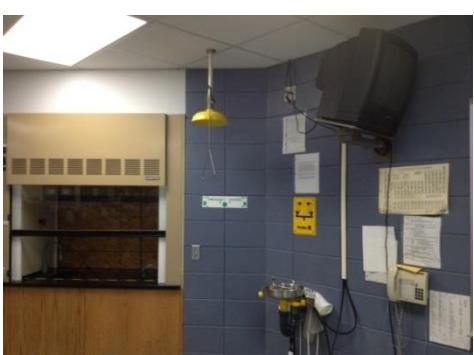
1. Plumbing fixtures in the original building are in fair condition. Modifications have been made in some

locations to update flush valves and faucets on existing plumbing fixtures.

- 2. Toilet rooms in the lower level team rooms are generally in poor condition and should be scheduled for replacement.
- 3. Toilet rooms in the 1998 addition are in good condition however the fixtures do appear to have some staining in the water closets and urinals which appear to be the result of hard water.

- 1. Plumbing fixtures located in the original building should be scheduled for replacement. Typically these rooms and fixtures are not ADA compliant.
- 2. Provide continual maintenance on all plumbing fixtures to increase the longevity of the fixtures.
- 3. We recommend that hot and cold water be routed to all emergency fixtures. An OSHA approved mixing valve is also required at these locations.
- 4. Provide emergency shut-off controls located in the classrooms for the natural gas piping and turrets located within the science rooms.

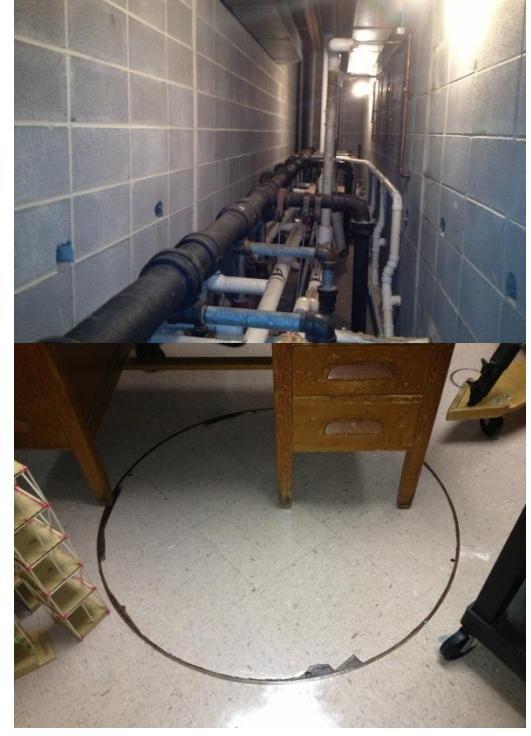
1. We recommend that the sanitary sewer in the team room and the Field House toilet rooms be viewed with a camera to determine the condition and integrity of the existing piping.

- 2. Continually monitor the Tru-Spun cast iron piping for problems. This piping may need replacement in the next 10-15 years.
- 3. Maintain the Acid Basin.

1. Replacement of Tru-Spun Cast piping may not be necessary. We recommend replacing the product as required. The estimated budget to replace the Tru-spun piping should this be required is \$100,000.

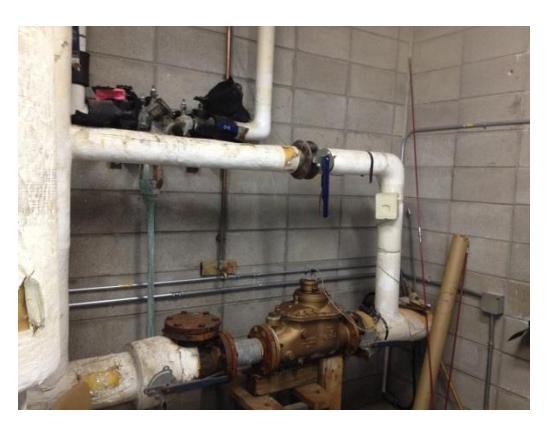
- Original portions of the building are provided with galvanzied domestic water piping. Additions and renovations have been piped using Type "L" copper tube.
- 2. Other than the shop areas, no problems with water pressure or water quality were reported. Further investigation is required to determine problems with the shop areas however it is expected that the old galvanized piping may be failing.
- 3. Water at the start of the school year is always very rusty. This problem occurs with the existing galvanized piping and will always occur until the galvanized water mains are replaced.

4. The building is supplied by a 4" domestic water service with a 4" water meter. A separate water meter and backflow preventer has been provided for irrigation to the athletic fields. The existing water service is not large enough to support a fire protection system for the building should one be desired in the future,

- 1. Galvanized domestic water piping should be scheduled for replacement.
- 2. Additions or major renovations to the building may require the building to be provided with a fire protection system. A new 6" domestic water service should be evaluated for the building.

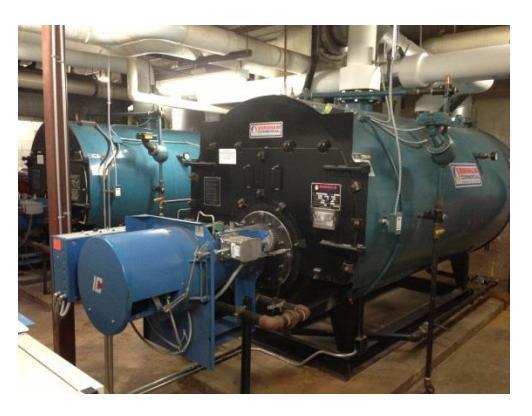
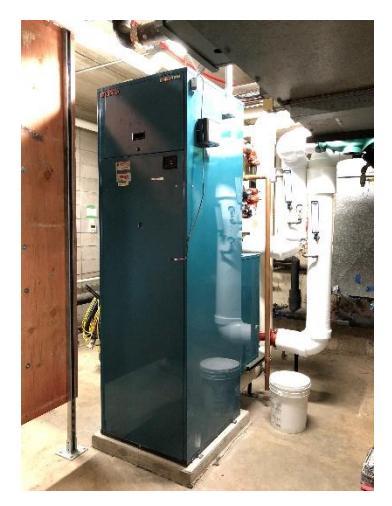
- 1. The boilers are in good condition and, with a proper maintenance program, should continue to serve the building for another 15 years or more.
- 2. Several classrooms that were previously larger and later partitioned into multiple classrooms did not receive revisions to the HVAC system zoning. As a result, multiple rooms are served by a single VAV box and a single room thermostat.

3. Both the hot water and chilled water systems contain chemical compound feeders. The chilled water system is also served by an in-line water filter.

1. Provide additional VAV boxes as needed to the classroom spaces that have been partitioned in the past without HVAC revisions.

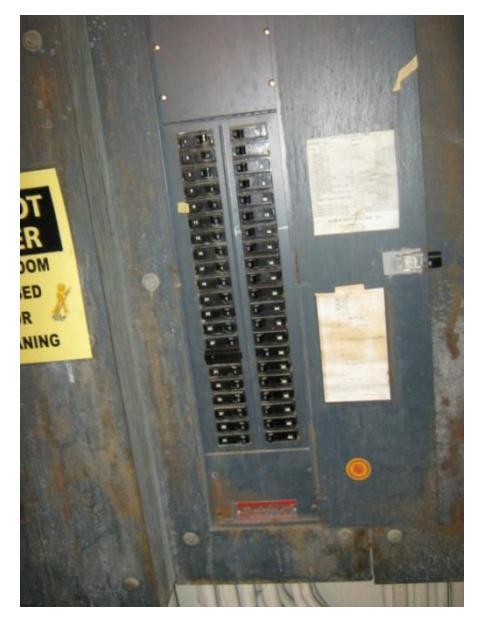
A. The panelboards are General Electric and were installed in 1968 or 1988.

- A. Replace the 1968 panelboards and feeder wire with new. New circuit breakers will allow for a safer and more expandable installation. \$7,000 EA for a Total of \$140,000.
- B. Provide one additional panelboard located adjacent to each 1988 panelboard. Observed a minimum of Seven (7) additional panelboards required. \$4,000 Each for a Total of \$28,000.
#### Generator

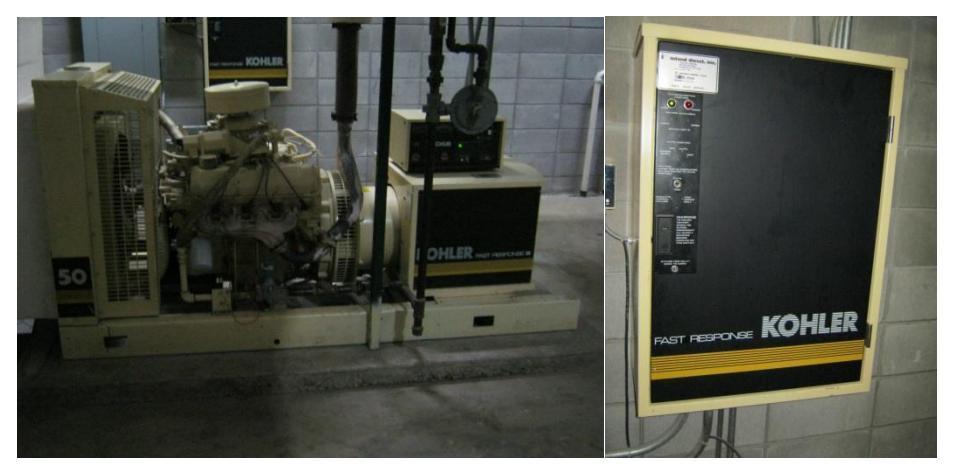
- A. This building has a 50 KW Kohler natural gas fueled generator. The generator is liquid cooled. It was installed in 1988. The generator is located in the gym mezzanine mechanical room.
- B. There is one Kohler automatic transfer switch mounted next to the generator.

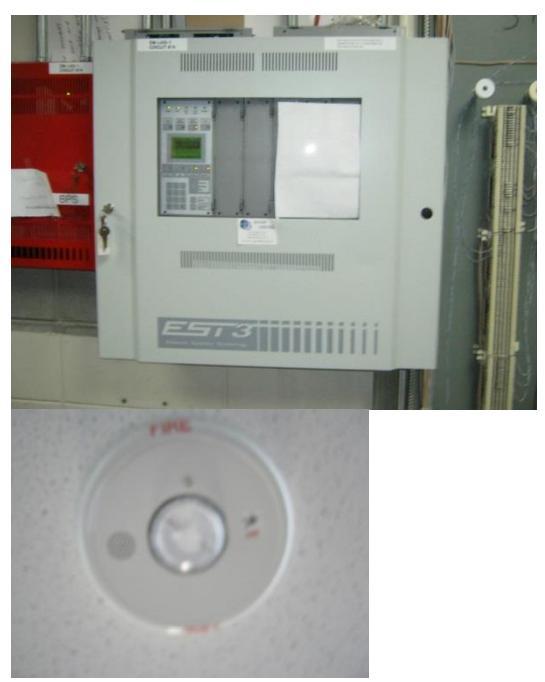
- A. The fire alarm is an EST3 addressable system. The system is 15 years old and was installed in 2003. End-Point devices such as manual pull stations, smoke detectors, notification devices, heat detectors, duct detectors, etc. were upgraded in 2012. The fire alarm control panel is located in the first floor electrical room near the main office.
- B. There are pull stations by all exterior doors.
- C. There are ceiling mounted horn strobe devices in the corridors and classrooms.
- D. There are smoke detectors in storage rooms. There are heat detectors in mechanical rooms.
- E. There are duct smoke detectors in the air handling units operating at 2000 CFM or greater.
- F. The majority of the fire alarm cabling is installed in 'free-air', not in conduit.
- G. This is a non-sprinklered building.

- A. Consider upgrading to an audio evacuation fire alarm system:
  - 1. Audio Evac Fire Alarm Systems are now the normal design practice for any size school.
  - 2. This building is not sprinklered.
  - 3. The Onalaska School District has made strides and have developed a new standard for fire alarm systems, for example the Northern Hills Elementary School has an audio evacuation fire alarm system. Recommend to continue on this path for all schools in the district.
  - 4. Budget estimate to upgrade to audio evacuation system installation \$150,000.

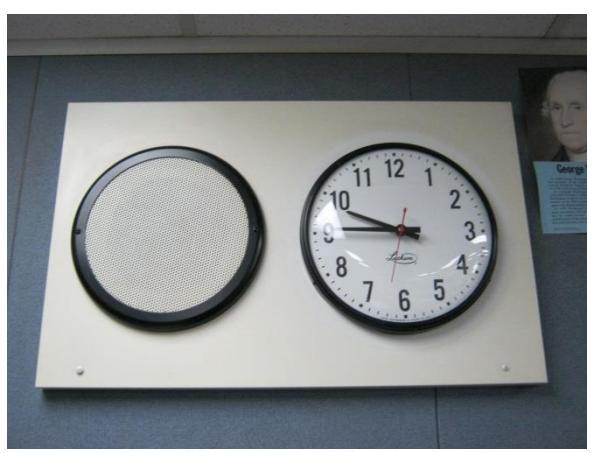
- A. A new Sapling Master Clock Controller was installed in 2017 which is the master for controlling the existing Lathem hard wired synchronized wall clocks. This master is ready for wireless clocks in the future. The clock master controller is located in the main office.
- B. There are Lathem hard-wired analog clocks in the classrooms, corridors, offices, and other public areas. These Lathem clocks are approaching 30 years old.
- C. The bell tone is controlled by the master clock controller.

A. Recommend budgeting for wall clock replacement, \$200 per clock depending on power option. The master clock is already upgraded. Total budget \$30,000.

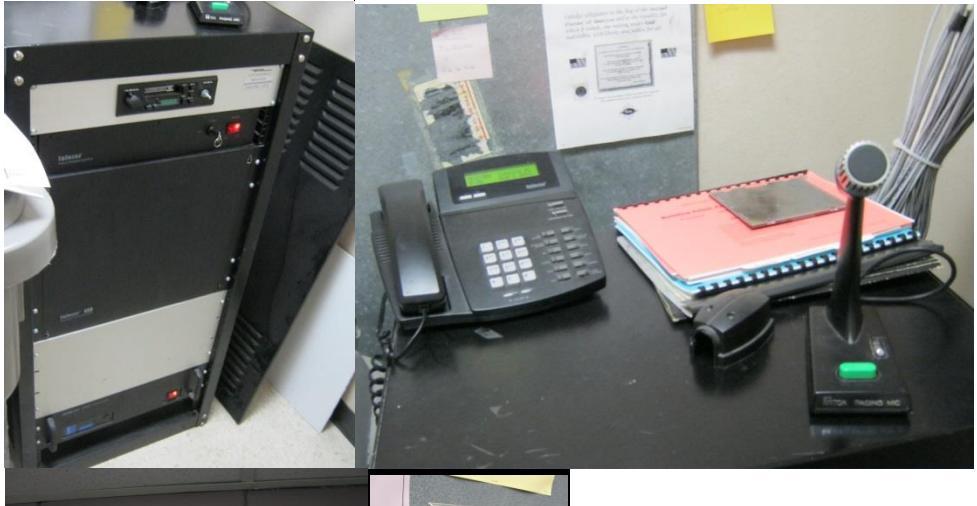
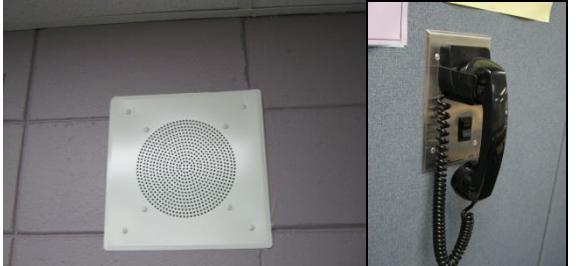
- A. There is a Telecor intercom system. The overall system is 30 years old. However the main CPU and Amplifier were replaced and upgraded in 2017. The amplifier is located in the main office storage room.
- B. There are wall mounted intercom phones in the classrooms to allow two way communications with the front office. The intercom is also accessed through the Mitel 3300 IP phone line which allows users with a code to perform a building page from any Mitel phone.
- C. There are surface and recessed wall mounted intercom speakers in the corridors.
- D. There are flush wall mounted combination clock speaker baffles in the classrooms.
- E. The bell system is toned through the intercom speakers.

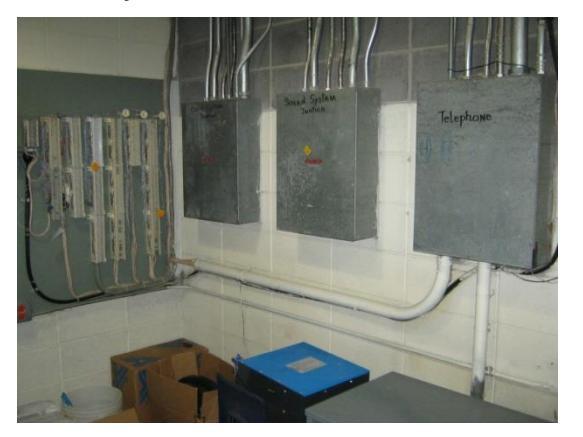
#### **Phone System**

- A. There is a recently installed Mitel 3300 IP (Internet Protocol) phone system. This system was installed in 2015 2016. New IP phones have been installed through-out the school.
- B. The phone cabling is CAT3 and is routed back to wall mounted voice wiring blocks. The voice wiring blocks are located in the first floor electrical room near the main office and in the lower level storage room. There are also voice wiring blocks in each of the 5 data closets.

A. Remove all CAT 3 wiring and replace with new CAT 6. Budget \$45,000.

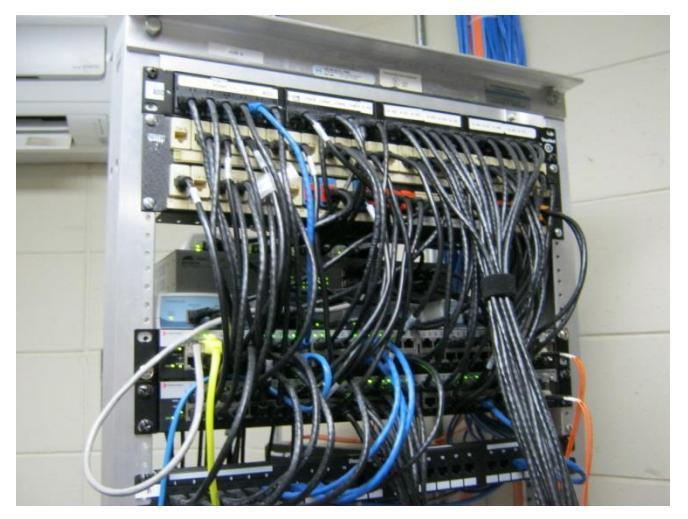
#### **Data System**

- A. The MDF data rack is located in first floor electrical room near the main office. There is one floor mounted data rack. There are 4 additional IDF data racks located throughout the building. New Cisco Switches for PoE and non-PoE was added in 2017. New Single-Mode Fiber Optic cable was added. The system is capable of transmitting 10 meg of broadband.

- A. Replace the old existing CAT3 cable with new CAT6 cable. \$150/data jack
- B. Provide additional switches, patch panels and equipment racks. Budget a total of \$75,000.

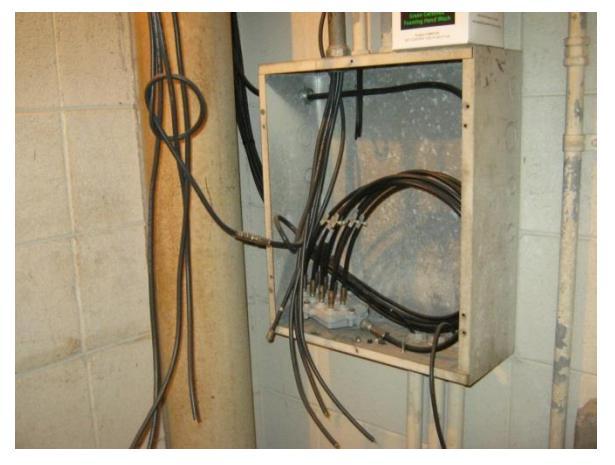
#### **CATV System**

- A. There is a CATV service to this building. CATV splitters are located in storage closets throughout the building. CATV system is no longer in use.
- B. There is a CATV jack in each classroom.

- A. Remove all CATV equipment and jacks.
- B. Remove all CATV Coax cable. Budget \$7,000.

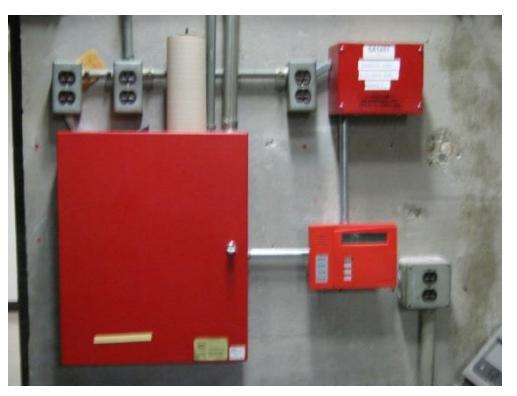
#### **Security System**

- A. There is an Ademco security system. The security control panel is located in the lower level laundry room.
- B. The security system has new motion sensors installed in 2017.

A. Due to advance age of the system, consideration should be given to replace the security system head-end equipment with a new modernized, programmable, software based, system which could be integrated with CCTV Cameras, Fire Alarm and Electronic Door Access Systems. Install 52 door contact switches Budget \$31,000.

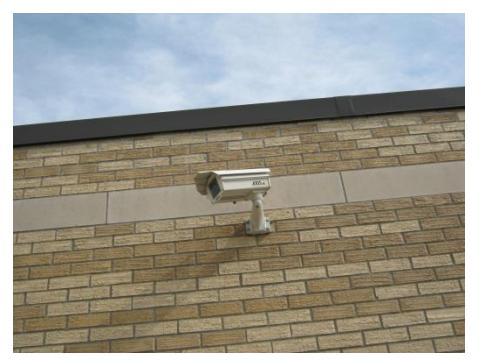
#### **CCTV System**

- A. There is a server based IP CCTV system used throughout all the buildings in the district.
- B. There are interior and exterior fixed color IP cameras.
- C. Current Network recorder has the capability of recording for 30 days.

A. Provide additional interior and exterior IP Cameras. \$1,000/camera for interior, \$2,000/camera for exterior. Estimate 10 exterior cameras and 20 interior cameras for a total of \$40,000.

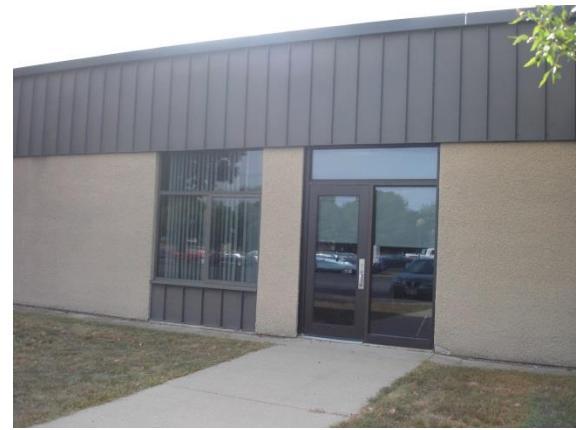
The existing aluminum windows are framed within the metal stud exterior walls. The wall area below the windows are clad with the same ribbed metal fascia panels.

Aluminum entrances are showing signs of significant wear from heavy usage.

Hollow metal doors and frames are also showing significant signs of typical wear and abuse.

Remove and replace existing aluminum windows with new thermally improved aluminum windows with high performance insulated glass. Replace wall section below windows with abuse resistant cladding over additional rigid insulation.

Aluminum entrances can likely remain for the present but should be included on the list for future replacement.

In general, hollow metal steel doors and frames can also continue to be used and repair as necessary. Replacement with new galvanized steel doors and frames should be considered for inclusion on any list for future building upgrades.

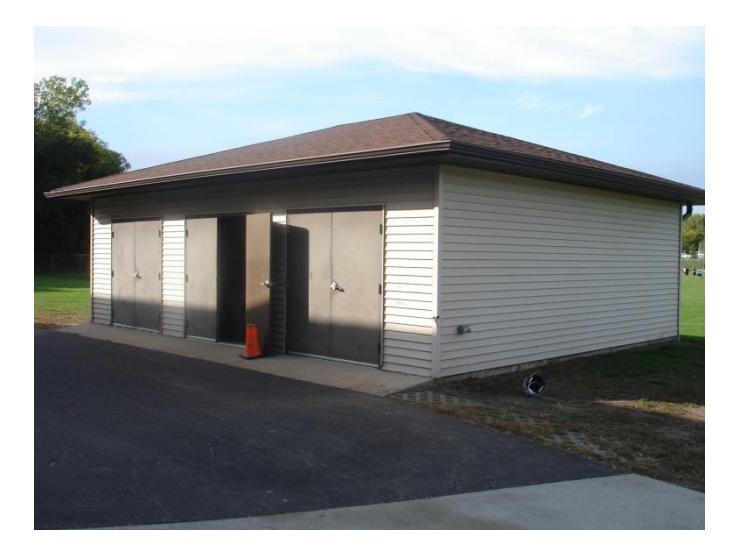
#### 2.7 MIDDLE SCHOOL GARAGE

2.1 A 30' x 24' wood framed storage garage is located on the north side of the school and utilized for miscellaneous equipment. The structure consists of a wood stud frames walls on a concrete floor slab, prefabricated wood trusses, vinyl lap siding and asphalt shingled roof. There are three pairs of hollow metal doors on the south side and a single pair on the north wall.

In general, the garage structure appears to be in satisfactory condition with the exception of a small damaged area of vinyl siding. The asphalt shingles should provide several more years before it becomes necessary to replace the shingles.

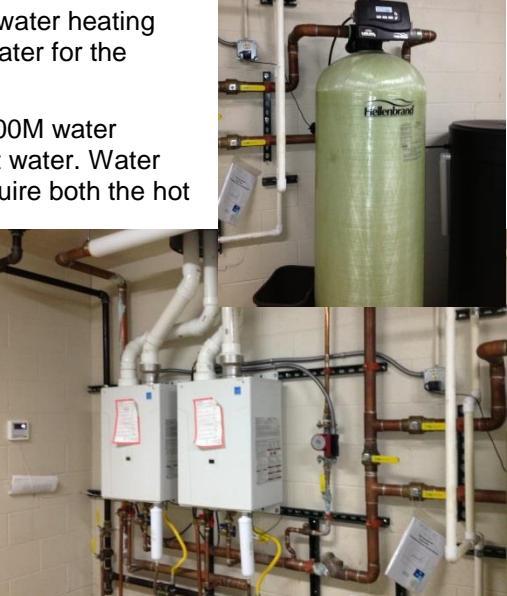
- 1. The expected remaining lifespan of the water heaters is 5 years
- 2. The expected remaining life cycle of the water softener is 10 years.

- 1. Instantaneous water heating equipment is required to be maintained for scale on a regular basis. Annual maintenance shall be provided on equipment as required.
- 2. Existing water softener may be capable of providing soft water for the entire domestic water demand. Softener would have to move to water service entrance.

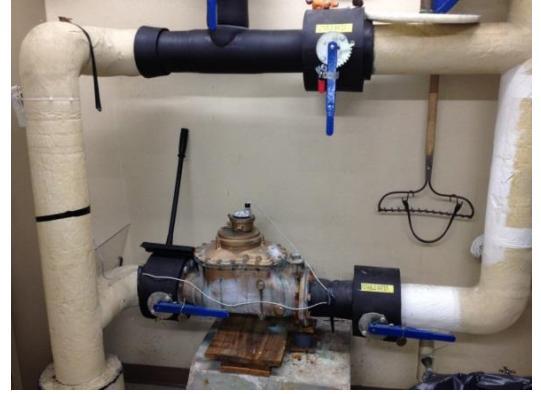
- 1. Original portions of the building are provided with a galvanzied domestic water piping. Additions and renovations have been piped using Type "L" copper tube.
- 2. In some areas PEX tubing was installed to provide circulation to the domestic hot water system. This system is not performing as expected.
- The building is supplied by a 4" domestic water service with a 4" water meter. A separate water meter and backflow preventer has been provided for irrigation to the athletic fields. The existing

water service is not large enough to support a fire protection system for the building should one be desired in the future.

- 4. There is a deduct water meter for HVAC cooling using cold water. This piping has a 4" RPBP for backflow protection.
- 5. Water pressure from city is over 80 PSI, there is a pressure reducing valve, Building pressure is 65 PSI.

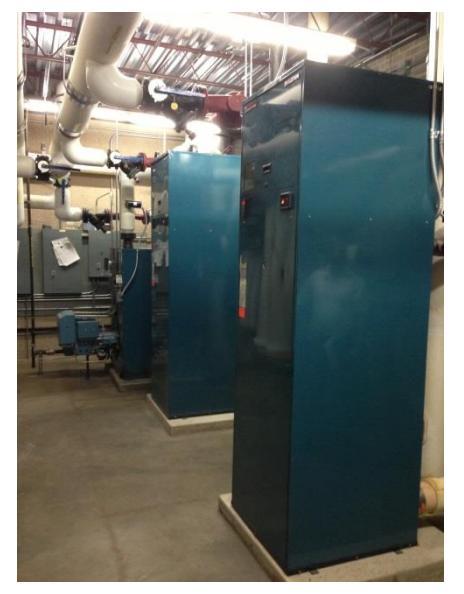
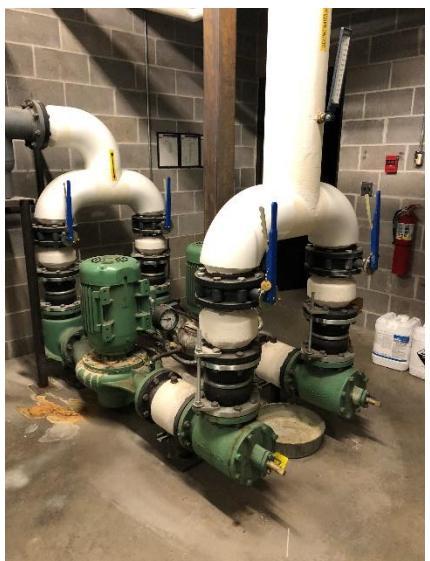
The boilers are in good condition and, with a proper maintenance program, should continue to serve the building for another 10-15 years.

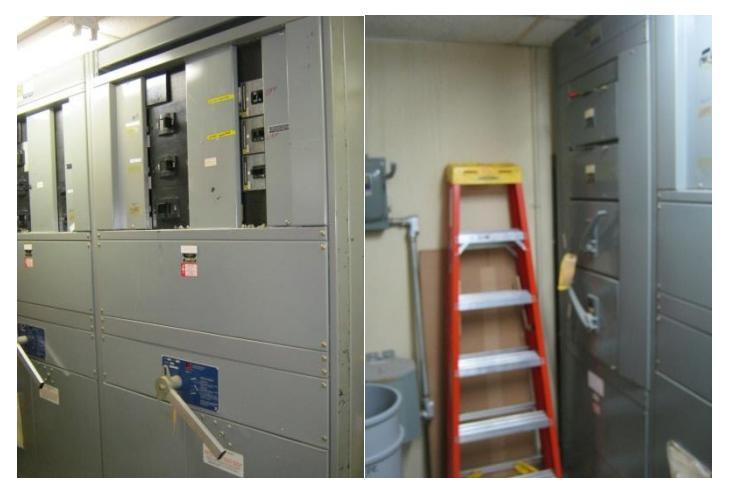
#### Main Electrical Service

- A. This school has a 2,500 amp 480 volt 3-phase 3-wire electric service. The service is fed from a utility owned pad mounted transformer. The CT's cabinet is pad mounted outside next to the utility transformer. The meter socket is mounted inside next to the main switchboard. The main service switchboard consists of two 2,500 amp circuit breaker distribution sections and one 2,500 amp fused switch distribution section. This switchboard has 6 main disconnects including 4 fused switches and two fused bolted pressure switches. This service equipment was installed in 1978. The switchboard is a Square D. There are 6 spare circuit breaker spaces in the switchboard.

A. Provide surge protection device on main service. \$4,000

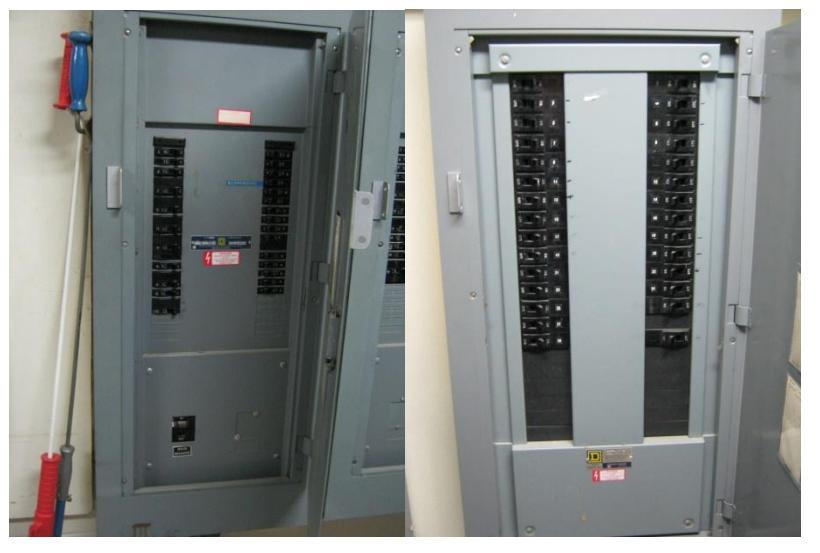
#### Panelboards

- A. The panelboards are Square D.
- B. The panelboards were installed in 1978.

- A. Replace any broken switches and receptacles. \$30 EA
- B. Add additional branch-circuits and receptacles to classrooms as required. \$380 EA
- C. Recommend a minimum of one branch-circuit per classroom.
- D. Budget \$19,000.

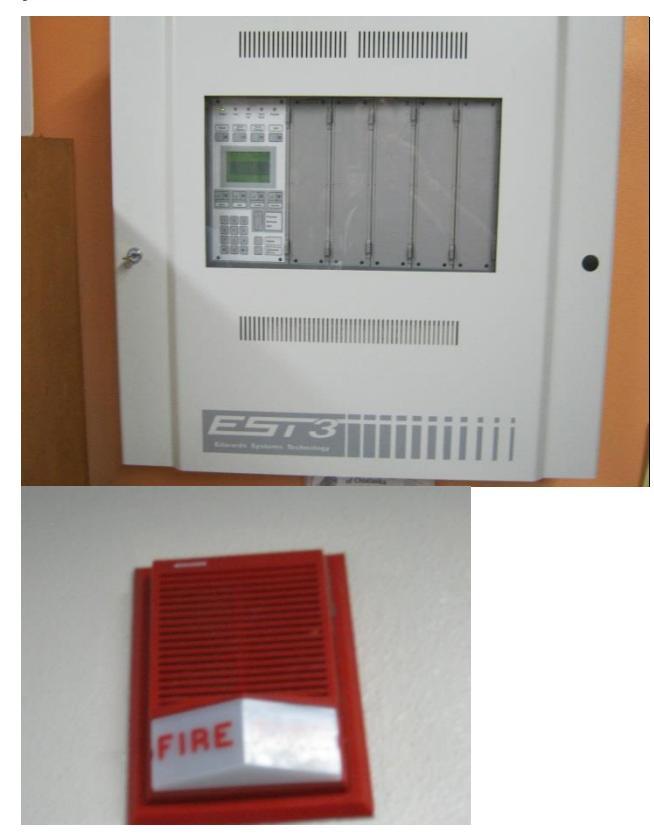
#### **Fire Alarm System**

- A. The fire alarm is an EST 3 addressable system. The system was recently upgraded. The fire alarm control panel is located in the east mechanical room.
- B. There are pull stations by all exterior doors.
- C. There are wall mounted horn strobe devices in the corridors and classrooms. Many of these old devices were reused when the system was upgraded. New EST devices have been added where required by code.
- D. There are smoke detectors in the corridors and storage rooms. There are heat detectors in mechanical rooms.
- E. There are duct smoke detectors in the air handling units operating at 2000 CFM or greater.
- F. All fire alarm cabling is installed in conduit.

- A. Consider upgrading to an audio evacuation fire alarm system:
  - 1. Audio Evac Fire Alarm Systems are now the normal design practice for any size school.
  - 2. This building is not sprinklered.
  - 3. The Onalaska School District has made strides and have developed a new standard for fire alarm systems, for example the Northern Hills Elementary School has an audio evacuation fire alarm system. Recommend to continue on this path for all schools in the district.
  - 4. Budget estimate to upgrade to audio evacuation system installation \$85,000.

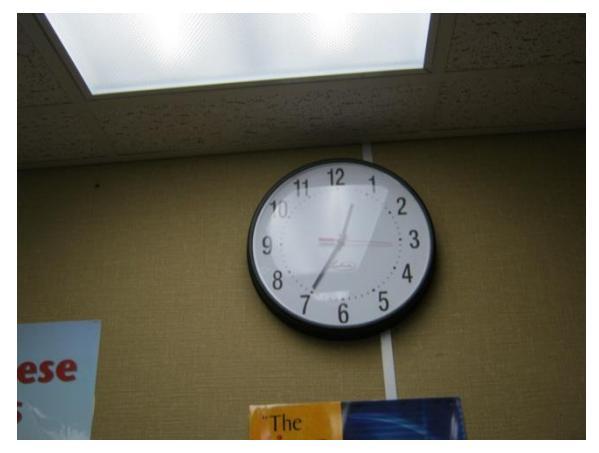
#### **Clock System**

- B. A new Master Clock Controller was installed in 2017, as well as new clocks throughout the facility.
- C. There are battery powered clocks in the classrooms, offices, and other public areas.
- D. The bell tone is controlled by the master clock controller.
- E. The clocks are new and recently installed.

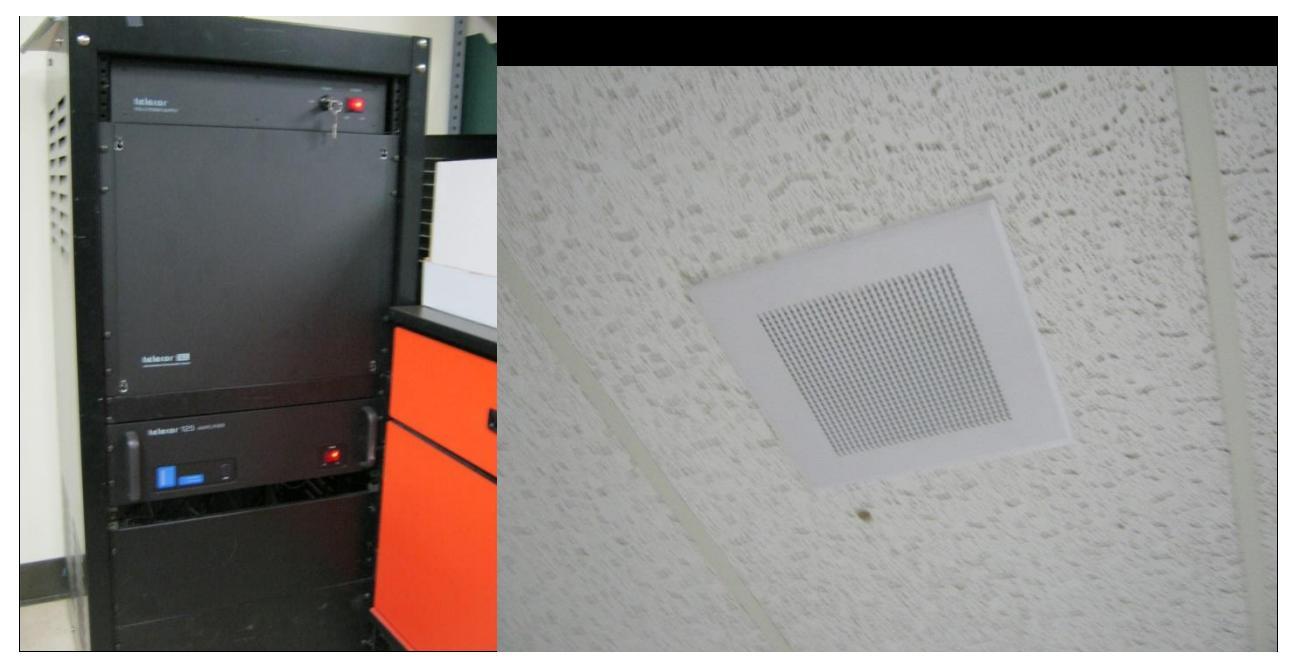
#### Intercom System

- A. There is a Telecor intercom system. This system is 12 years old and was installed in 2006. The amplifier is located in the IMC storage room.
- B. The intercom is accessed through the intercom phones in the classrooms. The intercom is also accessed through the Mitel IP phone line which allows users with a code to perform a building page from any Mitel phone.
- C. There are recessed ceiling mounted intercom speakers in the classrooms and corridors. There are recessed speakers in the exterior soffits near all doors.
- D. The bell system is toned through the intercom speakers.

A. Replace all existing CAT3 wiring and jacks with CAT6. Budget \$25,000

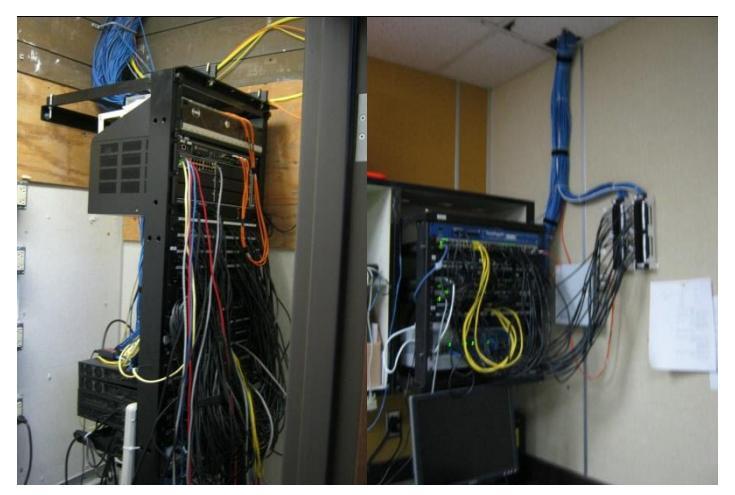
#### **Data System**

- A. The MDF data rack is located in main IT room. There is one floor mounted data rack. There is one additional IDF data rack located in the IMC A/V storage room.
- B. The IDF data racks are connected to the MDF data rack with multi-mode fiber optic cable. The MDF of all the schools in the district are connected together with single-mode fiber optic cable.
- C. The newest data cable is CAT6, the older cable is CAT5 plenum rated which is routed to patch panels in the data rack.
- D. There is one CAT6 Leviton patch panel in the data rack. The rest of the patch panels are CAT5.
- E. There is a rack mounted UPS.

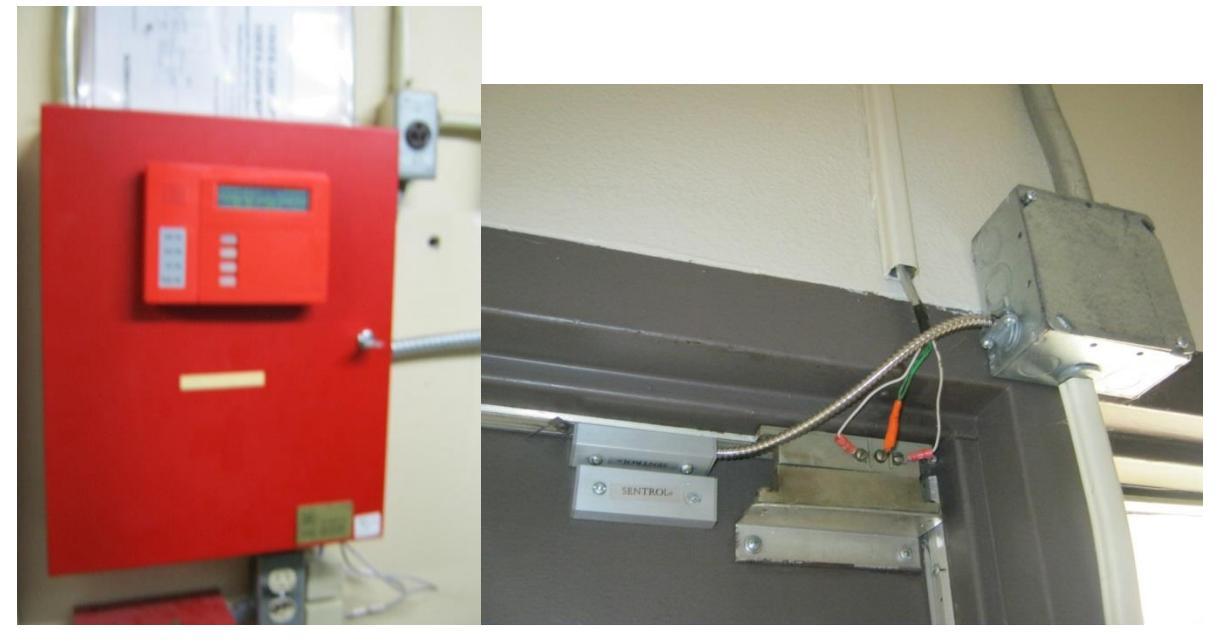
#### **Security System**

- A. There is an older Ademco security system. The security control panel is located in the main electrical room.
- B. The security system has motion sensors in the corridors.
- C. No contact switches on exterior doors.

- A. Upgrade system head-end equipment and devices.
- B. Security system replacement cost. \$500/security device
- C. Provide exterior contact switches. \$400/Each, 48 contact switches for a total of \$20,000
- D. Budget for system replacement \$30,000.

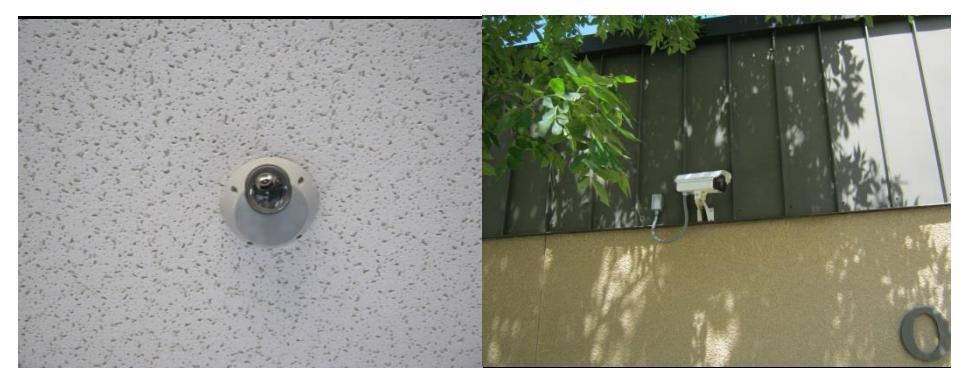
#### **CCTV System**

- A. There is a server based IP CCTV system used throughout all the buildings in the district.
- B. There are interior and exterior fixed color IP cameras.
- C. Current Network recorder has the capability of recording for 30 days.

A. Provide additional interior and exterior IP Cameras. \$1,000/camera for interior, \$2,000/camera for exterior. Estimate 5 exterior cameras and 10 interior cameras for a total of \$20,000.

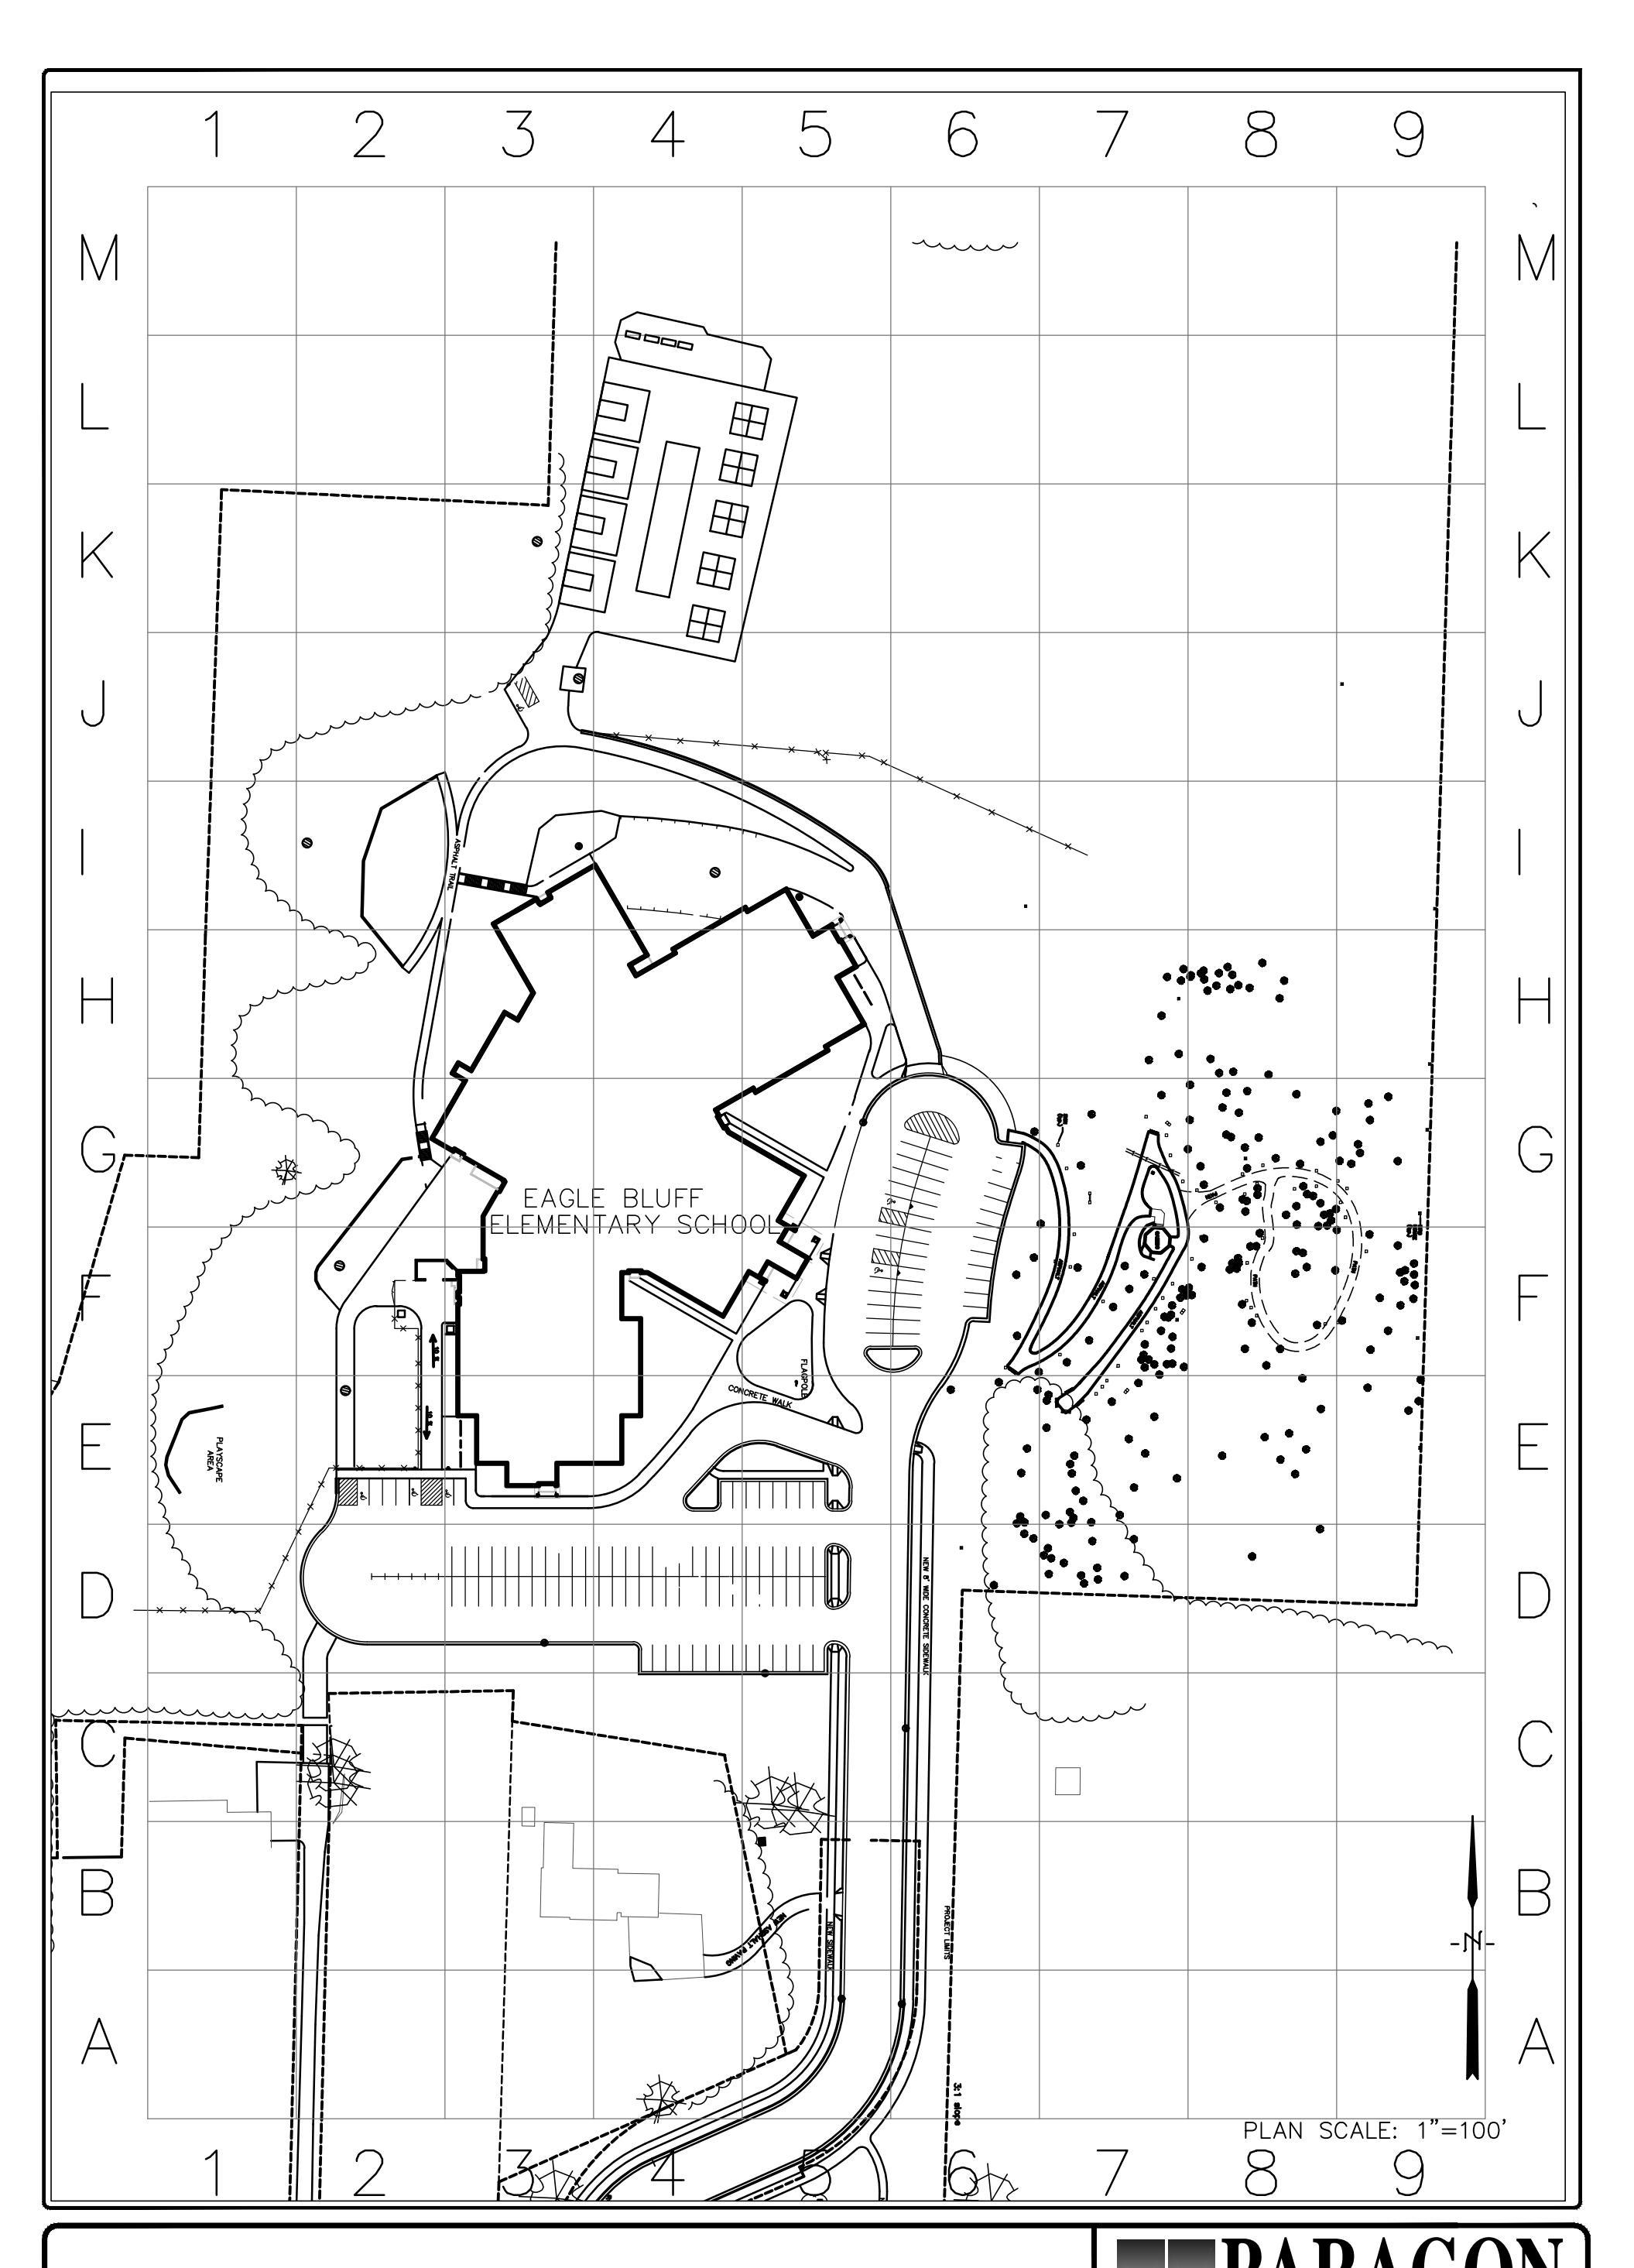
Eagle Bluff Elementary school is a relatively new facility and as expected site infrastructure is in generally good condition. Most of the pavement should remain serviceable for the foreseeable future with the exception of an area in I-4 that appears to have suffered some settlement damage. The sidewalks are generally in good condition except for some isolated areas of broken or vertical misaligned sections which should be corrected. Areas of significant misalignment have been identified in the Assessment. Some areas of curb have suffered plow damage but this is cosmetic. As is noted for the other district buildings, ADA parking is missing the required signage and is not located on the shortest accessible route to the building as required by Code. The number of stalls appears to be less than what is required. Drainage from the north play field could be improved by the addition of several area drains in the lawn to eliminate the ponding that occurs in the southwest corner.

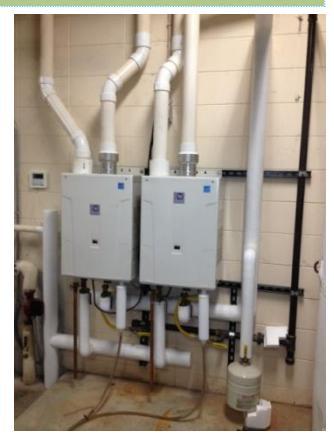
- Water heating equipment consists of two gas-fired instantaneous water heaters. The heaters appear to be in very good condition, (replaced in Spring of 2018). The water heaters appear to be appropriately sized for the facility.
- 2. A Duplex domestic water booster pump has been provided to maintain adequate water pressure within the building. Outlet water pressure on the system is set at 80 psi. This is a NON-VFD system with mechanical pressure reducing valves, it has recently be repaired, it has some leaks in the piping fittings. Motors are 3HP each.

- 1. Plumbing equipment should have a life span of 5 years on the water heating equipment.
- 2. Water Booster system will require on going issues/repairs, replacement with a VFD controlled system should be considered, there will be substantial energy savings and water pressure will be better controlled.

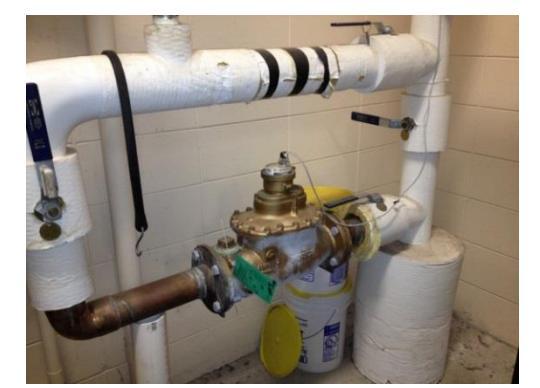
- 3. The existing building does not have a fire protection system. We were unable to determine the exact service size of the piping that enters the building. Based on this photo, it appears that a 6" combination service was installed. Should this be the case, a sprinkler system could be installed within the building.
- 4. All domestic water piping is Type "L" copper tubing and is in very good condition.

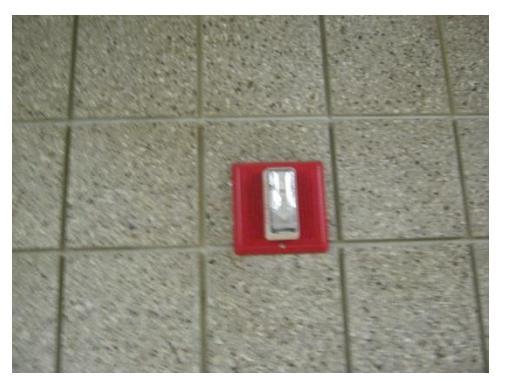
#### Fire Alarm System

- A. The fire alarm control panel is an EST3 addressable system. The fire alarm panel is located in the main electrical room.
- B. There are pull stations by all exterior doors.
- C. There are wall mounted horn strobe devices in the corridors and classrooms.
- D. There are smoke detectors in corridors, classrooms, and storage rooms. There are heat detectors in mechanical rooms.
- E. There are duct smoke detectors in the air handling units operating at 2000 CFM or greater.
- F. All fire alarm cabling is installed "open air" above the ceilings.

- A. Consider upgrading to an audio evacuation fire alarm system:
  - 1. Audio Evac Fire Alarm Systems are now the normal design practice for any size school.
  - 2. This building is not sprinklered.
  - 3. The Onalaska School District has made strides and have developed a new standard for fire alarm systems, for example the Northern Hills Elementary School has an audio evacuation fire alarm system. Recommend to continue on this path for all schools in the district.
  - 4. Budget estimate to upgrade to audio evacuation system installation \$85,000.
