# School District of Onalaska 2018 Facilities Condition Assessment April 24, 2018 - Final

# FACILITIES CONDITION ASSESSMENT Onalaska School District Onalaska, WI 54650

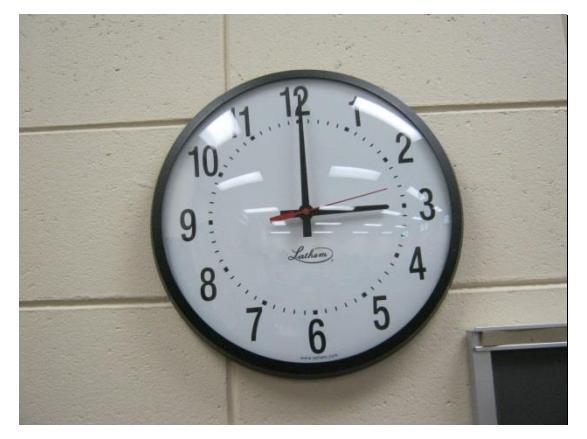
### **Clock System**

- A. There is a Lathem hard-wired synchronized clock system. This system is 19 years old. The clock master controller is located in the second floor data room.
- B. There are Lathem analog clocks in the classrooms, offices, and other public areas.
- C. The bell tone is controlled by the master clock controller.

- A. Replace the entire master clock system with new low voltage hard-wired Point-Over-Ether (POE) system or with line-voltage AC powered synchronized wireless system.
- B. Budget \$20,000.

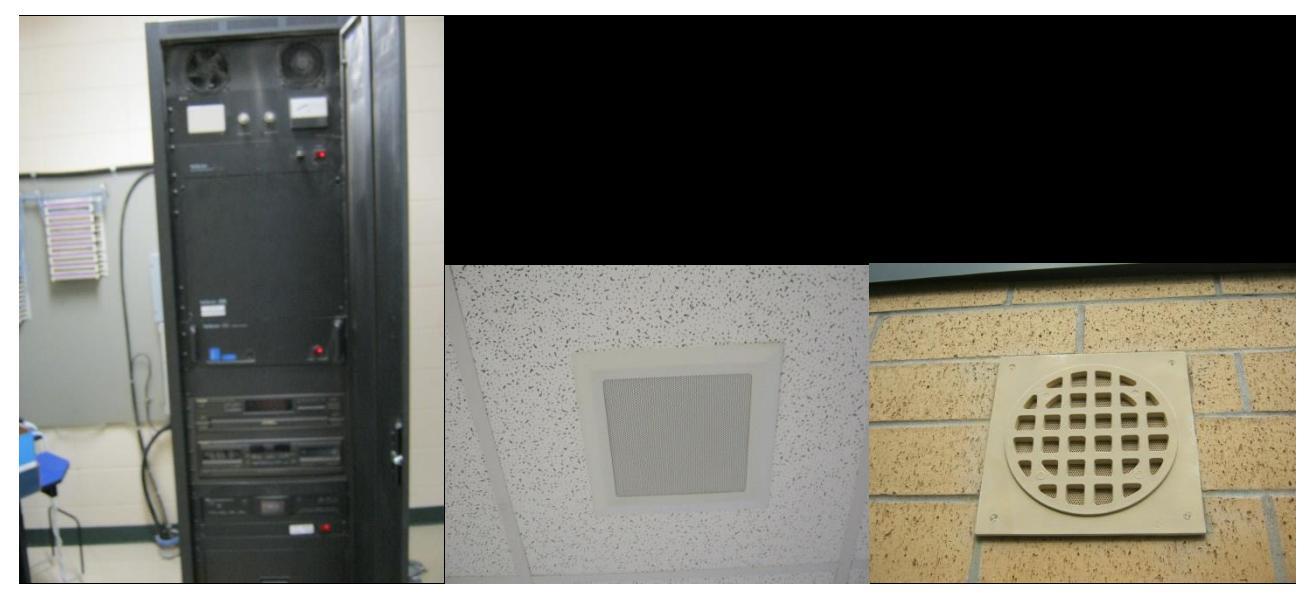
#### Intercom System

- A. There is a Telecor intercom system. This system is 19 years old. The amplifier is located in the second floor data room.
- B. The intercom system is accessed through the phone system.
- C. There are recessed ceiling mounted intercom speakers in the corridors and classrooms.
- D. There are flush wall mounted horns on the exterior of the building.
- E. The bell system is toned through the intercom speakers.

A. Replace with a new modernized system. Consider a system to integrate with modern technology such as mobile communication, pre-recorded messaging, etc. Budget allowance of \$45,000.

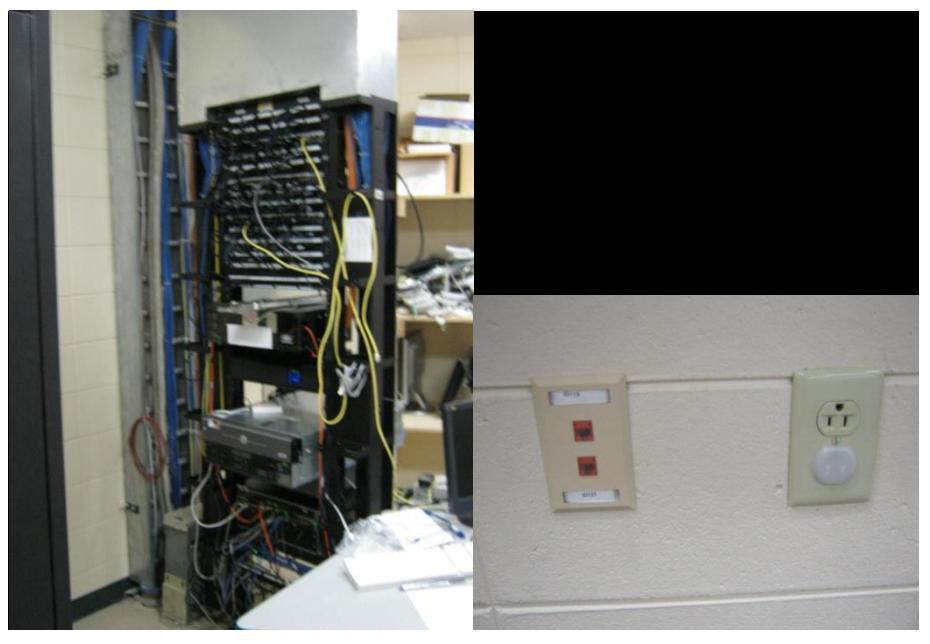
#### Data System

- A. The MDF data rack is located in the second floor data room. There is one floor mounted data rack. There is one additional IDF data rack in the other second floor data room.
- B. The IDF data racks are connected to the MDF data rack with single-mode fiber optic cable. The MDF of all the schools in the district are connected together with single-mode fiber optic cable.
- C. The data cable is CAT5e plenum rated which is routed to patch panels in the data rack.
- D. The patch panels in the data rack are CAT5e Hubbell.
- E. There is a UPS.

A. Replace the old existing CAT5e cable with new CAT6 cable. \$150/data jack for a total of \$80,000.

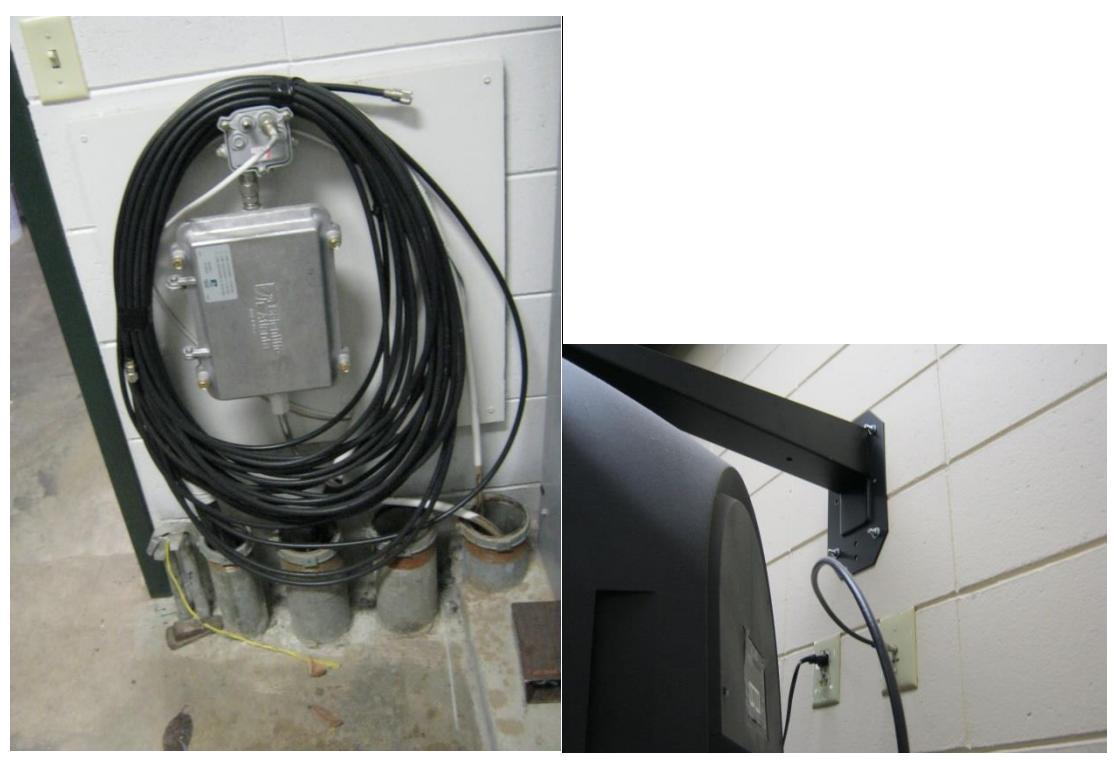
### **CATV System**

A. There is a CATV service to this building. The CATV distribution rack is located in the IMC work room. There is a CATV jack in each classroom.

- A. Remove all CATV equipment and jacks.
- B. Remove all CATV Coax cable. Budget \$5,000.

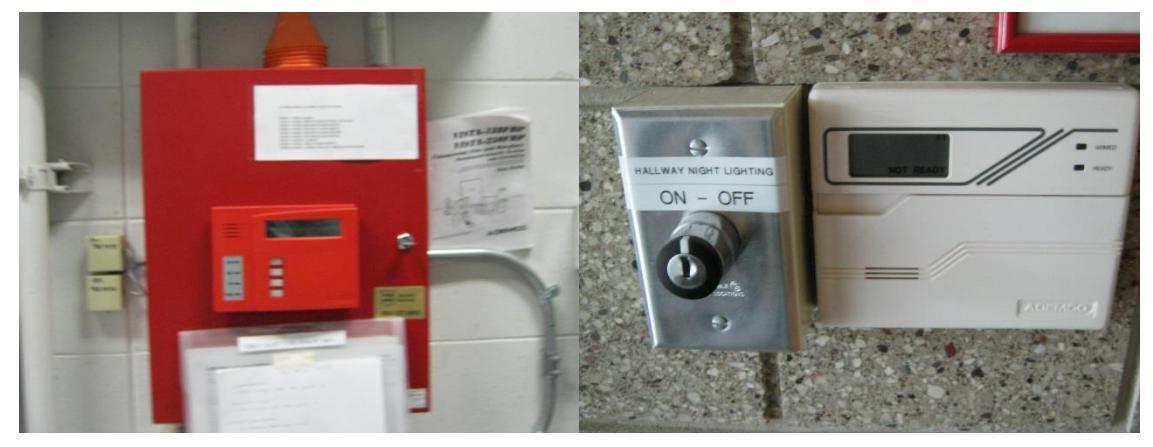
### Security System

- A. There is an Ademco security system. The security control panel is located in the main electrical room. This system is 19 years old.
- B. The security system has motion sensors in the corridors.

A. Add exterior door contact switches. \$400 Ea. X 30 doors = \$12,000.

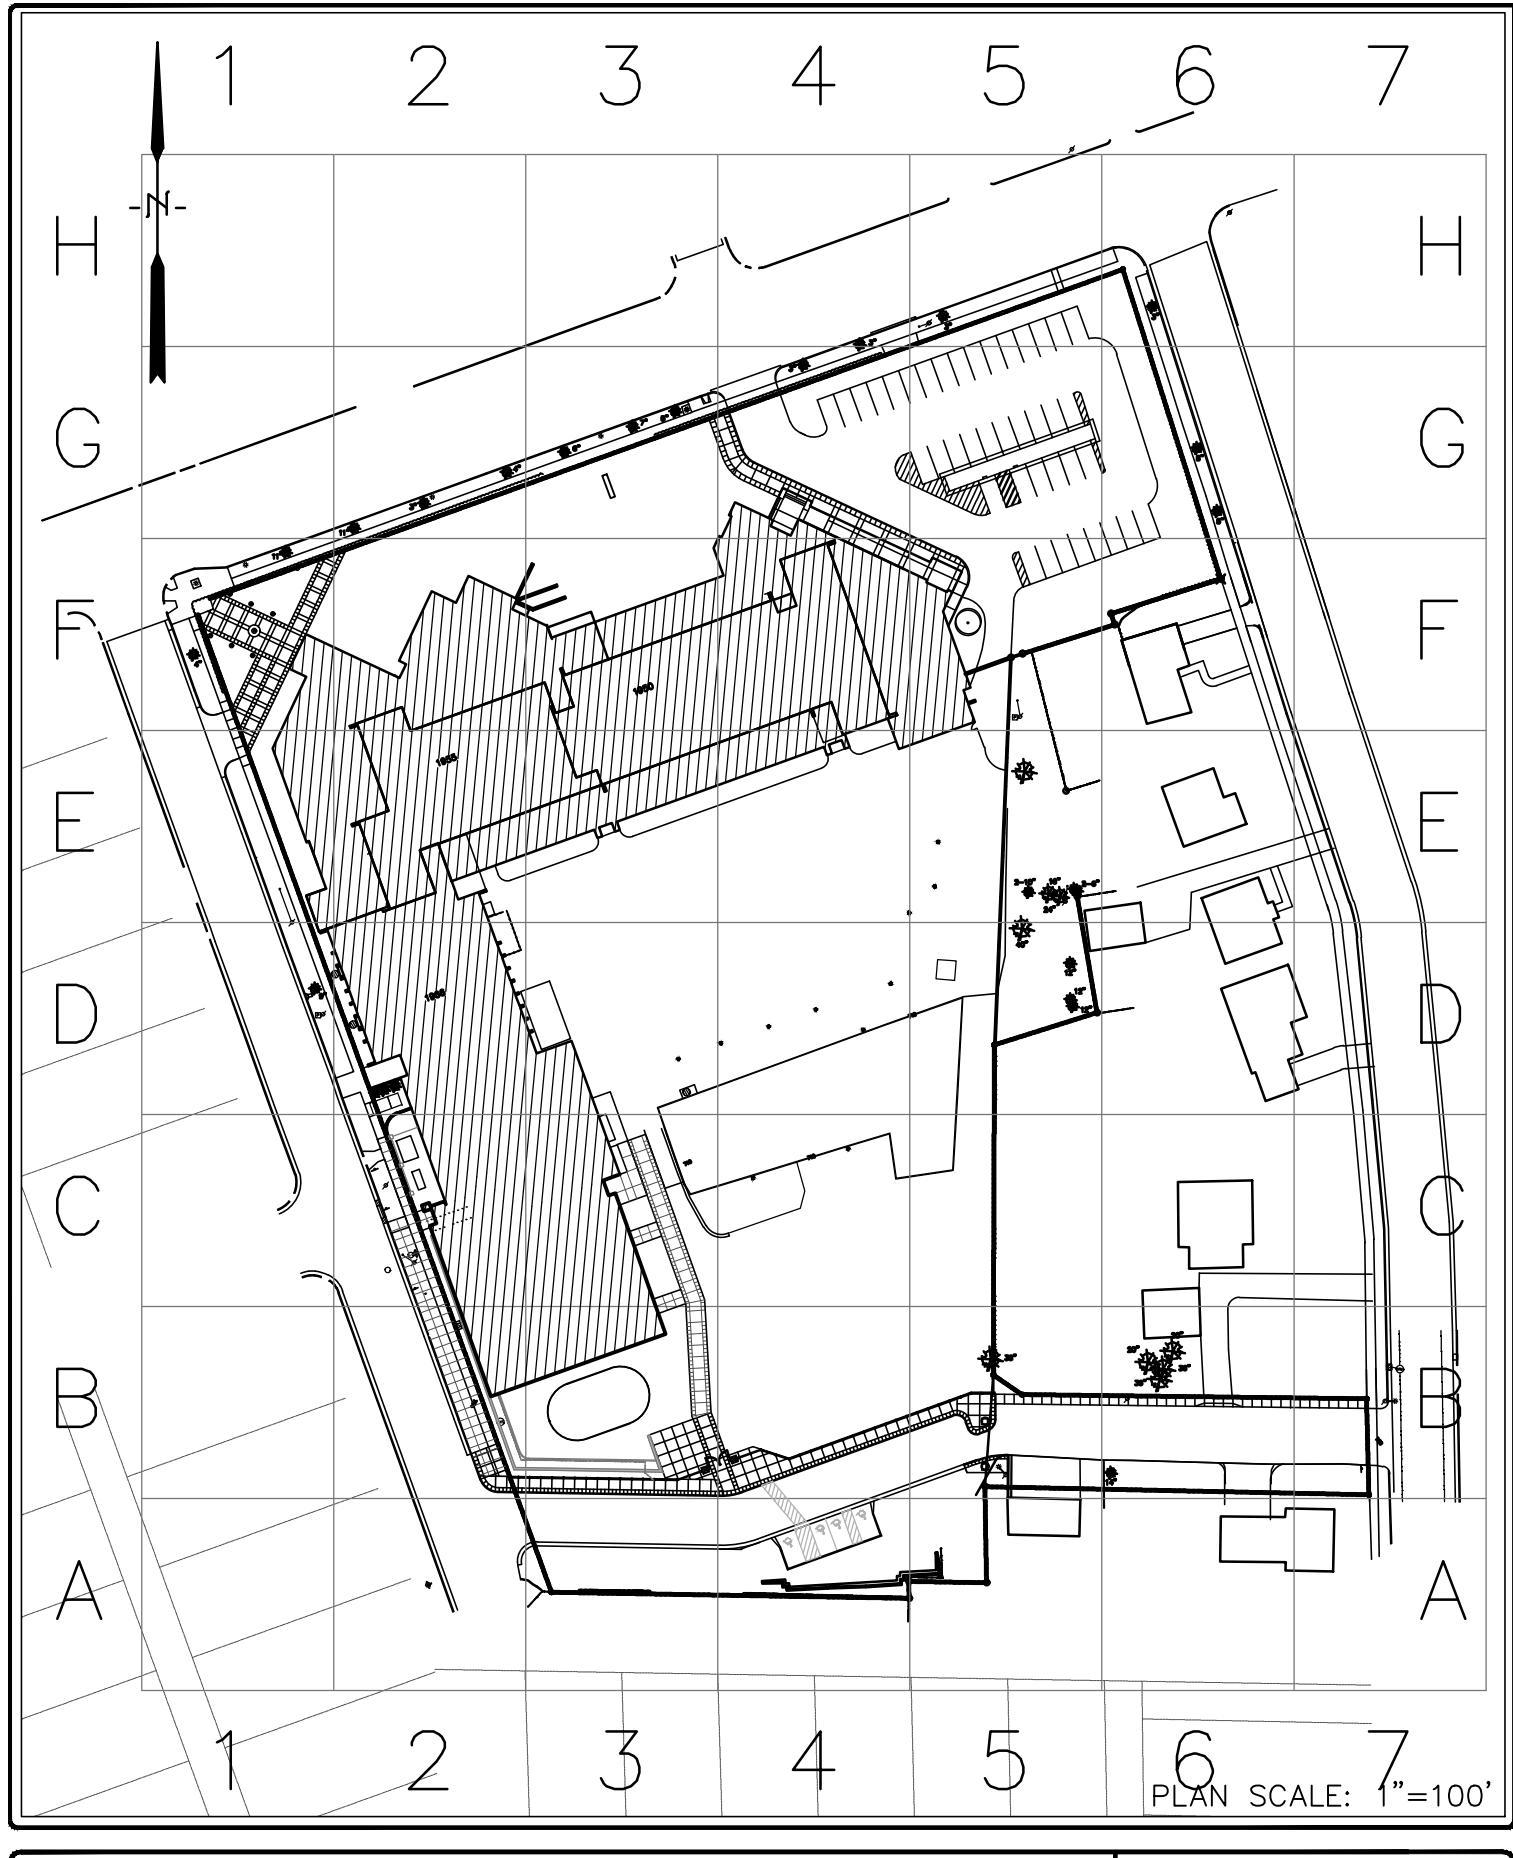
IRVING PERTZSCH ELEMENTARY ONALASKA, WISCONSIN DATE: 03/08/18

There are several areas where minor paving misalignments result in a tripping hazard. These are inexpensive and should be taken care of soon. In particular, the paving at the front entrance is misaligned in the area of the accessible route to the building. This results in about a 1.5" lip between the asphalt driveway and the entrance sidewalk. Based on the importance of this entrance this should be addressed immediately. Temporarily, the asphalt could be ground down to eliminate the lip. In the long term there should be a concrete apron placed in the area of the accessible route to prevent the misalignment in the future.

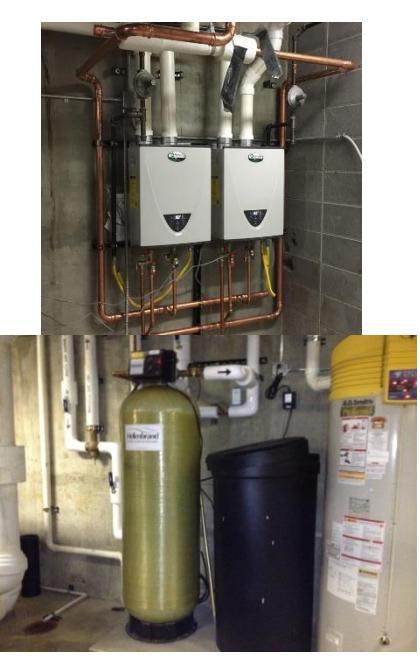
- Water heating equipment consists of two gas-fired instantaneous water heaters. The heaters appear to be in good condition. (New in 2016)
- 2. The Holby mixing valve is set at 130 degrees for the public and classroom water temps. The valve should be set to a maximum outlet temp of 115 degrees.
- 3. The building is served by a Simplex Hellenbrand water softener. The water softener appears to be softening only the hot water. Water hardness levels in this part of the state typically require both the hot and cold water to be softened.

- 1. Provide maintenance on water heaters as required.
- 2. Repair or reset existing Holby valve.
- 3. Existing water softener may be capable of providing soft water for the entire domestic water demand. This would allow the district to eliminate the water softener located in the kitchen. Additional investigation would be required.

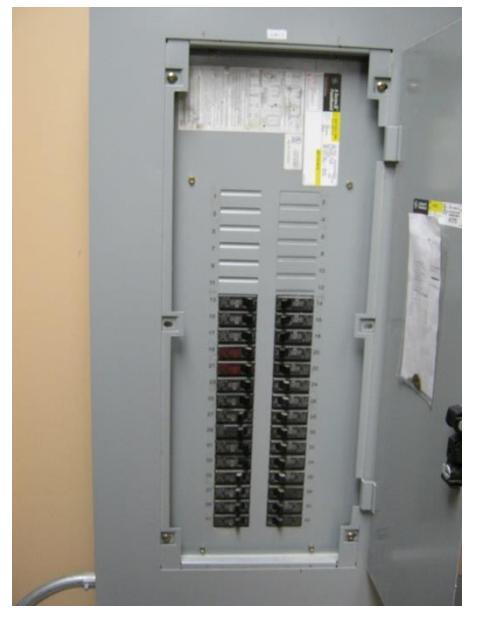
#### Panelboards

- A. The panelboards are General Electric.
- B. A majority of the panelboards were installed in 2006. There are a few panelboards from 1960 that are still in use.

A. Replace the 1960 panelboards and feeder with new. New circuit breakers will allow for a safer and more expandable installation. \$7,000 EA for a Total of \$42,000.

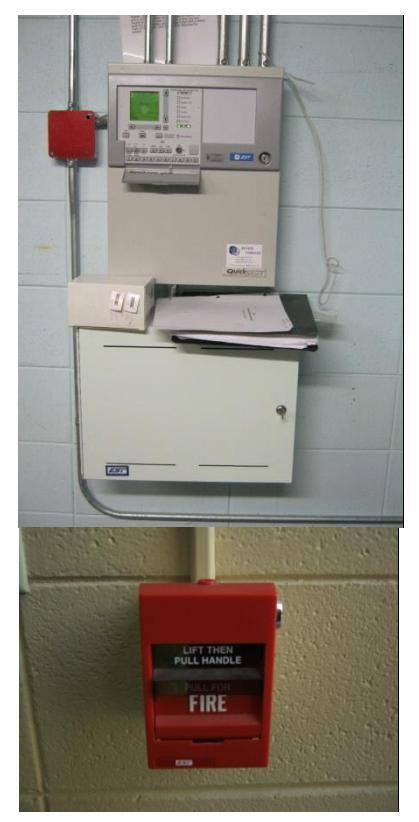
#### **Fire Alarm System**

- A. The fire alarm is an EST Quick Start addressable system. The system is 12 years old and has reached the end of it's life expectancy, it was installed in 2006. The fire alarm control panel is located in the lower level mechanical room. The control panel is obsolete and replacement parts are no longer available.
- B. There are pull stations by all exterior doors.
- C. There are ceiling mounted horn strobe devices in the corridors and classrooms.
- D. There are smoke detectors in the classrooms, corridors, and storage rooms. There are heat detectors in mechanical rooms.
- E. There are duct smoke detectors in the air handling units operating at 2000 CFM or greater.
- F. All fire alarm cabling is installed "open air" above the ceiling.

A. The fire alarm system is in adequate working order, however it is approaching end of life in age and should be replaced as soon as possible.

B. Upgrading to an audio evacuation fire alarm system:
- 1. Audio Evac Fire Alarm Systems are now the normal design practice for any size school.
- 2. This building is partially sprinklered.
- 3. The Onalaska School District has made strides and have developed a new standard for fire alarm systems, for example the Northern Hills Elementary School has an audio evacuation fire alarm system. Recommend to continue on this path for all schools in the district.
- 4. Budget estimate to upgrade to audio evacuation system installation \$105,000.

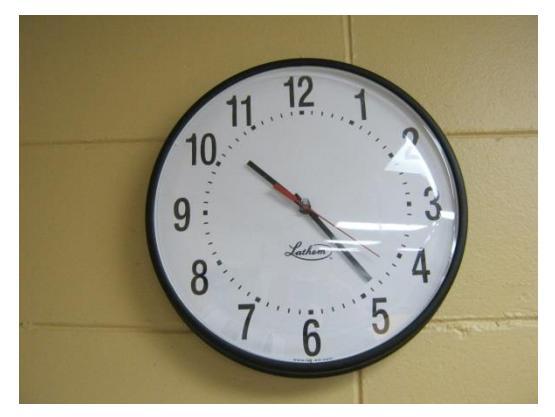
#### **Clock System**

- A. There is a Lathem wireless synchronized clock system. This system is 12 years old and was installed in 2006. The clock master controller is located in the main IT room.
- B. There are Lathem analog battery powered clocks in the classrooms, offices, and other public areas.
- C. The bell tone is controlled by the master clock controller.

A. The clock system is obsolete and should be replaced.

A. The existing system is obsolete and should be replaced. Budget \$20,000.

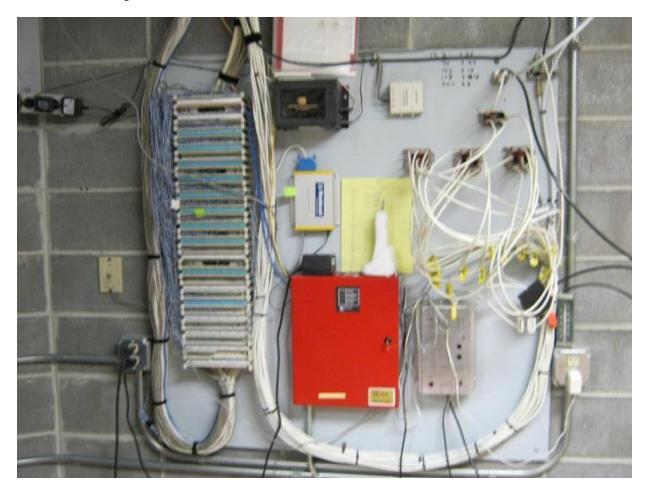
#### **Phone System**

- A. There is a recently installed Mitel 3300 IP (Internet Protocol) phone system. This system was installed in 2015 2016. New IP phones have been installed through-out the school.
- B. The phone cabling is CAT3 and is routed back to wall mounted voice wiring blocks. The voice wiring blocks are located in the main IT room.

A. Remove all CAT 3 wiring and jacks and replace with new CAT6. Budget \$30,000.

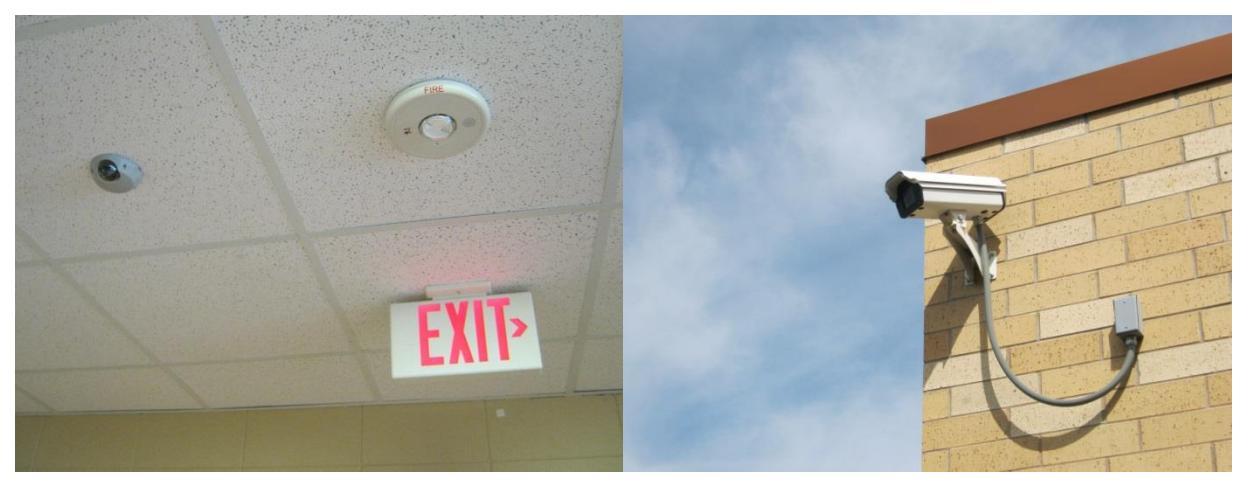
#### **CCTV System**

- A. There is a server based IP CCTV system used throughout all the buildings in the district.
- B. There are interior and exterior fixed color IP cameras.
- C. Current Network recorder has the capability of recording for 30 days.

B. Provide additional interior and exterior IP Cameras. \$1,000/camera for interior, \$2,000/camera for exterior as needed.

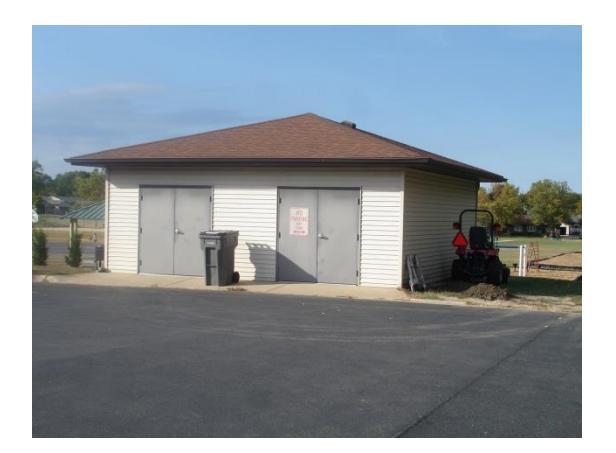
- 6.0 The building design incorporated energy efficiencies including increased roof and wall insulation, thermally efficient aluminum windows, energy efficient light fixtures and new HVAC systems.
- 7.0 Auxiliary Buildings: The existing storage garage is a 24' x 24' wood framed structure located off the northeast corner of the school and utilized for miscellaneous equipment. The structure consists of a wood stud framed walls on a concrete floor slab, prefabricated wood trusses, vinyl lap siding and asphalt shingled roof.

In general, the garage structure appears to be in satisfactory condition. The asphalt shingles should provide several more years before it becomes necessary to replace the shingles.

Add pole light at north side of garage to illuminate gazebo area.

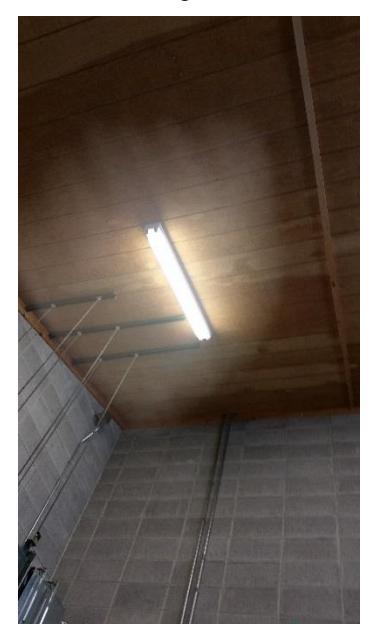
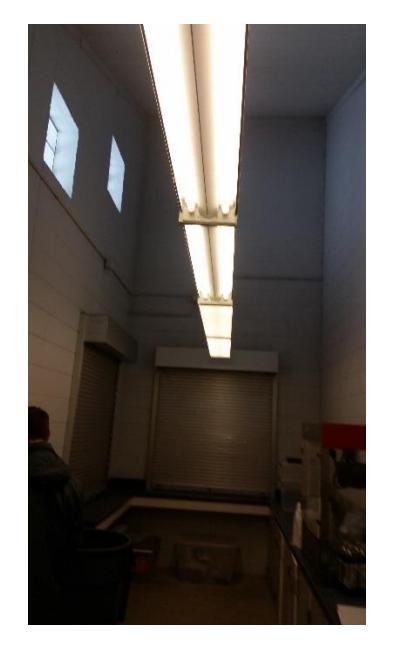
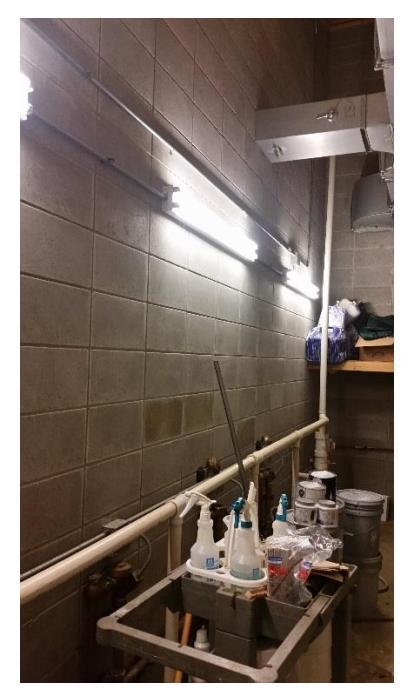
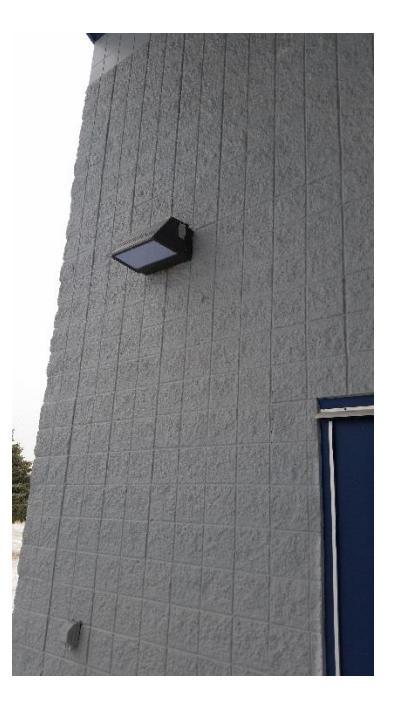
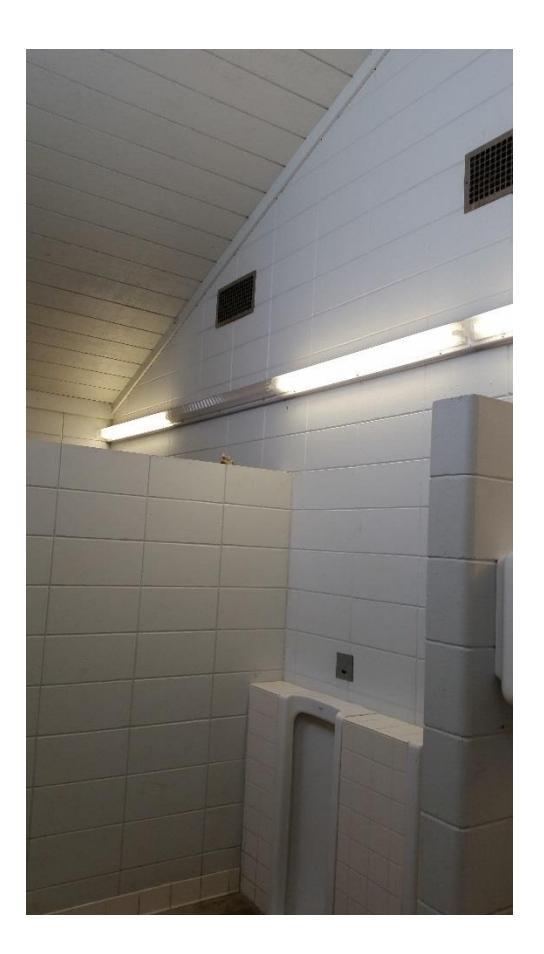
# **Lighting Fixtures and Controls**

- A. In the Storage Area there are 2-lamp fluorescent strip lights with electronic ballasts and T8 lamps.
- B. In the Concession Area there are 2-lamp fluorescent 'wrap' around with electronic ballasts and T8 lamps.
- C. In the Mechanical Room there are 2-lamp fluorescent strip lights with electronic ballasts and T8 lamps.
- D. The Exterior fixtures are LED wall-packs and were installed in 2017.
- E. In the Restrooms there are 2-lamp fluorescent 'vandal proof' lights with electronic ballasts and T8 lamps.

A. Replace interior fluorescent lighting fixtures with new energy efficient LED lighting fixtures. Budget - \$7,000.

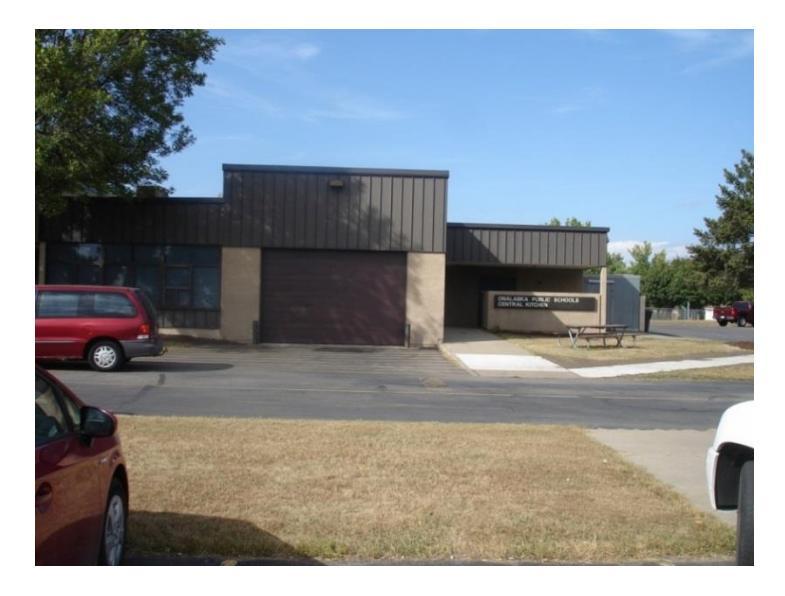
In general, the exterior cladding (stucco and metal panels) is in satisfactory condition.

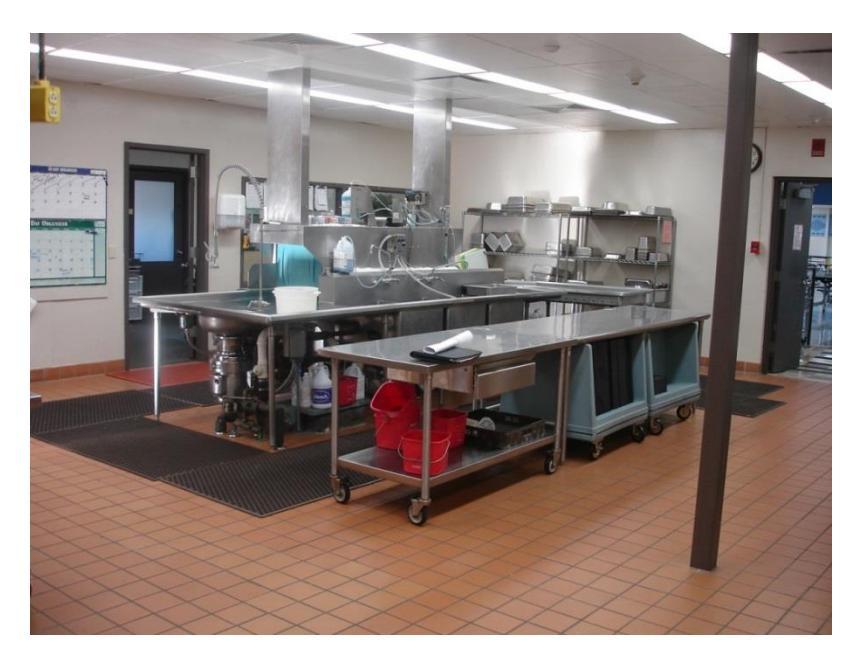
The Hobart dishwasher (1974) was replaced in 2014.

In general, the kitchen equipment in the 1999 north side addition is in satisfactory condition.

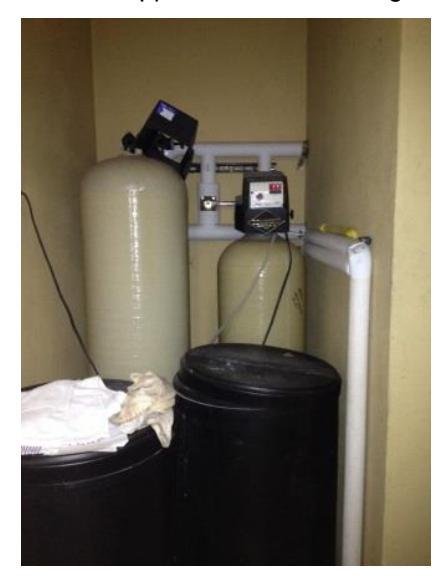
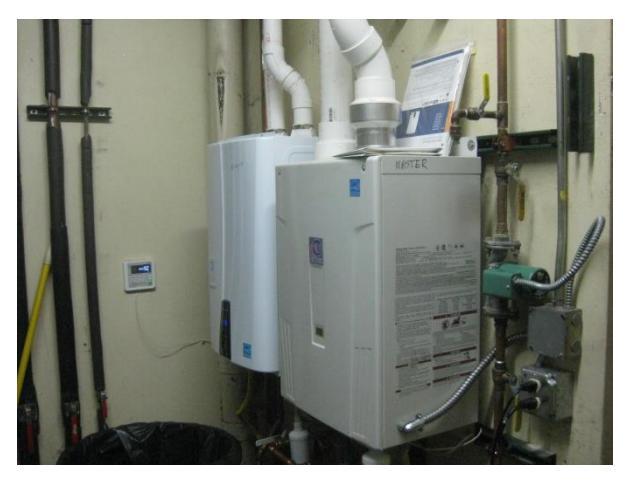
- 1. Water heating equipment is gas fired instantaneous water heating equipment. Currently 2 units @ 199MBH each provide hot water for the Kitchen. There is a HWR pump.
- 2. The building is served by a Small Simplex Diamond water softener. The water softener appears to be softening hot and cold water.

- 1. Instantaneous water heating equipment is required to be maintained for scale on a regular basis. Annual maintenance shall be provided on equipment as required.
- 2. Existing water softener should be verified for proper functioning
- 3. A large exterior grease interceptor should be considered
- 4. Moving gas piping to above grade should be considered
- 5. Adding Emergency gas shut off should be considered
- 6. Replacement of CI sanitary drain piping should be considered

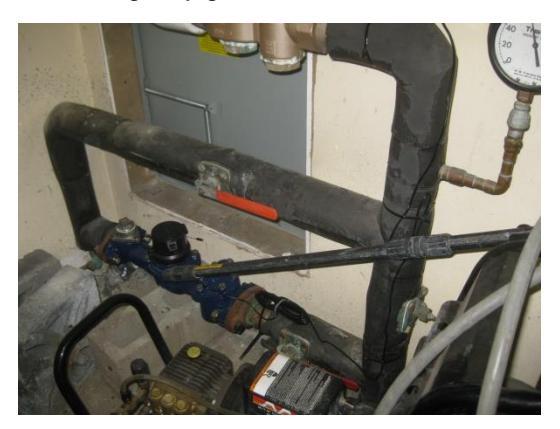
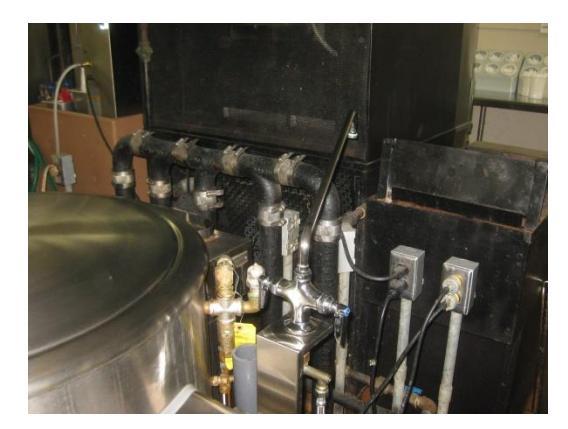
- 3. Kitchen is served by a 2" K copper water service and a 2" water meter, water pressure is 68PSI before pressure reducing valve, piping is copper
- 4. Water piping to fixtures is fed underground, it is K copper.
- 5. Gas piping is fed to Cook area underground, there does not appear to be an emergency gas shut off valve.

- 6. There is a small in ground grease interceptor for the 4 compartment sink. I do not think there is a grease interceptor for the large conveyor dishwasher.
- 7. The Kitchen has its own Gas Meter at the NE corner of building.

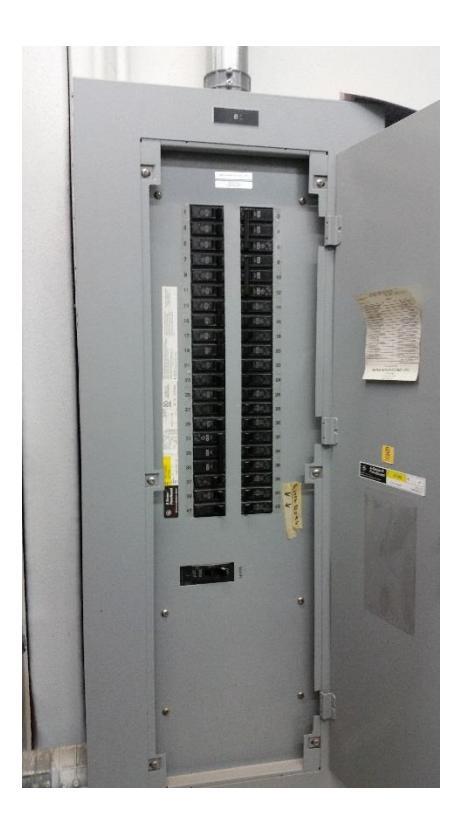
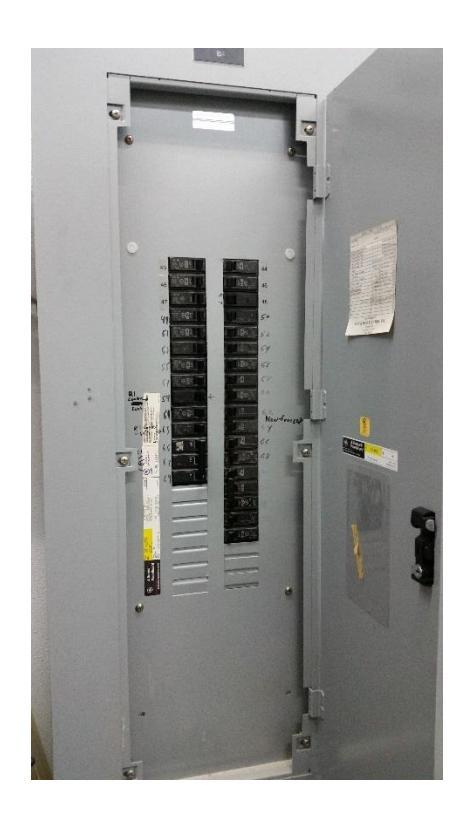
#### Panelboards

There are two (2) panelboards 'B1' and 'B2', 200 Amps., 120/208VAC, 3-Phase, 4- Wire with 42 circuits each serving the Central Kitchen, they are General Electric.

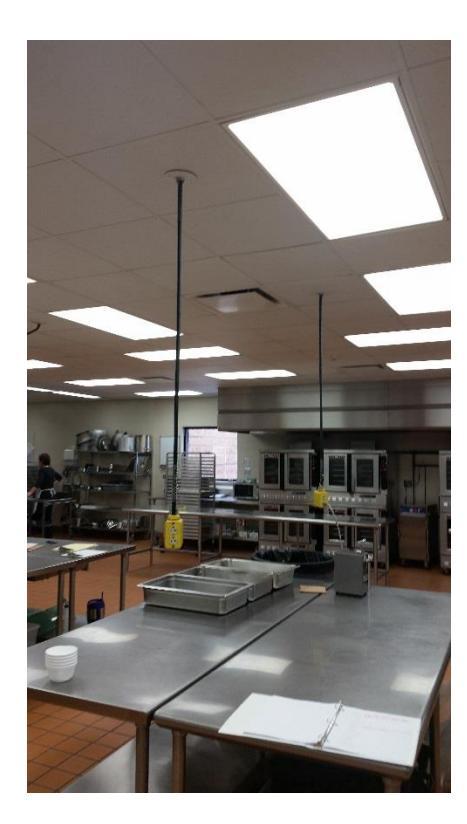
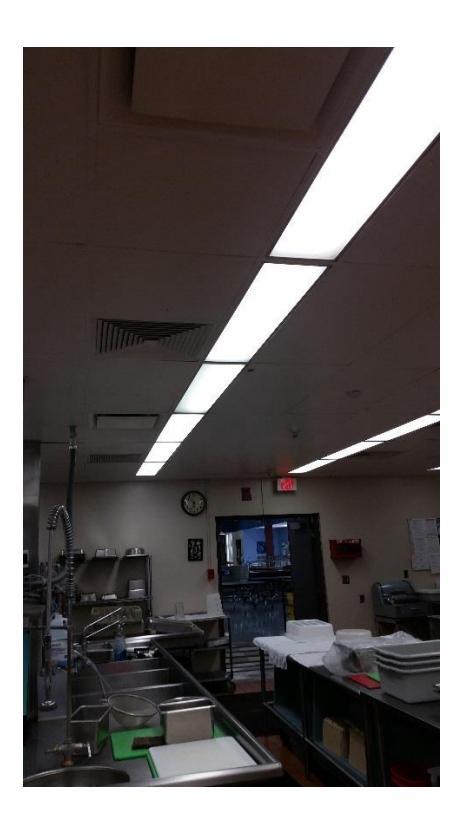
# **Lighting Fixtures and Controls**

- A. The kitchen has a combination of 2x4 acrylic lens 2-lamp fluorescent fixtures and 1x4 acrylic lens 2- lamp fluorescent fixtures. The lamps are T8 with a color temperature of 5000K. The ballasts are electronic. The light fixtures are on 8' centers in a variety of patterns.
- B. The offices have 2x4 fluorescent fixtures. The lamps are T8 with a color temperature of 5000K. The ballasts are electronic.
- C. Exterior perimeter wall-pack fixtures, canopy and parking lot lighting were recently updated to LED in 2017.

- A. Replace existing interior fluorescent lighting fixtures with LED upon failure or during future remodel projects. \$200 for each fixture.
- B. Replace all existing interior fluorescent lighting fixtures with LED and install new programmable digital computer network lighting controls to meet current energy codes and industry standards. Budget – \$30,000

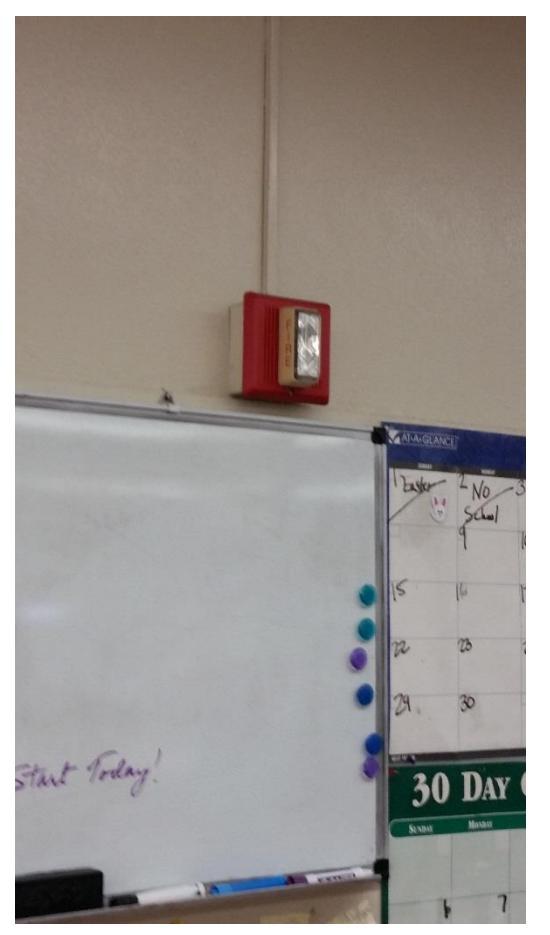
#### **Fire Alarm System**

- A. The fire alarm control panel is an EST3 addressable system and located in the Middle School electrical room.
- B. There are pull stations by all exterior doors.
- C. There are wall mounted horn strobe devices.
- D. There are smoke/heat detectors.

A. The majority of the system has reached its expected life expectancy and should be replaced with new.

- A. Consider upgrading to an audio evacuation fire alarm system:
  - 1. Audio Evac Fire Alarm Systems are now the normal design practice for any size school.
  - 2. This building is not sprinklered.
  - 3. The Onalaska School District has made strides and have developed a new standard for fire alarm systems, for example the Northern Hills Elementary
  - 4. hool has an audio evacuation fire alarm system. Recommend to continue on this path for all schools in the district.
  - 5. Budget estimate to upgrade to audio evacuation system installation \$10,000.

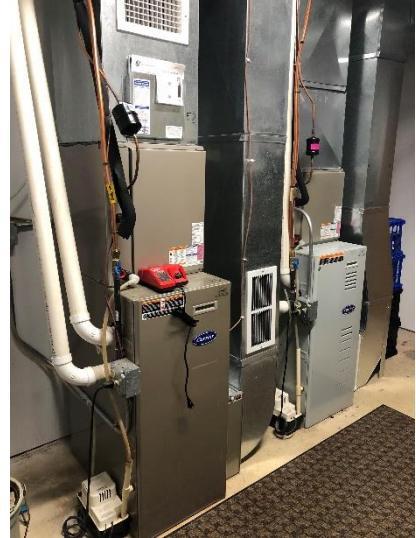
- 1. The existing equipment appears to be at least 10 years old and is in satisfactory condition. However, it was reported that the ability to control temperatures and humidity in the building is poor.
- 2. One of the Carrier ductless split system units serving the data center is not currently operational and in need of replacement.

3. The data workroom is currently not ventilated to meet code requirements for an occupied space. The electric space heater and the LG ductless split system do not provide any ventilation air to the room.

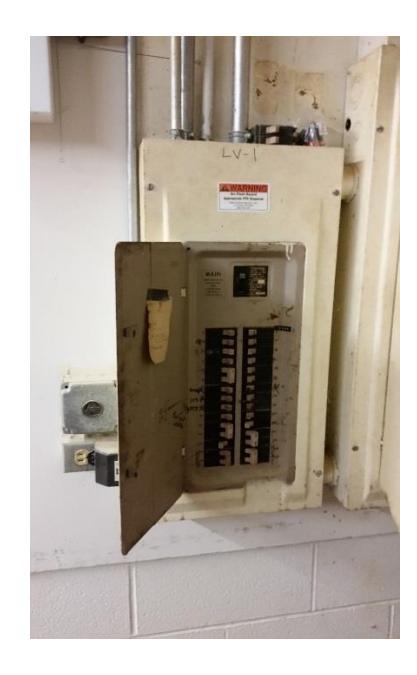
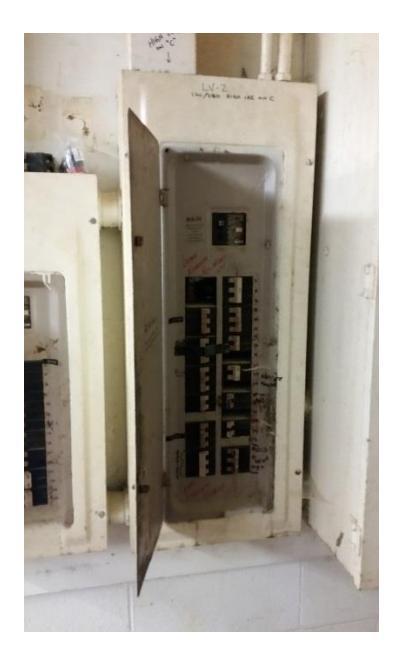
#### Panelboards

There is One (1) existing Cutler Hammer panelboard, 225 Amps., 120/208VAC, 3-Phase, 4- Wire with 42 circuits. The second panelboard is a Cutler Hammer, 125 amp., 120/208VAC, 3phase, 4-wire sub-panel with 30 circuits.

A. These panelboards are outdated and should be replaced with new during future remodel projects.

B. These panelboards have exceeded their useful life and should be replaced.

C. Replace with new panelboards.

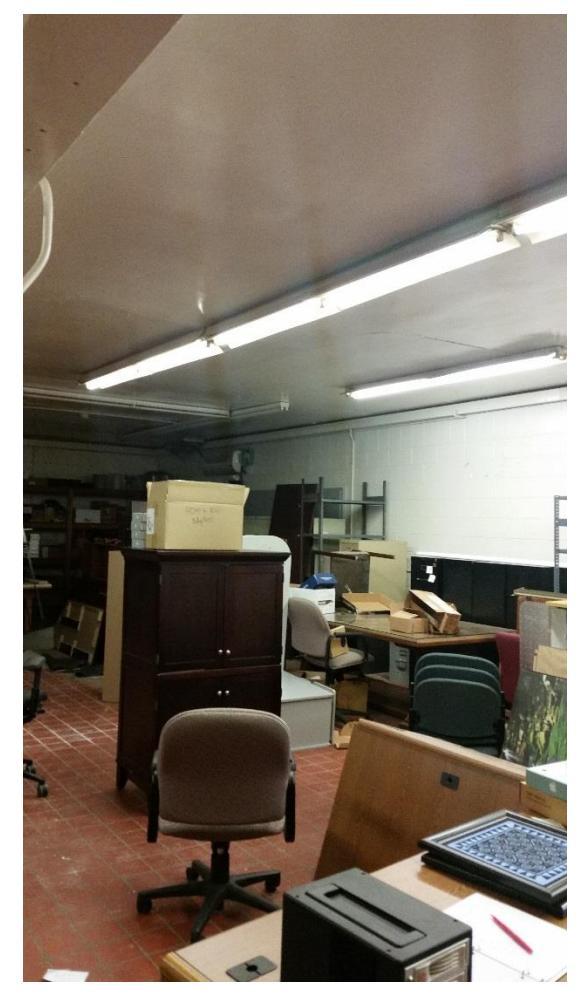
## **Lighting Fixtures and Controls**

- A. The interior lighting fixtures are 4'-0", single-lamp fluorescent 'strip' lights with electronic ballasts and T8 lamps.
- B. There are no emergency egress lighting units.
- C. There are no occupancy sensors or lighting controls.

A. The existing interior and exterior light fixtures are outdated and should be replaced with future remodel projects.

A. Replace with new energy efficient LED lighting fixtures and controls.

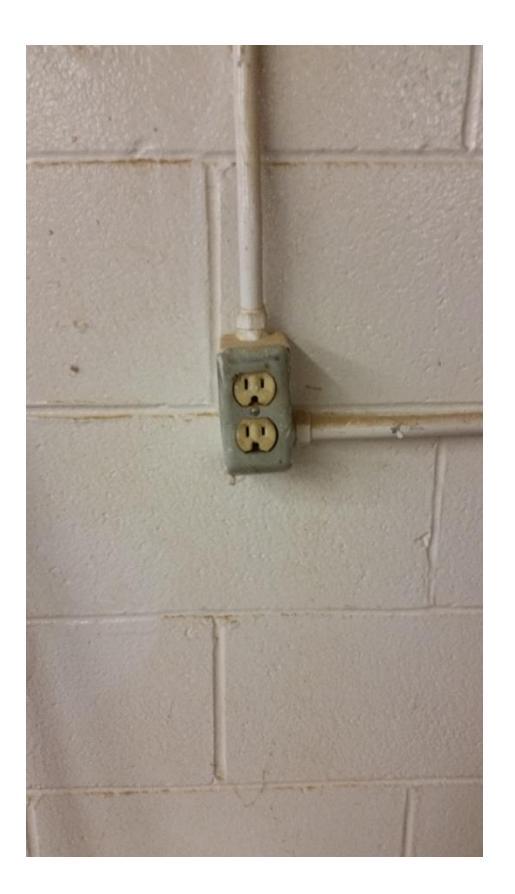
## **Wiring Devices**

A. There are 15 amp., and 20 amp. receptacles and toggle switches with metal cover plates.

A. The receptacles and toggle switches are outdated and should be replaced with new. A few receptacles are broken.

A. Replace with new.

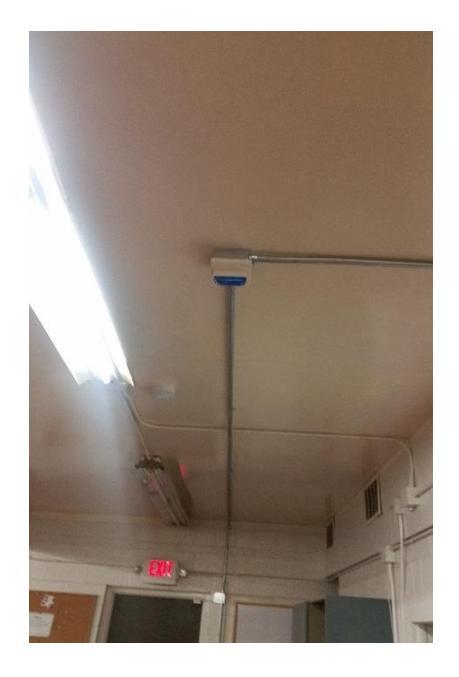
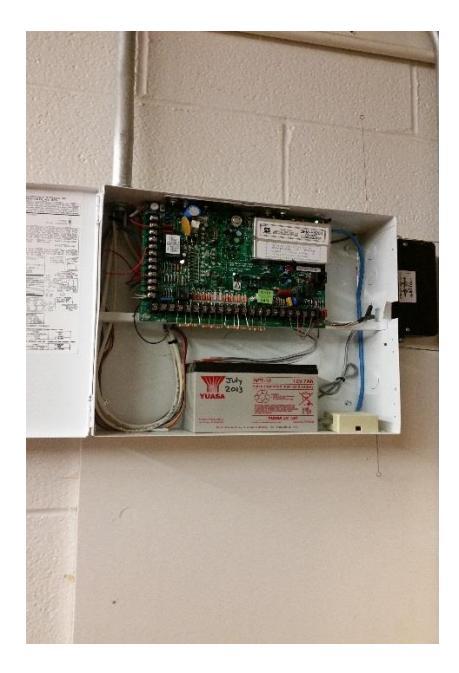
#### **Fire Alarm System**

- A. The existing fire alarm control panel is an outdated Gemini system in combination with the Security System. It is no longer functioning.
- B. There are no pull stations by exterior doors.
- C. There are ceiling mounted horn strobe devices.
- D. There are smoke/heat detectors.
- E. All fire alarm cabling is installed in conduit.

A. Replace with new.

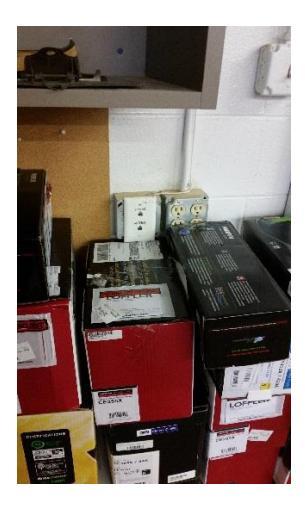
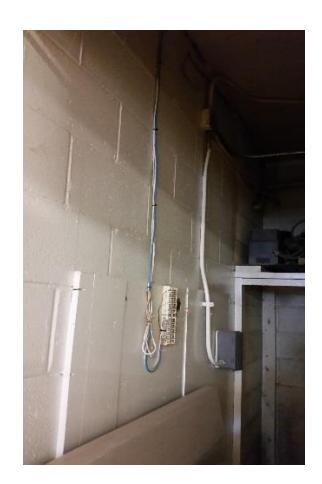
#### Phone and Data System

A. There is only One (1) phone jack and One (1) data jack in the building.

A. Replace with new.

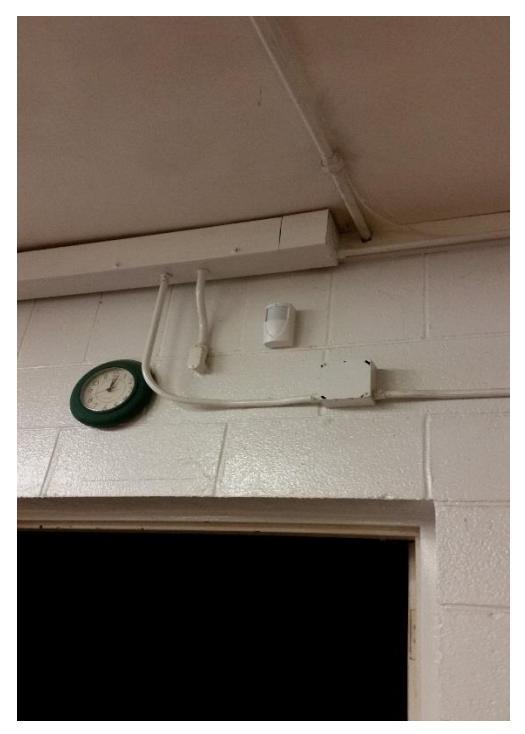
#### **Security System**

- A. There is an outdated Gemini security system.
- B. The security system has motion sensors and a keypad.
- C. There are exterior door contact switches.

A. Replace with new, match the same hardware and devices as previously installed in the District Office.
