School District of Onalaska 2013 Facilities Condition Assessment October 10, 2013

2013 Facilities Condition Assessment School District of Onalaska

FACILITIES CONDITION ASSESSMENT Onalaska School District Onalaska, WI 54650

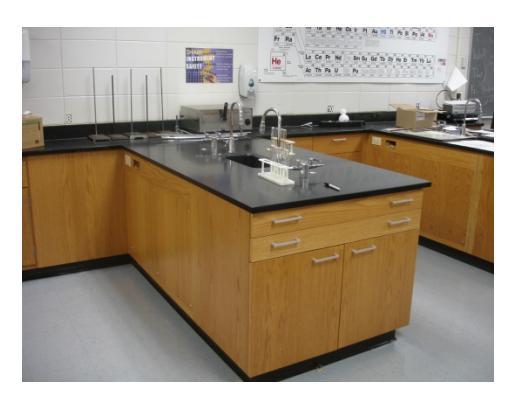
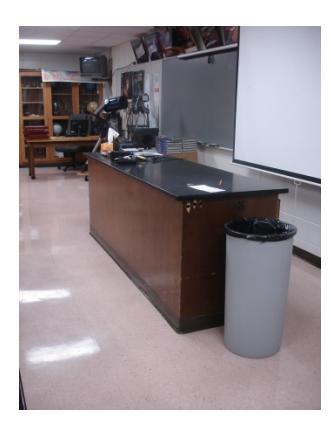
The high school science department was included under the 1988 project and consists of six (6) lab/classrooms located in the lower level at the west end. Each of the science labs has wood cabinetry with epoxy resin worksurfaces. The two chemistry labs have demonstration type fume hoods. Both chemistry labs also have emergency eyewash sinks and overhead emergency drench showers. Is is recommended that the eyewash sinks and showers be replumbed to add mixing valves to the water service to temper the water temperature. Chemistry room 119 was updated approximately 5 years ago with new faucets and gas turrets. All other gas turrets and gooseneck faucets are original (1989) and appear to be in good condition with a couple of exceptions.

The instructor's demonstration tables were salvaged at the time of the 1989 construction from the previous school's laboratories. These tables should be changed out with new ADA compliant demonstration tables. All other island and peninsula chemistry workstations appear to be in good condition with minimal signs of damage. Salvaged storage cabinets are also used in the science prep rooms. These cabinets appeared to be well built and should have several years of service left.

- 1. An annual budgeted allowance should be established for the replacement of any of the original faucets or gas turrets that may begin to wear beyong the ability to make cost effective repairs.
- 2. None of the six science labs offer provisions for handicap accessibility. It is suggested that the District replace the instructor's demonstration tables with new ADA compliant tables and also purchase a movable and adjustable height table and worksurface that could easily be shared and utilized should it be necessary to provide for wheelchair access to the student workstations.

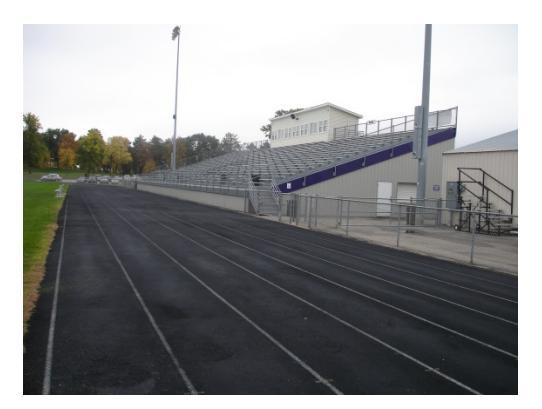
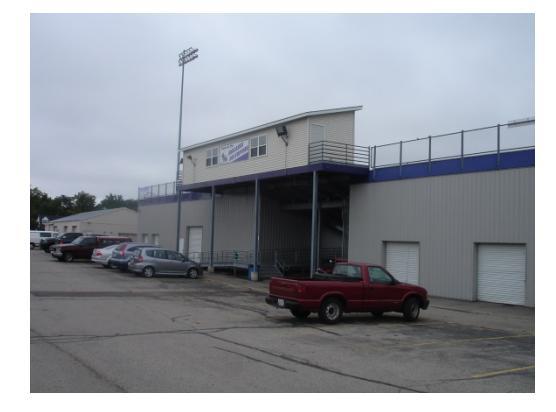
3.1 OUTDOOR FOOTBALL FIELD BLEACHERS & PRESS BOX

The main bleacher facility is located at the west edge of the football outside lane of the running track and was originally constructed without an underneath closure. The framing consists of steel substructure with aluminum bench seating and galvanized steel guardrails.

The underside was closed off with prefinished ribbed metal wall panels to provide secure storage for P.E. equipment and field maintenance equipment. The north end serves as concession sales. A wood framed press box was added in the 1990's and supported by wide flange steel columns. The west wall of the enclosed understructure includes three push-up coiling doors and three similar coiling counter doors at the concessions sales corner. With exception of the press box, the main structure and seating assemblies appear to be in satisfactory condition.

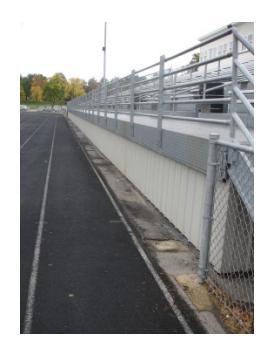
- Run-off from the football field passes unimpeded over the running track and then though the storage rooms under the bleachers collecting at a low point catch basin.

- Water run-off flows around the north end of the bleachers and continues to the catch basin off the west side of the bleachers.

Stormwater run-off management needs to be re-designed to prevent the water from passing through the enclosed under-bleacher storage areas This will involve a comprehensive plan that collects run-off from the football field and running track, routing it to an enlarged storm sewer system. Another consideration would be to create a storm water detention area in the lawn area to the south of the bleachers.

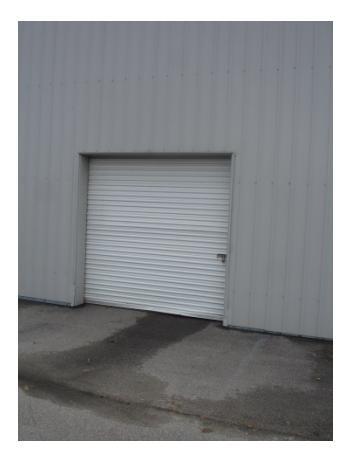
Also included on the list of improvements would be replacement of the push-up coiling garage doors which show signicant wear.

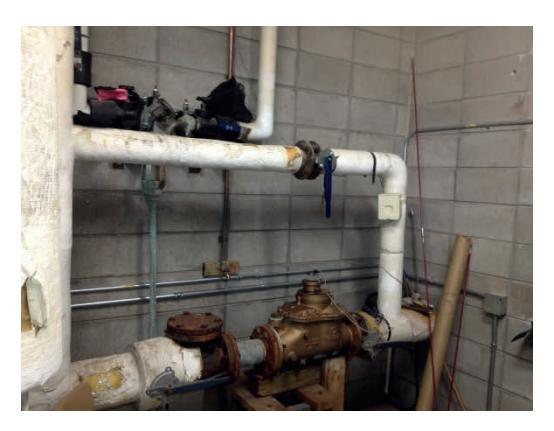
- Original portions of the building are provided with galvanzied domestic water piping. Additions and renovations have been piped using Type "L" copper tube.
- 2. Other than the shop areas, no problems with water pressure or water quality were reported. Further investigation is required to determine problems with the shop areas however it is expected that the old galvanized piping may be failing.
- Water at the start of the school year is always very rusty. This problem occurs with the existing galvanized piping and will always occur until the galvanized water mains are replaced.

4. The building is supplied by a 4" domestic water service with a 4" water meter. A separate water meter and backflow preventer has been provided for irrigation to the athletic fields. The existing water service is not large enough to support a fire protection system for the building should one be desired in the future,

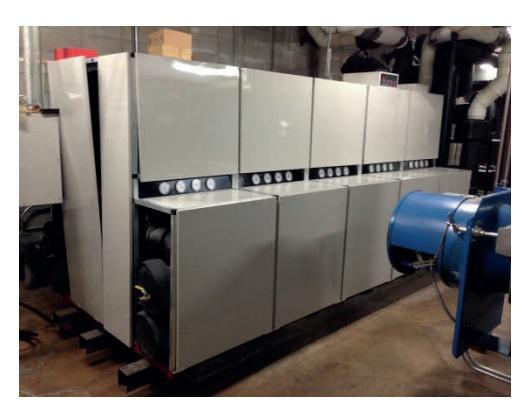
- The building is served by constant volume air handling units and air handling units with hot water VAV control. Some air handling units are original to the building from the 1960's while some have been replaced in recent years with newer modular Trane and McQuay equipment.

- 4. The entire building is controlled by direct digital control systems. Currently, this is split between Schneider Electric/Invensys controls and Trane controls.

- 1. The 1960's air handling units have exceeded their expected life span and are in need of replacement.
- 2. The boilers are in good condition and, with a proper maintenance program, should continue to serve the building for another 15 years or more.
- 3. The chilled water pump housing is currently not insulated and produces condensate which runs onto the boiler room floor.
- 4. Room thermostats are a mixture of adjustable and non-adjustable type. The nonadjustable are Schneider Electric and the adjustable are Trane.

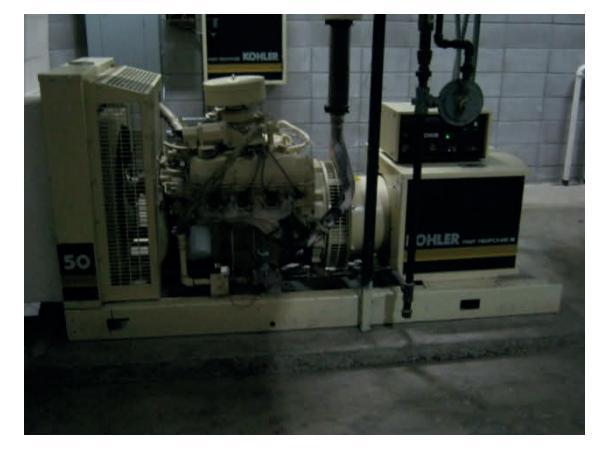
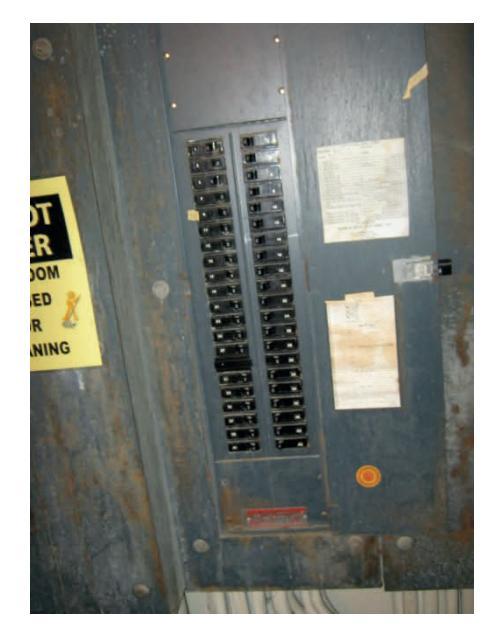
- The emergency panel fed from the transfer switch contains both life safety and equipment loads.
- 2. The generator is in good working order.

1. The expected remaining lifespan of the generator and automatic transfer switch is about 20 more years.

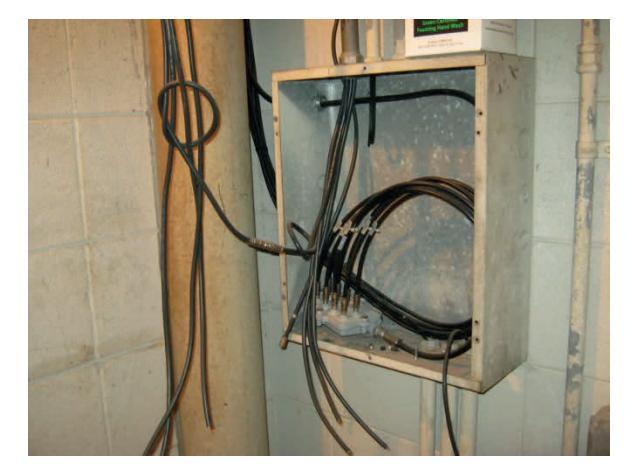
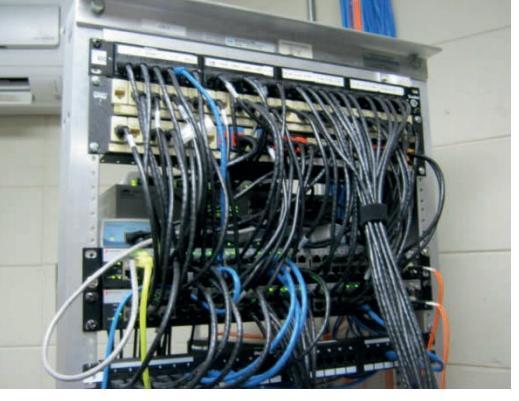
1. CATV system is in good working order.

2. Additional CATV jacks can be added.

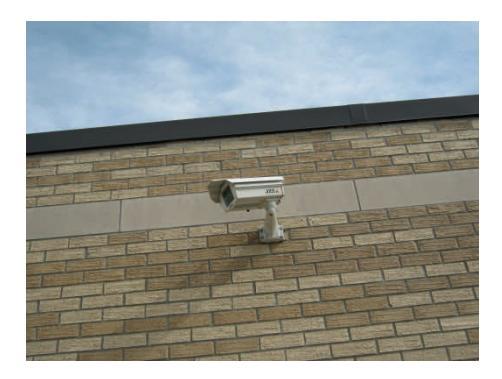
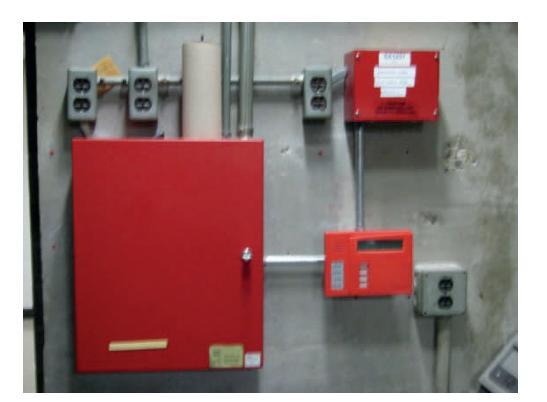
- 1. The CCTV system is in good working order.
- 2. Additional cameras can be added.

1. The expected remaining lifespan of the CCTV system is about 10-15 more years.

- 1. No recommendations at this time.
- 2. CCTV system replacement cost: \$1,500/camera

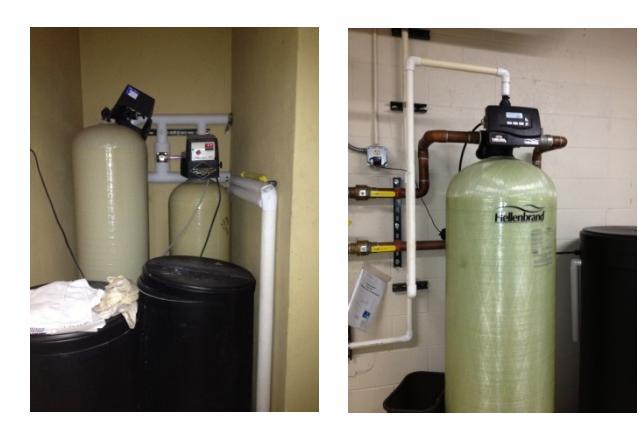
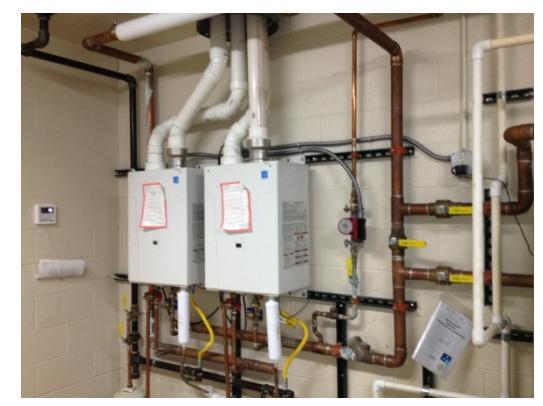
- 1. The expected remaining lifespan of the water heaters is 10 years
- 2. The expected remaining life cycle of the water softener is 20 years.

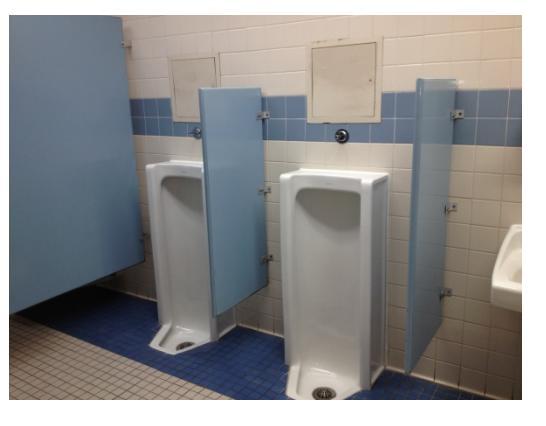
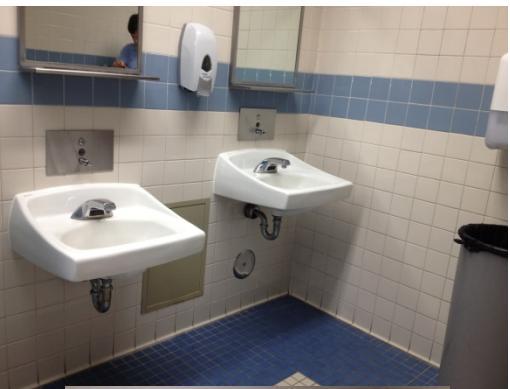
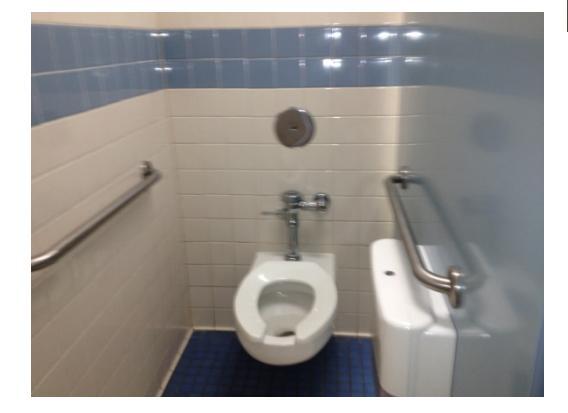
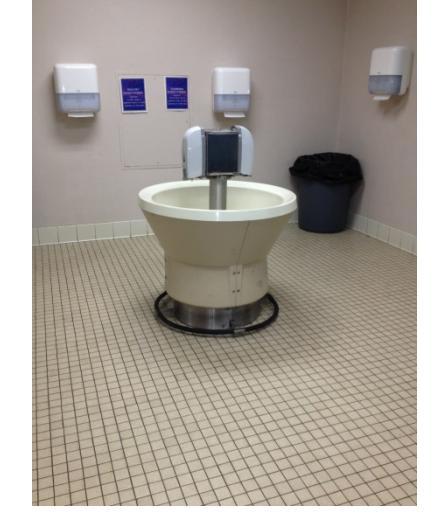
1. The expected remaining lifespan of the Plumbing Fixtures is 10 years. The estimated cost to replace the fixtures and associated piping is \$2,500 per fixture.

- 1. Plumbing fixtures should be scheduled for replacement.
- 2. Toilet rooms should be modified to be ADA compliant.

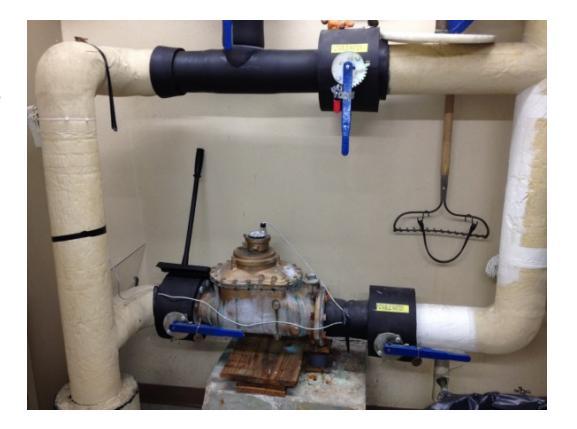
- Original portions of the building are provided with a galvanzied domestic water piping. Additions and renovations have been piped using Type "L" copper tube.
- 2. In some areas PEX tubing was installed to provide circulation to the domestic hot water system. This system is not performing as expected.
- 3. The building is supplied by a 4" domestic water service with a 4" water meter. A separate water meter and backflow preventer has been provided for irrigation to the athletic fields. The existing water service is not large enough to support a fire protection system for the building should one be desired in the future,

- 1. Galvanized domestic water piping should be scheduled for replacement.
- 2. The domestic water piping for this facility should be evaluated and potentially replaced to correct the problems with entire domestic water piping system.
- 3. Additions or major renovations to the building may require the building to be provided with a fire protection system. A new 6" domestic water service should be evaluated for the building.

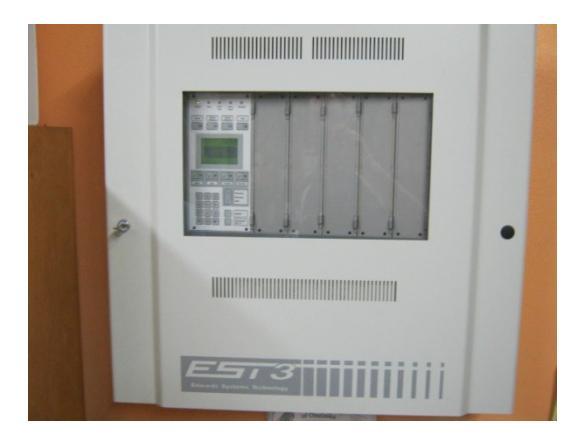
- The fire alarm is an EST 3 addressable system. The system was recently upgraded. The fire alarm control panel is located in the east mechanical room.
- 2. There are pull stations by all exterior doors.

There are wall mounted horn strobe devices in the corridors and classrooms. Many of these old devices were reused when the system was upgraded. New EST devices have been added where required by code.

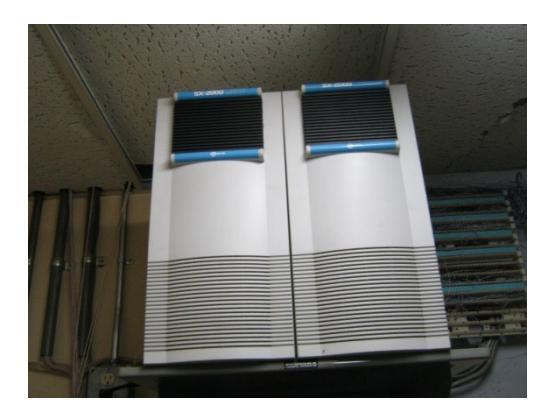
- 1. The phone system is in good working order.
- 2. Additional phones can be added to the system.

- The expected remaining lifespan of the phone system is about 15-20 more years.
- D. Recommendations
 - 1. None.

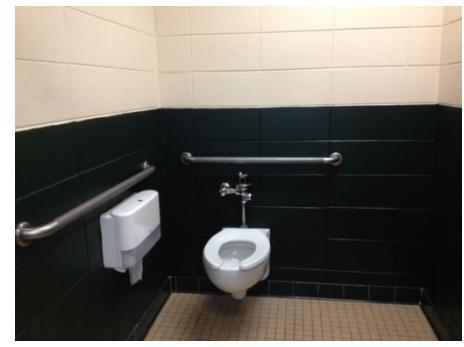
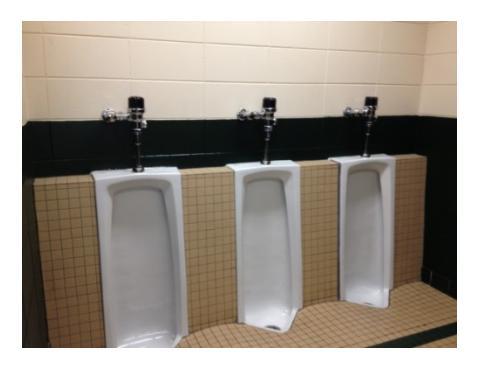
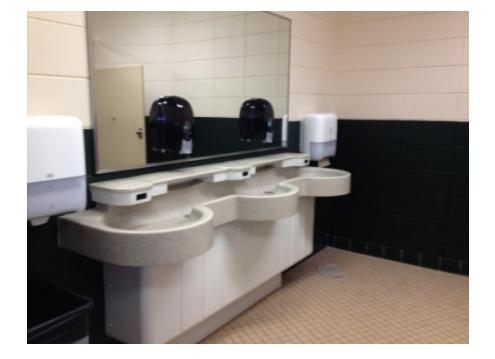
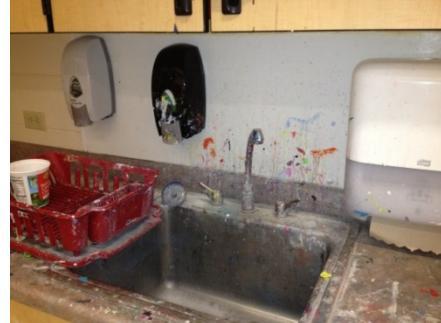
PLUMBING FIXTURES

- 2. Plumbing fixtures located within the toilet rooms and classrooms are generally in very good condition.
- 3. Toilet rooms in this facility are ADA compliant.
- 4. The owner indicated that the flush valves on the water closets and urinals need repair on a regular basis. This could be directly related to the hard water on the cold water.
- 5. The kitchen equipment is in very good condition.
- 6. Art room sinks are provided with plaster traps. Although messy, the sinks and faucets appear to be functioning well.

1. Toilet room fixtures in the original building should be scheduled for replacement.

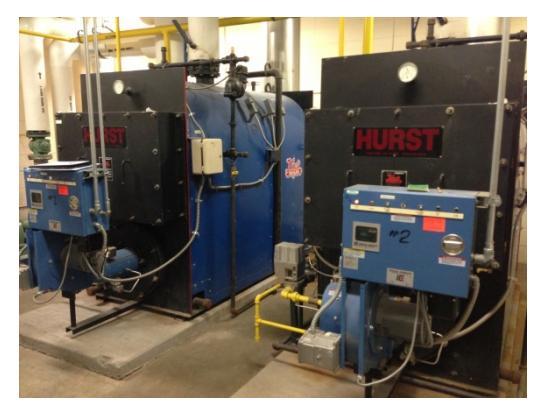
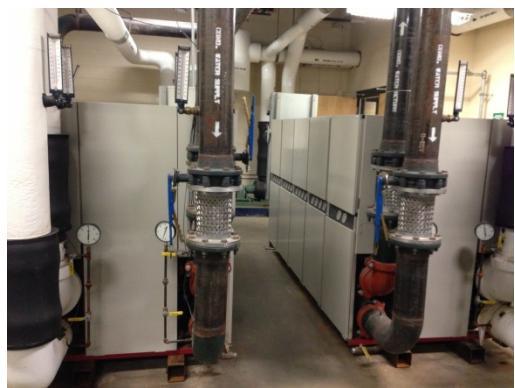
- The hot water heating system is in good condition and, with a proper maintenance program, should continue to serve the building for another 15-20 years.
- 2. The chilled water system is in good condition and, with a proper maintenance program, should continue to serve the building for another 15-20 years.
- 3. The digital control system contains several Barber-Coleman components from the original 1999 construction.
- 4. Hot water convectors and cabinet heaters are controlled by standalone electric thermostats that are not connected to the central digital control system.

- 1. Continue with the current preventative maintenance plan on all mechanical equipment.
- 2. Continue to maintain the existing Schneider Electric digital control system. We recommend maintaining the software with the latest updates to keep the system current. Replace the old Barber-Coleman components as part of the maintenance of the control system.

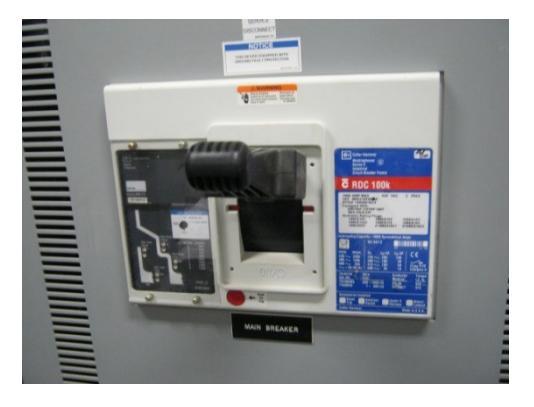
1. The main service switchboard is in good working order.

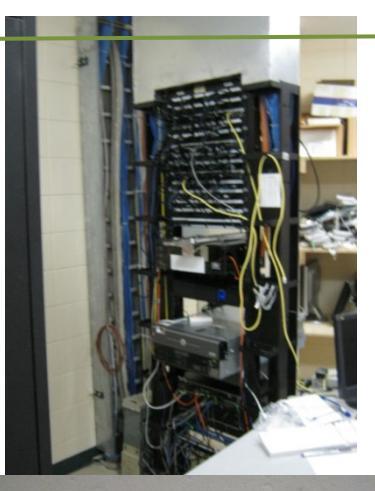
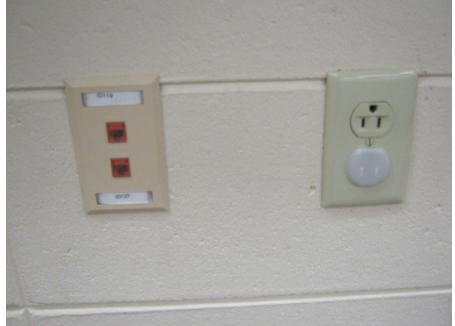
DATA SYSTEM

- 1. The data system is in good working order.
- 2. Additional horizontal runs of data cable can be added to the existing rack.

1. Replace CAT5 data cable with new CAT6 cable. \$100/data jack.

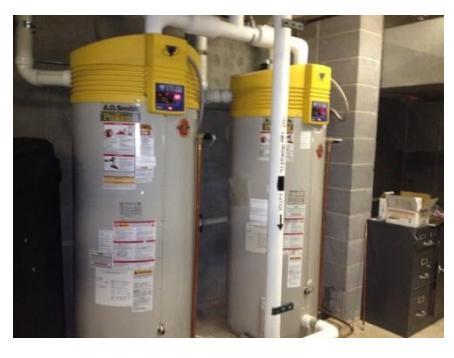
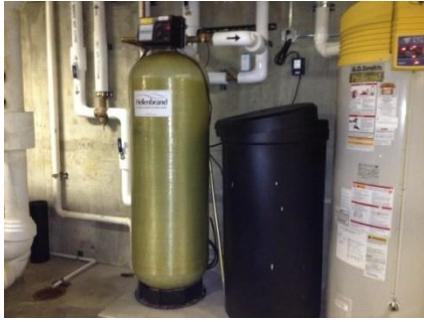
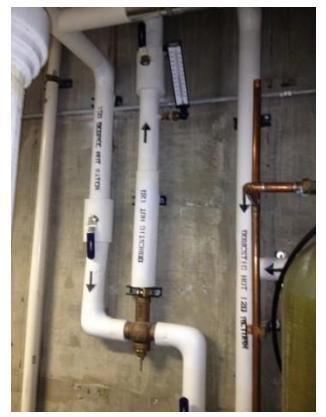
- Water heating equipment consists of two gas-fired AO Smith water heaters. The heaters appear to be in good condition however they appear to be slightly oversized for the current building demand.
- 2. The Holby mixing valve is set at 130 degrees for the public and classroom water temps. The valve should be set to a maximum outlet temp of 115 degrees.
- 3. The building is served by a Simplex Hellenbrand water softener. The water softener appears to be softening only the hot water. Water hardness levels in this part of the state typically require both the hot and cold water to be softened.

- 1. Provide maintenance on water heaters as required.
- 2. Repair or reset existing Holby valve.
- 3. Existing water softener may be capable of providing soft water for the entire domestic water demand. This would allow the district to eliminate the water softener located in the kitchen. Additional investigation would be required.

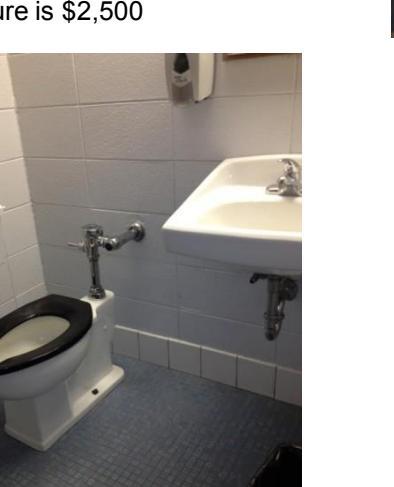
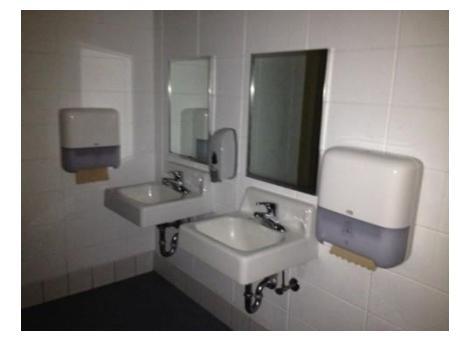
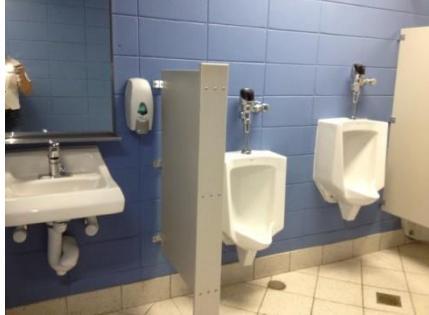
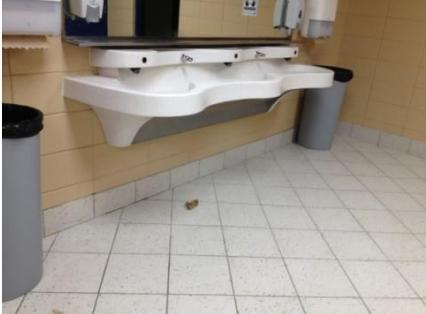
- 1. Plumbing fixtures located within the toilet rooms and classrooms are generally in very good condition.
- 2. The original toilet rooms are old and outdated and should be scheduled for replacement.
- 3. All classrooms are provided with sinks.
- 4. The kitchen equipment is in very good condition.

1. Toilet room fixtures in the original building should be scheduled for replacement.

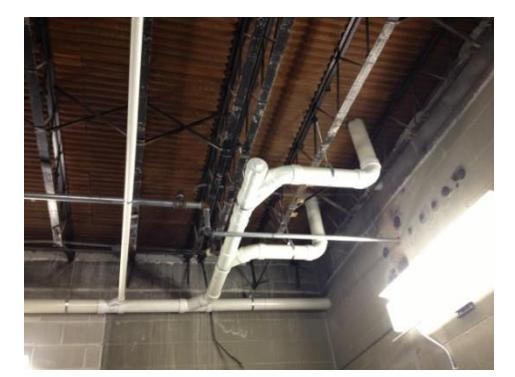
1. Sanitary piping in the original builing is cast iron. Sanitary piping in the addition is schedule 40 PVC piping. The owner did not indicate problems with the existing sanitary piping system.

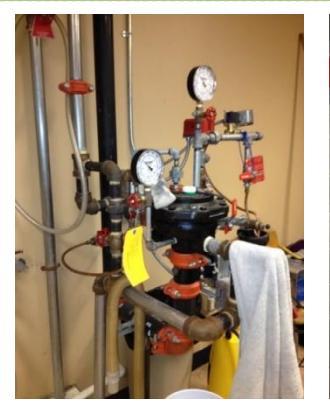
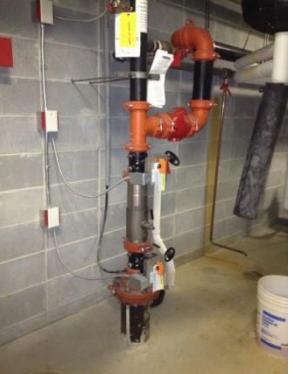
- The building is served by a 2" water service and meter. The existing service appears to be adequately sized for the building. The buildiong is also provided with a separate water meter for irrigation purposes.
- 2. The new addition is provided with a 6" water service which is designated for the fire protection system only. Only the new additon is provided with fire protection.
- 3. The Server room is provided with a preaction sprinkler system.

- 4. All new domestic water piping is Type "L" copper tubing and is in very good condition.
- 5. Original piping is galvanized piping

- 1. Galvanized domestic water piping should be scheduled for replacement.
- 2. The pre-action sprinkler system must be tested per NFPA and state and local fire codes.
- 3. Original galvanized domestic water piping should be scheduled for replacement.

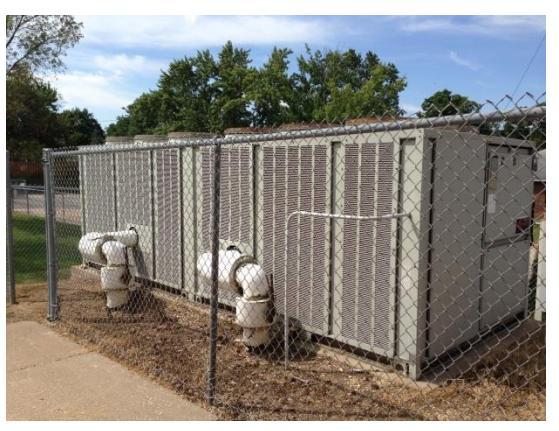
- 2. The building cooling system is a central chilled water system that consists of a 100 ton outdoor air-cooled Trane chiller and a 50 ton indoor Multi-Stack heat recovery chiller. The heat recovery chiller provides cooling during light load and spring/fall conditions while the condenser water loop is connected to the hot water system piping to provide warm water for reheat and areas requiring lighter amounts of heat. If the condenser water heat cannot be rejected to the hot water system, a modulating 3-way valve directs the water to an outdoor fluid cooler. The pumping system is a primary-secondary

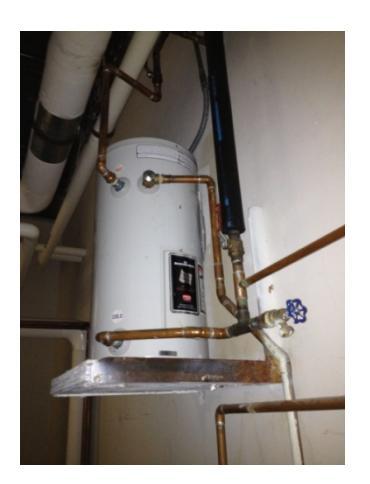
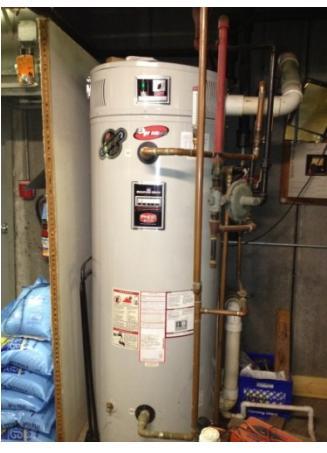
- A. Observations
 - The water heater has been recently replaced and is in excellent condition. The unit is a gas fired, high efficiency, sealed combustion unit. The unit appears to be oversized for the facility.
 - 2. A small electric water heater was installed in one of the mechanical rooms to provide hot water to adjacent toilet rooms.
 - 3. The water softener is old and only supports the hot water.

- 1. Provide continual maintenance on the water heater.
- 2. Replace the existing water softener with a new unit large enough to handle the hot and cold water demand.

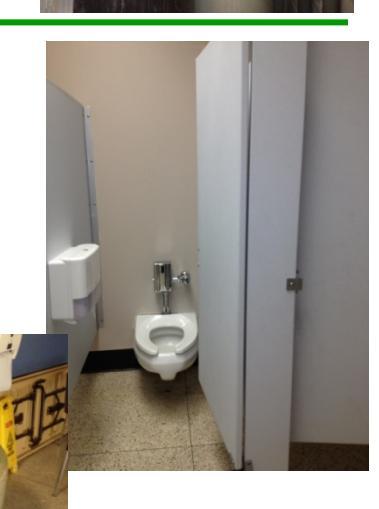
NH - 12

- 1. Plumbing fixtures located within the toilet rooms and classrooms are generally in poor condition and should be scheduled for replacement
- 2. New flush valves have been installed for the urinals and water closets. These items could be reused should the toilet rooms be upgraded.
- 3. The existing wash fountains are nearing the end of their life expectancy and are not ADA compliant.
- 4. Toilet rooms are not ADA compliant per today's standards.
- 5. The kitchen is extremely small and the kitchen sinks are in poor condition.

- 1. Plumbing fixtures should be scheduled for replacement.
- 2. Toilet rooms should be modified to be ADA compliant.

1. Plumbing fixtures and associated piping are due for replacement. Estimated cost of plumbing fixture replacement is \$2,500 per fixture.

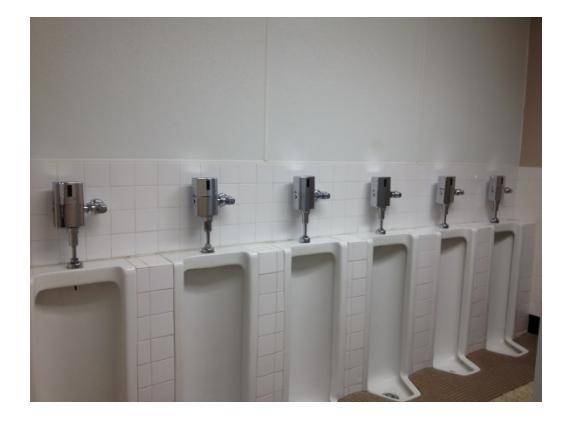
- Sanitary piping is cast-iron. The piping has failed in some areas. Old cast iron piping has been replaced with Schedule 40 PVC piping. The owner indicated that in some areas the saniatary piping drains very slow.
- 2. An interior grease interceptor has been provided for the kitchen. The grease interceptor is original to the building and does not appear to be maintained on a regular basis.

- The owner indicated problems with the existing cast iron piping. Tthe piping should be scheduled for replacement. We recommend that the interior sewers be investigated with a camera.
- 2. The grease interceptor should be continually maintained and monitored. Budget for a new grease interceptor that is adequately sized.

1. It's unknown if the grease interceptor is operational. A new grease interceptor is budgeted at \$4,000. An exterior grease interceptor, if desired, is estimated at \$15,000.

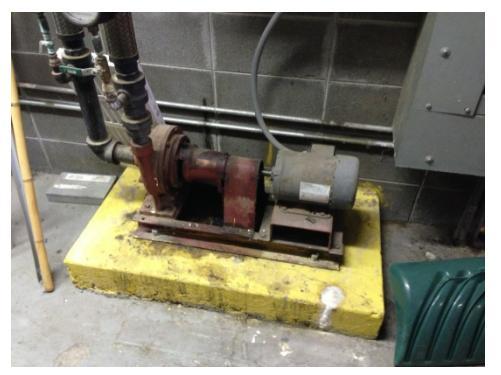
- The boilers and pumps are in marginal to poor condition and are in need of a complete replacement.
- 2. The outdoor air-cooled condensing unit serving the 1991 building is in fair condition but is near the end of its expected service life.
- 3. The indoor modular chiller is in good condition. This chiller operates on R410a refrigerant which is considered a current and environmentally-friendly product.

- 1. The hot water systems serving the building are in poor condition and are in need of replacement. Remove the existing boiler plants and replace with a single central high efficiency boiler plant with a variable flow pumping system.

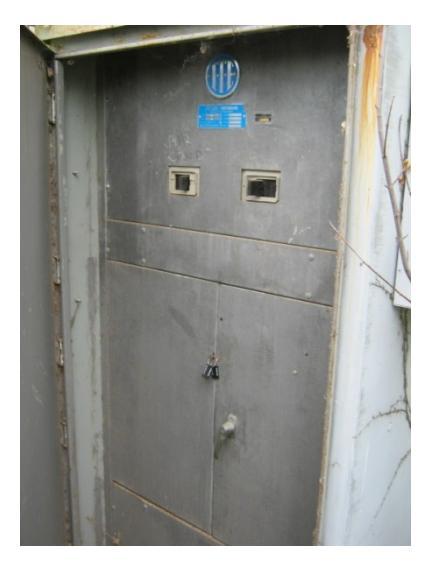
- 1. The main service switchboard does not have a surge protection device.
- 2. The main service switchboard is approaching the end of its useful life due to the operating lifespan of circuit breakers.
- 3. Bus duct disconnects to access and service above the ceiling.

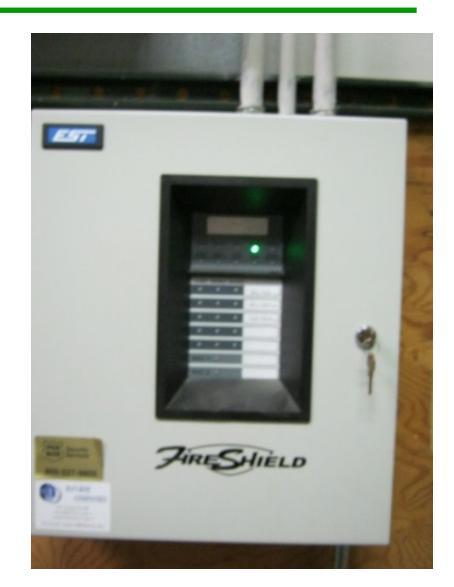
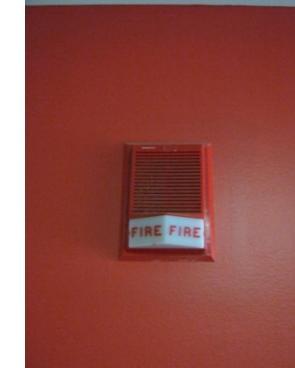
- 1. The fire alarm system is in good working order.
- 2. A few classrooms do not have horn strobe devices.

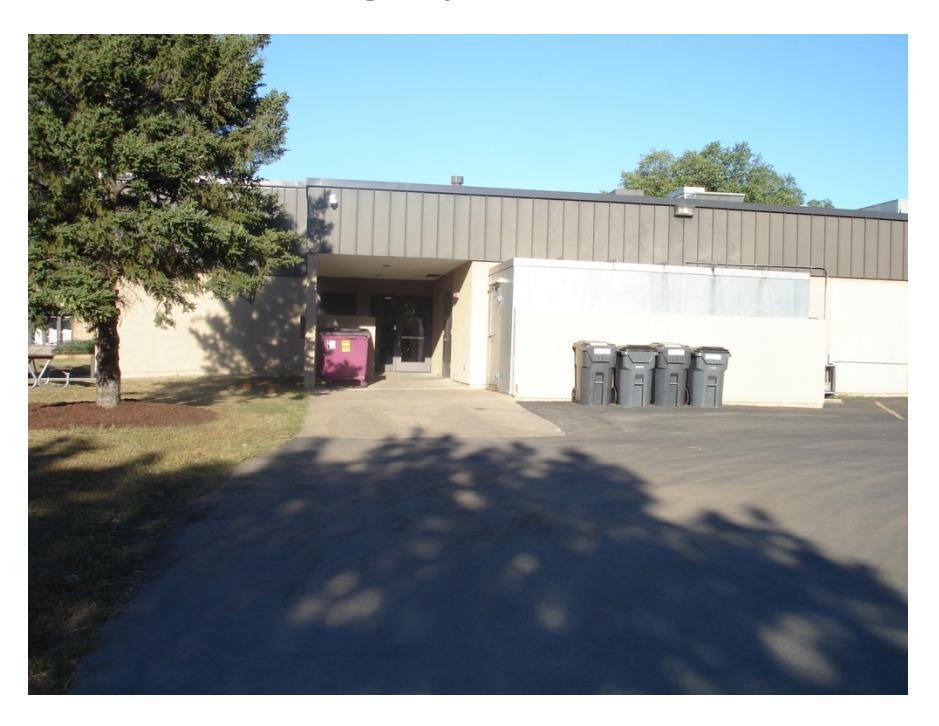
An "accessible route" is a continuous, unobstructed path leading to a building entrance from off-site (public streets) and on-site parking or walkways. The Central Kitchen site currently provides accessible routes from the dedicated staff parking lot on the east side and from the Middle School parking areas to the south of the central kitchen.

Recommended Action: No additional work is required.

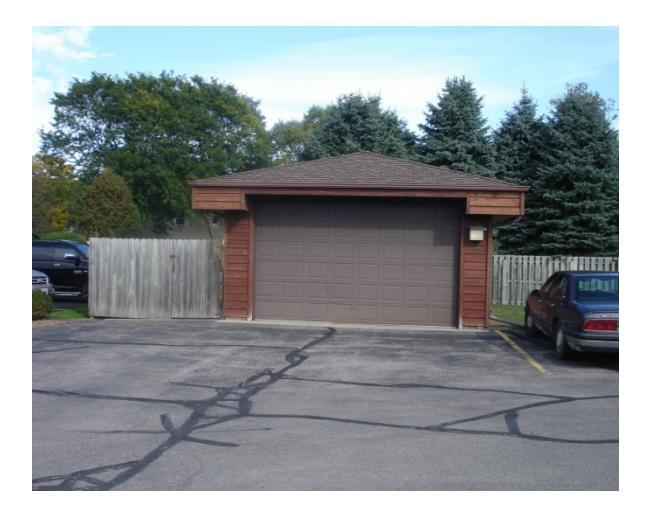
The existing 450 SF garage located off the east side of the parking lot is wood framed with wood lap siding and asphalt shingled roof. The garage primarily serves as paper storage for the Copy Center. The garage structure appears to be in satisfactory condition. The asphalt shingled roof appears to have several years of service left before any re-roofing project is scheduled. The wood lap siding is showing signs of weathering and should be receive a new weather resistant coating (paint or stain).
