Bridges Academy

1702 McLaughlin Avenue, San Jose, CA

Bridges Academy - Master Planning Evaluation

Evaluation Summary

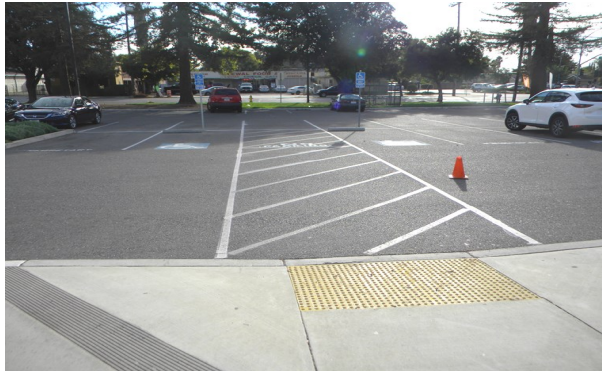
A bottle filler station should be installed in the cafeteria to meet ADA compliance.

It is recommended that the DA parking spaces be restriped and signage added.

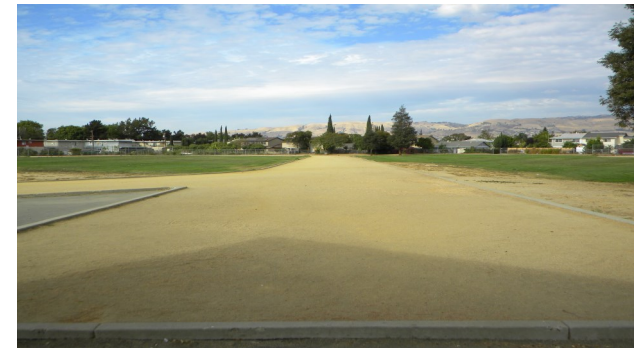
6. Landscaping and Irrigation

Planting has been upgraded throughout the last few years at the front and interior of the campus. At the rear parking lot, many trees were thinned out to increase the ability for security and ease of maintenance.

It is recommended that drainage be added at the perimeter of the larger lawn areas as this area is typically wet.

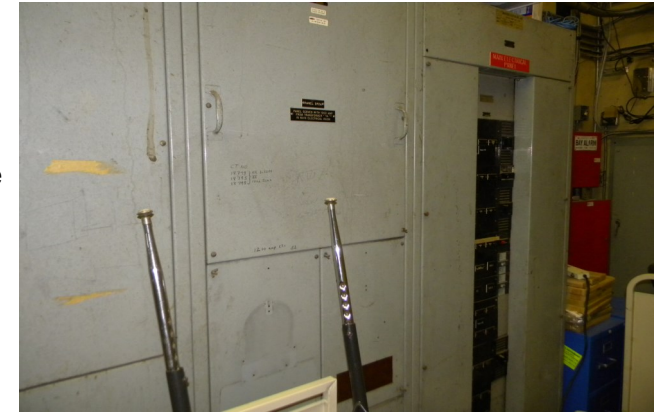
10. Main Electrical Service

This site has adequate electrical service to this site.

There is no need for additional electrical upgrades to the service.

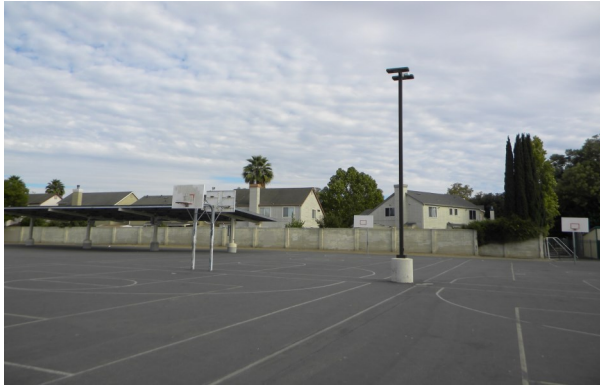
12. Site Lighting

Exterior lighting was added during the renovation to the main parking lot at the front of the

school. LED lighting was added in 2013. The new exterior LED lighting is adequate at this site.

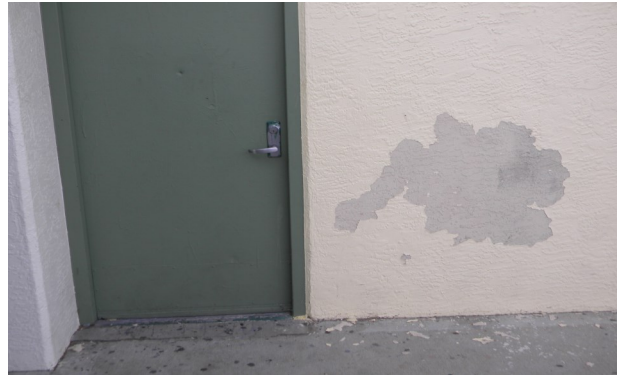
24. Building Insulation and Windows

The original campus buildings were constructed in an era when natural resources such as natural gas and electricity were inexpensive. Windows are single glazed throughout and insulation does not currently meet new construction standards. The skylights in the Gymnasium

have exceeded their intended life. The existing thickened lamination system is discolored and decaying. It is recommended that insulation be added to all exterior walls and added to all ceiling cavities. Windows should be replaced with double glazed window systems. It is recommended that the skylight system in the Gymnasium be replaced.

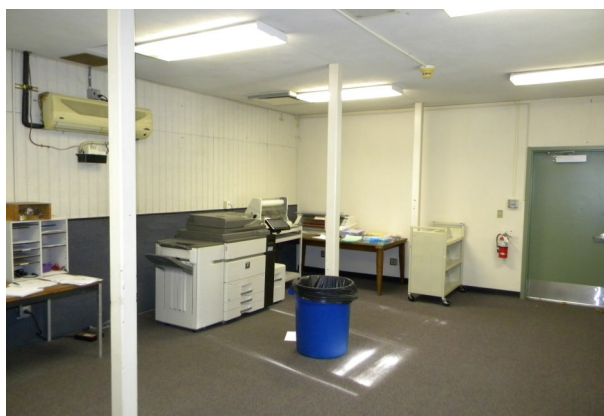
35. Electrical Power Distribution

Currently, the existing power distribution is relatively moderate in the classroom locations. Class learning is relying more on technological teaching tools. Most classroom spaces are in need of additional electrical outlets. The transformer to this site has a smaller capacity than needed.

It is recommended that additional electrical outlets be installed in walls throughout the classrooms.

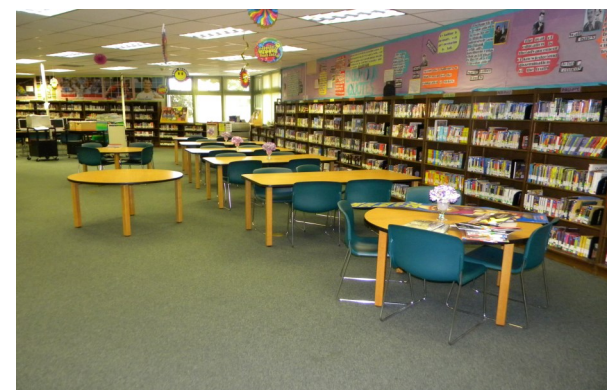
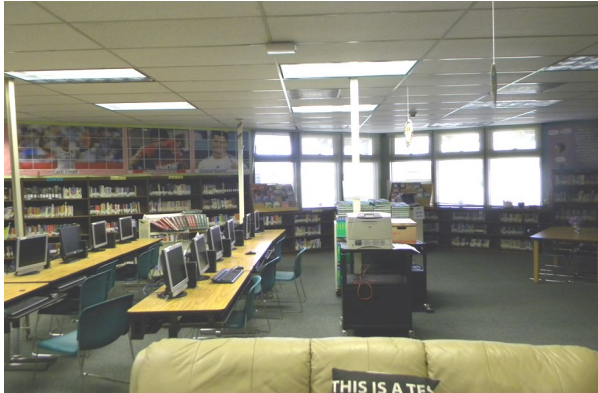
42. Library

The current Library space is adequate and meets the minimum size for the Franklin-McKinley School District. The computer lab is shared with the library space. The use of computer labs and library spaces for school func-

tions have changed. Library space is now a more social learning space and computer labs are not a function of a classroom space.

It is recommended that the computer lab be dis-

persed and blended into a new student social center whereas laptops be incorporated into the space. Book storage should be rearranged to be housed along the perimeter of the existing space whereas the old library becomes transformed to become a more desirable open space with clusters of seating spaces more conducive of the “new” library.

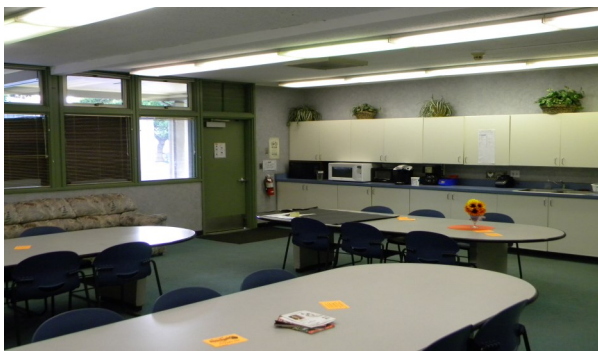
43. Work Room/Lounge

The current work room and lounge need to be

modernized.

It is recommended that the existing administration support spaces be renovated and altered to meet the District current needs at this site.

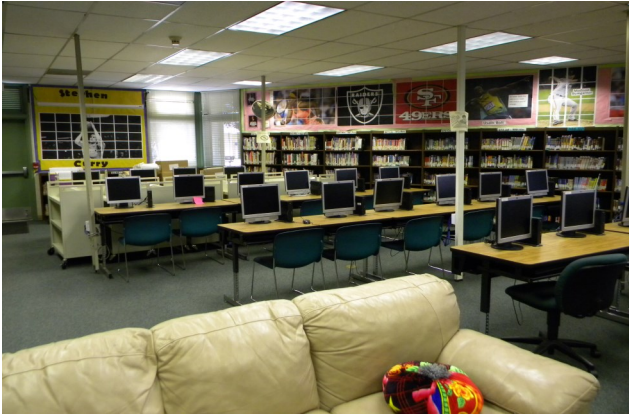
48. Computer Lab

There is a computer lab set up in the existing media center/library space. There is an additional computer lab in room B6 that is not used

as it was originally intended as technology and teaching has changed over time.

It is recommended that the computer lab in room B6 be converted to an teaching space conducive of what is needed to meet educational specifications.

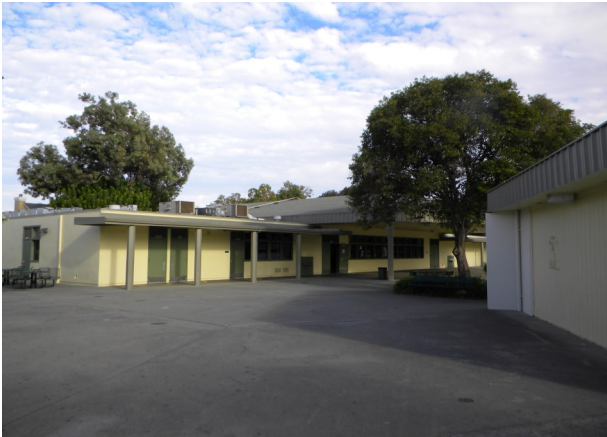
56. Covered Eating Structure or Outdoor learning

The only existing covered area is adjacent to the cafeteria. The existing space adjacent to the cafeteria could incorporate outdoor learning. It would be desirable to have another large covered structure to provide additional outdoor eating and learning.

It is recommended that a new large outdoor covered structure be added to this campus to allow for additional outdoor eating and learning. It would be desirable to add permanent outdoor furnishings that would allow for outdoor learning under the new covered structure.
