Dahl Elementary School

3200 Water Street, San Jose, CA 95111

Captain Jason M. Dahl Elementary - Master Planning Evaluation

Evaluation Summary

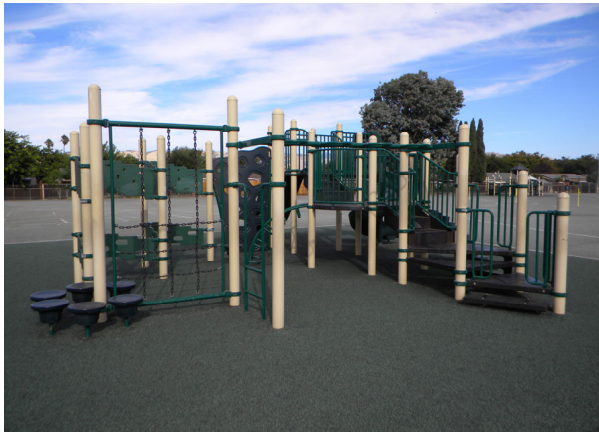
3. Play Equipment

This campus's play structures are in fairly good condition. The upper and lower play apparatus do not have shade structures. The kindergarten play structure has a shade structure.

It is anticipated that new fall protection matting and play equipment will need to be replaced in the next seven years. It would be desirable to add shade structures at the play apparatus at the time of future replacement.

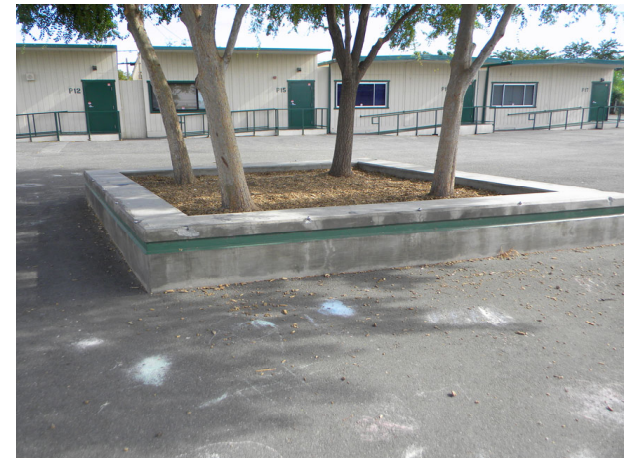
6. Landscaping and Irrigation

Planting has been upgraded throughout the years at this site. There is a significant amount of ivy growing over the neighbors fence and has become an ongoing maintenance issue. It is recommended that the ivy on the neighbors fence line be completely removed.

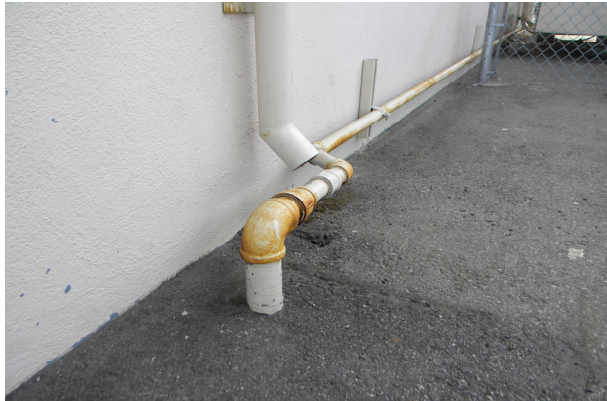
9. Site Utilities

Underground utilities supplying gas and water to the site are over were upgraded during the last large modernization. There are no known reoccurring issues at this site.

There is no known reason to replace any underground utilities at this time.

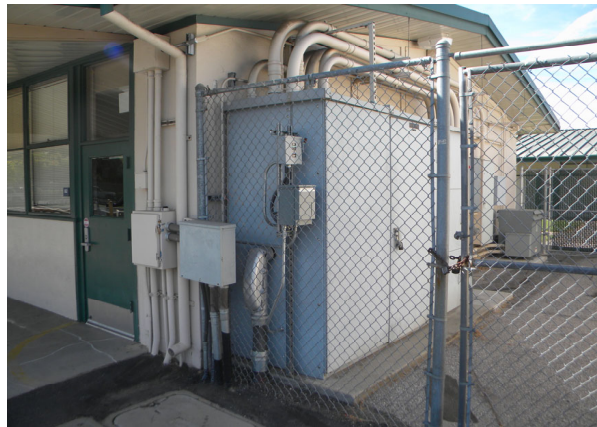
10. Main Electrical Service

This site has adequate electrical service to this site.

There is no need for additional electrical upgrades to the service.

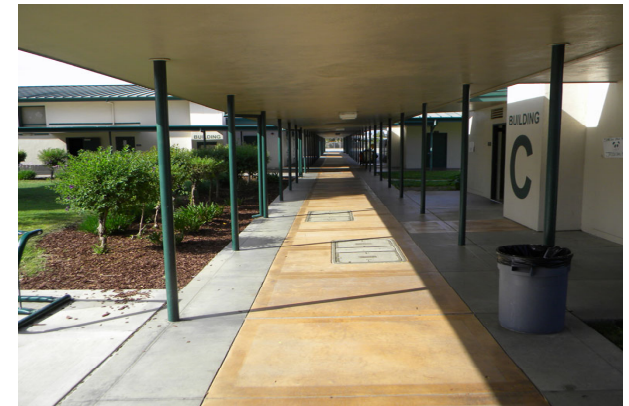
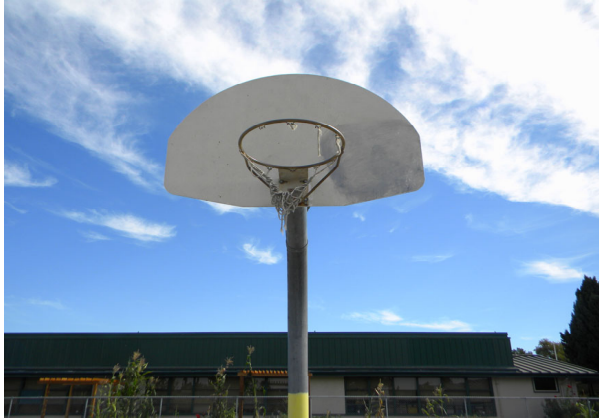
14. Basketball Backstops/Ball Walls/ Misc. Play Apparatus

The existing basketball backstops are in good condition. There currently is no walking track at this site which is highly desired.

There is no need to upgrade or replace the existing play apparatus at this time. The site is in need of a new DG walking track at the grass field area. (Refer to Section 5).

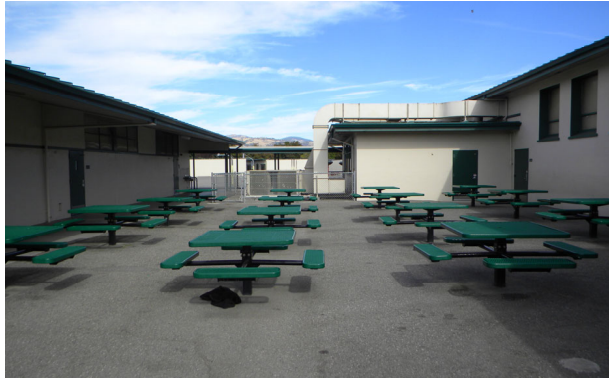
17. Existing Covered Eating Structure

This campus is lacking a covered outdoor eating structure.

It would be desirable to add new metal shade structure over the existing outdoor seating area adjacent to the cafeteria.

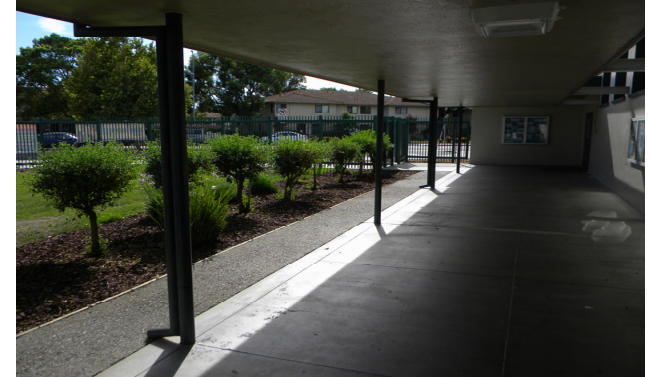
19. Electrical Wiring

The electrical wiring was upgraded during the full modernization. There are no known electrical issues at this campus.

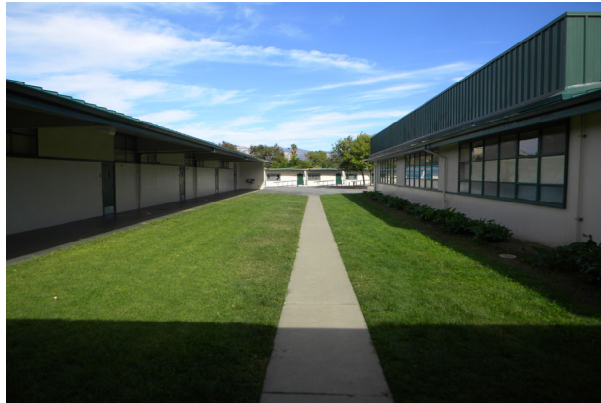
24. Building Insulation and Windows

The original campus buildings were constructed in an era when natural resources such as natural gas and electricity were inexpensive. Windows are single glazed throughout. Ceiling and wall insulation was

replaced during the modernization in 2010. It is recommended that windows be replaced with double glazed window systems.

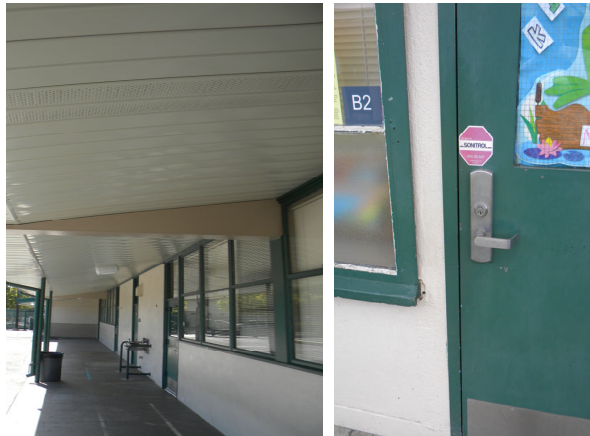
25. Exterior Doors and Hardware

This campus was renovated in 2009/2010 where all of the hardware was replaced with what was the District standard at the time. The hardware is in good condition and does not need to be upgraded at this time.

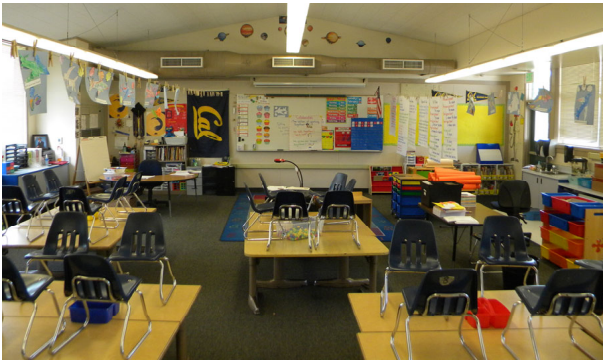
30. Ceilings

All ceilings were upgraded during the 2009/2010 modernization. There is no need for upgrades to ceilings at this time.

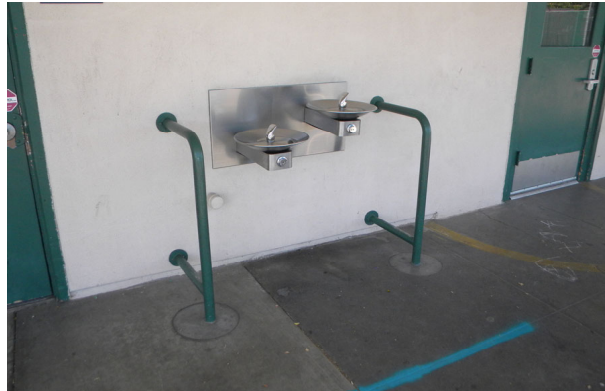
32. Drinking Fountains

Exterior drinking fountains have been upgraded or replaced to meet ADA requirements. The latest District standard is to incorporate bottle fillers in the drinking foundation locations.

It is recommended that a bottle filler drinking system be installed in the cafeteria and at one of the main exterior drinking fountain locations.

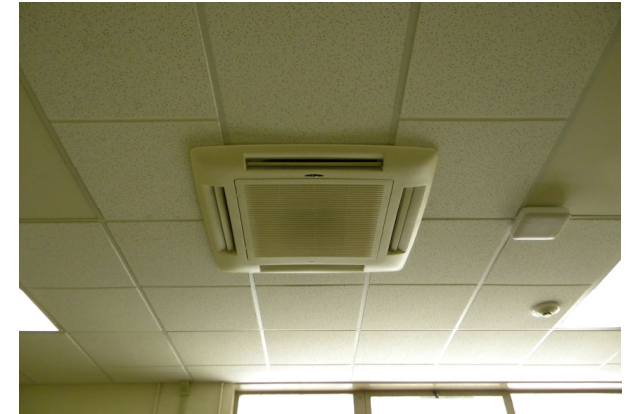
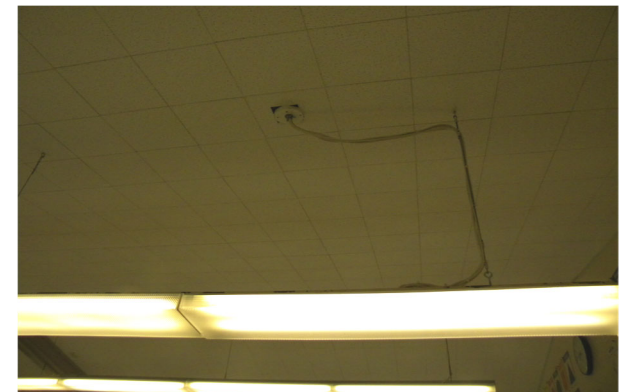
34. Interior Lighting

The current interior lighting adequately performs and meets the minimum requirements expected as they were replaced in the 2009/2010 modernization. Unfortunately the lighting in the classrooms are on programmable ballasts which was set on a proprietary programmable system which is no longer available for programming by the District.

It is recommended that the programmable

ballasts be upgraded to a non-proprietary system.

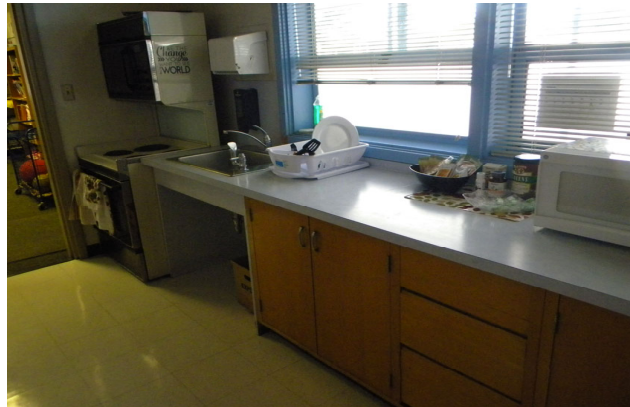
44. Cafeteria/Kitchen/Gymnasium/ Music/ Weight Room

The existing Kitchen and cafeteria is in satisfactory condition. The kitchen is in need of a new refrigeration and freezer unit.

It is recommended that the refrigerator and freezer units be replaced.

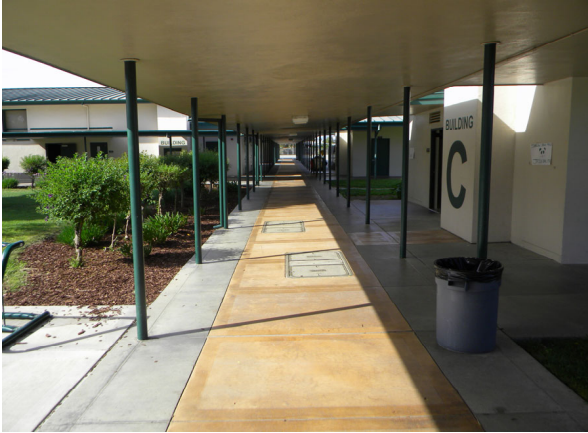
51. Covered Walkways

The site has several area where students can travel from some classrooms to other

classrooms without getting wet from inclement weather. The existing portable cluster of classrooms does not have covered walkways between the main campus and the portable cluster.

It is recommended that new covered walkways be added connecting the isolated portable cluster of new classroom wing as described in other sections.

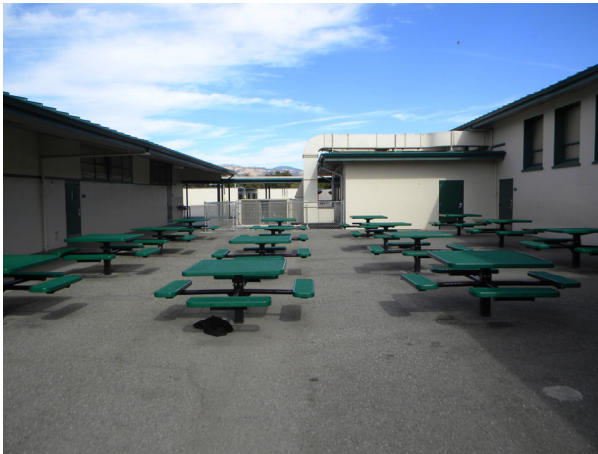
56. Covered Eating Structure or Outdoor learning

The only existing covered area is adjacent to the kindergarten. The location of the photovoltaic structures are not located allowing these to function as outdoor learning nor

It is recommended that the existing outdoor eating area be modified with new permanent outdoor rated furnishings suited for outdoor learning and eating. It would be desirable to equip the new covered learning area with wi-fi as well.

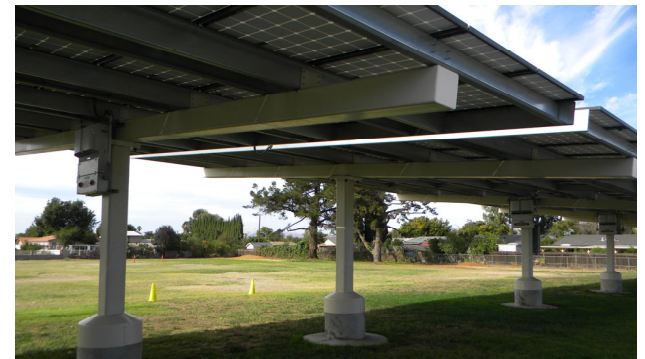
59. Alternative Energy Source

This campus was retrofitted to house new photovoltaic structures in 2014. The FMUSD will continue to look into alternative energy sources.
