# Lairon College Preparatory

3975 Mira Loma Way, San Jose, CA

## Lairon College Preparatory Academy - Master Planning Evaluation

### Evaluation Summary

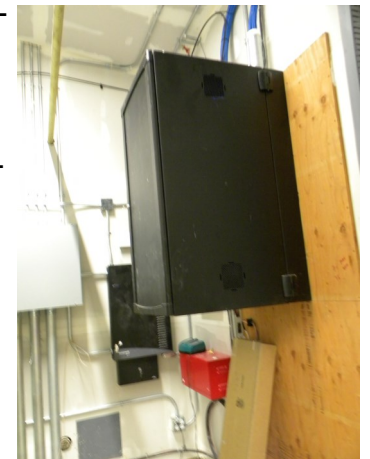
### **39. Fire Alarm**

The existing fire alarm system for the entire campus was replaced during the 2019 modernization.

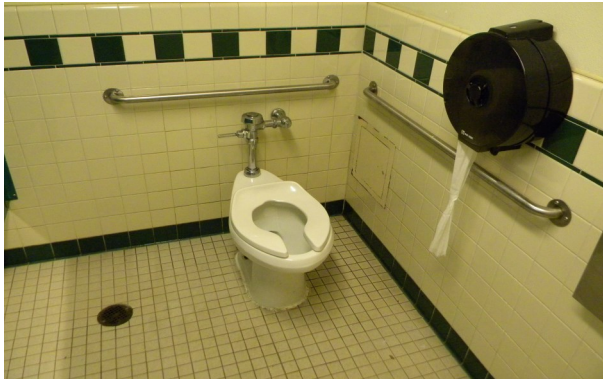
There appears to be an adequate number of restrooms at this campus located in relatively ideal locations.

There is no need to add restrooms facilities at this campus.

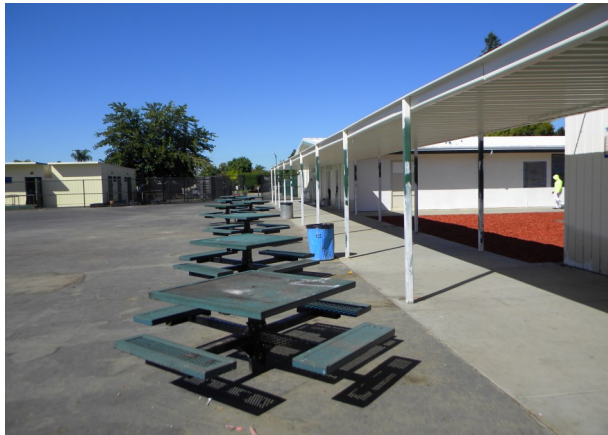
This site does not have an outdoor eating area or outdoor learning space.

It is recommended that a new covered shade structure be installed adjacent to the cafeteria that can be used as an outdoor eating area and double up as an outdoor learning area.
