Franklin Elementary School

420 Tully Road, San Jose, CA 95111

Franklin Elementary School - Master Planning Evaluation

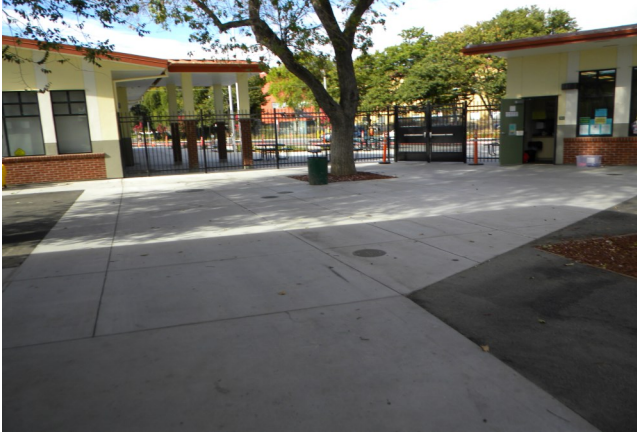
The existing bus drop off area is original and there were not enough funds in the original modernization budget to address the flow of busses and the automobile flow of traffic.

It is recommended that the bus drop off area be redesigned to work better with the new parking lot. The rear overflow parking area should be paved.

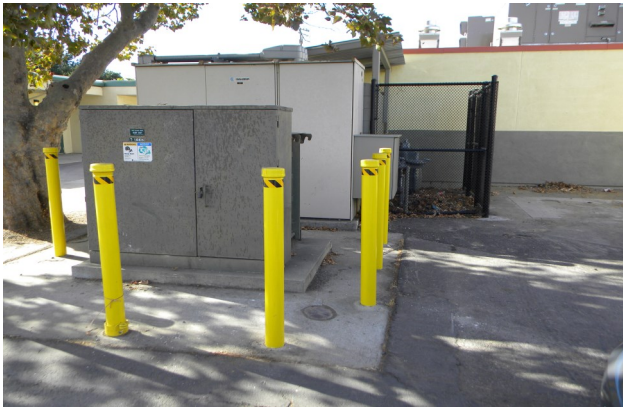
10. Main Electrical Service

This site has adequate electrical service to this site.

There is no need for additional electrical upgrades to the service.

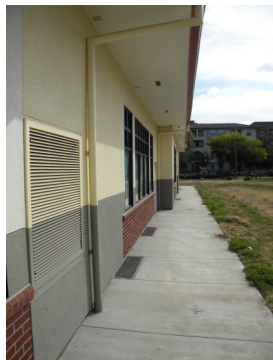
12. Site Lighting

Exterior lighting was added during the renovation

that meets the needs of the user and district standards.

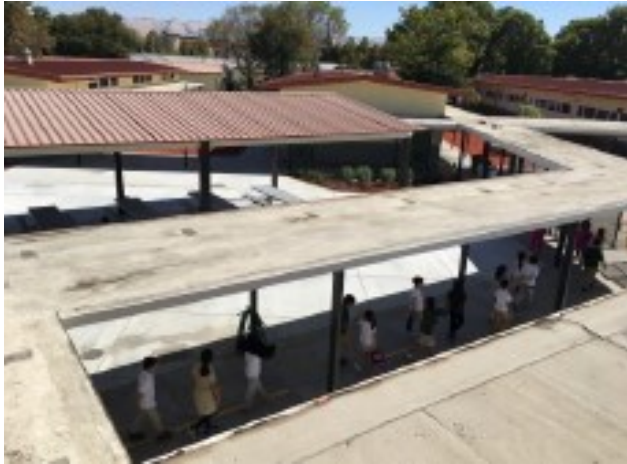
22. Roofing

The entire campus was re-roofed with standing seam metal roofing which is anticipated to last for up to and over fifty years with minimal maintenance. The walkways were reroofed with built up roofing. Based on the roofing report, it is recommended that the covered walkways received ongoing standard maintenance including curb flashing and membrane inspections. Areas receiving foot traffic and excessive water such as metal roofing valleys will need attention in the future. The report recommends money be set aside for minor yearly upgrades and maintenance.

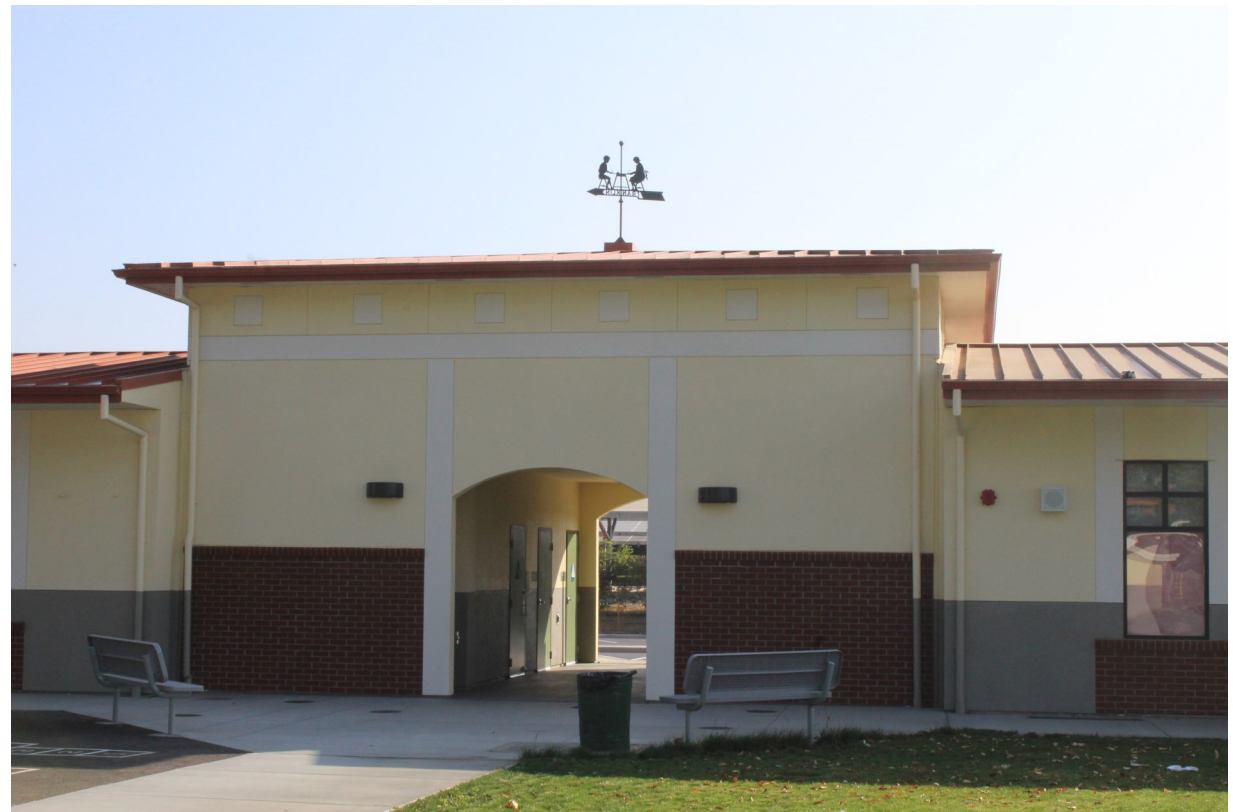
This campus was modernized without a budget to install a photovoltaic system. There is no photovoltaic system at this site.

It is recommended that a large photovoltaic system be constructed at this site over the parking lot area. The District has been exploring battery backup to be included as part of the PV installation.
