Hellyer Elementary School

725 Hellyer Avenue, San Jose, CA 95111

Hellyer Elementary School - Master Planning Evaluation

Evaluation Summary

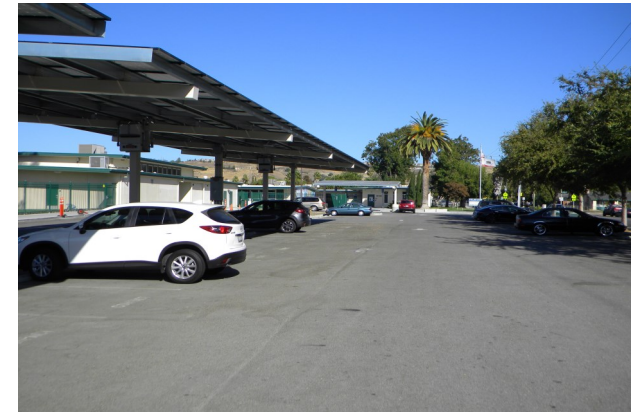
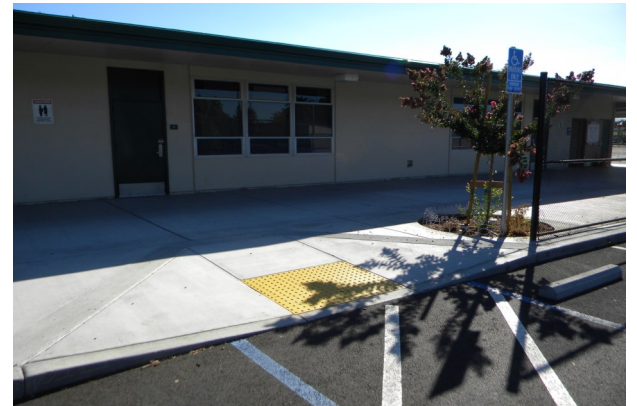
2. Site ADA Compliance

Hellyer school have been modernized through several project in the last five years. Most of the known ADA issues have been eliminated or up-

graded. There is no known ADA issues at this campus at this time.

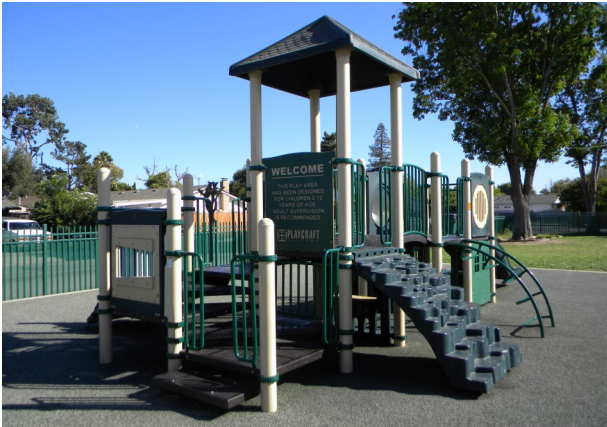
3. Play Equipment

The existing play equipment is in good condition. There is no need for upgrades to the existing play equipment at this time.

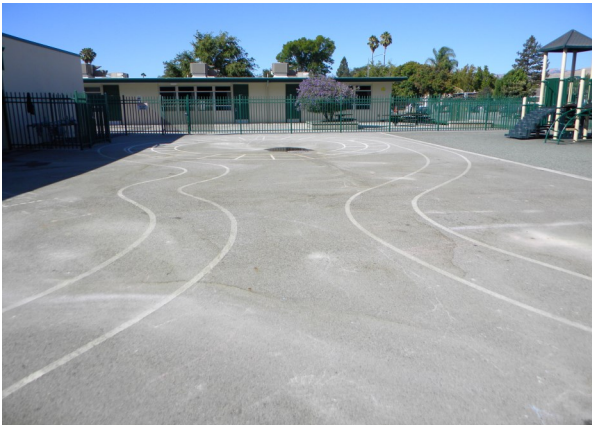
4. Paved Play Area

Hellyer's existing paved play area is in fair condition.

There is no need for repair to the black top at this time.

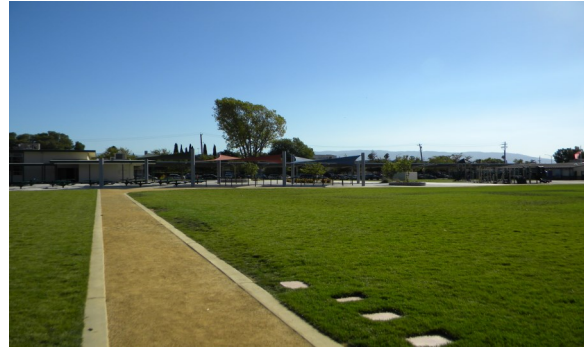
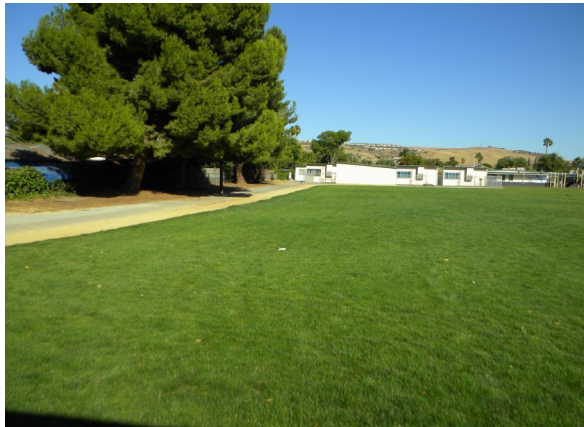
5. Turf Play Area and Synthetic Track

In the summer of 2017, turf areas were re-graded and re-planted with new lawn and irrigation was re-engineered for better coverage. A new walking track was installed around the perimeter of the grass turf area.

There is no need for upgrades to the turf play area of the synthetic track.

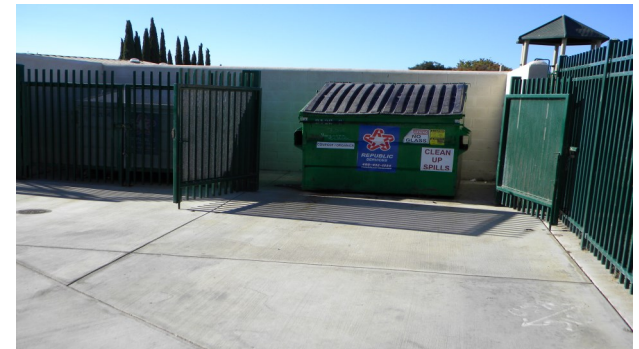
8. Trash Enclosure

The existing trash enclosure is in good condition. There is no need for improvements at this time.

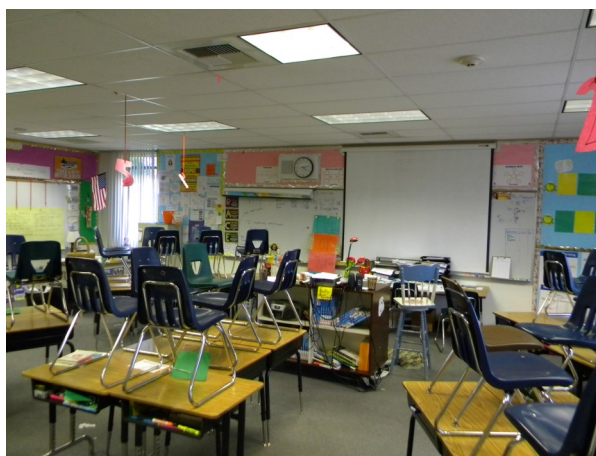
34. Interior Lighting

The current interior lighting adequately performs and meets the minimum requirements

expected.

There is no need for changes to the interior lighting system.

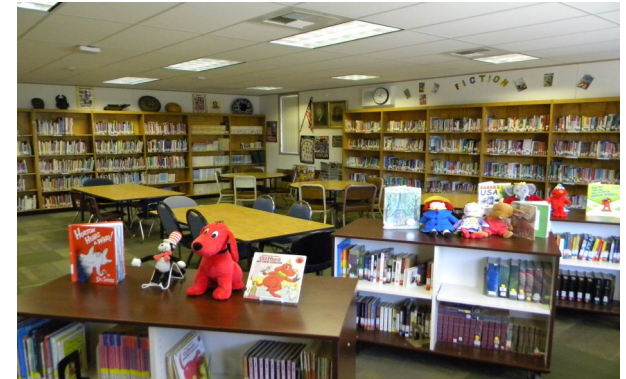
The current Library space is adequate and meets the minimum size for the Franklin-McKinley School District. Library space is now a more social learning space and computer labs are not a function of a classroom space.

It is recommended that book storage should be rearranged to be housed along the perimeter of the existing space whereas the library be transformed to become a more desirable open space

with clusters of seating spaces more conducive of the "new" library.

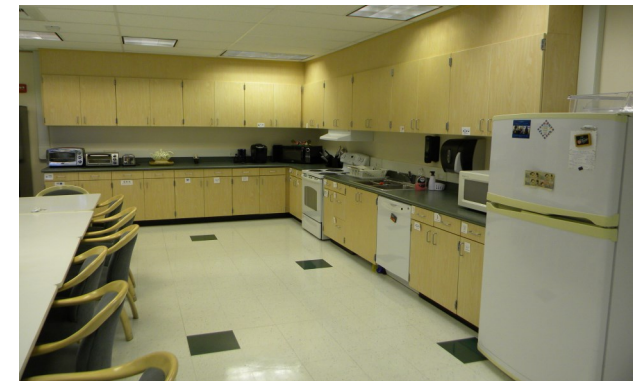
43. Work Room/Lounge

The current work room and lounge are in good condition and do not need upgrades at this time.

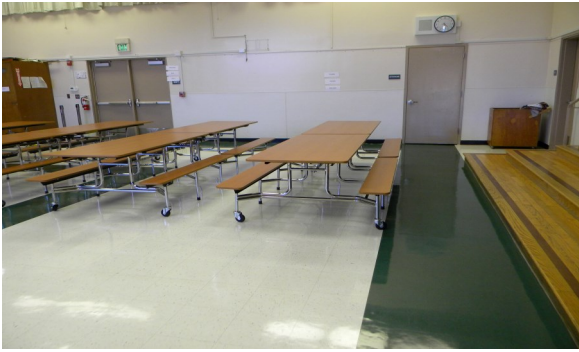
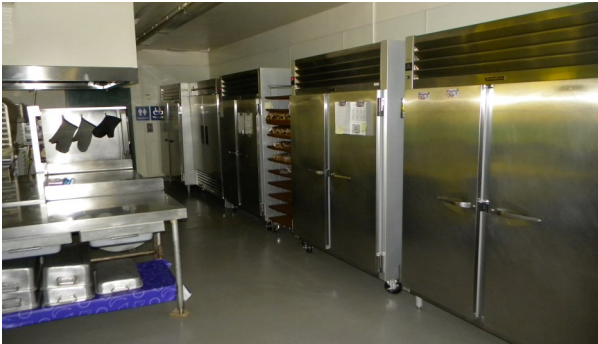
44. Cafeteria/Kitchen/Gymnasium/Music/Weight Room

The cafeteria and kitchen are in good condition. There are no upgrades needed at this time. (Refer to Section 32).

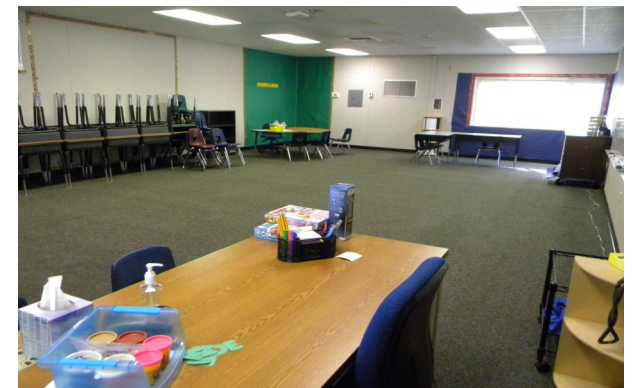
53. Portable or Modular Classrooms

There are a sufficient number of classrooms serving this campus. There is a doublewide portable classroom that is smaller than District standards would allow.

There is no need for additional portable classrooms at this time. (Refer to Section 41 and 60).
